Hiland Crude, LLC

2.9-mile Crude Oil Pipeline – Williams County

Case No. PU-21-353

As-Built Construction Inspection Report

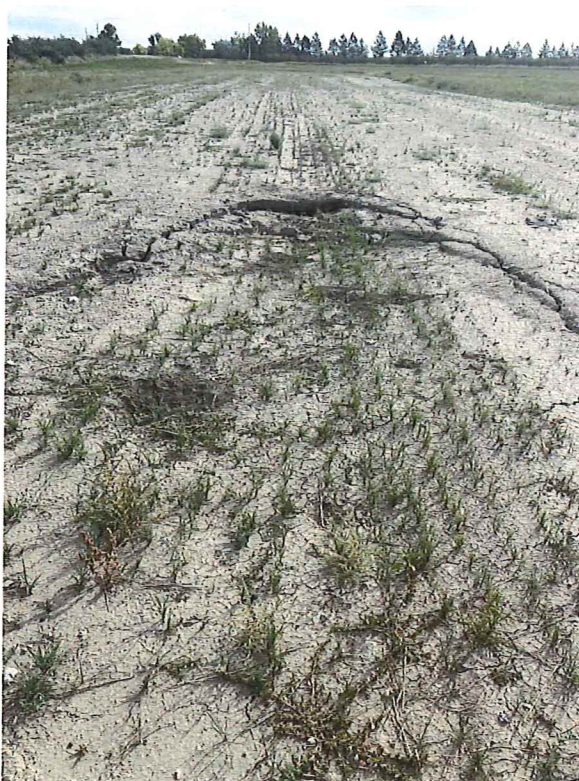
Photo 32

A majority of this pipeline has crossed over privately owned crop land and from observations taken, much of this land has been reclaimed and is covered in vegetation. However, some of the crop land does have some sinking along the trench line that needs attention, along with a large sink hole pictured in photos 32-33.

- Photos 32-34 - Large sink hole and soil cracking along buried pipeline. This area needs to be re-graded and seeded.
- Photos 48-50 - Water runoff has created an erosion channel along the buried pipeline and caused some sinking. This area needs re-graded and seeded.
- Photos 53-54 - Sinking along buried pipeline. This area needs re-graded and seeded.
- Photo 57 - Sinking area along buried pipeline. This area needs re-graded and seeded.
- Photos 55-59 - Needing more vegetative cover to prevent erosion issues. This area needs re-seeded.

Notes: Sunken Trench

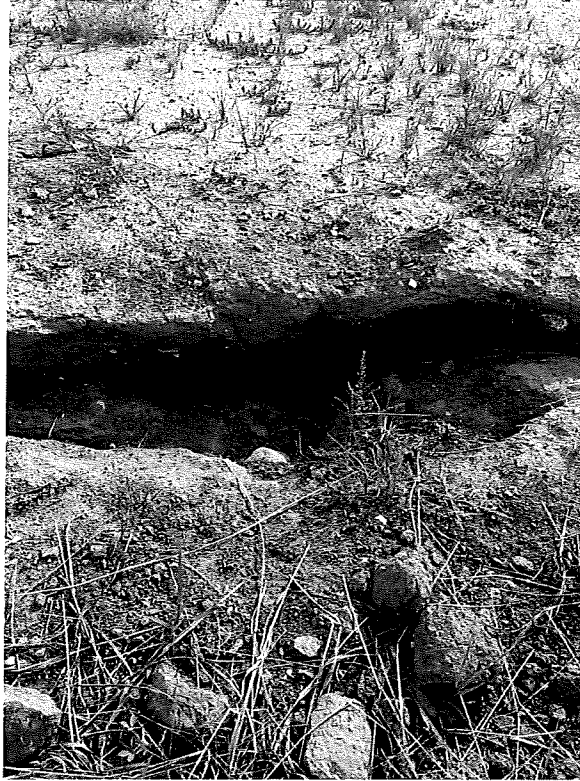
Photo 33

Notes: Sunken Trench

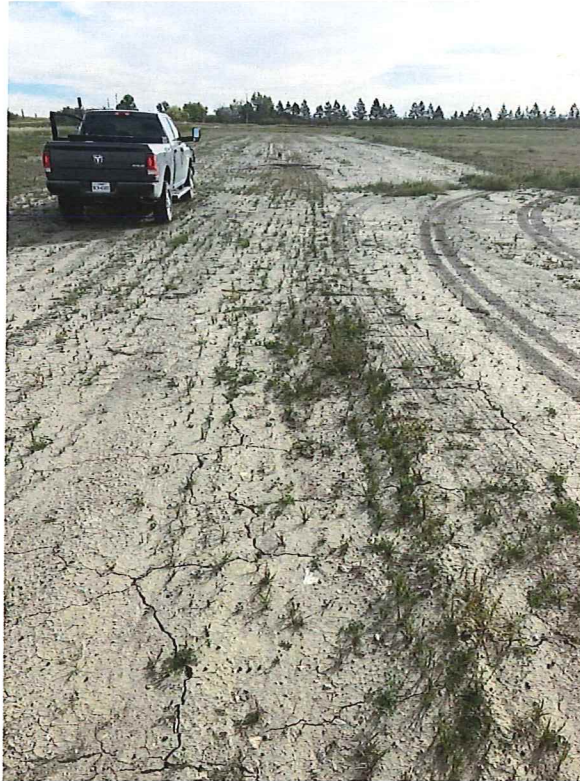
Photo 34

Notes: Cracking along trench line

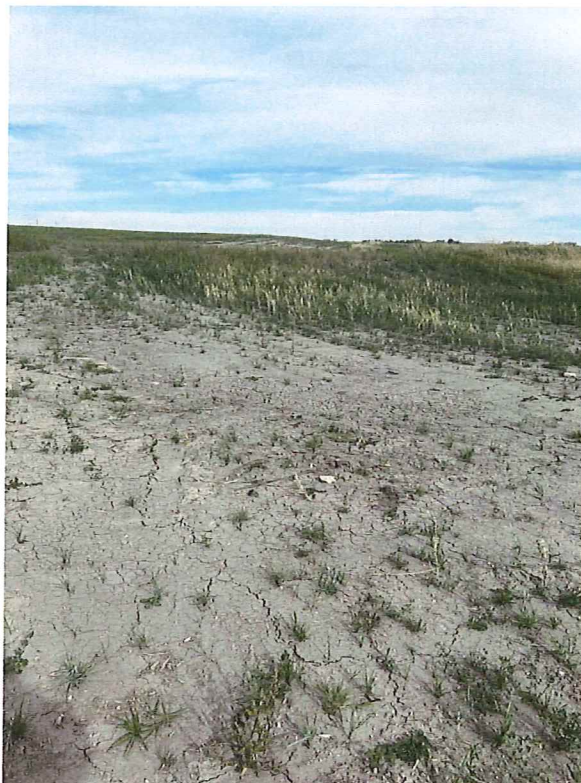
Photo 36

Notes: Some soil cracking

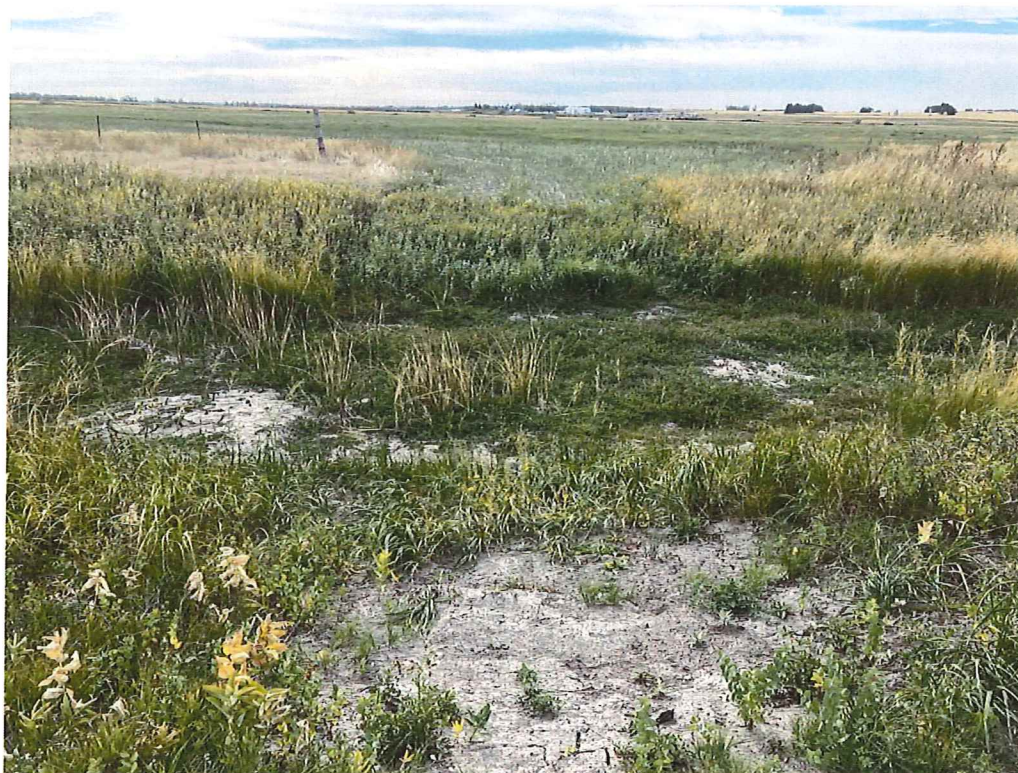
Photo 37

Notes: Creek is dry, no noticeable erosion issues

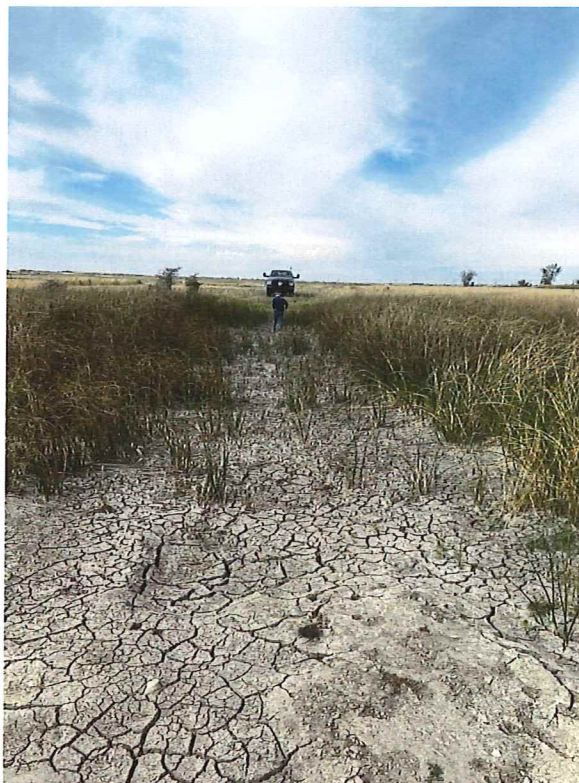
Photo 42

Notes: Floating bridge was used here, no noticeable environmental concerns

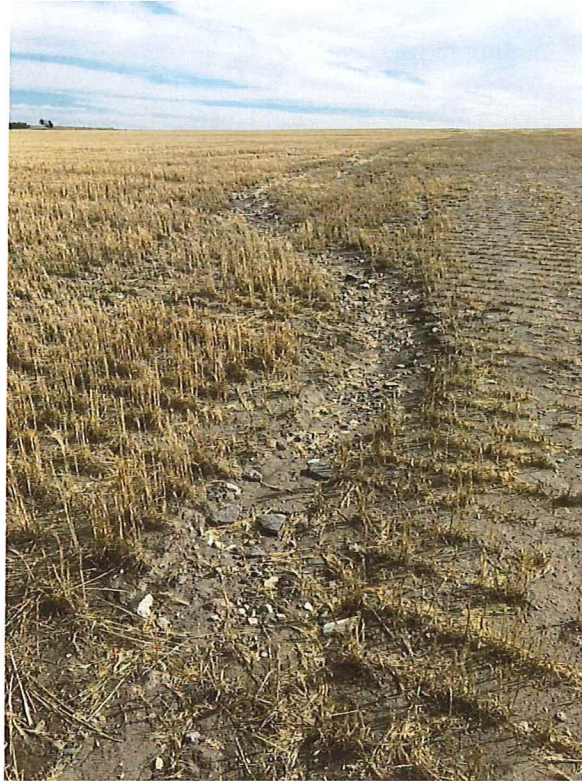
Photo 48

Notes: Water drainage

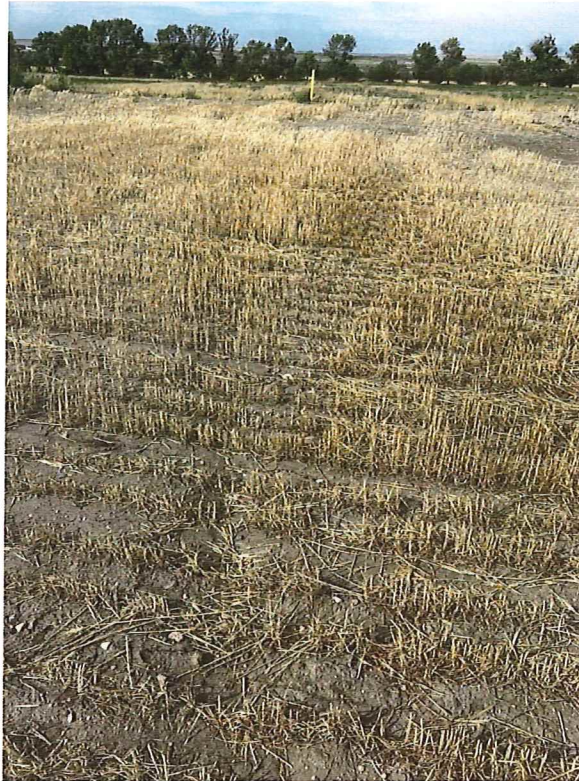
Photo 49

Notes: Slight sinkage on trench line

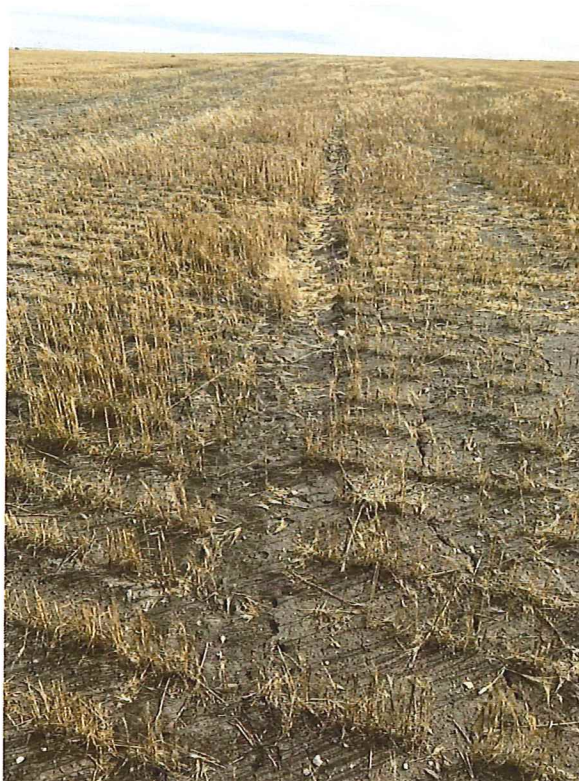
Photo 50

Notes: Trench Line Sinkage

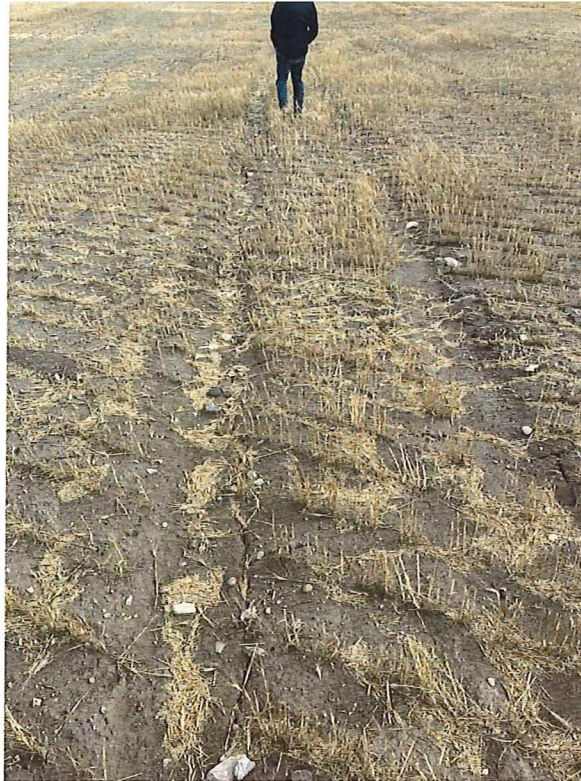
Photo 53

Notes: Sunken trench line, water way

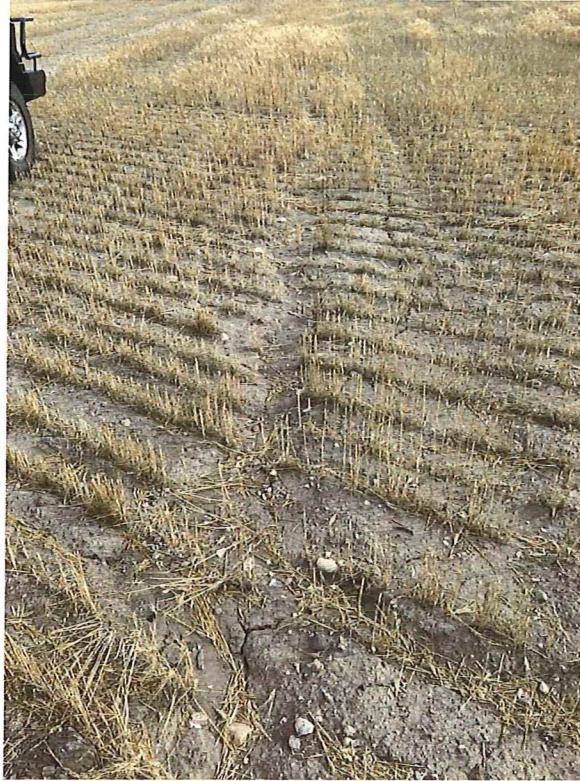
Photo 54

Notes: Sunken trench line

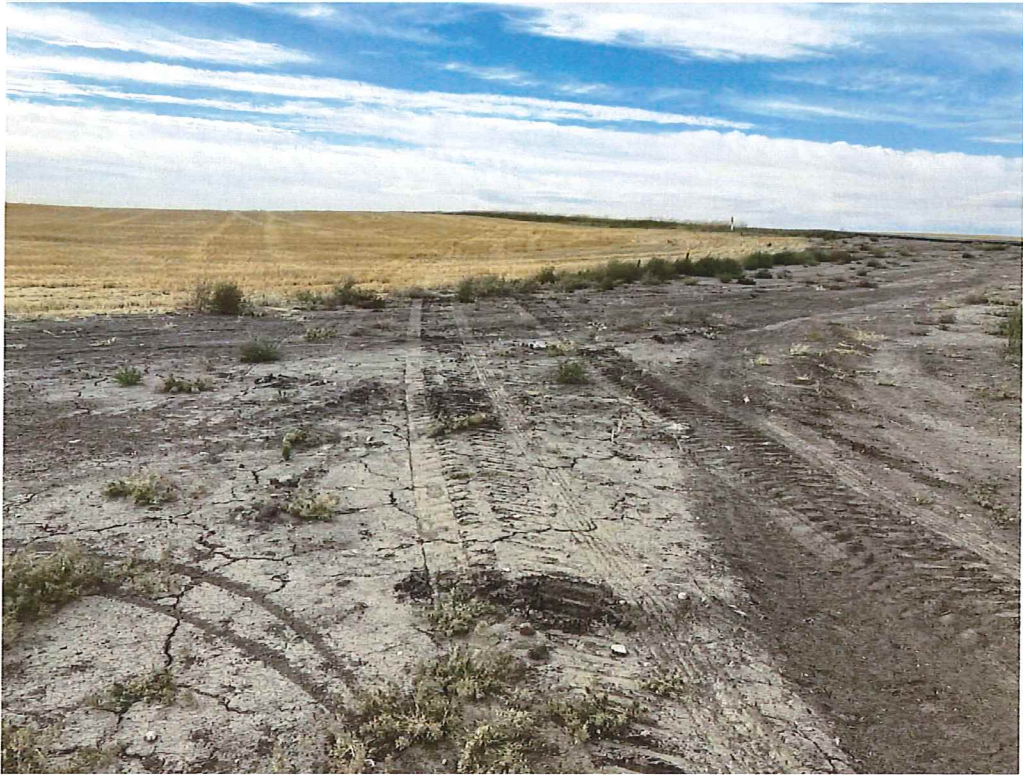
Photo 55

Notes: No issues

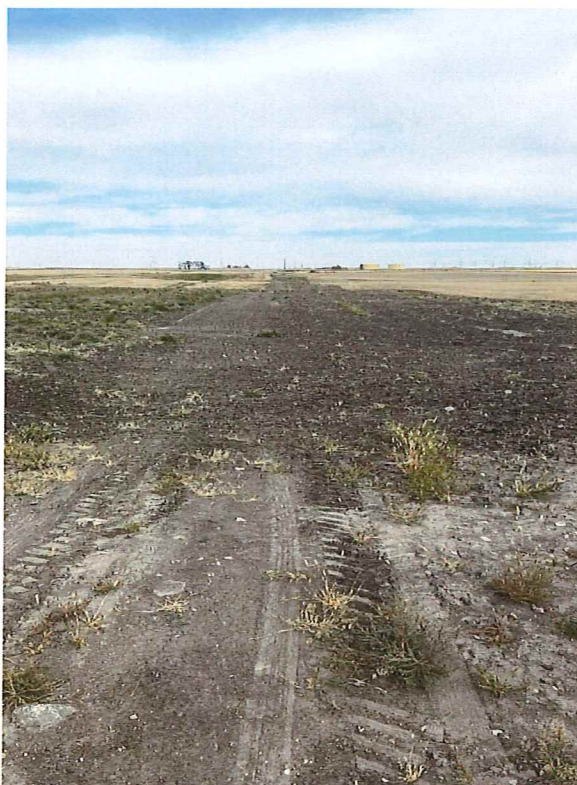
Photo 56

Notes: No issues

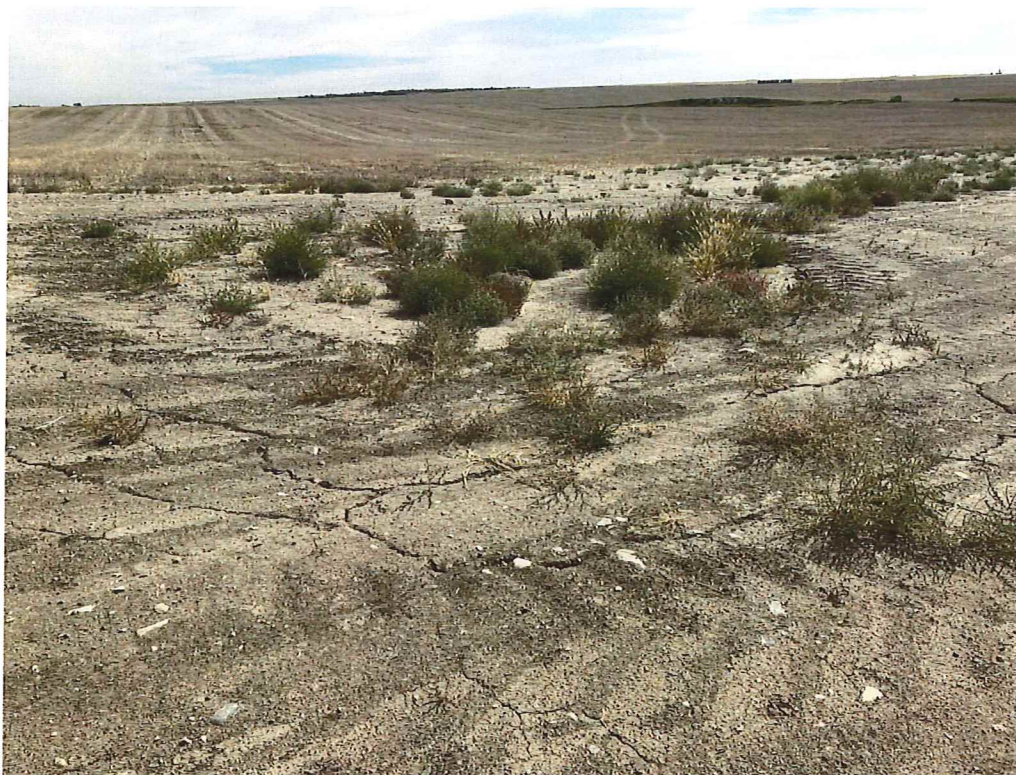
Photo 57

Notes: Sunk spot

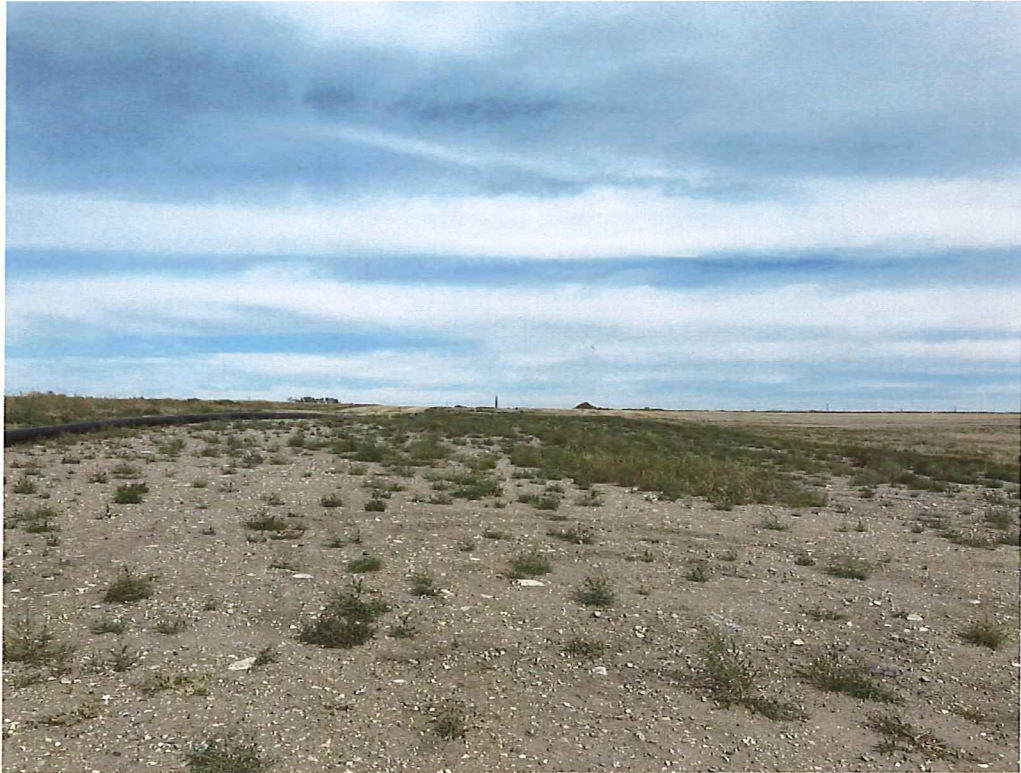
Photo 58

Notes: No issues

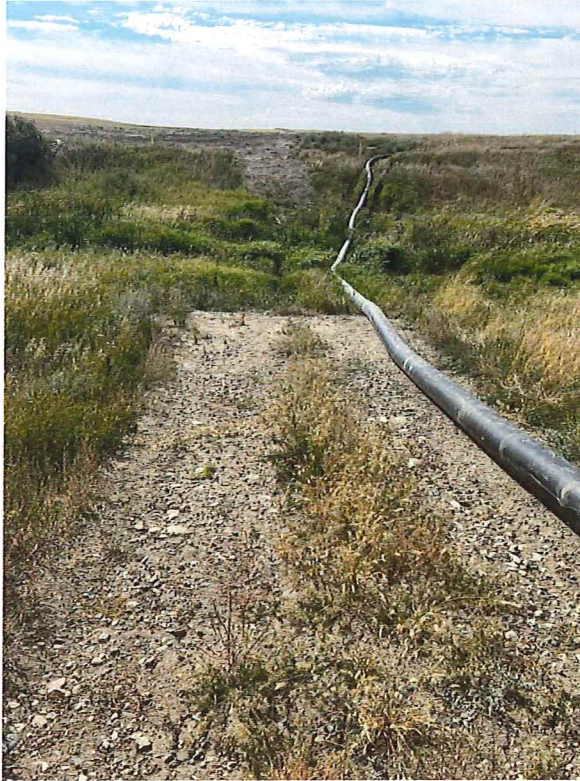
Photo 59

Notes: No issues
