Hiland Crude LLC

2.9-mile Crude Oil Pipeline— Williams County

Case No. PU-21-353

Reclamation and Revegetation Inspection Report

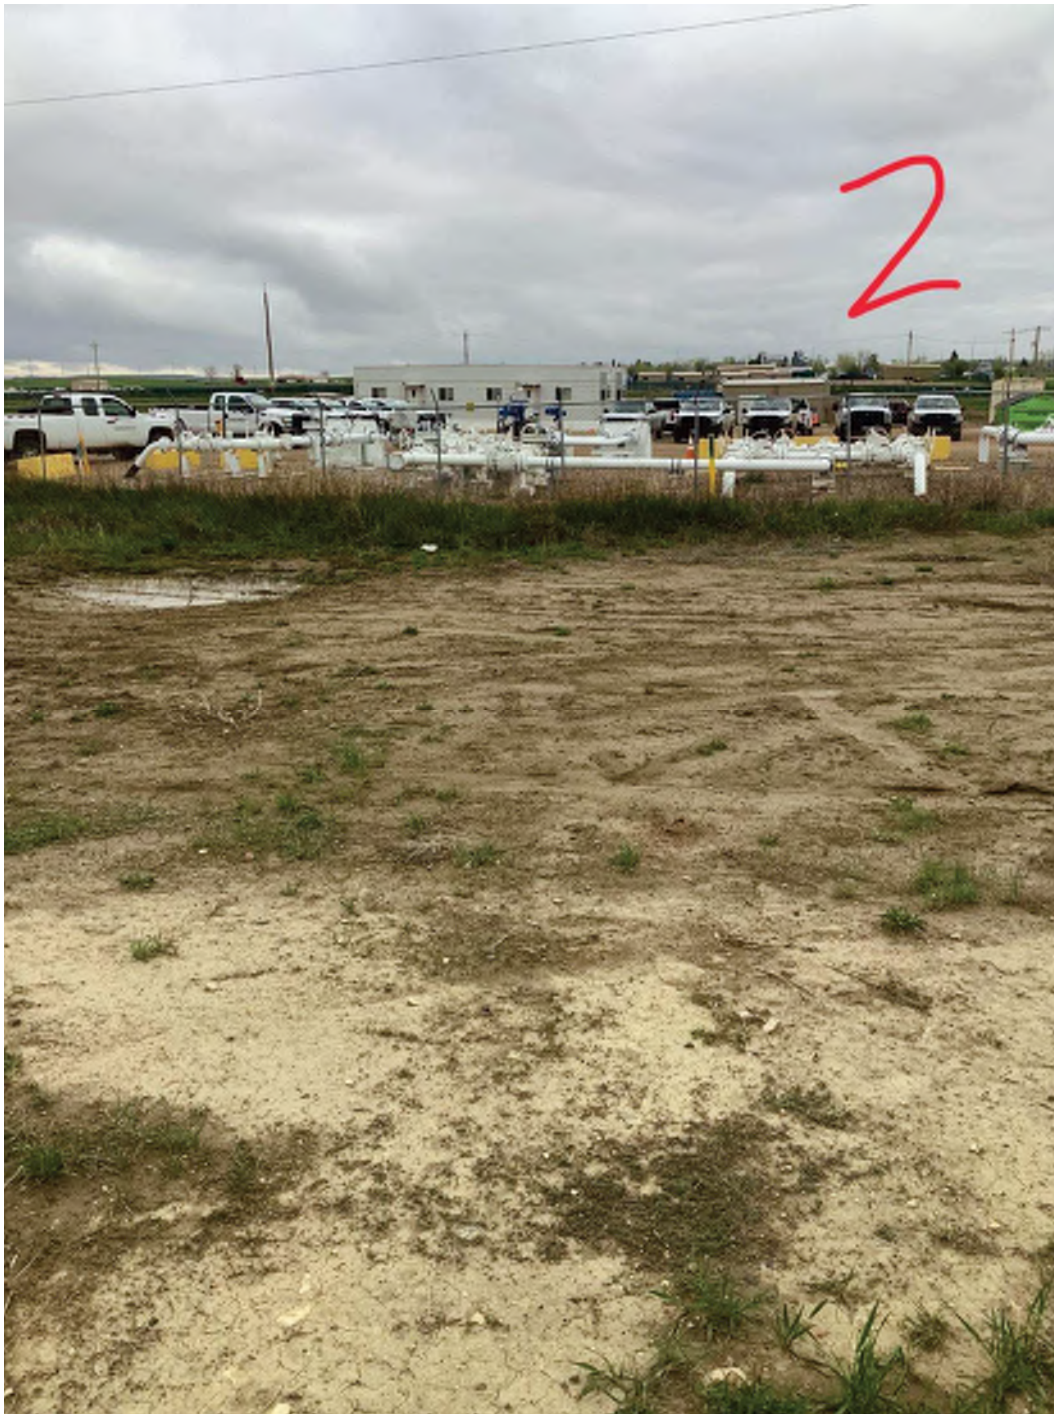
P2: Looking North at terminal. Area is still actively being used as an access world.

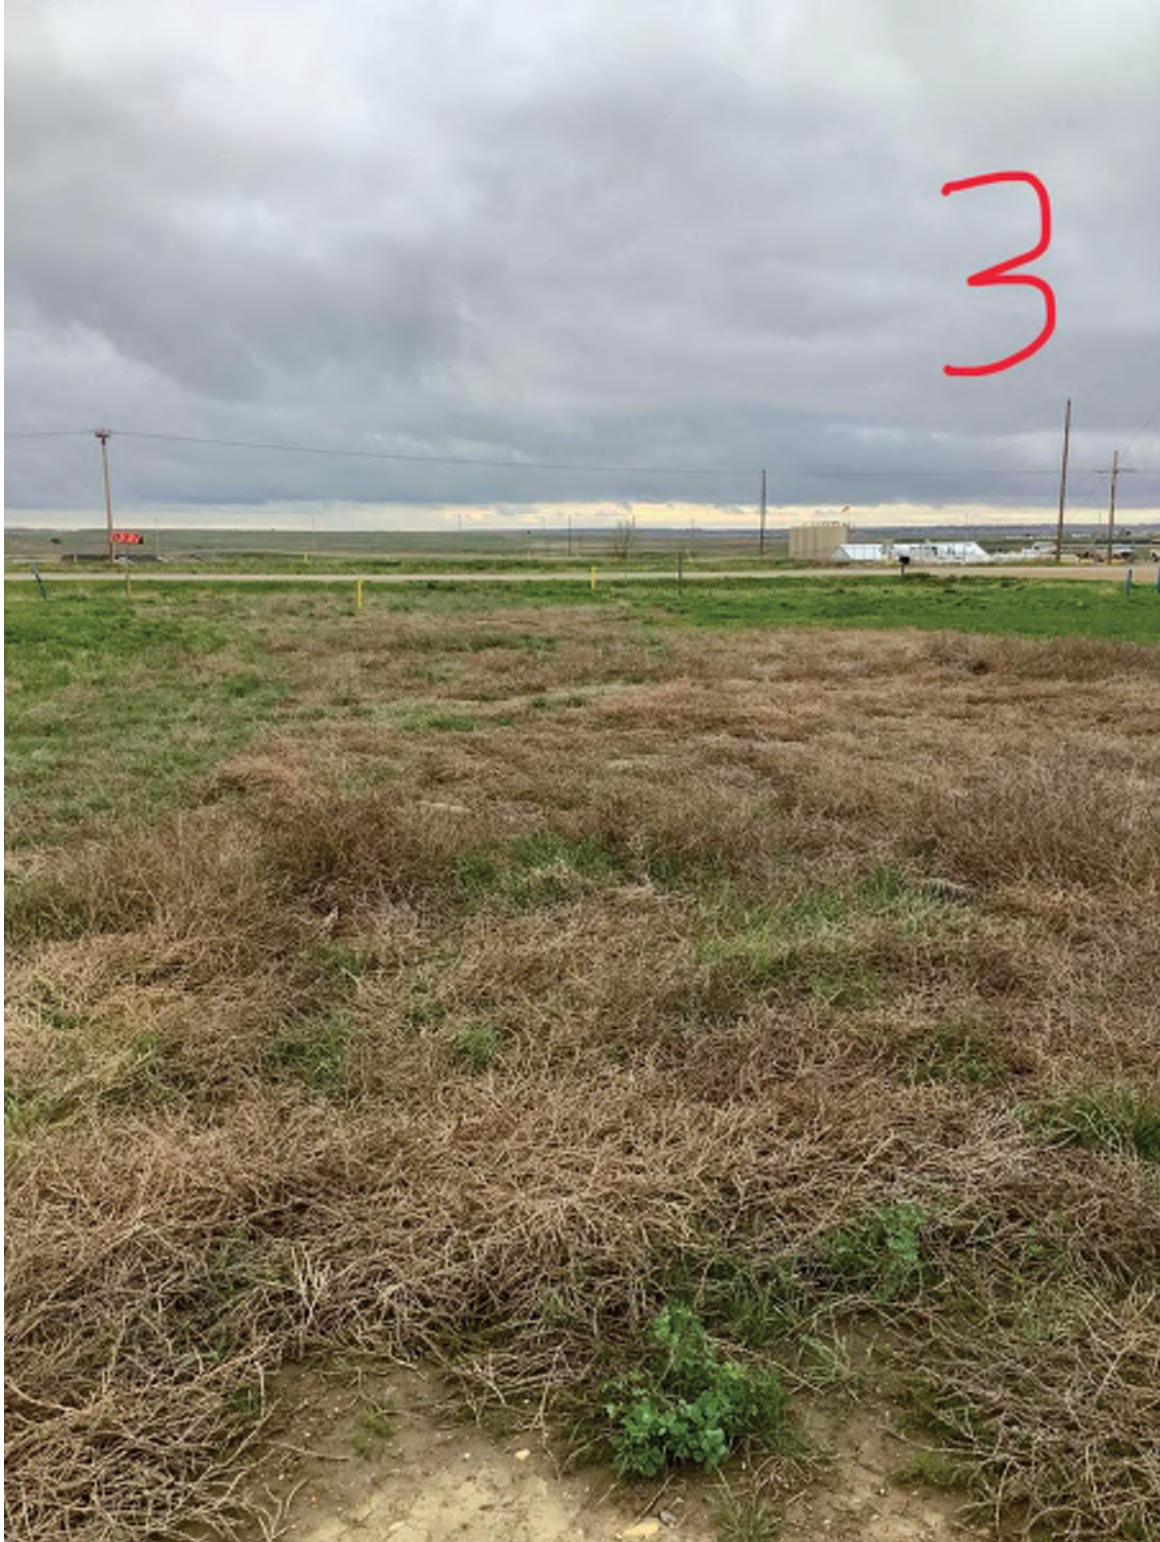
P3: looking West, substantial vegetative cover.

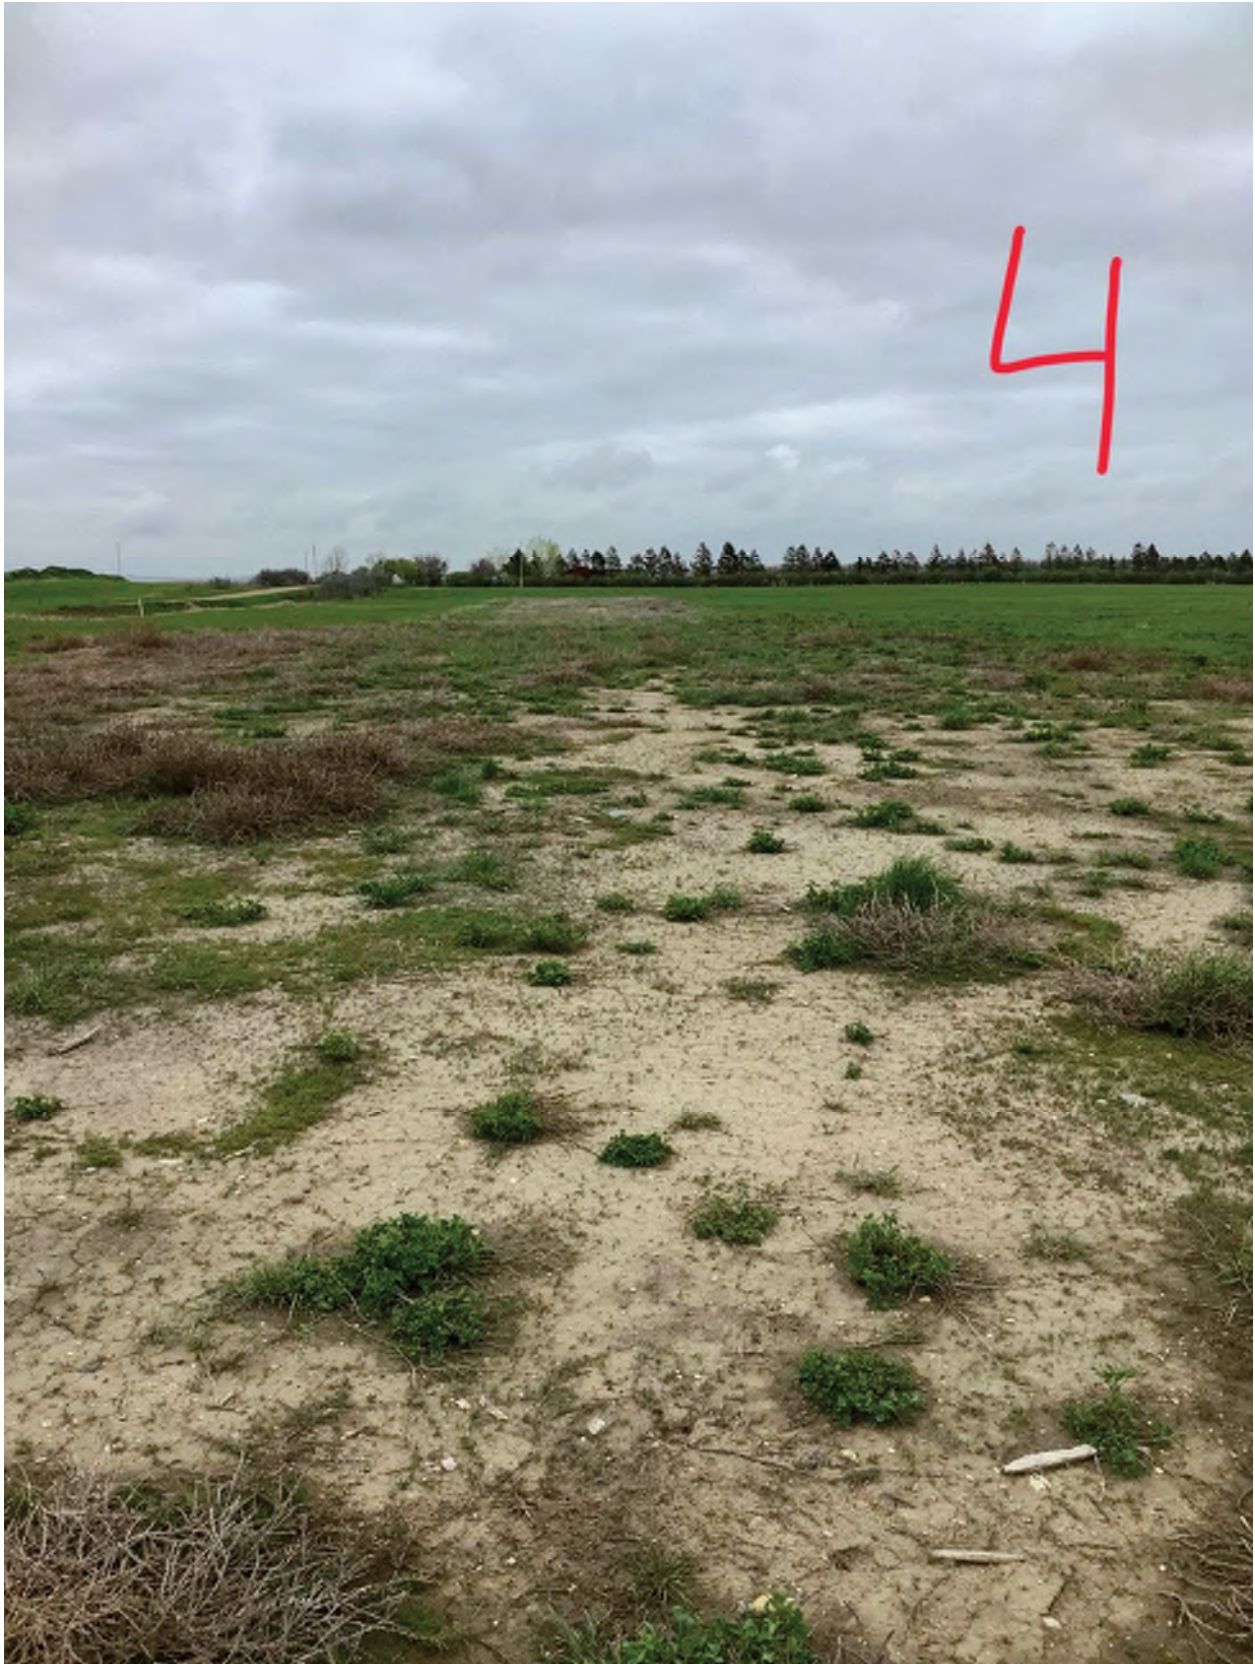
P4: looking East, evidence of plant growth, but lots of bare soil.

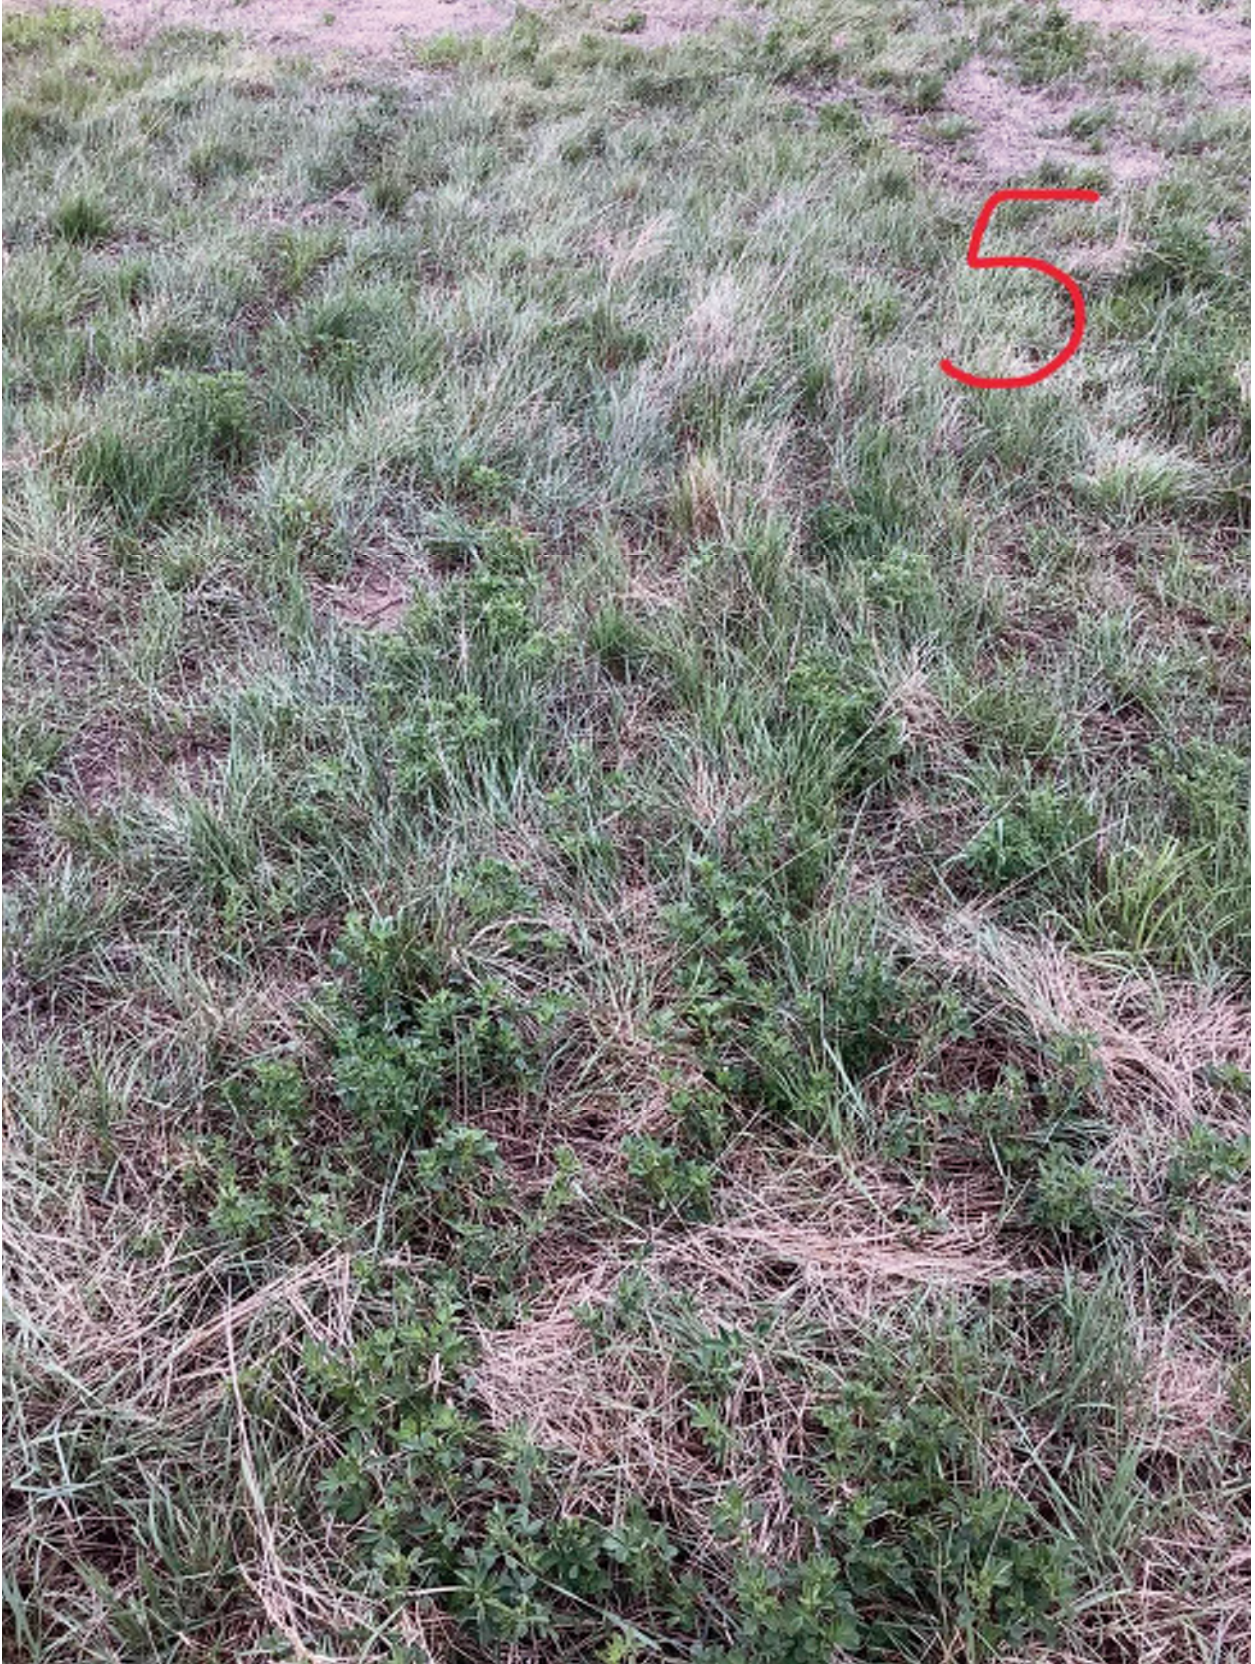
Evidence of sufficient plant growth includes pictures P5, P10, and P33.

P5: Looking East, substantial vegetative growth.

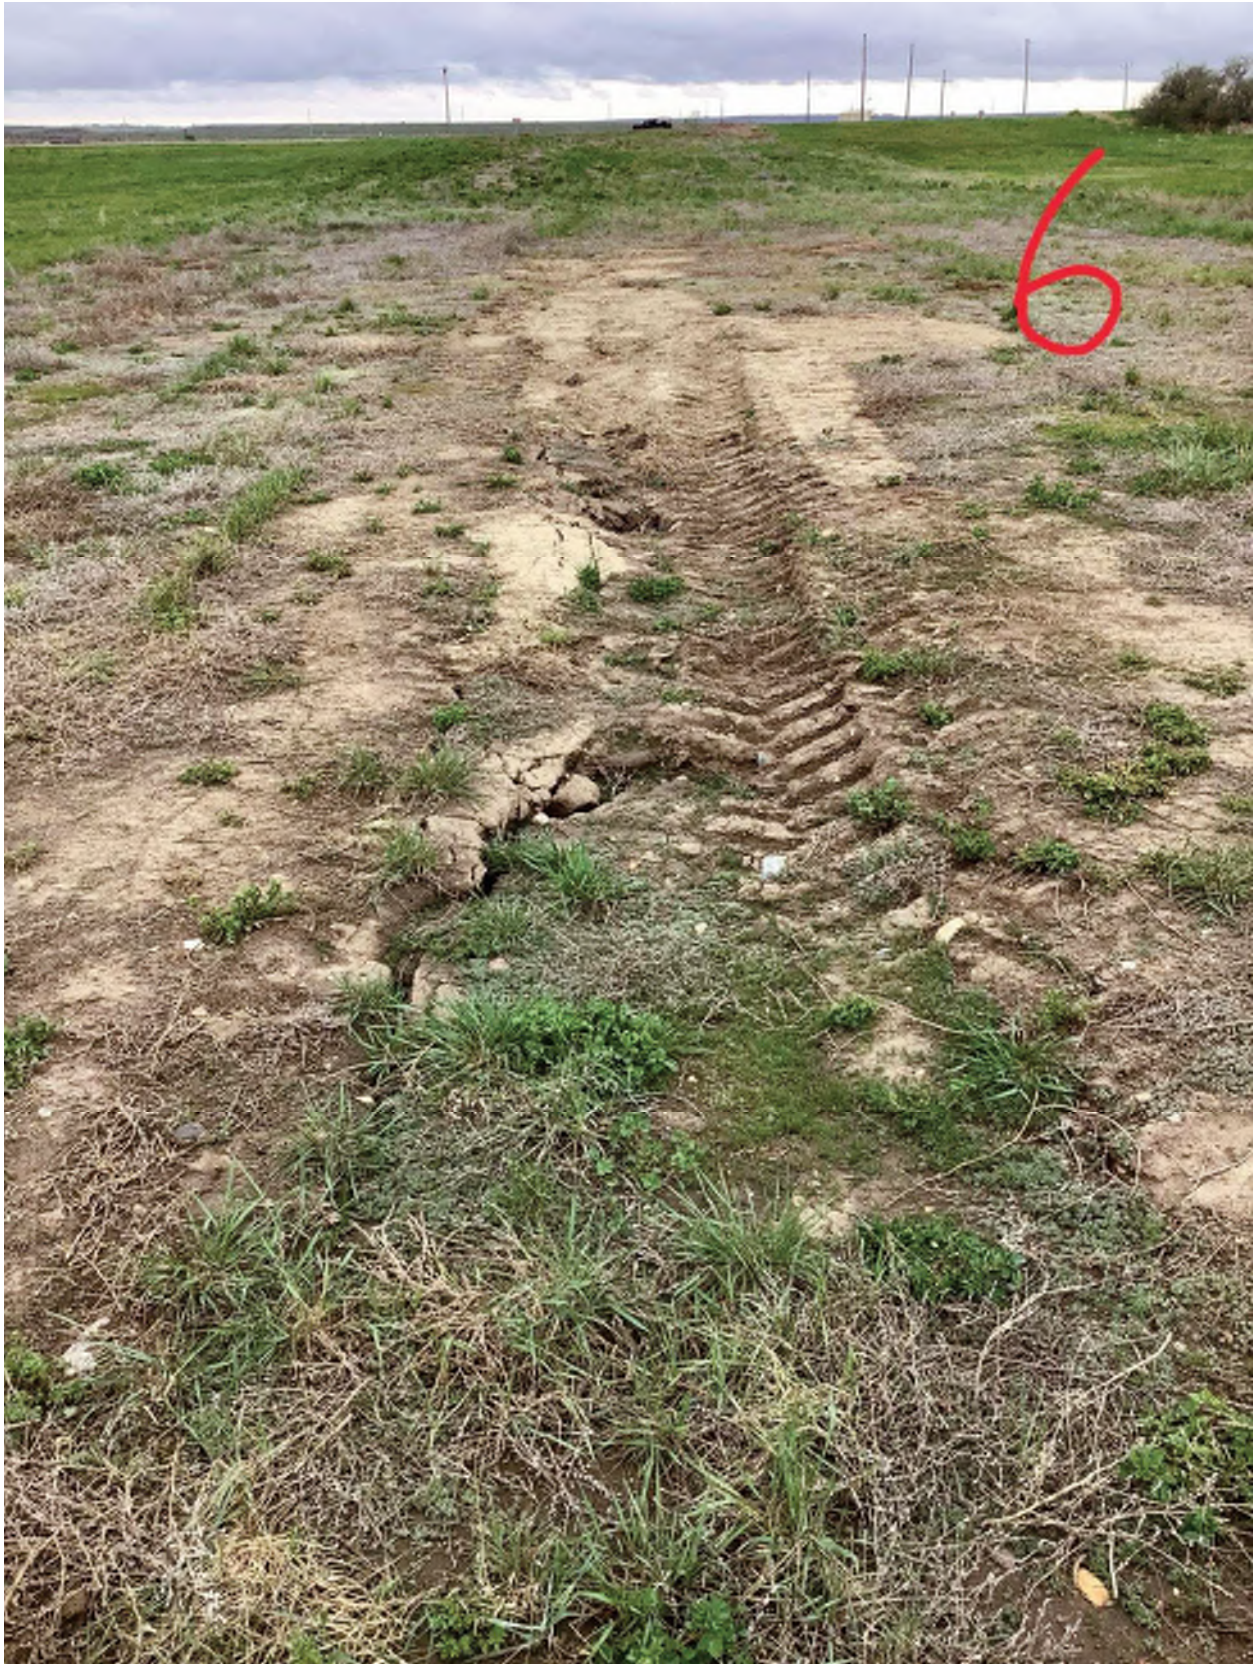
It was noted in several spots (documented in pictures P6-8, and P28-29) that the landowner had remedied localized trench settlement by moving soil and placing it over the settled areas.

P6: looking West: Area where landowner has filled previous trench sinkage on their own.

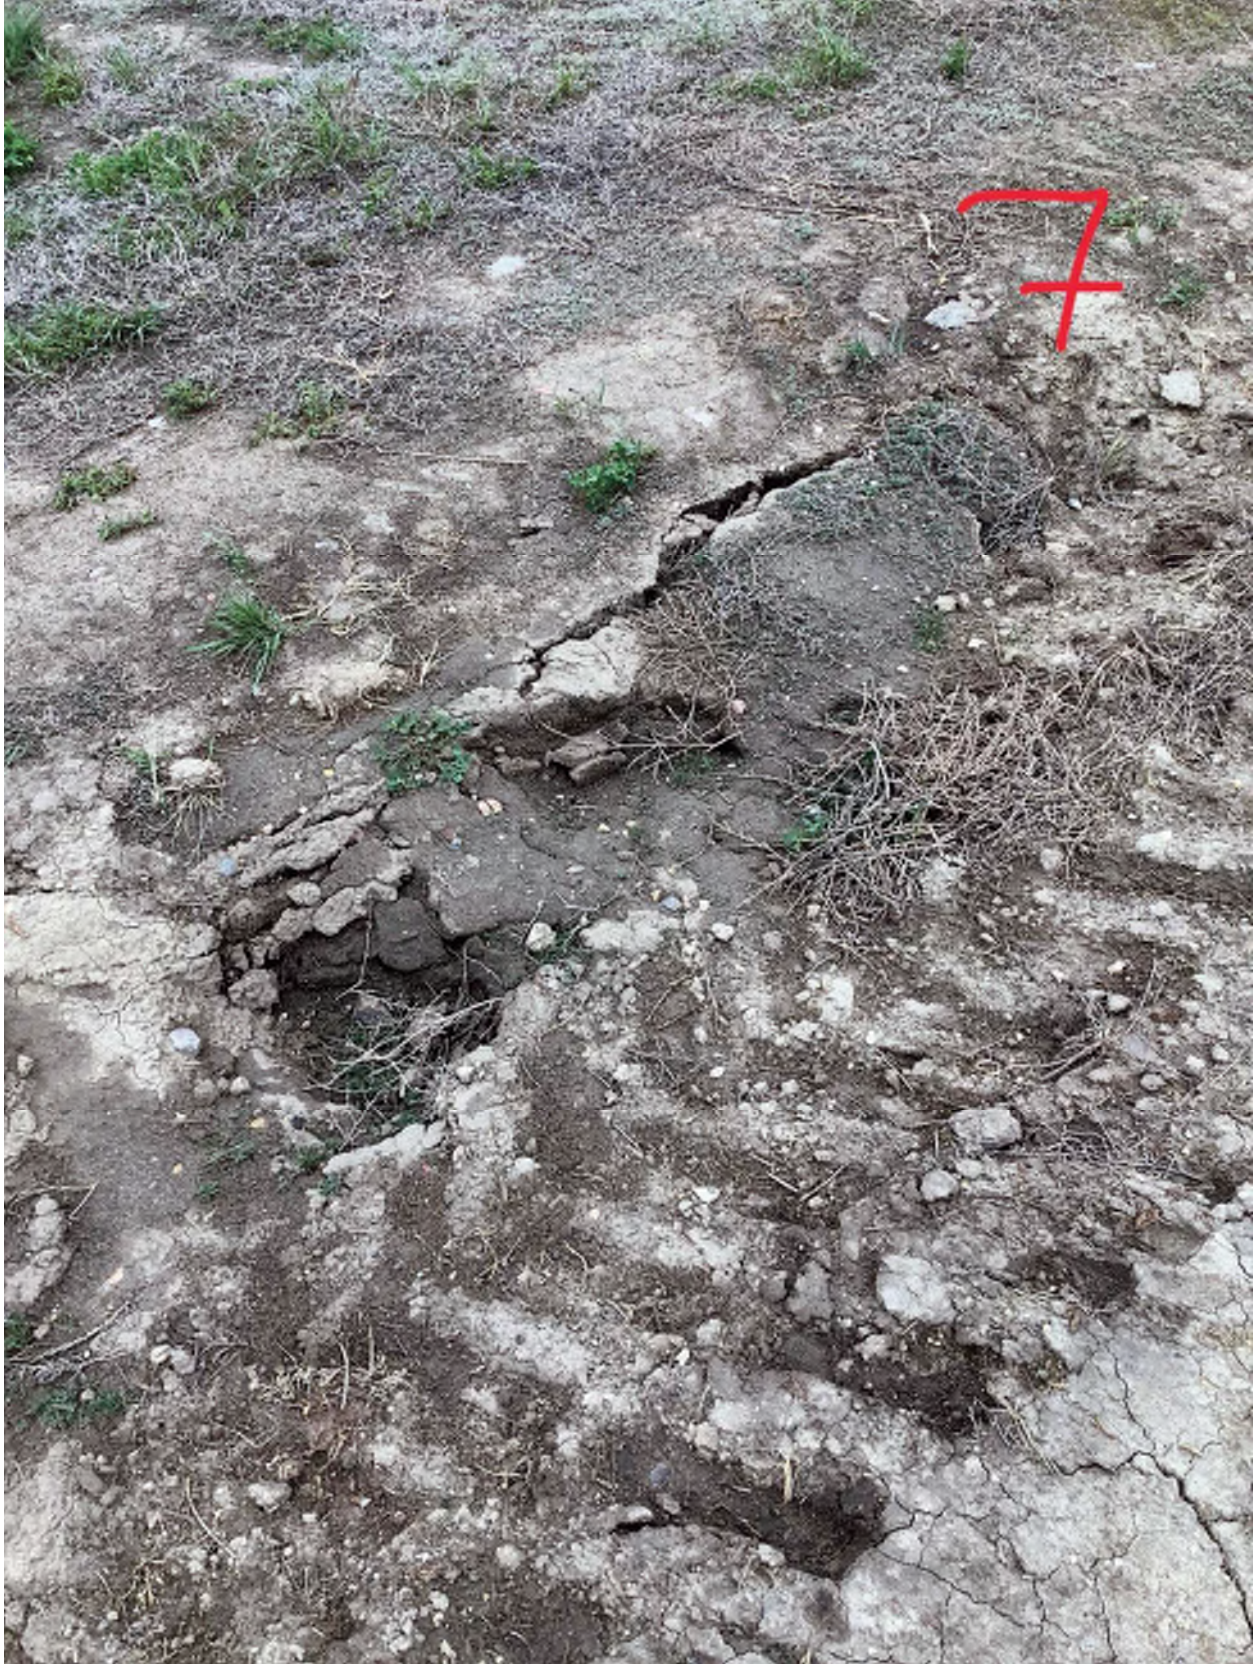
P7: Looking SW, farmer filled in section of trench sinkage, almost no vegetative cover.

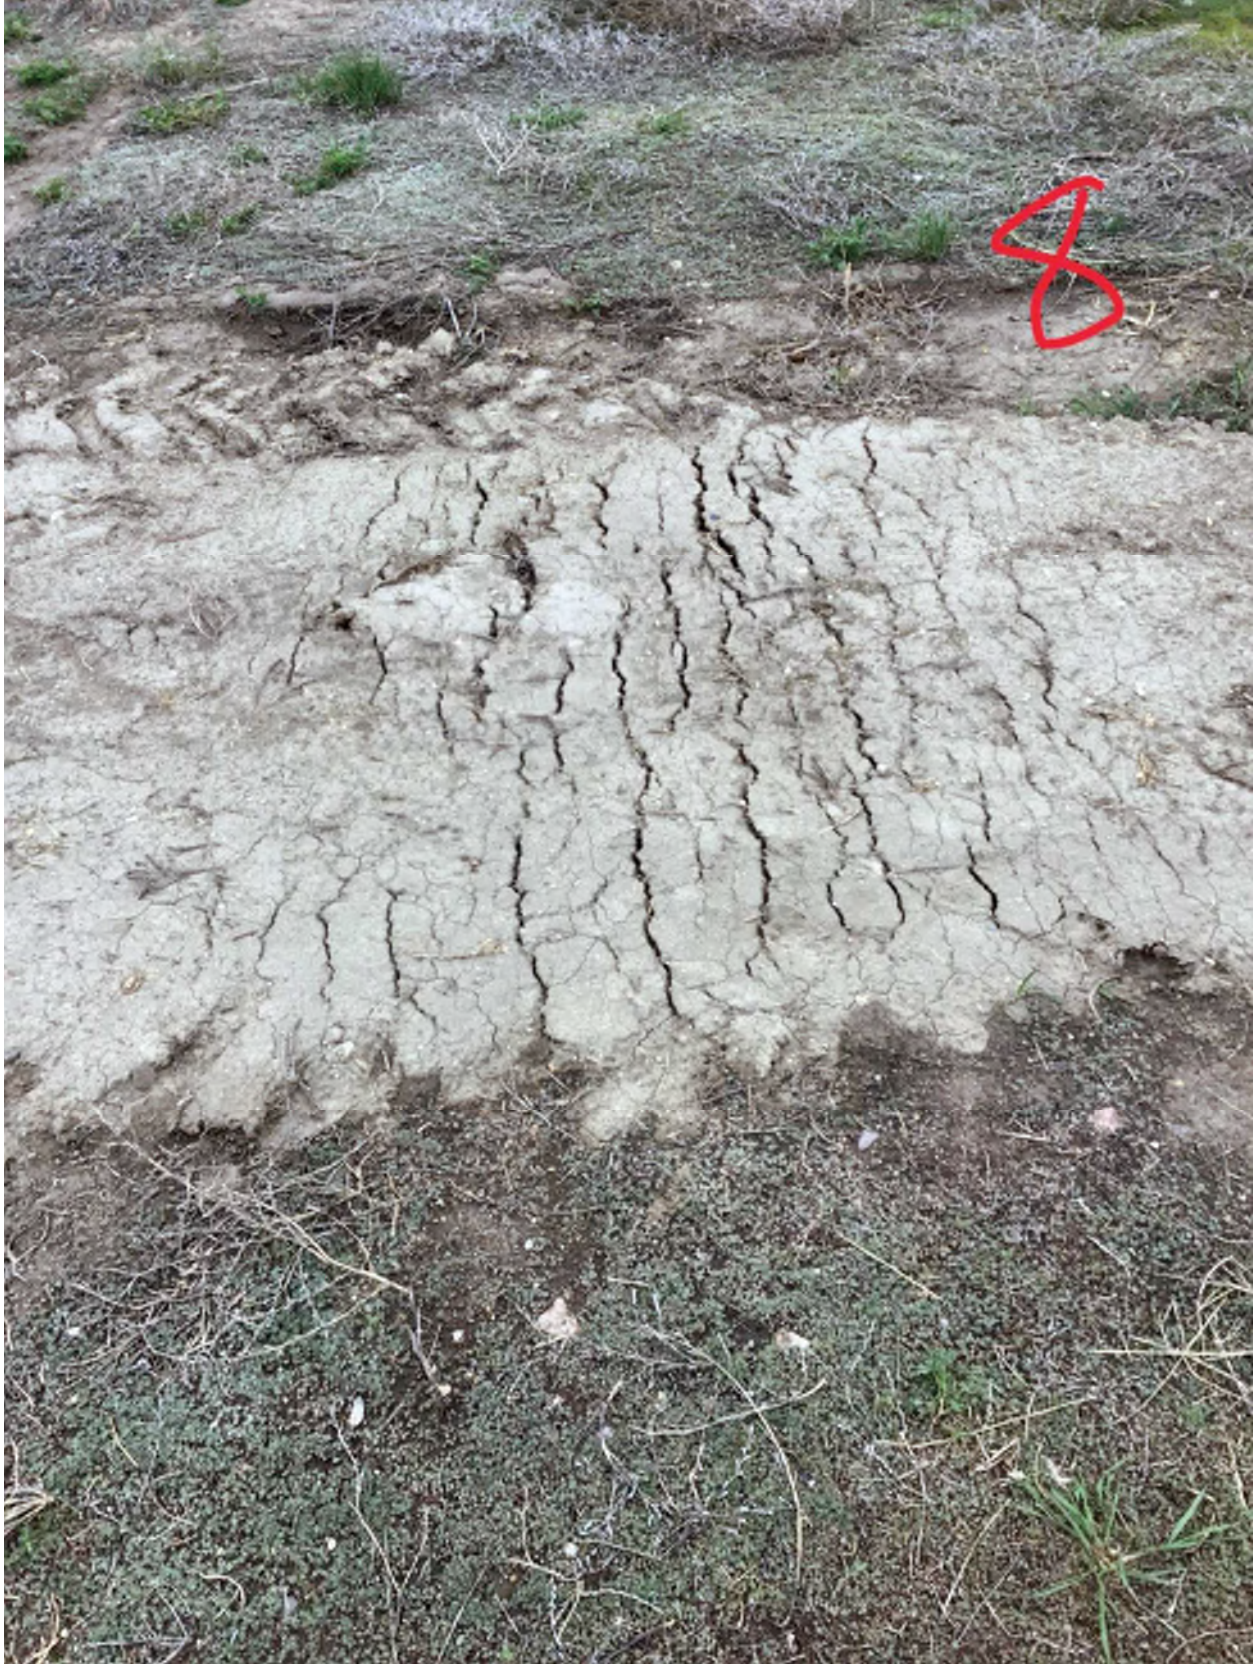
P8 looking S, sinkage remedied by the landowner, notice plant cover adjacent to fill location.

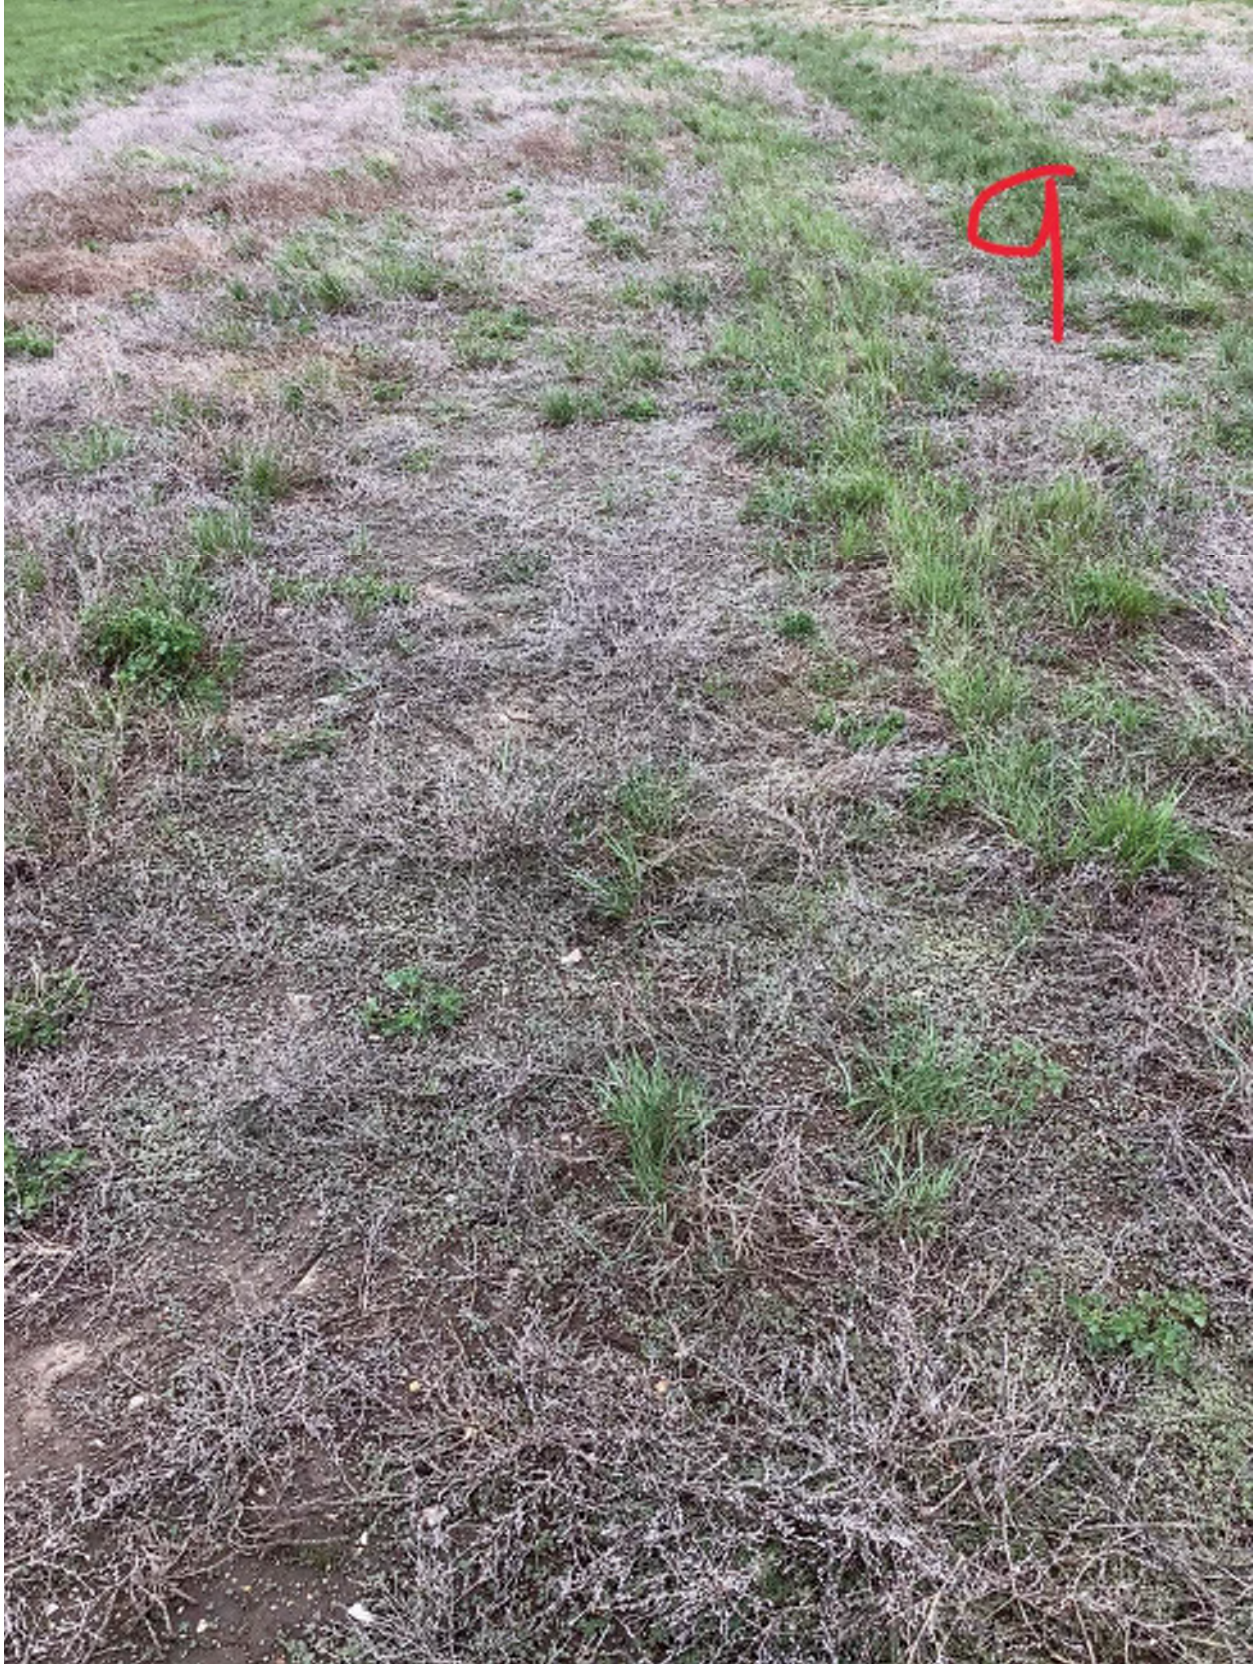
P9 looking East, adequate vegetative cover along ROW, no issues.

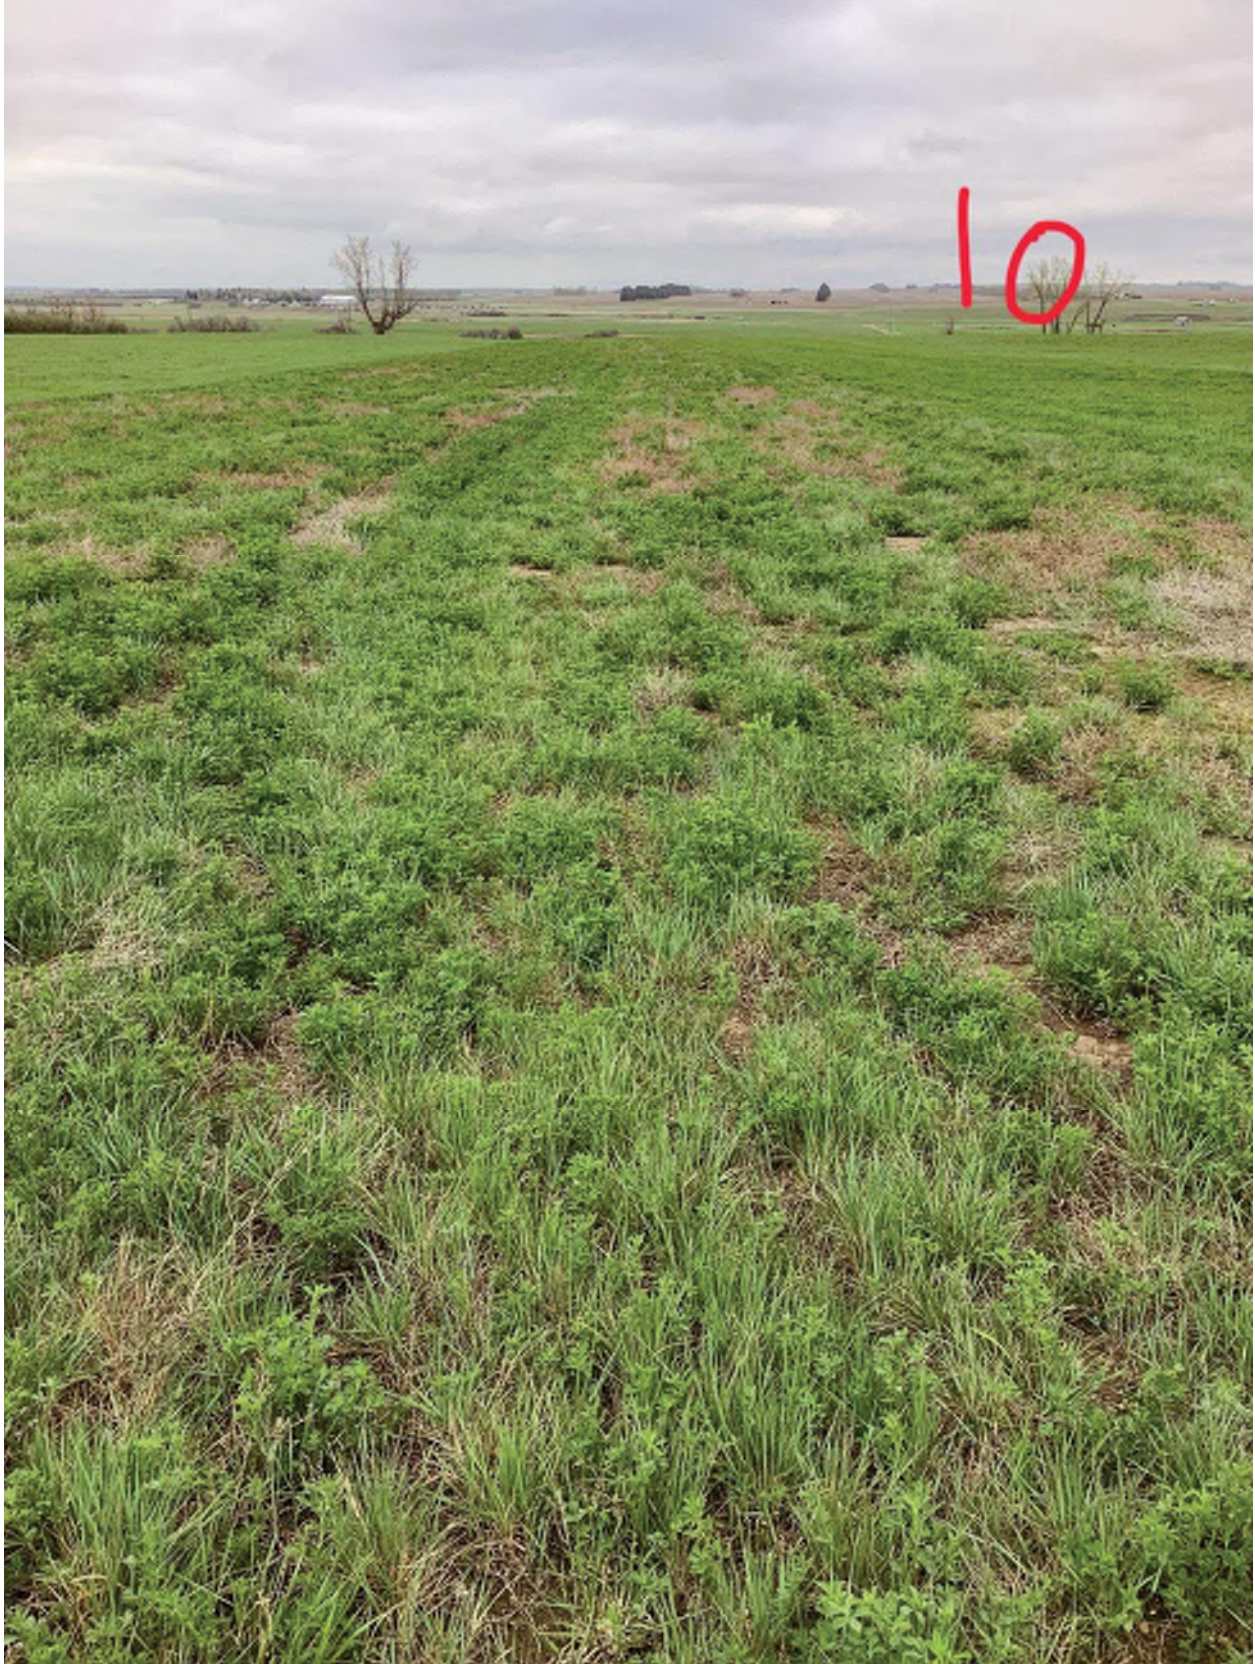
P10 looking South, substantial vegetative cover. No issues.

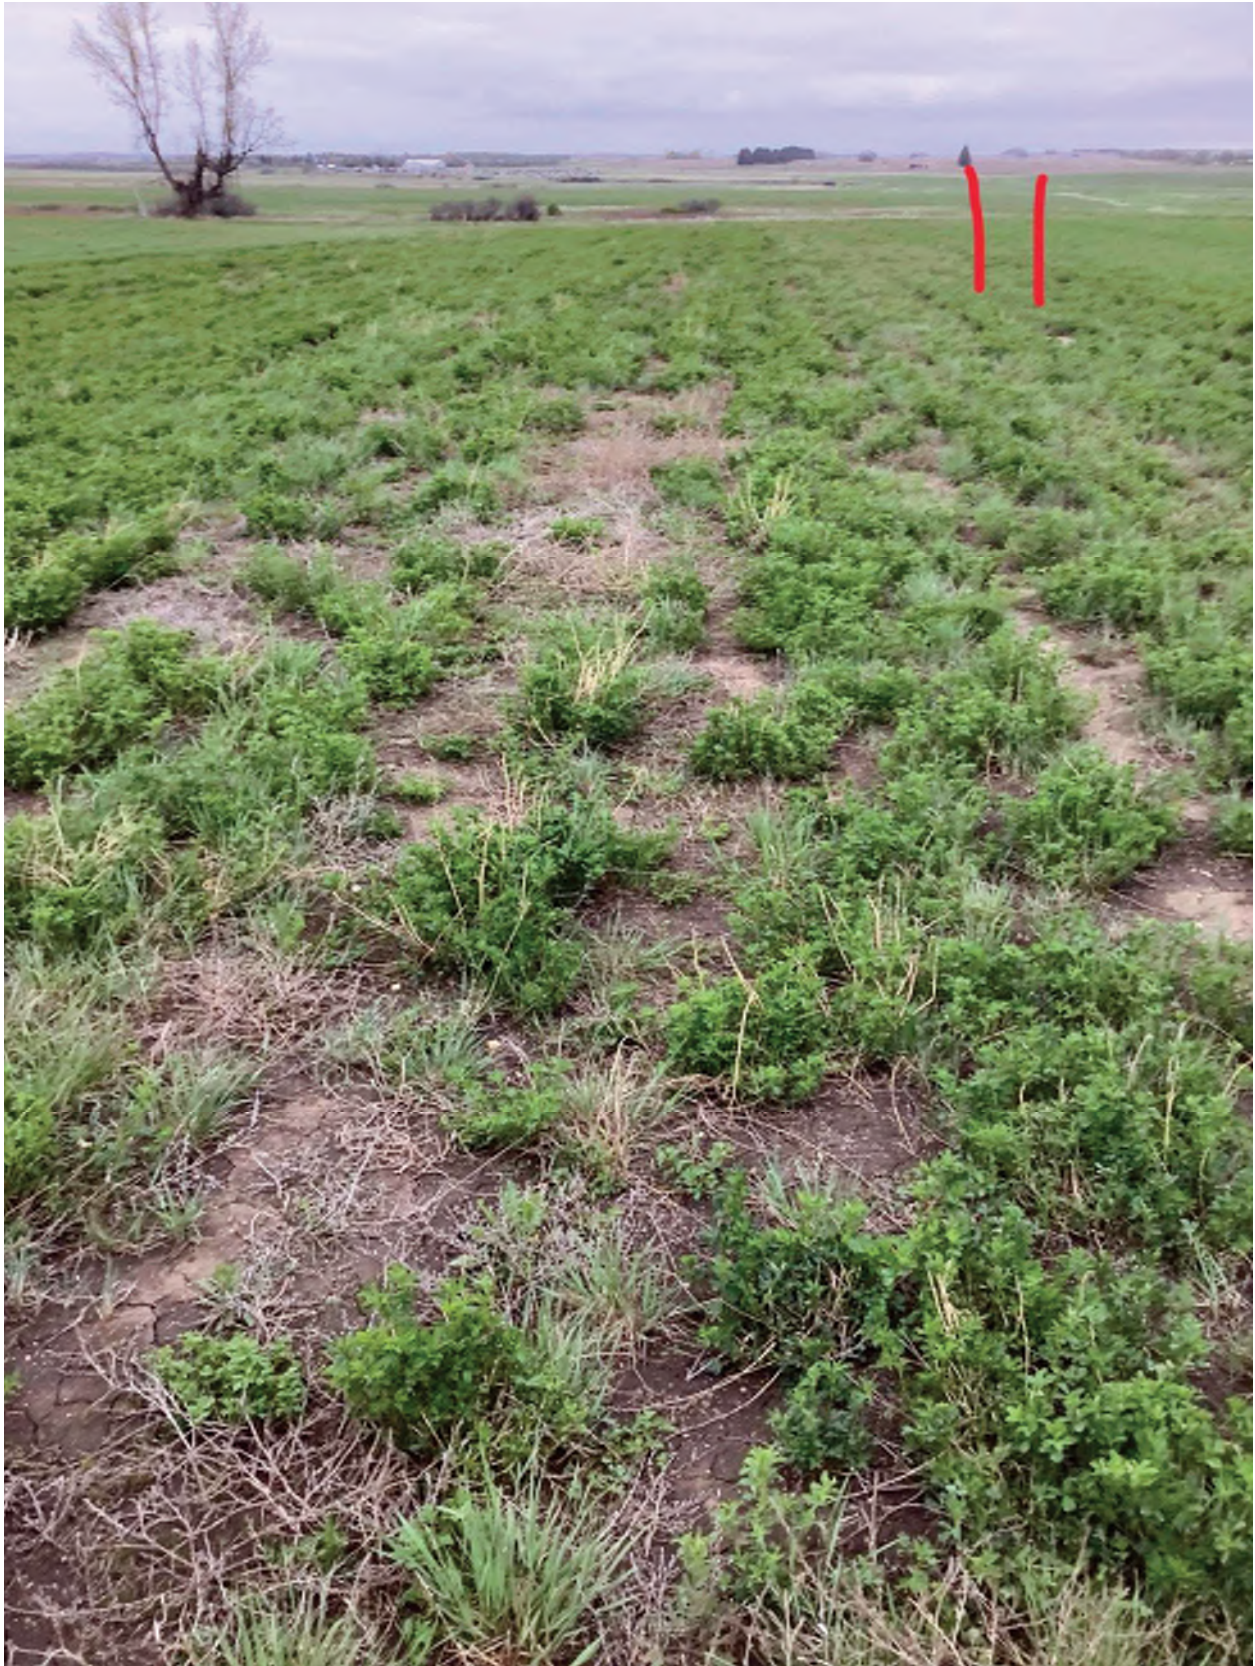
P11 looking SSE, adequate vegetative cover, and evidence of seeding.

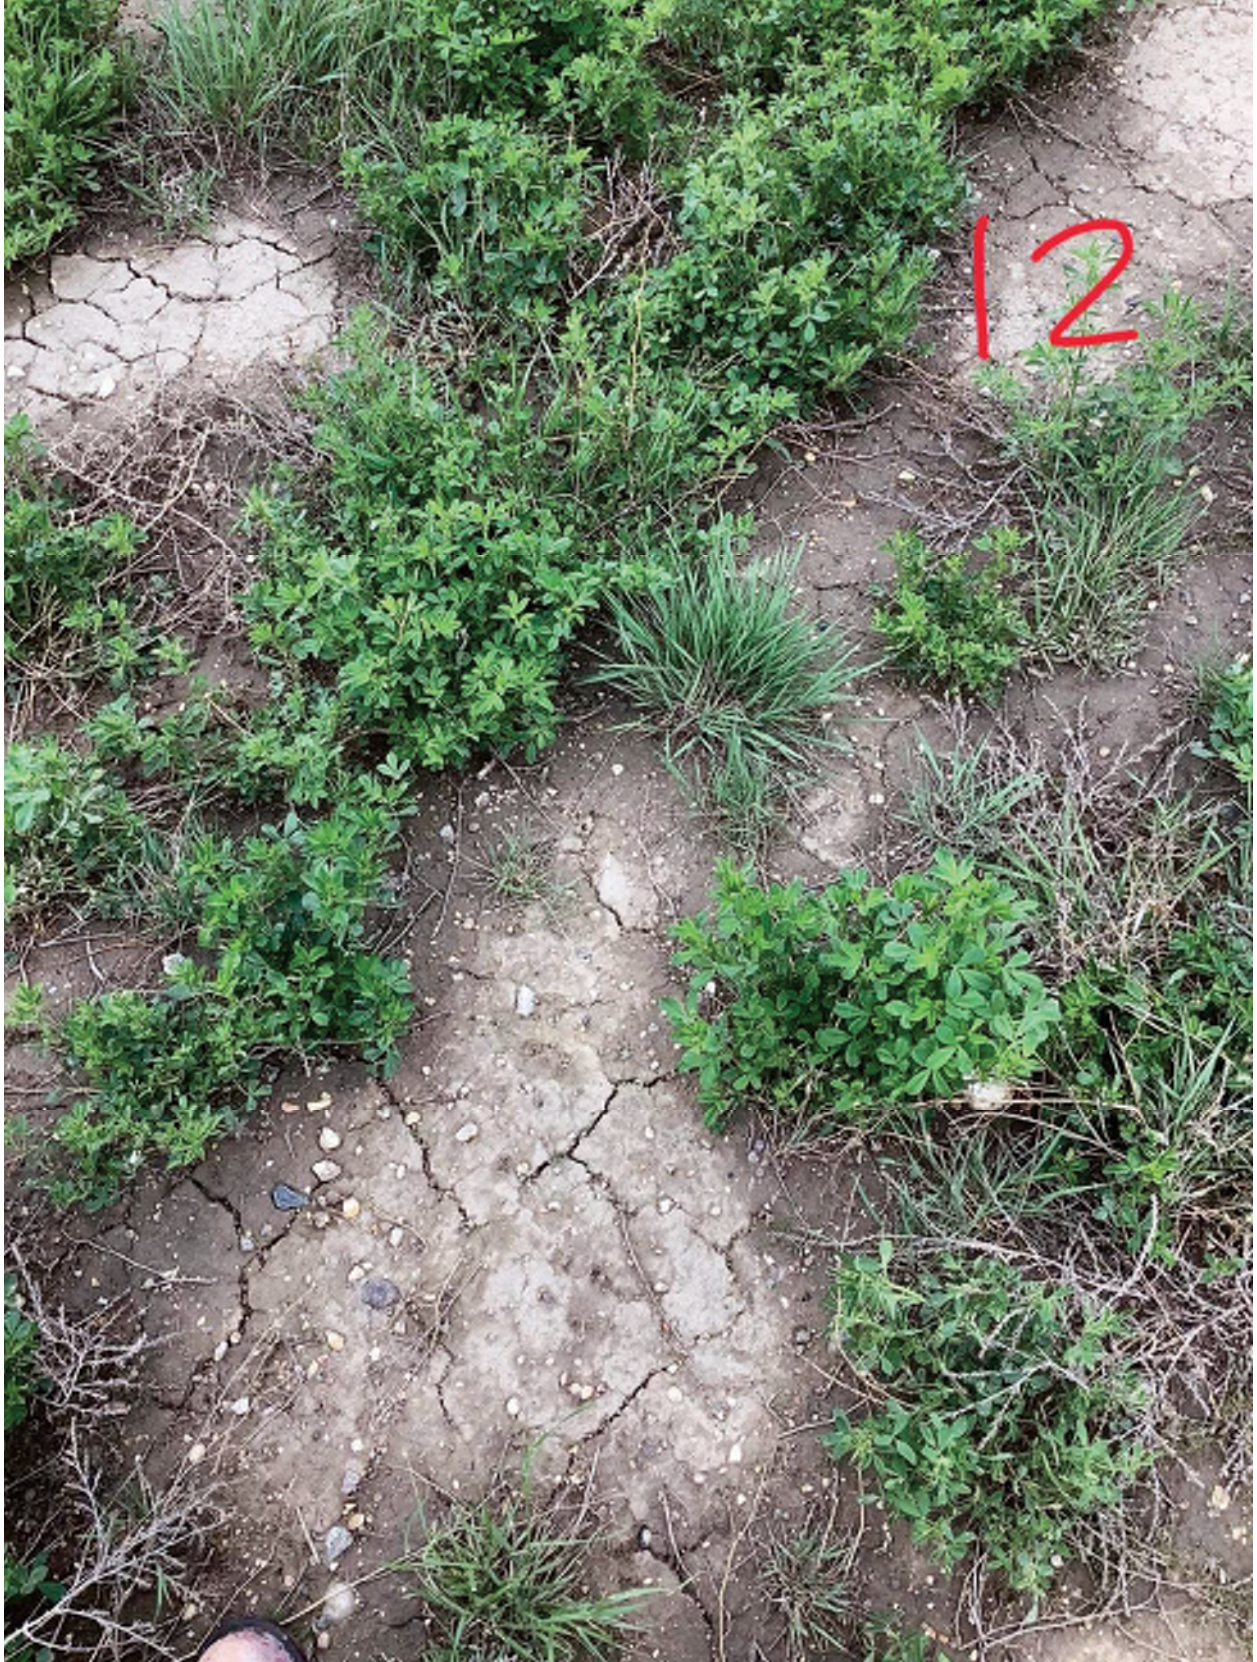
P12 looking SE, some bare patches of soil, and some cracking present.
