Hiland Crude LLC

2.9-mile Crude Oil Pipeline— Williams County

Case No. PU-21-353

Reclamation and Revegetation Inspection Report

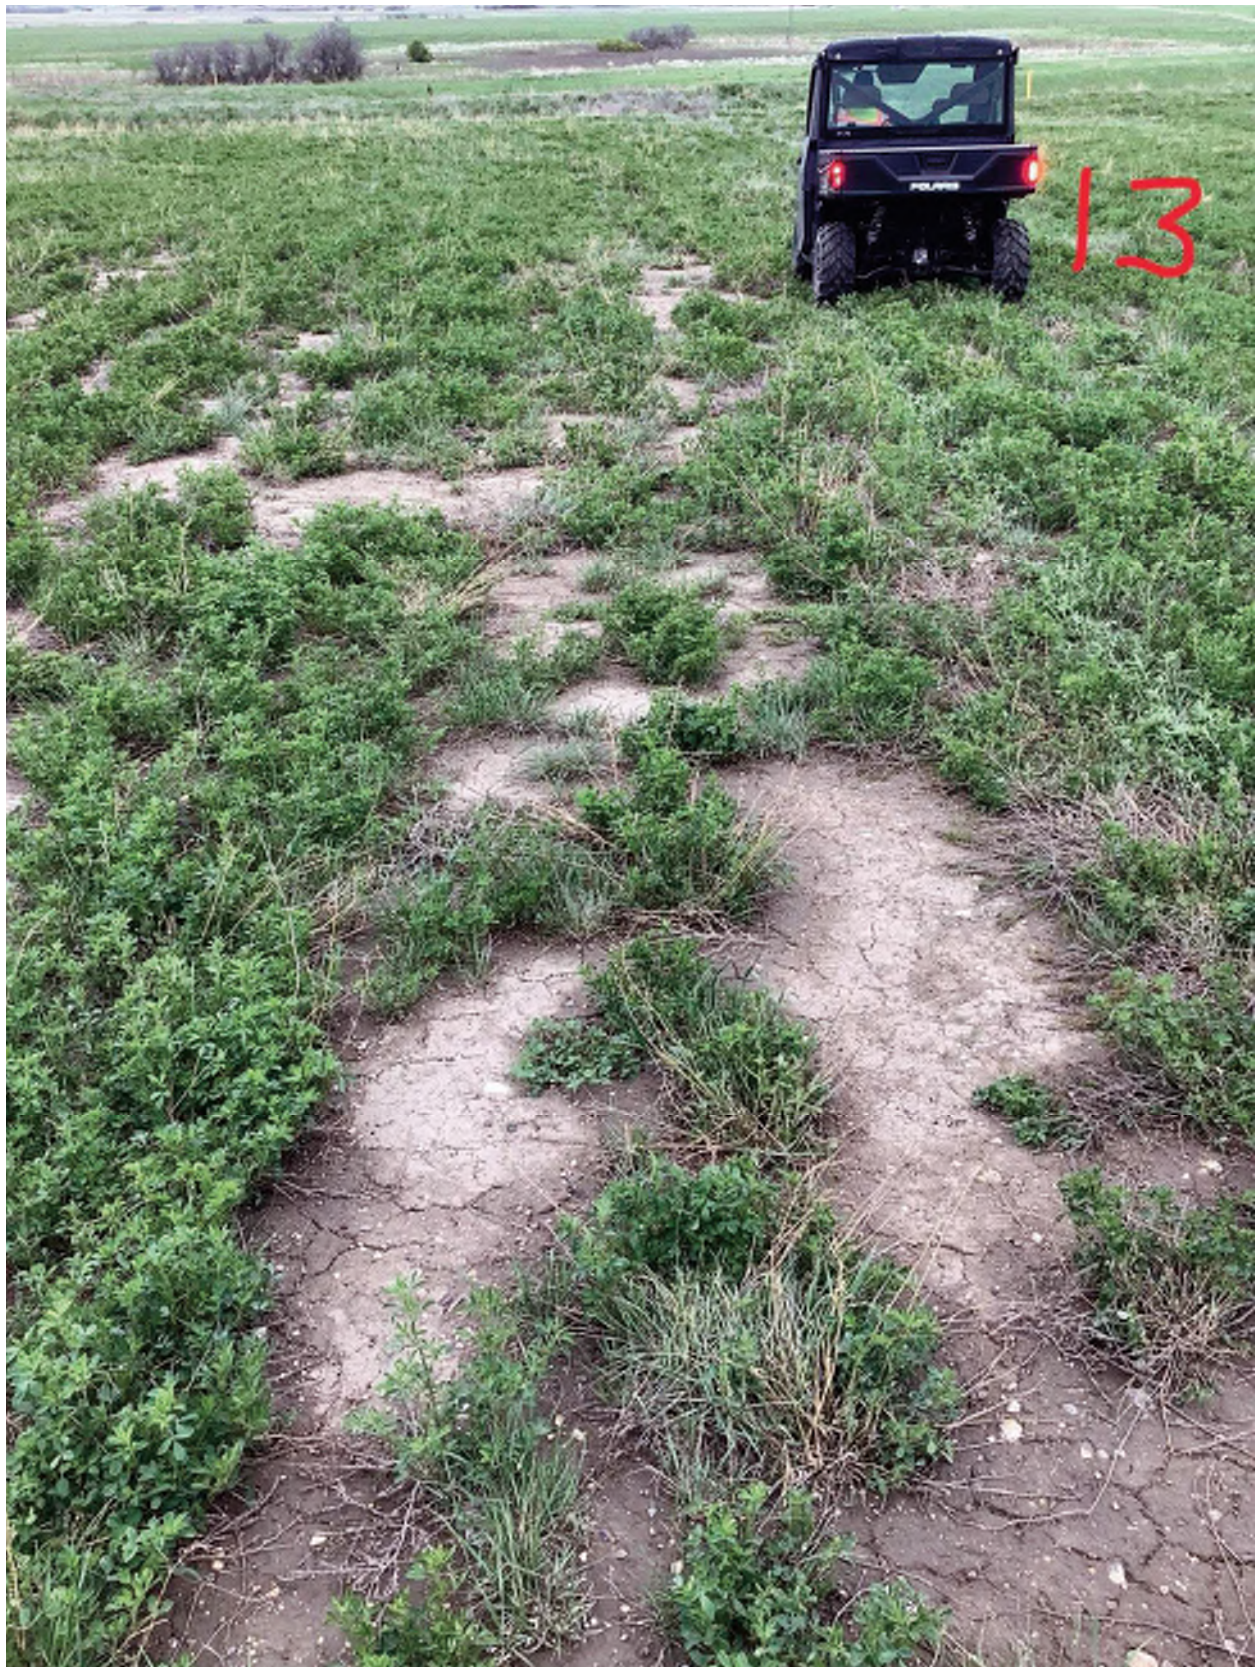
P13 looking S, patches of soil visible, however, seeding pattern is visible. This spot hasn't grown in yet.

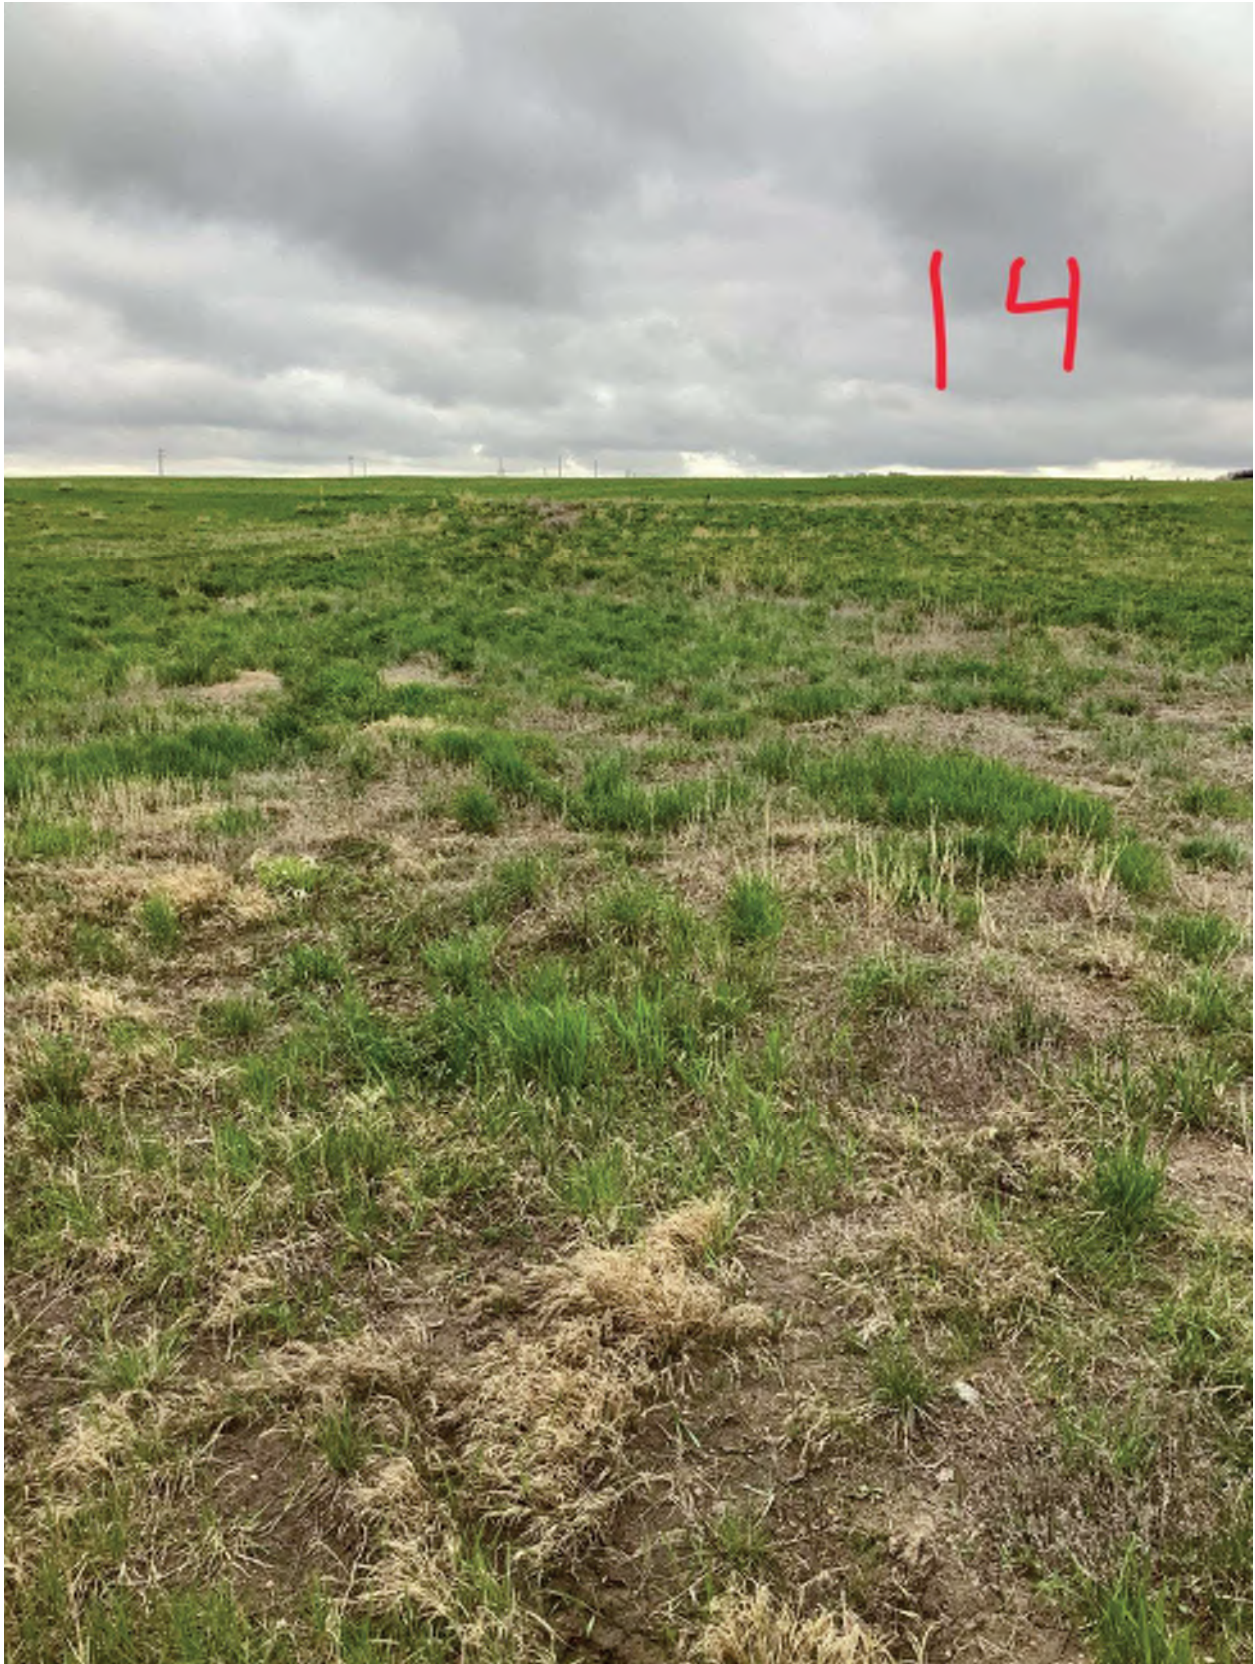
P14 looking NNW, adequate vegetative cover established.

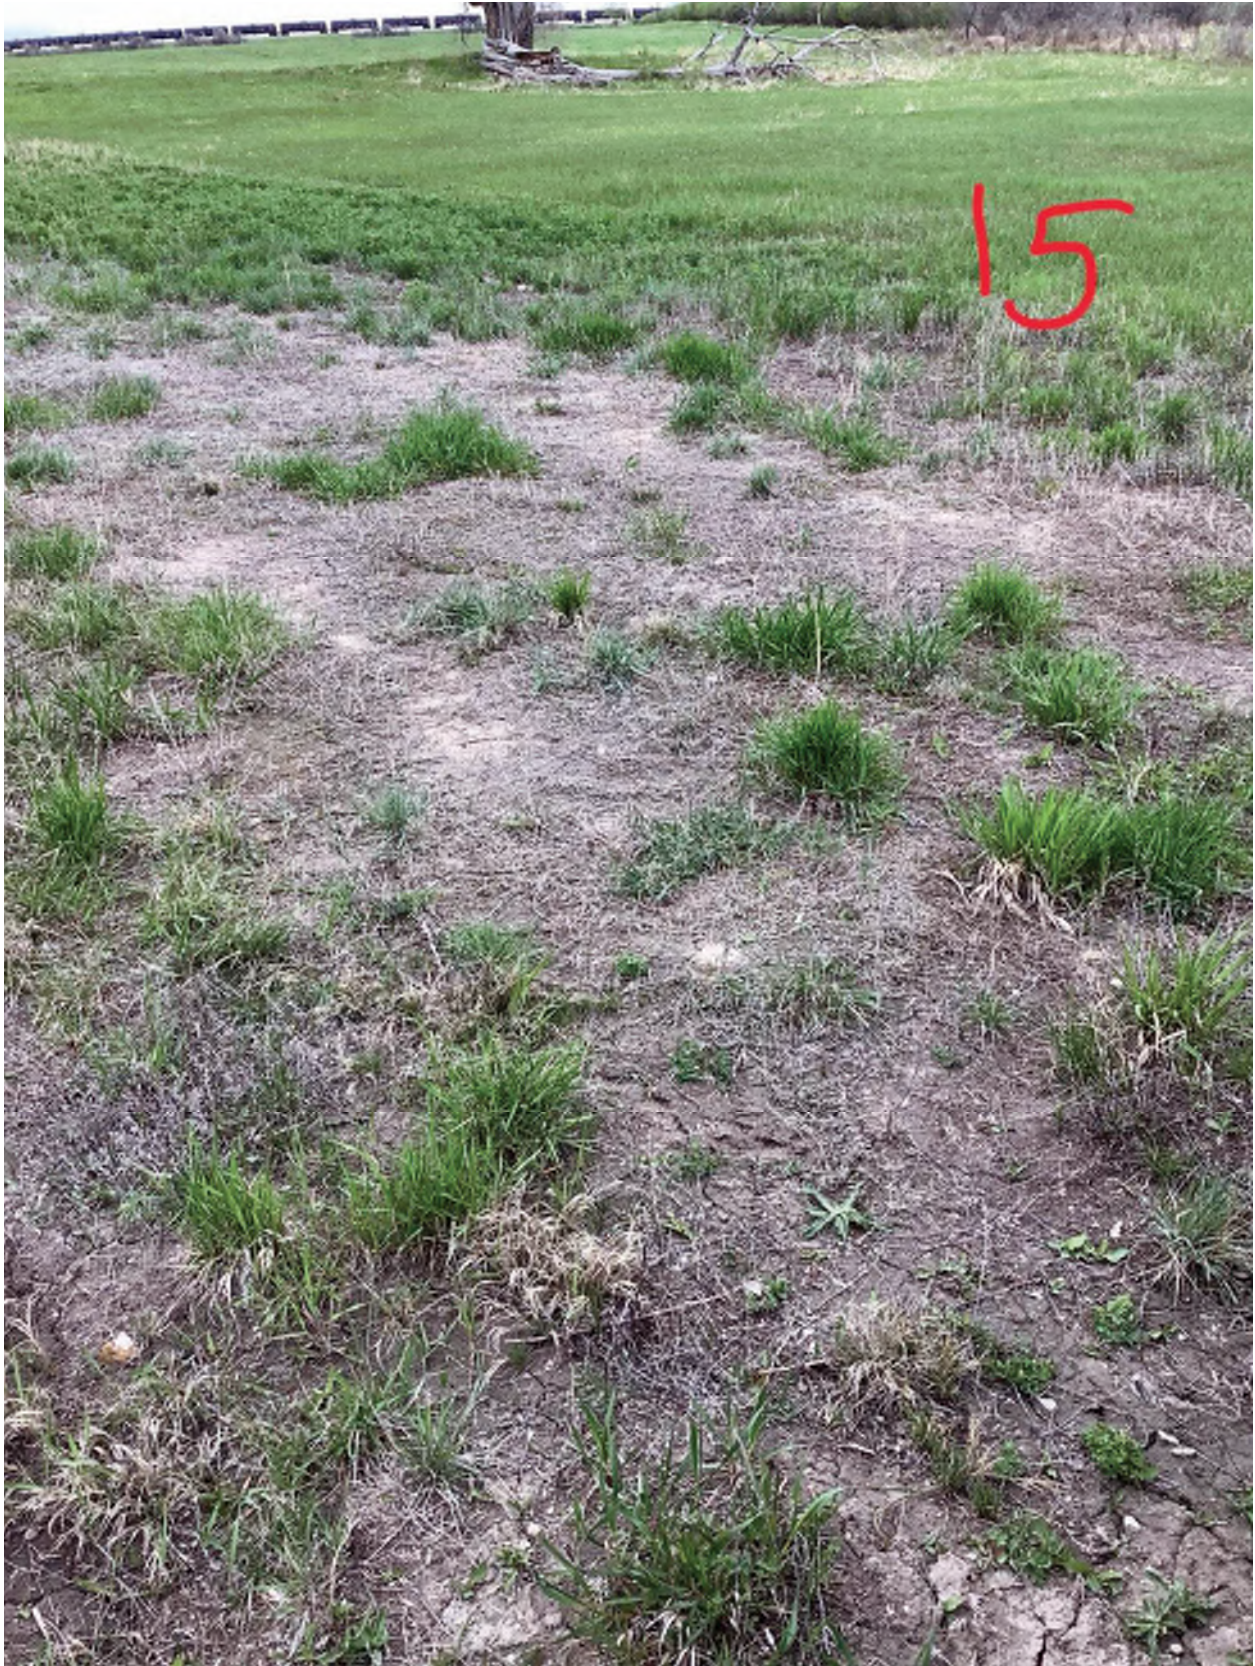
P15 looking NE, visible dead grass, and some soil visible.

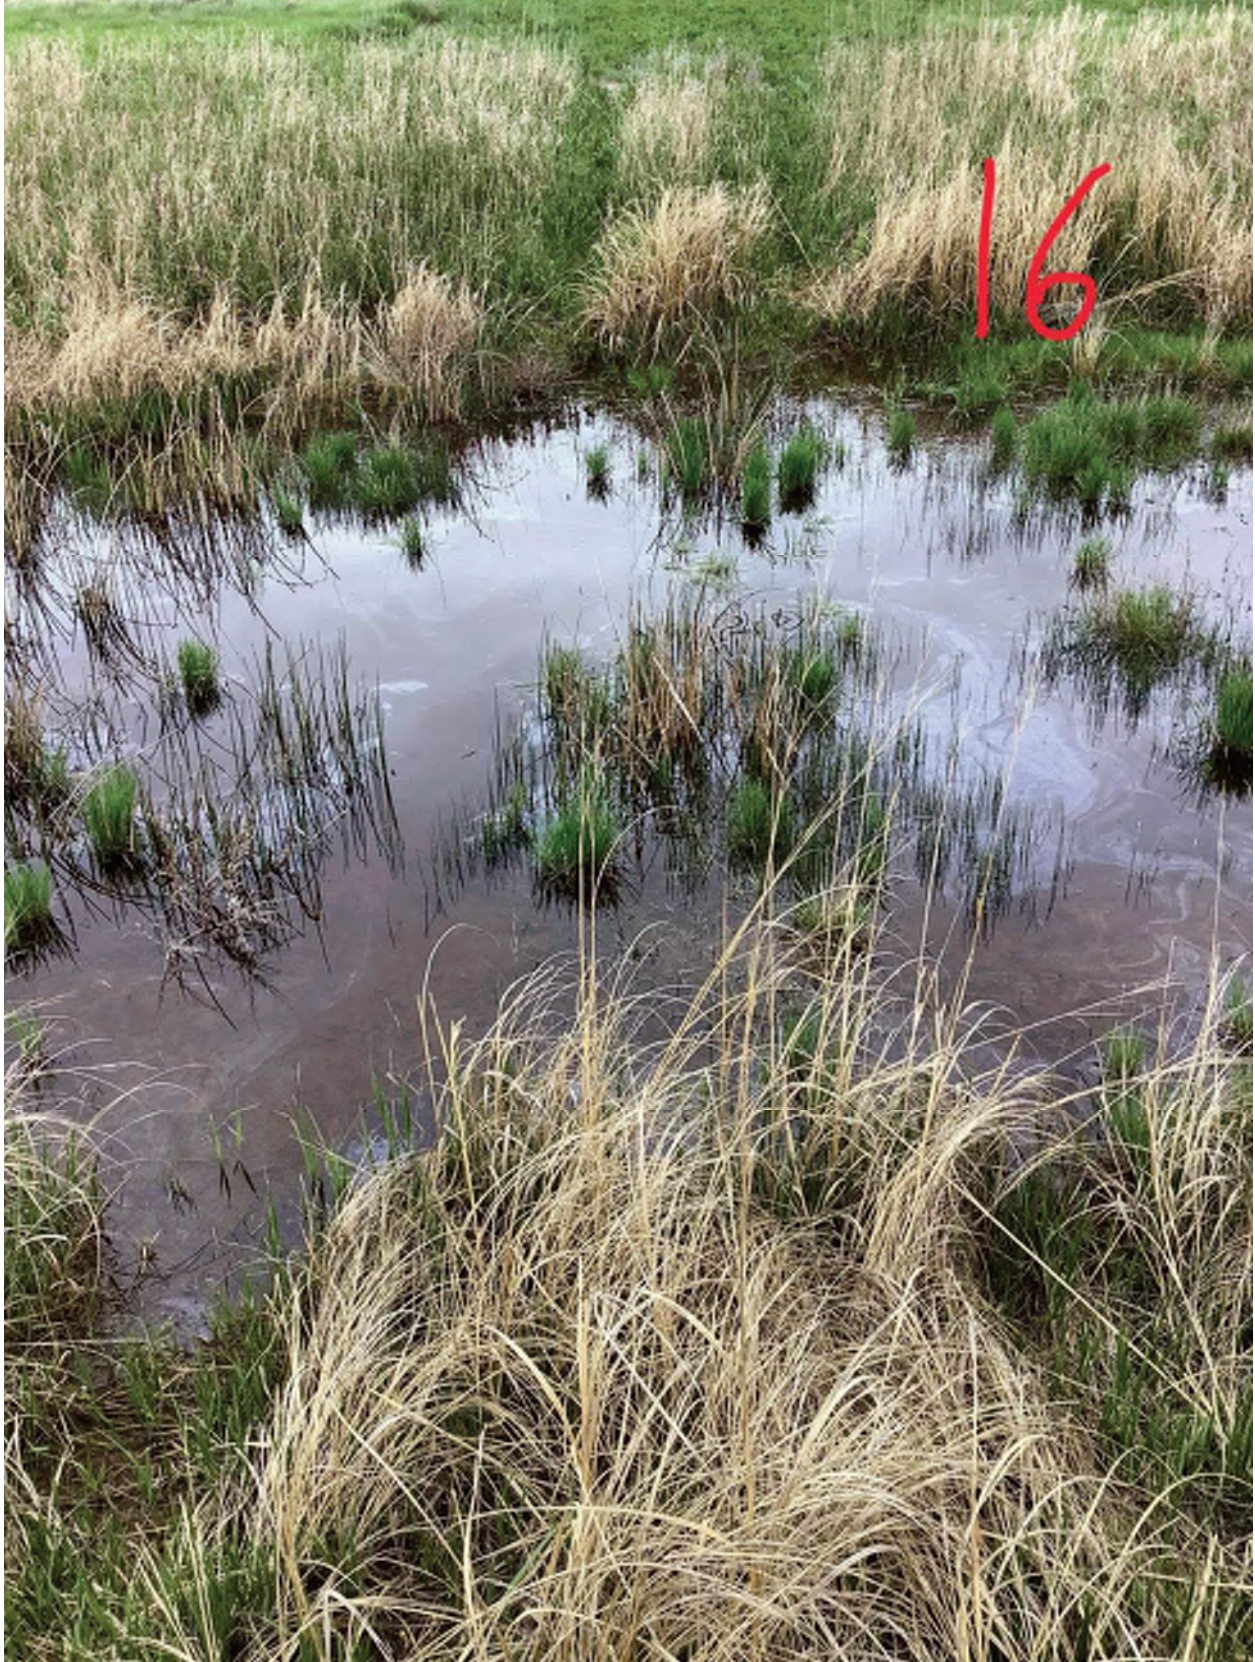
P16: No evidence of sediment deposit in the creek. Marshy areas seem undisturbed.

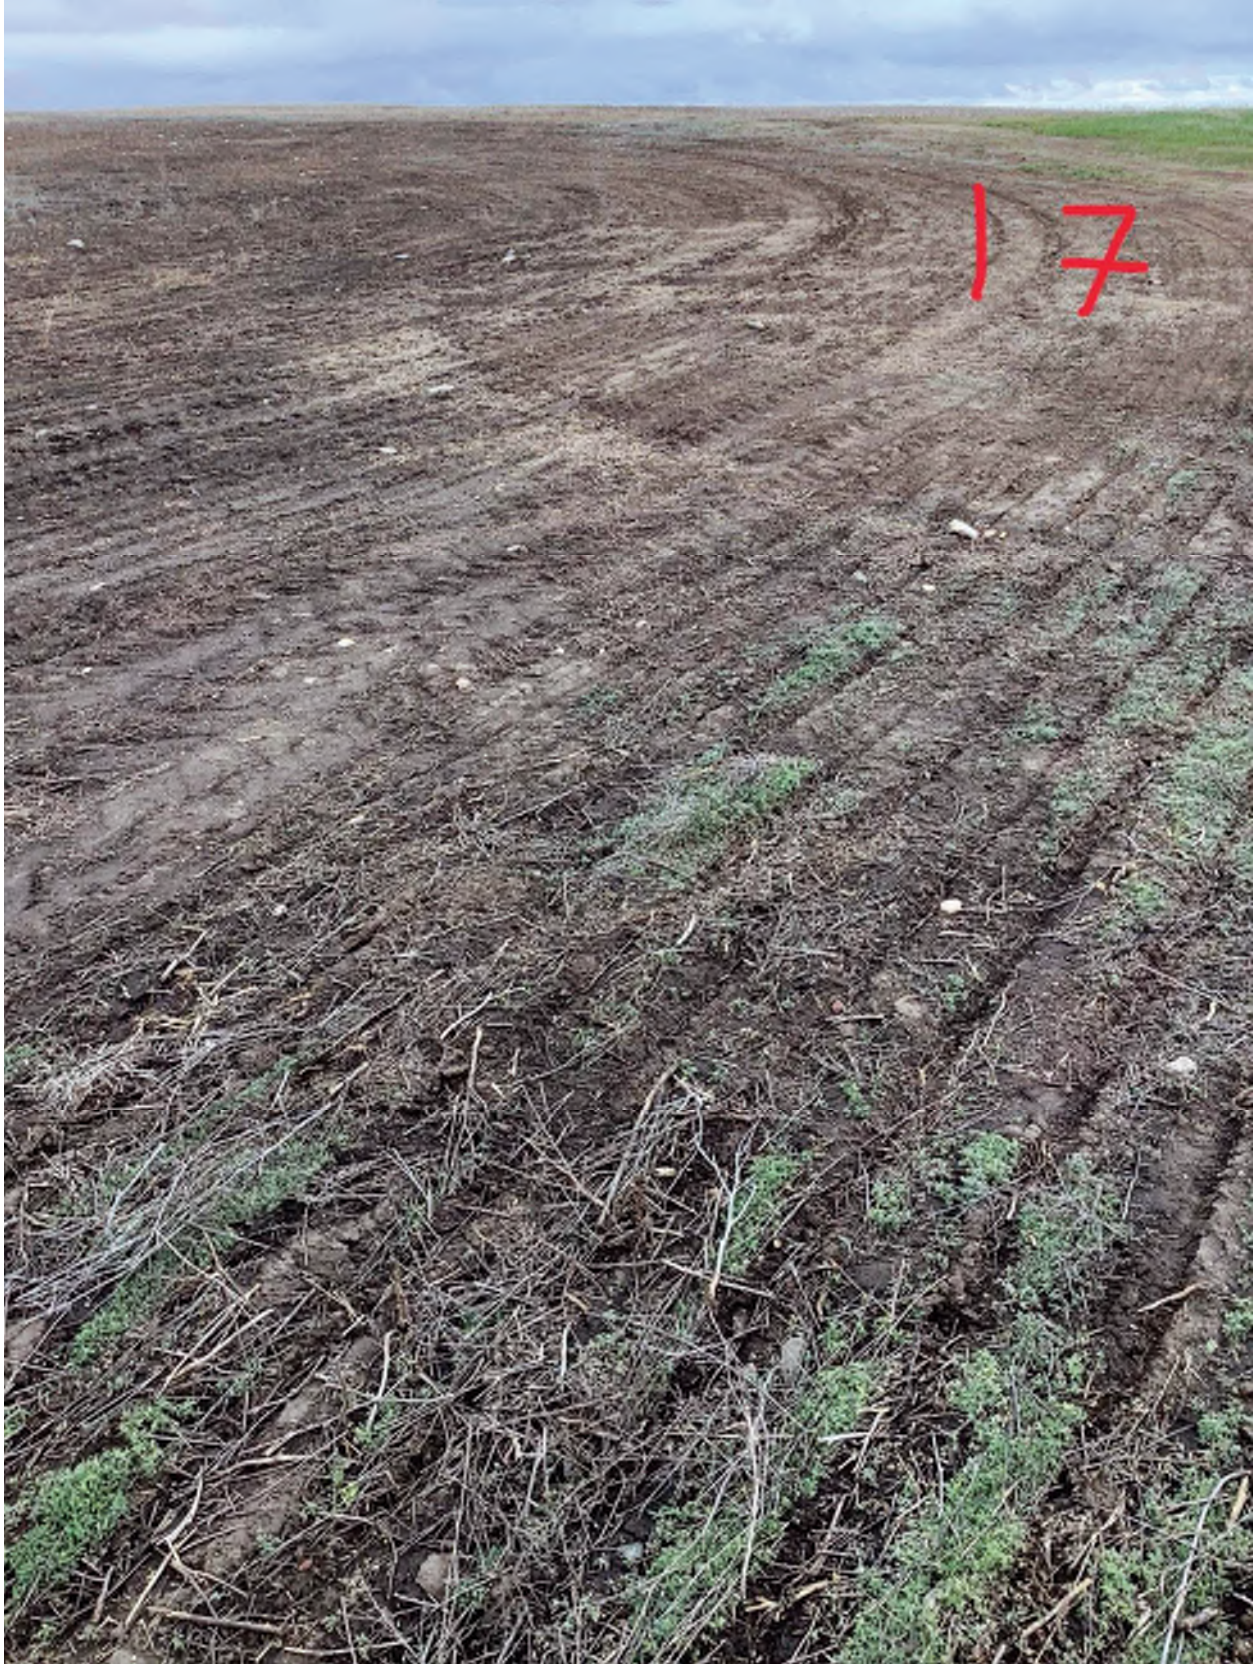
P17, looking SW, landowner has been working field. No issues.

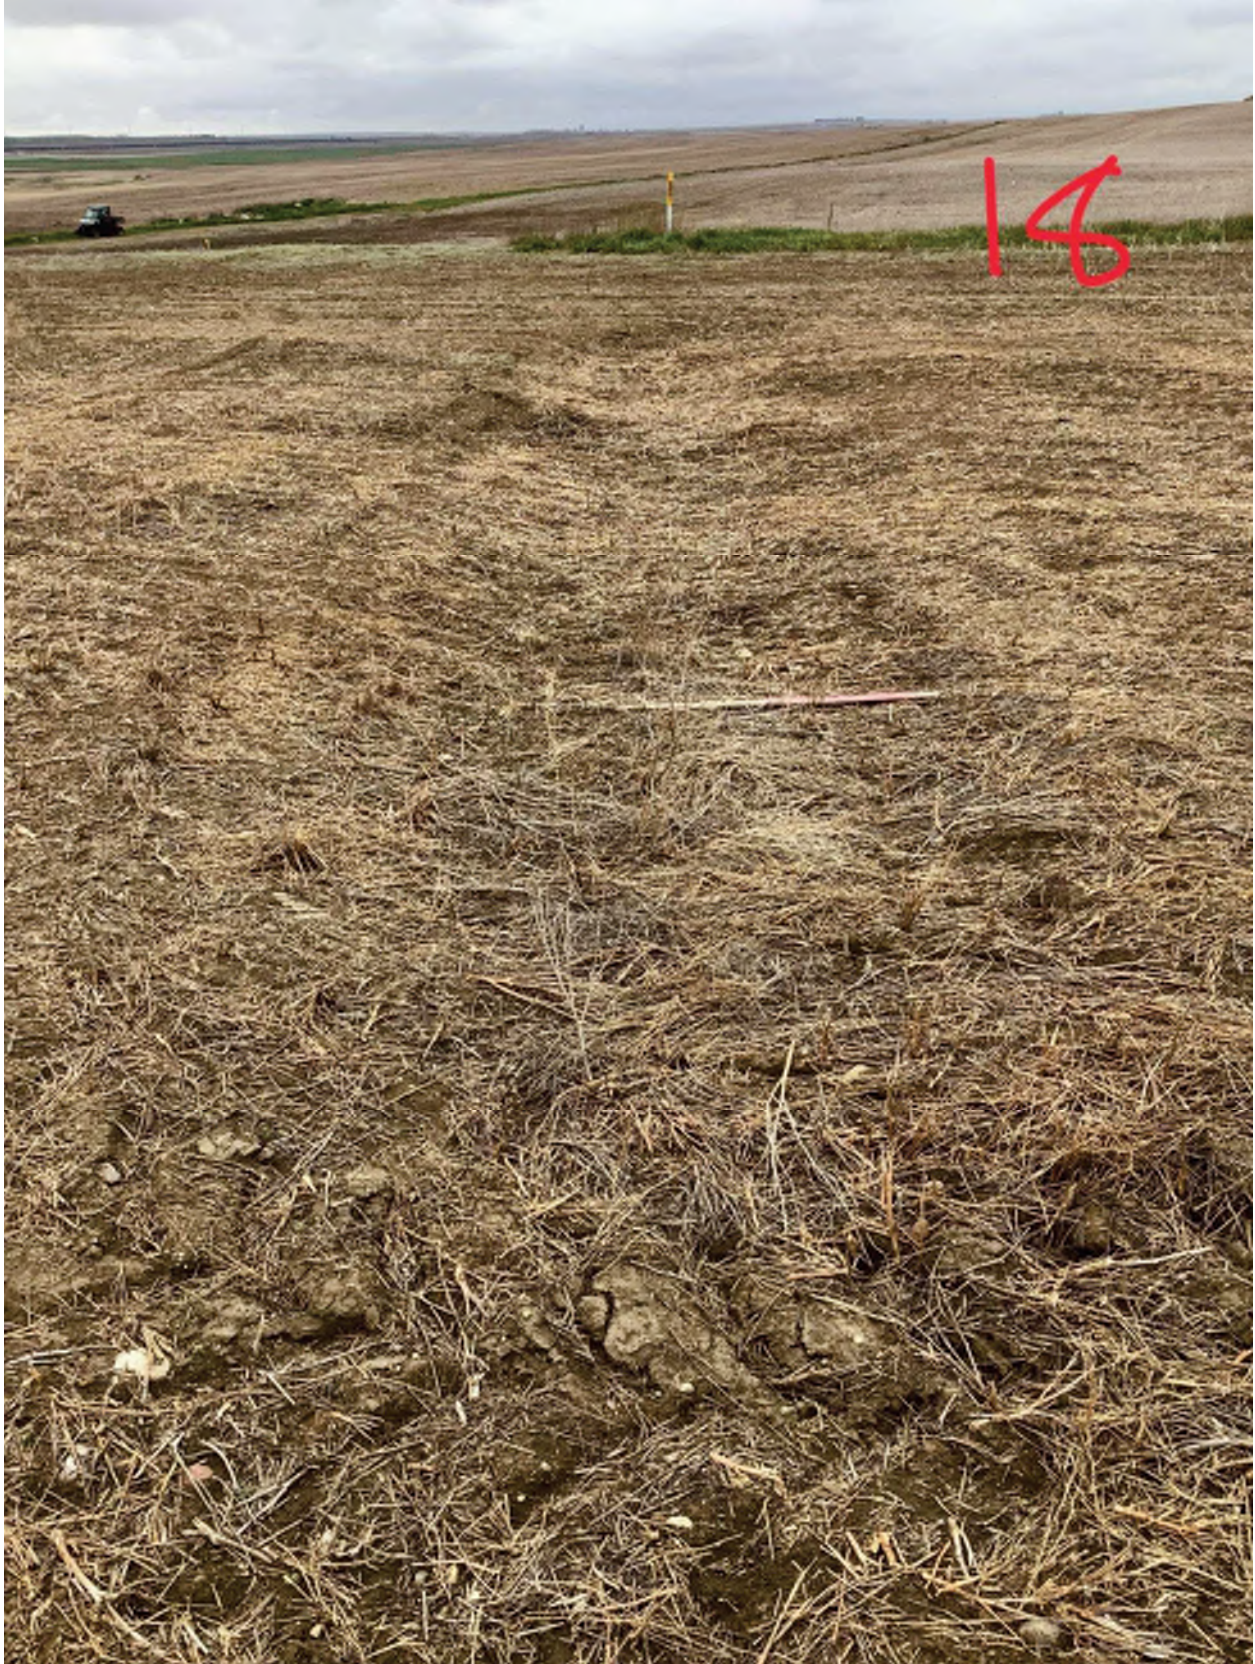
P18 looking NE, minor trench sinkage and substantive crop cover. Landowner has been working the field.

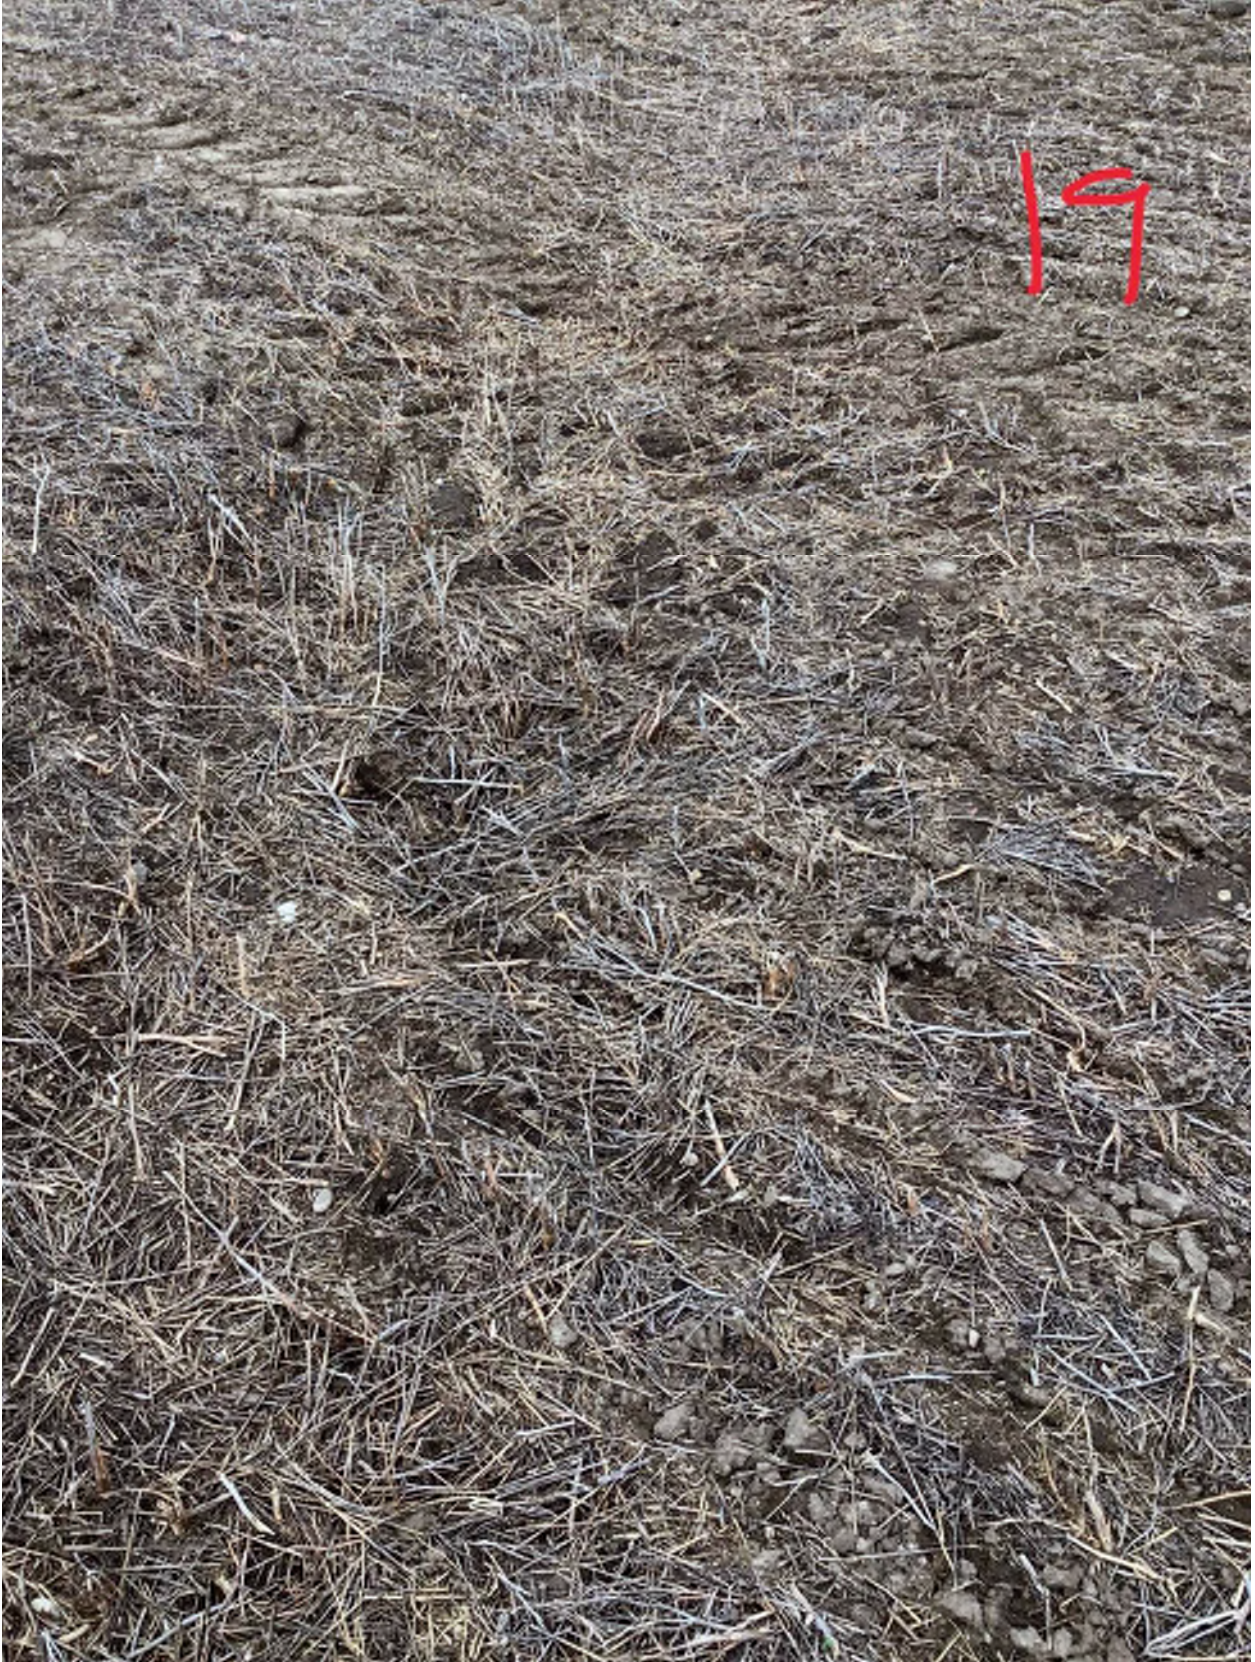
P19 looking SW, No issues.

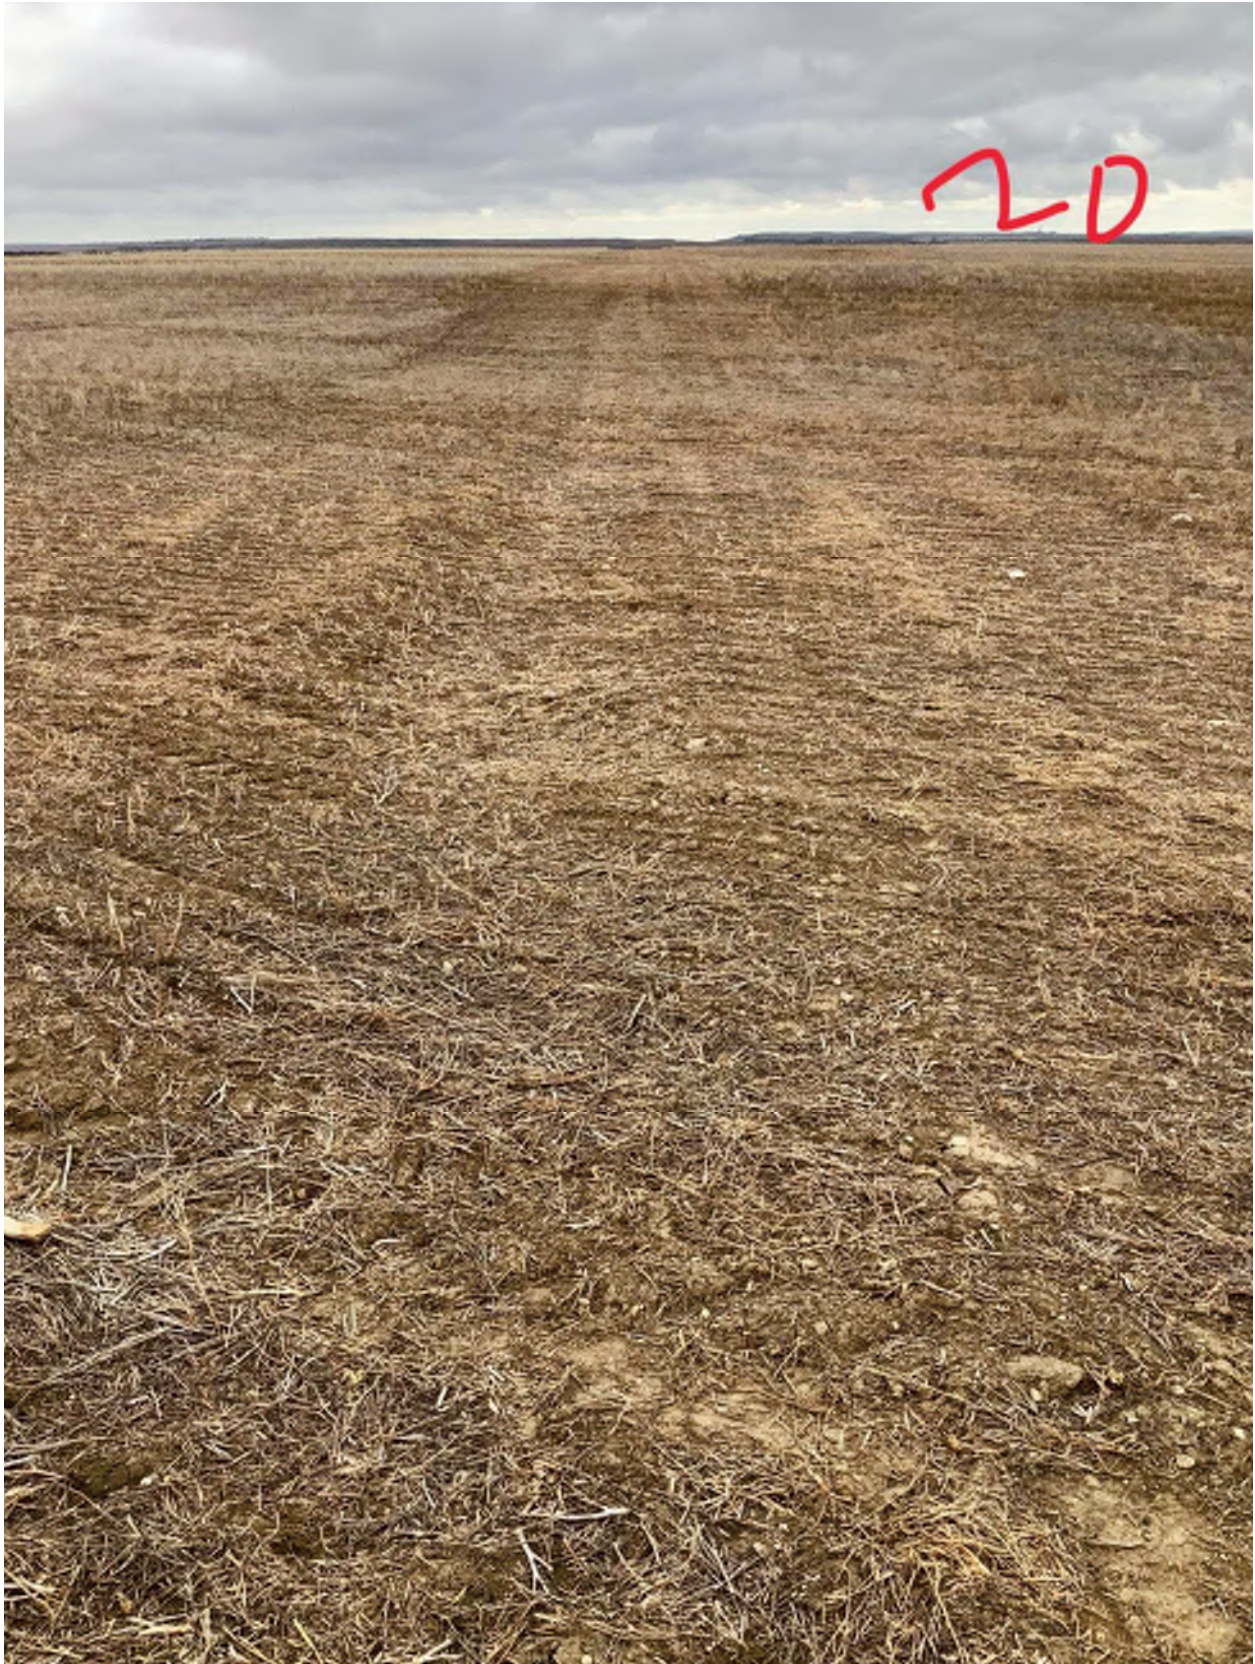
P20 looking WSW, No issues.

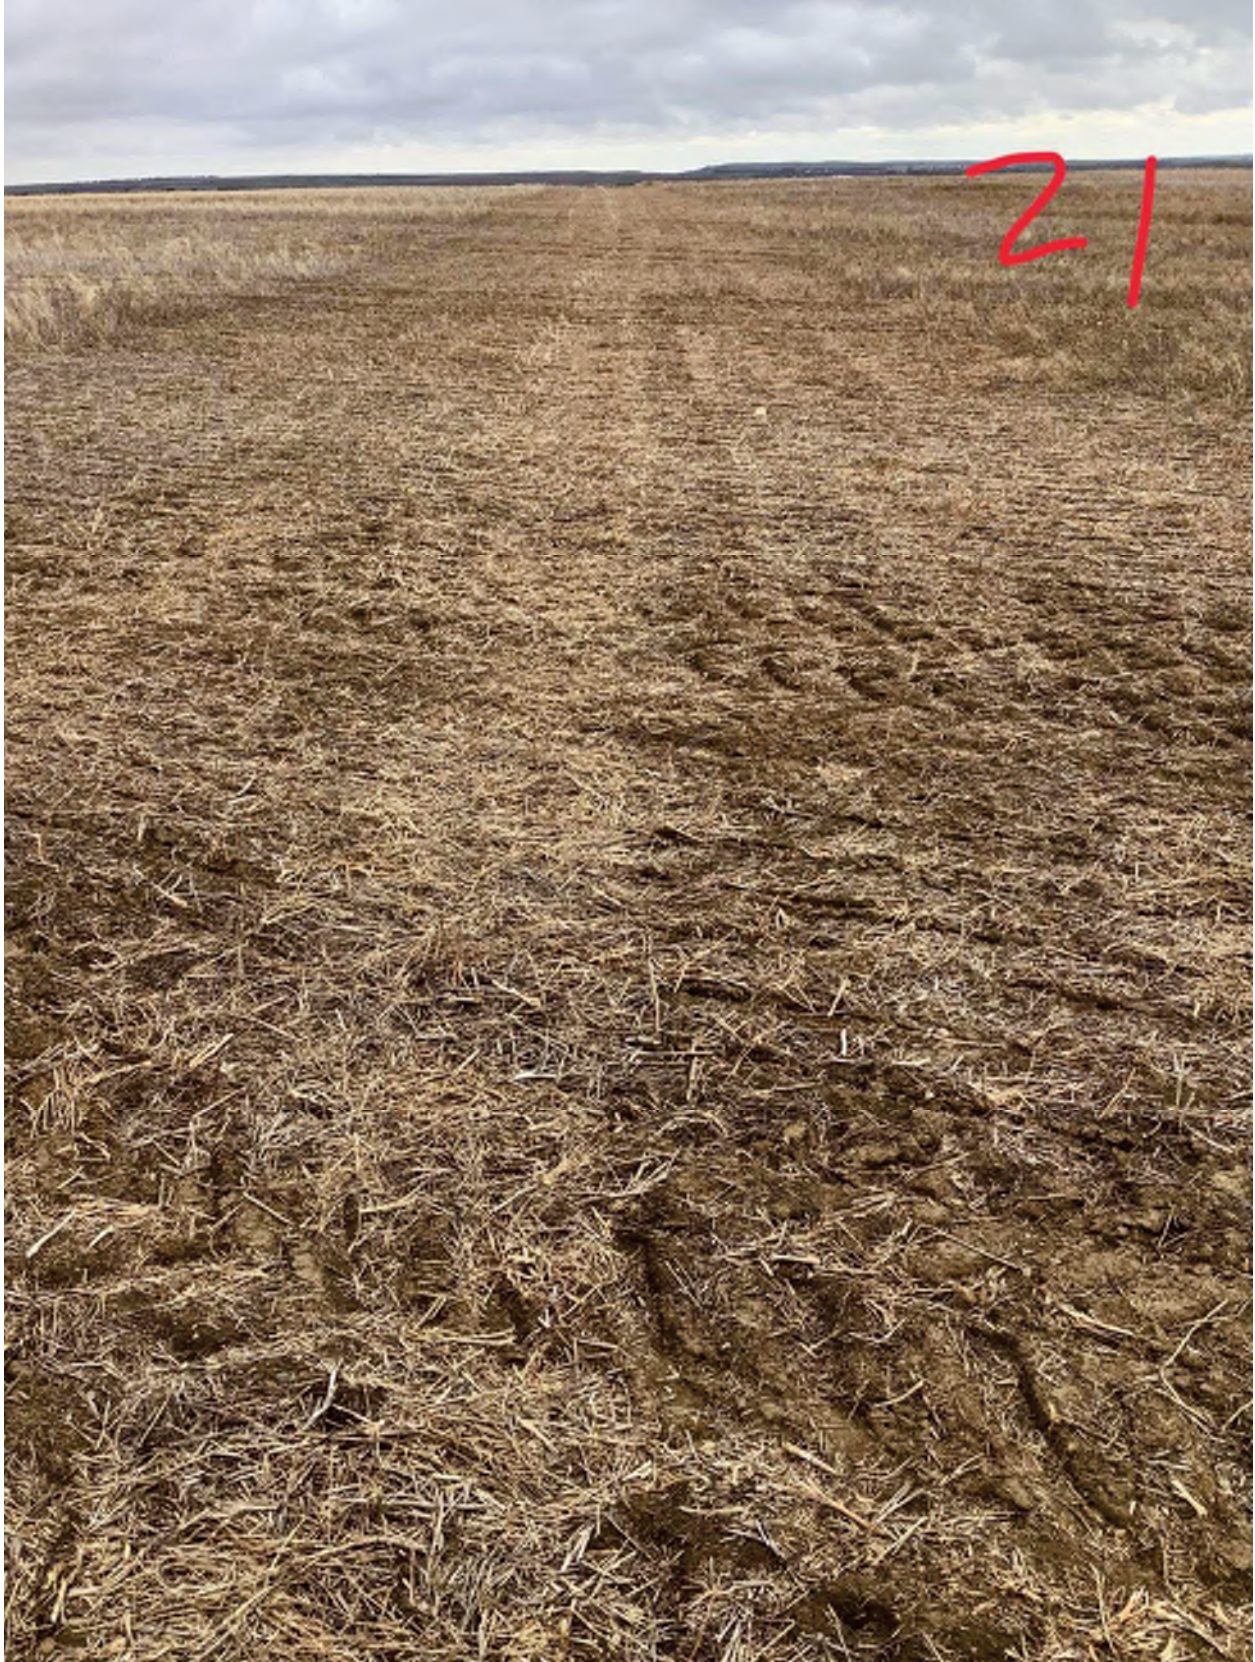
P21 looking WSW, no issues.

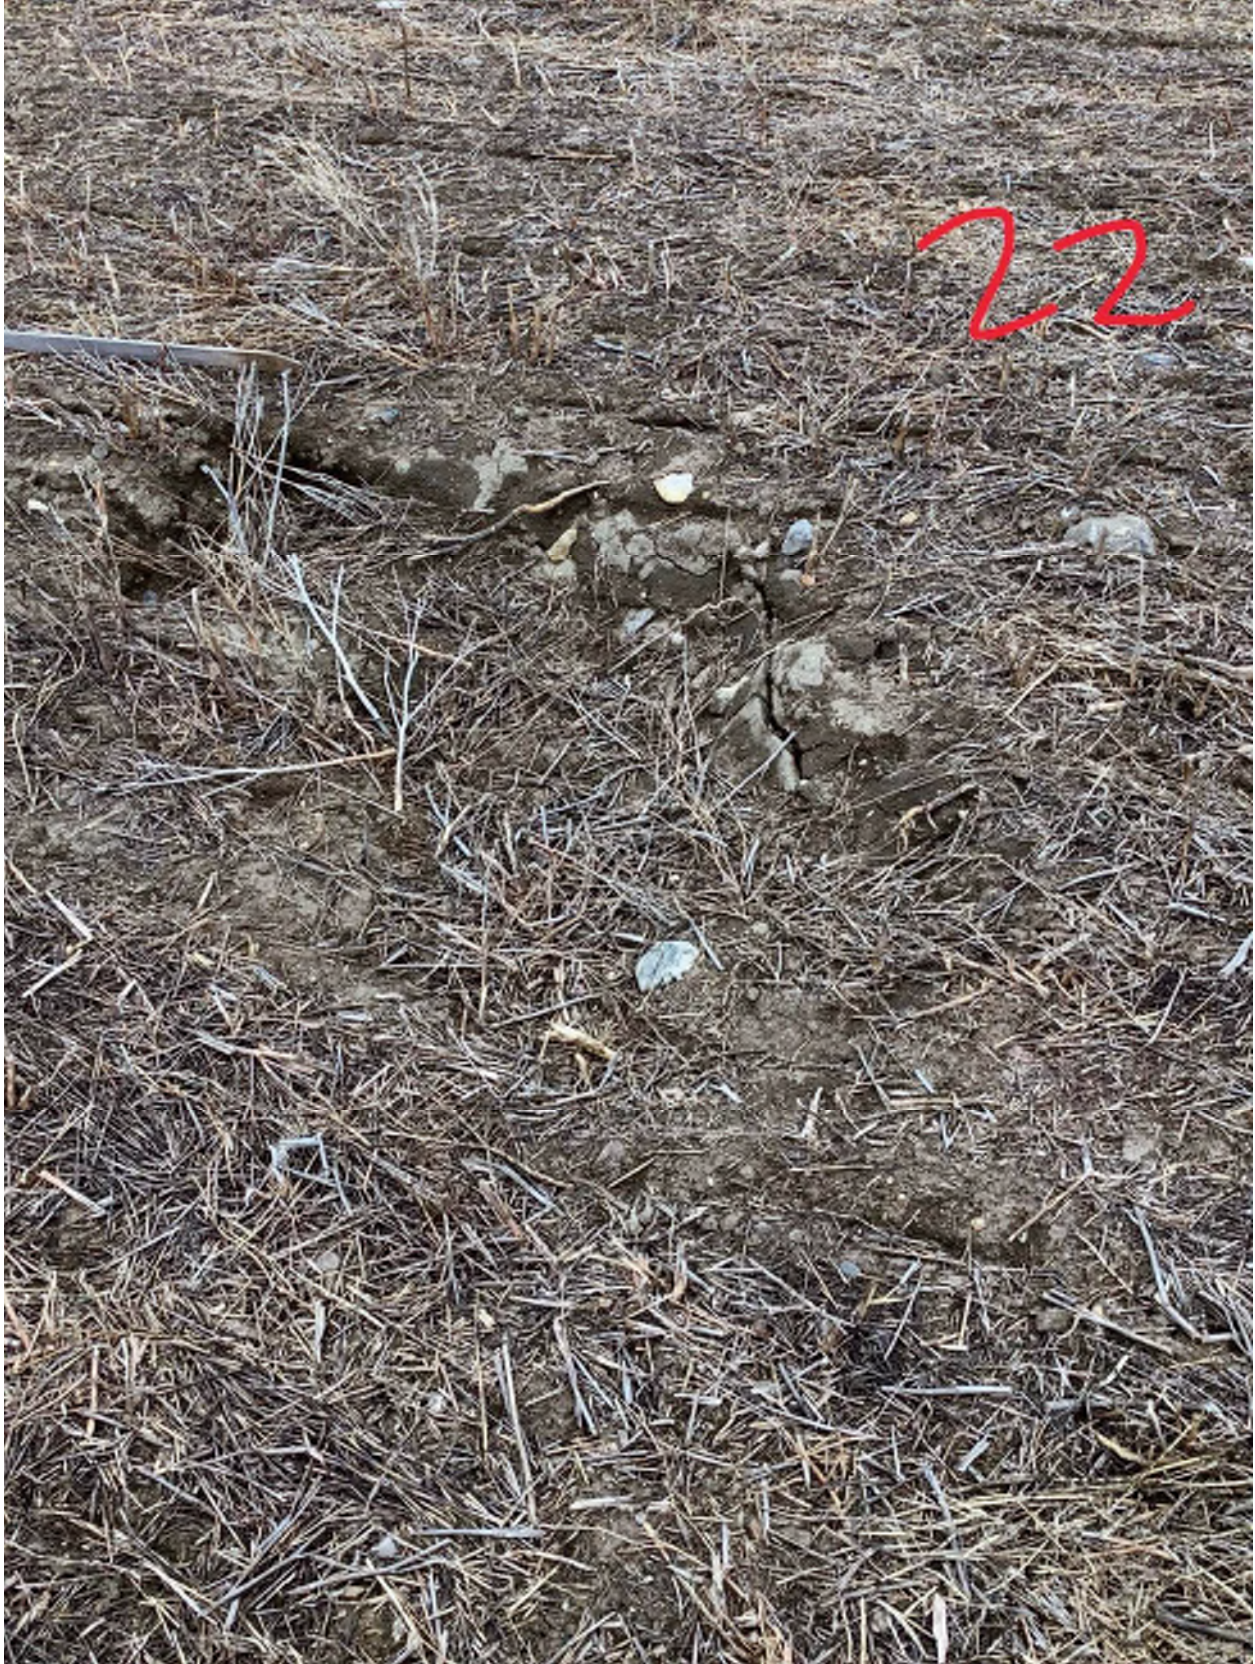
P22 looking SW, localized trench sinkage and soil cracking.

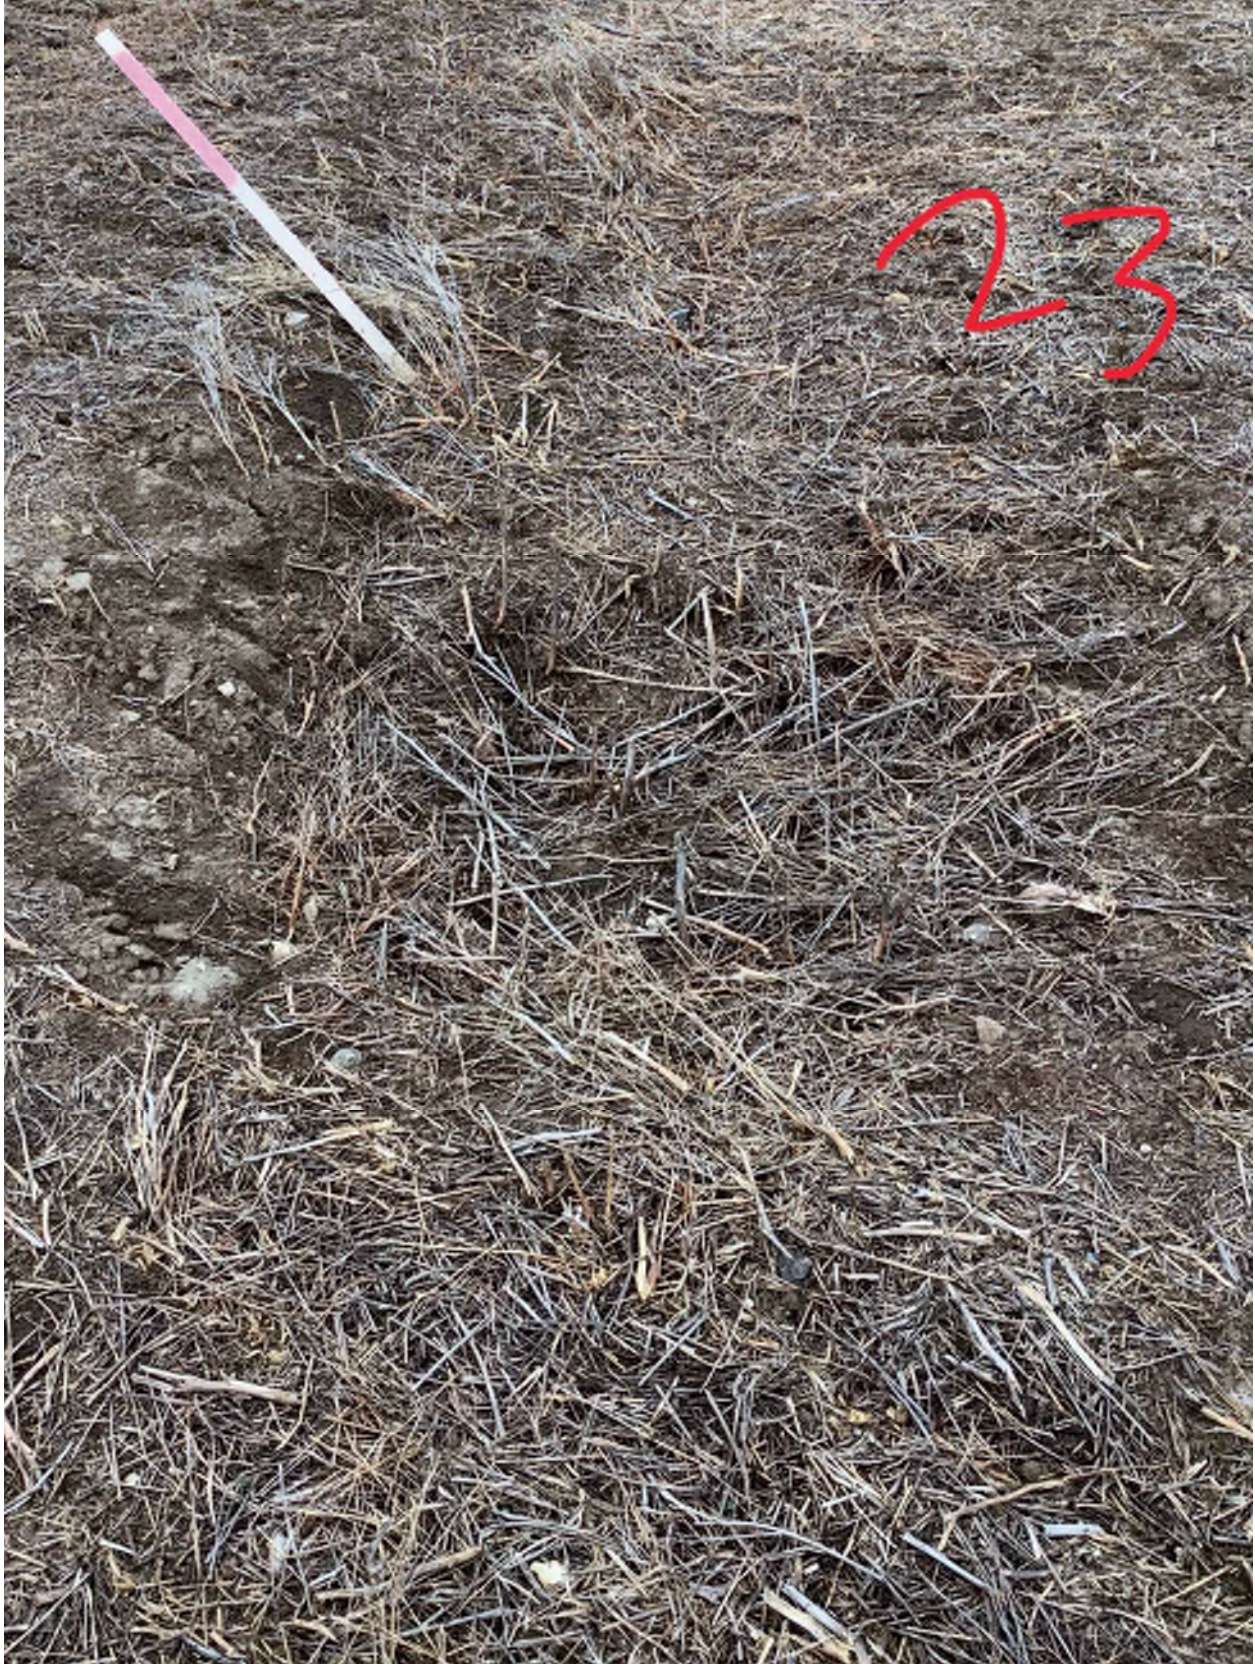
P23 looking NE, localized trench sinkage.
