Hiland Crude LLC

2.9-mile Crude Oil Pipeline— Williams County

Case No. PU-21-353

Reclamation and Revegetation Inspection Report

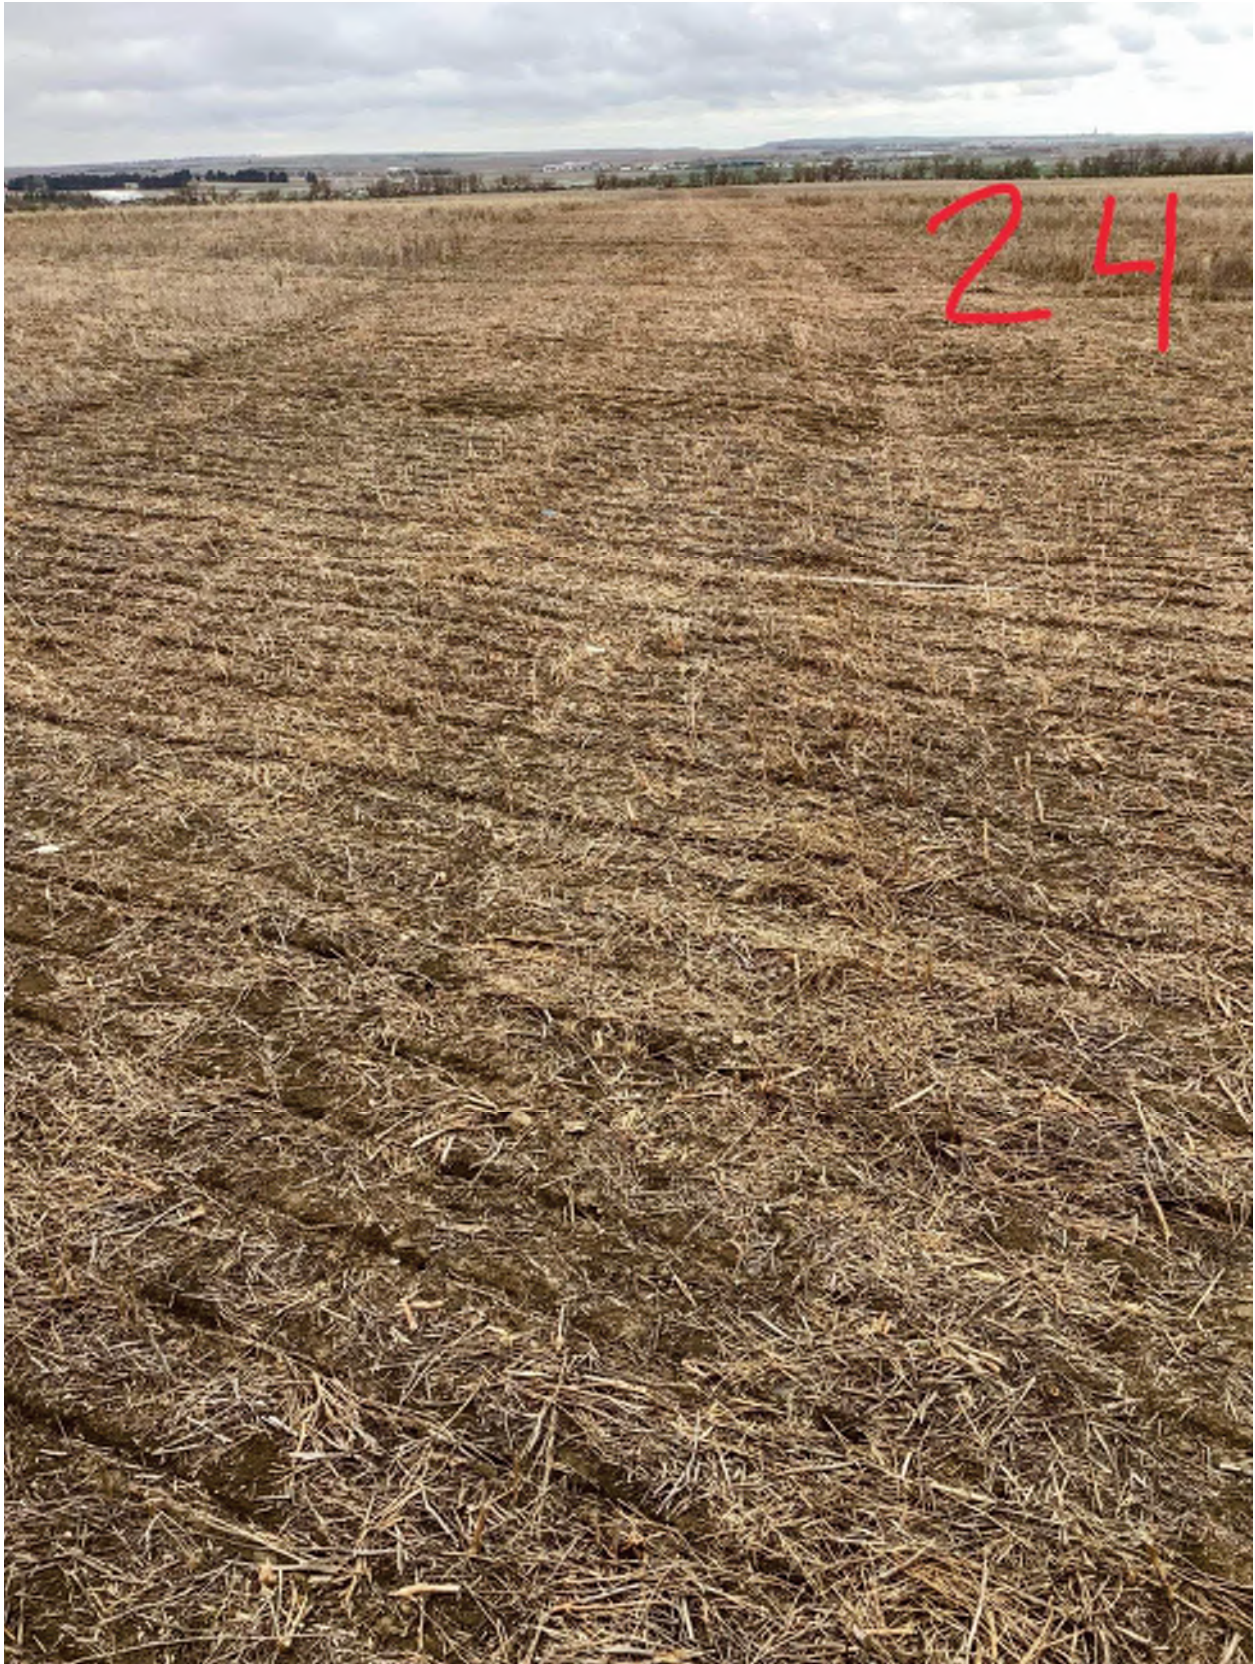
P24 looking SW, no issues.

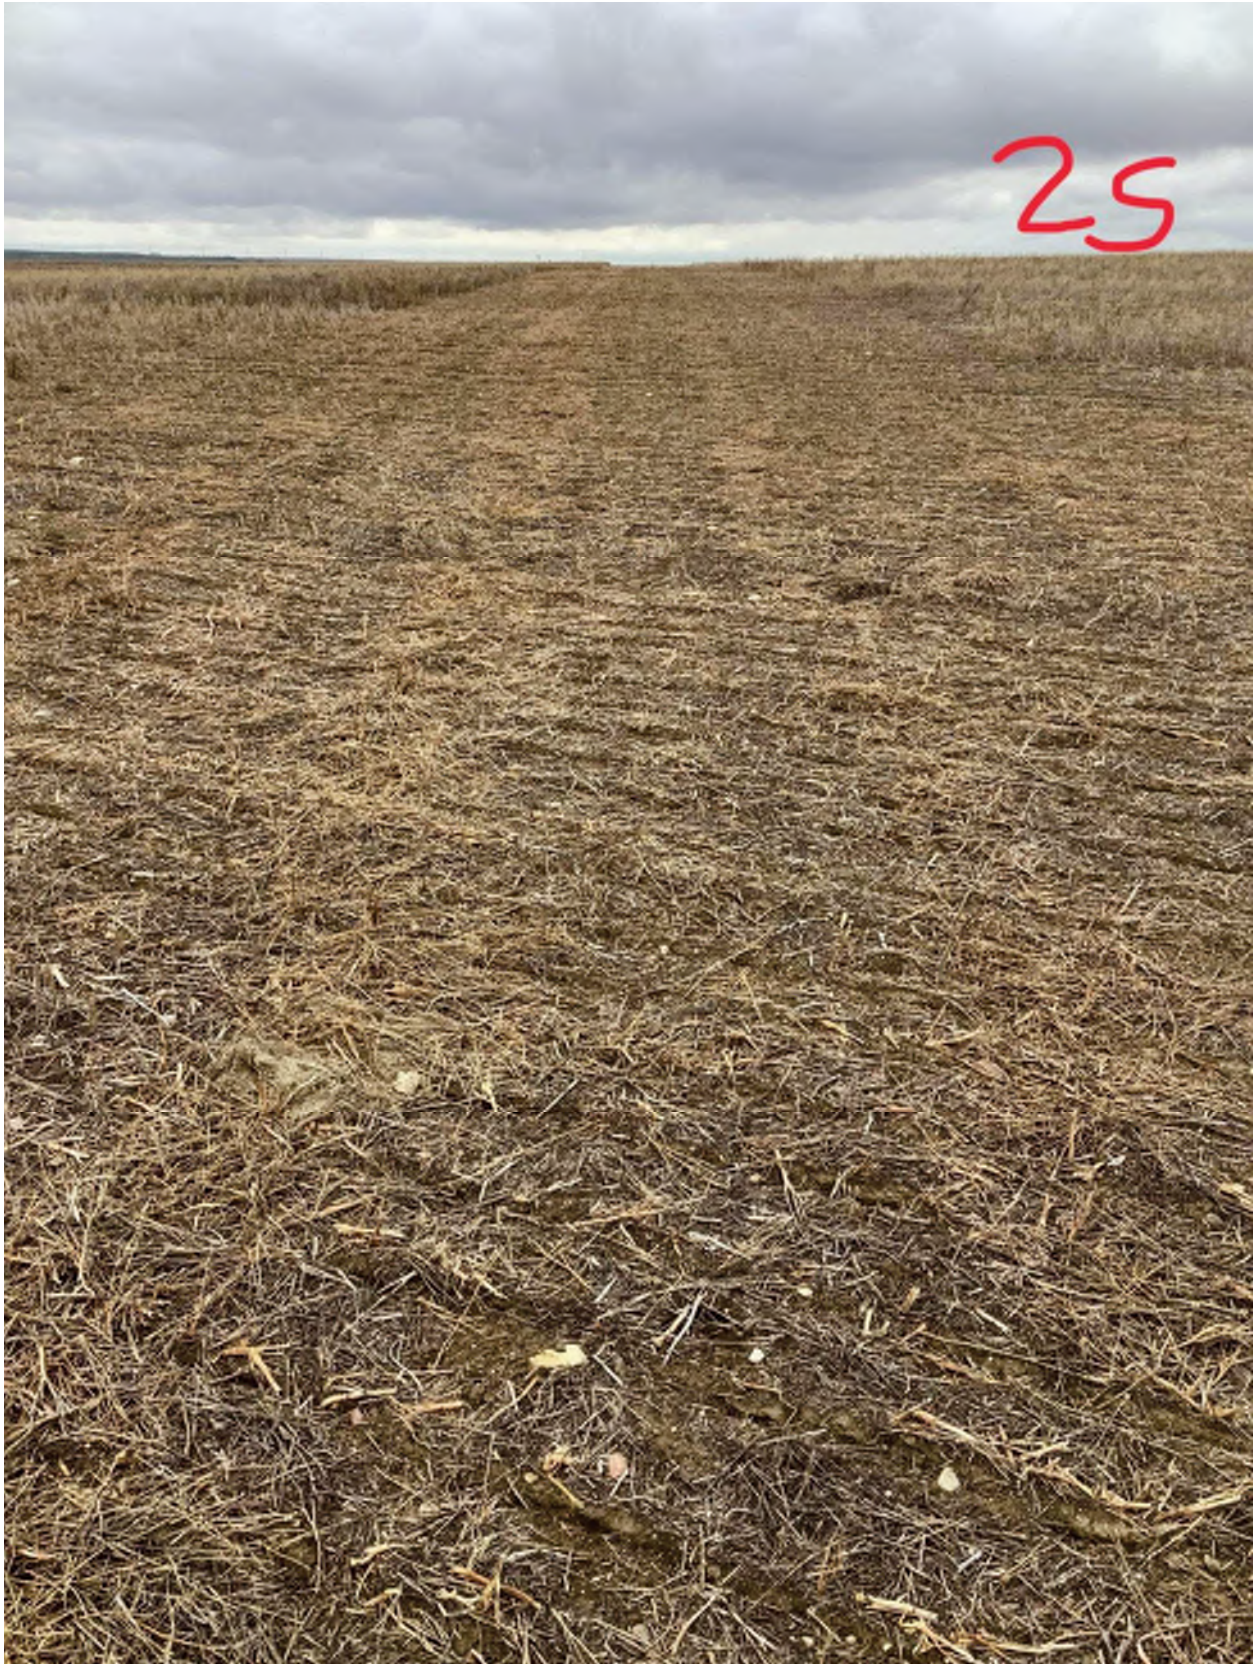
P25 looking NE, no issues.

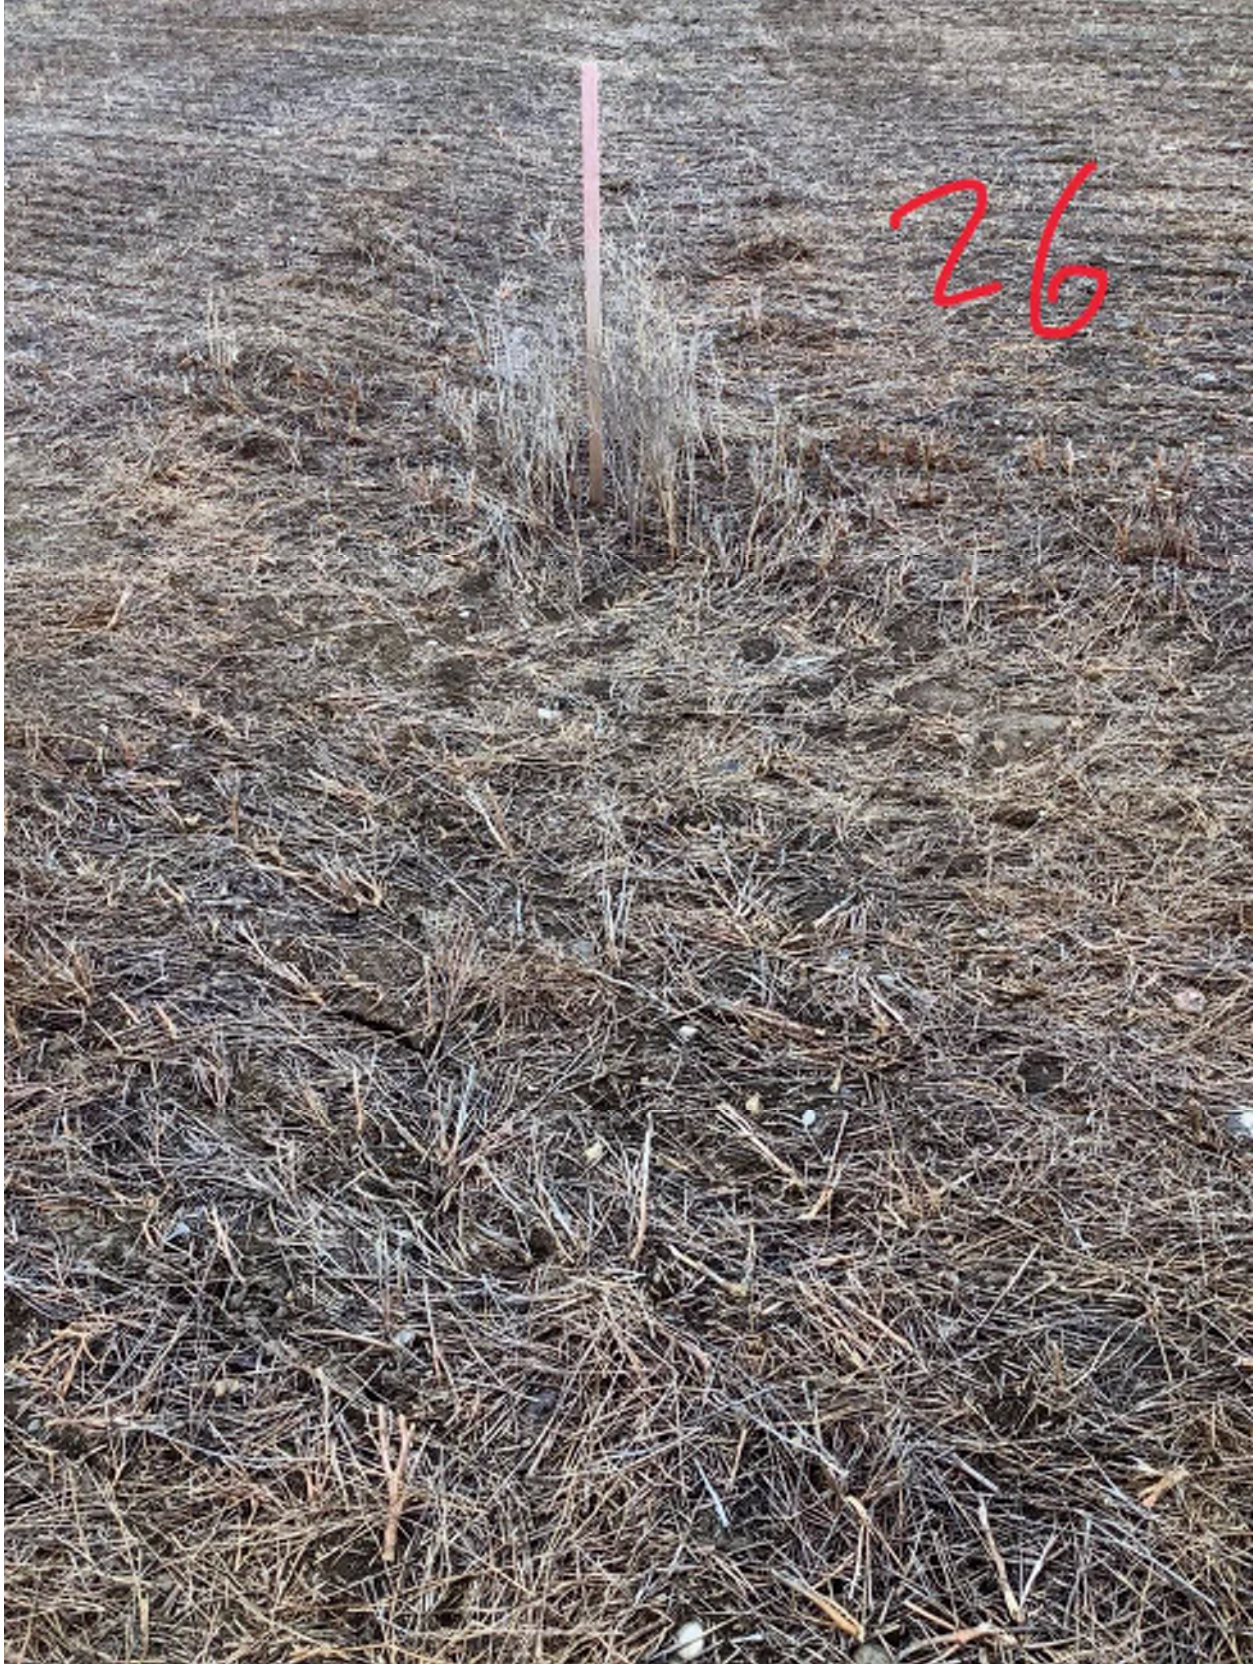
P26 looking SW, minor trench sinking along ROW. Landowner has been utilizing the area.

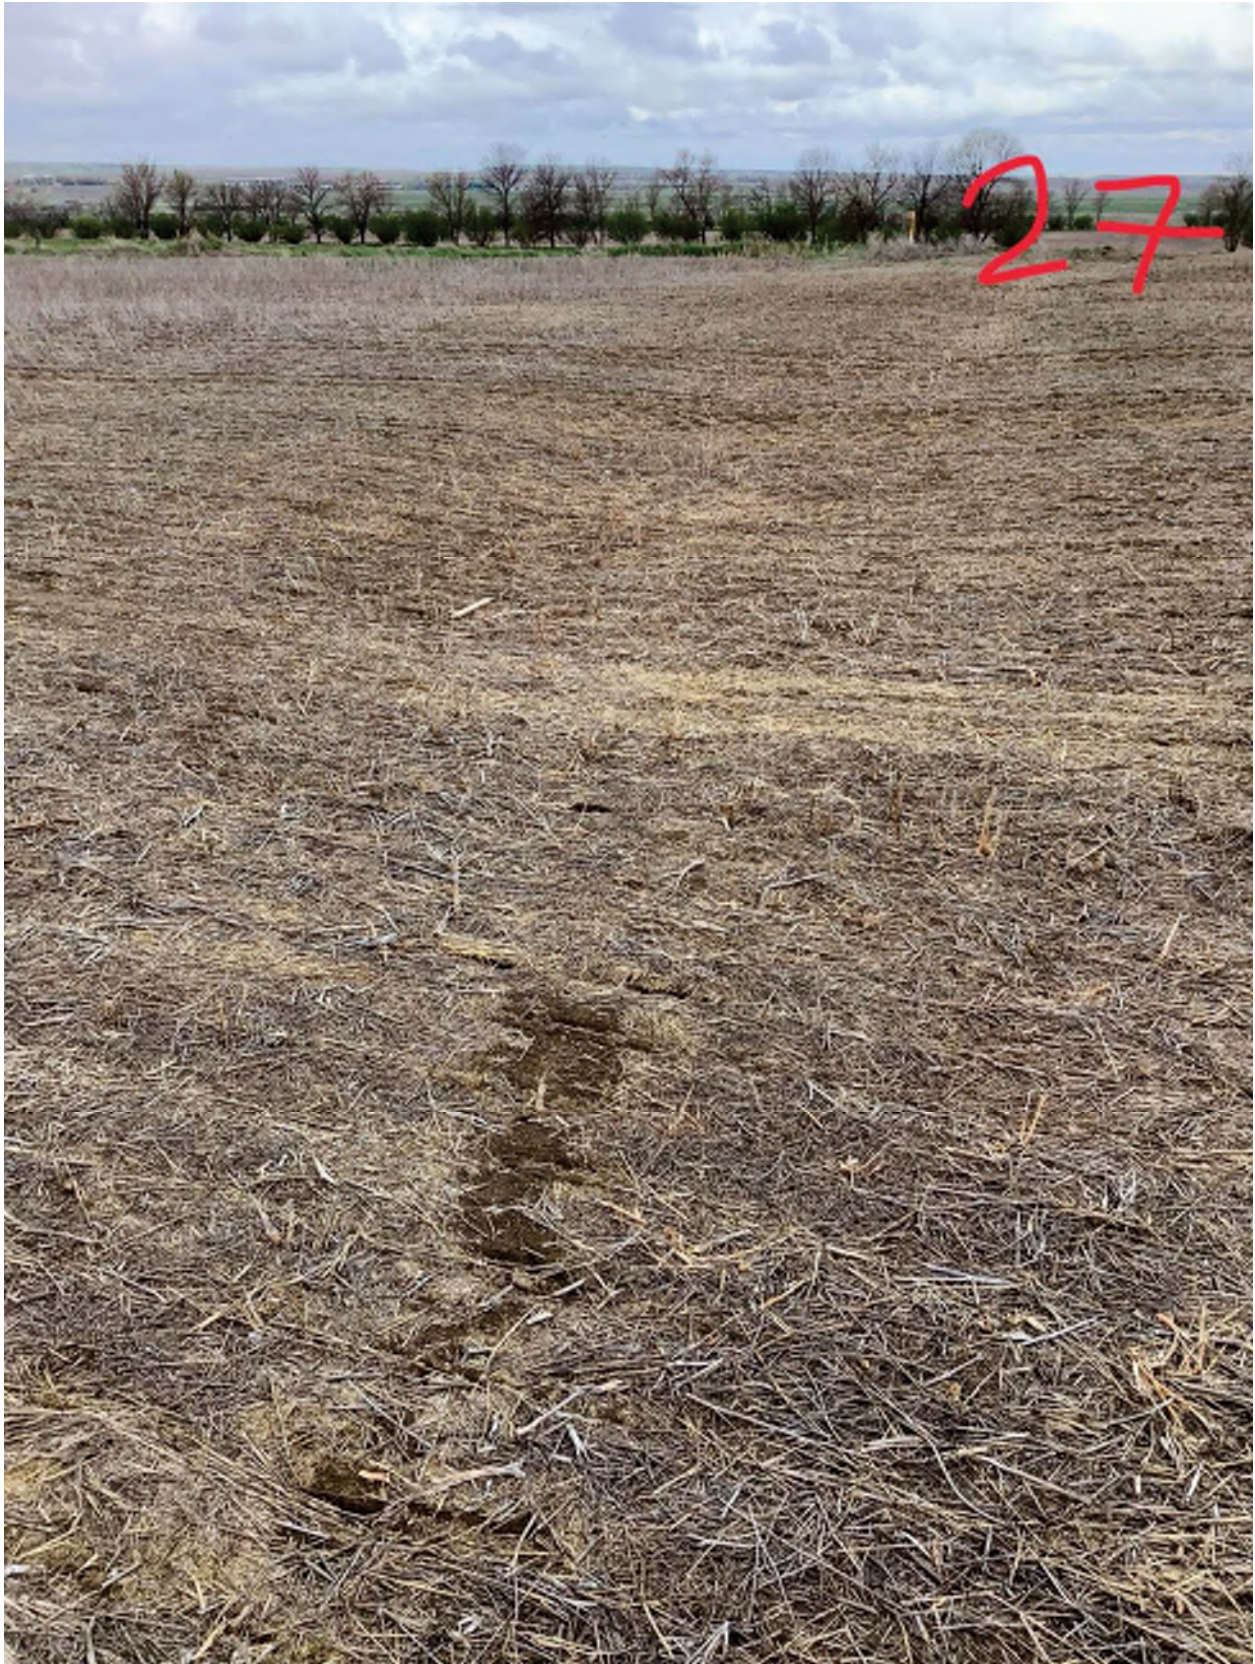
P27 looking WSW, no issues.

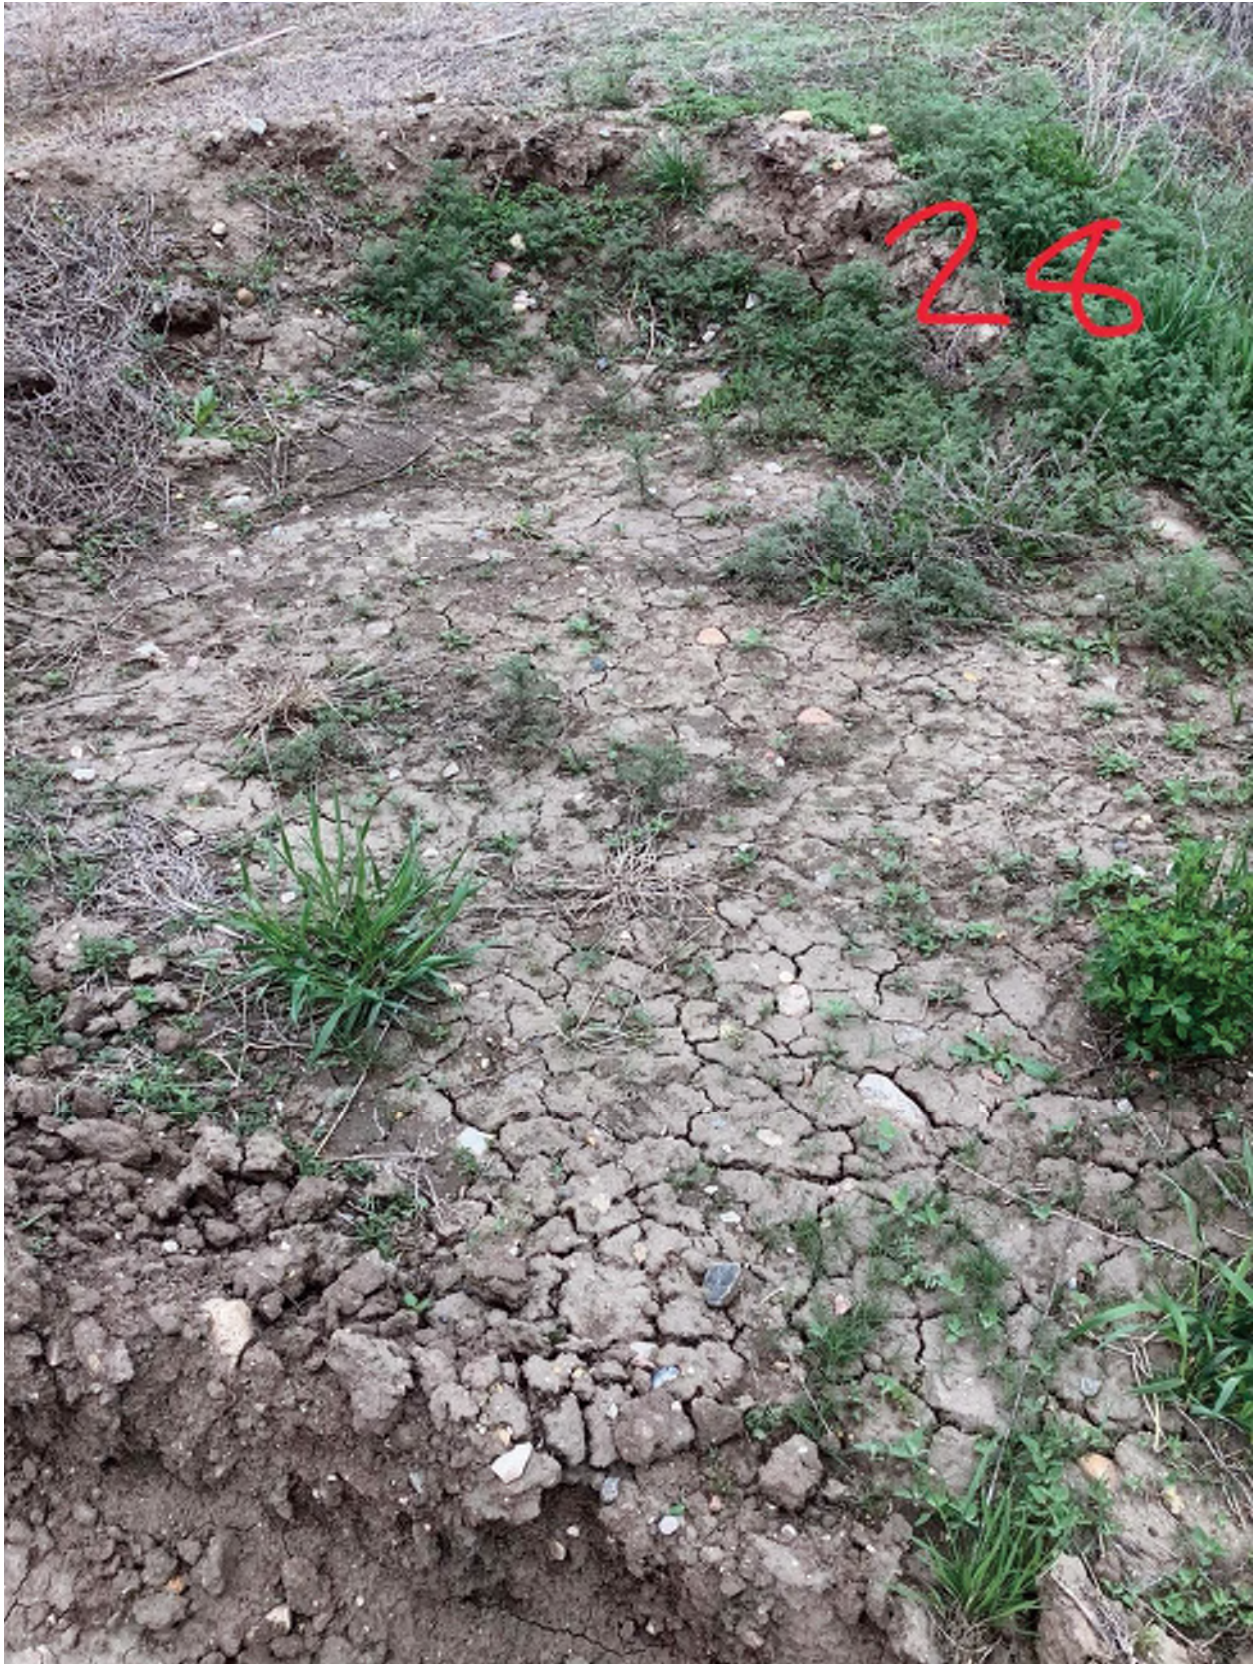
It was noted in several spots (documented in pictures P6-8, and P28-29) that the landowner had remedied localized trench settlement by moving soil and placing it over the settled areas.

P28 looking S, spot where landowner came in and removed soil to fill trench sink spots.

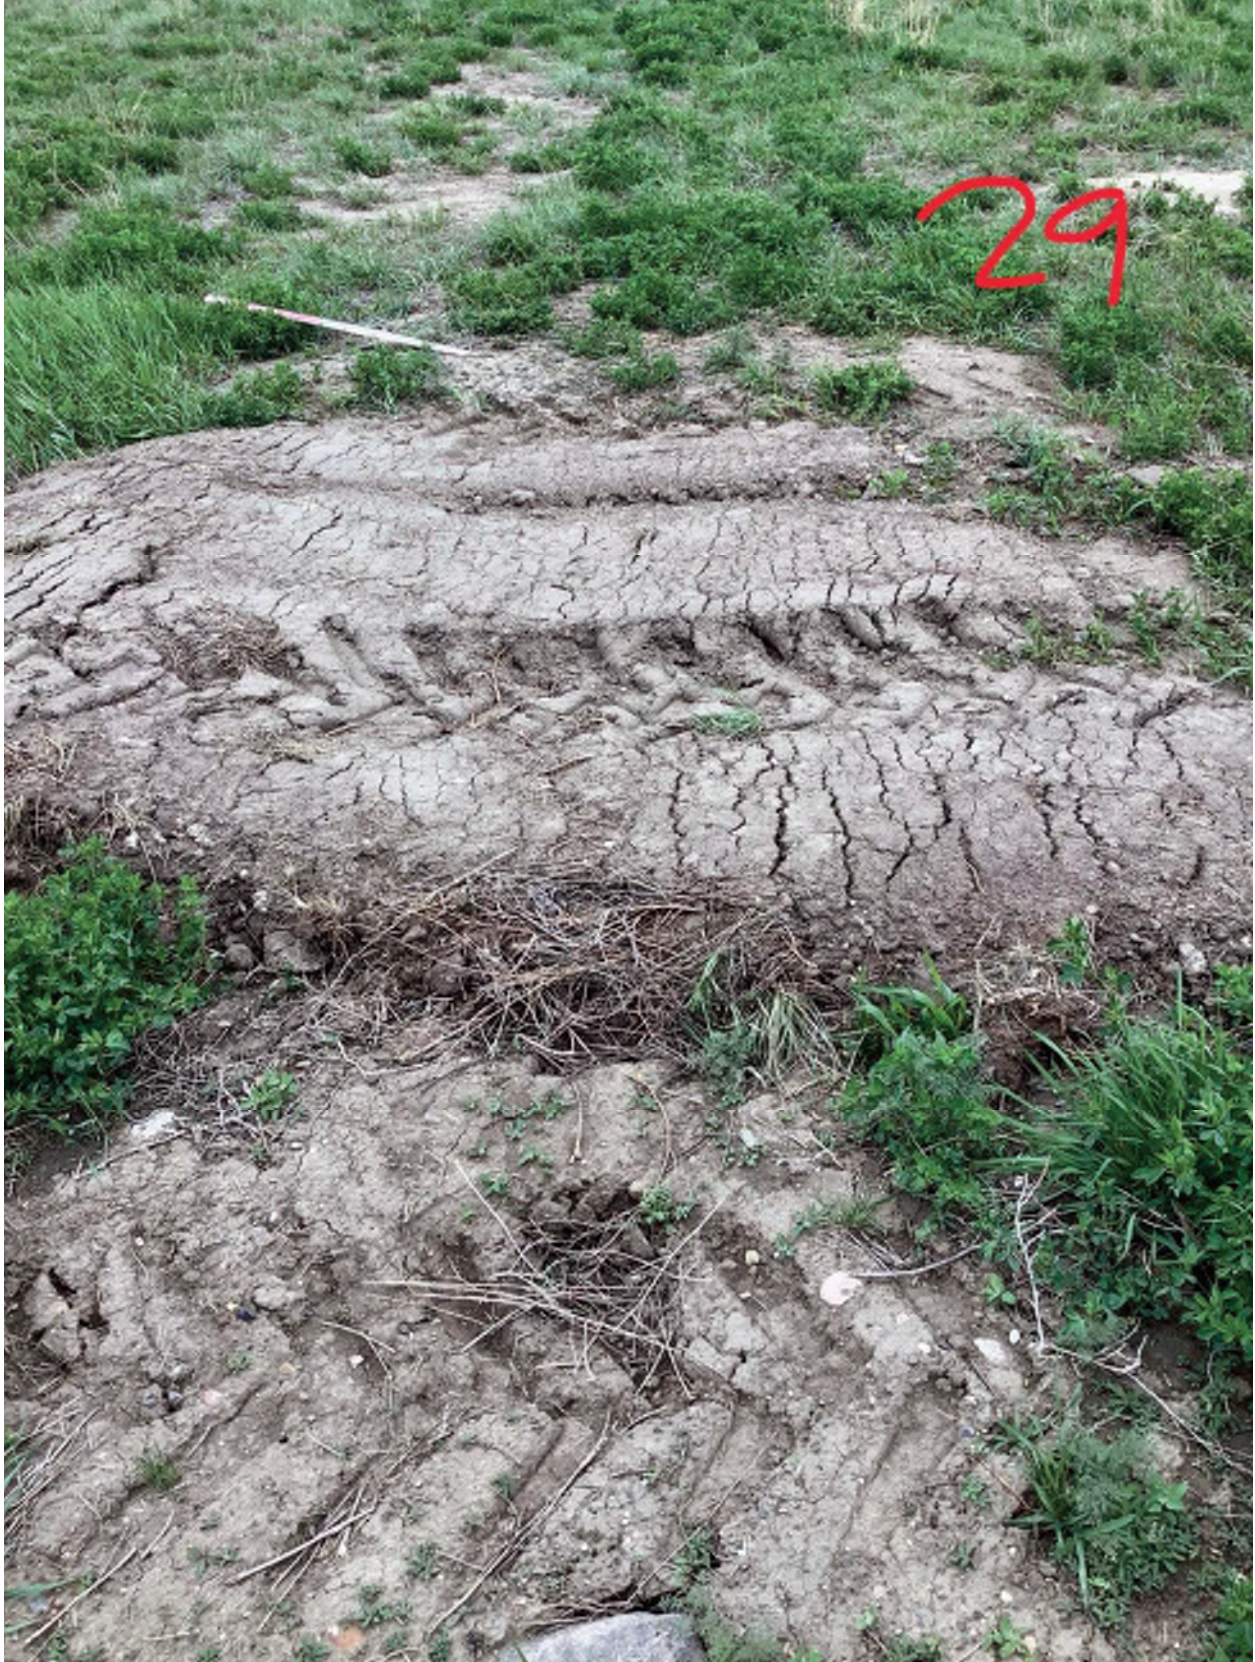
P29 looking W, area where landowner deposited soil to cover trench sink.

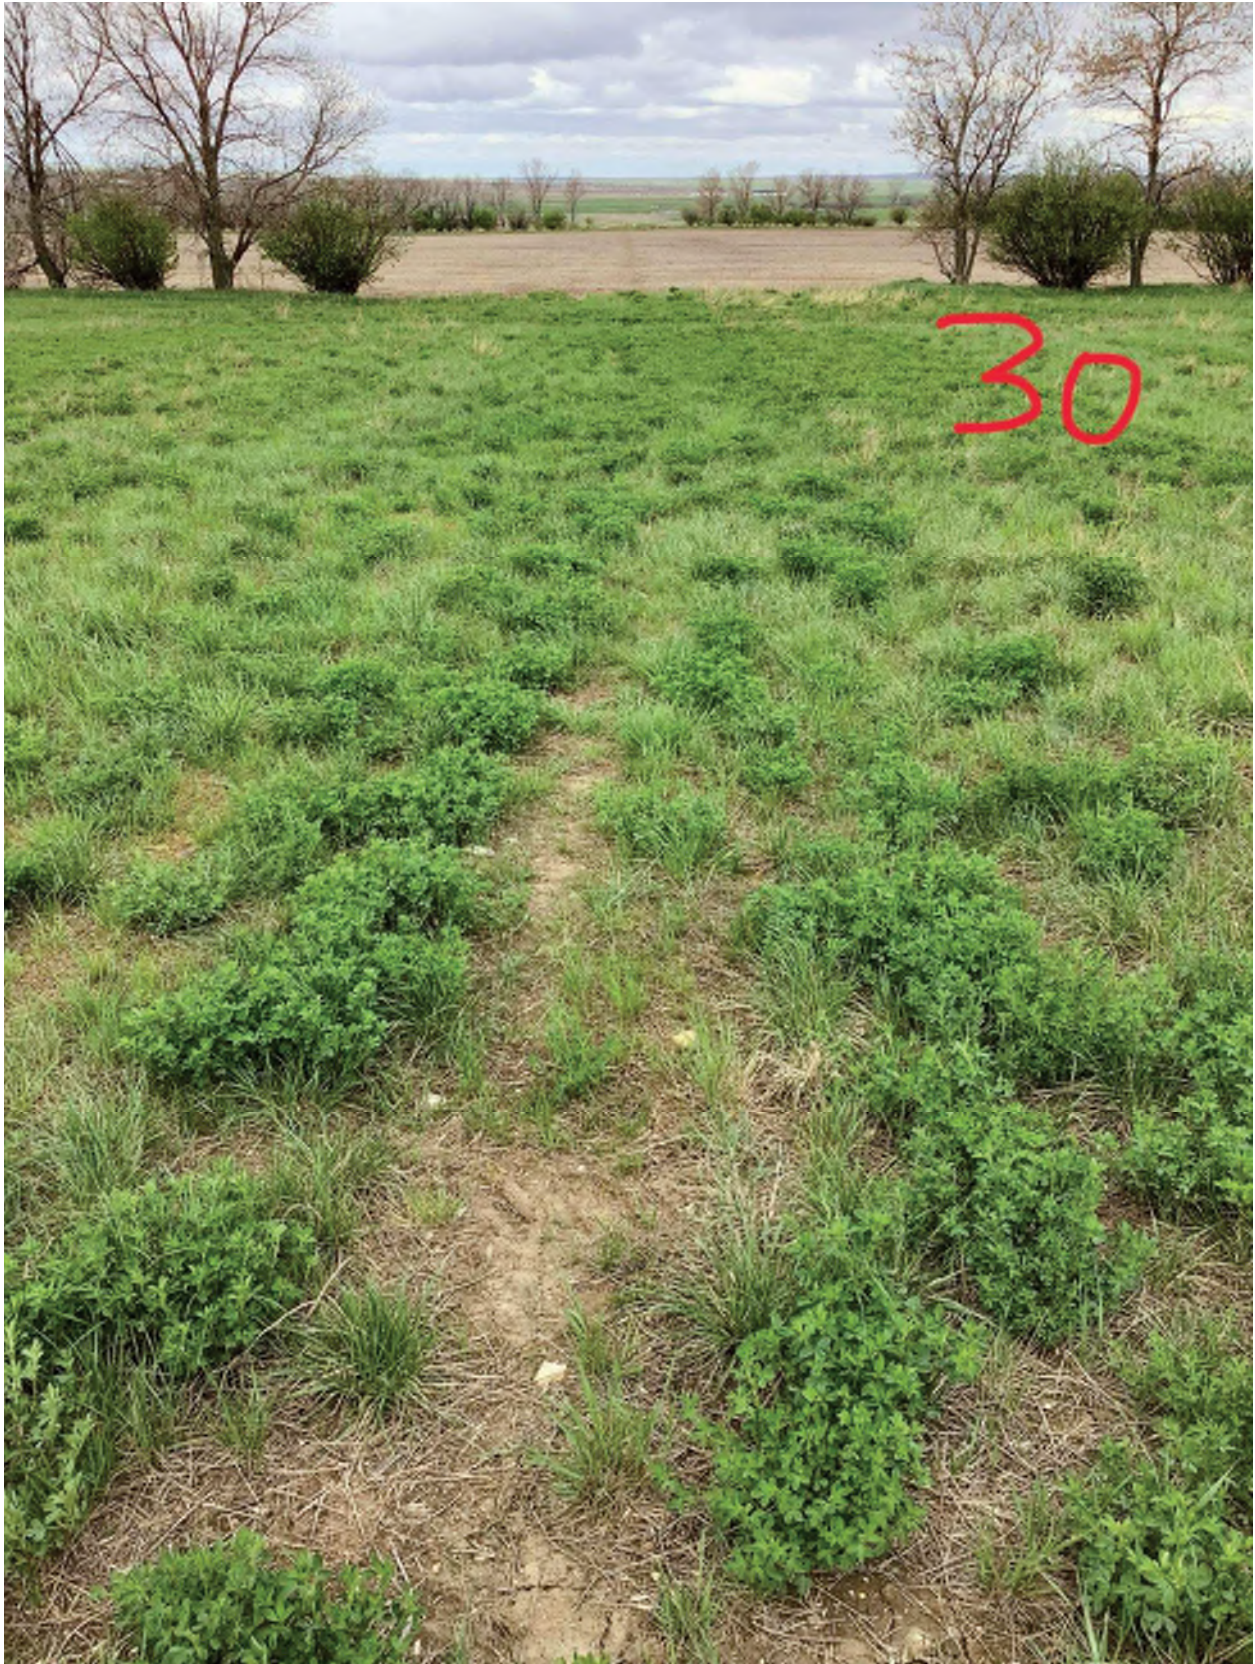
P30 looking W, no issues.

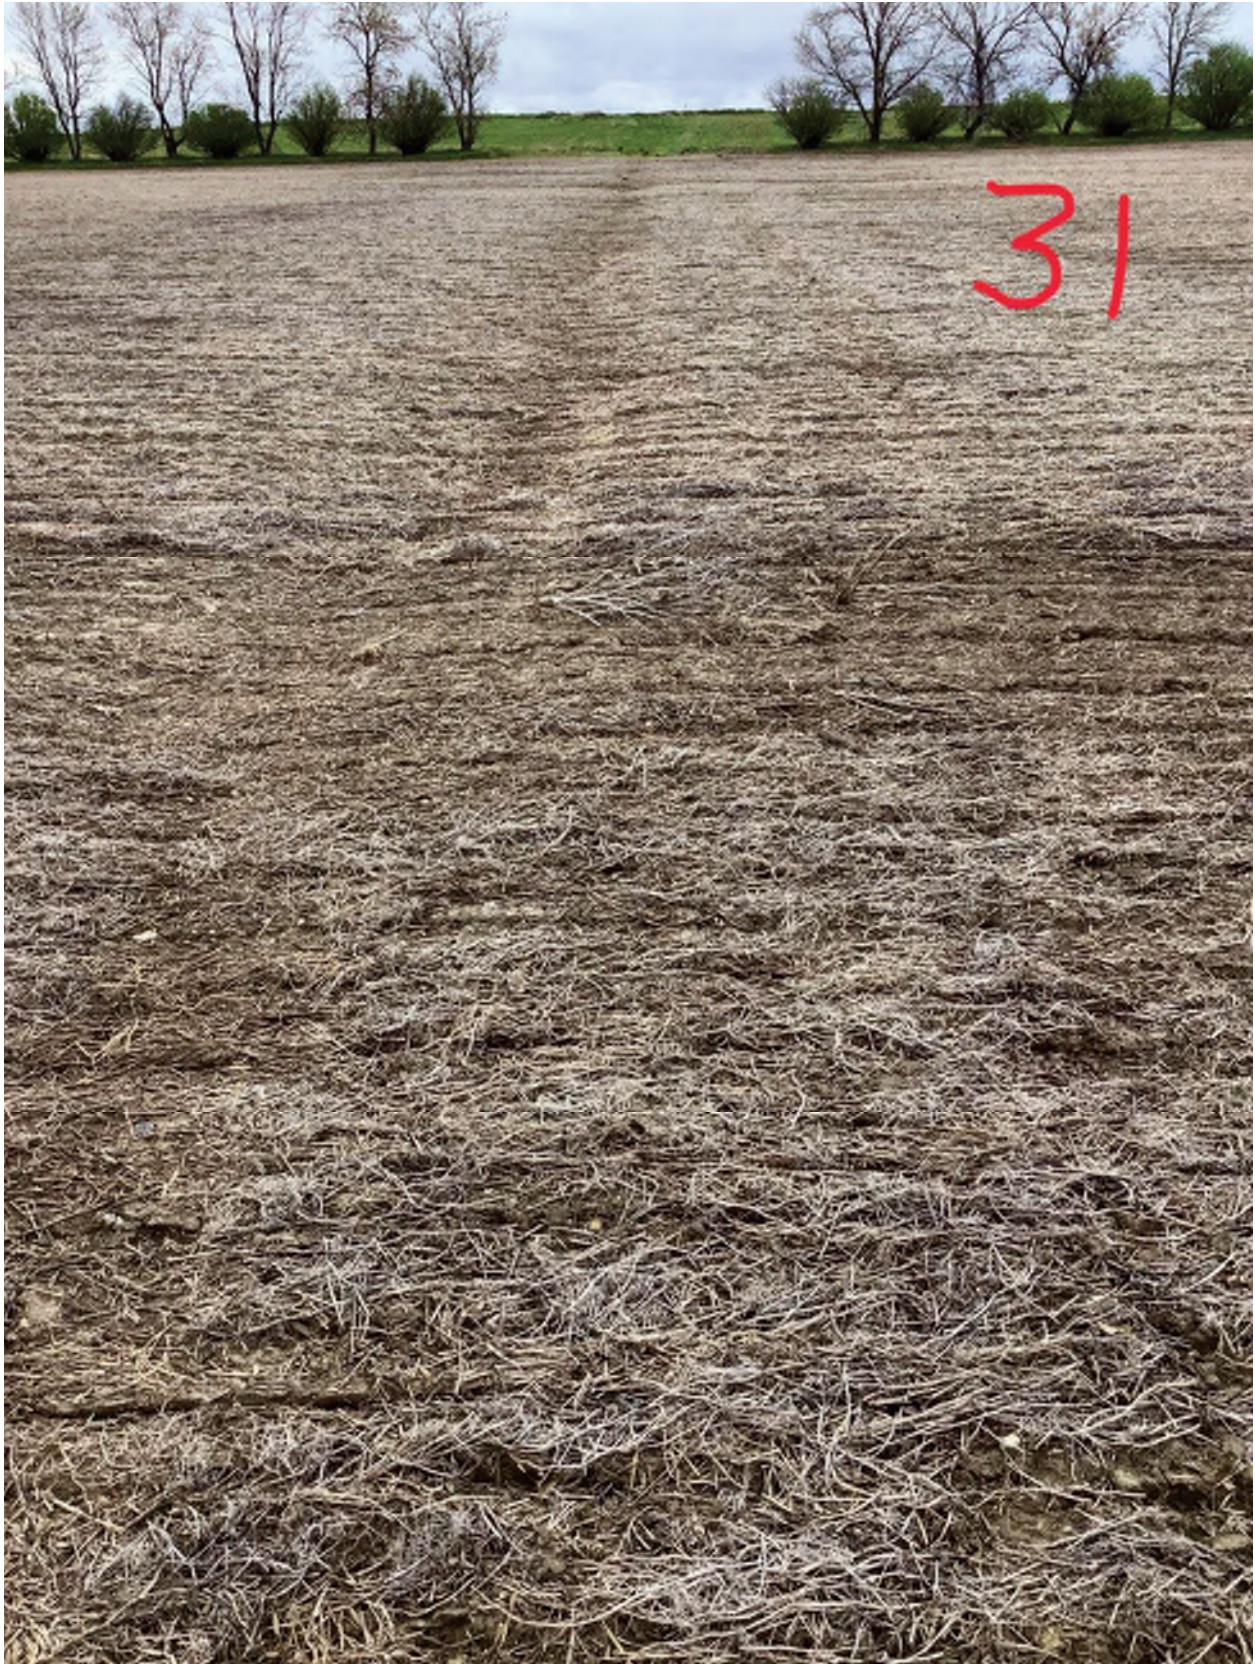
P31 looking W, no issues. Landowner worked land previously.

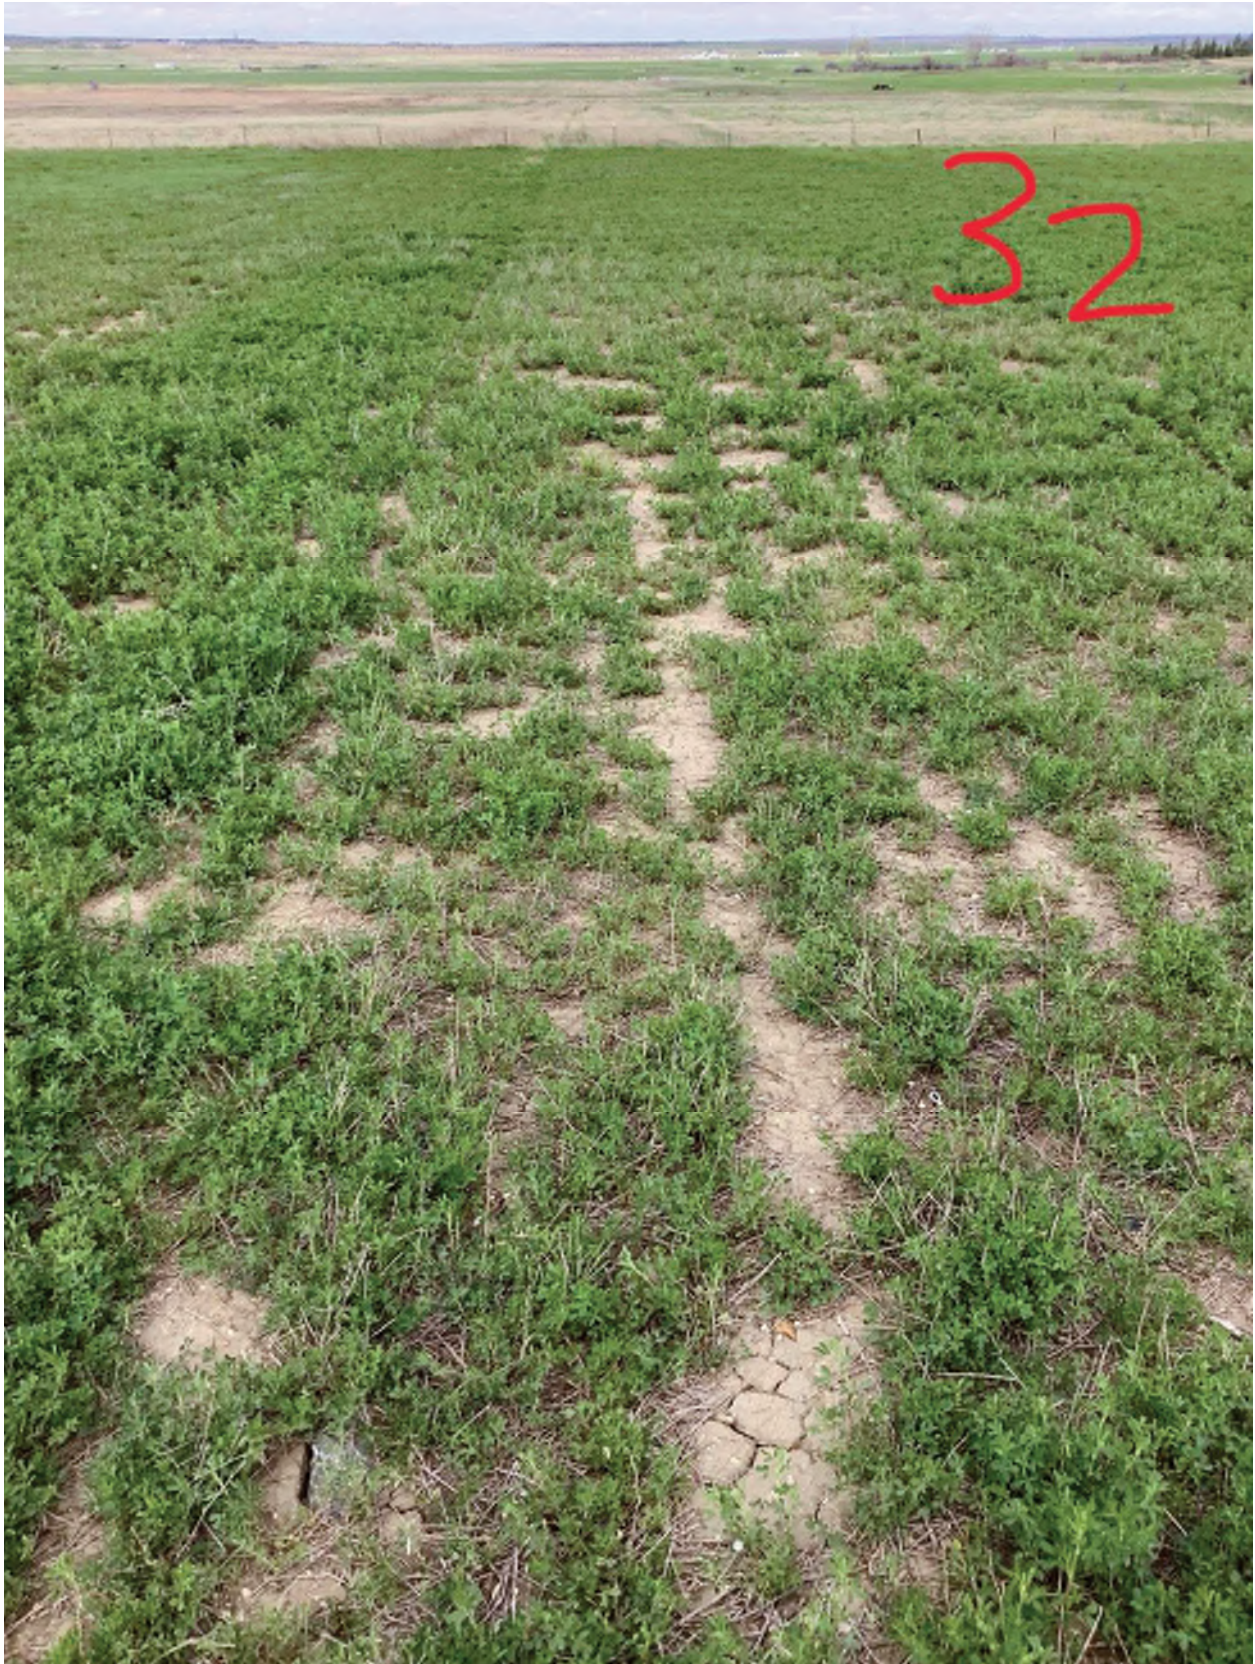
P32 looking W, vegetative cover present, some bare spots present. Likely needs more time to grow.

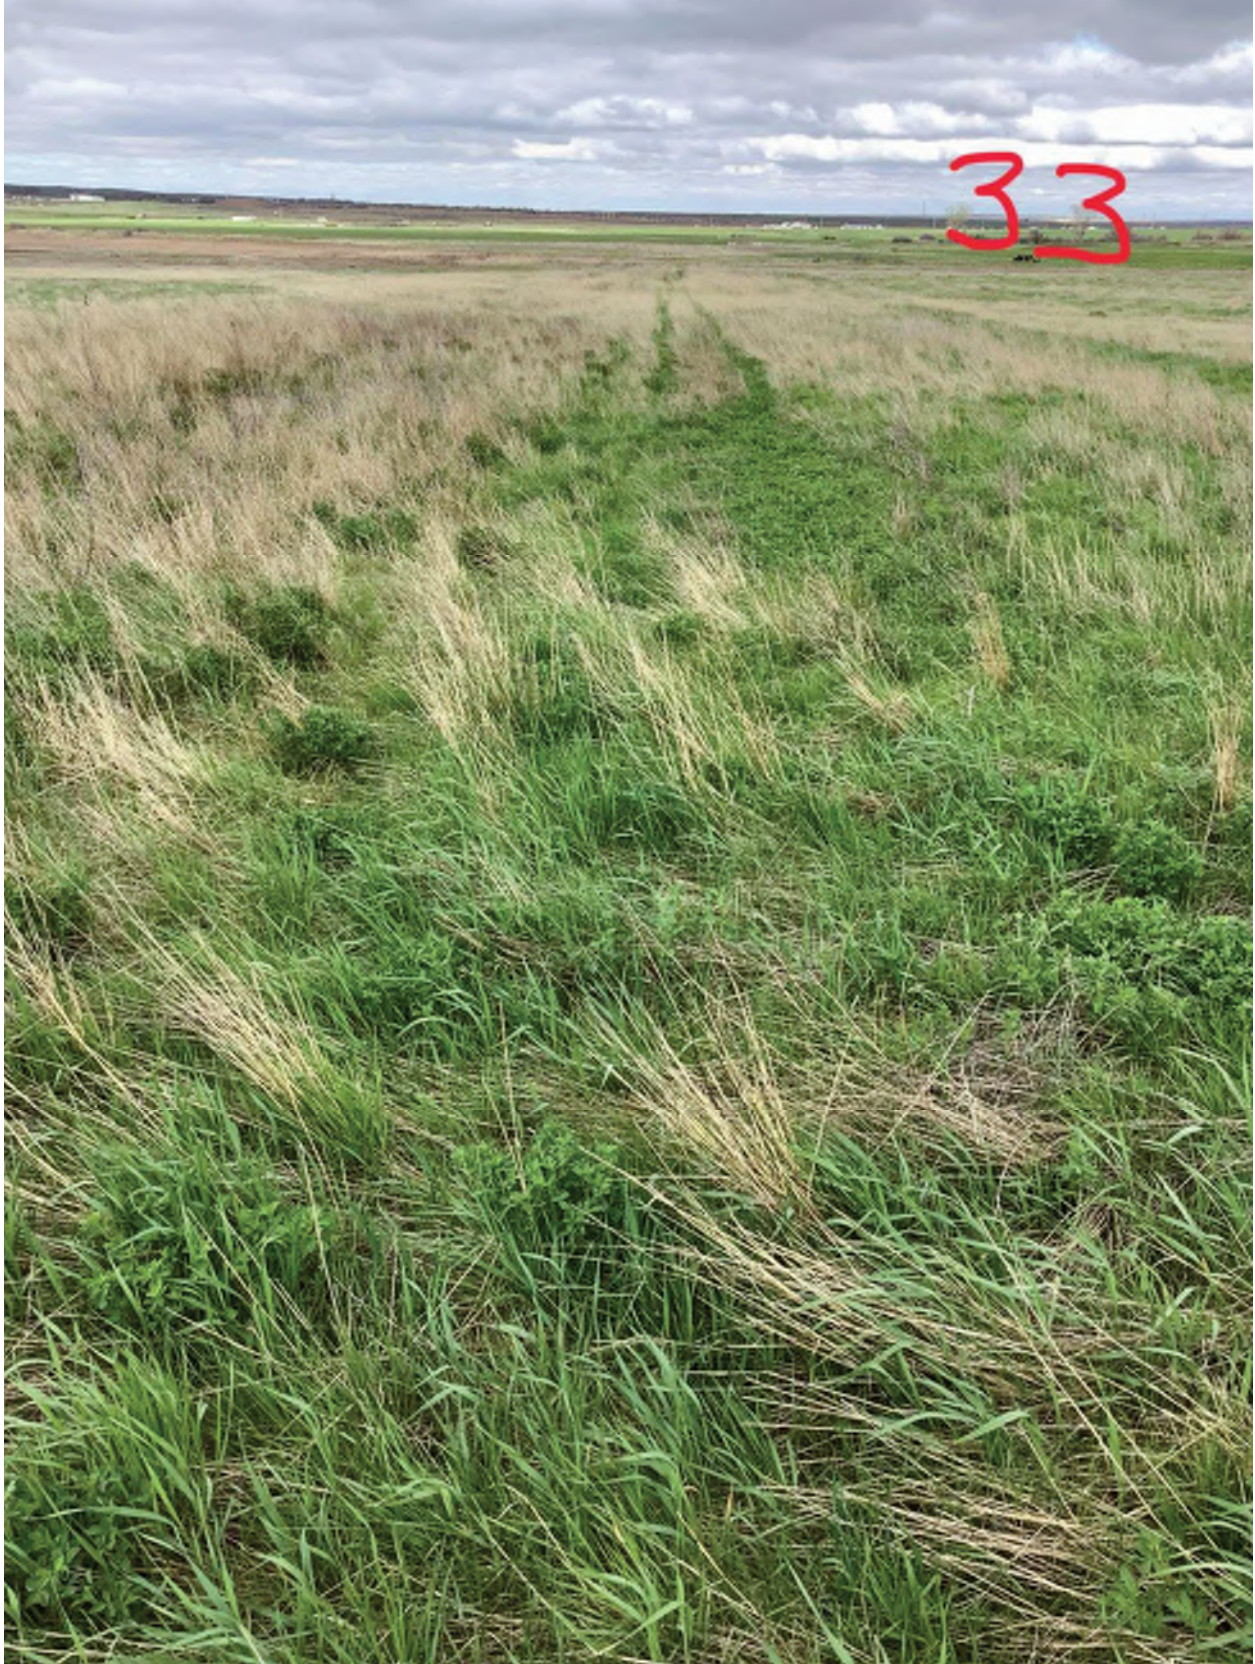
Evidence of sufficient plant growth includes pictures P5, P10, and P33.

P33 looking W, ground completely covered with plant life.

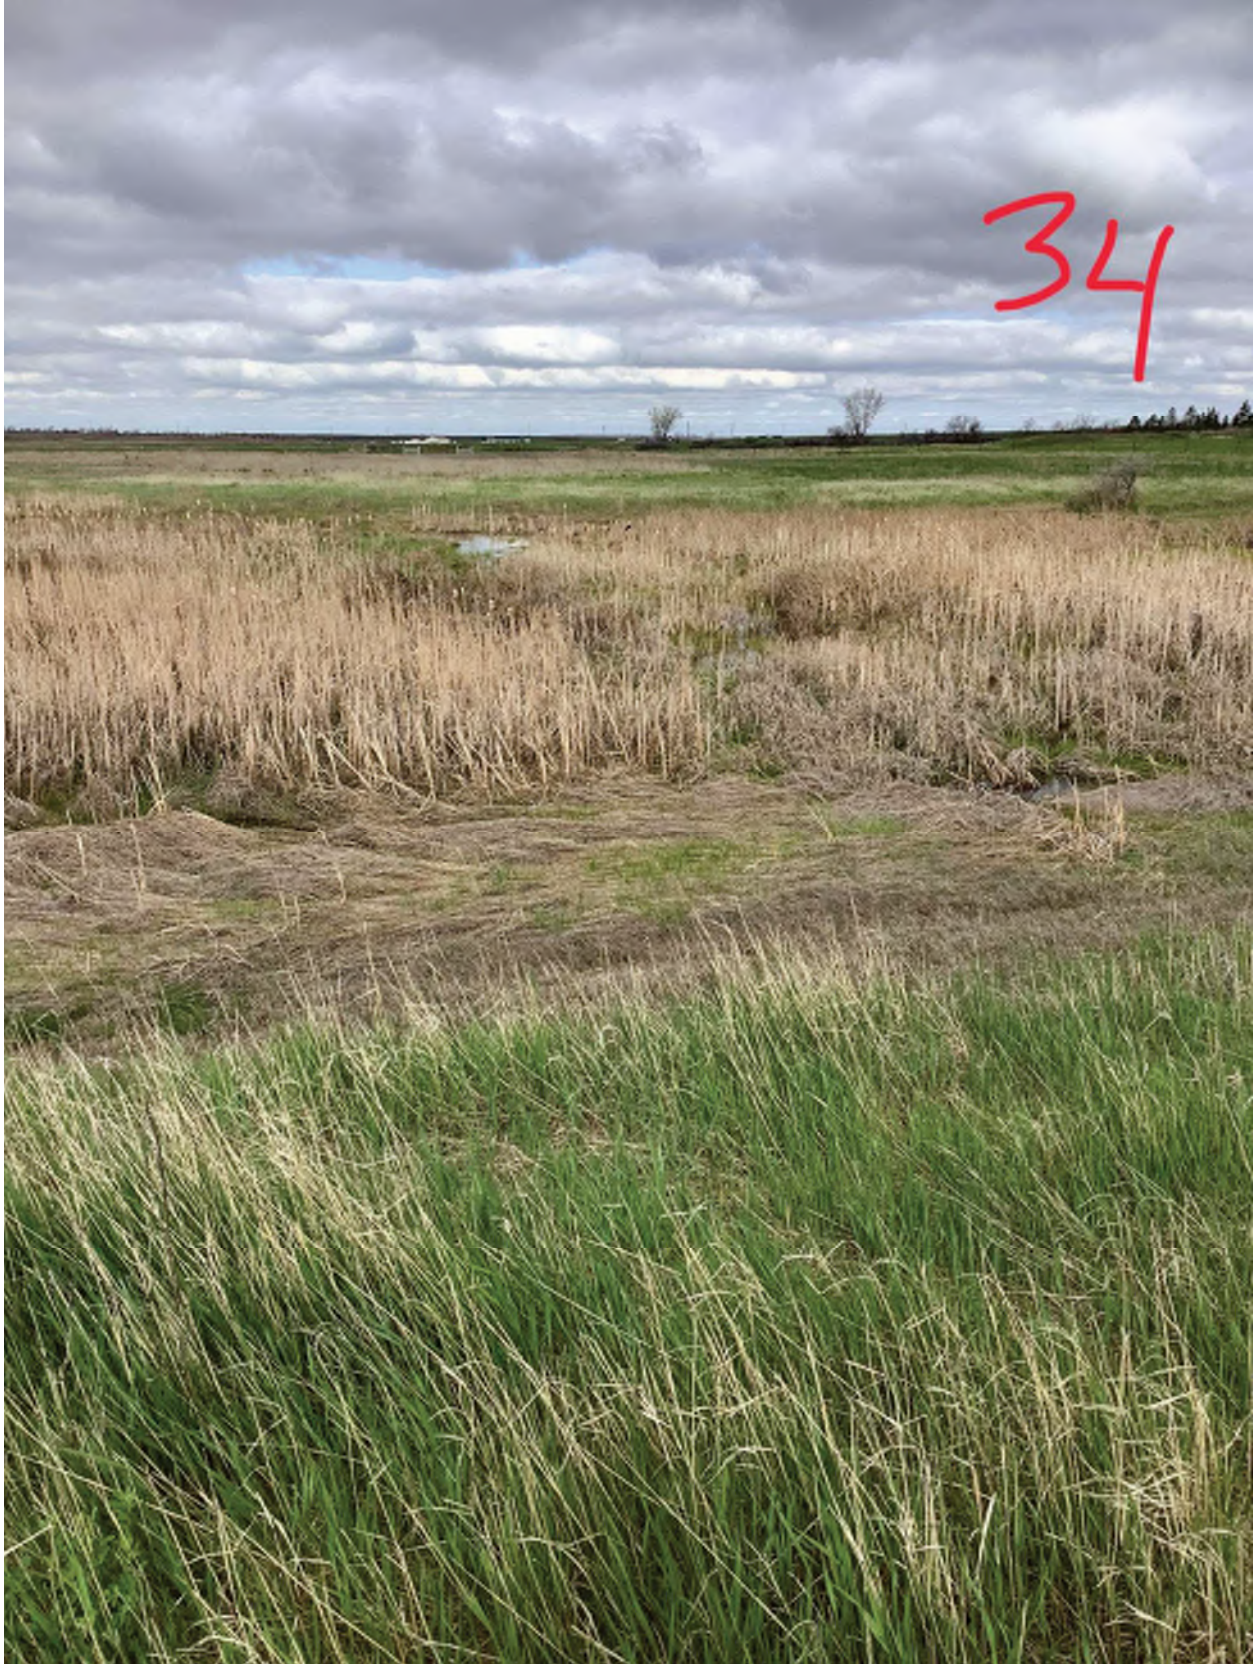
P34 looking W, wetlands untouched. No issues.
