Hiland Crude LLC

2.9-mile Crude Oil Pipeline— Williams County

Case No. PU-21-353

Reclamation and Revegetation Inspection Report

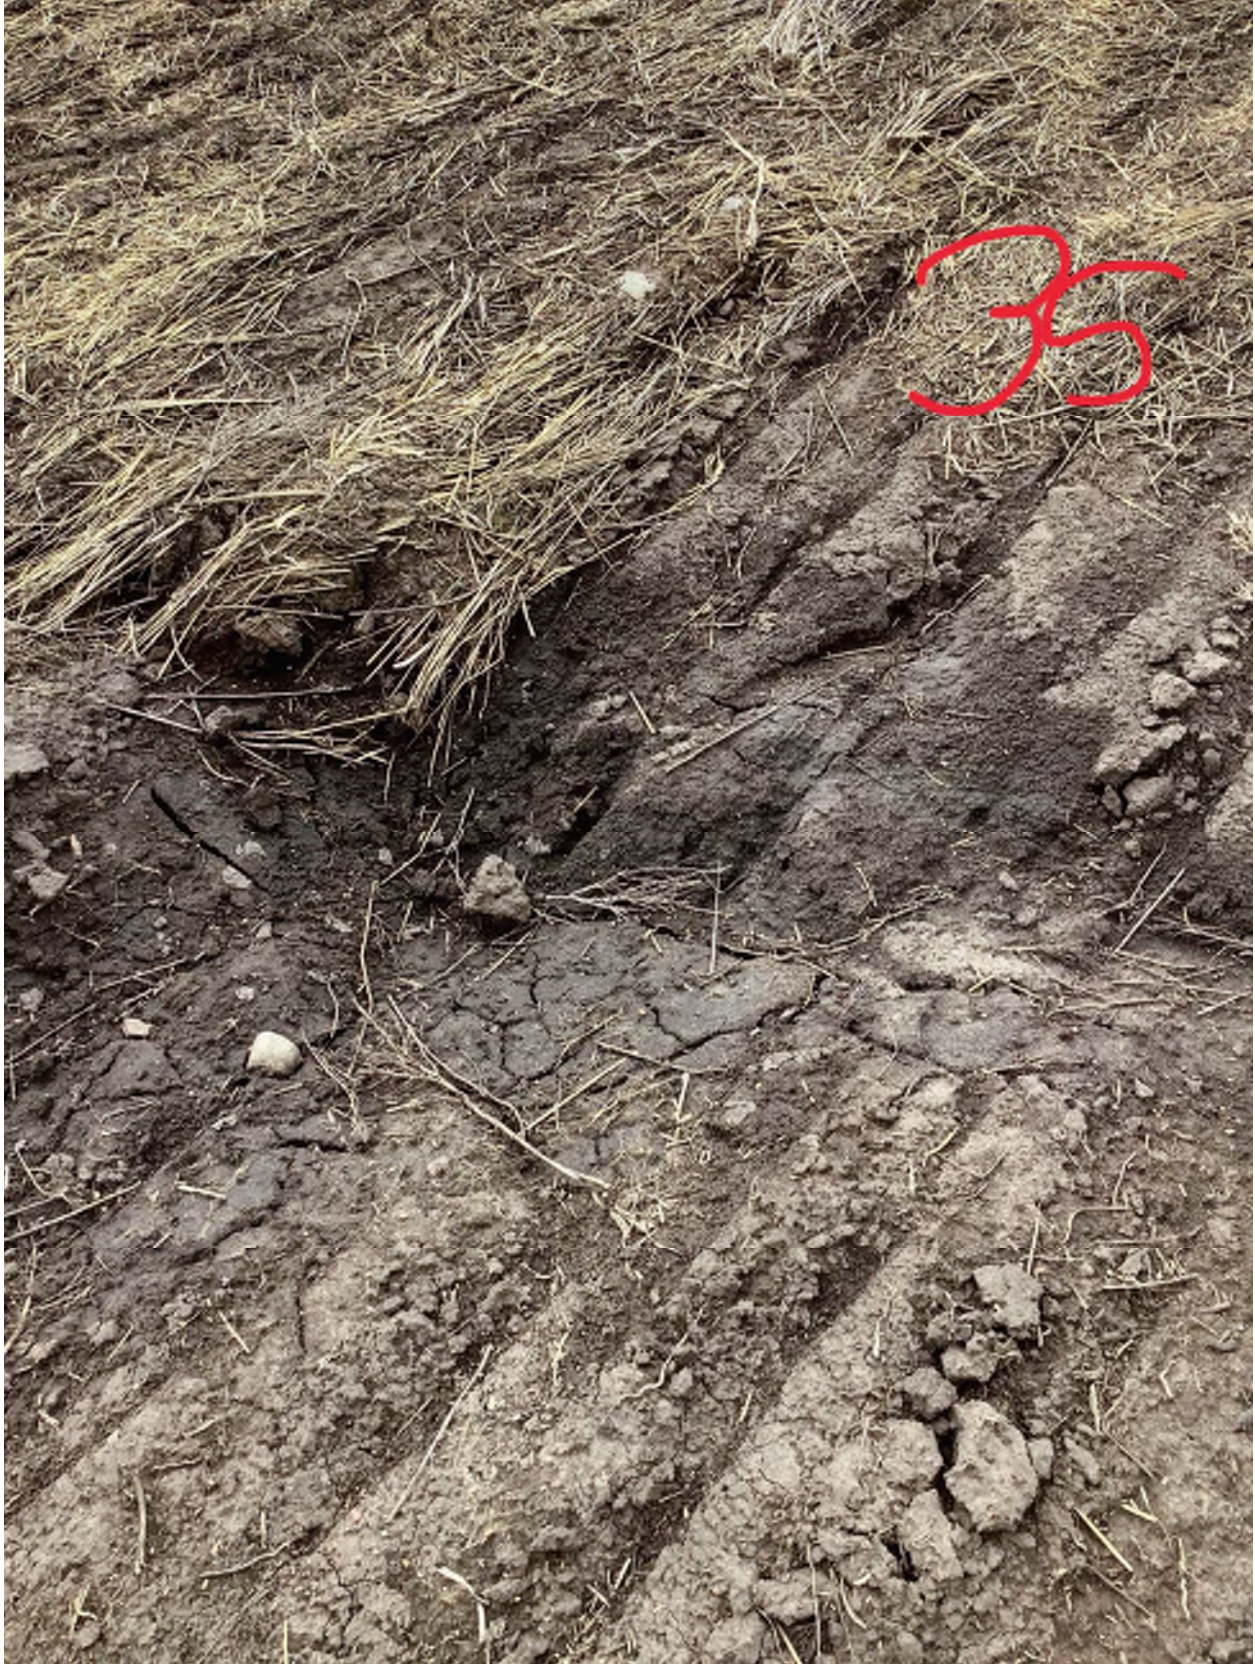
P35 looking SE, localized sink in farm field, however, landowner was working land anyway.

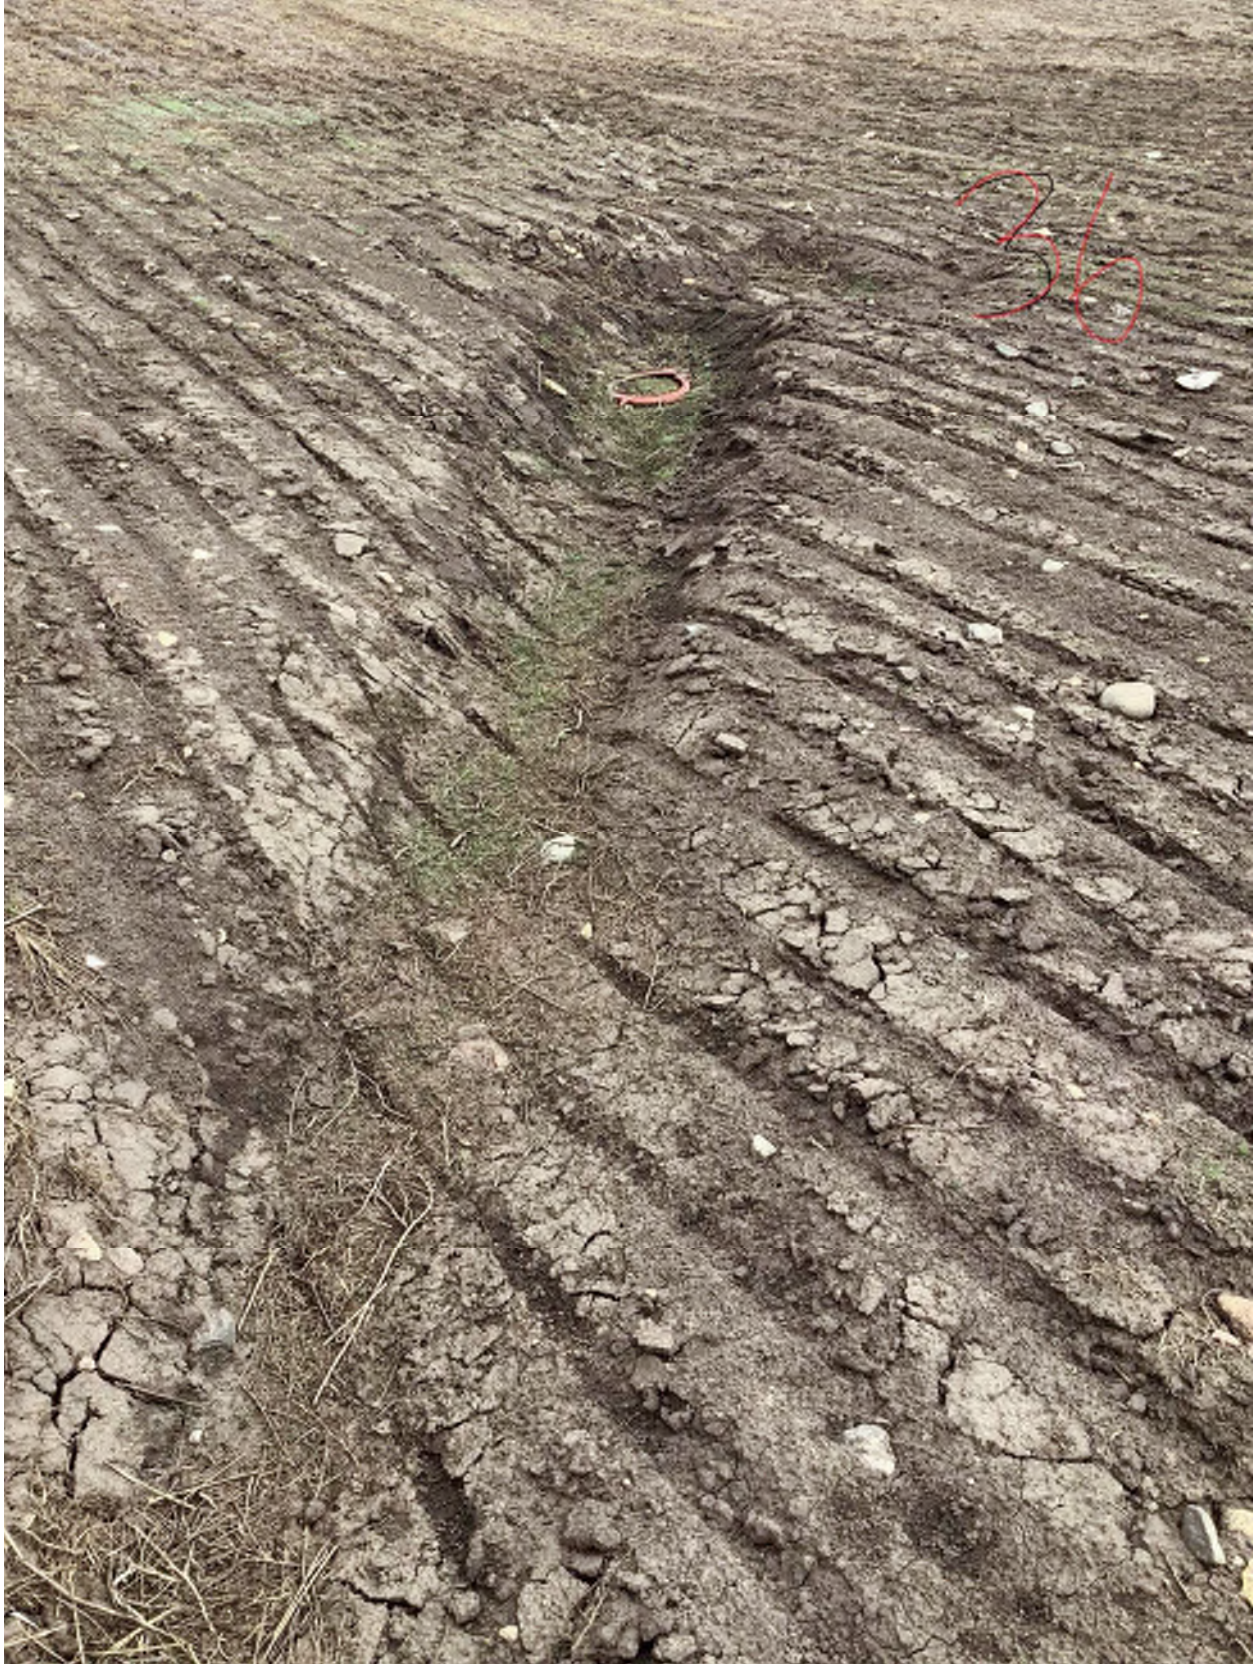
P36 looking NE. Minor trench sink, however landowner was working land anyway.

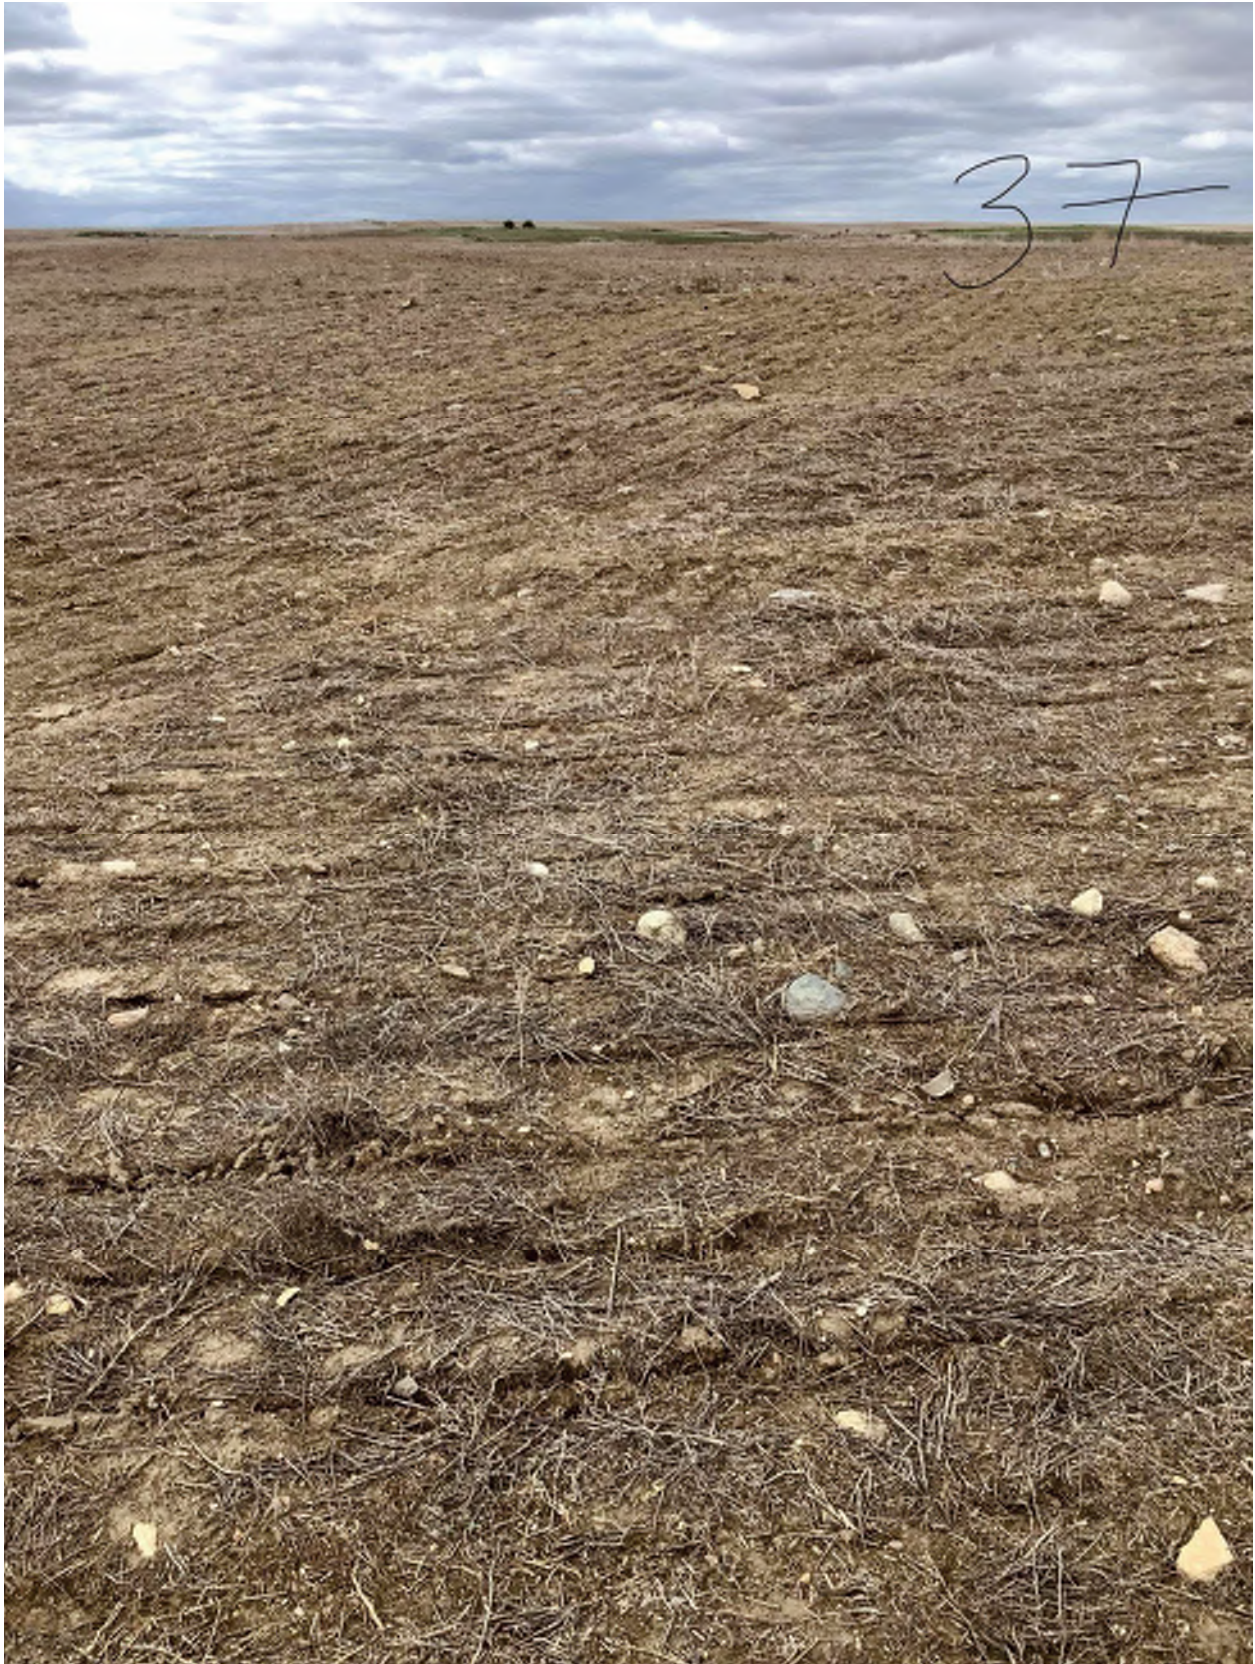
P37 looking SSE, no issues.

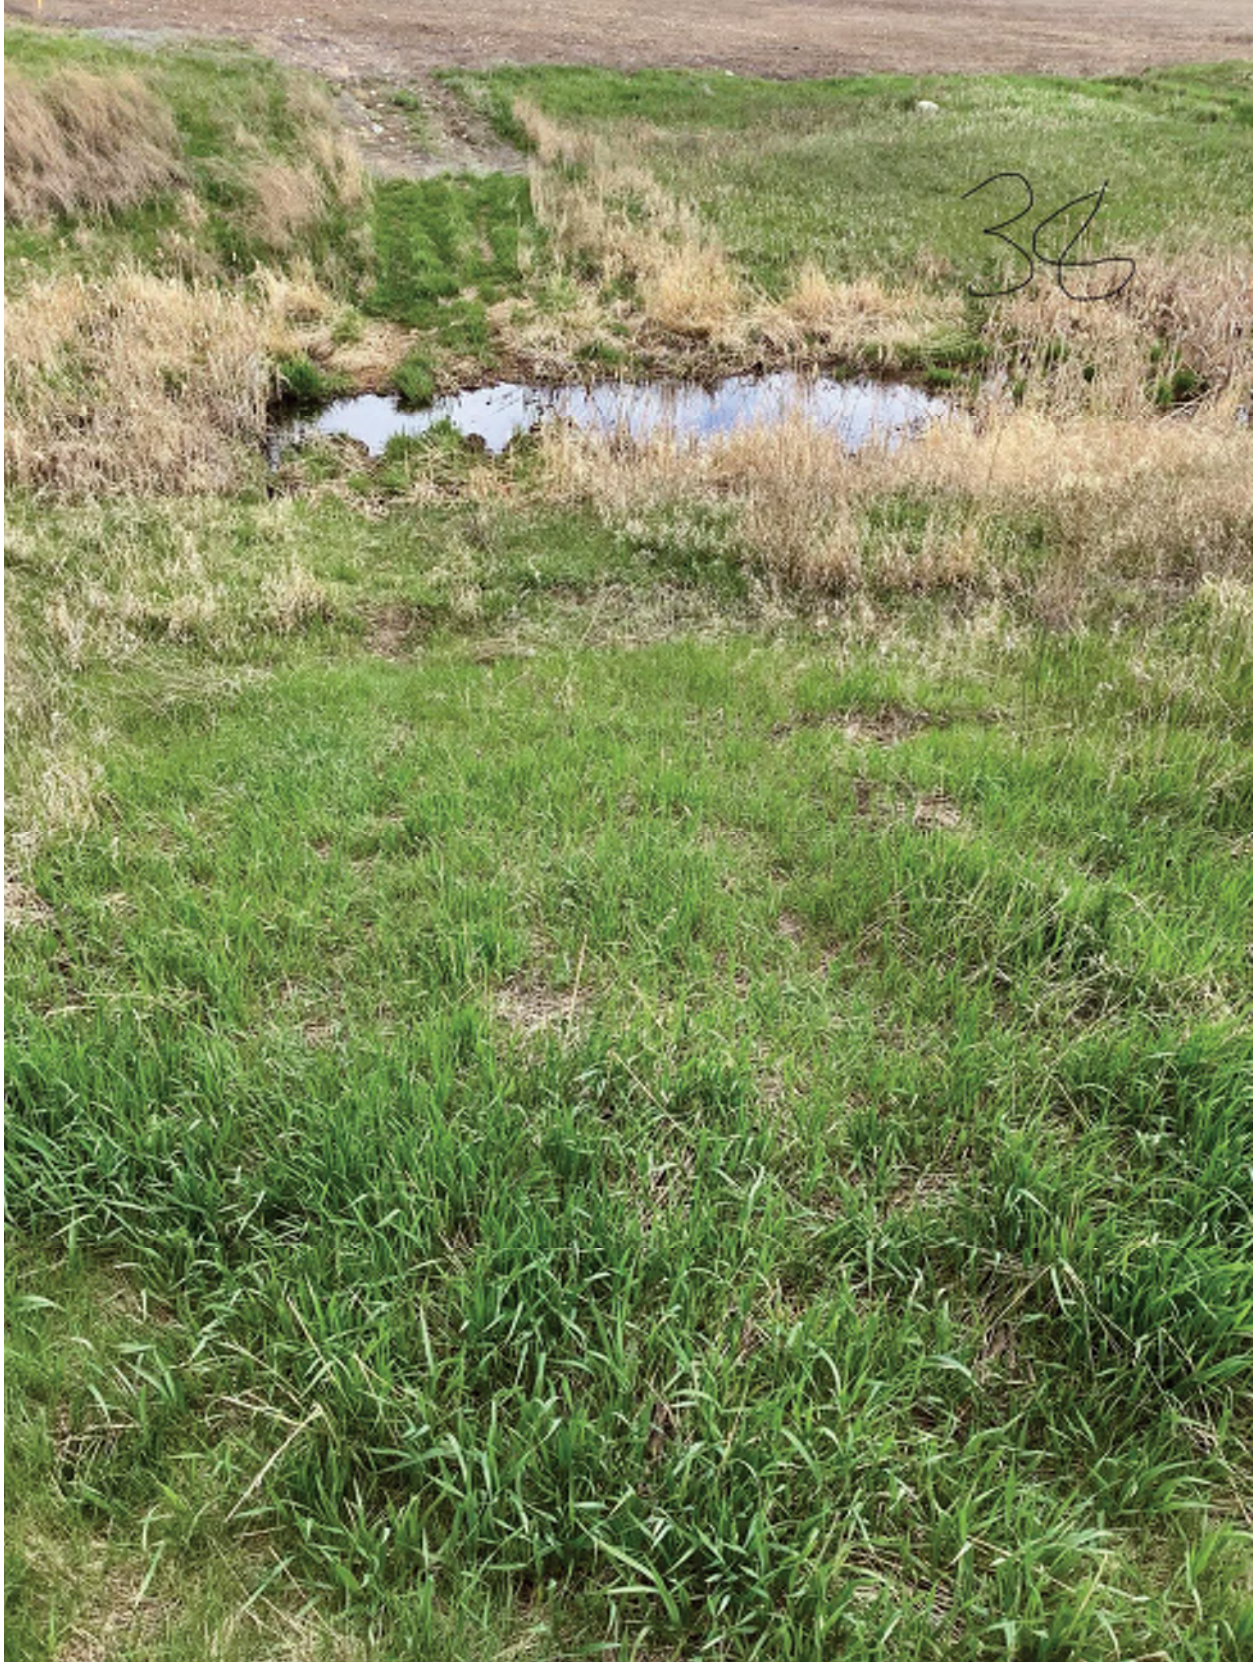
P38 looking N, no evidence of sediment deposition in creek.

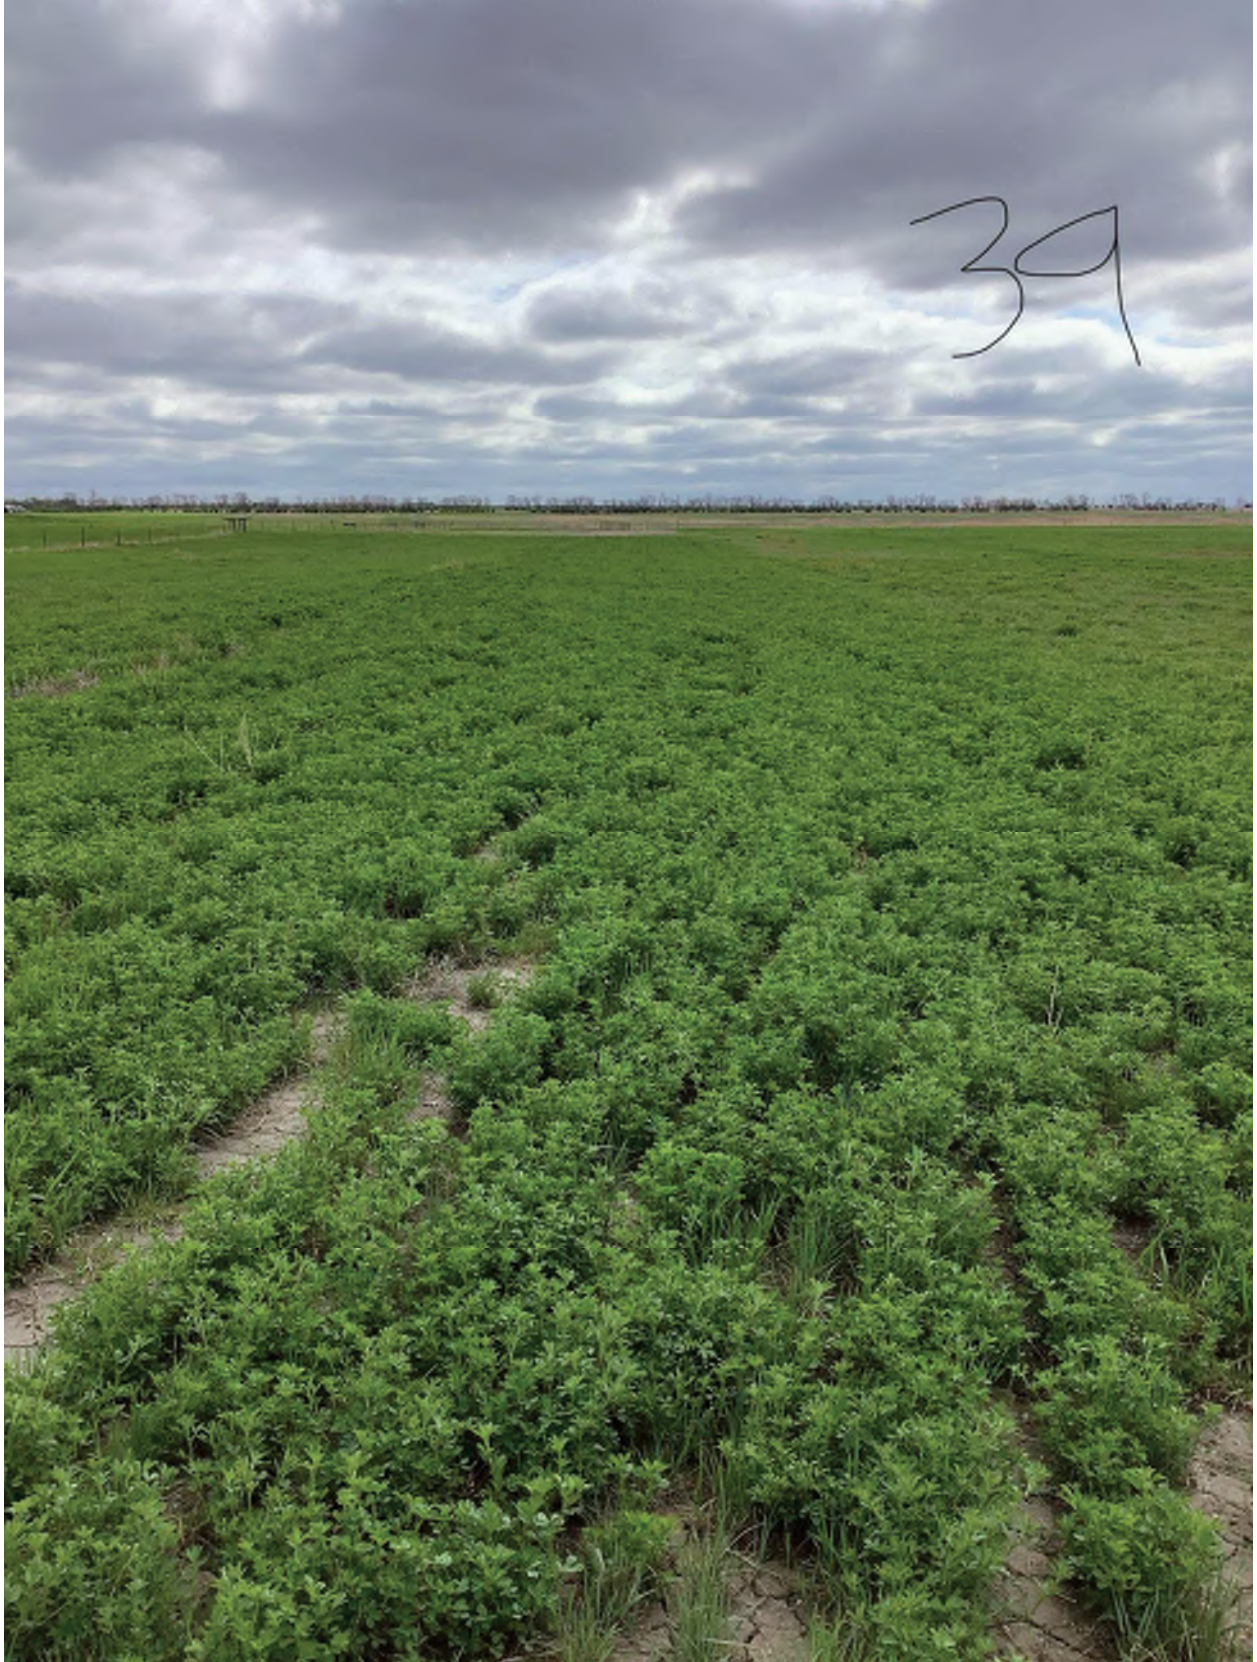
P39 looking East, no issues.

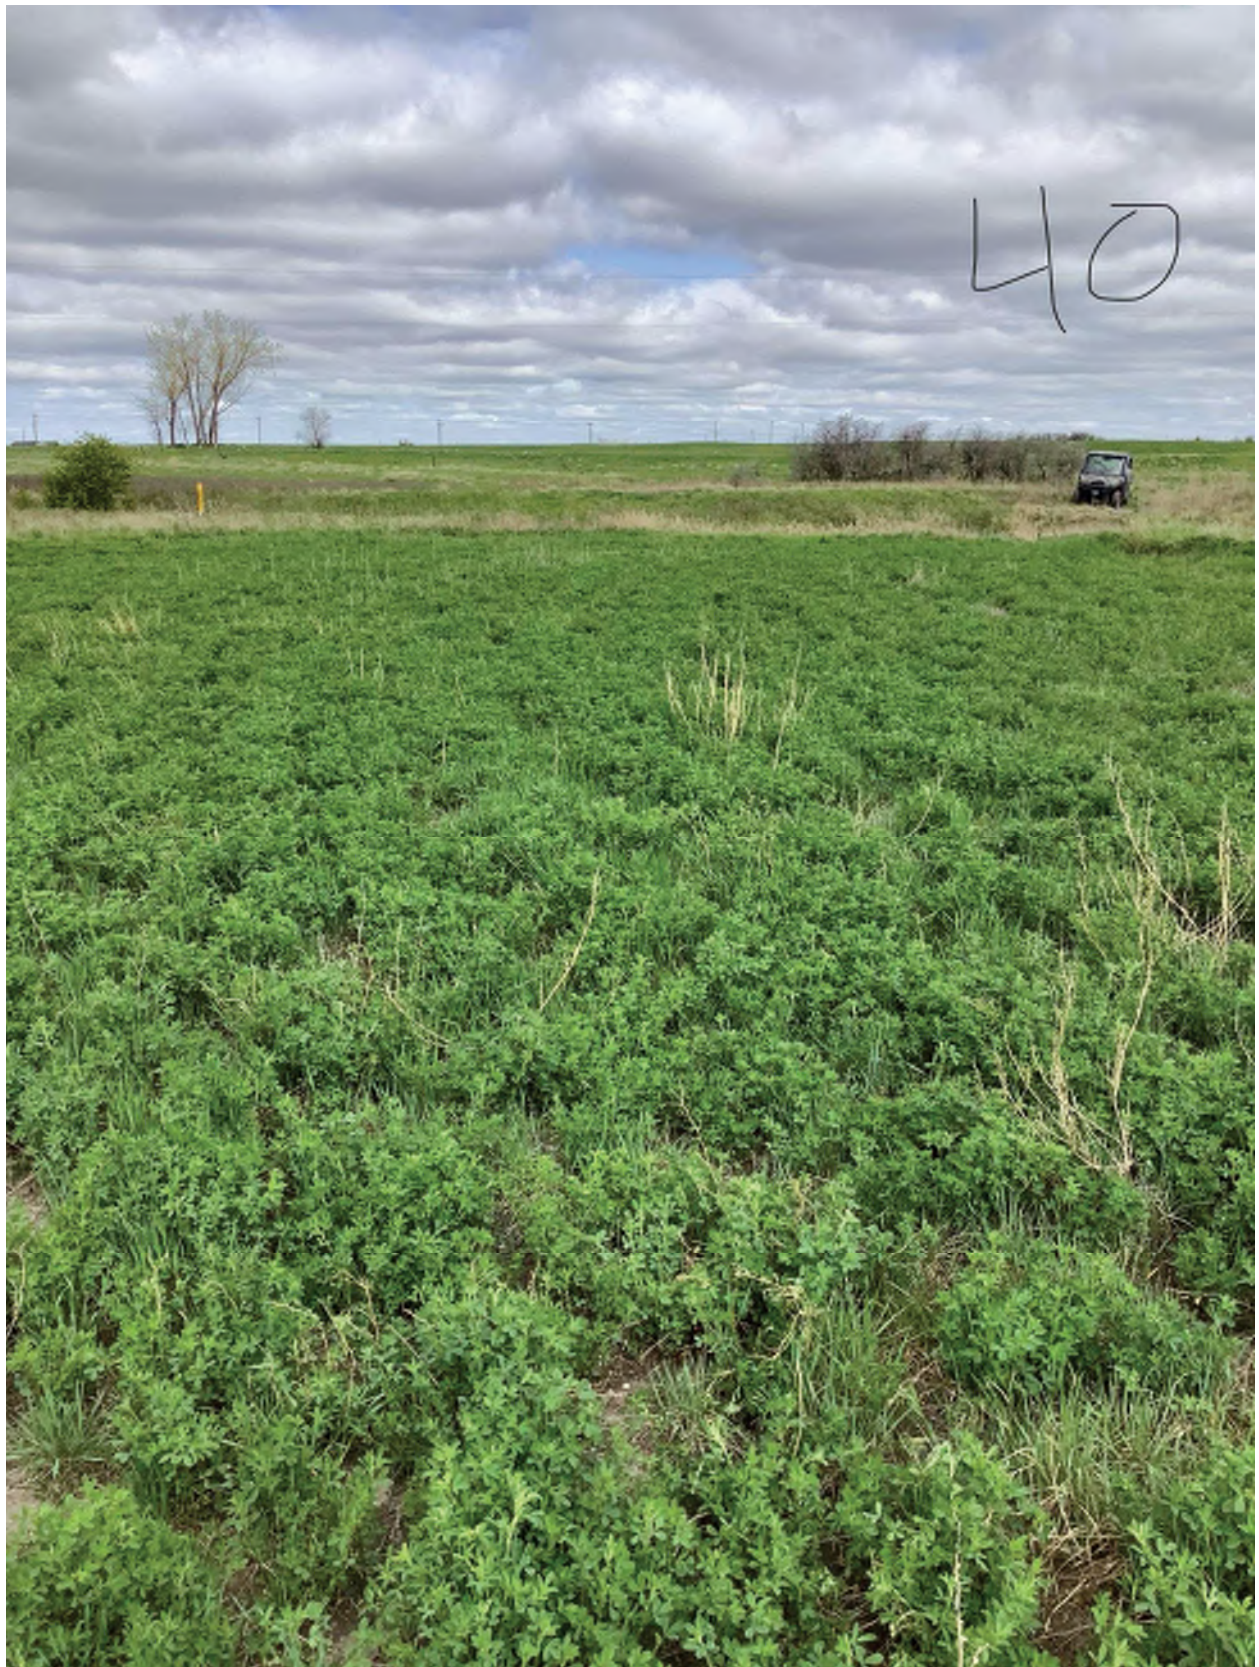
P40 looking NW, no issues.

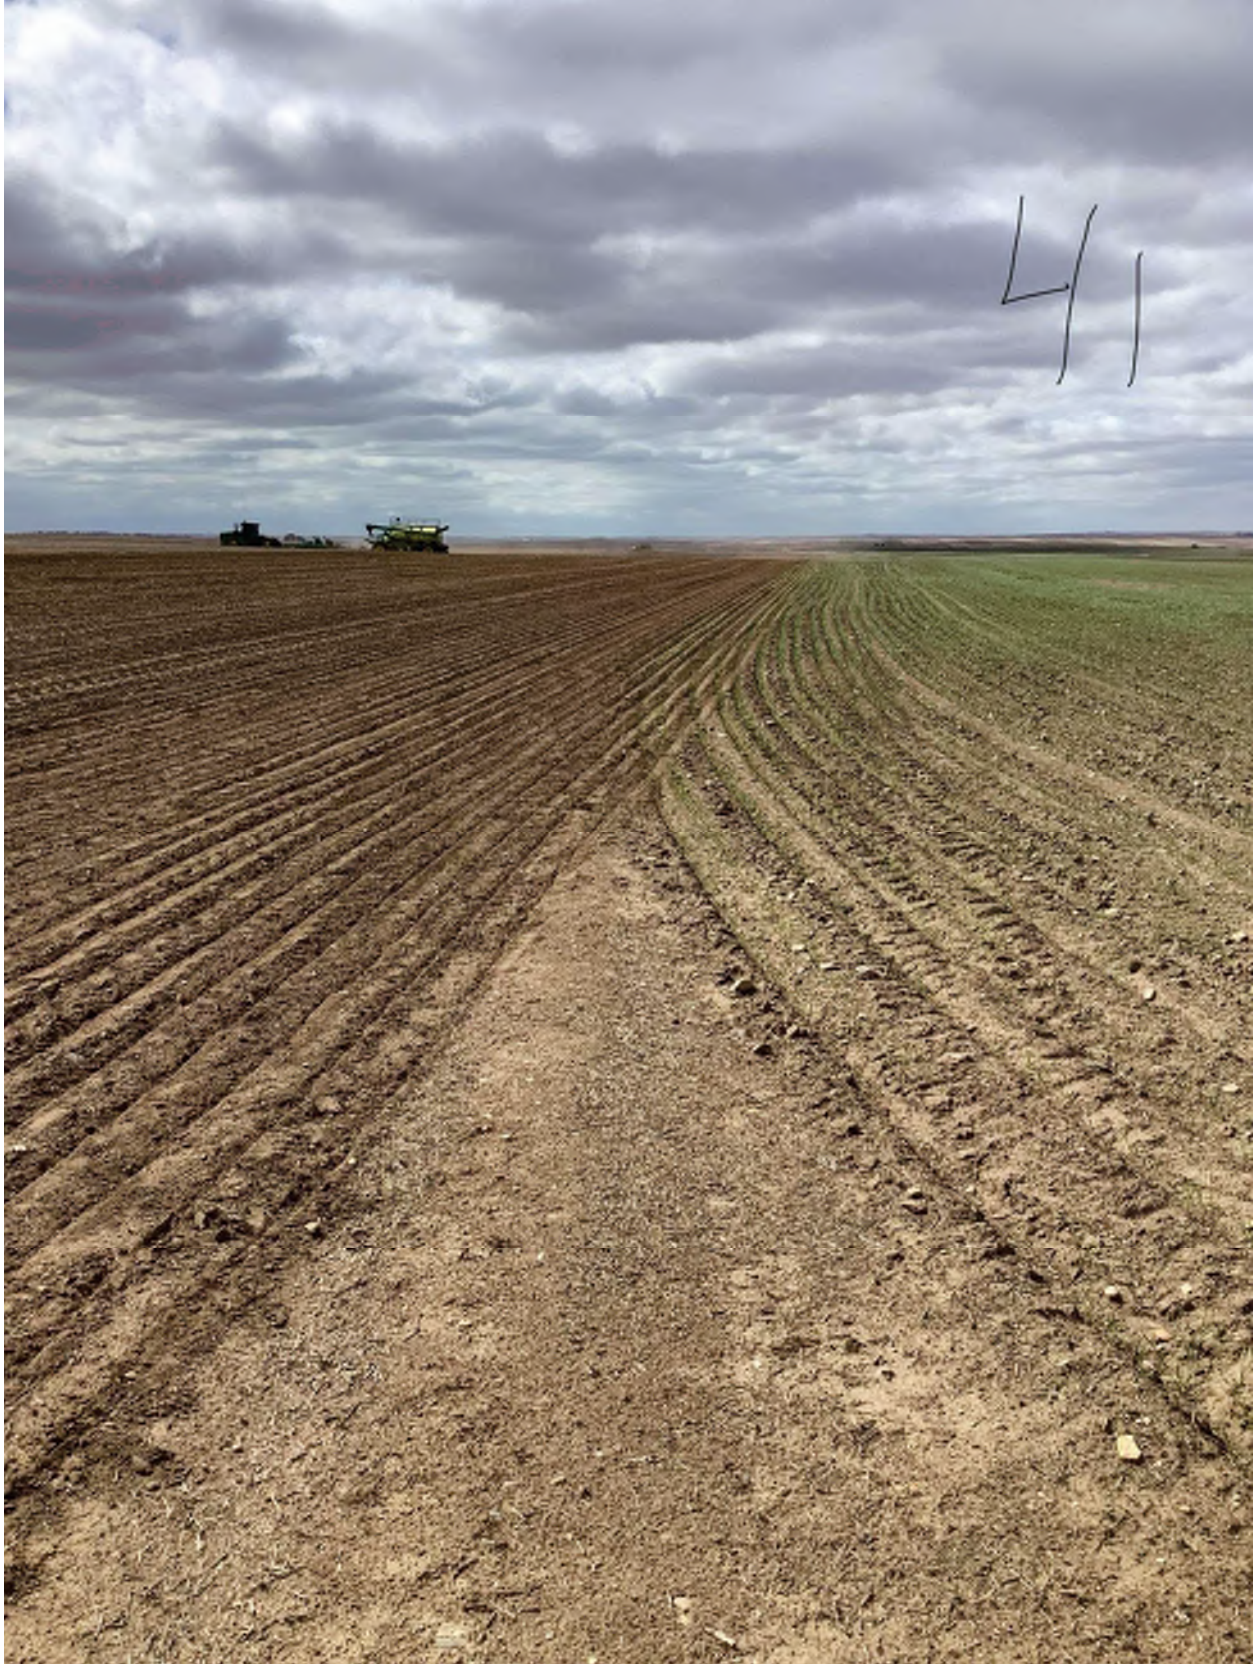
P41 looking SSE, no issues. Farmer actively working their land.
