## INCIDENT INVESTIGATION #211506

506 Bruegger, Alexander, ND

3 PU-21-377 Filed 09/03/2021 Pages: 6  
Incident Investigation  
ELM

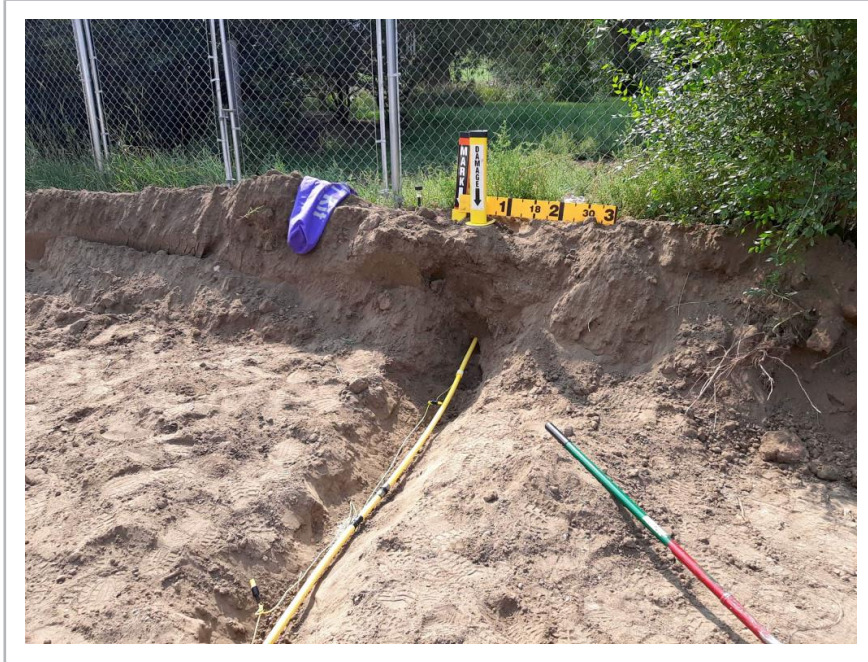
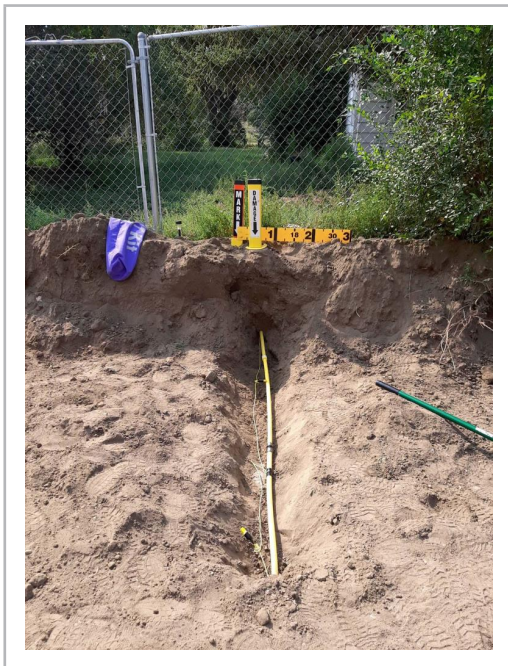
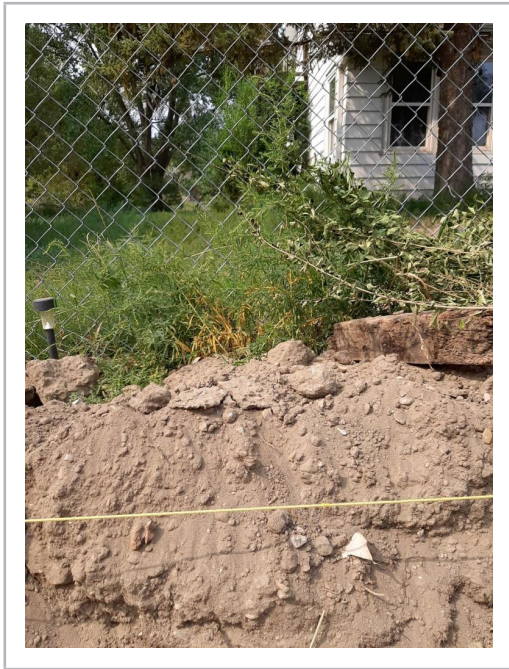
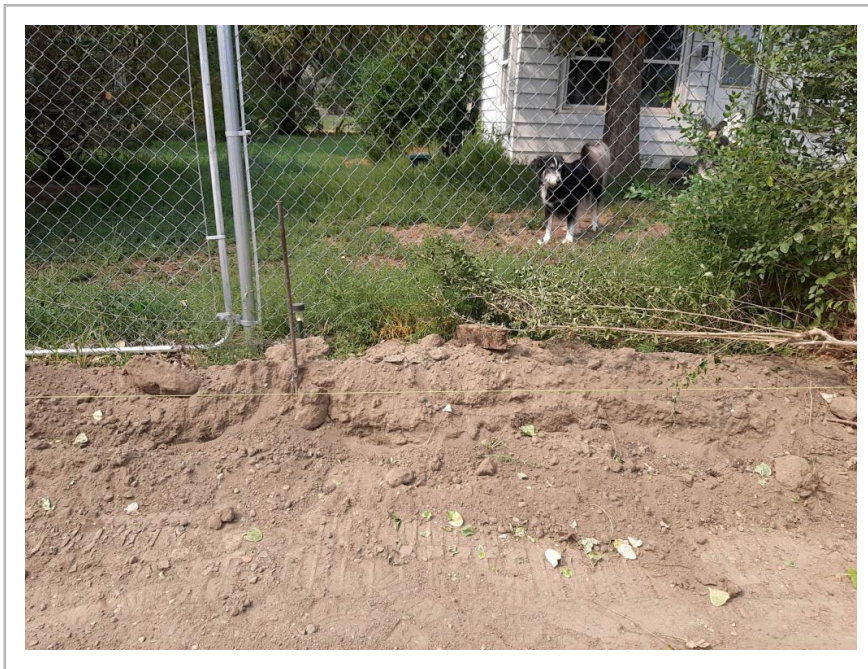
**Assessment Comments:** BEK raised gas service line to 506, due to clearance for concrete drainage line. BEK failed to notify anyone they had done this. Making line approximately 4-6" deep. BEK was doing final grade and snagged it with skid steer. MDU Dana/Chuck on-site. BEK rep acknowledged that they were at-fault.
