BEK Consulting, LLC

Re: PU-21-377

I am responding to your letter of September 1st concerning Case Number PU-21-377 regarding a ND One Call Complaint Against BEK Consulting submitted by tana Dakota Utilities. Corresponding locate ticket for PU-21-377 is 21103481.

2021 ROADWAY IMPROVEMENTS PROJECT
ALEXANDER, NORTH CAROLINA
STORM SEWER PLAN & PROFILE - BRUEGGER ST III

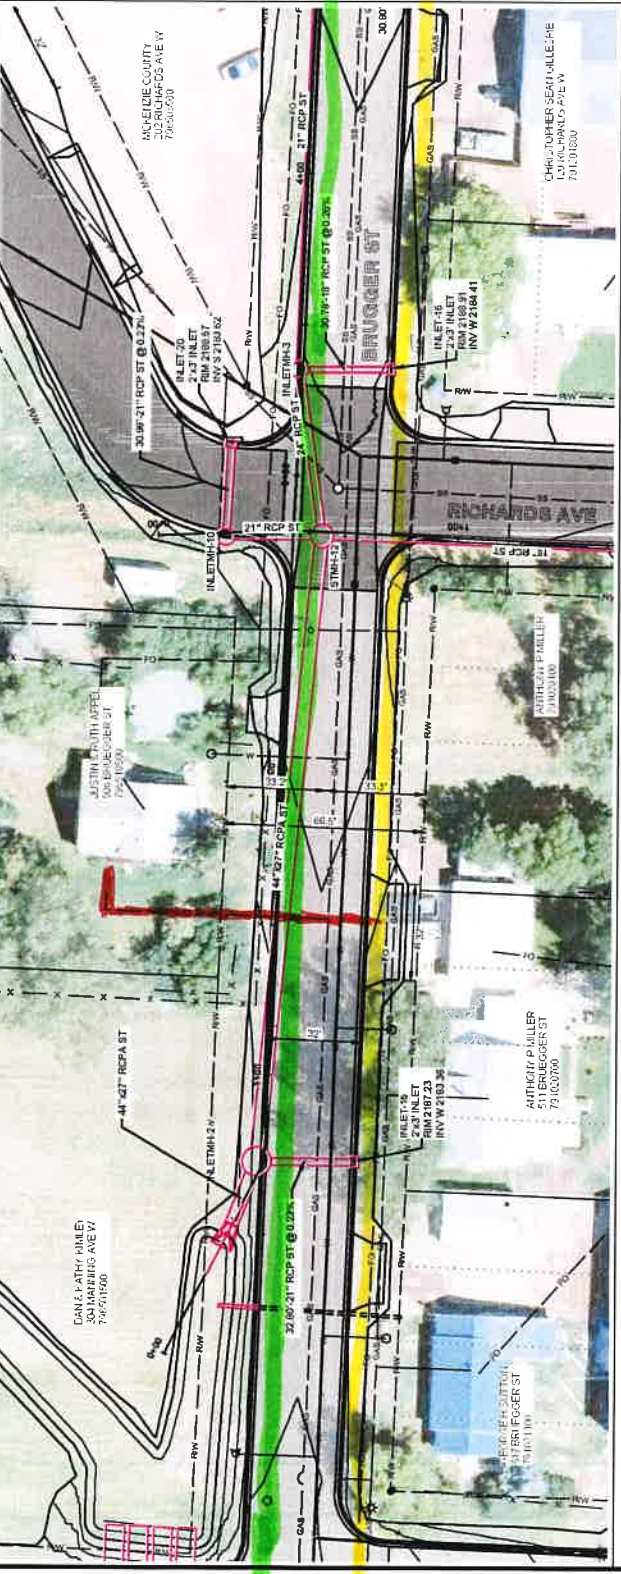
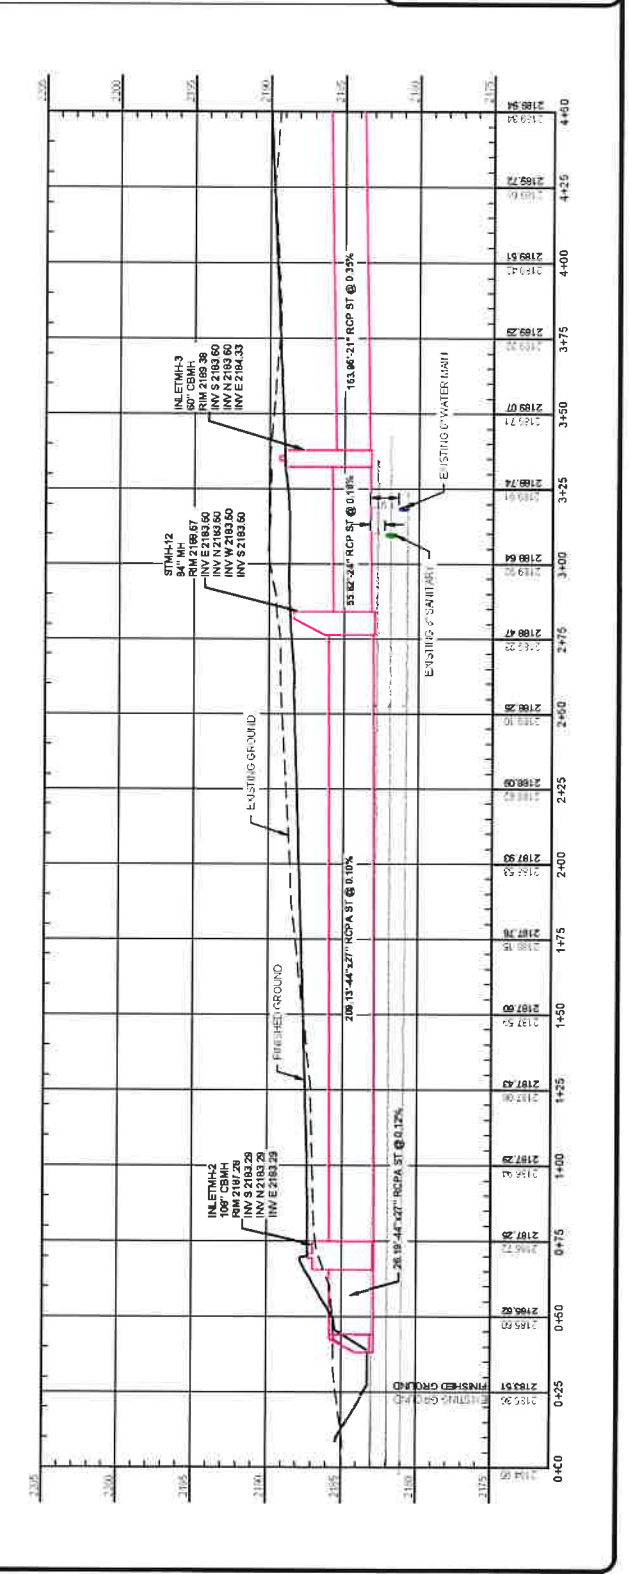
STS-19

Attached is a copy of the plan sheet of where the utility hit occurred. The red line is the approximate location the service line, and the green line indicates where the existing gas main actually was. Per the plan sheet, the gas main was shown on the opposite side of the street. The yellow line is where MDU relocated the gas main behind the curb line in the existing ditch line. Down at the intersection of Brugger St and Richards Ave, MDU went down 8 feet to get under the existing sewer and water mains, but the gas main was not buried anywhere near that depth where the gas service line came across the street to connect to the main.

Prior to MDU beginning their work to relocate the gas main and service lines, grade stakes were present showing the necessary cut depths required for the installation of the storm sewer not only in this area but in all the areas where their utility lines needed to be relocated. They knew what depth their lines needed to be to address any utility conflicts with the storm sewer, sanitary sewer, and water lines. In this instance, the service line was not deep enough for us to go over it as we should have been able to. When we were installing the storm sewer in this area, we located the service line and we ended up having to go under the service line, lifting the service line over the top of our pipe, which brought the service line up very close to the top of the subgrade. MDU did not adequately relocate this line for us to do our job properly and safely. Instead, they ignored the cut stakes and failed to bury their line at the proper depth setting up the next contractor to come along for failure.

Mr. Renfandt, the issue here that makes this complaint invalid is the fact that we were not even digging when the line was hit. We were in the process of laying reinforcement fabric down and placing aggregate base course preparing for the placing of the curb and gutter. We had an operator in a skid steer fine grading, leveling out ruts and bumps in the subbase when the service line was hit. Contrary to any statements by MDU personnel, neither our dirt foreman, the pipe foreman or the project manager were questioned by any MDU personnel as to what the depth of the gas line should have been. Again, the cut stakes showing the invert of the pipe being placed were in place for the MDU crews to place their utilities at the proper depth. If you should have any technical questions regarding the surveying and staking or anything else of the project, you may call Kory Schweitzer, onsite supervisor for Houston Engineering, the project engineers. His contact information is: Cell - 701-590-0148 and Email - kschweitzer@houstoneng.com
