INSPECTION REPORT

DATE OF INSPECTION: July 27, 2021

PERMITEE - MINE: Dakota Westmoreland Corporation - Beulah Mine

PERMITS INSPECTED: KRSB-8603, KRSB-8802

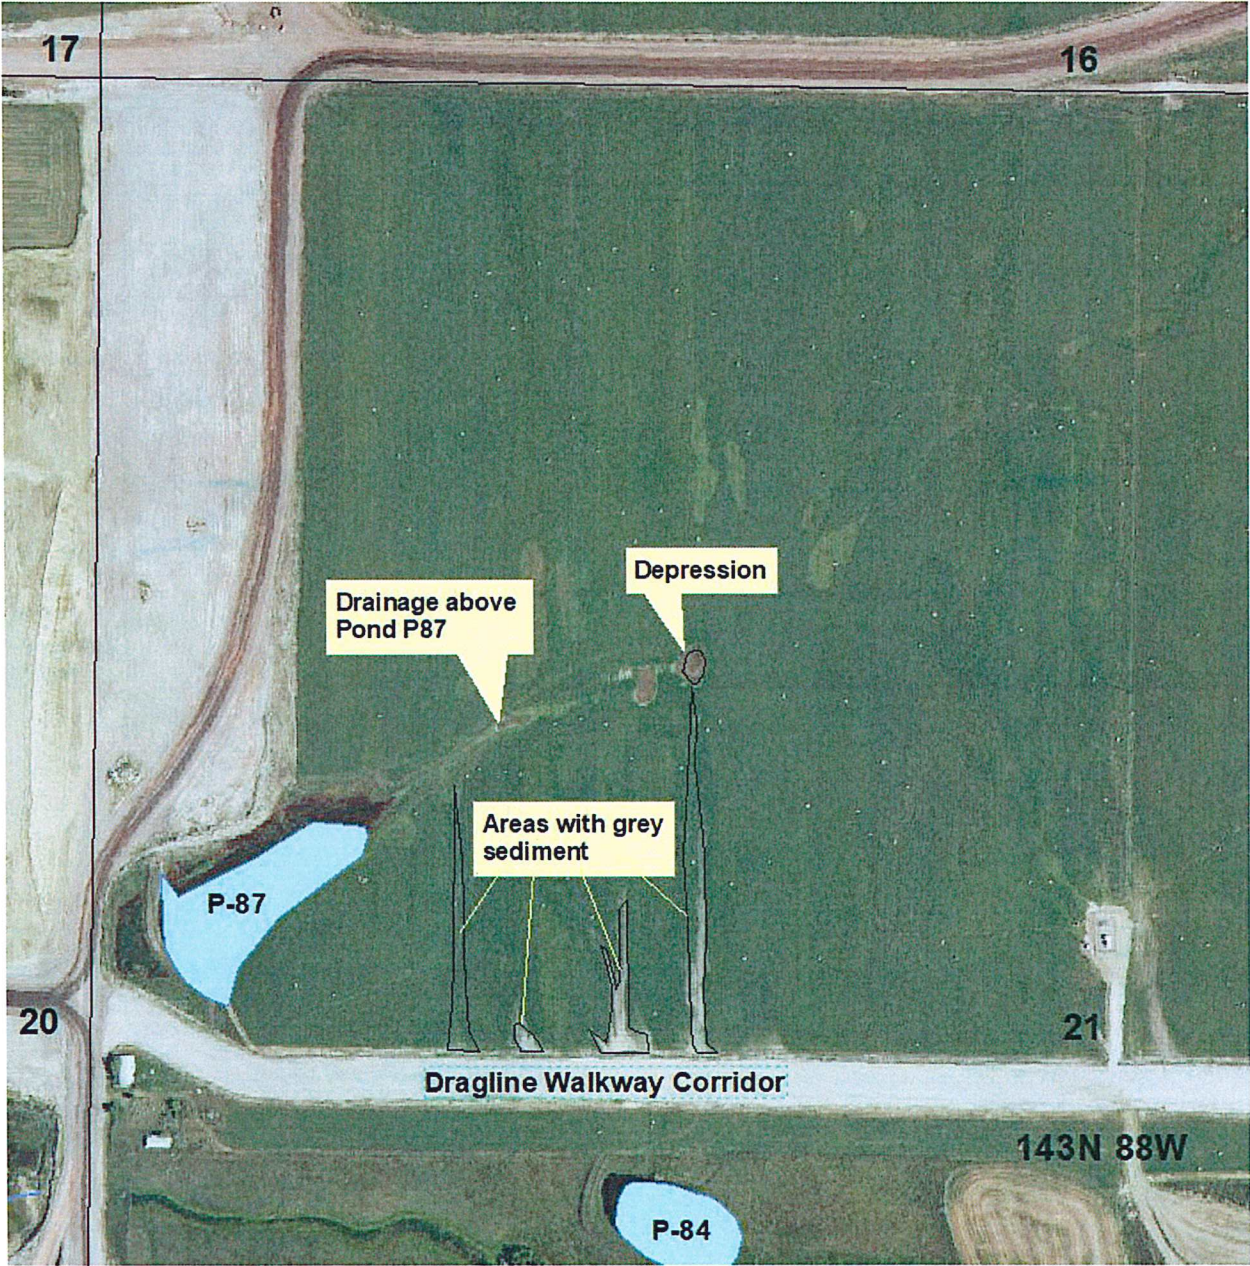
The drainageways were walked and a shovel was used to estimate the depth of sediment accumulation in areas affected. Six to eight inches of sediment has accumulated on reclaimed hayland in areas immediately adjacent the dragline walkway and the depth of accumulation gradually decreases downslope (north) from the dragline walkway. Brown colored topsoil was found under the grey sediment and alfalfa crowns and litter were observed on the topsoil below the layer of sediment. The alfalfa crowns document the height of the topsoil when the site was seeded. Alfalfa, intermediate wheatgrass and smooth brome grass are established throughout areas affected with sediment, but only a thin stand of smooth brome grass is present in areas where the sediment deposition is greater than 4 to 5 inches. Sediment that

is only an inch or two deep does not appear to be adversely affecting the established vegetation, but plant vigor is reduced in areas where the sediment accumulation is greater than approximately 4 inches and only a thin stand of smooth brome grass is growing in these areas. The total area affected by sediment is estimated to be approximately 1.3 acres.

The gray colored sediment affecting reclaimed land clearly originated from the dragline walkway corridor which was constructed with spoil from the Gold Pit as described in the General Mining Plan on pages 11 and 12 of Section 3.1 of Permit KRSB-8603. Exhibit 3.1.8b in the permit indicates that topsoil was respread on virgin land that was affected and on reclaimed land that was re-affected by construction of the dragline walkway in the NW1/4 of Section 21. There was no evidence that topsoil had been removed from areas affected by sediment and a topsoil stripping edge was not present. No water management best management practices (BMP's) were observed adjacent the dragline walkway when the site was inspected July 20, 2021. DWC has since constructed a berm along the north side of the dragline walkway to convey runoff to sediment pond P87 and sumps have been excavated in the north dragline walkway ditch adjacent areas affected with sediment.

Figure 1: 2016 NAIP imagery showing sediment deposition on reclaimed land in NW1/4 of Section 21 of Permit KRSB-8603

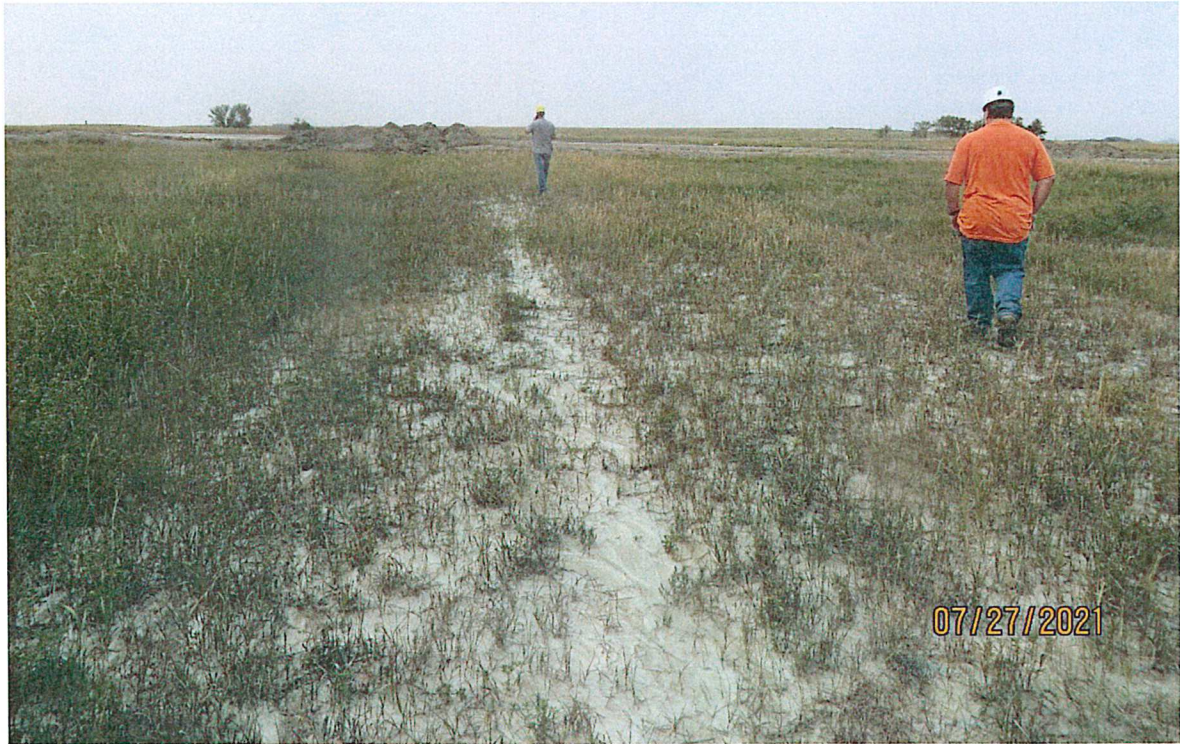
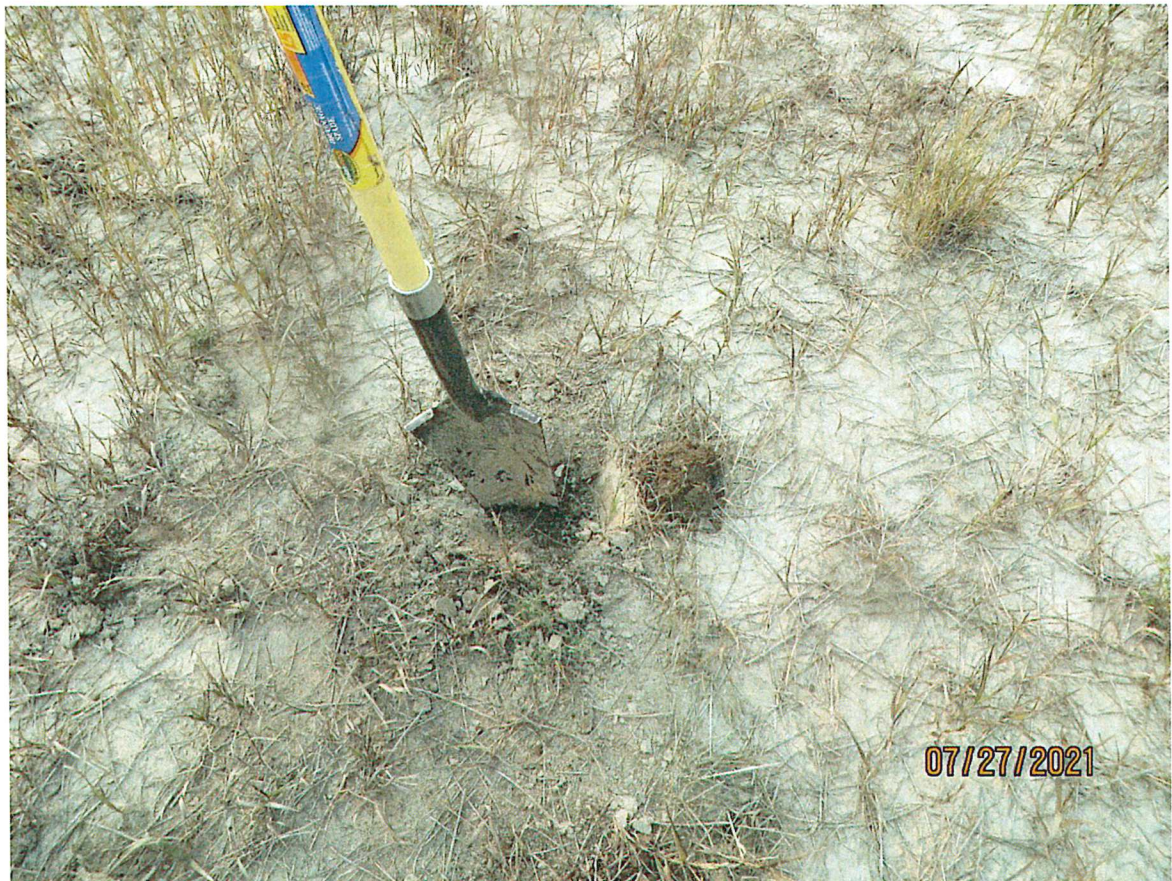
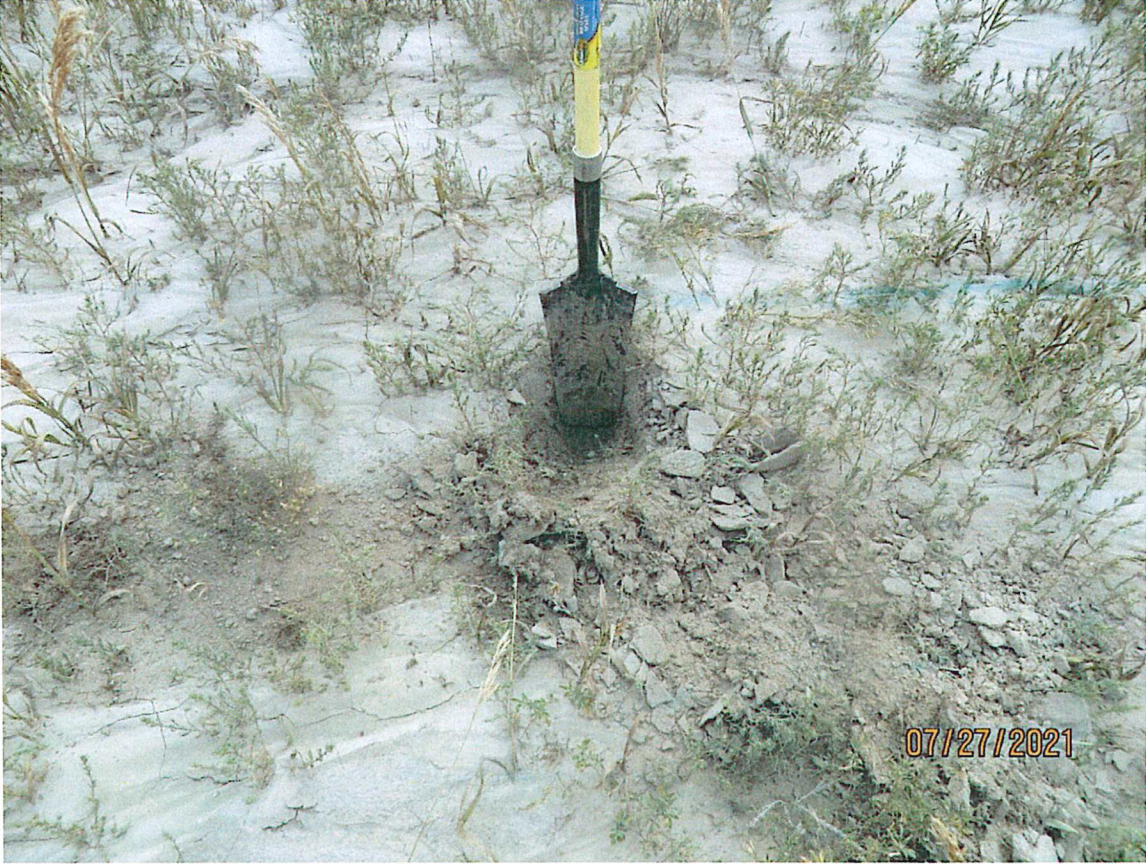
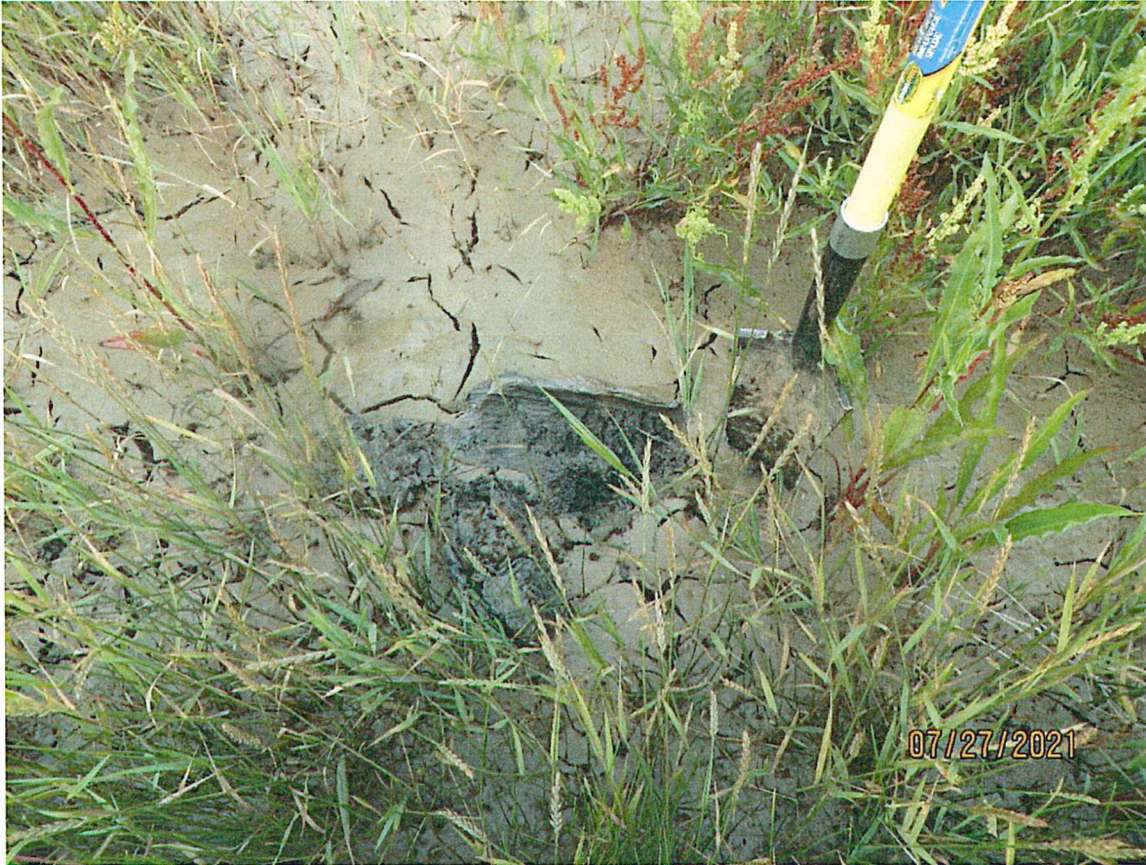
**Photographs of sediment on reclaimed land in the S1/2NW1/4 of Section 21,
Permit KRSB-8603**
