**Site/Project Location:** MDU 12-inch Water Pipeline- Morton County      **Date of Inspection:** 14 May 2022

54 PU-22-34 Filed 05/25/2022 Pages: 4  
Topsoil Inspection Report  
Keitu Engineers & Consultants, Inc.

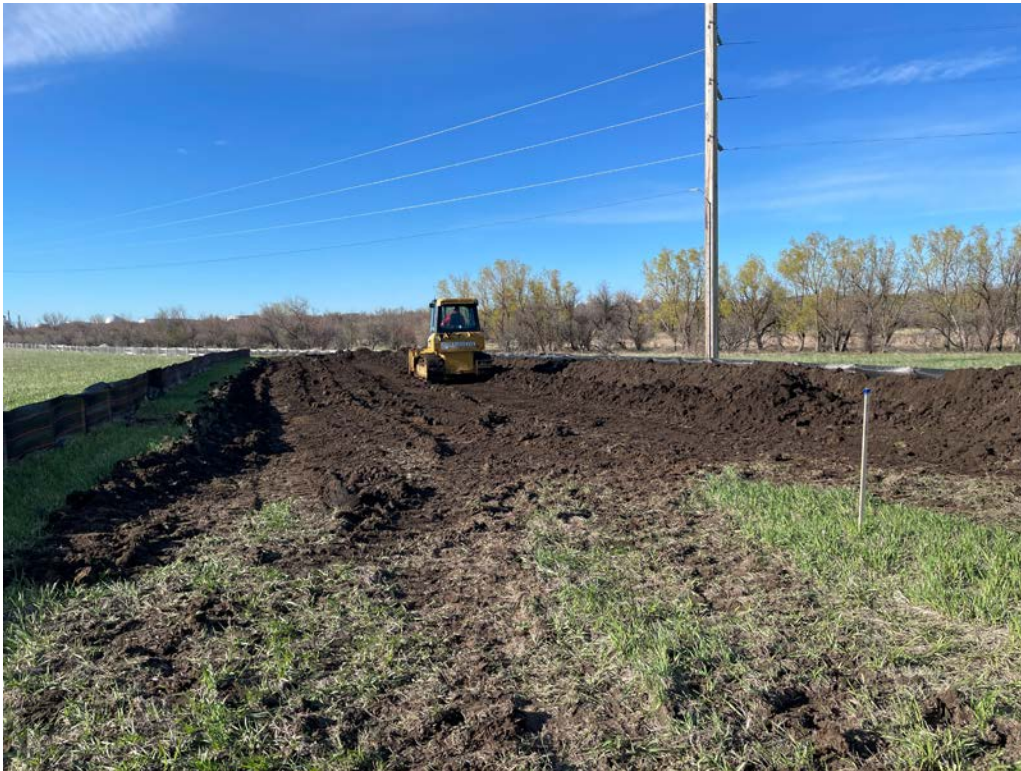
A bulldozer started stripping topsoil along the ROW in the north end of the Project on the south side of 38<sup>th</sup> Street. Topsoil was placed along the west side of the ROW. Topsoil depth varied from 10-12 inches in lower elevations to 6-8 inches in higher elevations. No subsoil was removed during the inspection. All subsoil being removed will done during the excavation of the pipe trench and will immediately be used to backfill the trench once the pipe is laid in the ground. All subsoil removed during the excavation process will be placed on the east side of the ROW, opposite of the topsoil berm to keep them segregated from one another.

**Report Photo #1 "Bulldozer Stripping Topsoil along ROW"**

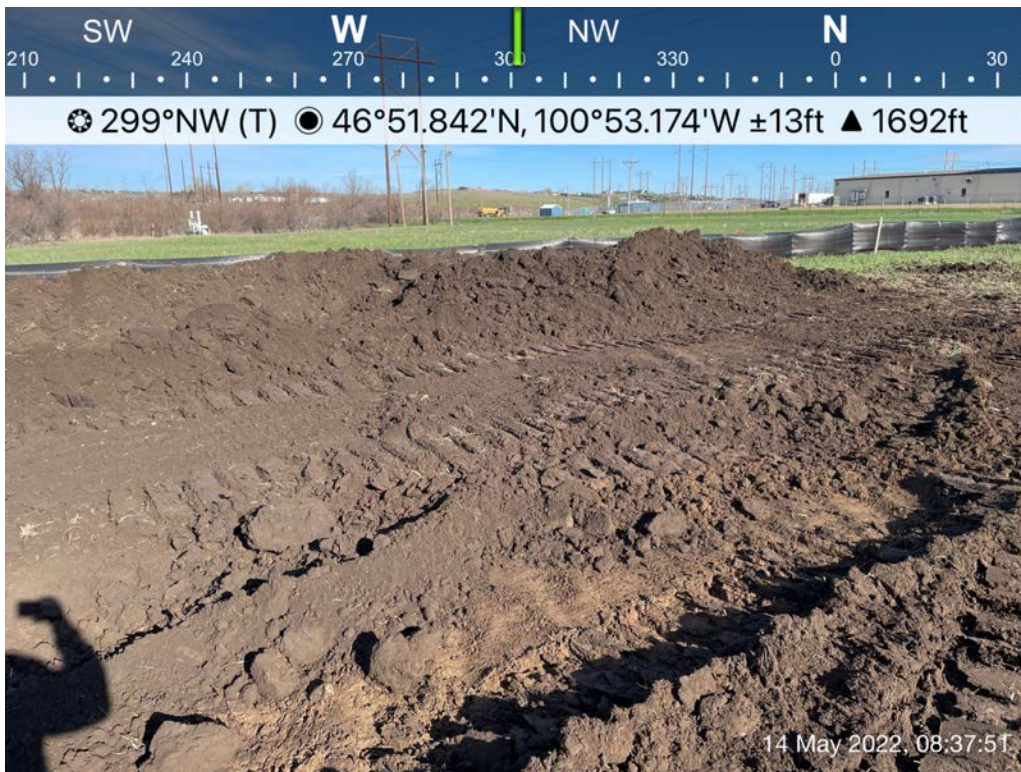
The bulldozer operated carefully removed the topsoil until the subsoil layer became visible and moved the topsoil into a berm on the west side of the cleared area. The bulldozer operator demonstrated proper understanding of the rules and regulations for topsoil removal and removed the topsoil to a depth where the subsoil started to appear. Multiple passes were made over the same ground to remove the topsoil in increments to smoothly strip the topsoil layer at proper depths across the varying contours of the field.

**Report Photo #2 "Topsoil Pile on the West Side of the Cleared Area"**

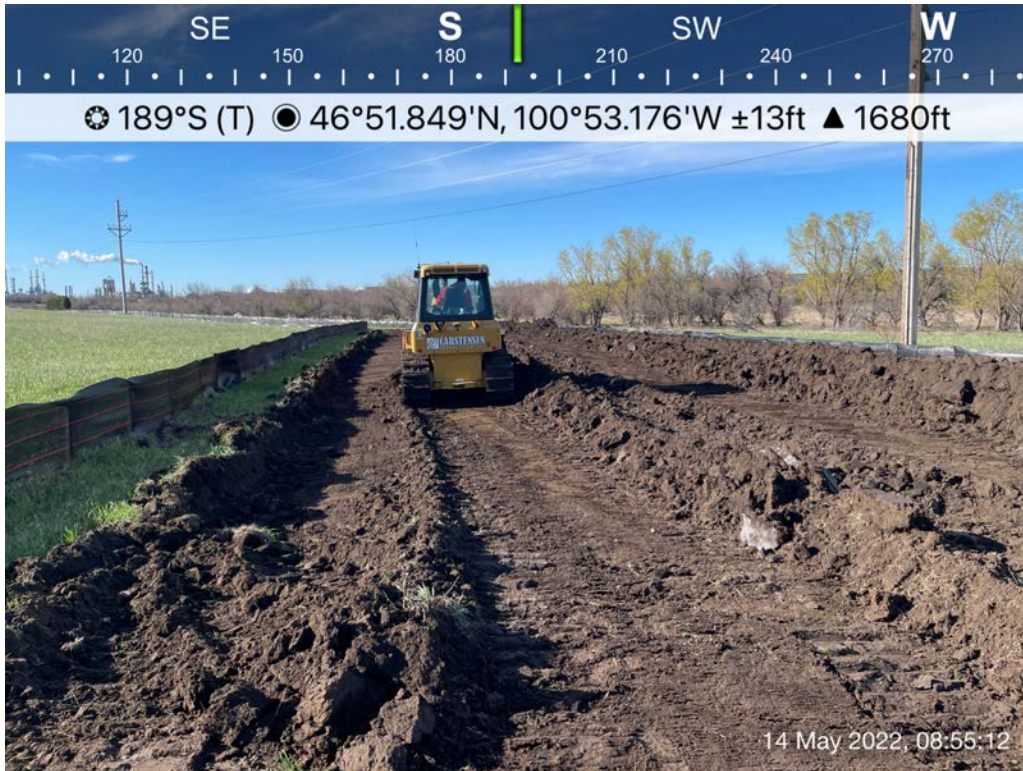
The MDU 12-inch Water Pipeline Project kicked off its construction in North Dakota at the time of the visit. A bulldozer stripped the topsoil along the Project ROW on the North end of the line near the Heskett Station in the NE ¼ of Section 15, Township 139N, Range 81W in Morton County. Soil was not stripped past the point where subsoil was visible. Subsoil was not removed at the time of the inspection.

**Report Photo #3 "Topsoil Being Stripped Showing Color Change from Topsoil to Subsoil"**

Topsoil segregation was noted to be acceptable at this time in the areas observed. Equipment operator was reminded to strip soil, where it existed, down to a maximum of 12 inches or to the depth where subsoil appeared. Equipment operators have demonstrated proficiency in topsoil removal and segregation in compliance with the Commission's Order.
