# Badger Wind LLC

Amend-Badger Wind Project-Logan & McIntosh Counties

Case No. PU-24-87

Topsoil Removal Inspection Report

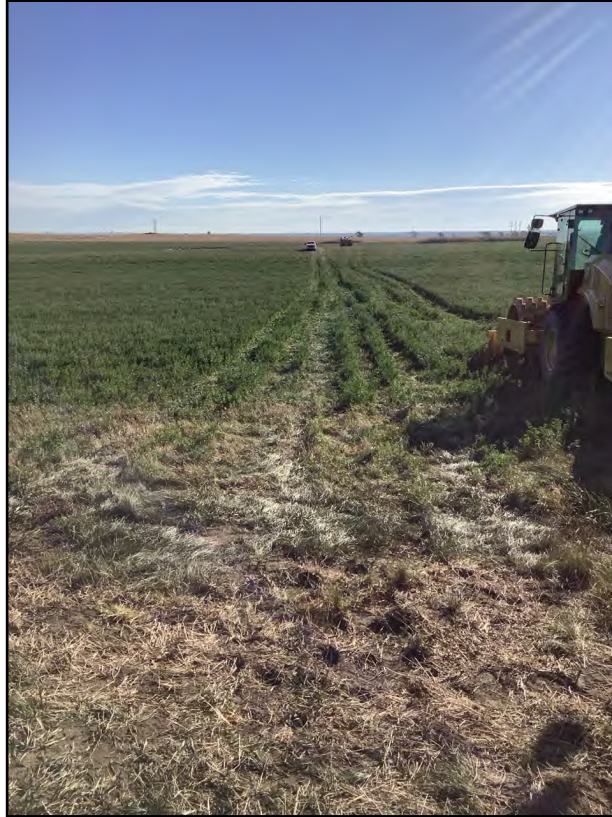
Point 1

Access road to first site existing conditions

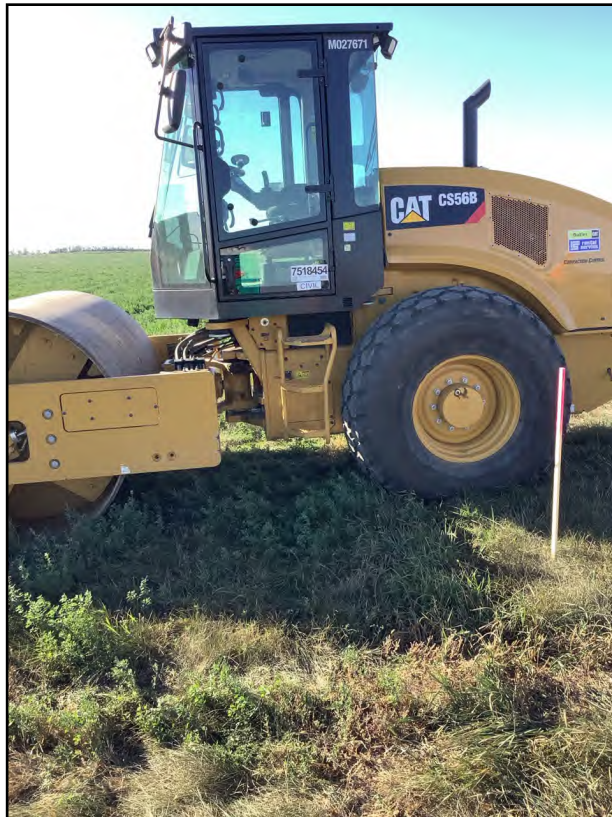
Point 2

CAT CS56B

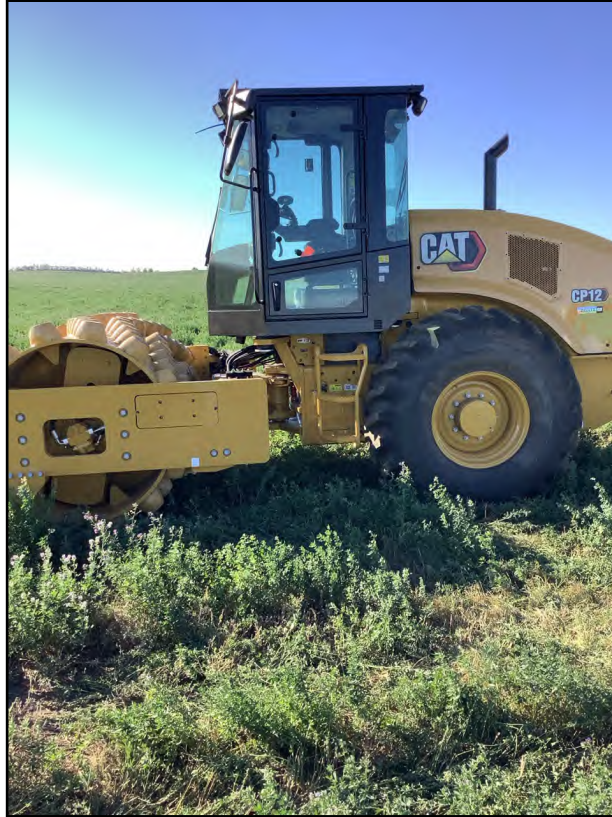
Point 3

CAT CP12 Sheep's foot roller

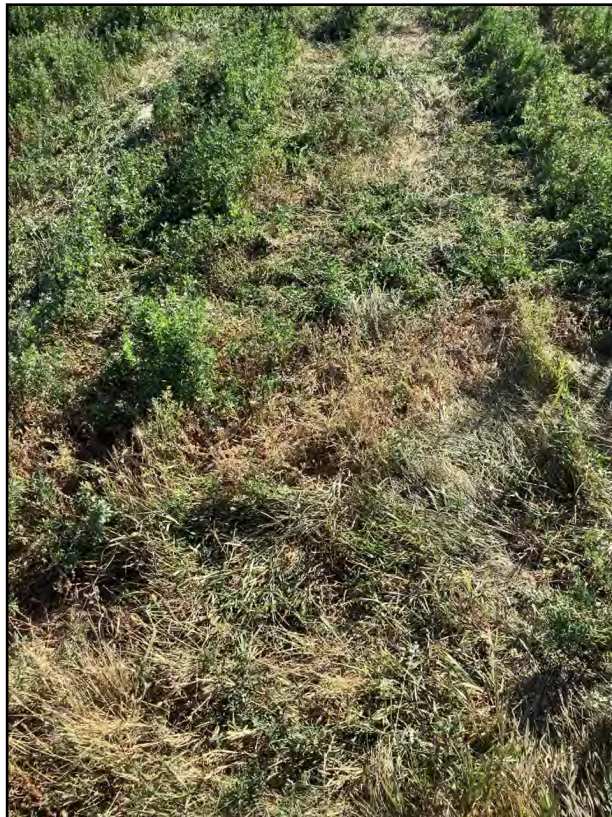
Point 4     Field

Haul road existing conditions

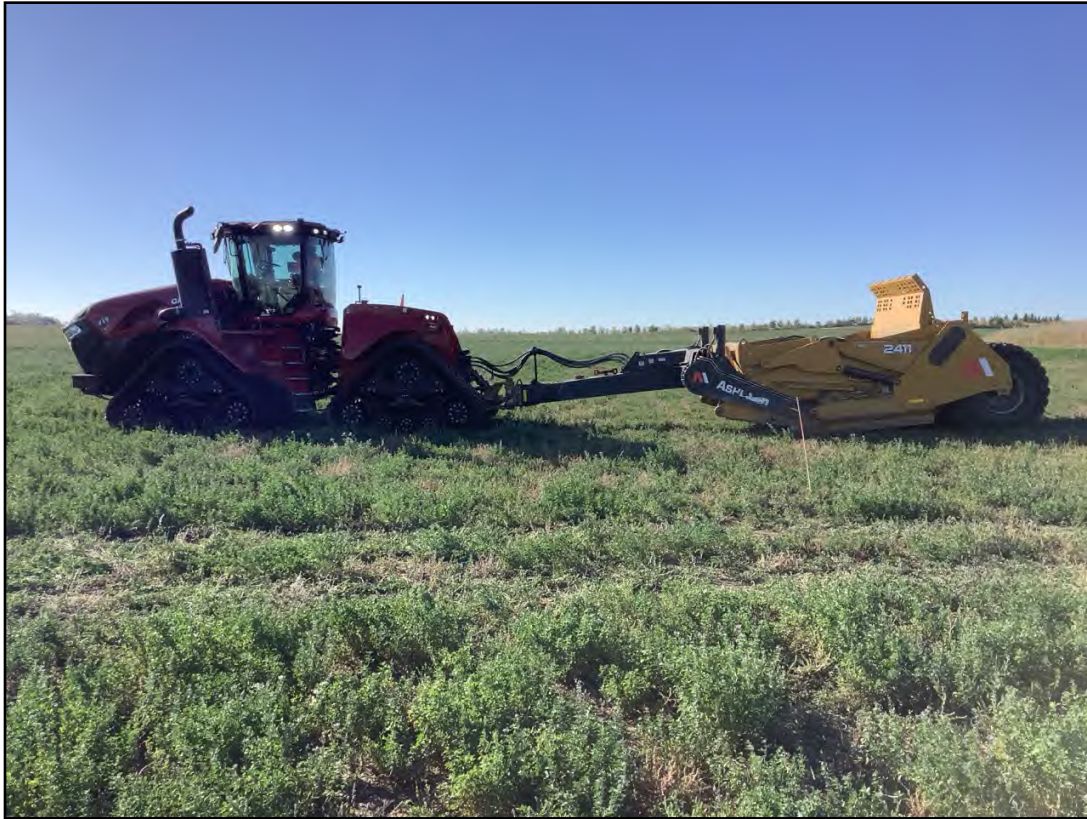
Point 5      Wind turbine site 1

Ashland 2411E scraper pulled by a CASE III Quadtrac

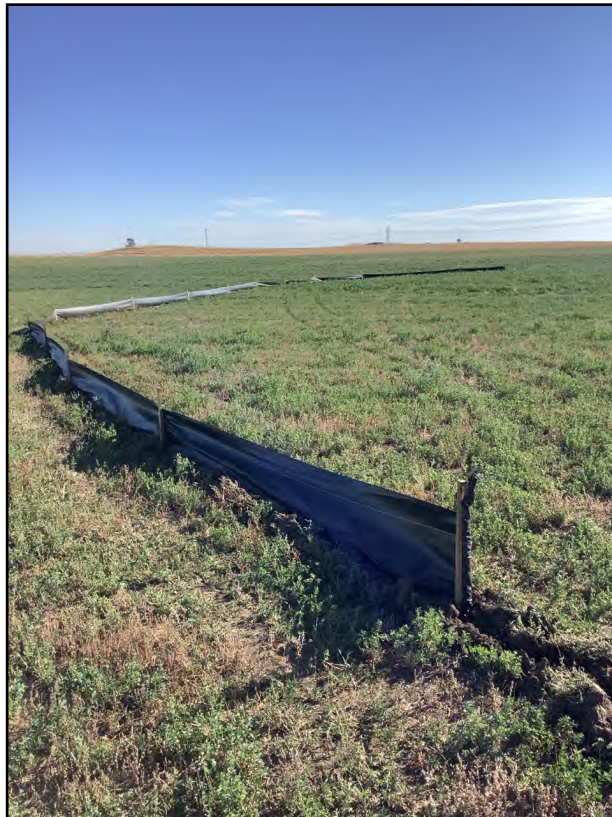
Point 6      Wind turbine site 1

Silt fence installed on downslope of site.

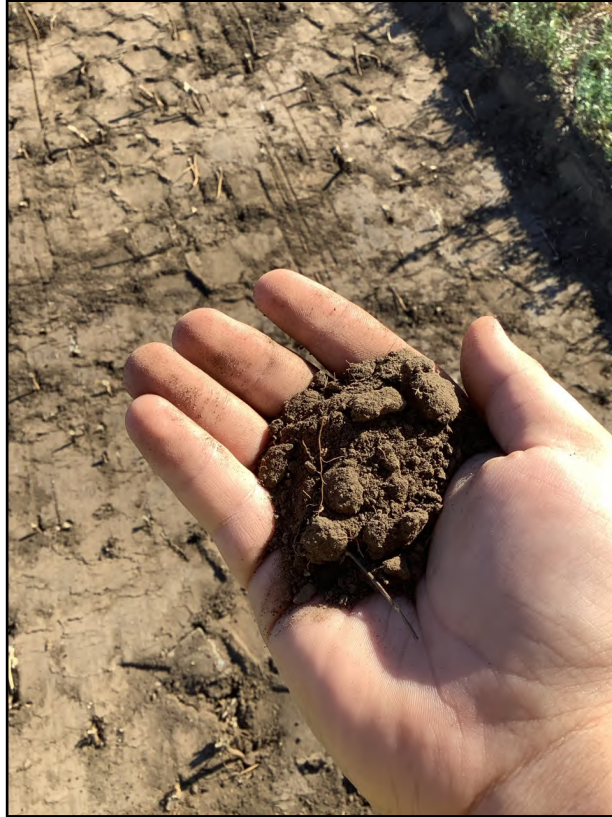
Point 7      Wind turbine site 1      Topsoil is a light brown, silty loam

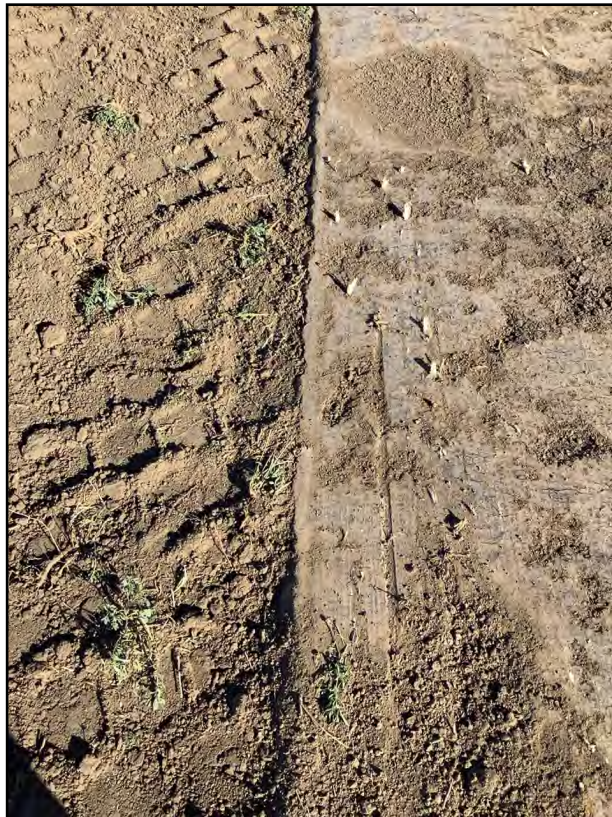
Point 8      Wind turbine site 1      Topsoil left, subsoil right

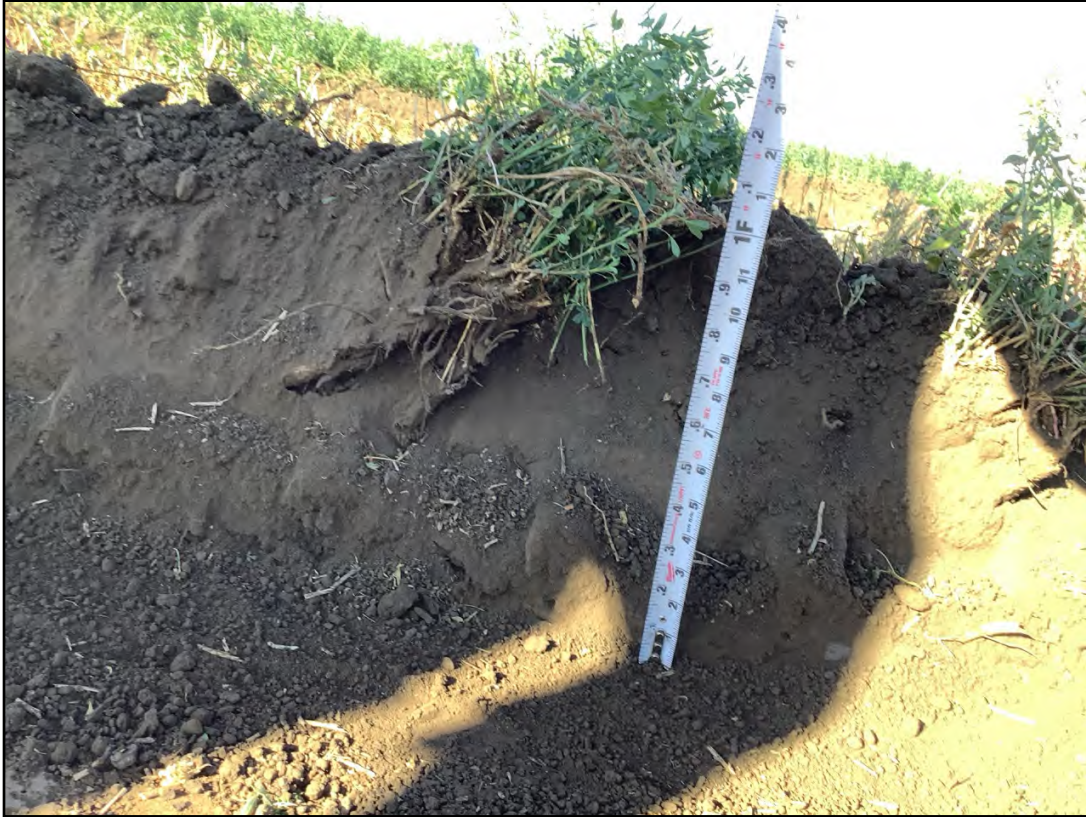
Site 1: Crew used a CASE III tractor to pull a CAT scraper around the site in strips and stripped the topsoil to a depth of 12", verified by inspector (see P9), loading it into the scraper bucket. Once full, the tractor would pull the scraper bucket and dump it on the East side of the job site, creating a windrow of topsoil see (P10 & 19). Similarly, for access road construction, a blade was used to strip topsoil to a depth of 12" running from the East road shoulder to the construction site. A dozer was used to move topsoil along the steeper grades of the road shoulder, and material was windrowed along the sides of the access road (see P21, 23, & 24). From there, the tractor collected the material in its scraper bucket and moved it to the stockpile. In the afternoon when the wind really came up, dry conditions caused blowing dust to occur.

Point 9      Wind turbine site 1      Topsoil depth ~12inches

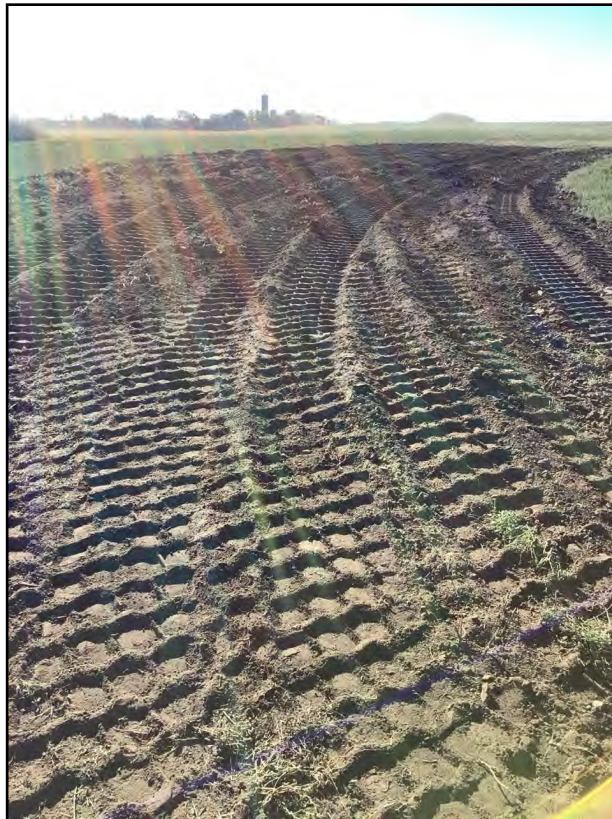
Point 10      Wind turbine site 1      Windrow of excavated topsoil placed on eastern border of site 1

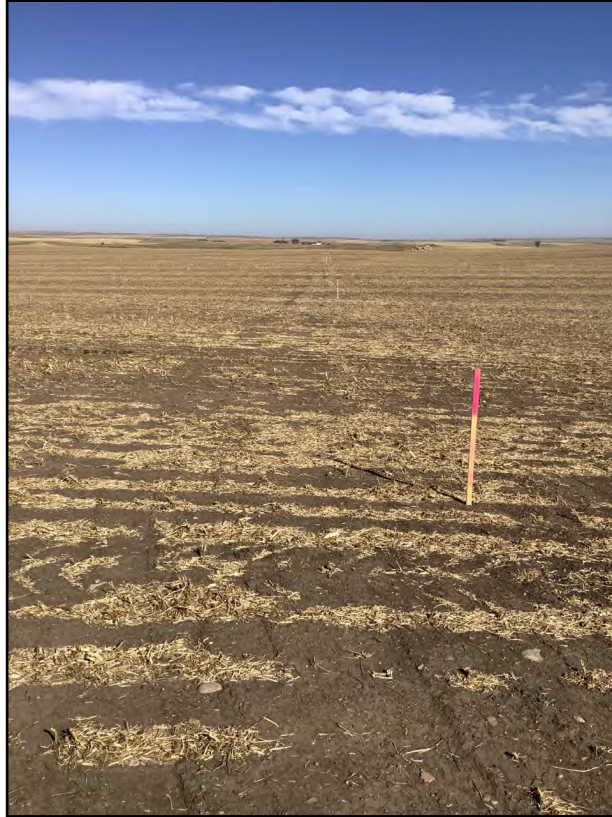
Point 11    Structure 3 access road    Existing conditions for site 3 (structure 65) and site

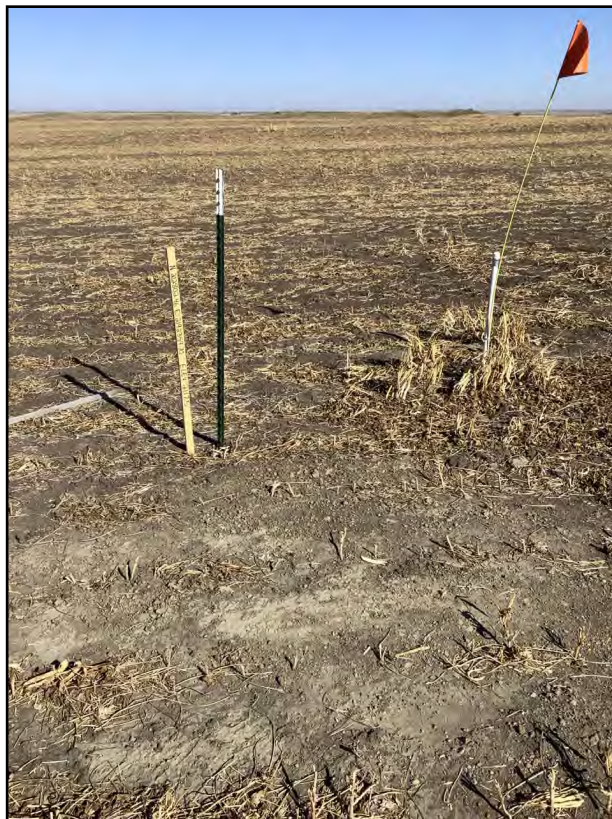
Point 12    Site 3 (structure 65)    Existing conditions for site 3 (structure 65). Soybean field.

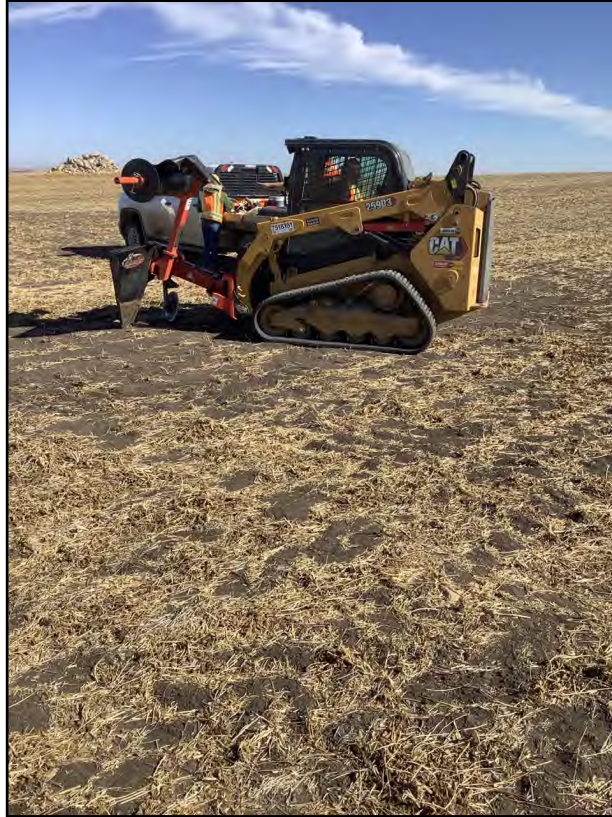
Point 13     Site 3 (structure 65)     CAT 259D3 skid steer with silt fence installation attachment.

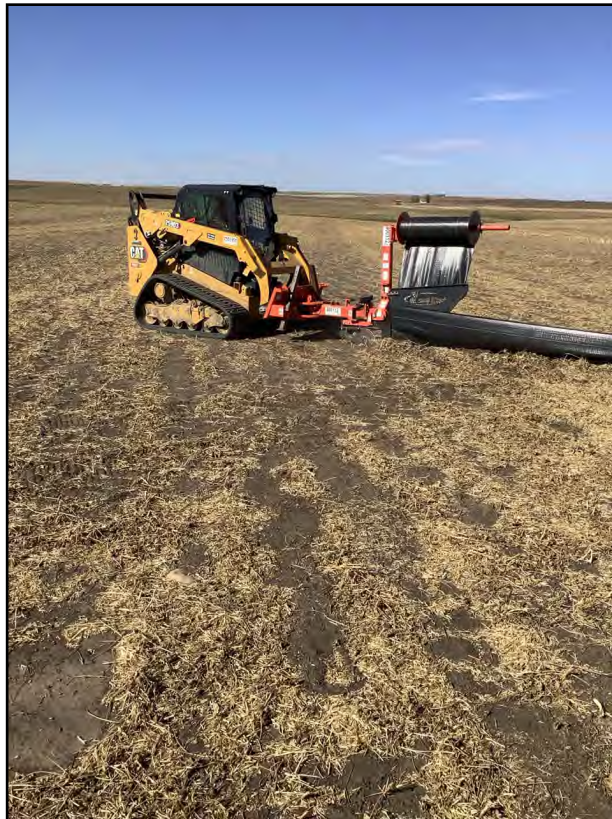
Point 14     Site 3 (structure 65)     Crew installing silt fence along NW edge of site.

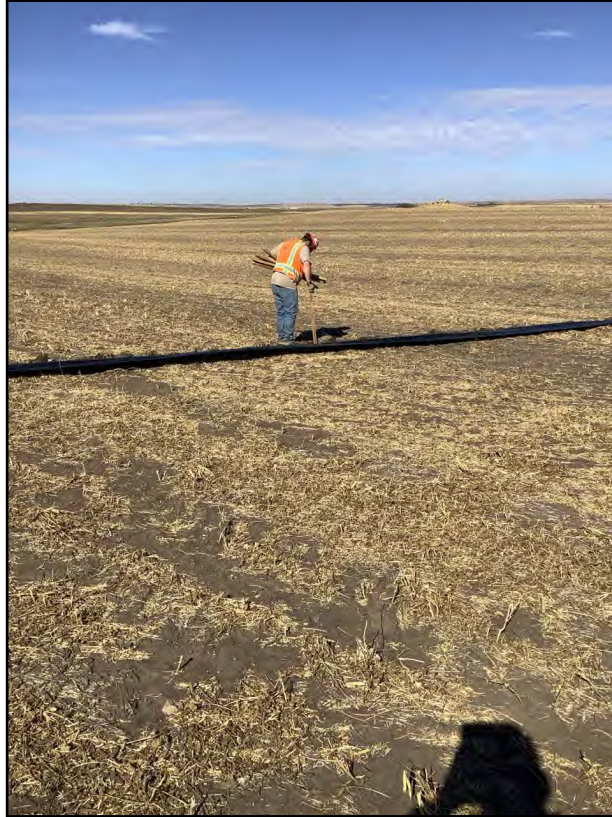
Point 15    Site 3 (structure 65)    Crew installing silt fence posts

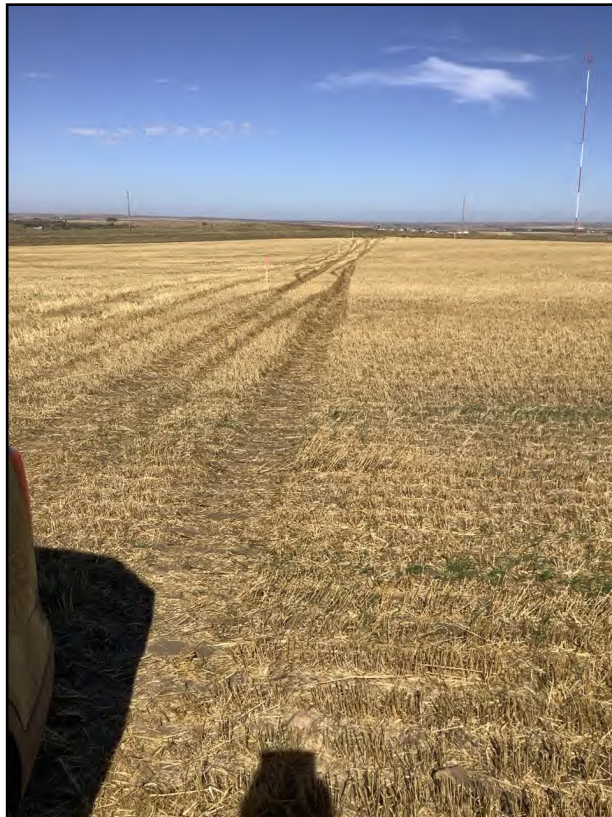
Point 16    Site 5 (structure 109)    Wheat field existing conditions

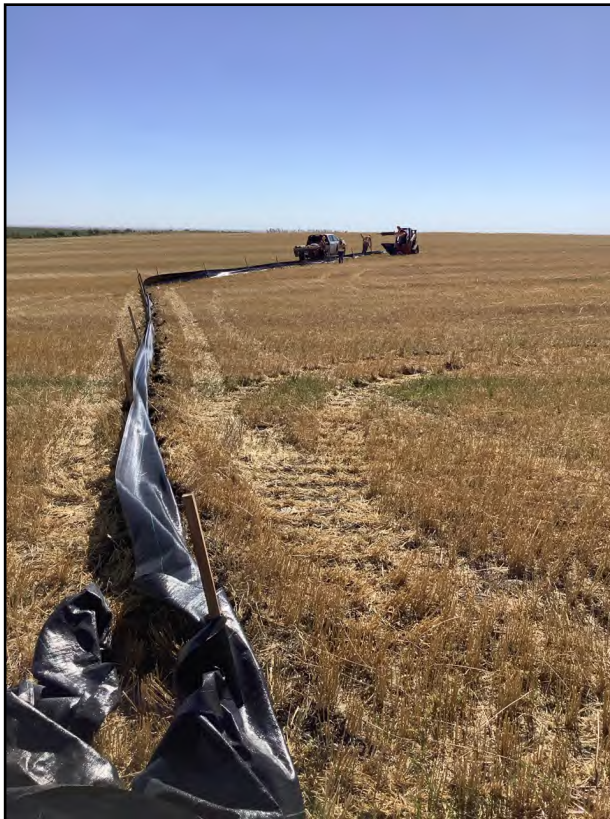
Point 17 Site 5 (structure 109)

Crew installing silt fence on Eastern edge of site, downslope from construction operations

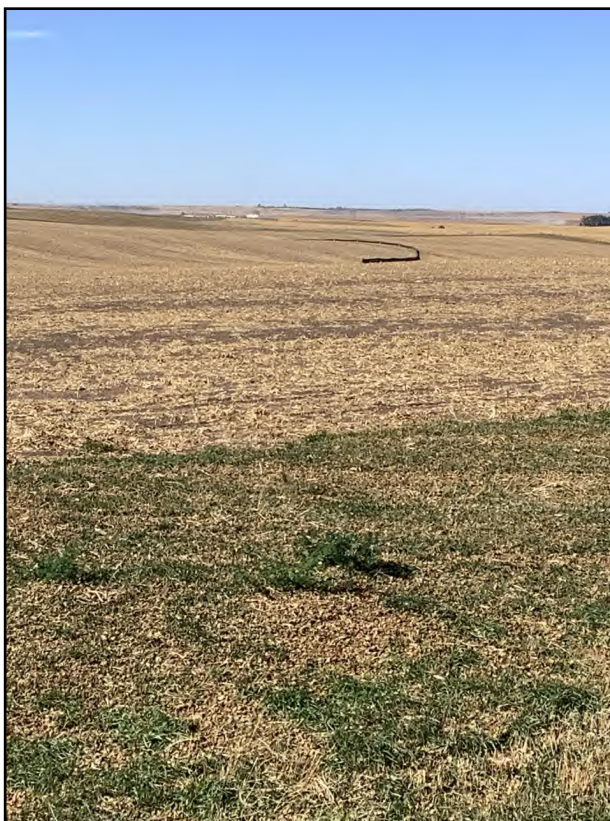
Point 18 Site 2

Silt fence installed on site 2.

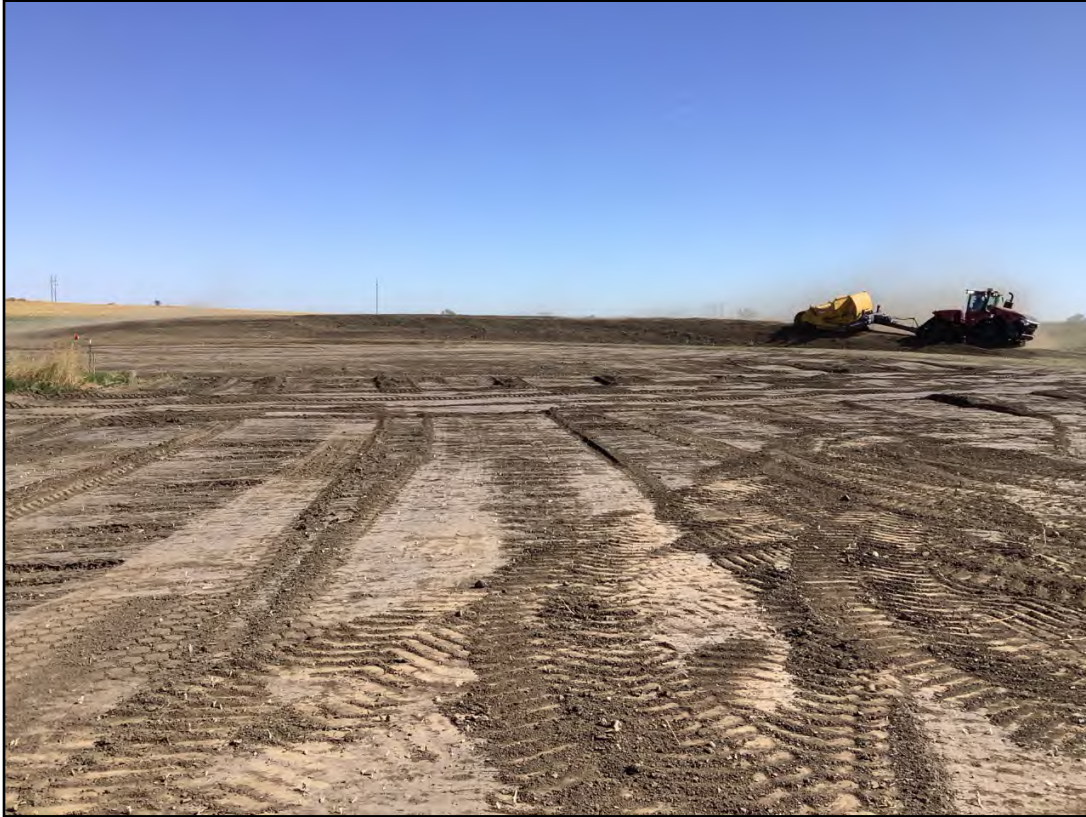
Point 19    Site 1

Progress of site 1 topsoil stripping. No issues noted.

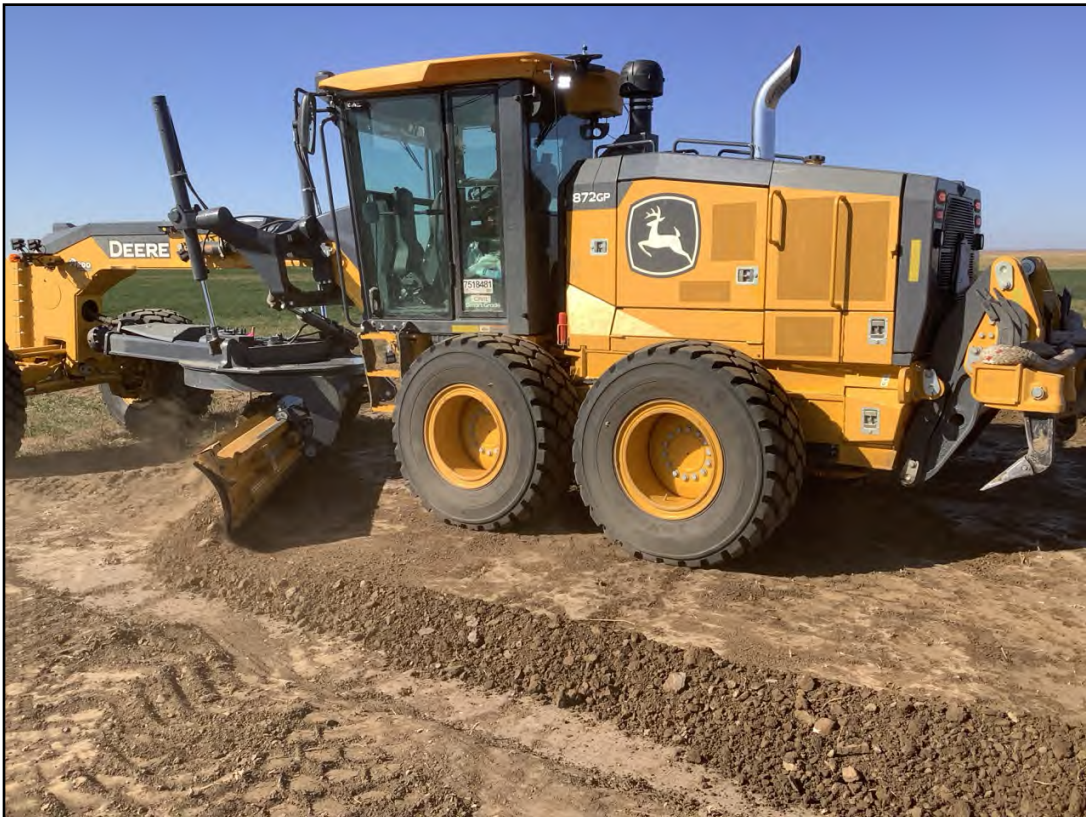
Point 20    Site 1

CAT 872GP blade which is being used to strip topsoil along site 1 access road. Topsoil is being windrowed on both sides of access road.

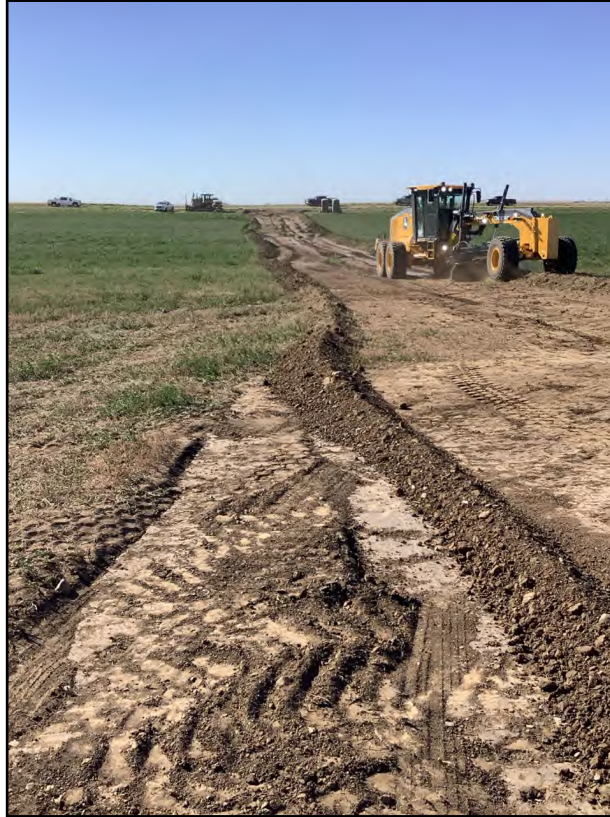
Point 21    Site 1

Access road for site 1 progress.

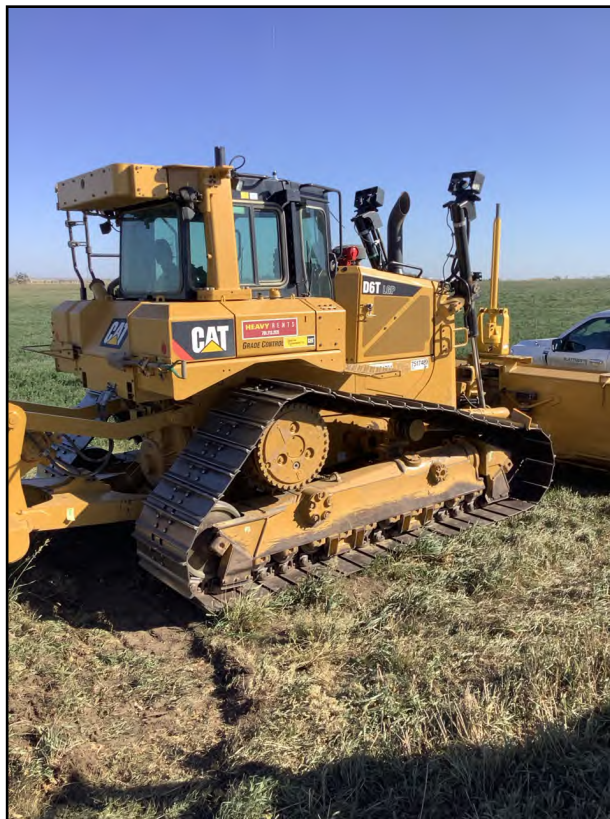
Point 22    Access road to site 1

CAT D6T LGP dozer to be used on access road

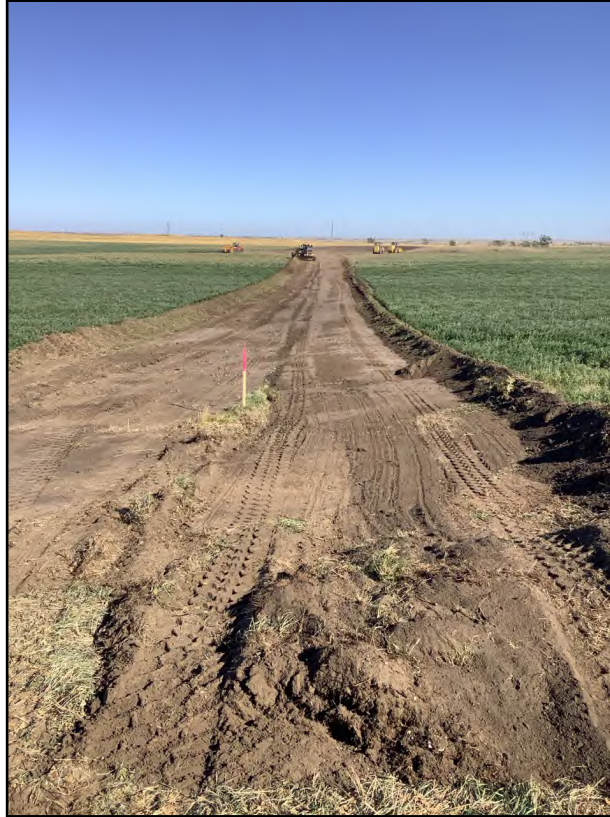
Point 23 Access road to site 1

Access road conditions after topsoil stripping.

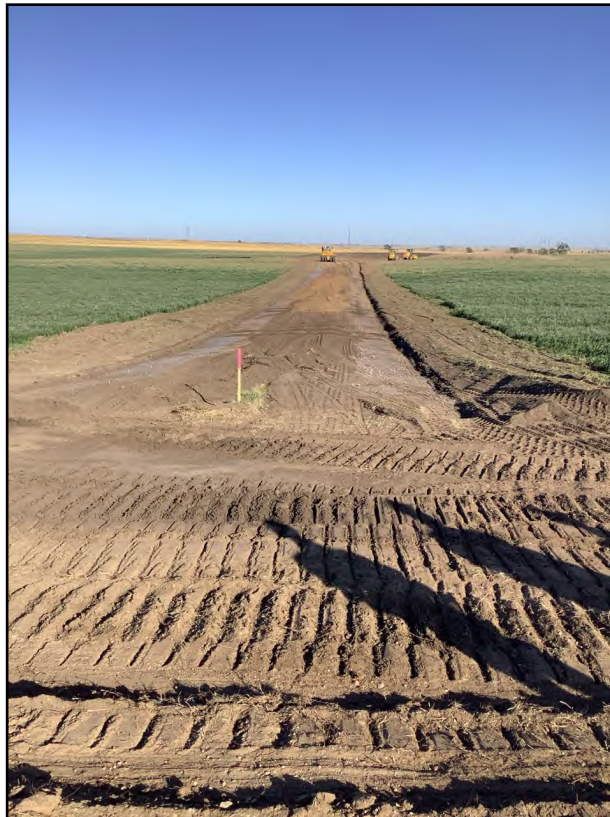
Point 24 Site 1 access road

Crew is knocking down subsoil and using it to grade and level access road.
