Site/Project Location: Buddy Domingo Pipeline- Morton County **Date of Inspection:** 16 August 2022

52 PU-22-141 Filed 08/29/2022 Pages: 4
Topsoil Inspection Report
Keitu Engineers & Consultants, Inc.

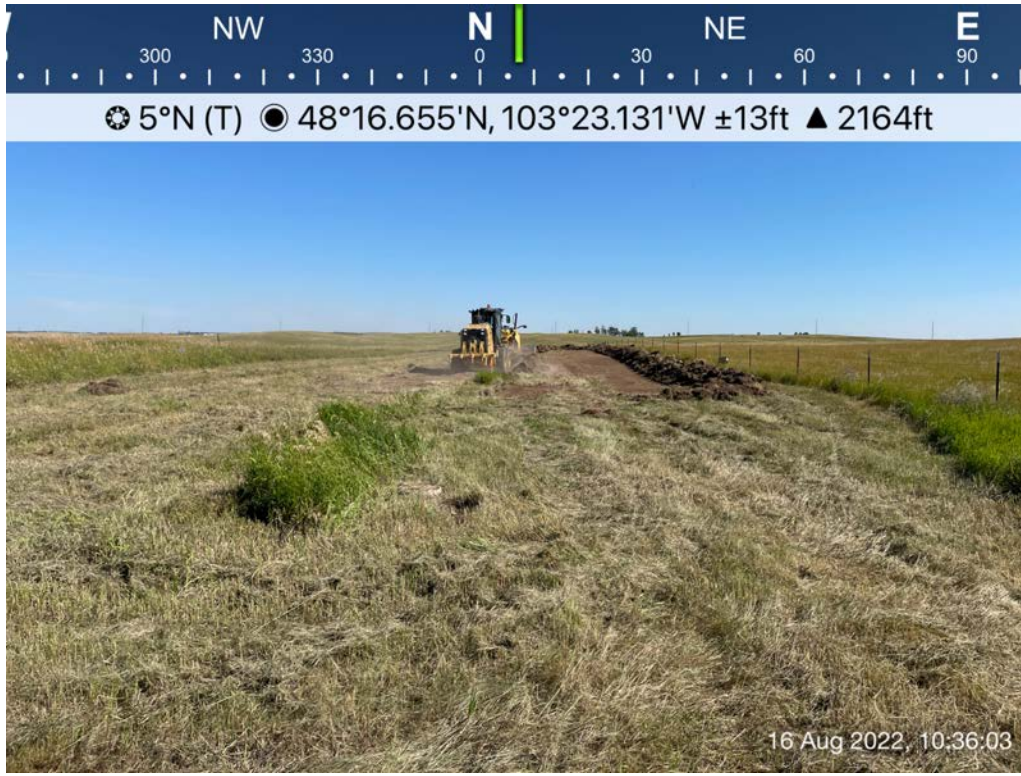
Report Photo #1 "Motor Grader Stripping Topsoil along ROW"

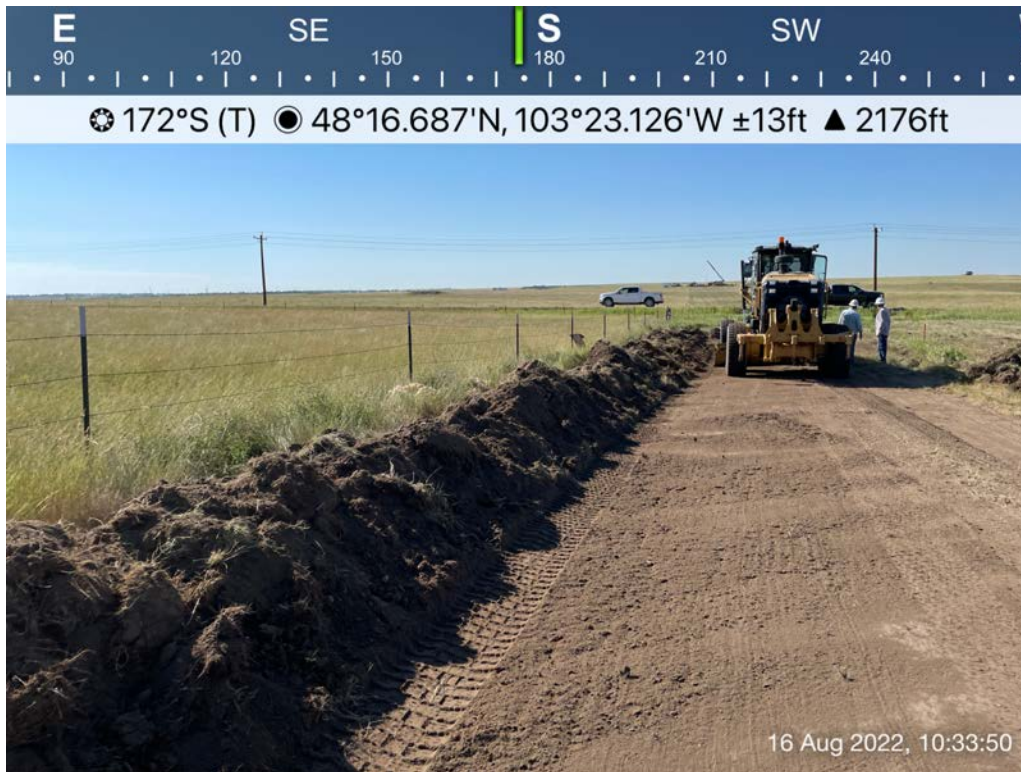
Report Photo #2 "Topsoil Pile on the East Side of the Cleared Area"

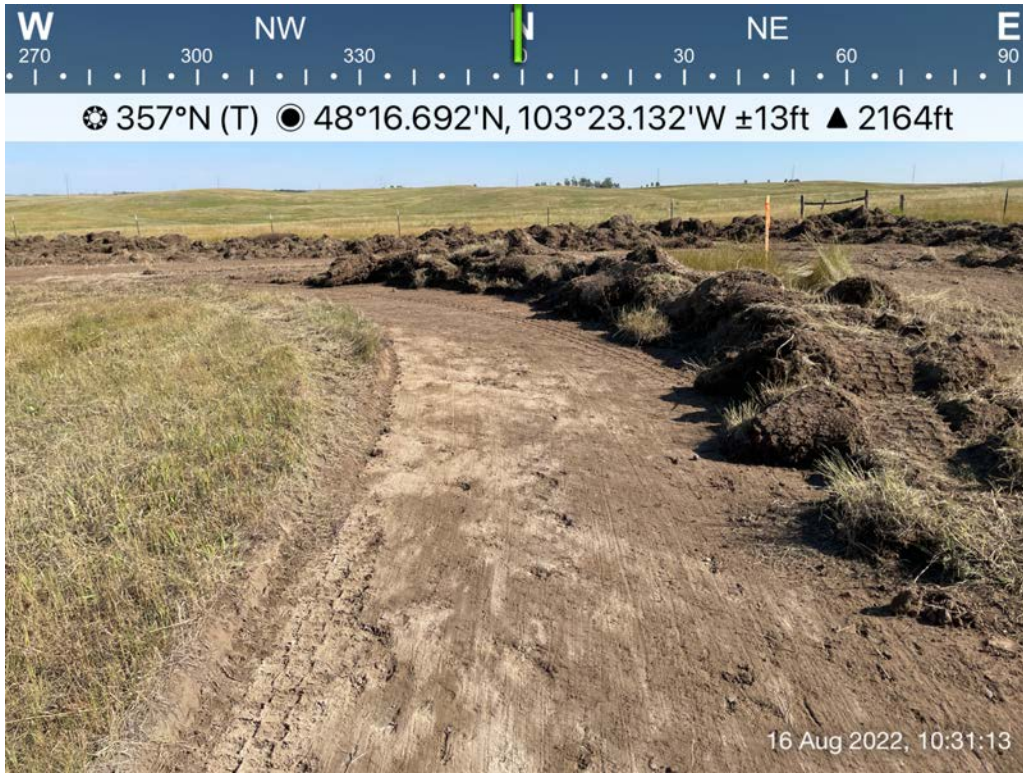
Report Photo #3 "Topsoil Being Stripped Showing Color Change from Topsoil to Subsoil"
