Reclamation and Revegetation Inspection Report

Continental Resources, Inc.

8-inch NG Buddy Domindgo Pipeline

ND PSC Case No. PU-22-141

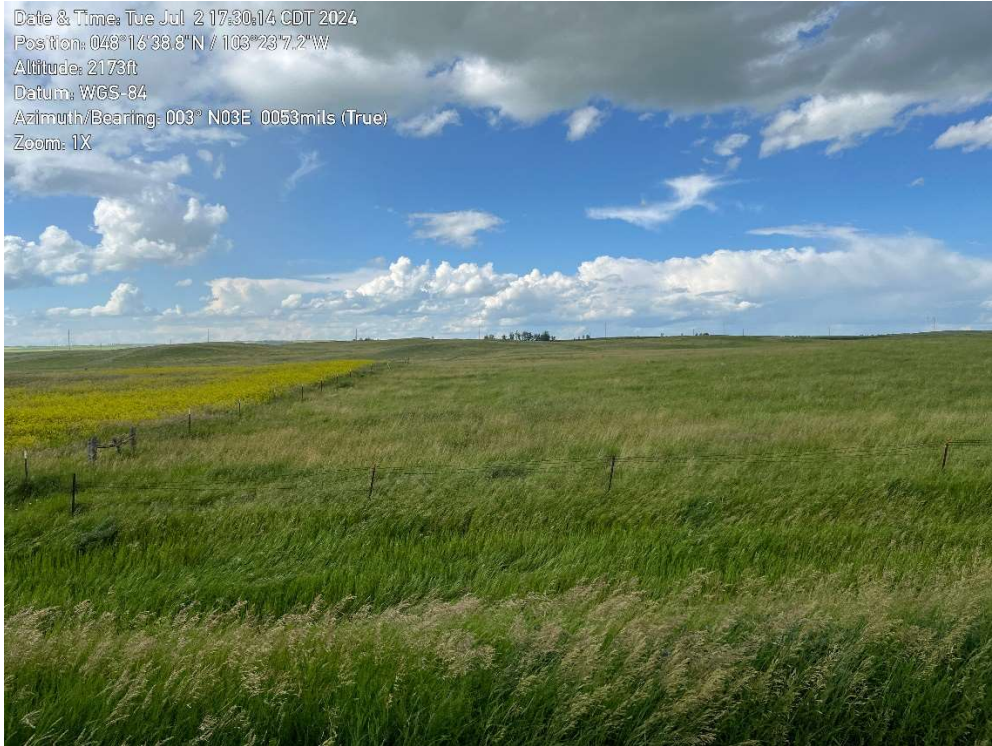
One area of the pipeline ROW near the south end / natural gas tie-in location had an approximate 50-foot-long area of subsidence.

Vegetative cover had been well-established along the entire length of the ROW typically with planted wheat, canola or alfalfa crop. No erosion control devices remained. The area of prior surface subsidence appeared to have been corrected.

Report Photo #1: South End of ROW with Soil Subsidence Addressed & Crop Cover Apparent

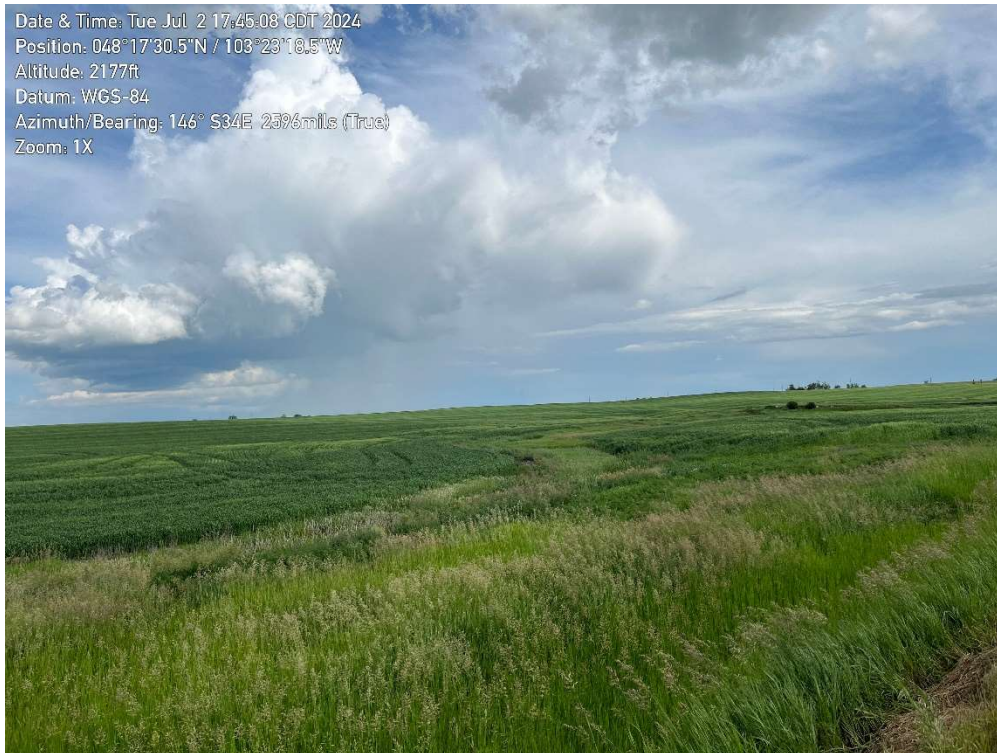
It was noted that that time several areas where the pipeline was constructed encroached within 20 feet of an unnamed creek and/or wetland and no vegetative cover had been established on the ROW soil surface. Suitable erosion control/stormwater protection features were not apparent in these areas adjacent to open water.

Report Photo #2: Mid Portion of ROW Adjacent to Wetlands with Established Vegetation

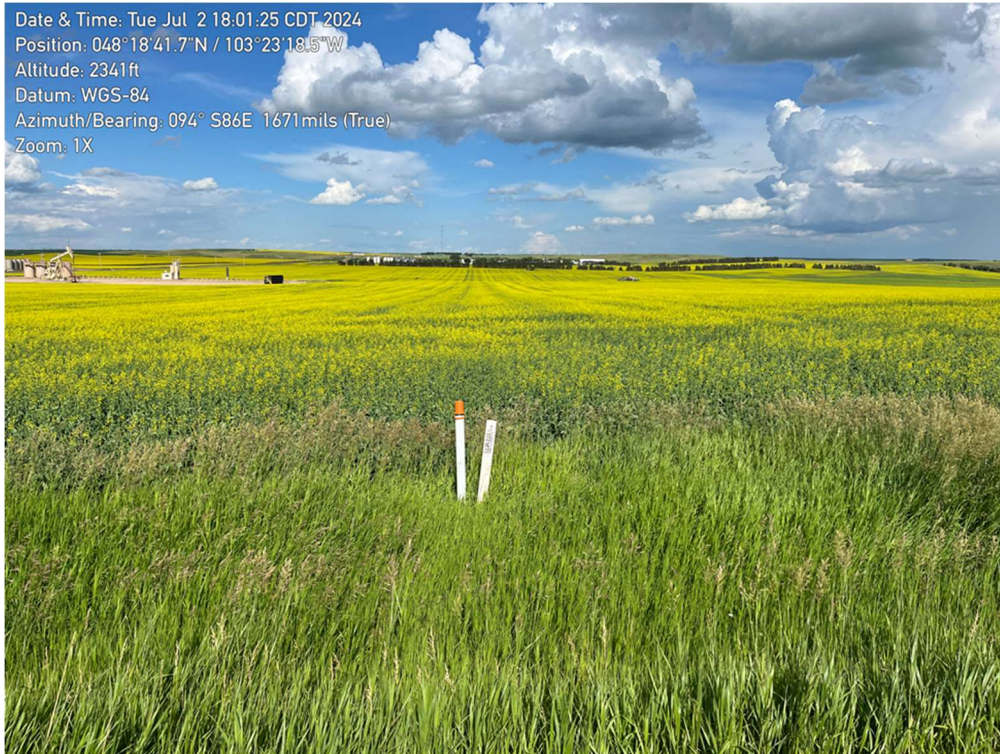
Report Photo #3: Northern Portion of Pipeline ROW with Revegetation Apparent

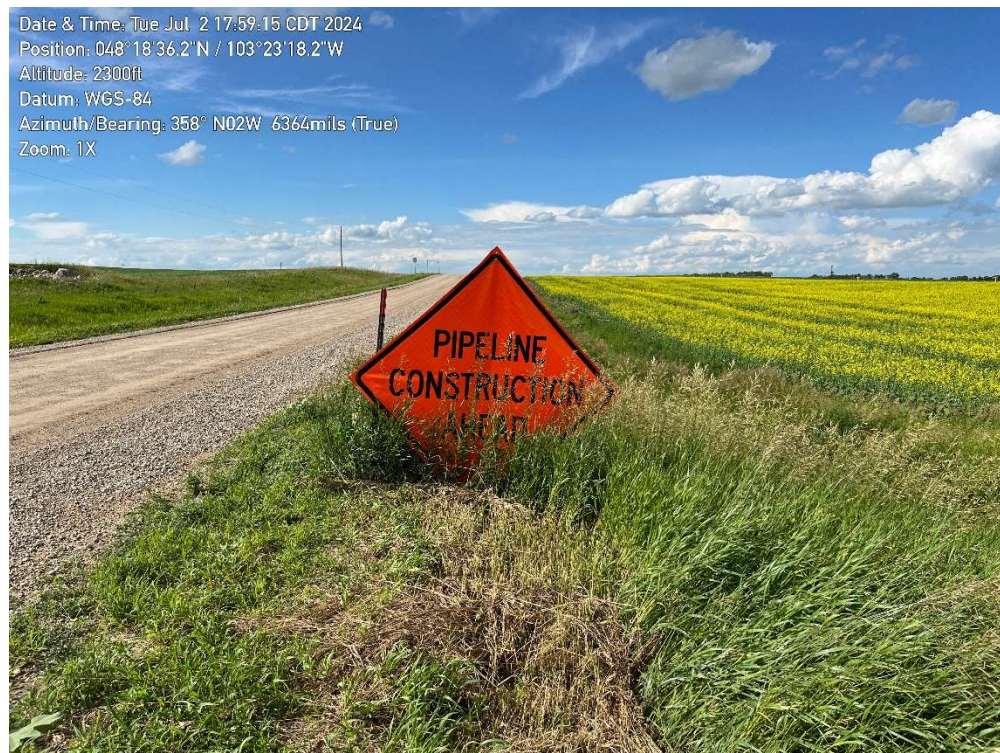
Report Photo #4: Northern Portion of Pipeline ROW with Revegetation Apparent

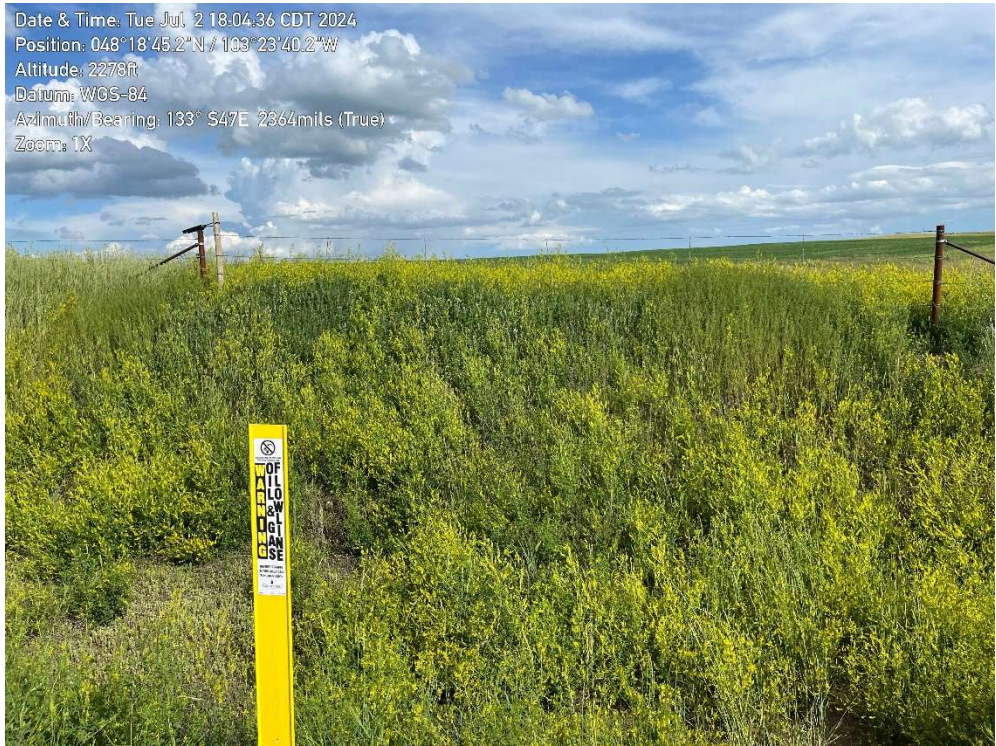
Report Photo #5: North Portion of Pipeline ROW with Revegetation Apparent

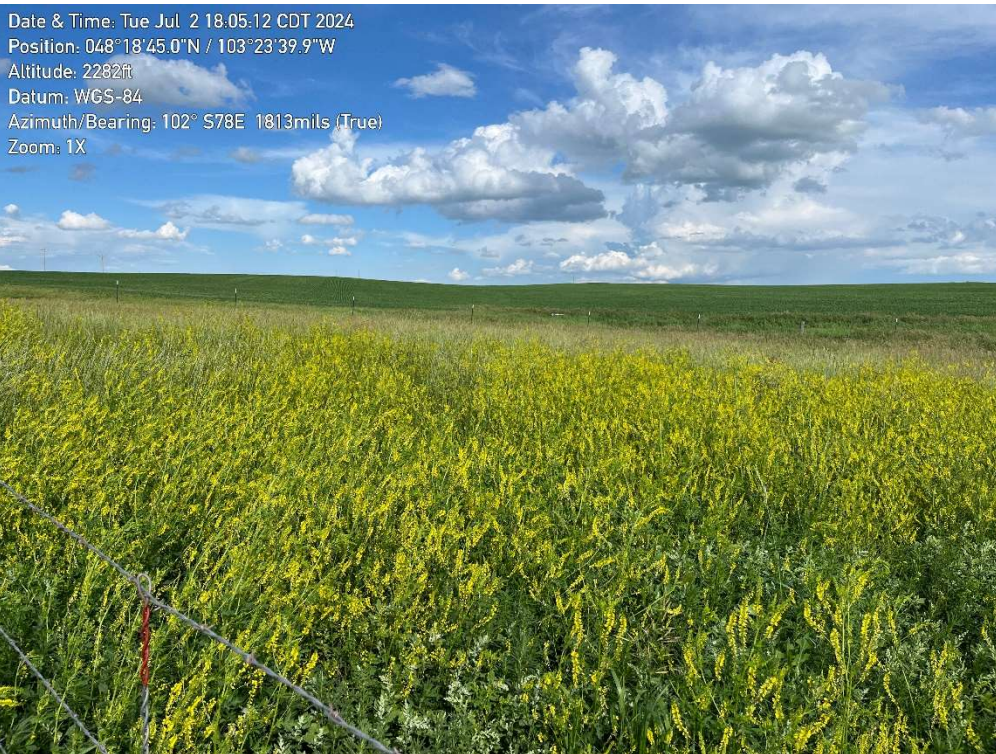
Report Photo #6: North Portion of Pipeline ROW with Revegetation Apparent

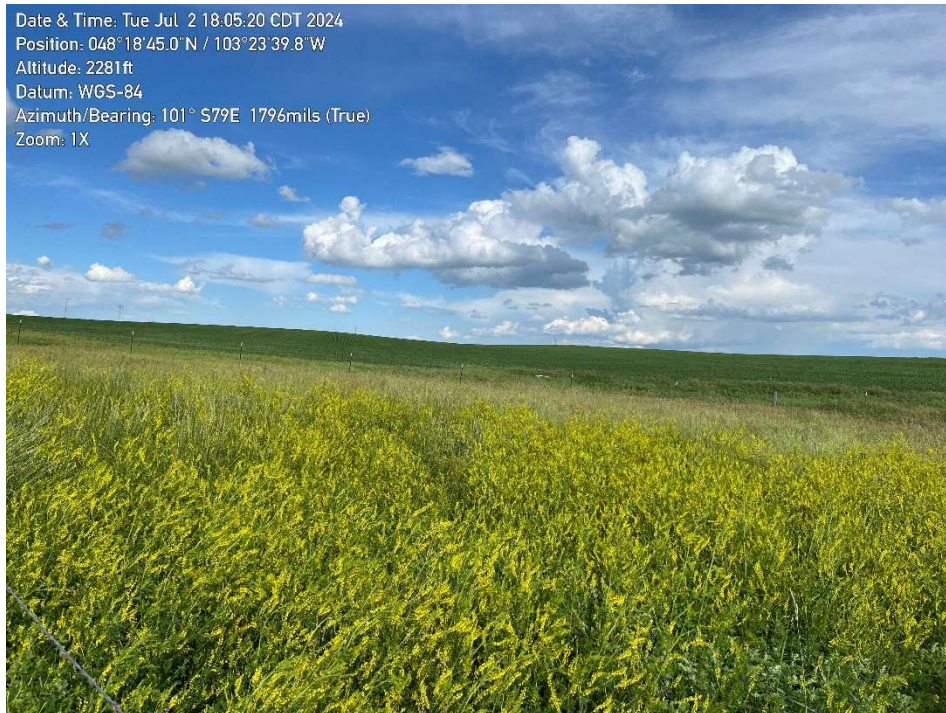
Report Photo #7: North Portion of Pipeline ROW with Revegetation Apparent
