31 **PU-22-164** Filed: 7/18/2022 Pages: 5  
**Topsoil Inspection Report**

**Site/Project Location:** Spring Creek II Pump Station- McKenzie County      **Date of Inspection:** 7 July 2022

Keitu staff visited the ONEOK Spring Creek II Pump Station Project for a start of project topsoil inspection at the location being cleared. Inspection of construction sites to focus on (1) confirming surface disturbance/work occurring within ND PSC-approved work corridor and/or route; (2) topsoil segregation occurring; (3) vegetation removal consistent with tree & scrub mitigation plan.

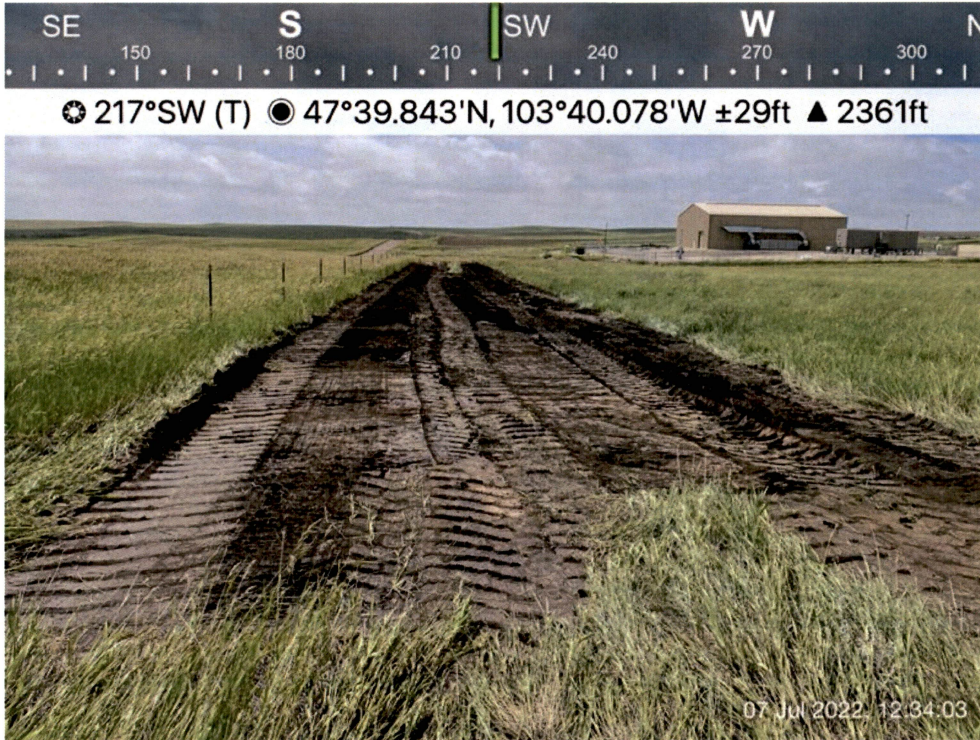
**Report Photo #1 "Project Perimeter with Stripped Topsoil"**

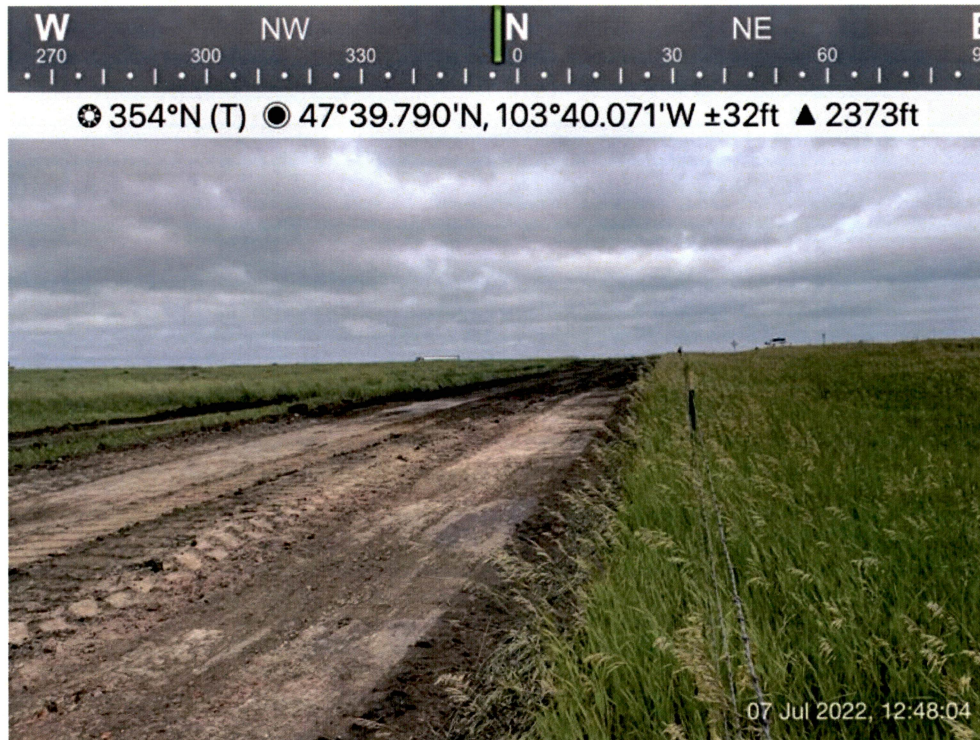
**Report Photo #2 "Subsoil Showing Along Project Perimeter After Topsoil Removed"**

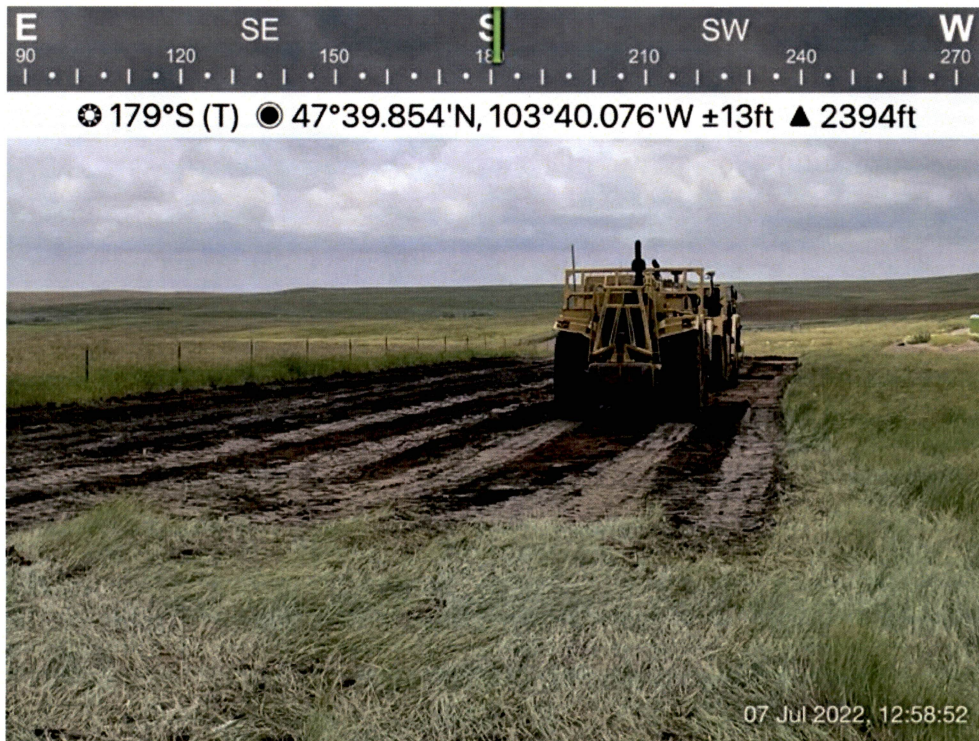
**Report Photo #3 "Graders Stripping Topsoil Along Project Perimeter"**

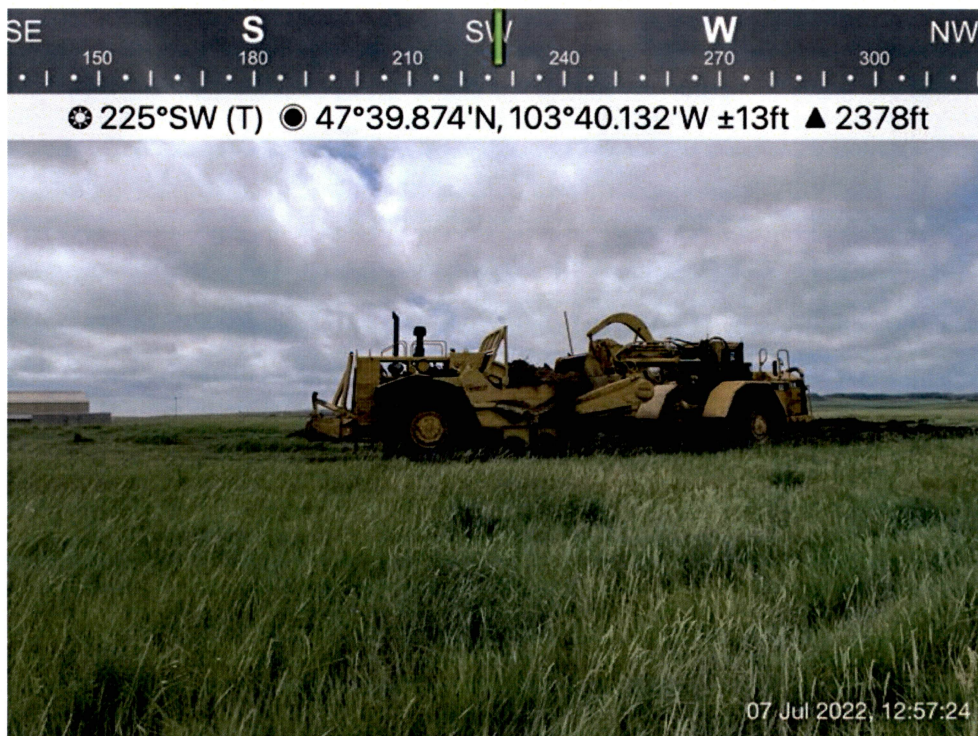
**Report Photo #4 "Graders Moving Stripped Topsoil to Pile Outside Pad Boundary"**
