Site/Project Location: McKenzie County

Date of Inspection: 6, September 2022

The ONEOK Spring Creek II Pump Station Project consisting of approximately 8 acres was visited during civil/foundation work construction and the start of equipment placing. Inspection of pump station construction site to focus on (1) confirming surface disturbance/work occurring within ND PSC-approved work corridor and/or route; (2) topsoil segregation occurring; (3) vegetation removal consistent with tree & scrub mitigation plan.

33 PU-22-164 Filed 09/15/2022 Pages: 5
Construction Inspection Report
Keitu Engineers & Consultants, Inc.

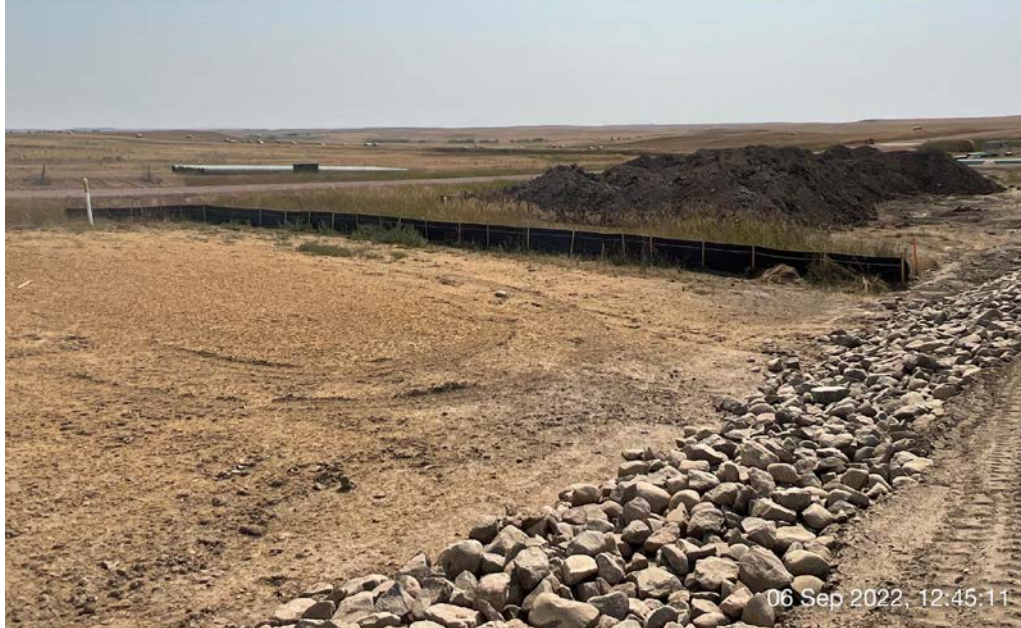
Topsoil segregation piling was completed prior to the site visit. Topsoil piling was located on southeast side of the station property. Subsoil was used for construction landscaping. Temporary subsoil piling was located at southwest side of site. Storm water BMPs were also installed.

Report Photo #1 "Topsoil Pile"

North Elevation

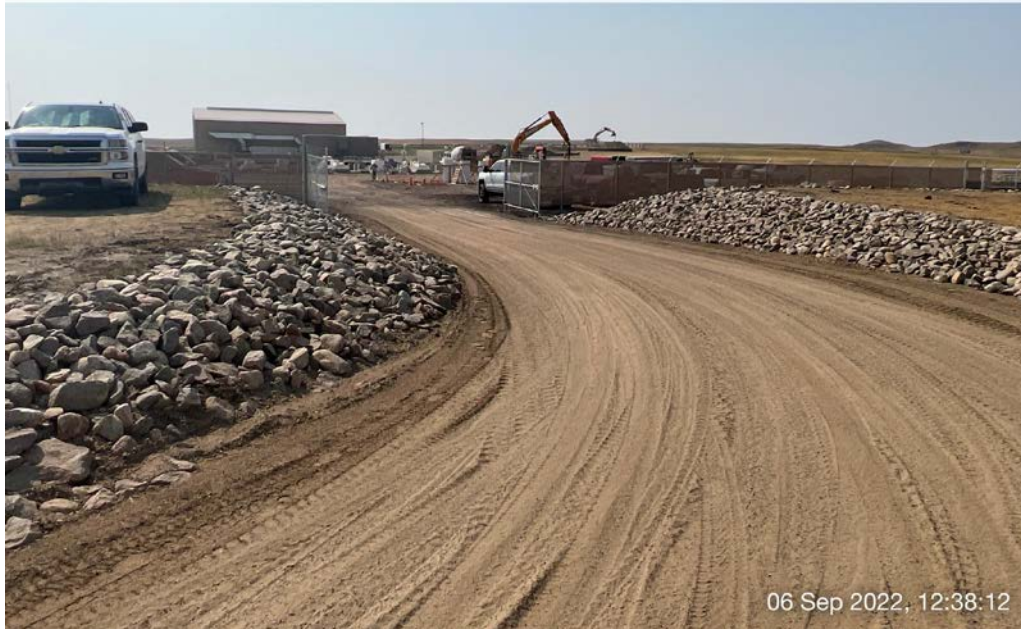
Report Photo #2 "Site Entrance facing Southwest"

North East Elevation

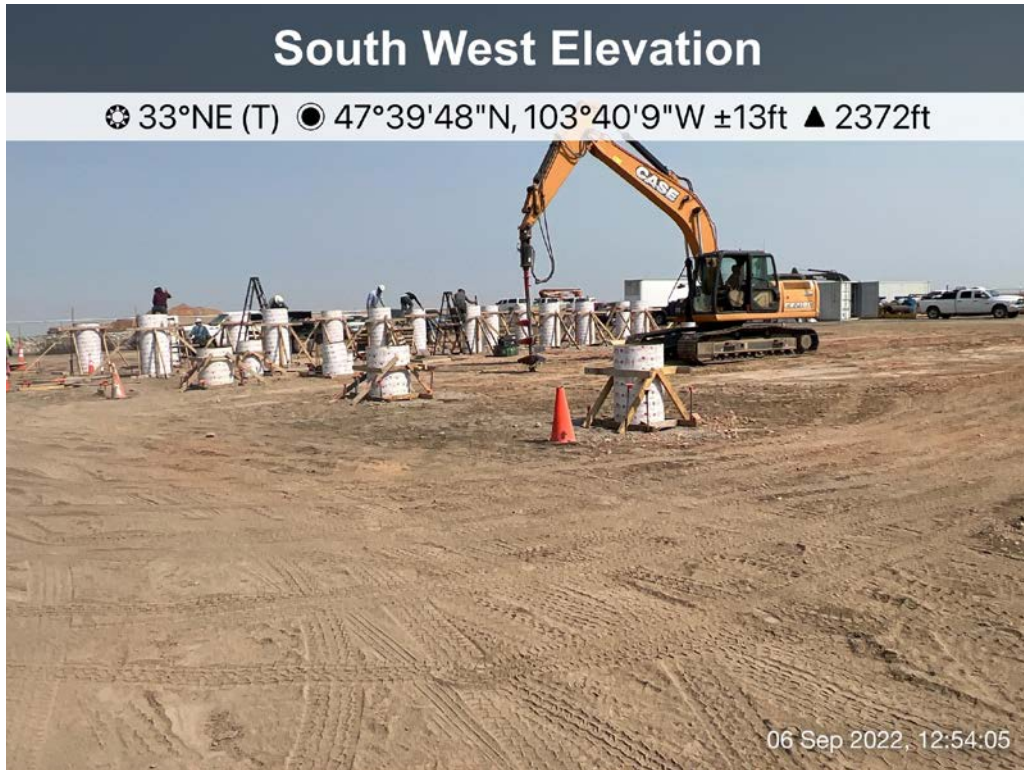
Rough grading was complete upon site visit. Concrete foundations were in progress. A concrete washout area berm was repaired after being torn by a concrete truck. The concrete wash was still contained within the containment area. In the equipment laydown area, ancillary equipment (generator and equipment fuel supply tank) was located inside an earthen containment.

Report Photo #3 "Foundation being poured"

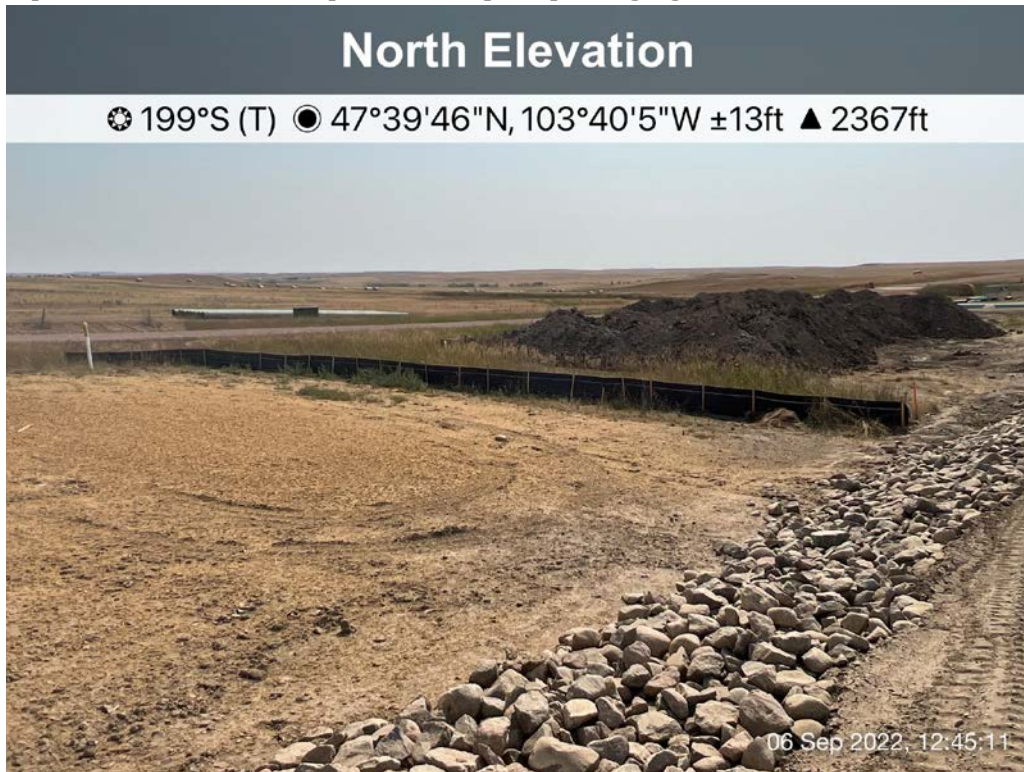
Topsoil segregation and storage was completed on all grounds stripped for the station. Storm water management practices have been implemented. Overall site conditions were good and mostly dry.

Report Photo #4 "BMP's in place and Topsoil pile segregated"

Upon visit, Keitu inspector deemed that topsoil segregation and storage was adequate. Storm water management practices were in respected spots and were being maintained routinely.

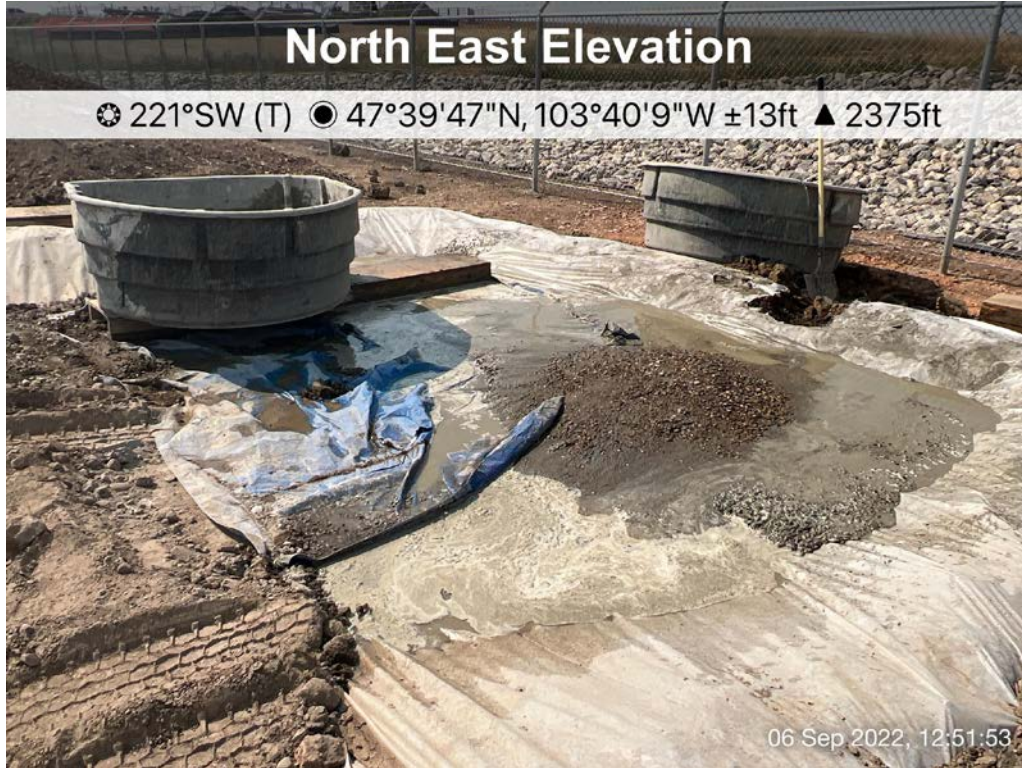
Report Photo #5 "Concrete washout area berm damage"

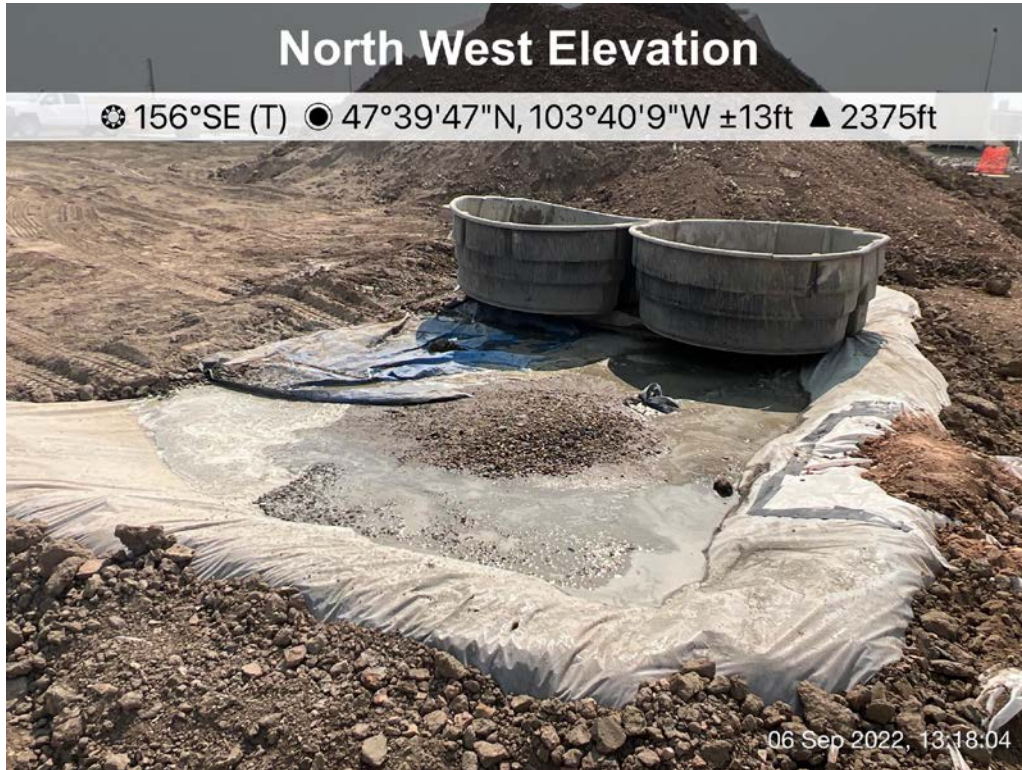
Report Photo #5 "Concrete washout area berm repaired"
