# Reclamation and Revegetation

## Inspection Report

ONEOK Bakken Pipeline, LLC

Spring Creek II Pump Station

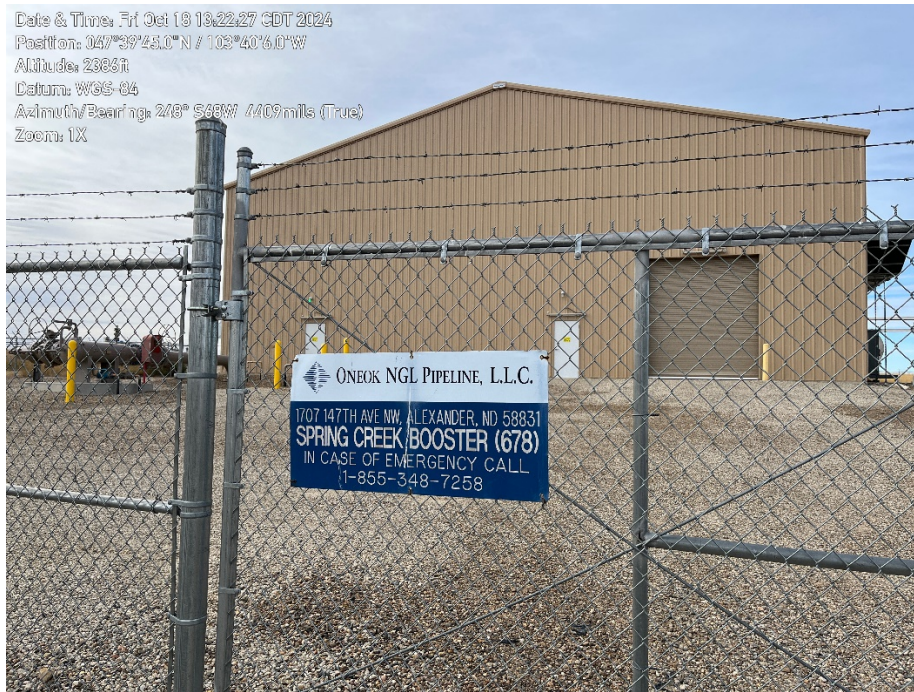
**Report Photo #1: Station Sign along Main Gate**

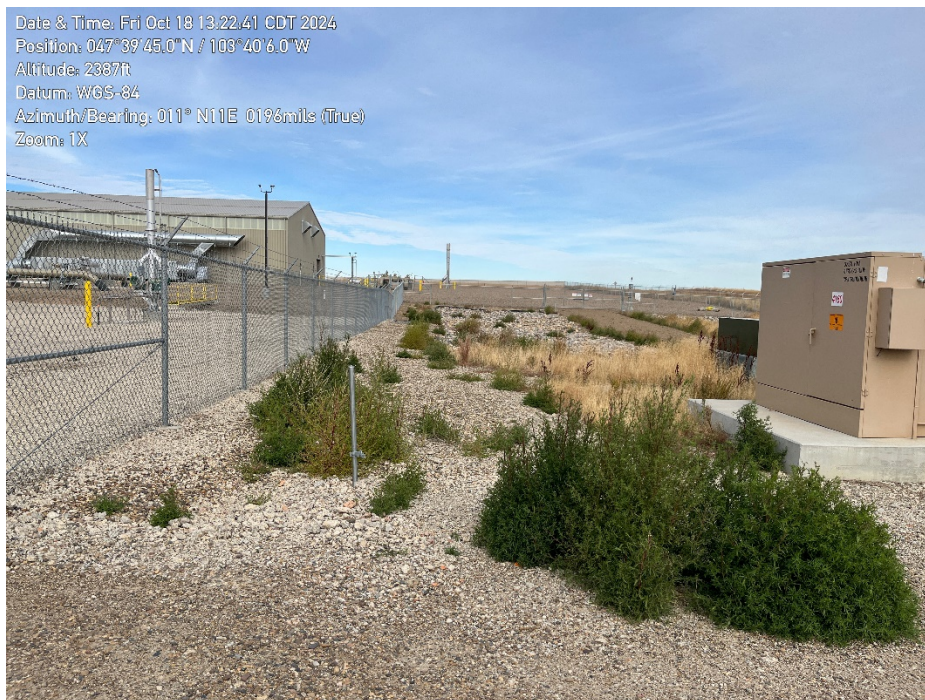
**Report Photo #2: Mid Portion of ROW Adjacent to Wetlands with Established Vegetation**

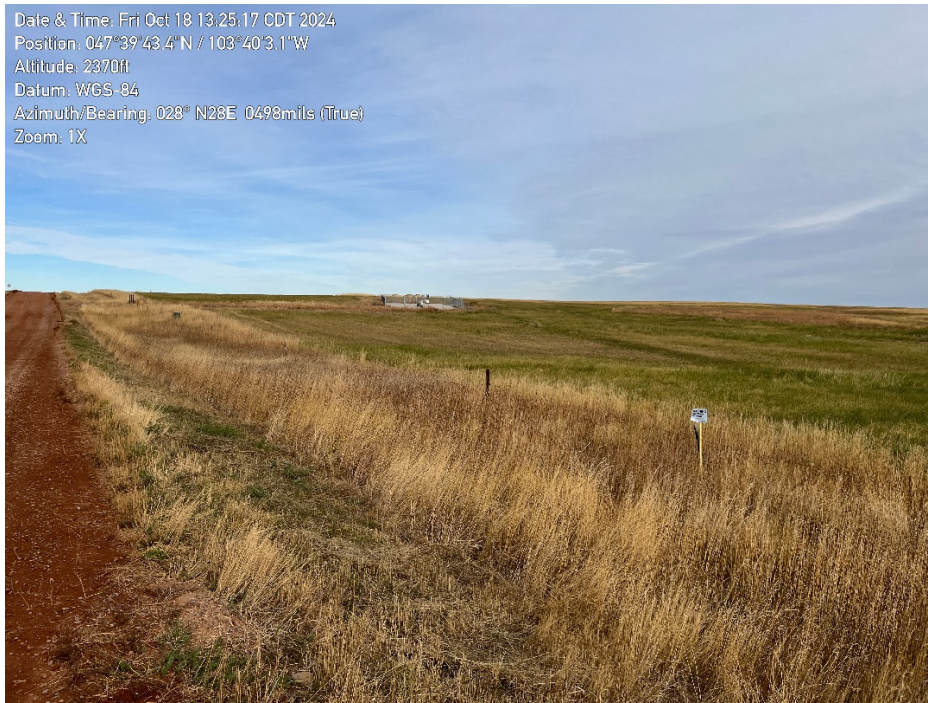
Vegetative cover had been well-established along the areas adjacent to the site perimeter fences along both the pump station and new valve stations as well as the construction laydown areas to the west and the north of the site. Good vegetative cover has been established with native grasses and forbs along the entire length of the revised pipeline right-of-way (ROW).

**Report Photo #3:** Reclaimed Pipeline ROW east of Pump Station to New Valve Station

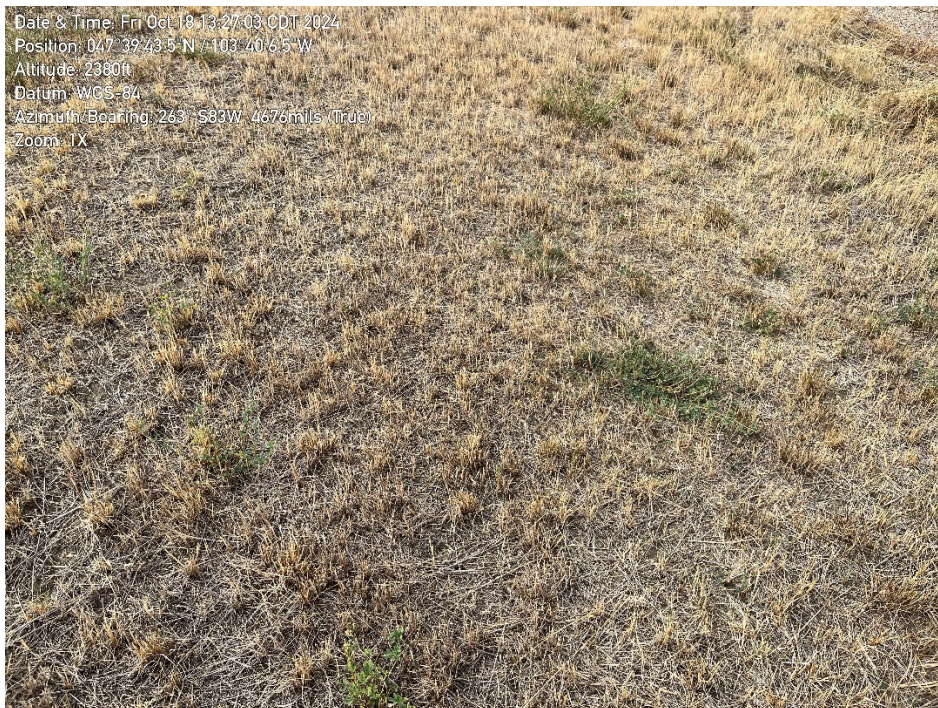
**Report Photo #4:** Vegetative Cover of Mowed Former Laydown Areas Outside of Fence

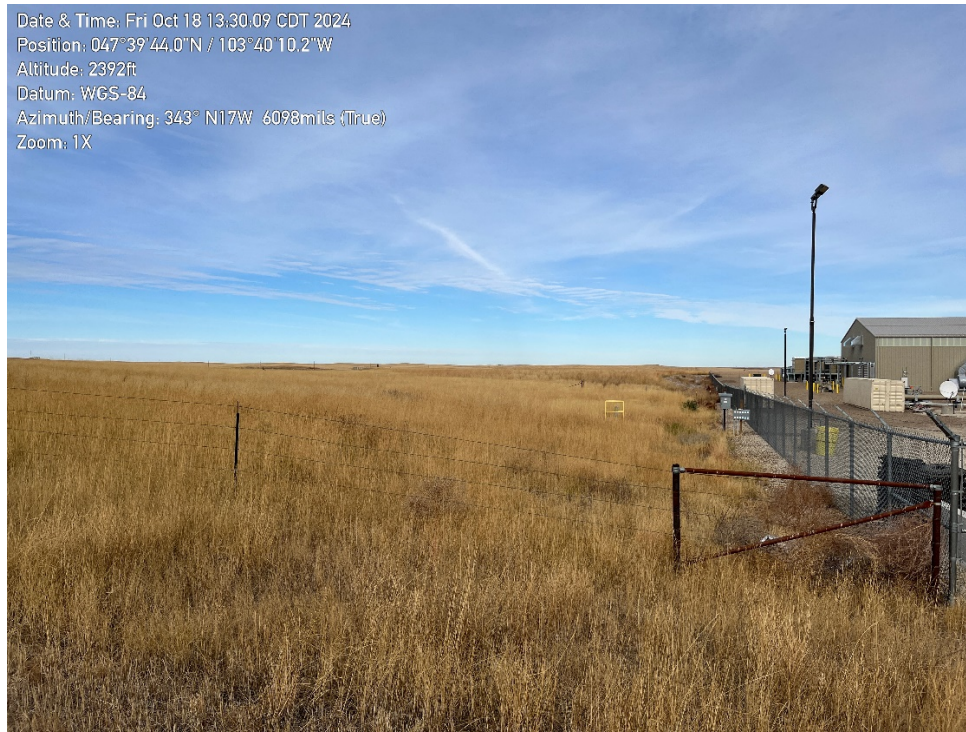
**Report Photo #5:** Restored Vegetative Cover on West Side of Station

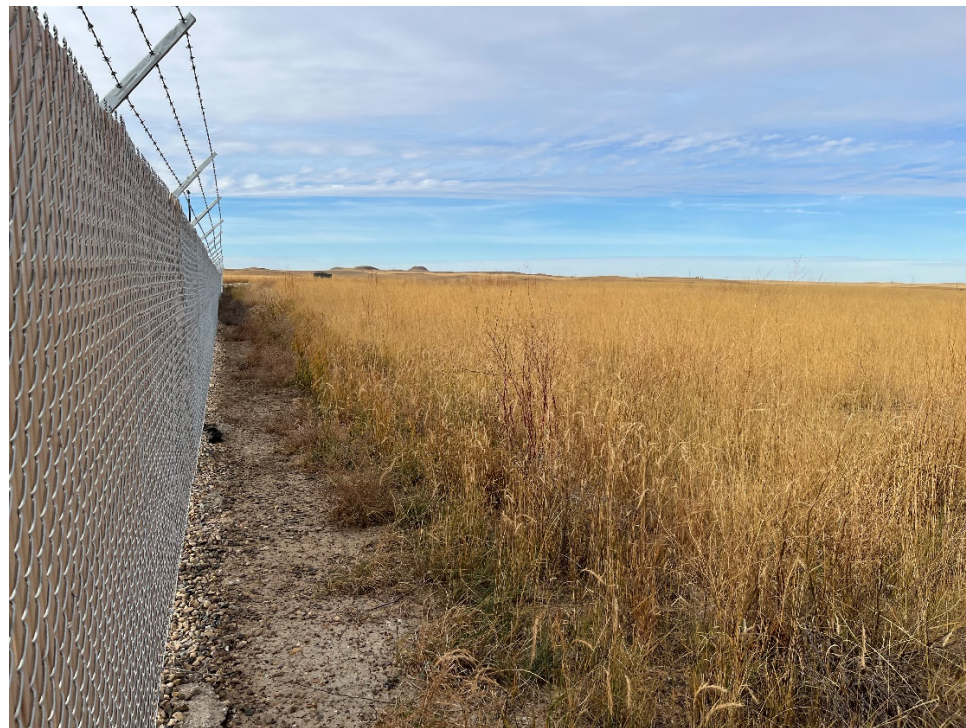
**Report Photo #6:** Restored Vegetative Cover on North Side of Station

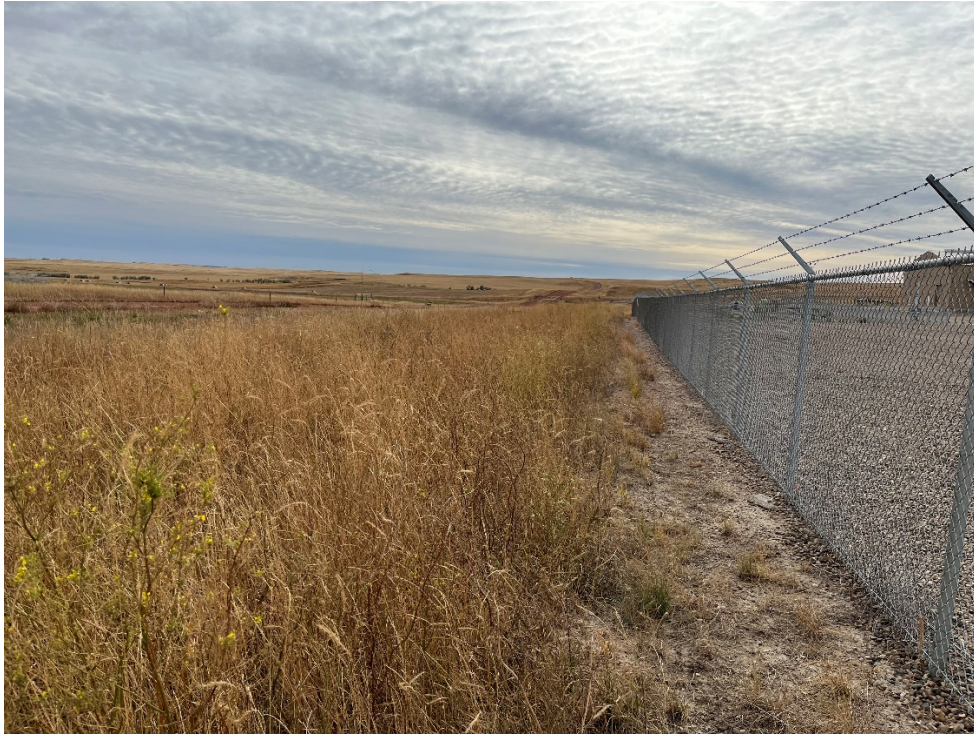
**Report Photo #7:** North Portion of Pipeline ROW with Revegetation Apparent

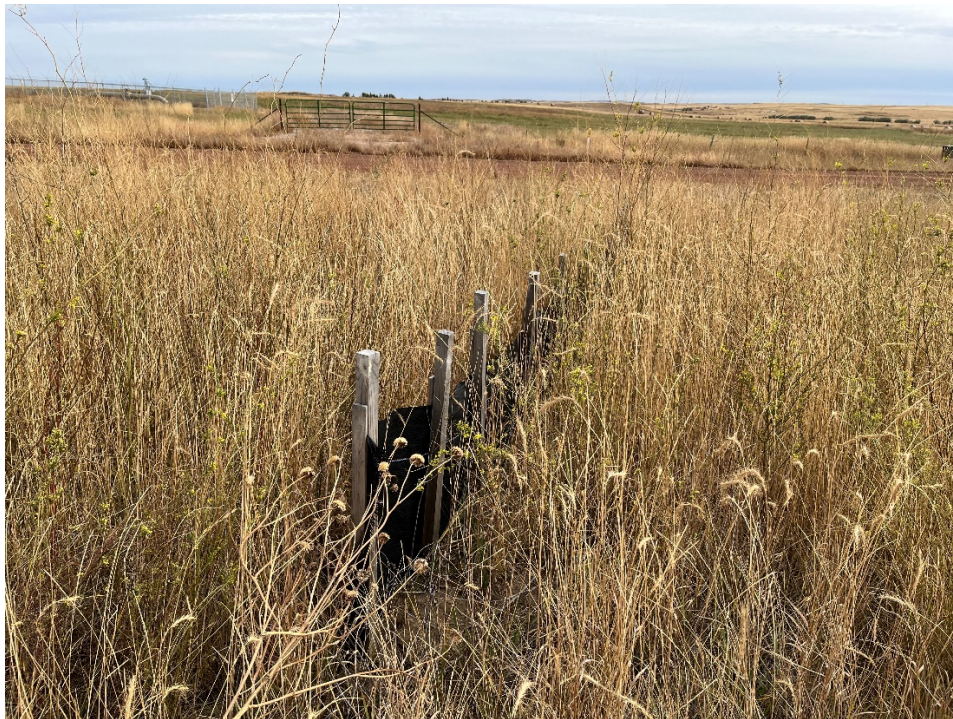
Several silt fences remained in place along the westside drainage ditch along 147<sup>th</sup> Avenue NW (i.e., county road along east perimeter) within waist-high grass vegetative cover.

**Report Photo #8:** Silt Fence Remaining in East of Fence Line West of County Road
