Public Service Commission State of North Dakota

INSPECTION REPORT

DATE OF INSPECTION: October 26, 2022
TYPE OF INSPECTION: Final Bond Release Inspection
PERMITTEE - MINE: Falkirk Mining Company - Falkirk Mine
PERMITS INSPECTED: NAFK-8405
PERSONS ACCOMPANYING INSPECTORS: Jason Frye, Steve Burke, Luke Gilbert, Steve Cottingham, and Tanner Jochim
INSPECTION CONDITIONS: The inspection was conducted between 9:50 a.m. and 1:00 p.m. CDT. Skies were mostly sunny, and the temperature was near 45° F. The wind was from the southwest at 5 mph. Access was unrestricted.

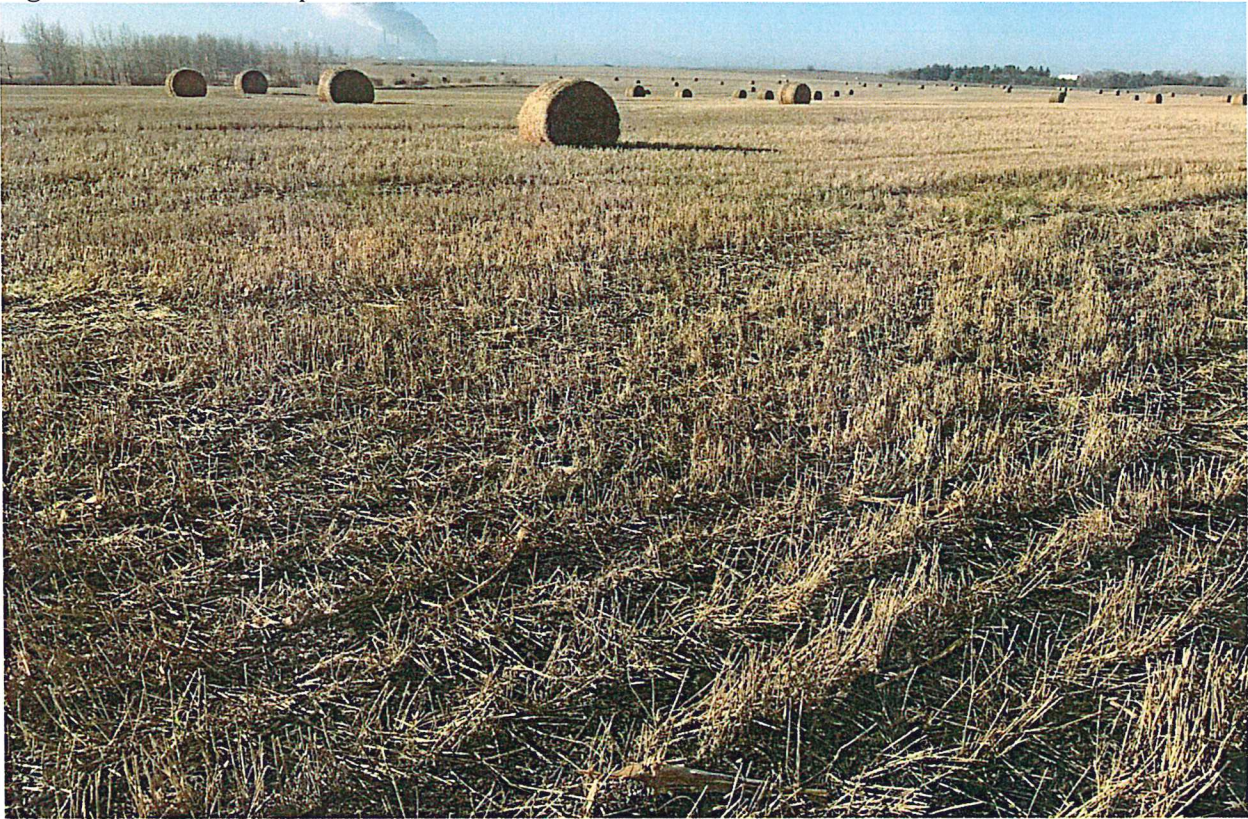
The reclaimed cropland in Sections 22 and 27 were planted to annually seeded crops in 2022. The NW¼ of Section 27 had wheat stubble, and straw had been baled (**Figure 1**). The reclaimed cropland had surface undulations in the SE¼SW¼ of Section 27, but the surface irregularity did not appear to impede any planting or harvesting of the cropland. The surface undulations also did not appear to retain water. The grassed waterway in the W½NW¼ of Section 27 is well established with perennial vegetation and functioning as intended. The SW¼ of Section 22 had standing unharvested corn (**Figure 2**). The corn appeared to be ready for harvest and appears to have suffered from wind damage. Each plant was only supporting a single cob that was smaller in size than normally observed. The entire S½ of Section 22 is fenced with barbed wire and a fence has been installed along the east side of the NW ¼ of Section 27.

Figure 1. Reclaimed Cropland in NW¼ of Section 27.

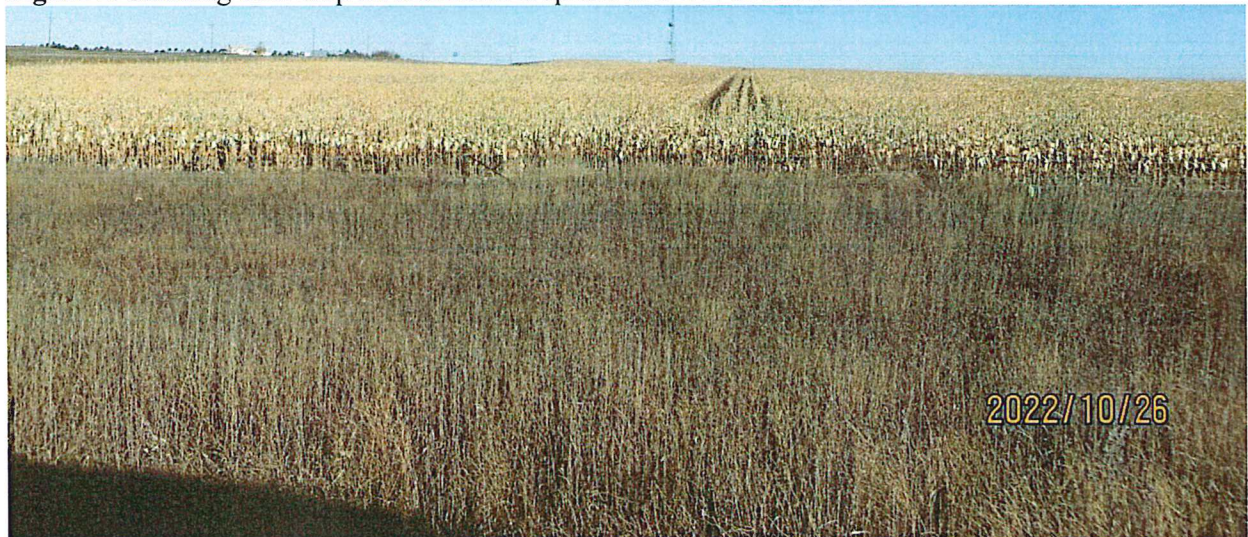
Figure 2. Standing corn crop on reclaimed cropland in SW¼ of Section 22.

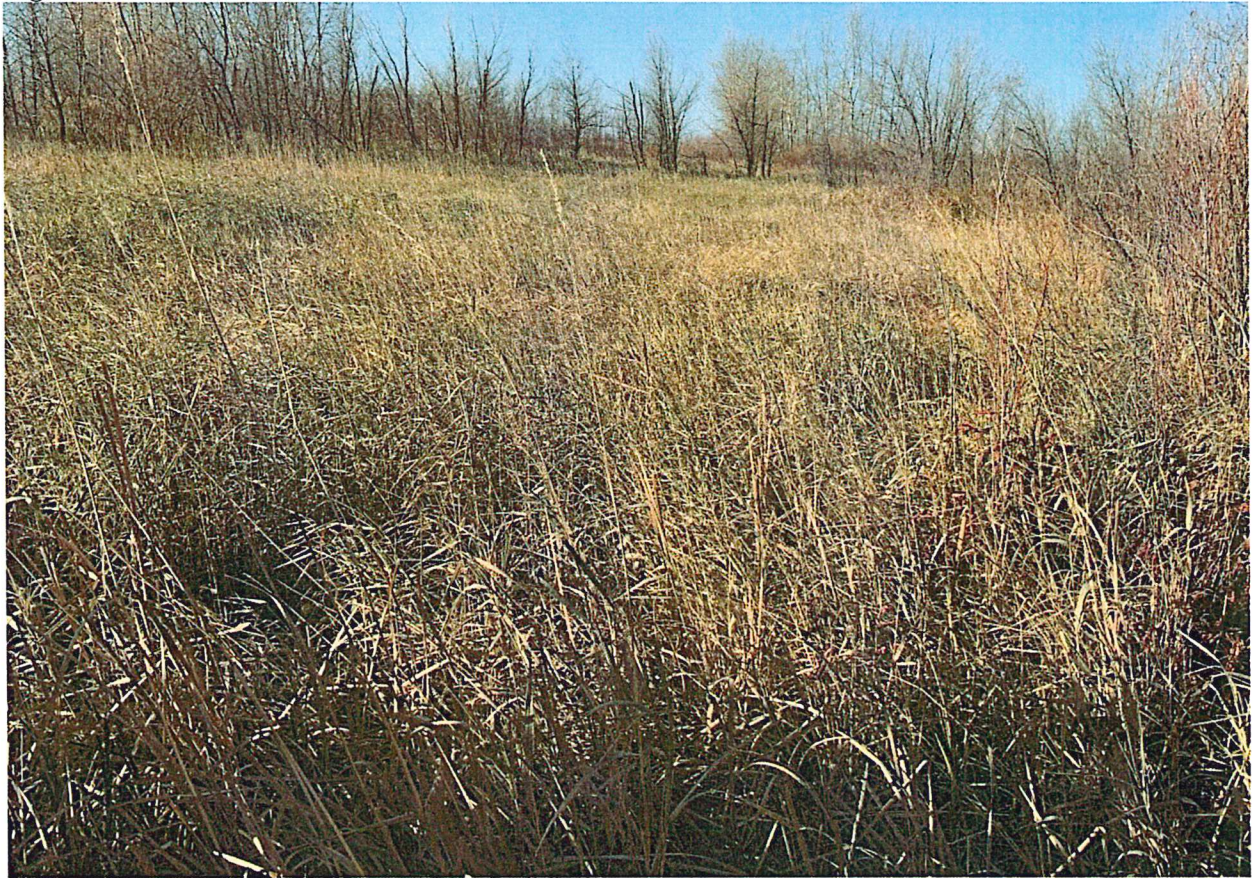
Reclaimed season wetlands R-E27-01 and R-E27-02 were both dry (**Figures 3 & 4**). Volunteer trees and shrubs, primarily cottonwood and sandbar willow, have established around the perimeter of reclaimed

wetland R-E27-01 and throughout the pool area of reclaimed wetland R-E27-02. The vegetation throughout the bottoms of both wetlands indicates that these wetlands typically do not hold water for an extended period. Species observed growing in the shallow marsh and wet meadow zones in these wetlands included reed canary grass, slough sedge, smartweed, common cattail, curly dock, and other species. The low prairie zone is supporting smooth brome grass, Kentucky bluegrass, quack grass, alfalfa, switchgrass, and other species. The wetland buffer zone around these wetlands is established with perennial vegetation consisting primarily of Kentucky bluegrass, alfalfa, smooth brome grass, and big bluestem. The wetland buffer zone is managed as hayland and bales from this year's harvest have not been removed. These wetlands provide landscape diversity and cover for a wide range of wildlife species.

Figure 3. Seasonal wetland R-E27-01.

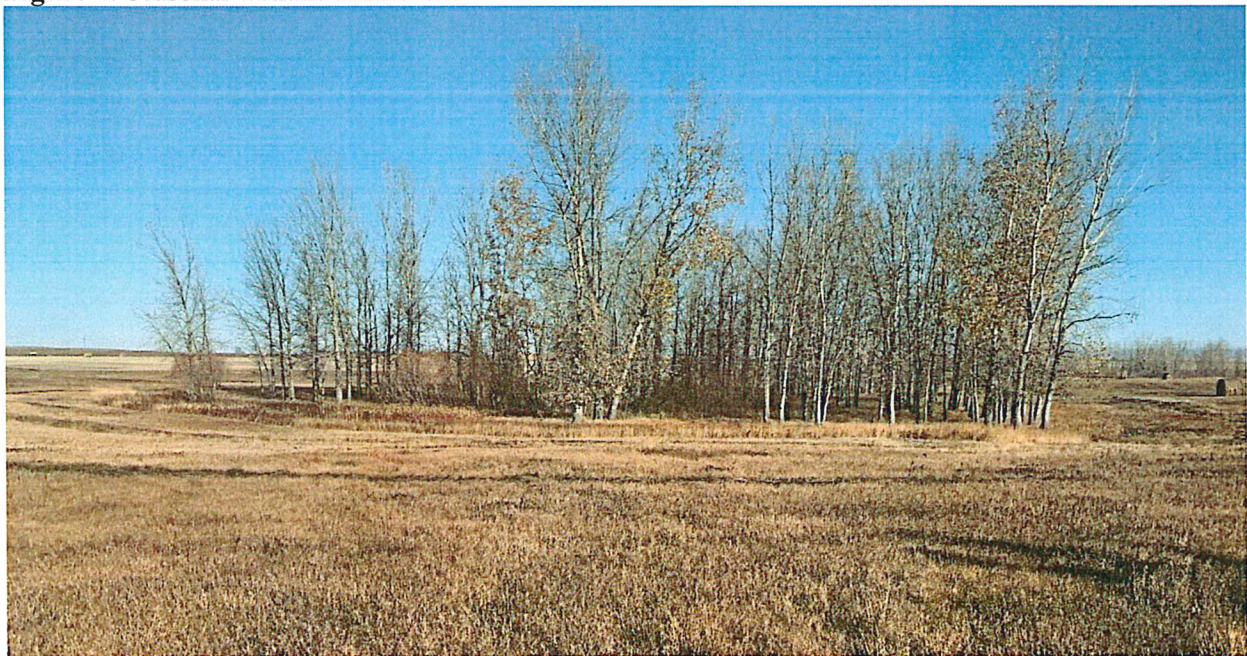
Figure 4. Seasonal wetland R-E27-02.

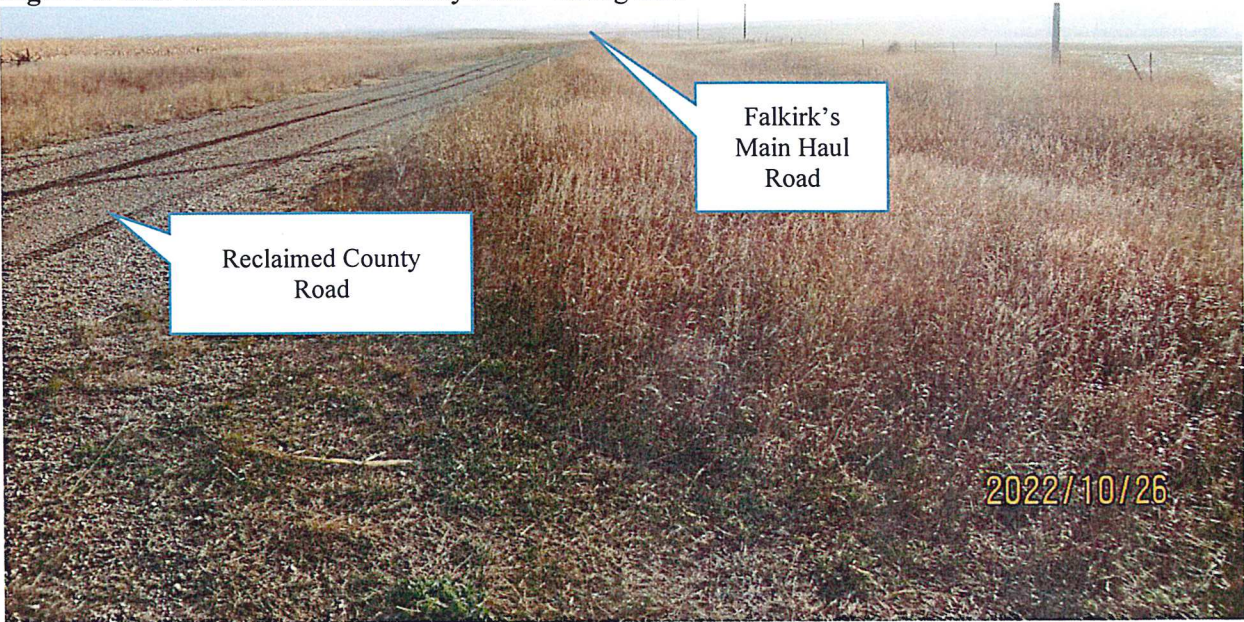
The county road between Sections 22 and 27, east of Highway 83, has been reclaimed (**Figure 5**) but will remain closed to the public because the road crosses a primary Falkirk haulroad.

Figure 5. East-west section-line county road – facing east
