# Public Service Commission State of North Dakota

## INSPECTION REPORT

DATE OF INSPECTION: August 12, 2020  
TYPE OF INSPECTION: Partial  
PERMITTEE - MINE: Coteau Properties Company - Freedom Mine  
PERMITS INSPECTED: Portions of Permits NACT-9501 and NACT-0201  
PERSONS ACCOMPANYING INSPECTORS: Ms. Lucille Sailer, private landowner  
INSPECTION CONDITIONS: The inspection was conducted between 10:30 a.m. and 12:15 p.m. CDT. Skies were mostly clear. The temperature was near 80° F. Access was good.

# Freedom Mine Inspection Report

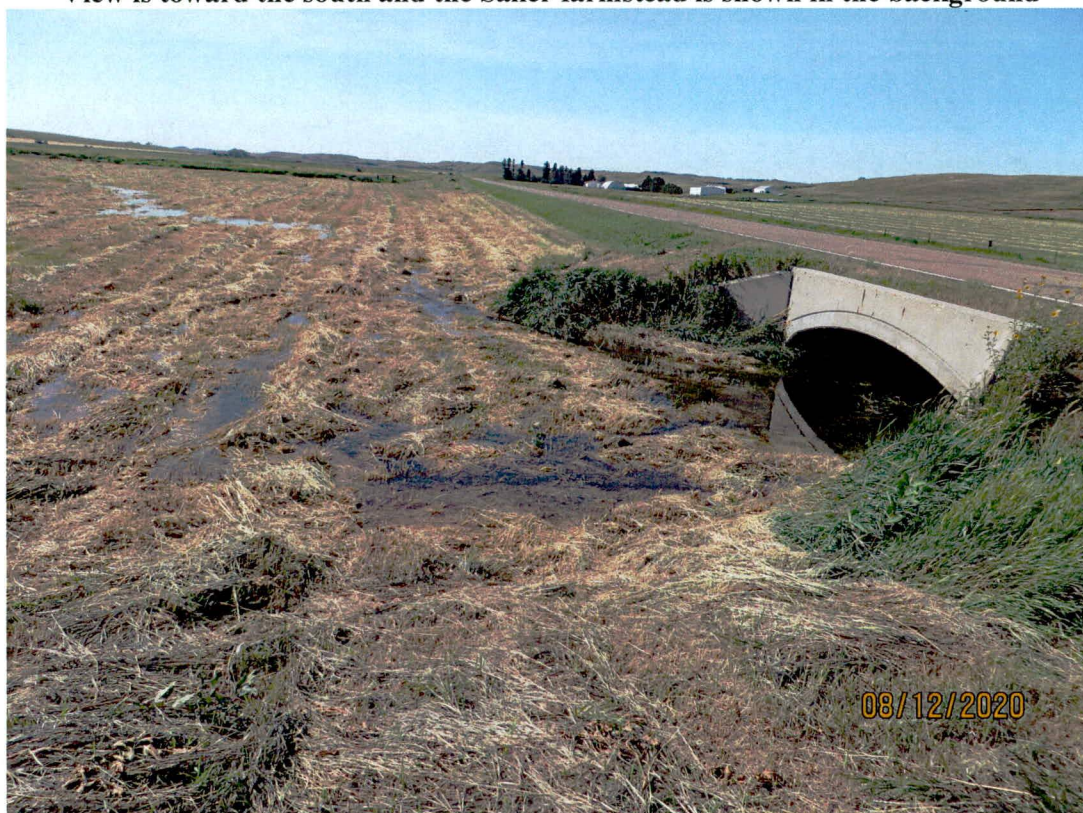
and incised into the underlying alluvium. The hayfield was saturated with visible areas of standing water to the point that Mr. Gustafson was unable to bale hay within those areas of the field. It appeared the affected area was about two acres in size. Ms. Sailer indicated that similar wet field conditions were also located across County Road 15 to the west in hayland within the NE1/4 of Section 28 bordering the creek; however, the creek channel is significantly more contained within its banks in the NE1/4 of Section 28 and we did not inspect that particular field because the main area of Ms. Sailer's concern/complaint was in the NW1/4 of Section 27.

**Figure 1.**  
**View of a portion of the flooded hayfield in the NW1/4 of Section 27**  
**View is toward the south and the Sailer farmstead is shown in the background**

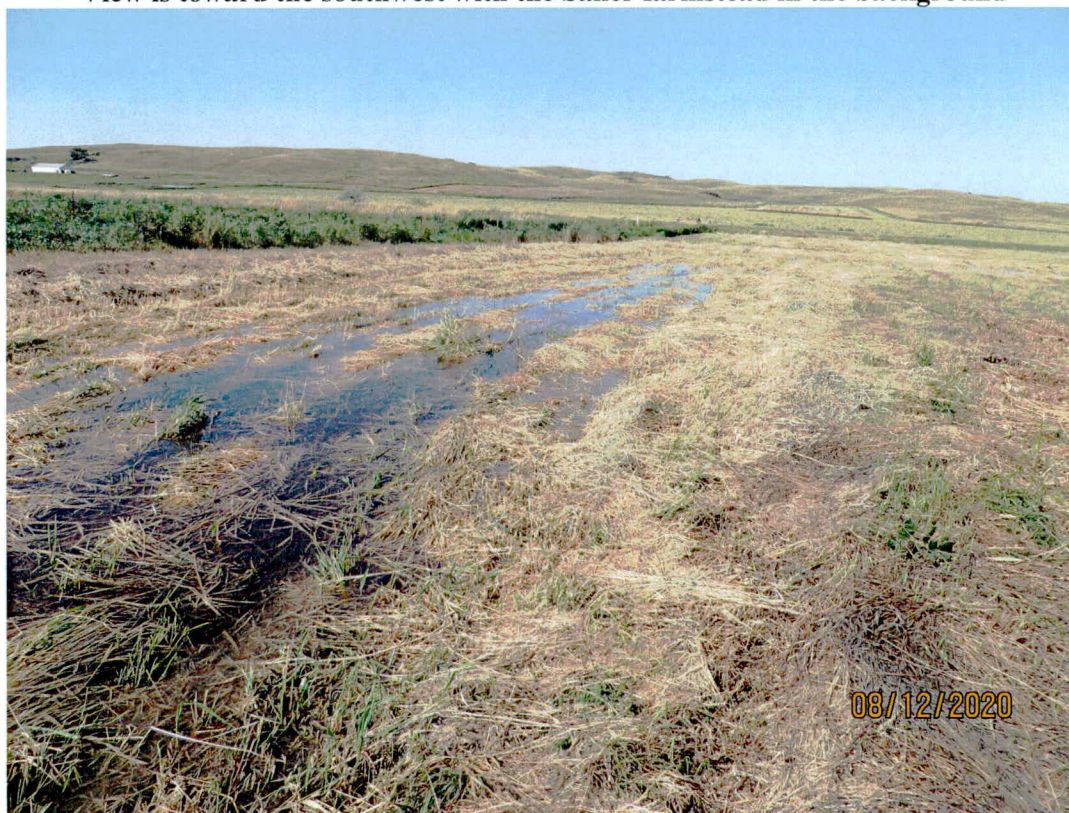
**Figure 2** shows a constructed diversion that runs in an east-to-west direction along the south side of the NW1/4 of Section 27. The diversion was apparently constructed years ago to direct and contain stream flow coming from the east, but also converges with the creek coming from the south.

**Constructed diversion along south side of the Sailer hayfield in the NW1/4 of Section 27  
View is toward the southwest with the Sailer farmstead in the background**
