INSPECTION REPORT

DATE OF INSPECTION: September 16 and 17, 2014

PERMITTEE - MINE: Coteau Properties Company - Freedom Mine

PERMITS INSPECTED: NACT-8102, NACT-8203, NACT-8401, NACT-8503, NACT-8601, NACT-9001, NACT-9101, NACT-9501, NACT-0201, NACT-0401

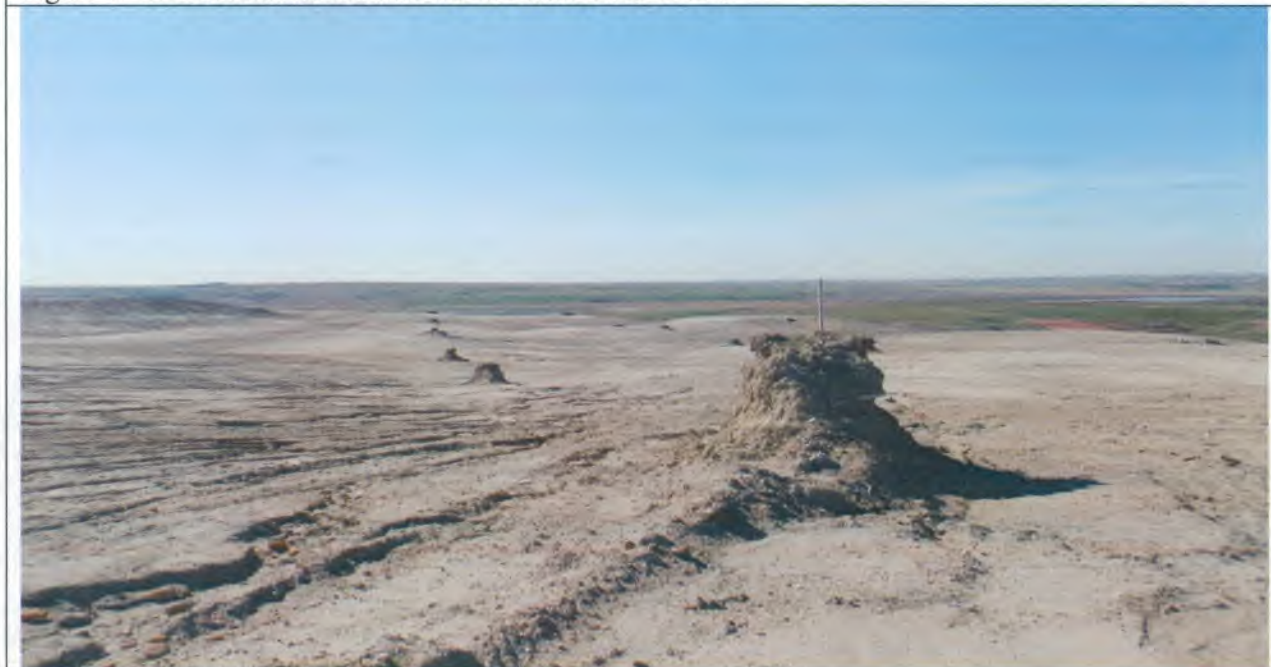
In Permit NACT-0201: Several SPGM removal areas were inspected and field approved. It appeared that all available SPGM had been removed from the inspected areas. The soil monuments were easily read and displayed the required information and field approval was granted. Mr. Flaa stated that the details of the soil removal areas would be sent to the Reclamation Division in a subsequent email.

Figure 1: SPGM removal monuments in Permit NACT-0201

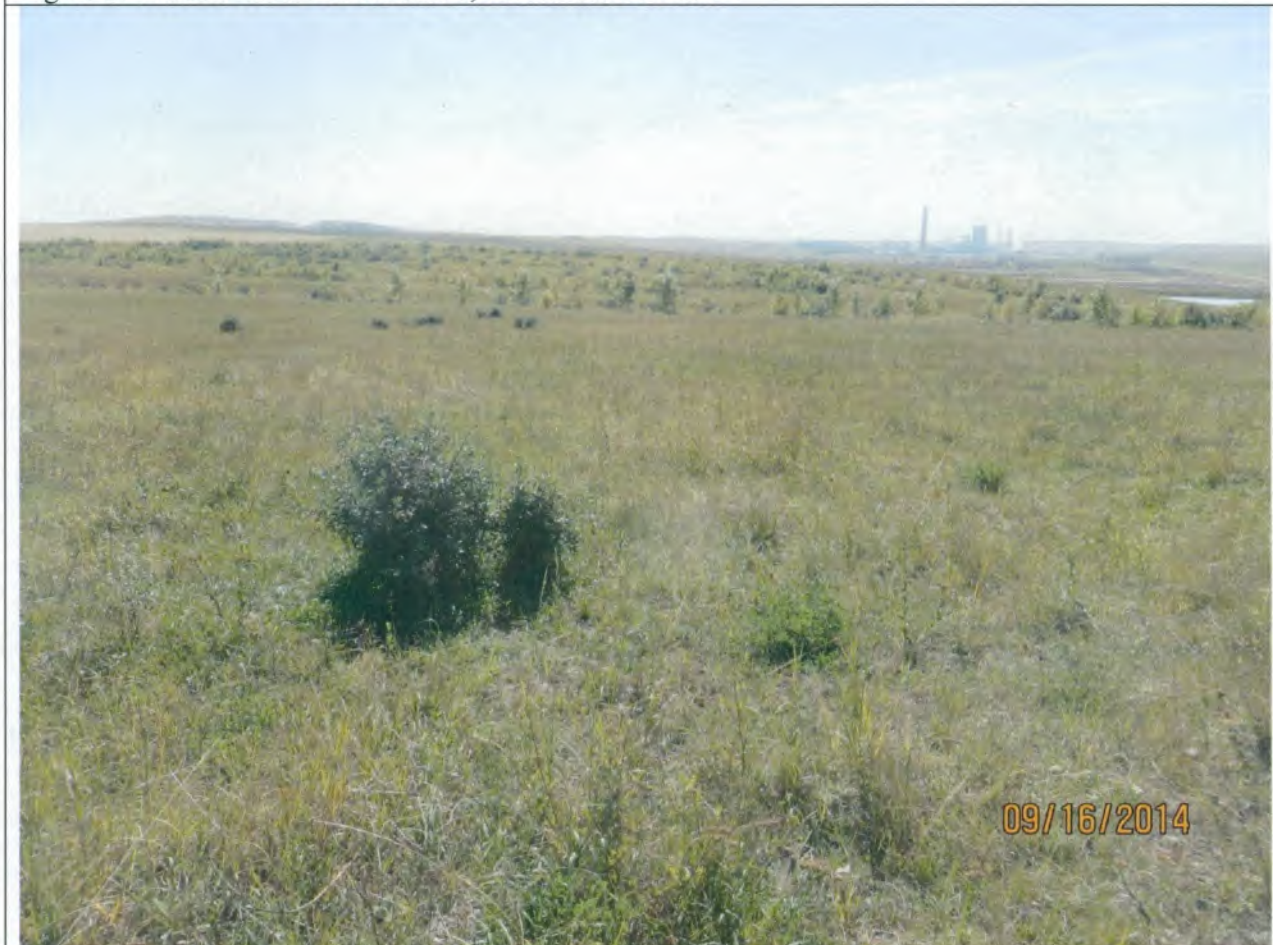
Of the areas looked at during this inspection, the N1/2 of the SW1/4 and part of the NW1/4 of Section 1 and the eastern portion of Section 2 of Permit NACT-9001 contained reclaimed native grassland that most closely resembled undisturbed native grassland. The seeded species, western wheatgrass, green needlegrass, sideoats grama, switchgrass, little bluestem and blue grama are all present in good quantities on these and smooth brome grass was present in varying amounts. What makes these areas look especially successful is the number and relative abundance of desirable native grasses, native forbs and shrubs that were not seeded but are present on these lands. This diversity is obviously a result of direct respraying of native grassland topsoil. Grass species observed growing in Section 1 but were not seeded included porcupine grass, awned wheatgrass, prairie sandreed, big bluestem and prairie cordgrass. Native forbs observed growing included prairie coneflower, silverleaf scurfpea, Aster ericoides, fringed sagewort, wavyleaf thistle, daisy fleabane, American licorice, curleycup gumweed, Missouri goldenrod and purple coneflower. Buckbrush or western snowberry is prevalent in portions of these tracts and numerous volunteer buffalo berry shrubs have re-established on the native grassland in Section 1 and portions of Section 2. Species composition differences were observed between and within various seeding dates on these tracts and smooth brome is present in varying amounts throughout but grazing makes this species appear to be less prevalent. Plant vigor was very high this year and these reclaimed lands yielded very well this year. Figure 2 shows a volunteer buffalo berry plant on reclaimed native grassland located in the N1/2 of the SW1/4 of Section 1.

Figure 2: N1/2 of SW1/4 of Section 1, Permit NACT-9001

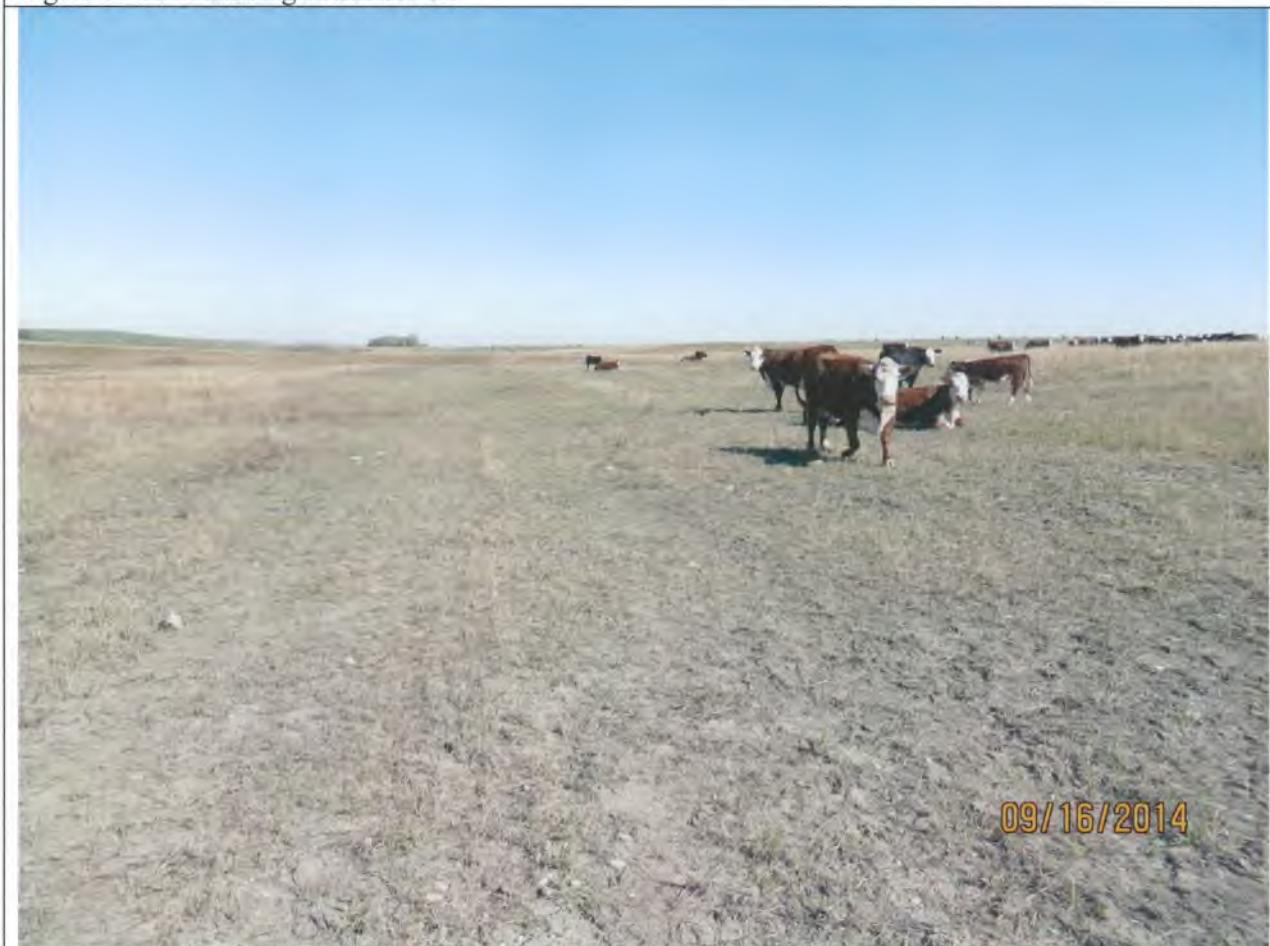
The reclaimed native grassland Tracts that are being hayed and grazed in Sections 22, 26, 34, 35 and 36 are generally all well established with the previously mentioned seeded species. Utilization levels were generally moderate to light and the established vegetation on the older stands are protecting the sites from erosion. The 2014 seeded area in the NW1/4 of Section 36 is heavily grazed as depicted in Figure 3 below. The 2013 seeding in this area is dominated with slender wheatgrass and annual weeds and the other seeded species are establishing. Smooth brome grass appeared to be quite prevalent on the 2003 seeded area in Section 36.

Figure 3: 2014 seeding in Section 36

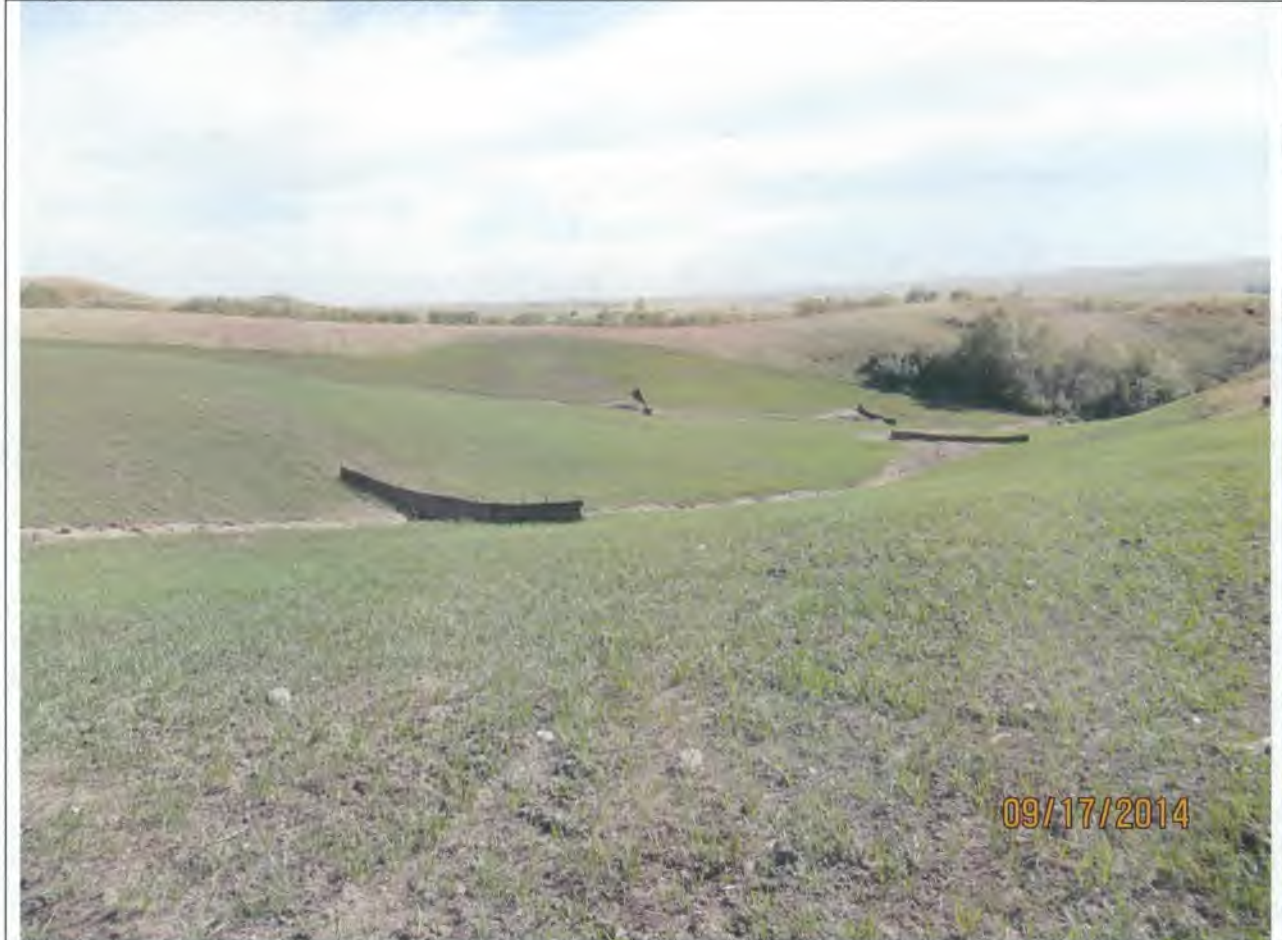
Erosion was also observed on the steep slopes where sediment pond P-H16-05 was reclaimed. The April 22, 2014 pond removal plan states that straw/coconut fabric will be installed if determined to be needed by a post-construction field review. The steep portions of the drainages associated with this pond removal should be stabilized with fabric. Figure 4 shows this area.

Figure 4: Reclaimed pond site P-H16-05
