Public Service Commission State of North Dakota

INSPECTION REPORT

DATE OF INSPECTION: April 26, 2018
TYPE OF INSPECTION: Partial
PERMITTEE - MINE: Coteau Properties Company - Freedom Mine
PERMITS INSPECTED: NACT-9501
PERSONS ACCOMPANYING INSPECTORS: Clyde Eisenbeis, Jerome Boeshans and Jaymie Boeshans
INSPECTION CONDITIONS: The inspection was conducted between 10:00 a.m. and 12:30 p.m. CDT. Skies were clear and the temperature was near 55° F. Access was unrestricted.

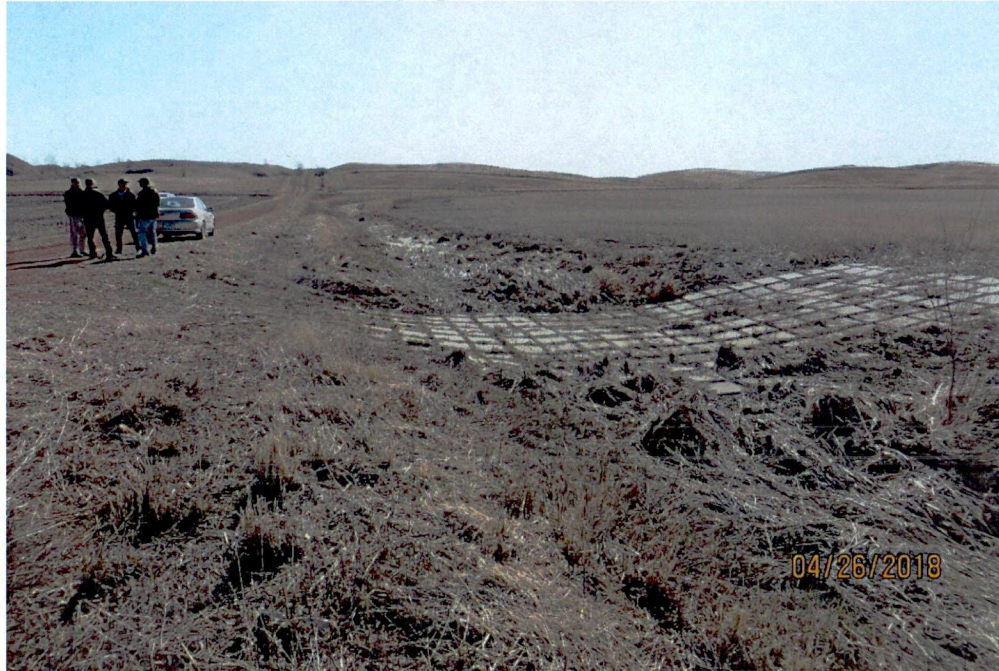
1. Figure 1 also depicts the locations where the photographs in Figures 2 through 11 were taken. Figures 2 and 3 are photographs of the Flexcrete crossing. Mr. Eisenbeis claims Coteau did not have the proper authorization to reconstruct the diversion on his property and the deeper road ditch now limits equipment access to his land. Mr. Eisenbeis said one potential renter was not interested in leasing his cropland because of poor access to his field.

The current tenants, Jerome and Jaymie Boeshans, have rented the NW $\frac{1}{4}$ of Section 34 for the past two years. During the inspection, Boeshans' said they cannot move a semi and other equipment into the field because of the size and slopes of the flexcrete crossing in the road ditch. Boeshans' grew beans in 2016 and canola in 2017. They chose these crops, in part, because they produce less volume of seed at harvest. Boeshans' are considering planting corn this year, but they have concerns because corn produces more volume at harvest. Last year when harvesting canola, the flexcrete crossing could only be crossed with half-loaded grain carts resulting in twice the normal trips across the tract. Boeshans' are concerned about the additional time, hassle and cost associated with moving grain off the field.

**Figure 2. Flexcrete crossing in the road ditch on the north side of the NW¼ of Section 34.
Photograph taken facing east.**

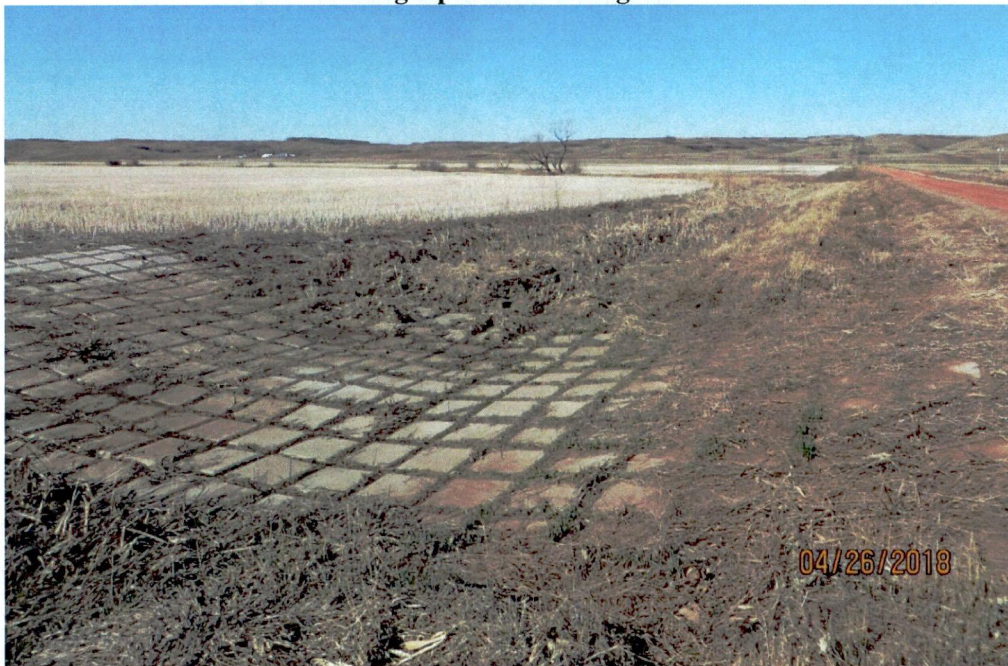
**Figure 3. Flexcrete crossing in the road ditch on the north side of the NW¼ of Section 34.
Photograph taken facing west.**

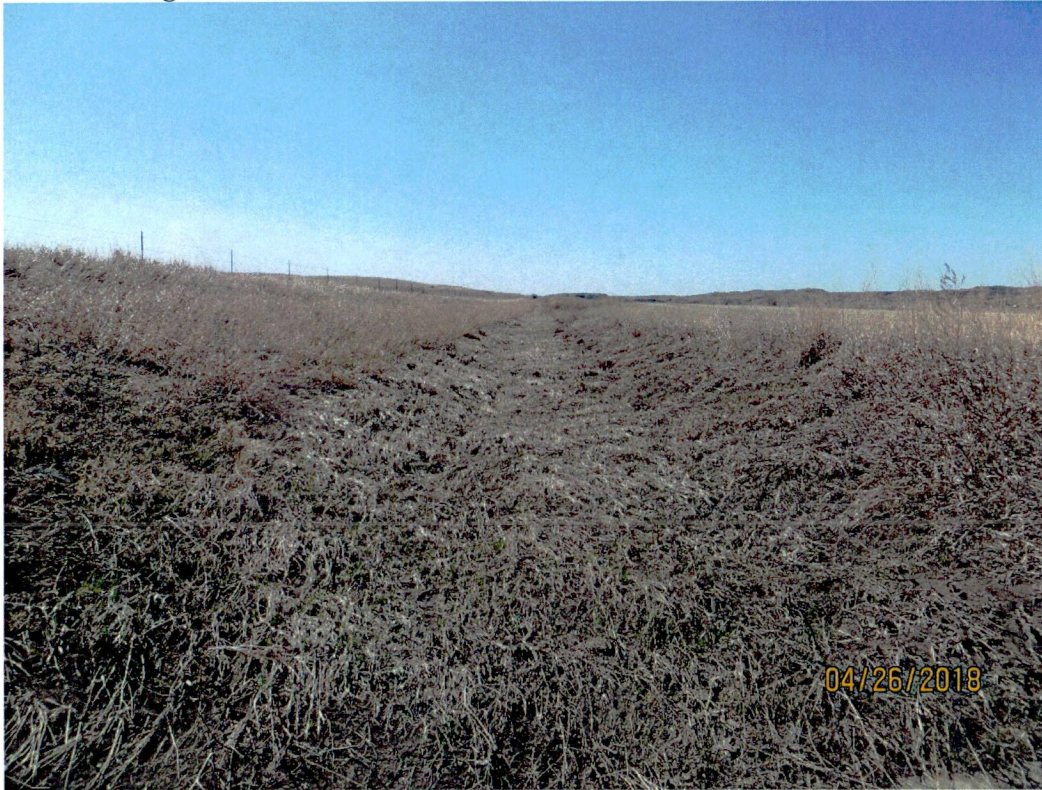
The diversion and its associated berm are generally well established with perennial vegetation, primarily smooth brome grass. Figure 4. Vegetation is not well established on approximately 100 feet of the west side of the diversion berm and some soil sloughing has occurred in this area. Figure 5. This area is down slope from the drainage of reclaimed sediment pond P-H34-04.

Figure 4. Diversion on the east side of the NW¼ of Section 34.

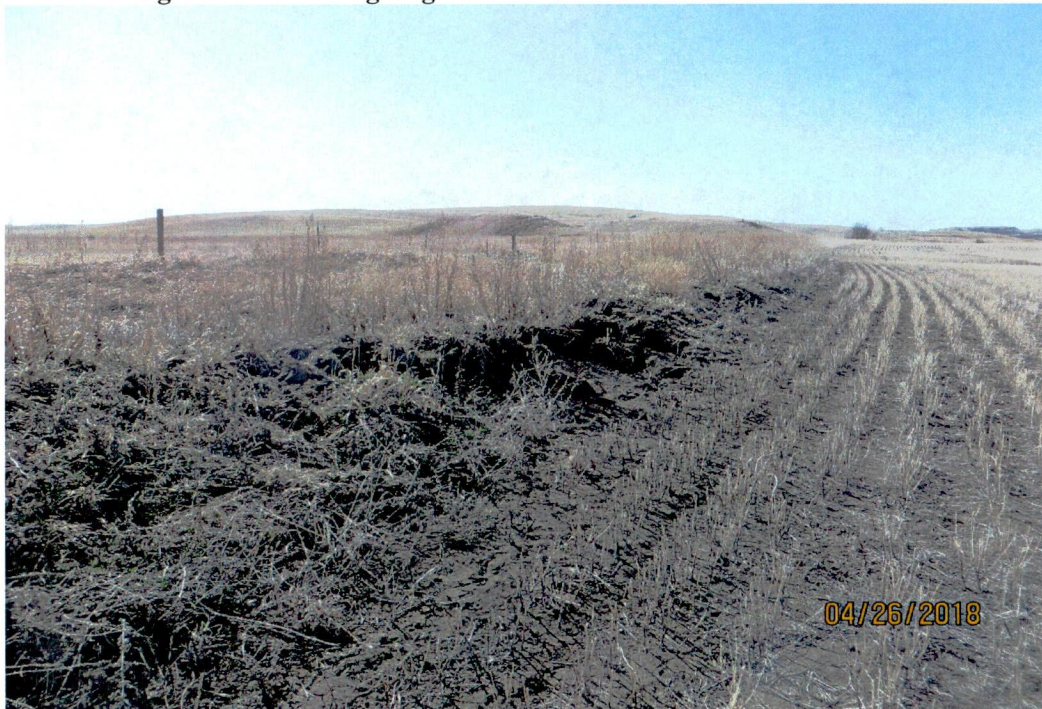
Figure 5: Soil sloughing on the west side of the diversion berm.

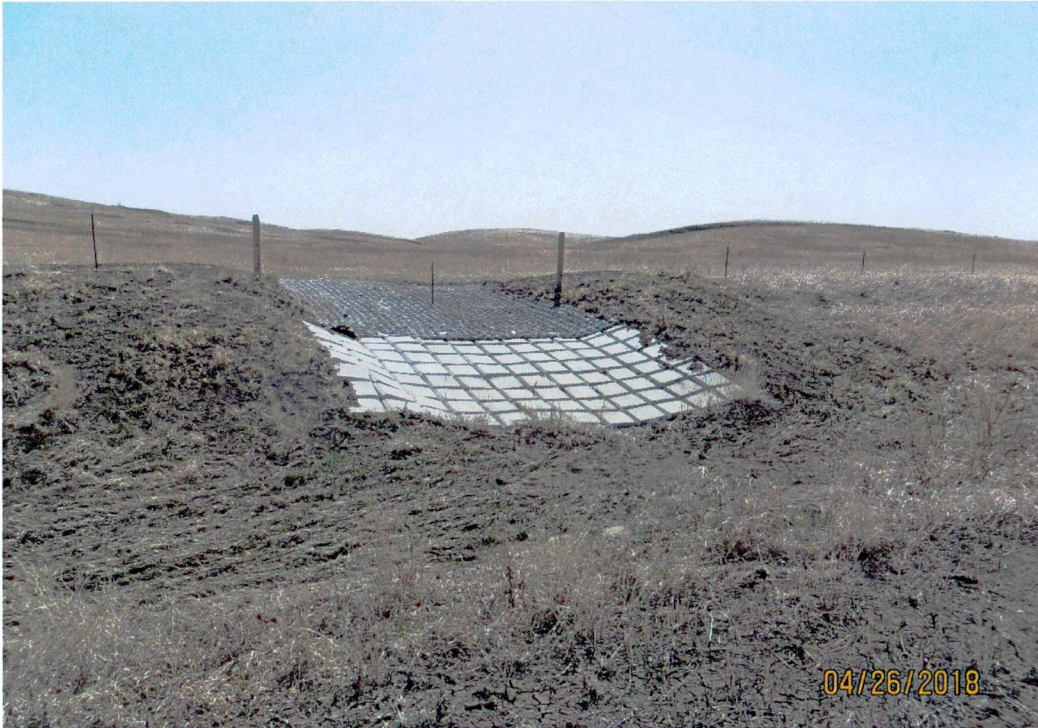
Runoff from the north drainage in the NE $\frac{1}{4}$ of Section 34 enters the reconstructed diversion in the NW $\frac{1}{4}$ of Section 34 at a right angle and drops approximately 10 feet to the bottom of the diversion. This entry point is lined with concrete flex matting and the site appears stable after this year's spring snow runoff event(s). This drop structure was originally constructed of Creflex blocks; however, much of the Creflex was replaced with Flex-A-Mat in June 2017 when erosional features were repaired. Figure 6.

Figure 6. Concrete flex matting at the inlet where water enters the diversion from the NE¼ of Section 34.

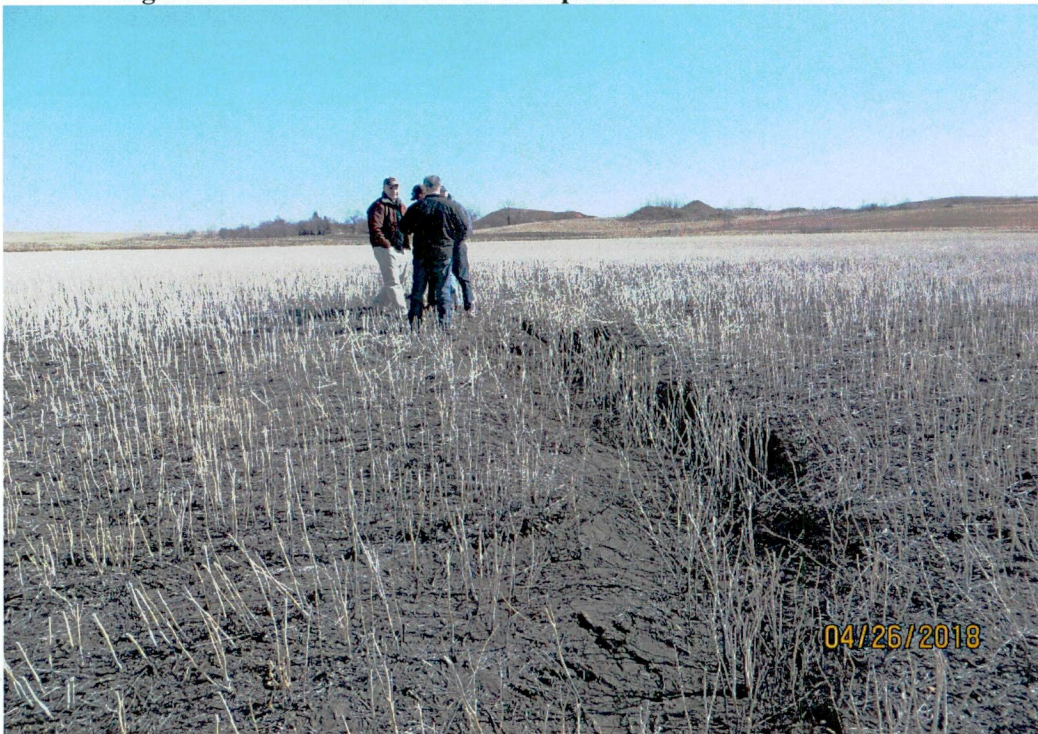
Other erosional features were observed on the Eisenbeis property and most were located in the E $\frac{1}{2}$ NE $\frac{1}{4}$ NW $\frac{1}{4}$ of Section 34. It appeared these erosional features were created from runoff that occurred last spring because canola stubble from last year's crop was present in these features. Only minor sediment deposition from runoff that occurred this spring was observed (up to an inch or two of deposition in portions of the older erosional features). The erosional features varied in size and the largest one observed was approximately 16 inches deep, 2 feet wide and 25 feet long. Figures 7, 8, and 9.

Figure 7: Erosional features on cropland in NW1/4 of Section 34.

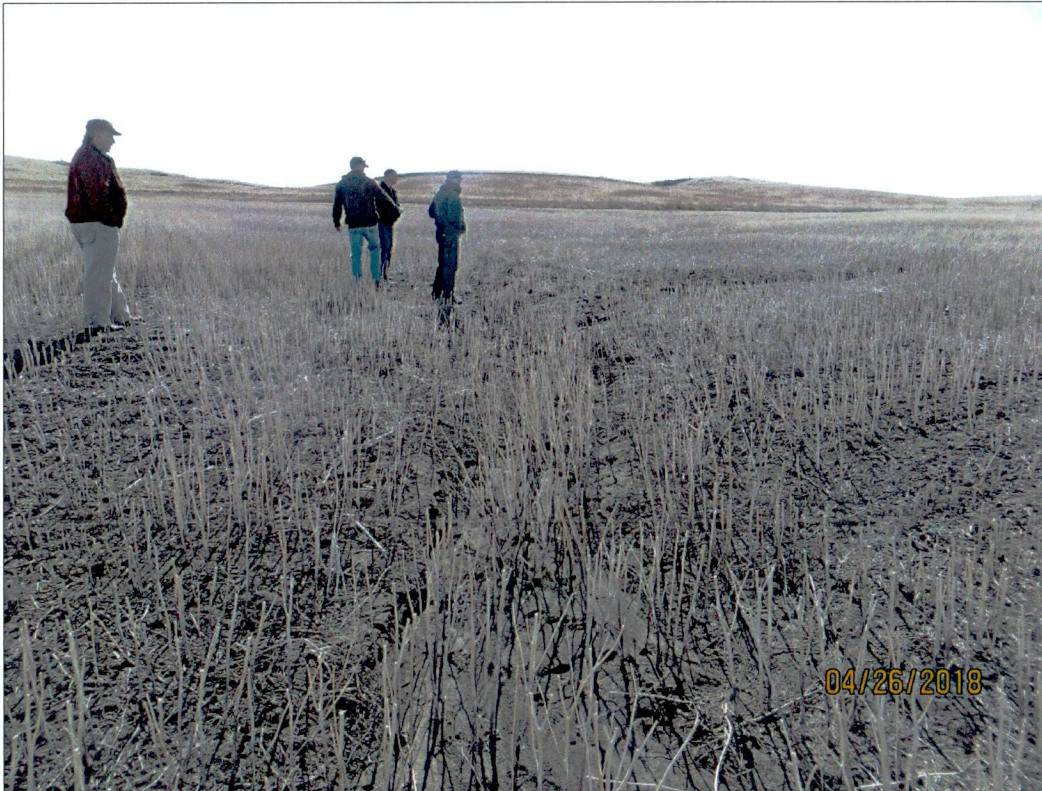
Figure 8: Erosional features on cropland in NW1/4 of Section 34

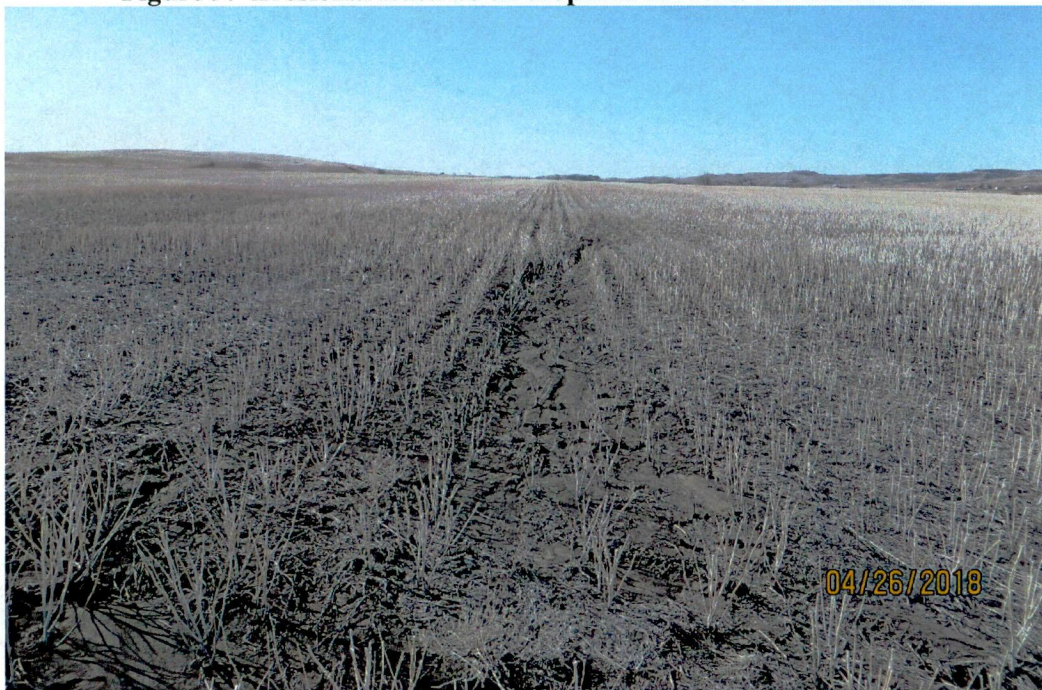
Figure 9: Erosional features on cropland in NW1/4 of Section 34

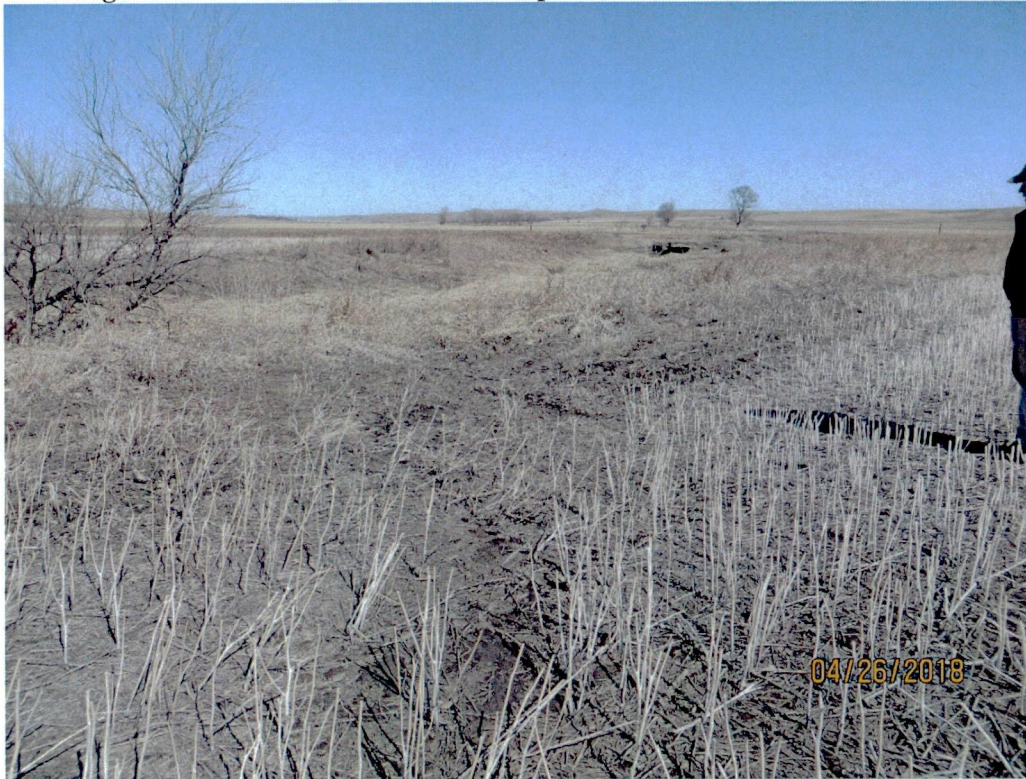
Additional erosional features were observed in the NW $\frac{1}{4}$ NE $\frac{1}{4}$ NW $\frac{1}{4}$ of Section 34 where runoff from the field enters a natural drainageway. These erosional features appeared to have formed last year. Figure 10. Several handfuls of erosion control fabric and an anchoring staple were collected in the field during the inspection.

Figure 10: Erosional features on cropland in the NW1/4 of Section 34.

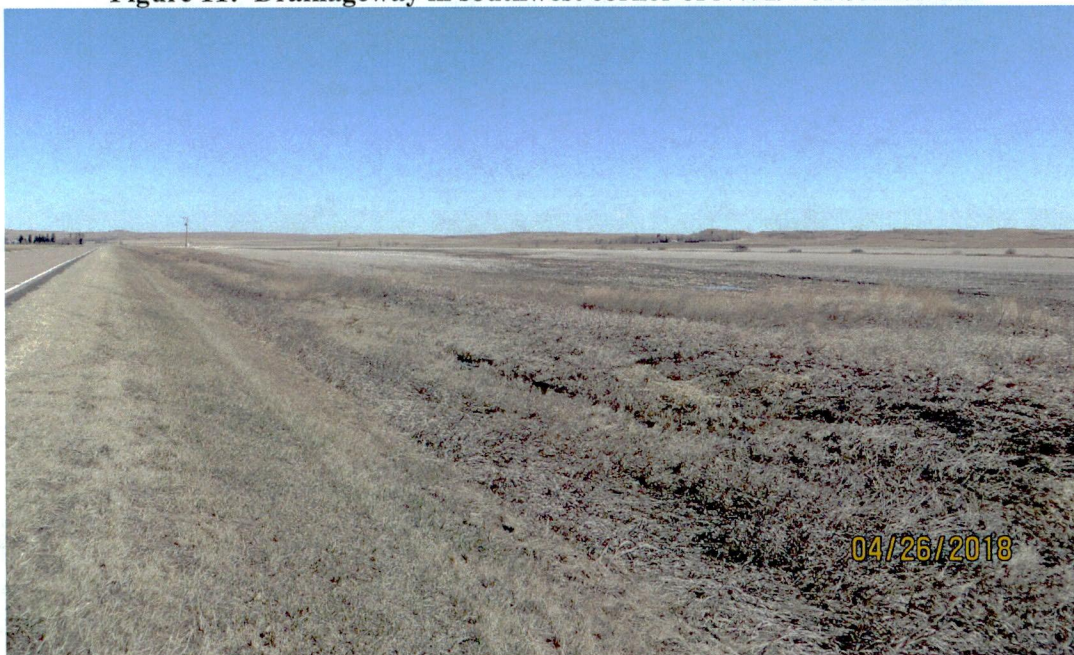
drainageway in cropland in the NW $\frac{1}{4}$ SW $\frac{1}{4}$ of Section 34. The natural drainageway extends northward into the Eisenbeis property at the southwest corner of the NW $\frac{1}{4}$ of Section 34 and continues meandering northward through the Eisenbeis cropland. With the exception of a small portion of the southwest corner, the drainageway is cropped when it is dry enough to support planting equipment; during wet years the drainageway and adjacent area are left idle. The drainageway was too wet to be cropped in 2017 but the field was cultivated when it dried out last summer or fall. Figure 11.

Figure 11: Drainageway in southwest corner of NW1/4 of Section 34.
