# Public Service Commission State of North Dakota

## INSPECTION REPORT

DATE OF INSPECTION: June 28, 2022  
TYPE OF INSPECTION: Partial  
PERMITTEE - MINE: Coteau Properties Company - Freedom Mine  
PERMITS INSPECTED: NACT-9501 Boundary and Adjacent Lands  
PERSONS ACCOMPANYING INSPECTORS: Clyde Eisenbeis (property owner); Sarah Flath, Rylan Sundsbak and Dillon Belisle (Coteau Properties Company - adjacent landowner)  
INSPECTION CONDITIONS: The inspection was conducted between 12:45 p.m. and 1:45 p.m. CDT. Skies were sunny. The temperature was near 75° F. Access was unrestricted.

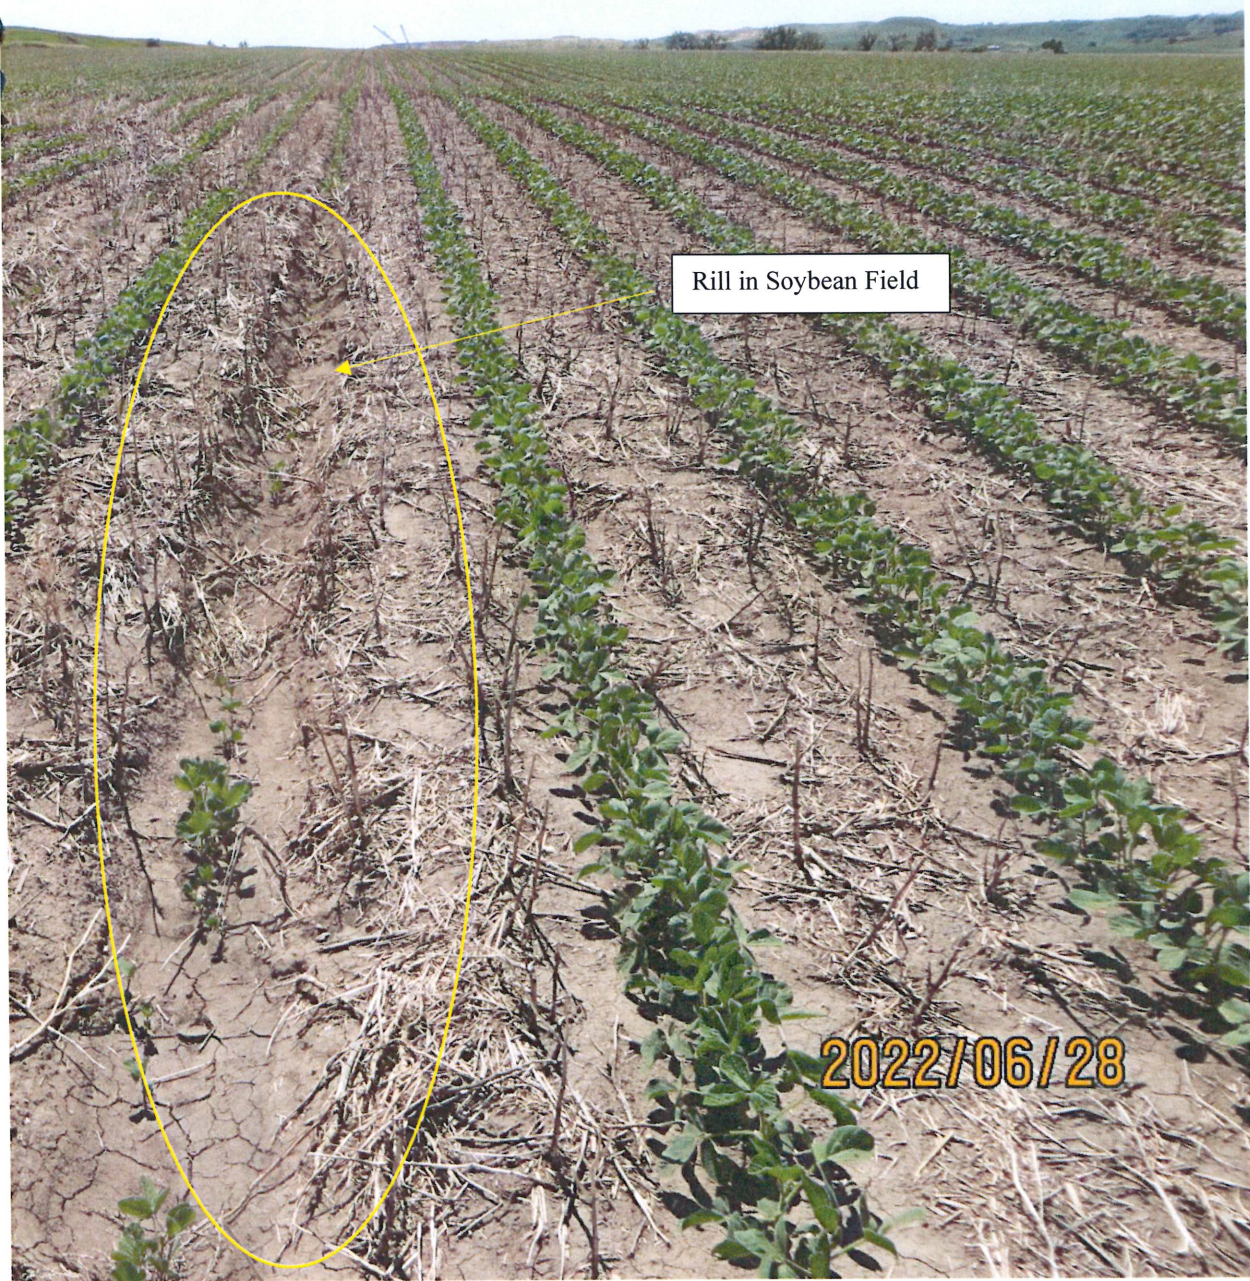
The cropland in the NW¼ of Section 34 was planted to soybeans this spring with minimal tillage and canola stubble from last year's crop remains on the soil surface. A rill approximately 1 foot wide, 6 inches deep, and about 40 feet in length was observed in the crop about 150 feet west of the diversion (**Figure 2**). A row of soybeans was planted in this rill which means it had formed prior to spring seeding. No other significant active erosional features were observed in the cropland field.

**Figure 2.** A rill approximately 1 foot wide, 6 inches deep, and about 40 feet in length was observed in the cropland about 150 feet west of the diversion. The photo was taken facing south.

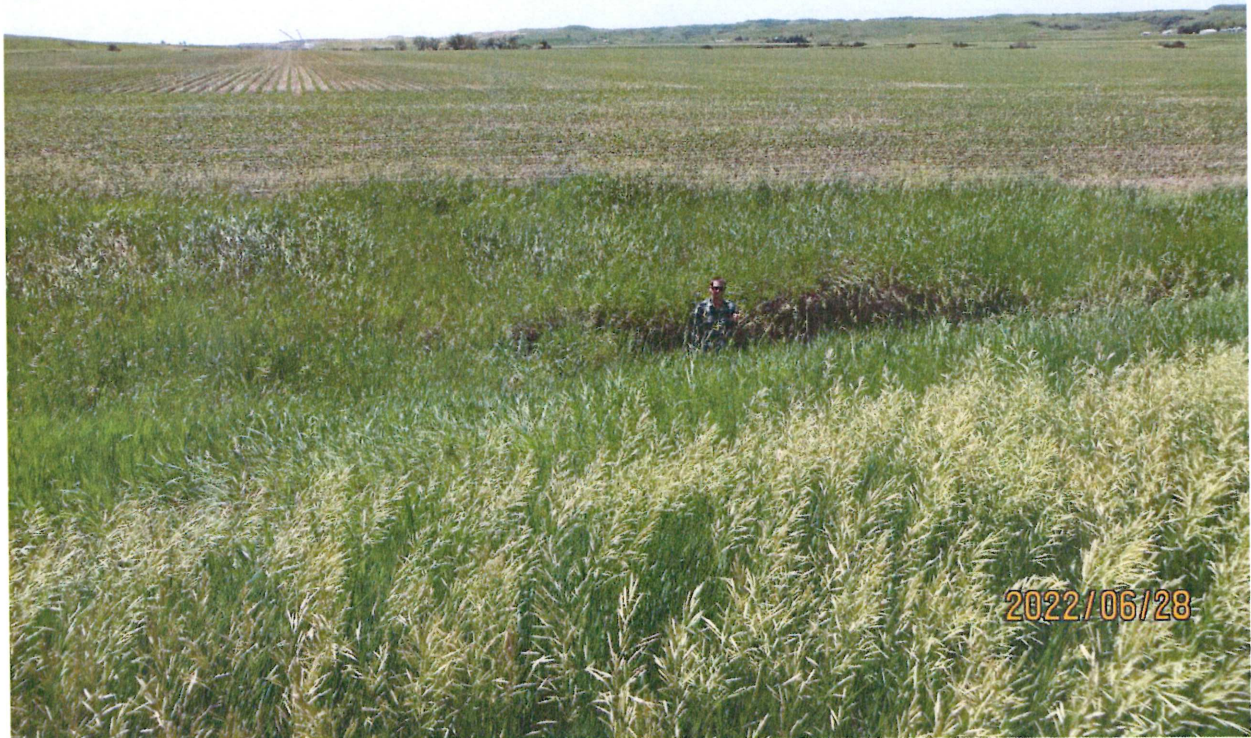
As previously documented in a June 8, 2022 inspection report, several erosional features have formed in the diversion in the northeast corner of the NW¼ of Section 34. The most significant feature is a head cut that is approximately 40 feet in length, 6 feet wide, and 3 feet in depth (**Figure 3**). This feature was about

40 feet from the center of the county road to the north. A similar, but smaller head cut, was present in the diversion upstream from the larger feature and several small (1 cubic foot) scour erosion features were observed upstream from this feature. The smaller head cut was about 20 feet in length, 3 feet wide, and 2 feet deep and was approximately 70 feet from the center of the county road. These erosional features were observed in the diversion bend where the diversion transitions into the county road ditch. The entire length of the diversion was walked, and no other erosional features were observed in the diversion or the road ditch.

**Figure 3.** A head cut in the diversion that was approximately 40 feet in length, 6 feet wide, and 3 feet in depth. The inspector standing in the diversion head cut is 6 feet tall. The photo was taken facing south.

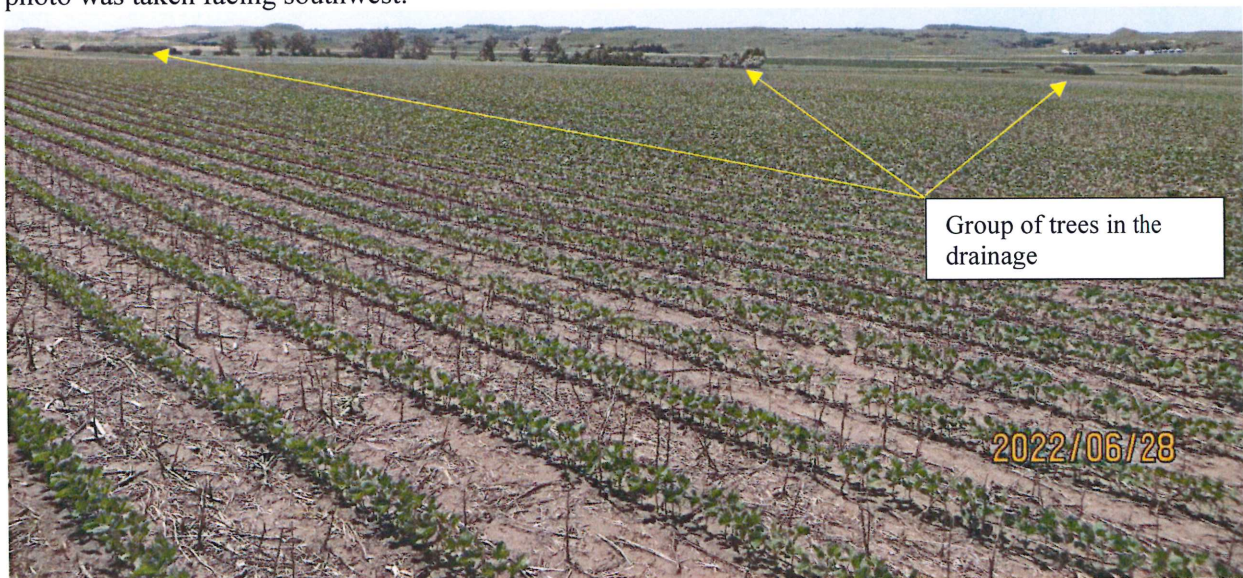
The diversion is well vegetated with a dense stand of grass, primarily smooth brome grass. A few patches of Canada thistle and absinth wormwood plants were observed in the diversion. A few trees have established in the county road ditch and in the primary drainage that passes through this property. A group of trees was also observed from a distance in the NE¼ of the SW¼ of Section 34 (**Figure 4**). Mr. Eisenbeis alleged that all these trees have established because of increased water in the drainage directly related to surface coal mining discharges.

**Figure 4.** A group of trees were also observed from a distance in the NE $\frac{1}{4}$  of the SW $\frac{1}{4}$  of Section 34. The photo was taken facing southwest.
