Basin Electric Power Cooperative
Pioneer Generation Station Ph. IV – Williams County
Case No. PU-22-380
As-Built Construction & Reclamation Inspection Report

RE: Case No. PU-22-380
Basin Electric Power Cooperative
Pioneer Generation Station Ph. IV –
Williams County
As-Built Construction & Reclamation
Inspection Report

Date: 5/28/2026	Inspection - 05/22/2026, Report - 05/28/2026
-----------------	--

Project: PU-22-380 Pioneer Generation Station Ph. IV	
--	--

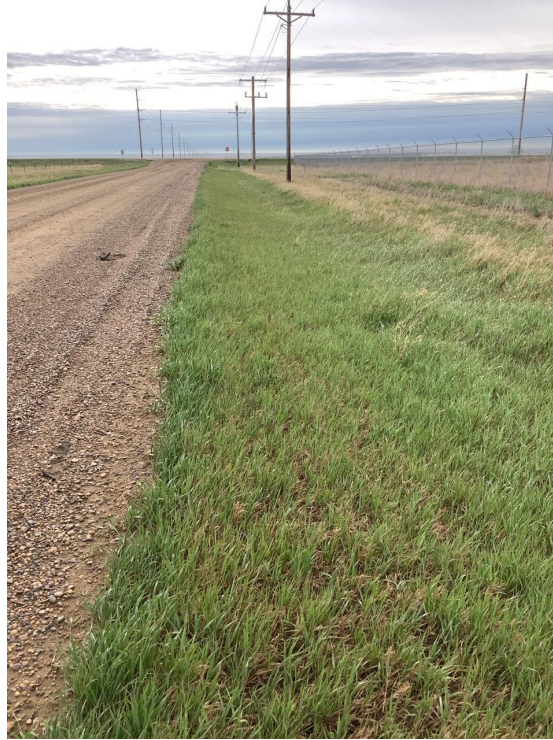
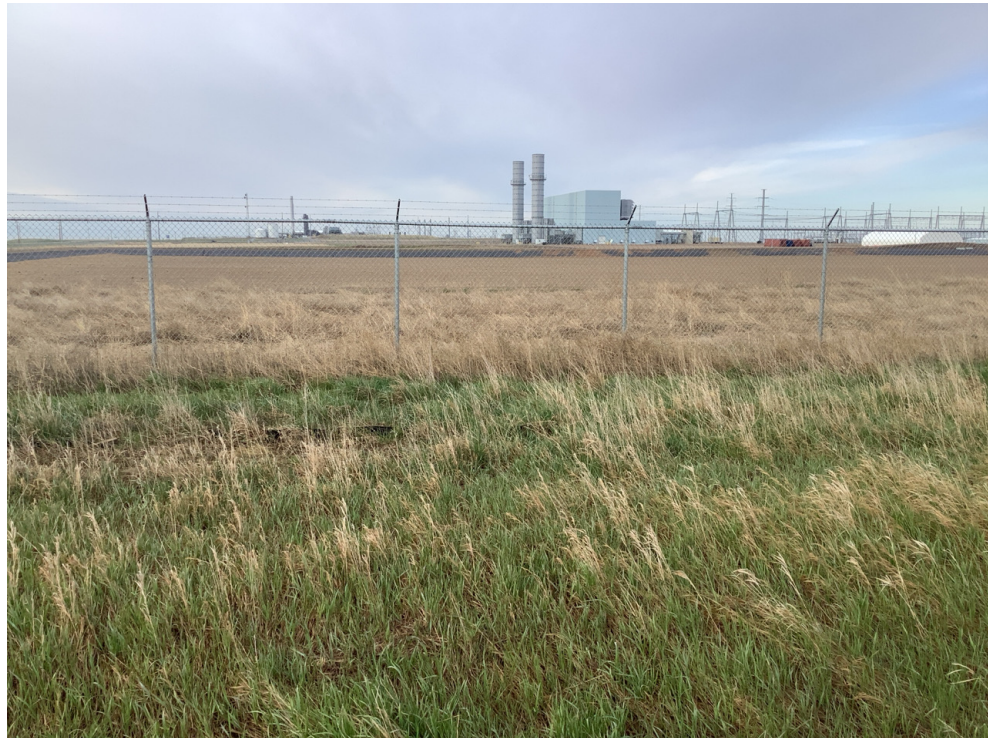
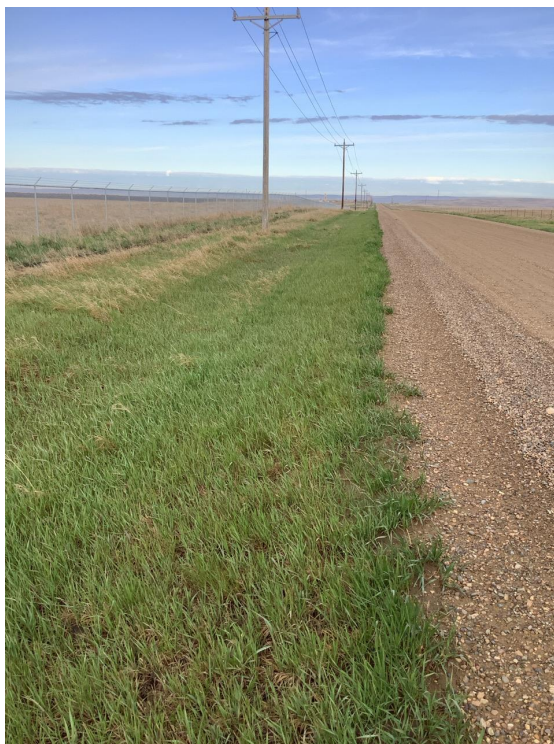
Point Number: 1

Notes: Ditch row vegetation conditions on north edge of site.

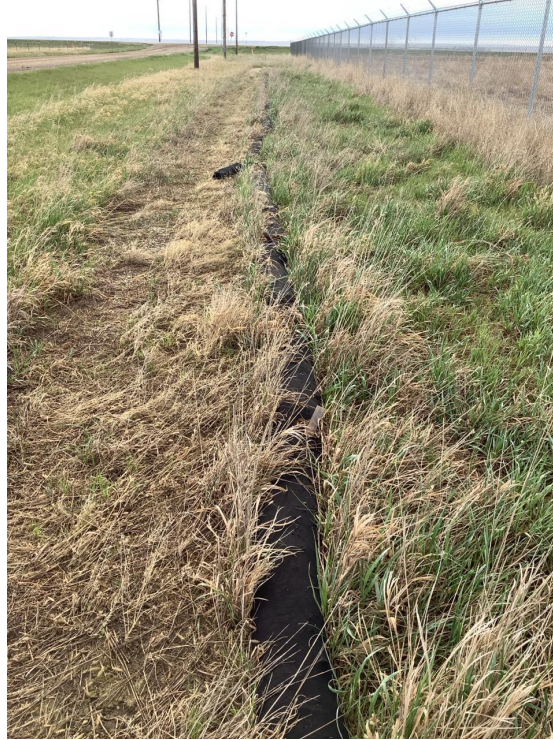
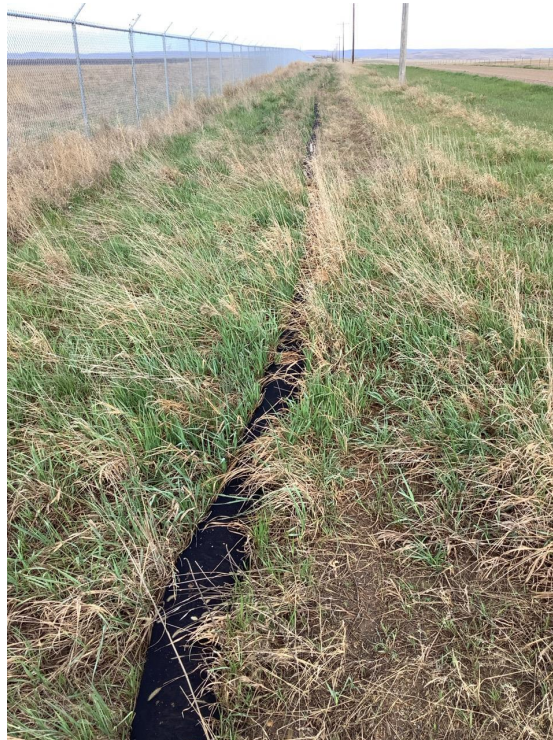
Point Number: 2

Notes: Permanent erosion control surrounded by vegetative cover.

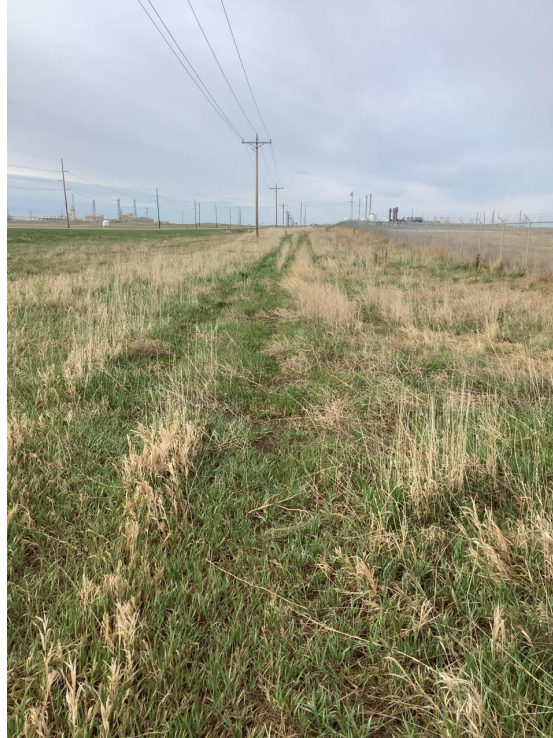
Point Number: 3

Notes: Vegetative cover along east edge of property.

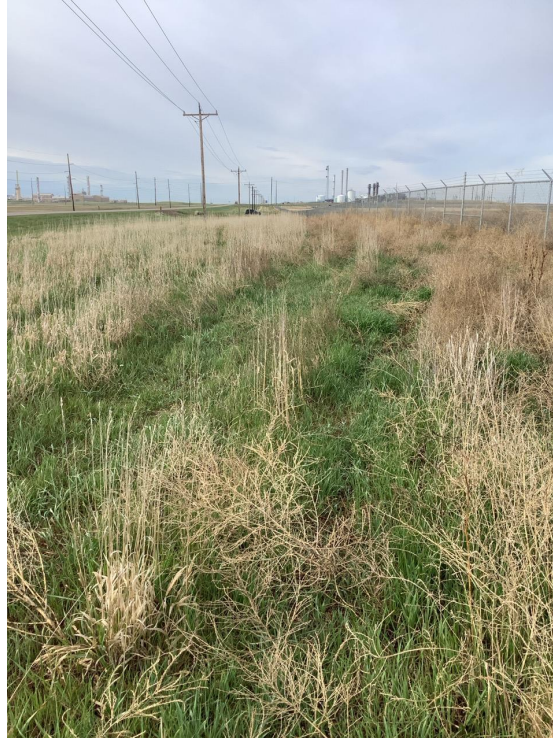
Point Number: 4

Notes: Post construction conditions. Substantive vegetative cover.

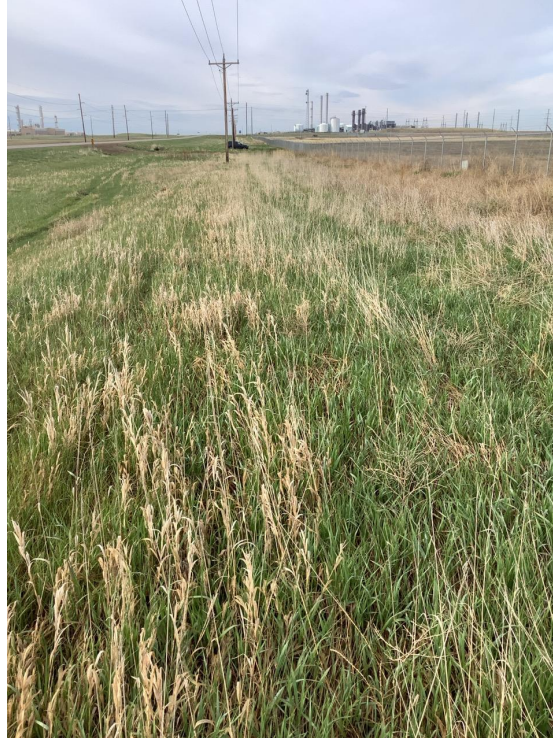
Point Number: 5

Notes: Property edge vegetation is over 1' tall and very densely growing.

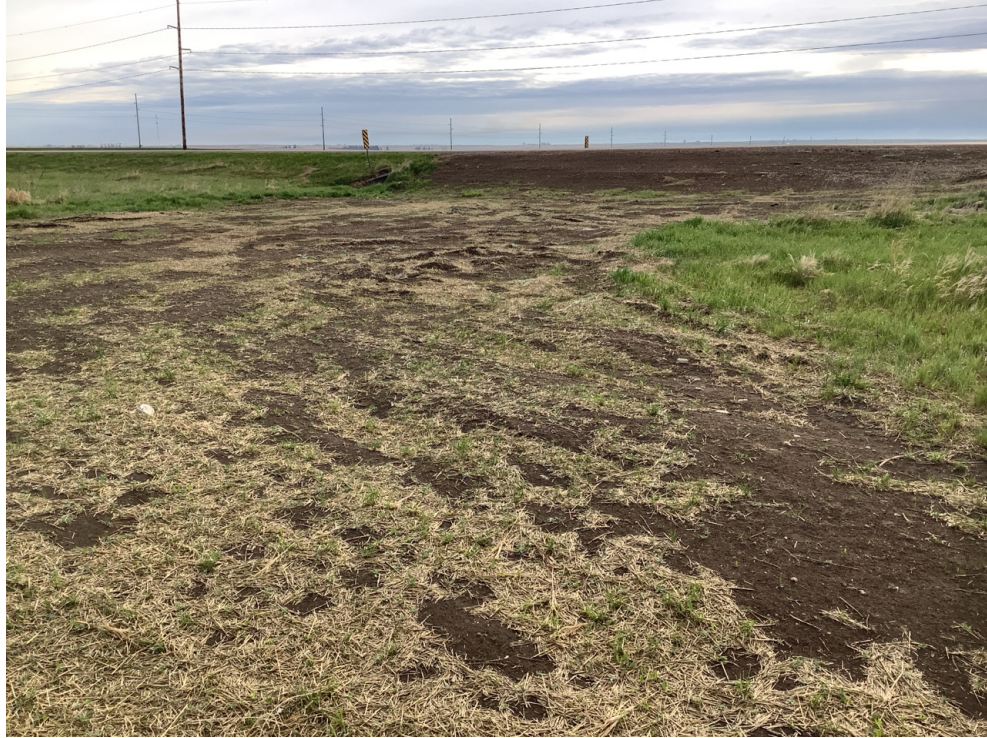
Point Number: 6

Notes: Previous construction access. Contractor rep mentioned this was seeded and mulched last fall. Grass is starting to come in, but has not reached "substantial cover" yet.

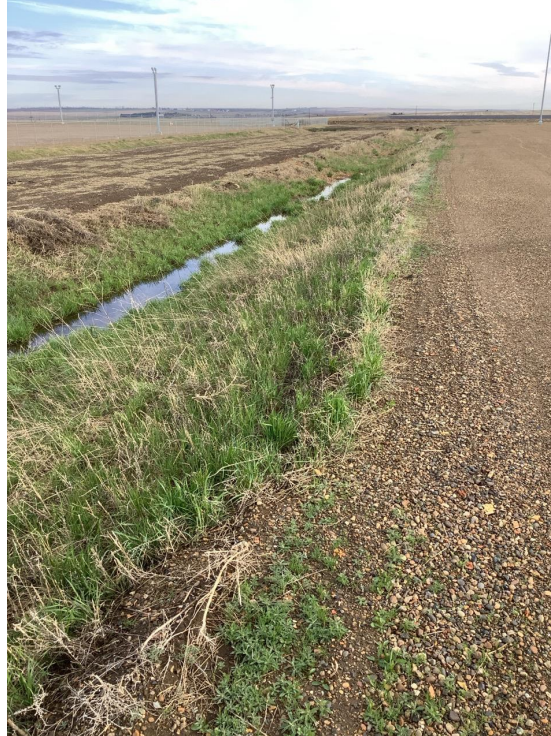
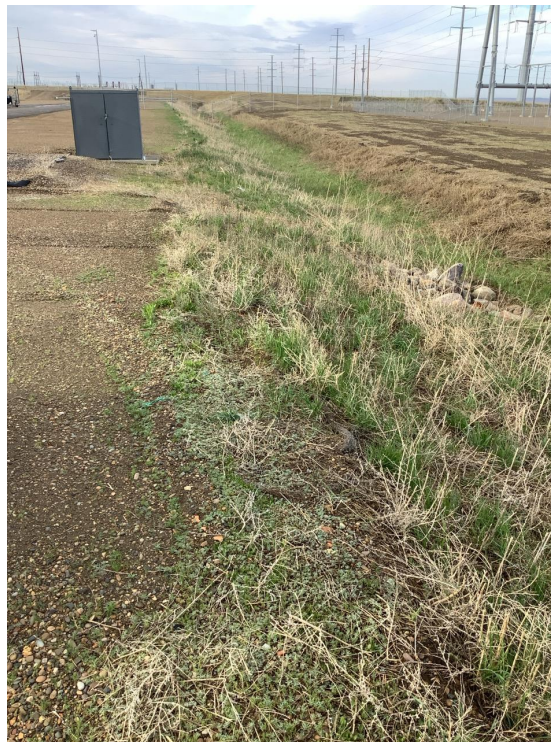
Point Number: 7

Comments: Contractor rep states that drainage ditches were seeded and mulched long before the top section to help with erosion control, which is why the ditches had established vegetation, but the top did not.

Notes: Drainage ditch appears fully vegetated.

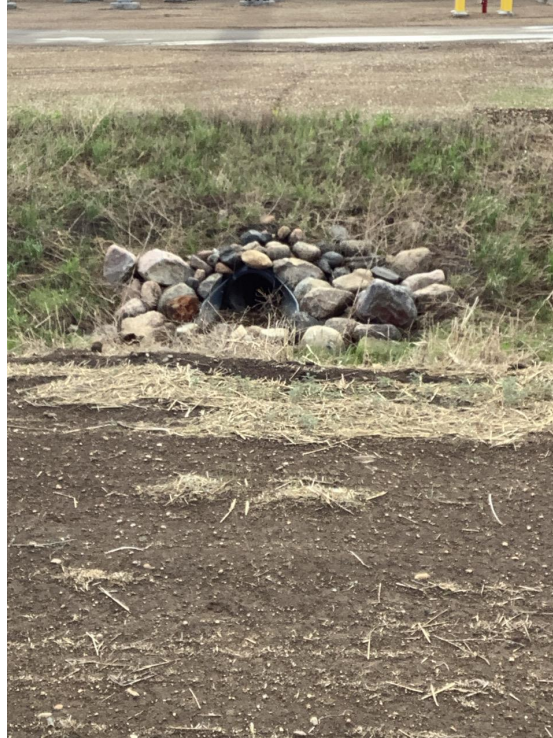
Point Number: 8

Notes: Rip rap at storm outlet for drainage ditch.

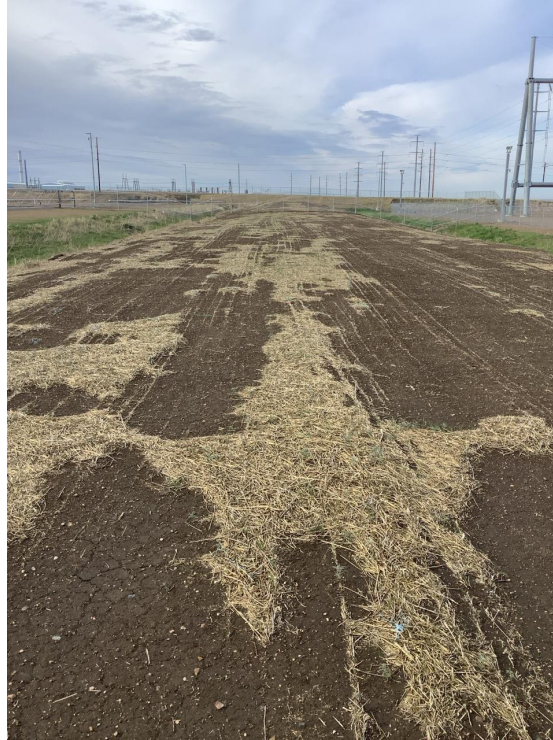
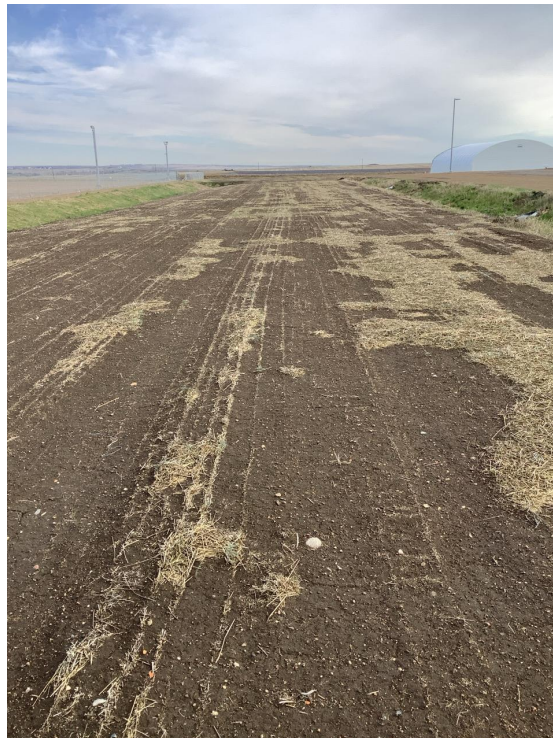
Notes: Spot of reclamation: evidence of seeding and mulching operations, vegetative growth not yet established.

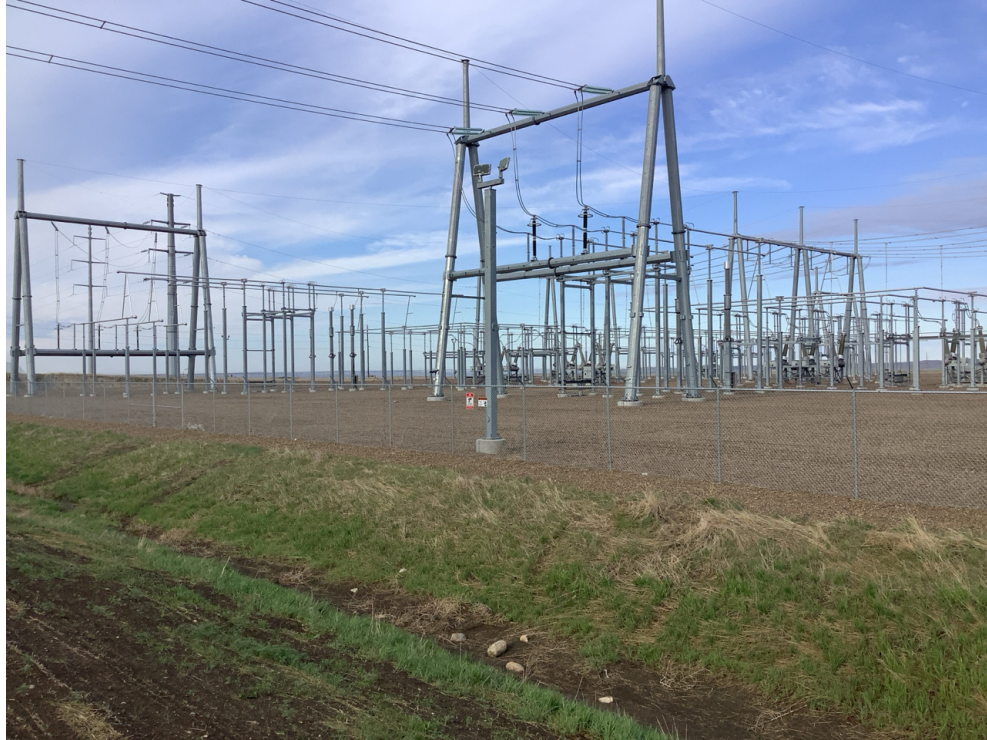
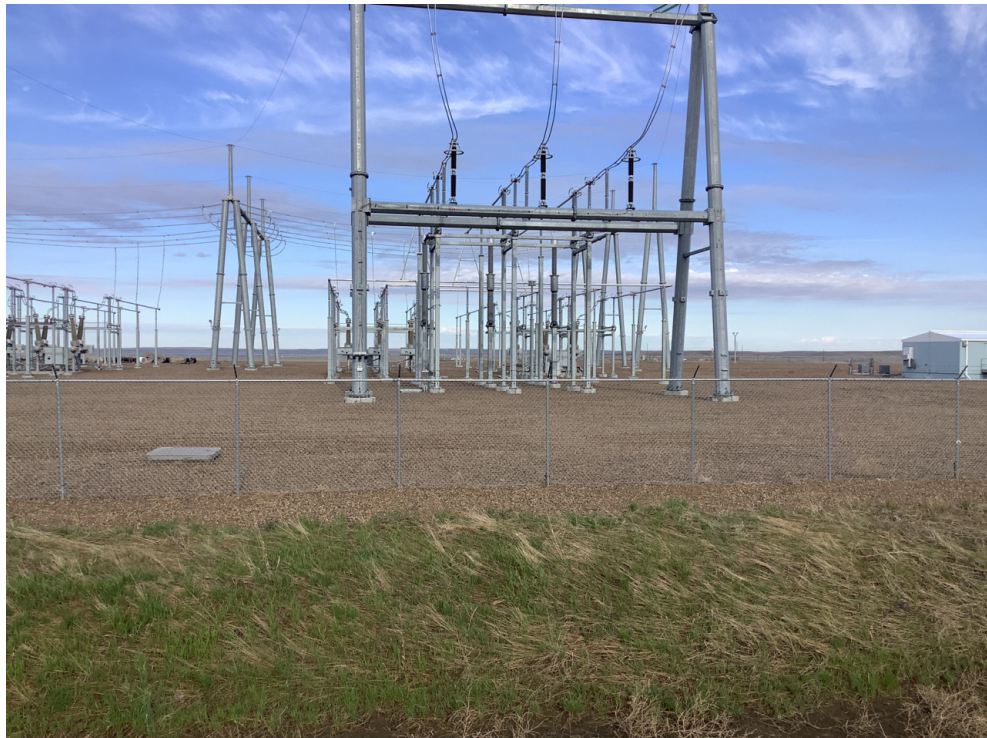
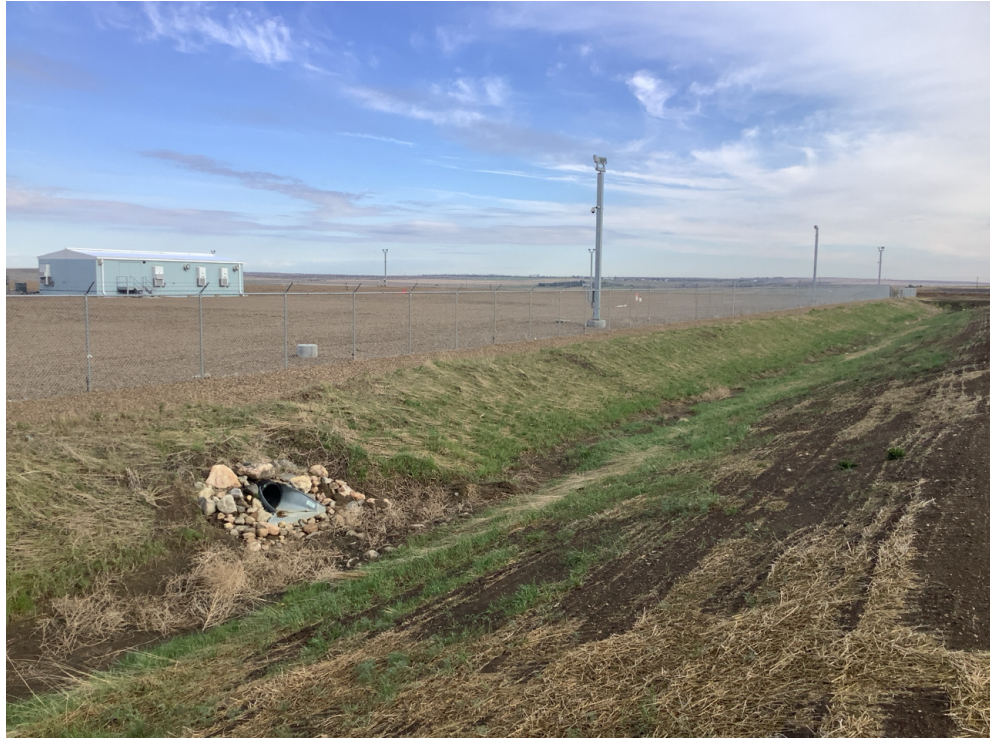
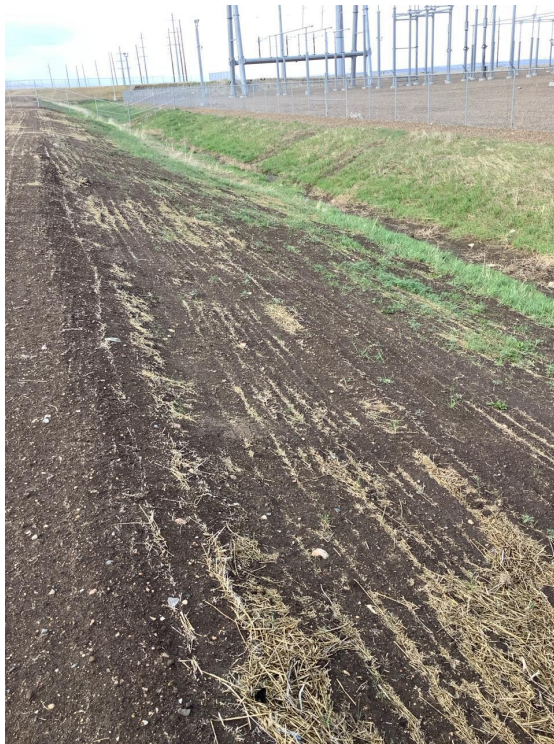
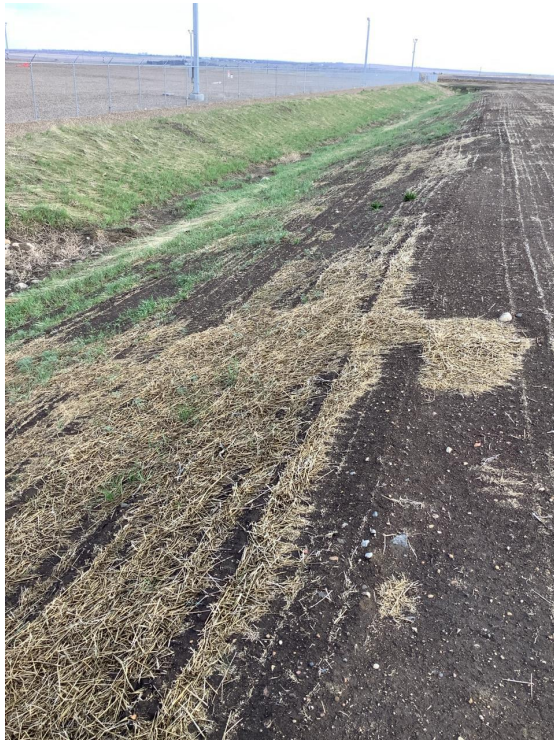
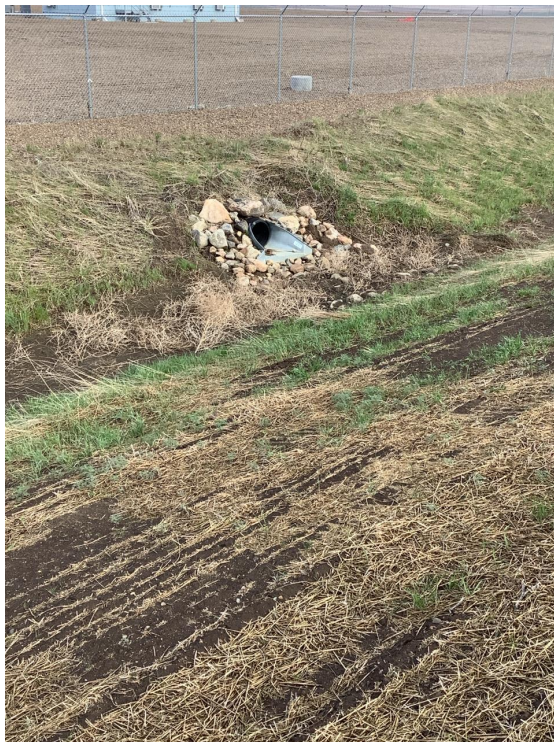
Point Number: 10

Notes: Another drainage ditch, evidence of seeding and mulching but vegetative cover not established yet. Preliminary growth visible. Outlet of storm culvert with rip rap. Completed substation facility.

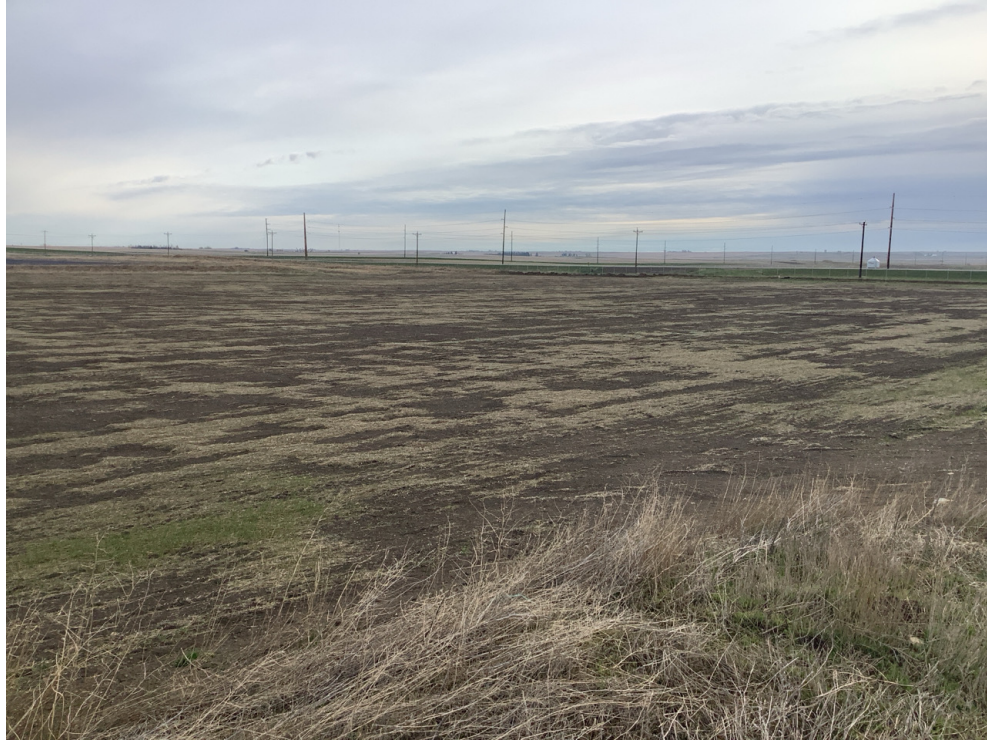
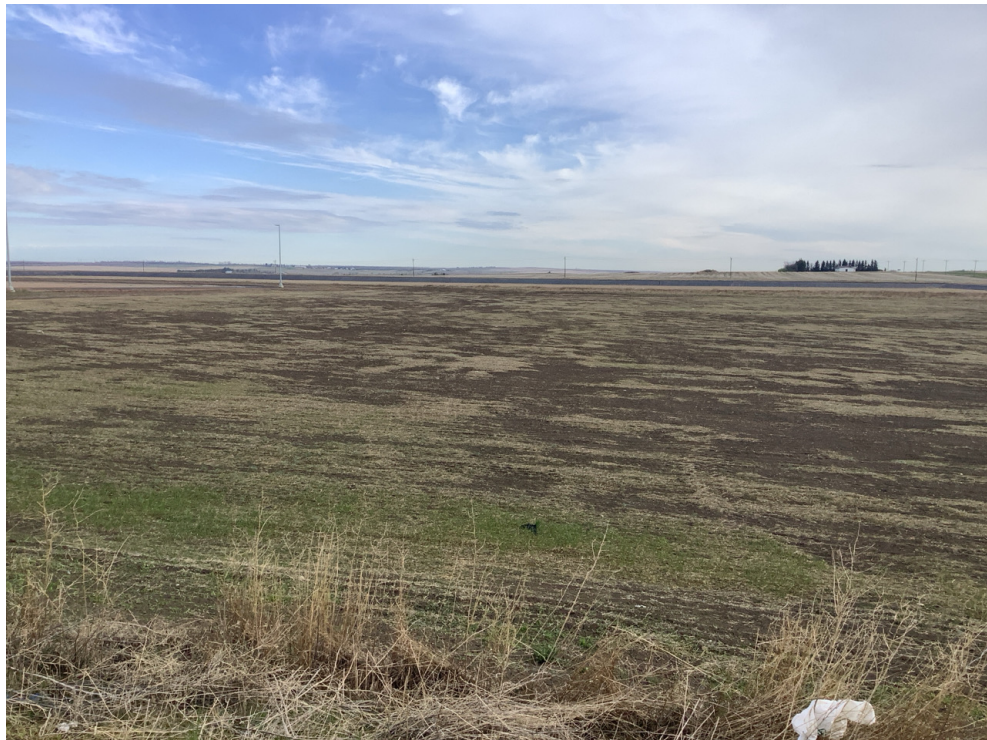
Point Number: 11

Notes: Construction contractor parking lot current conditions. Lot has clear evidence of seeding and mulching, with preliminary growth visible, but vegetative cover not established yet.

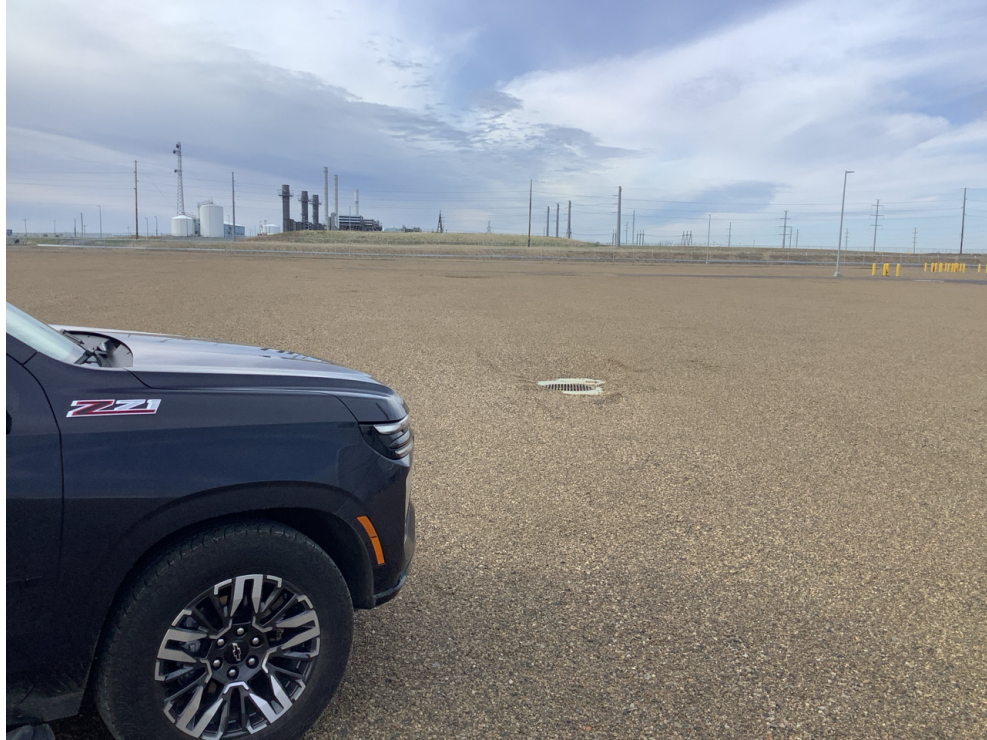
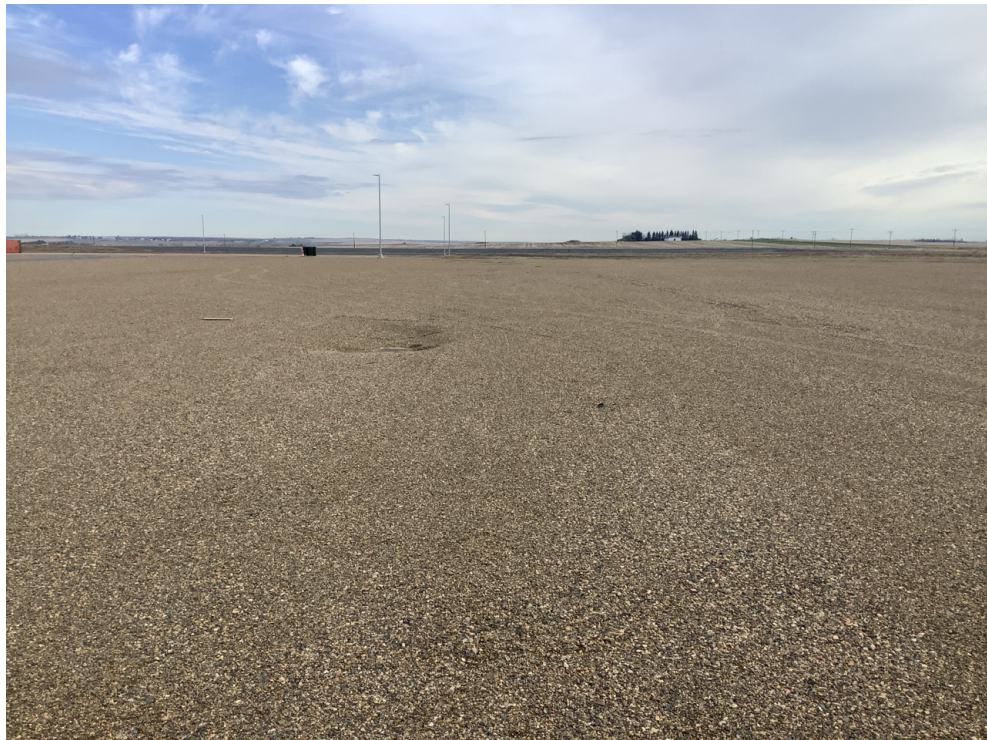
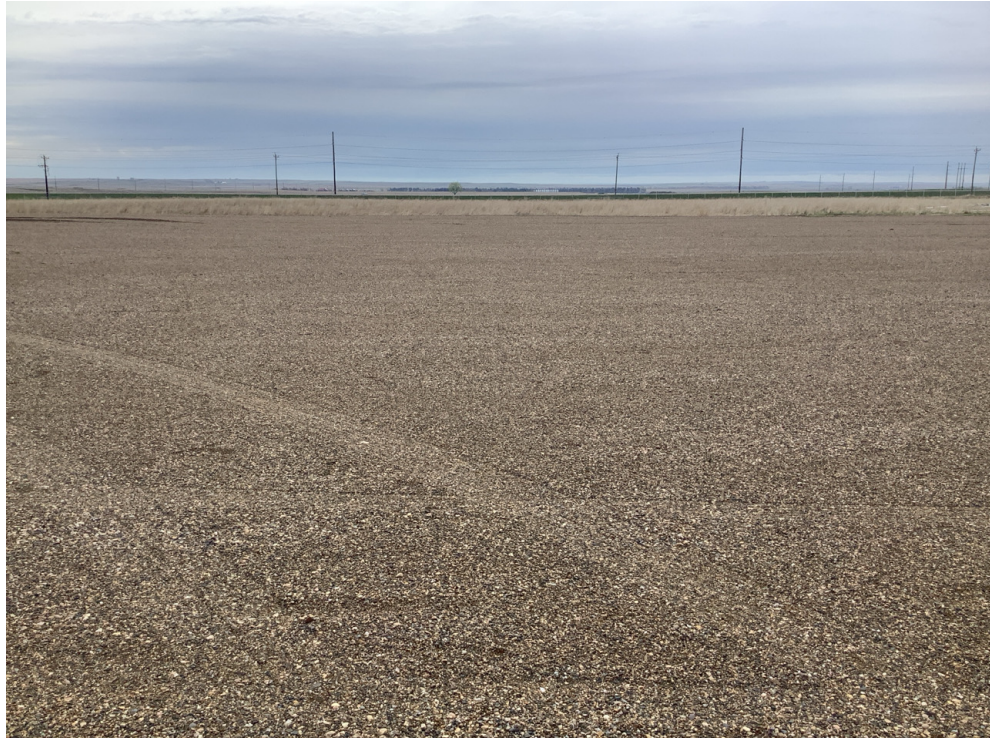
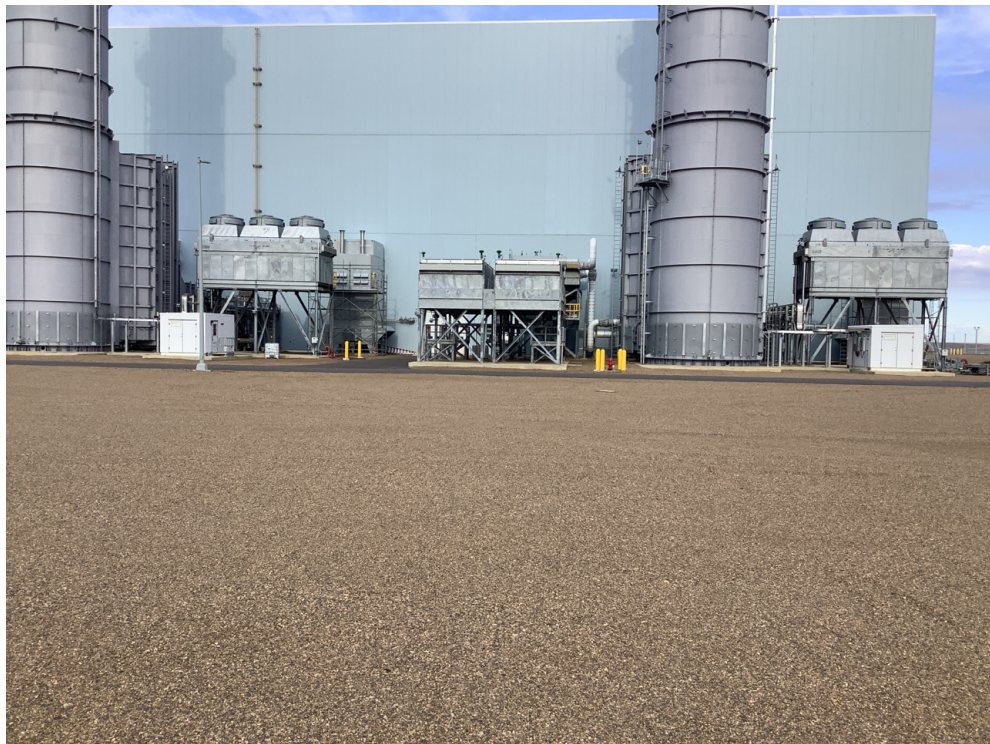
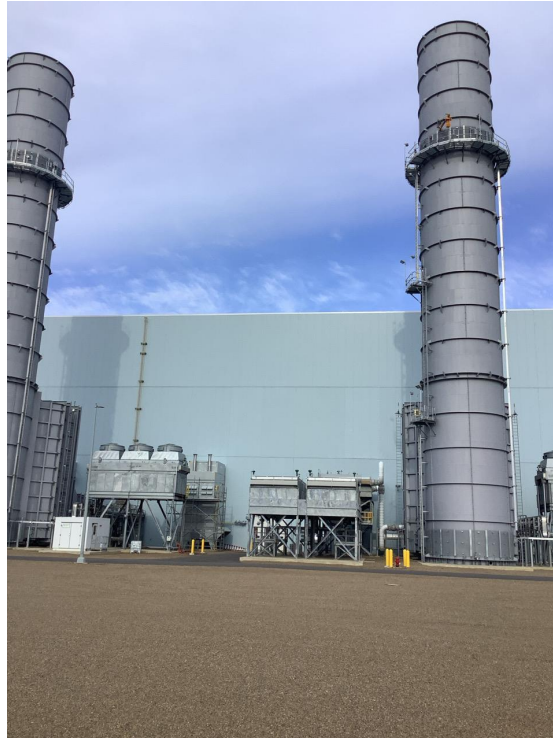
Point Number: 12

Notes: Lay down yard current conditions: the entire area has been graded and is now a gravel work yard. Station is operational.

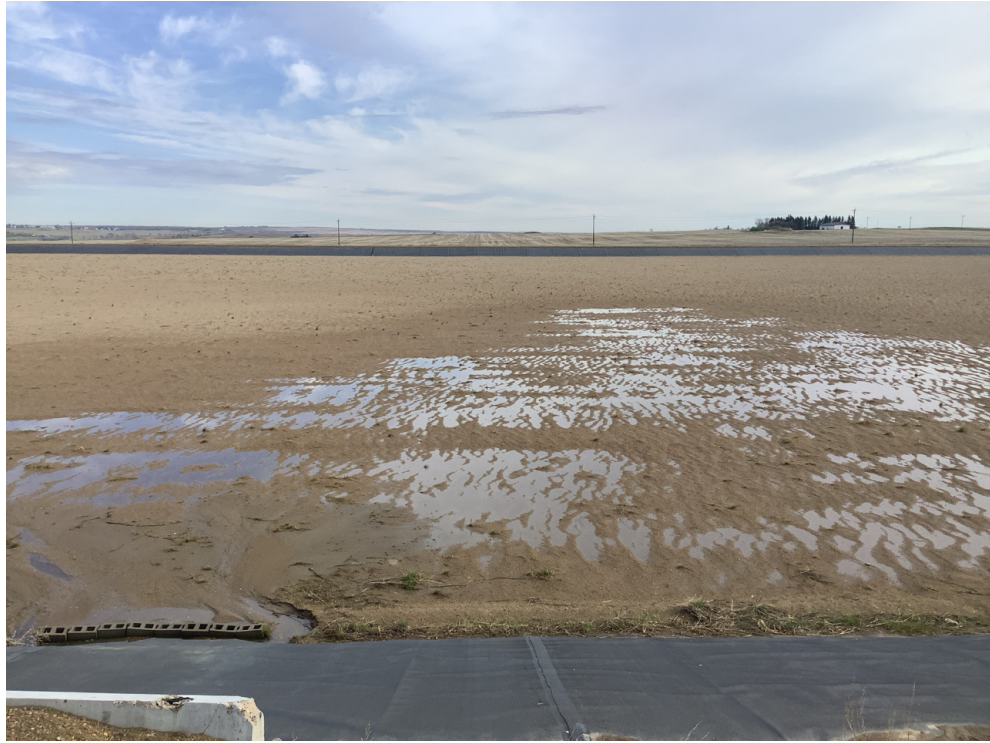
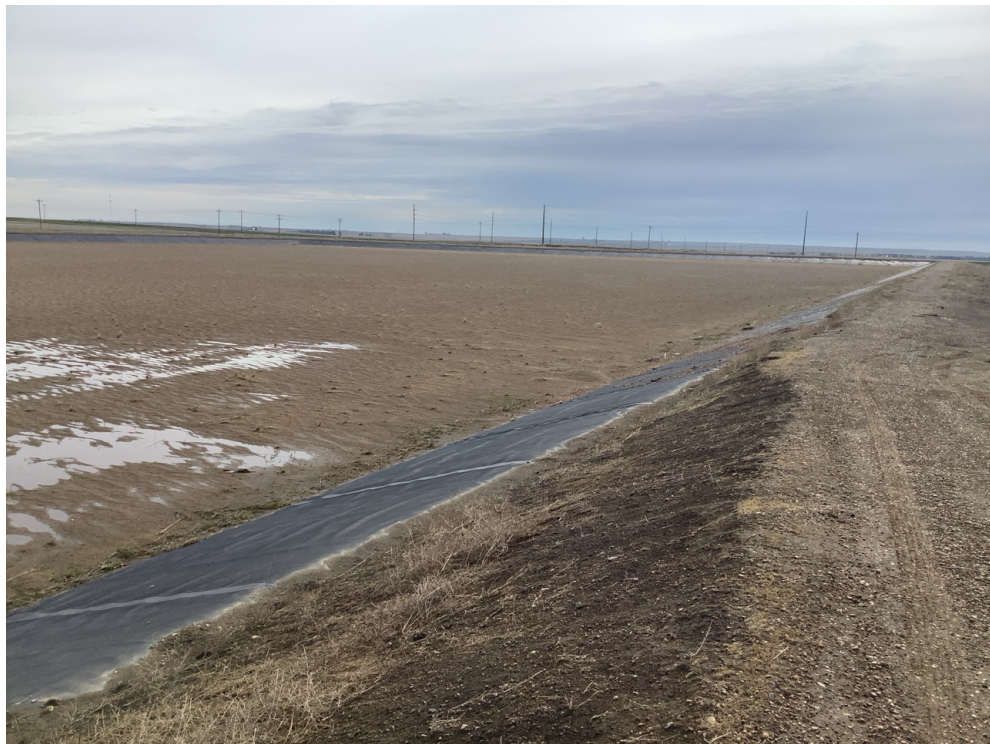
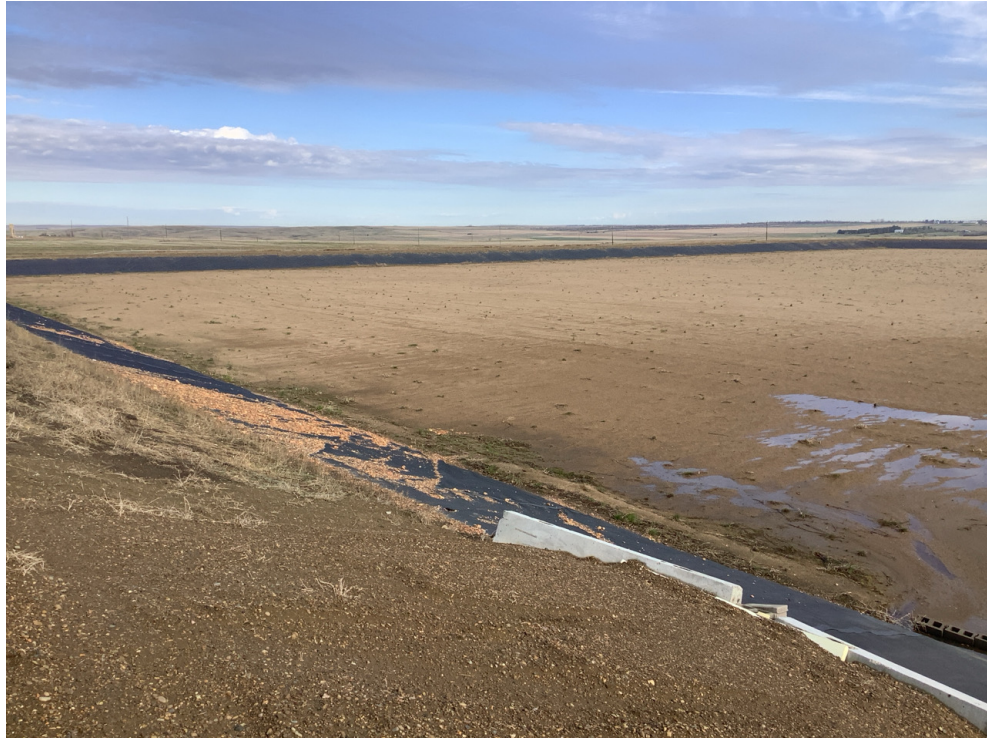
Point Number: 13

Notes: Completed storage pond with liner installed.

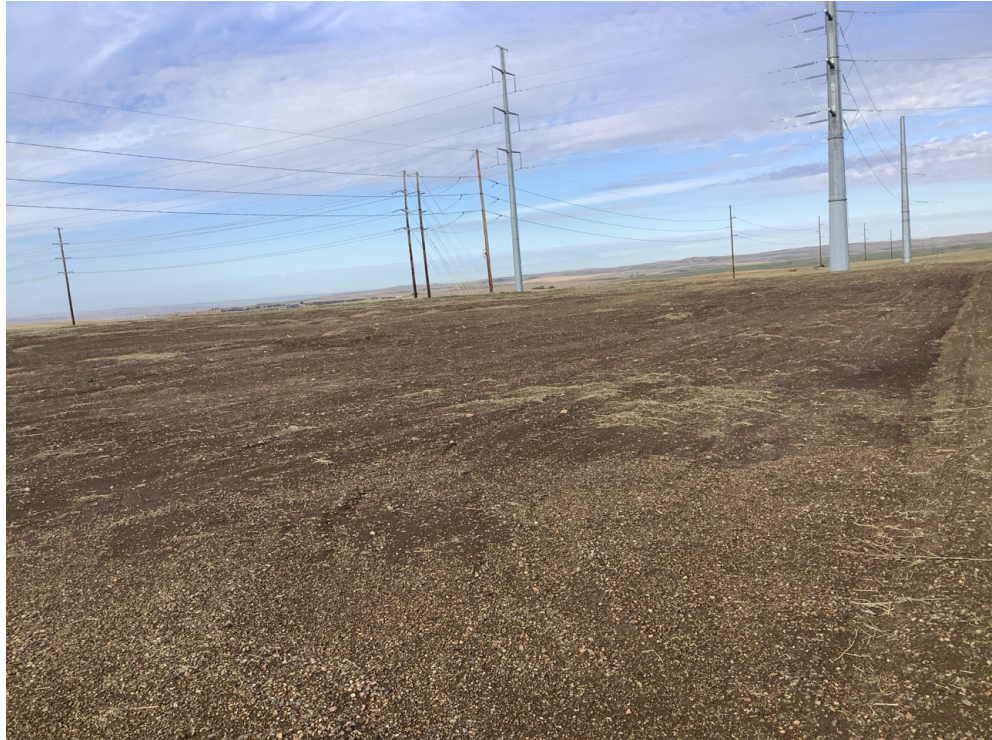
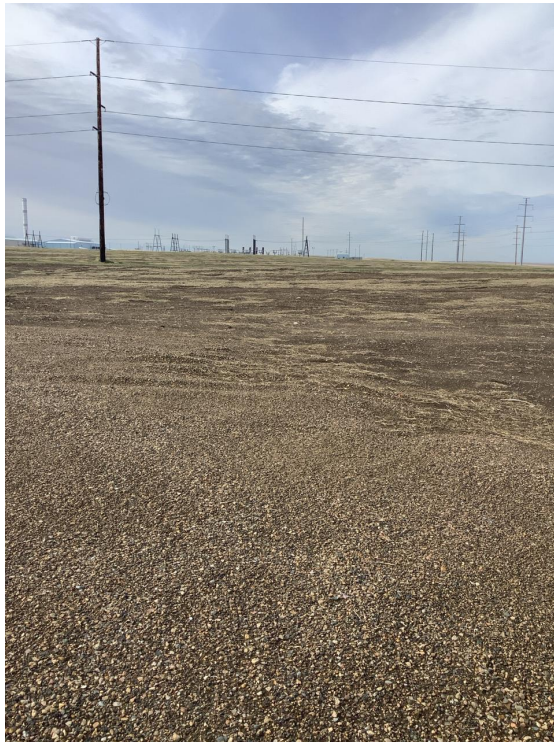
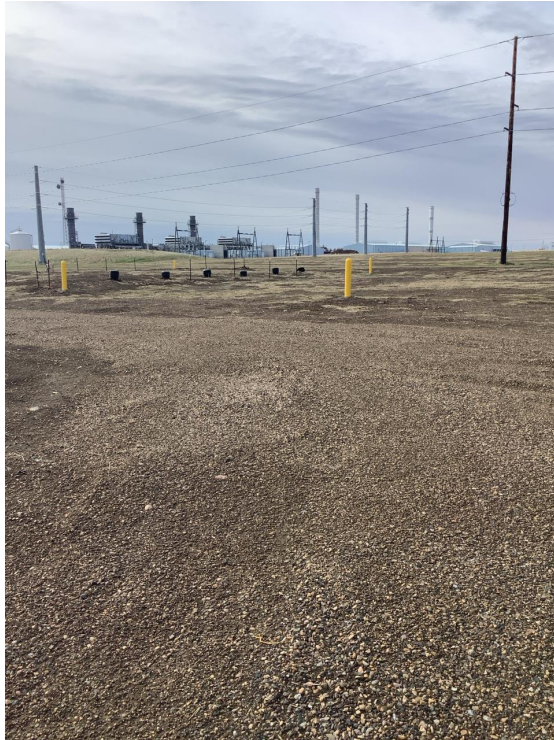
Notes: Current conditions of previous topsoil storage area. Evidence of seeding and mulching, but vegetative growth not established yet.

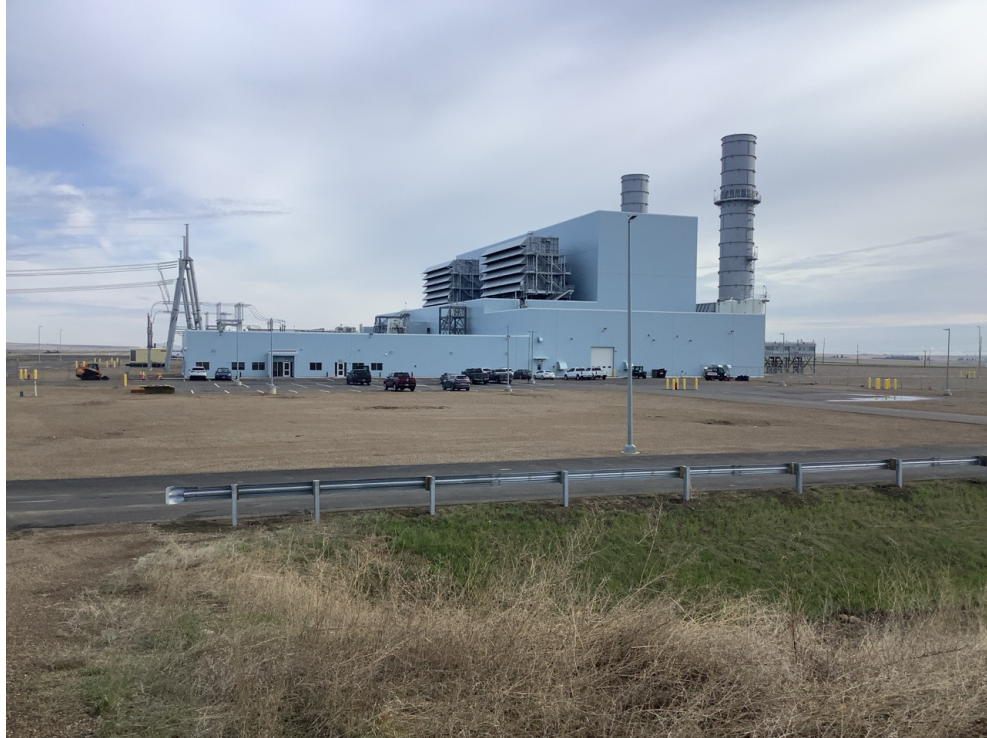
Point Number: 15

Notes: Pioneer power station.

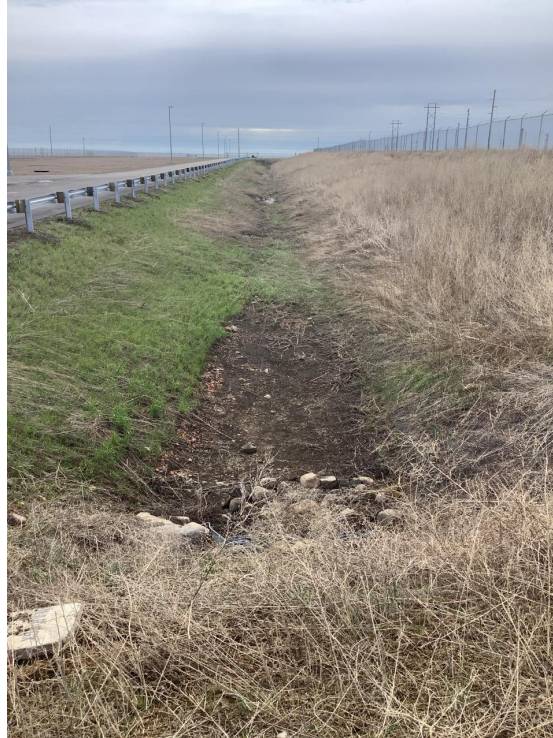
Point Number: 16

Notes: Drainage ditch with sufficient vegetative cover except at area where water appears to pond during rain events. Erosion control blanket is in place in this spot and rip rap surrounds the inlet.

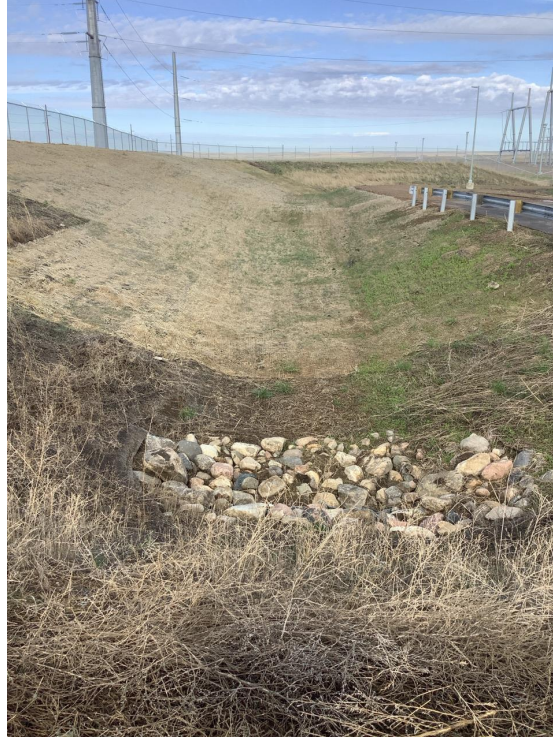
Point Number: 17

Notes: Drainage ditch with substantial vegetative cover and rip rap around outlet. Erosion control blanket in place.
