Principal Investigator Wesley Mathews
Acting Accident Investigation Director Chris Ruhl
Date of Report May 26, 2022
Subject Failure Investigation Report - Denbury Gulf Coast
Pipelines, LLC – Pipeline Rupture/ Natural Force Damage

Date of Failure February 22, 2020
Commodity Released Carbon Dioxide
City, County and State Satartia, Yazoo County, MS
OpID and Operator Name 32545, Denbury Gulf Coast Pipelines, LLC
Unit # and Unit Name 75379 – MS-2
WMS Activity ID 20-176125
Milepost (MP) / Location MP 6.6 / Pipeline Stationing 348+63
Type of Failure Natural Force Damage
Fatalities None
Injuries None
Description of Area Impacted Rural, “Could Affect” High Consequence Area (HCA) -
Other Populated Area
Total Costs \$ 3,947,009

Failure Investigation Report – Denbury Gulf Coast Pipelines LLC
Pipeline Rupture/Natural Force Damage
February 22, 2020

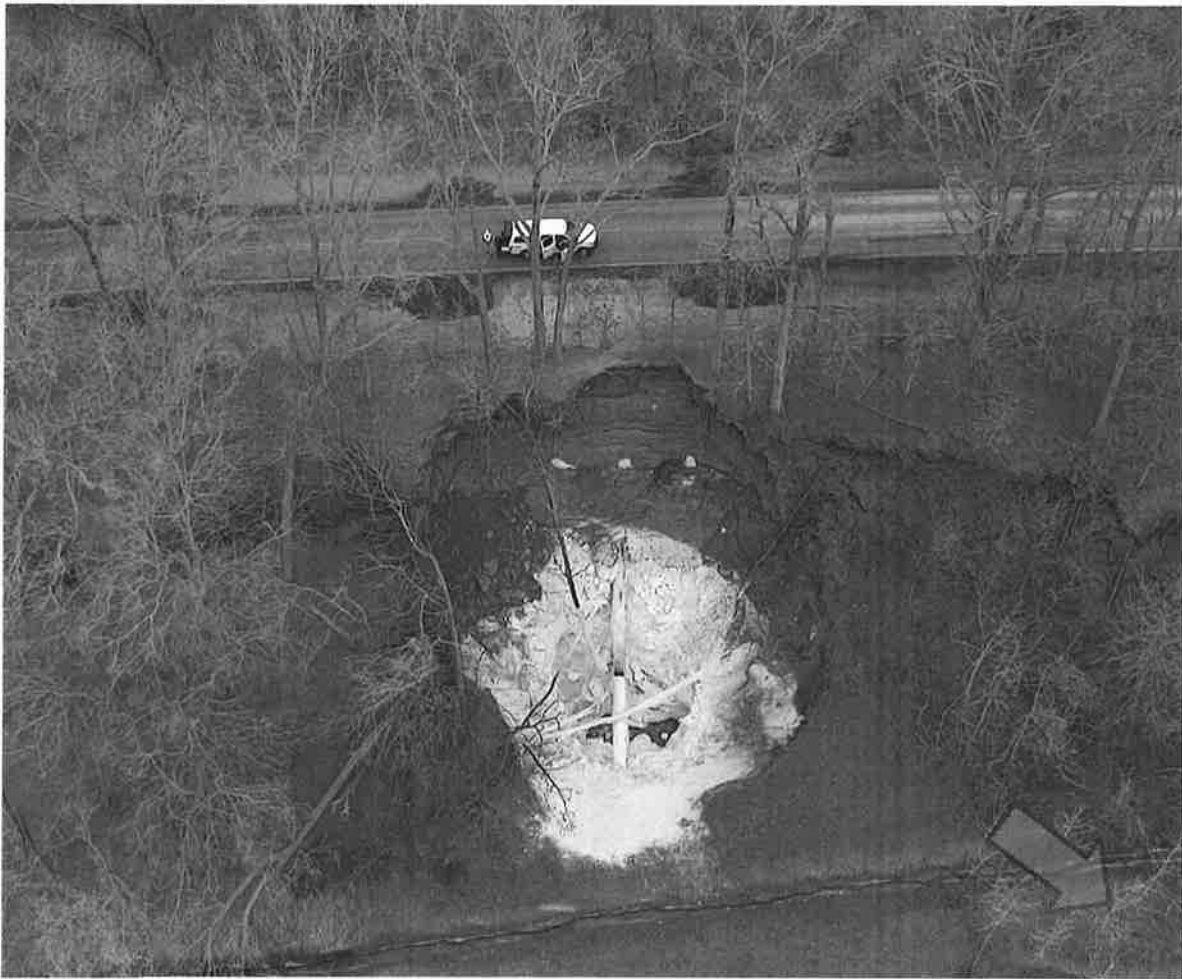
On February 23, 2020, at 10:09 a.m., a PHMSA AID investigator from Oklahoma City arrived at the intersection of HWY 433 and Highway 3 to meet with Denbury representatives and emergency response organizations. The group then proceeded to the site of the rupture (Figure 2). By that time, the IC had demobilized, and roadblocks had been removed. Denbury crews were in the process of setting up caution fencing and slowing traffic on HWY 433 for public and worker safety. The rupture crater was on the northeast side of HWY 433 (Figure 2).

*Figure 2: Vehicle is Parked on HWY 433 - The White is Ice Generated by the Release of CO₂ - The Blue Arrow Points North
(Aerial Drone Photograph Courtesy of the Mississippi Emergency Management Agency)*

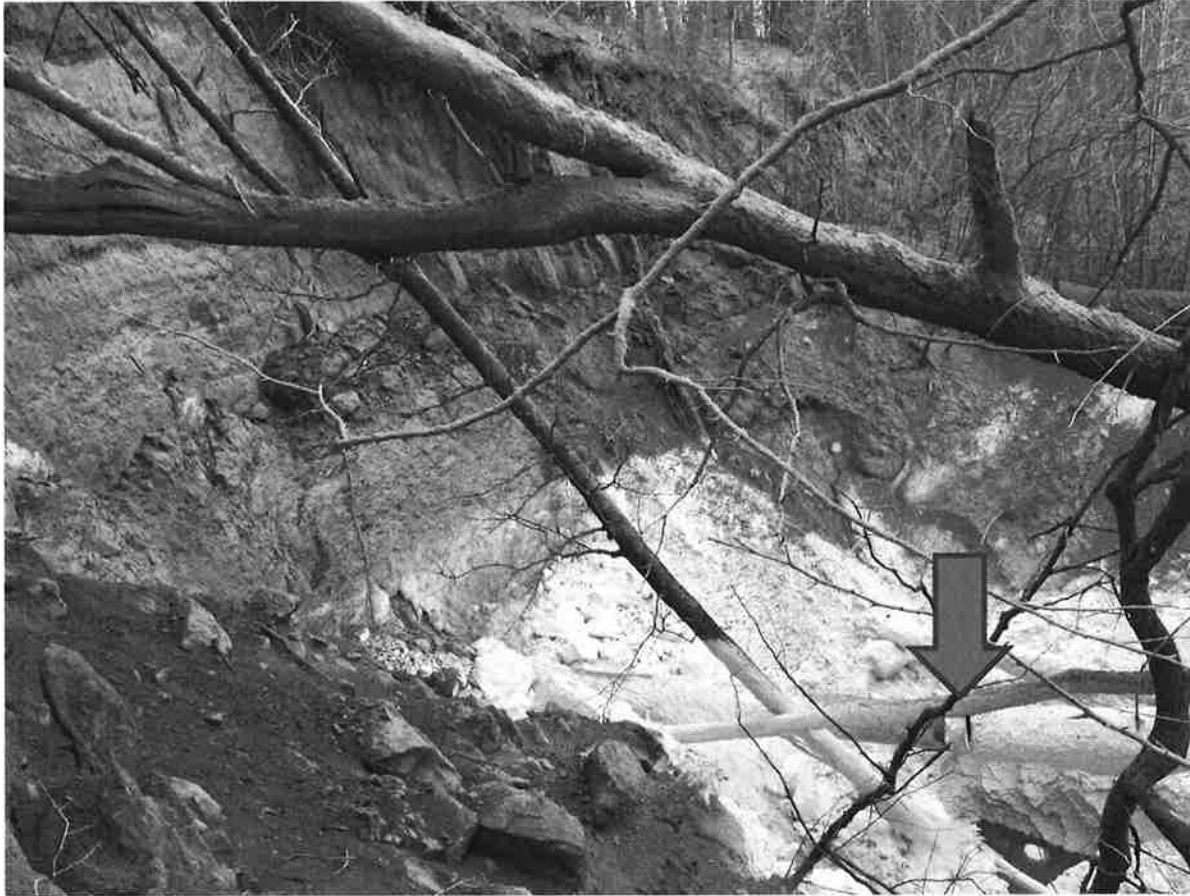
*Figure 3: Crater Created by the Rupture Containing Fallen Debris (dry ice, and the failed pipe sections)
(Blue Arrow is Pointing at the Pipeline Separation)*

The pipeline separated at a girth weld. The pipeline self-excavated due to the discharge of CO₂. The auto refrigeration generated by the CO₂ discharge and accompanying chance in phase covered the area with a thick layer of ice (Figures 2, 3, and 4). The upstream section of pipe was not covered in ice, and a slightly jagged edge was observed on the rupture edge (Figure 4). The crater was an estimated 40-feet-deep on the downstream (HWY 433) side and about four-feet-deep on the upstream side.

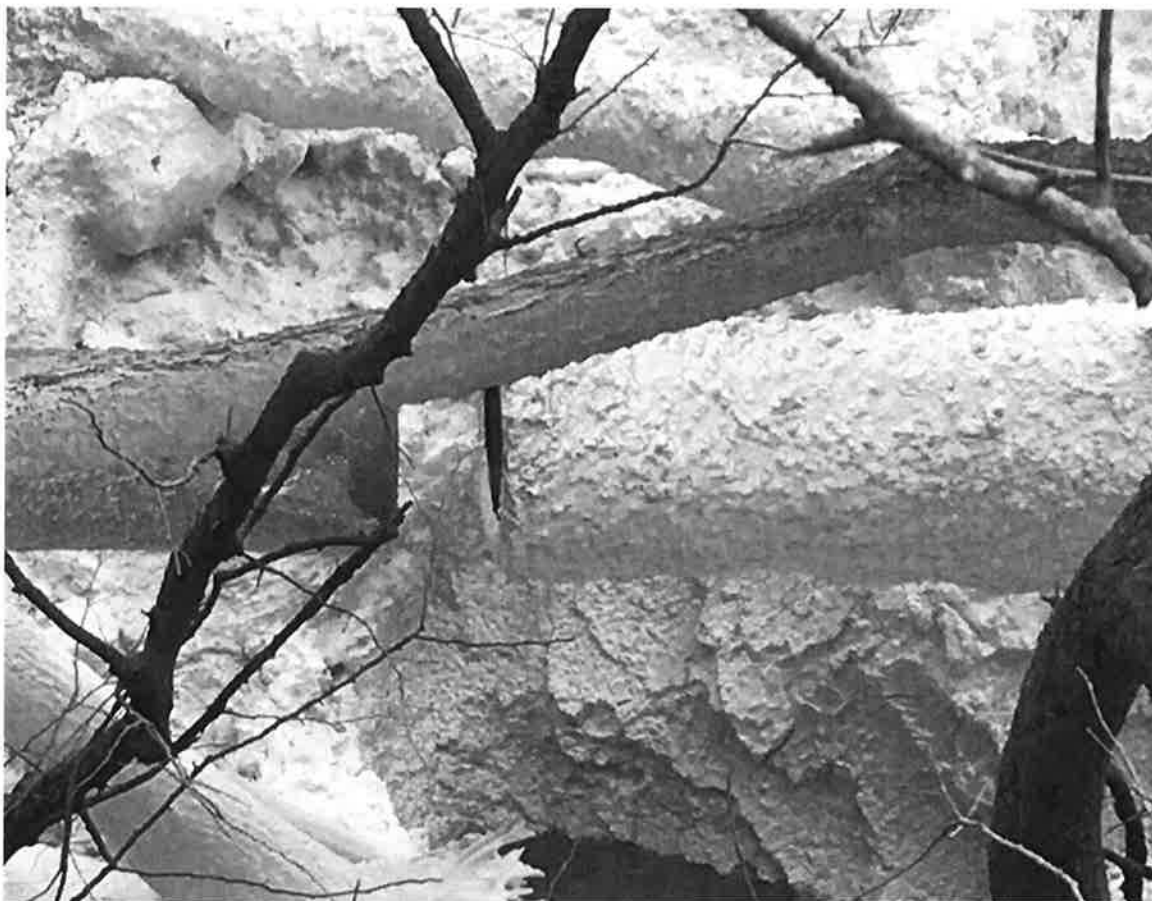
Figure 4: The failed pipe sections shown separated by a few inches.

PHMSA notes the failed girth weld exhibited both ductile and brittle fracture appearances. A typical overload condition in these circumstances is expected to be ductile, unless the grain structure of the steel is susceptible to brittle failure, or the material has been chilled below its transition temperature from ductile to brittle behavior. A failure scenario whereby a leak initiates, and the refrigeration effect associated with vaporization of the liquid CO₂ results in a brittle failure is plausible, although a distinct failure origin within the girth weld was not identified.

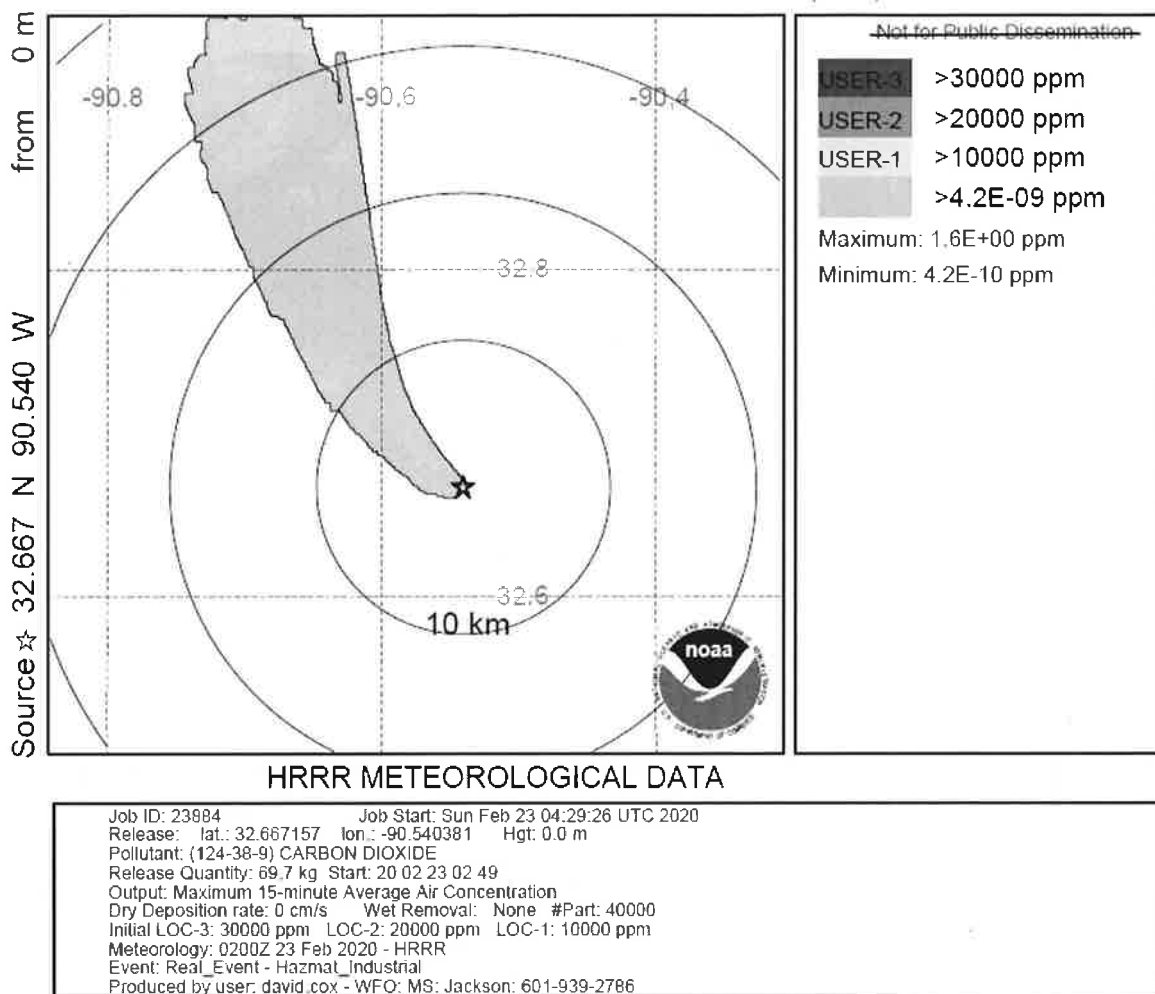
Figure 5: This Chart Shows the Plume Model Data Generated by the National Weather Service/NOAA - The Model Indicates the Direction a Plume or Cloud of CO₂ Would Have Followed from Ground Level While Dissipating, According to Atmospheric Data at the Time of the Release - Each Ring is 10 Kilometers (Satartia is Less Than Two Kilometers Northwest of Release Site, Indicated by the Star)⁸

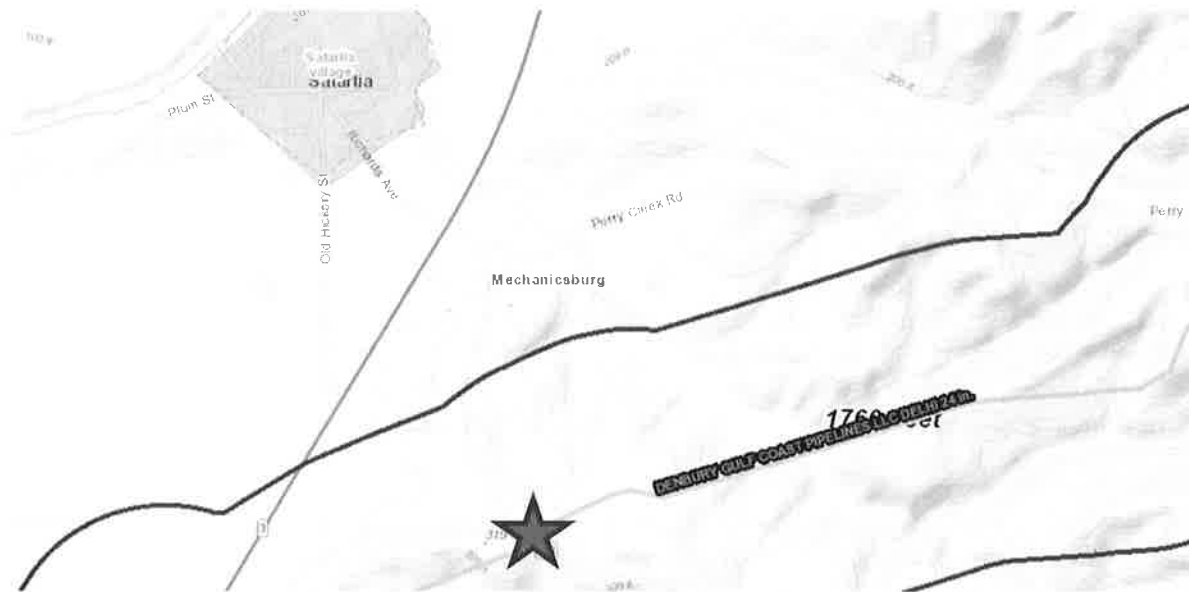
emergency response plans. The rupture location was one mile from the center of Satartia, where the entire town was evacuated.

Figure 6: Topographical Map Showing the Delhi Pipeline (Green) and Denbury's Buffer Zone (Red) on Either Side of the Pipeline and the Proximity to Satartia (Blue Star Indicates the Rupture Site)
