Phase II Landslide Assessment
Proposed Carbon Capture Pipelines
North Dakota

Project Number TXG0484

August 15, 2023

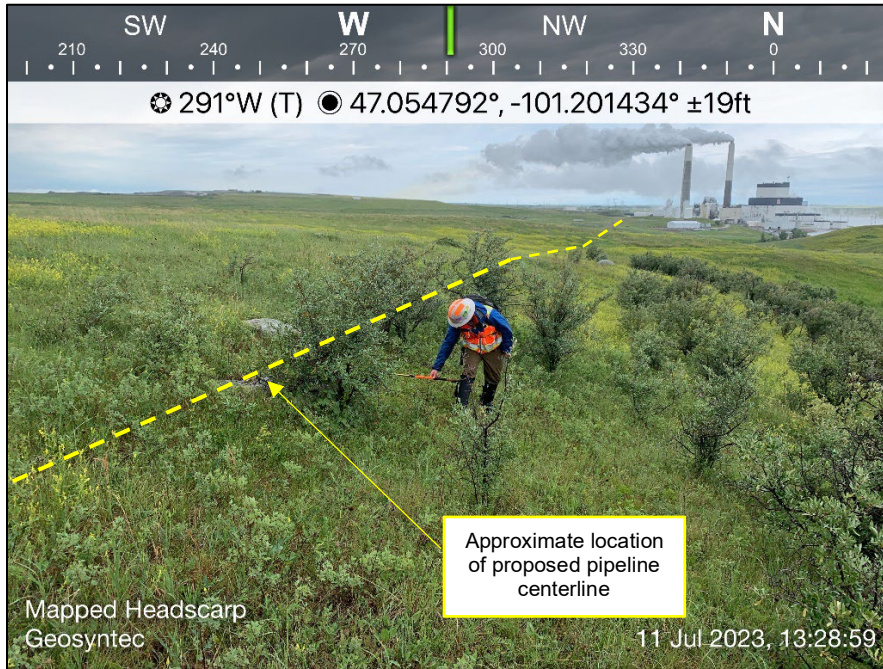
Looking northwest along the mapped headscarp of Site #2 where it intersects the proposed pipeline centerline. Geosyntec field personnel is pointing at the mapped headscarp that appeared as a <1 ft subdued slope break. The approximate location of the proposed pipeline centerline is represented by the dashed yellow line.

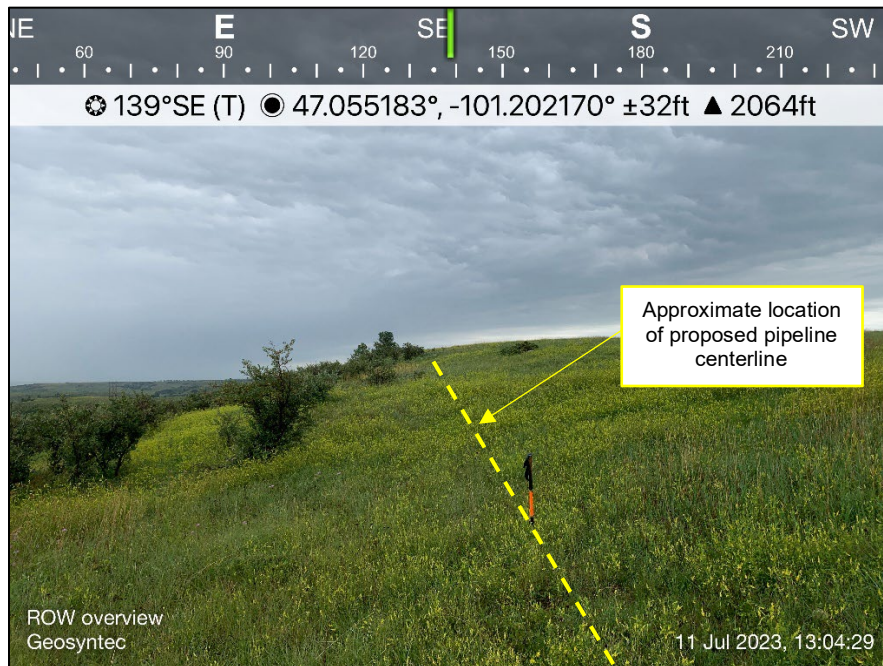
Looking southeast along the approximate location of the proposed pipeline centerline as represented by the dashed yellow line. Site #2 is located on the gradual side slope to the left of the image.

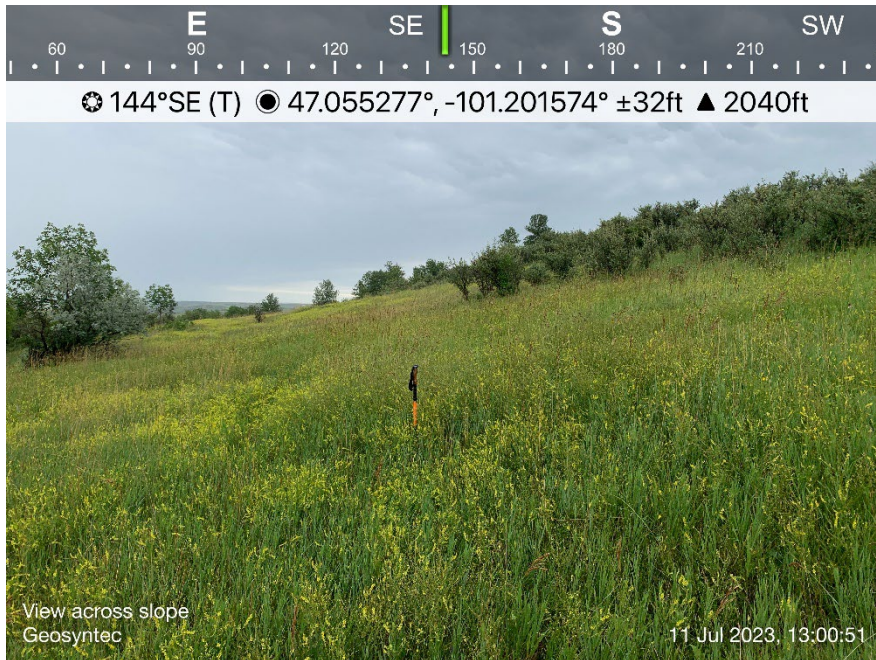
Looking southeastward across the body of the landslide mapped at Site #2. The proposed pipeline centerline is located out of view at the top of the slope to the right of the photo.

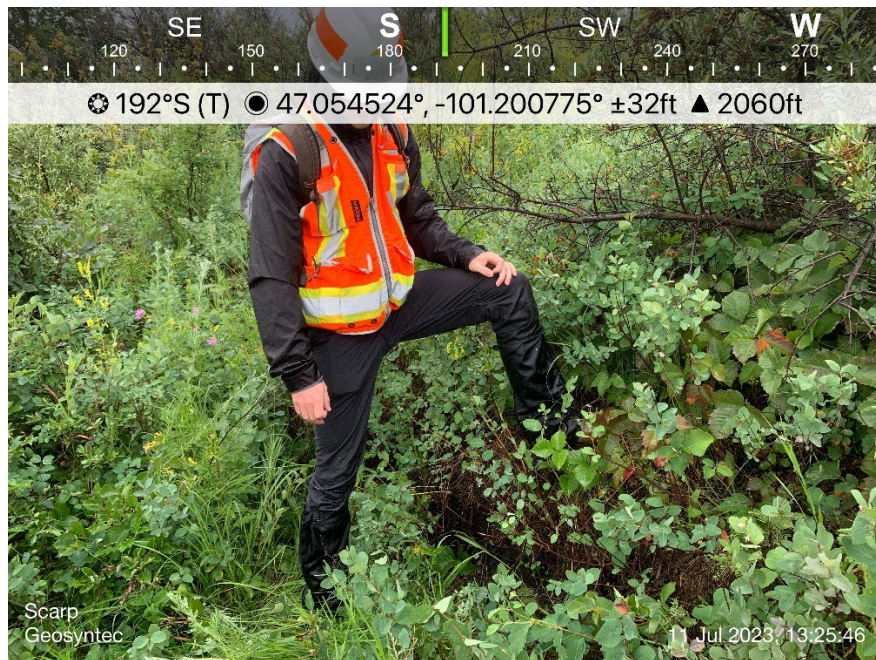
Example of a 2 ft high distinct internal scarp that is associated with the smaller landslide mapped by the NDGS to the southeast of Site #2. The feature is ~50 ft downslope of the proposed pipeline centerline.

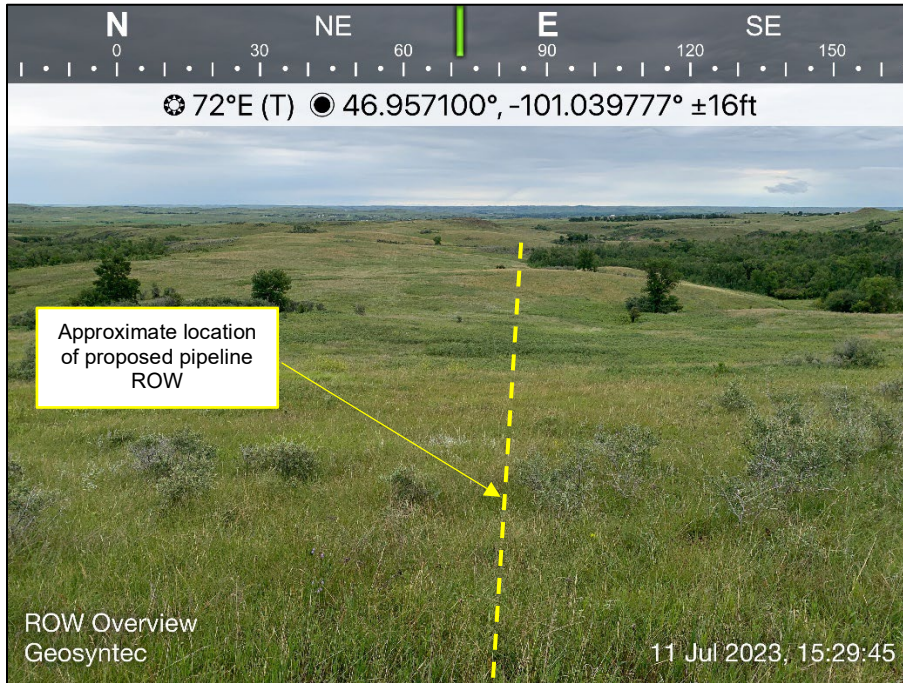
View to the east downslope along the proposed pipeline ROW. No apparent landslide morphology is visible in the photo. The proposed pipeline centerline is approximated by the yellow dashed line.

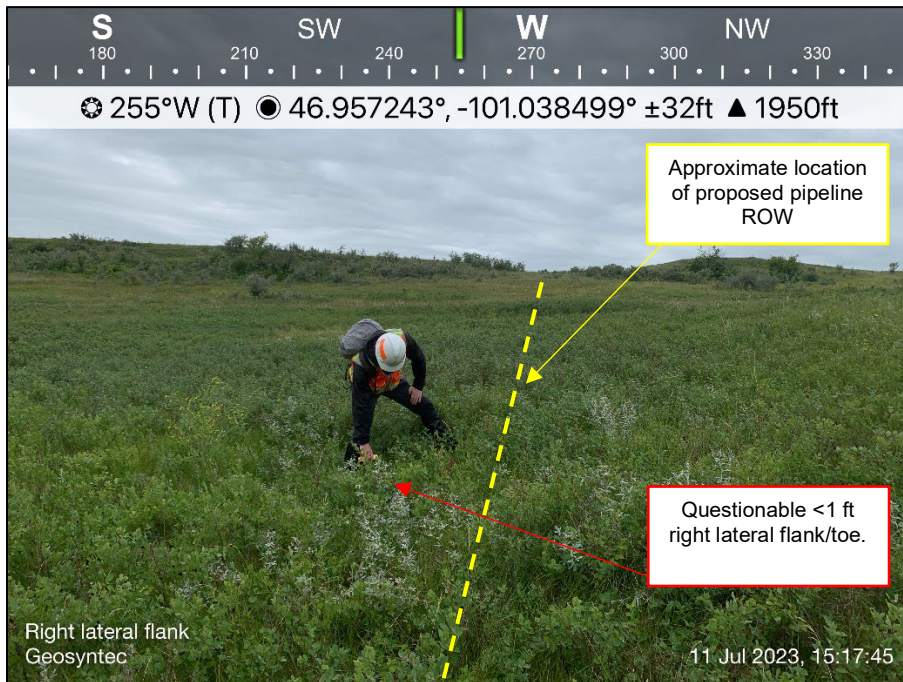
View looking upslope to the west along the proposed ROW. Geosyntec personnel is approximating the height of the questionable right lateral/toe where crossing the proposed pipeline centerline. The proposed centerline is approximated by the yellow dashed line.

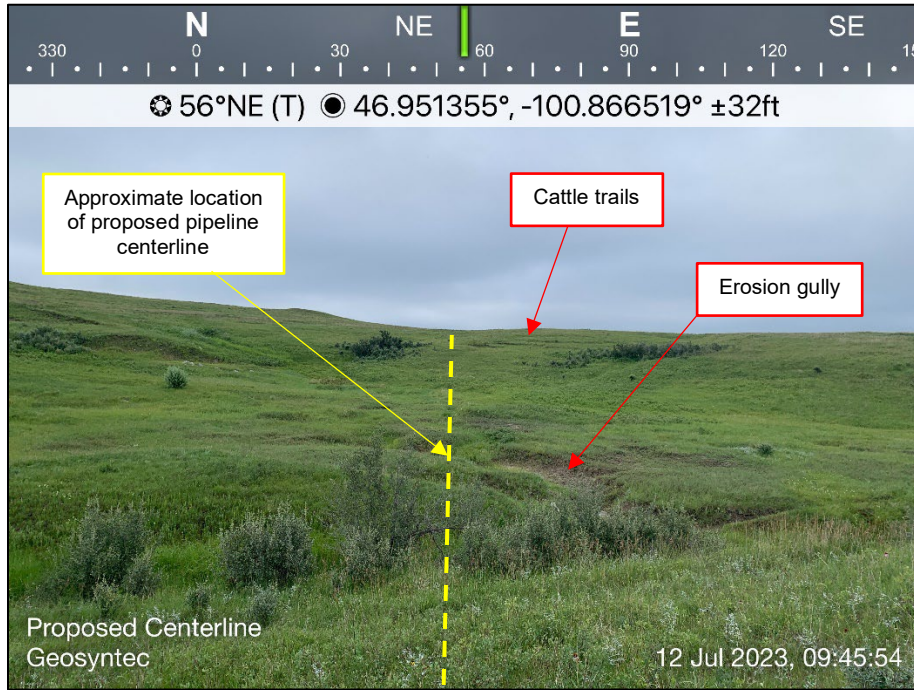
View northeast along the proposed pipeline centerline with erosion visible in the foreground of the image. To the right of the proposed centerline near the crest of the slope are cattle tracks. The proposed pipeline centerline is approximated by the dashed yellow line.

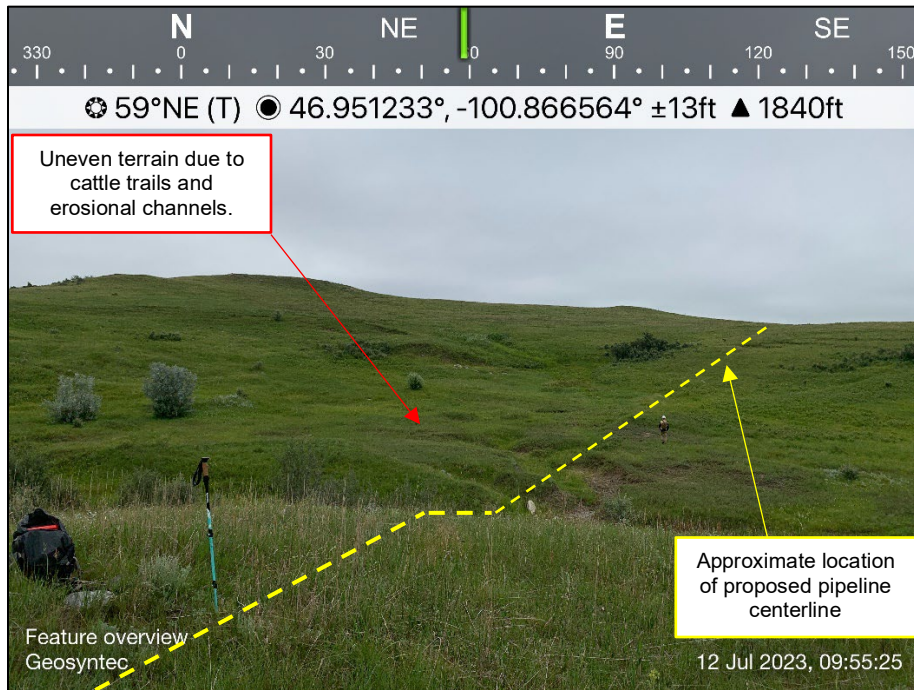
View northeast of the overall site with Geosyntec personnel for scale. The proposed pipeline centerline is approximated by the dashed yellow line.

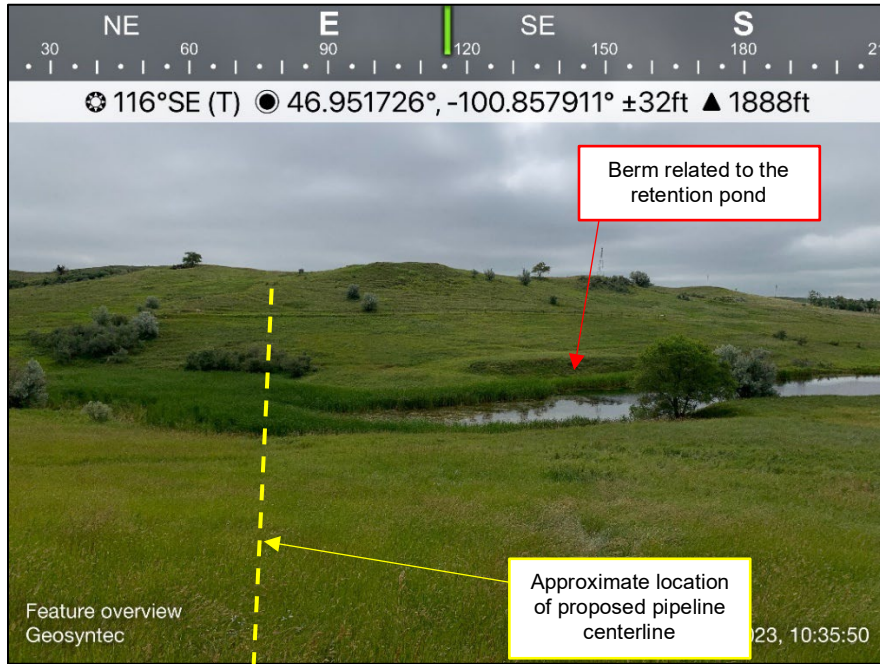
View of the overall slope looking southeast from the opposite slope. The terrain crossed by the proposed pipeline centerline appeared as a generally smooth and gradual slope with no evidence of landslide morphology exhibited. Multiple cattle trails traversed the slope and there was a distinct berm constructed to the south of the ROW. The proposed pipeline centerline is approximated by the dashed yellow line.

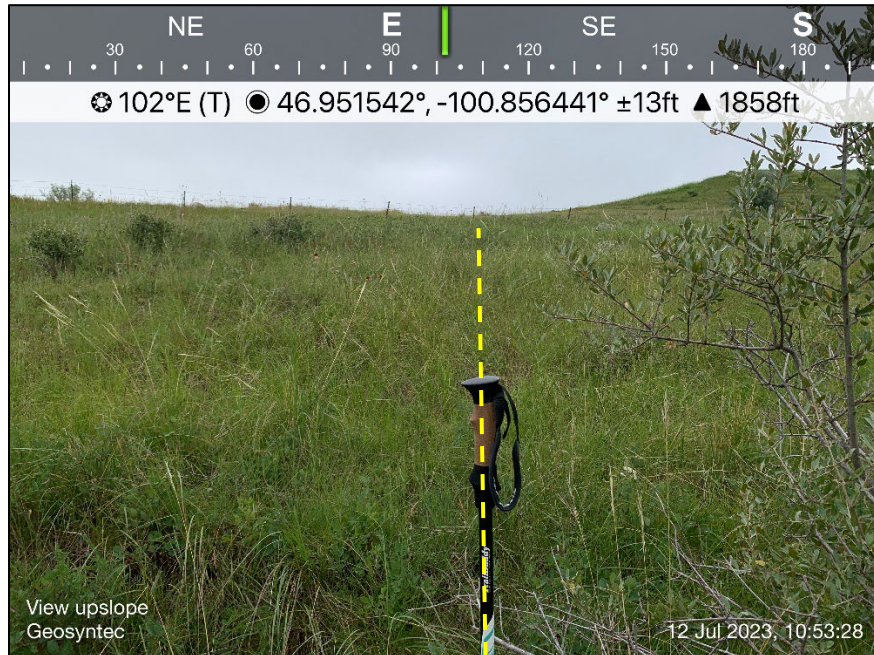
View facing east and upslope along the proposed pipeline centerline from within the mapped boundary. The slope was generally smooth and uniform with no observed geomorphic indicators of a landslide headscarp. The proposed pipeline centerline is approximated by the dashed yellow line.

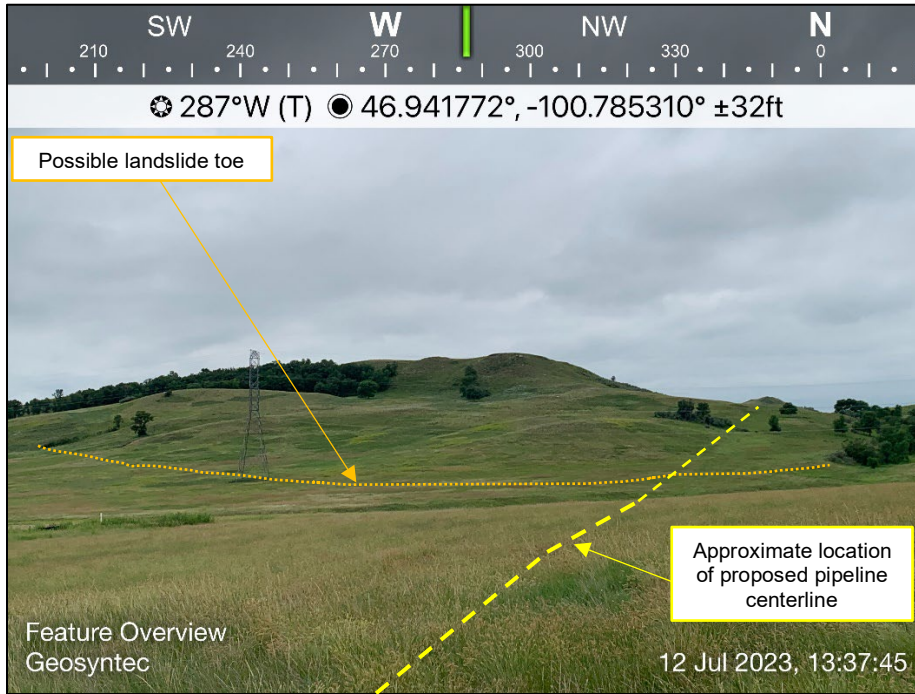
Overview of the possible landslide complex looking west. The possible features of the landslide were large in scale but rounded and subdued. The proposed pipeline centerline is approximated by the dashed yellow line.

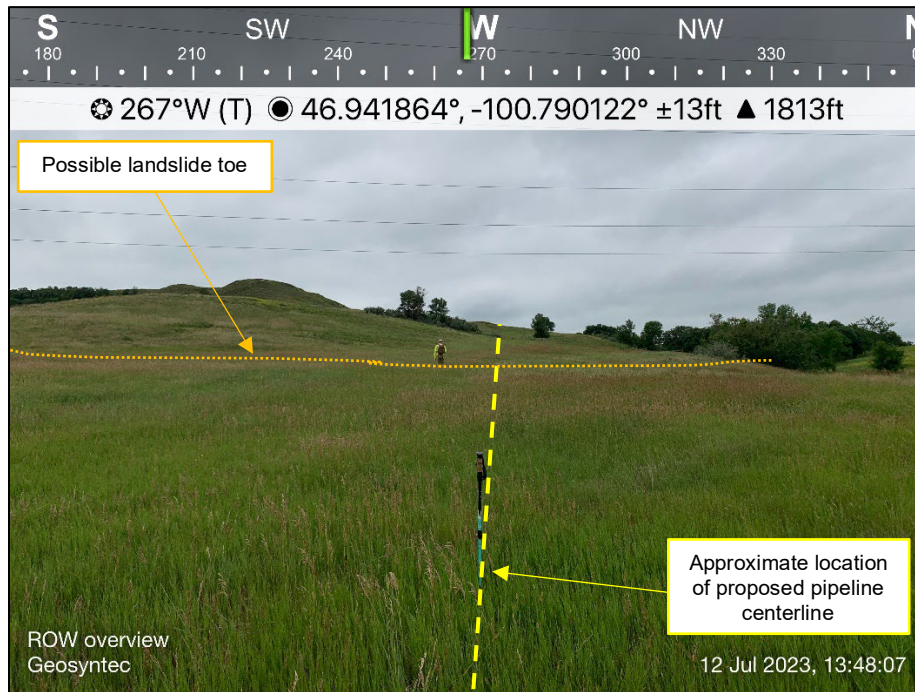
View facing west along the proposed pipeline centerline with the mapped landslide toe visible in the background. The proposed pipeline centerline is approximated by the dashed yellow line.

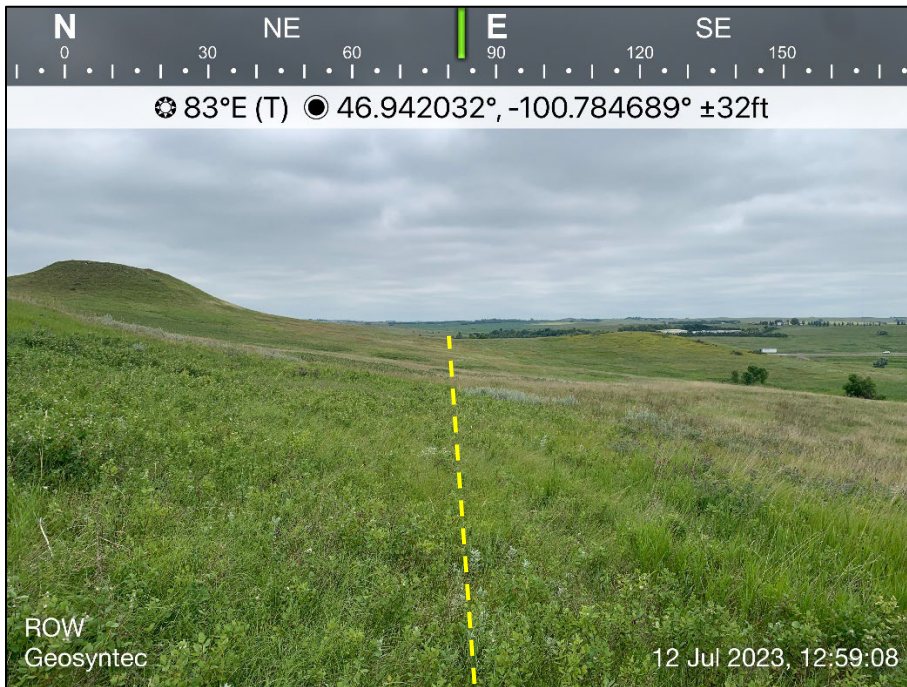
View facing east along the proposed pipeline centerline. The area is a generally smooth and gradual side slope with no discernible landslide morphology. The proposed pipeline centerline is approximated by the dashed yellow line.

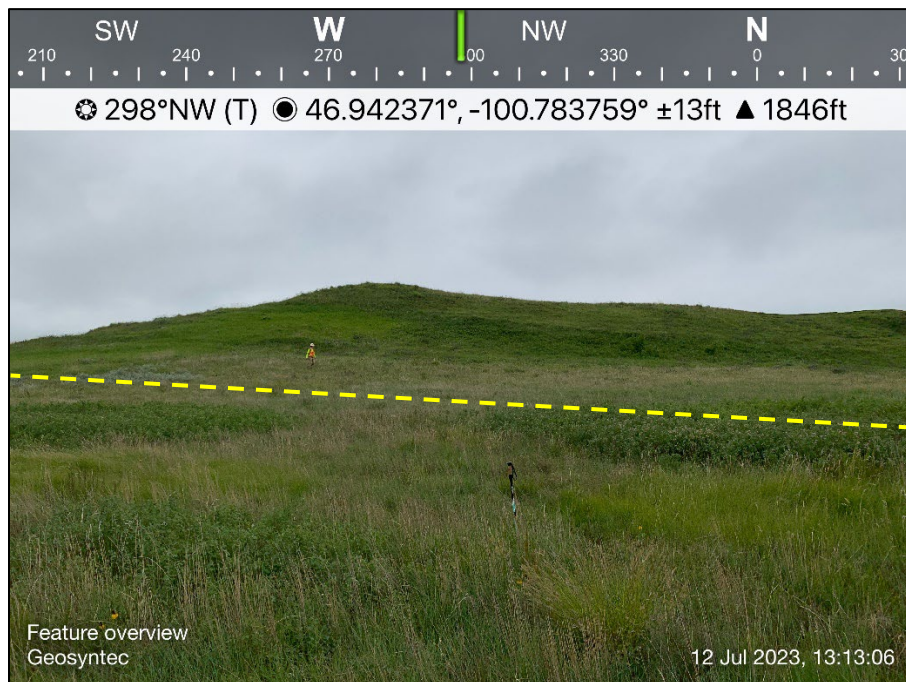
View facing northwest and upslope across the proposed pipeline centerline. No discernible landslide morphology was observed as the slope increases in steepness towards the ridgetop. The proposed pipeline centerline is approximated by the dashed yellow line.

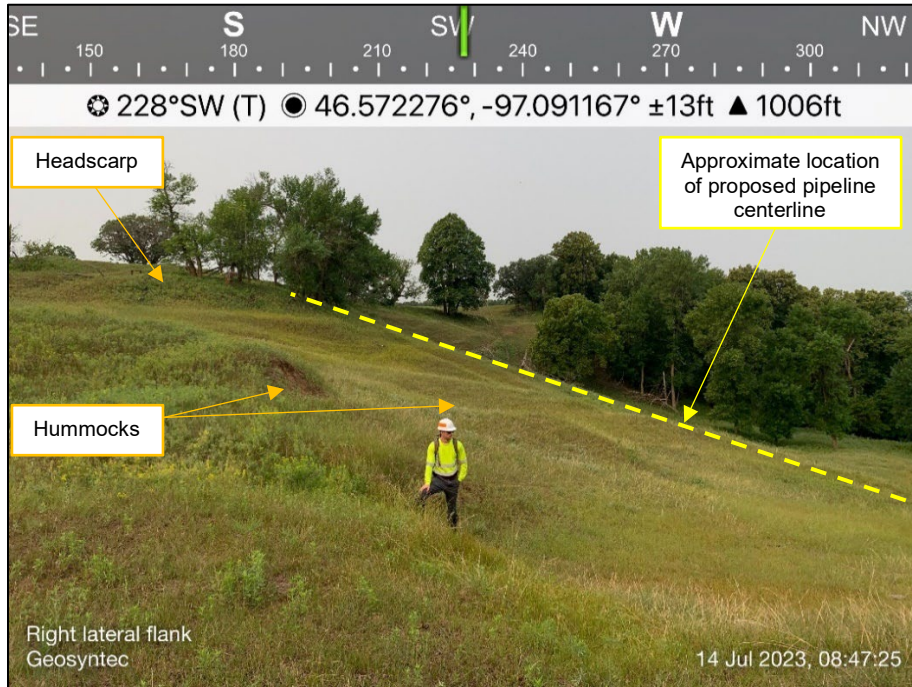
View facing southwest overlooking the landslide with the 4- to 10-foot-high headscarp slope and 4-foot-high hummocks visible in the background. The proposed pipeline centerline is approximated by the dashed yellow line.

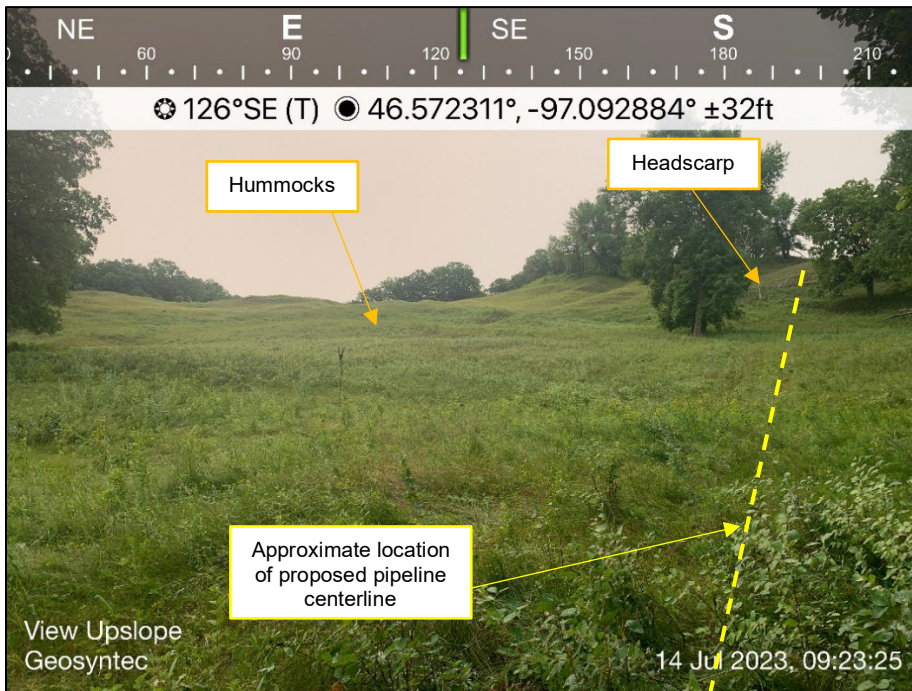
View facing southeast looking upslope along the proposed pipeline centerline with the 4- to 10-foot-high headscarp slope and 4-foot-high hummocks visible in the background. The proposed pipeline centerline is approximated by the dashed yellow line.

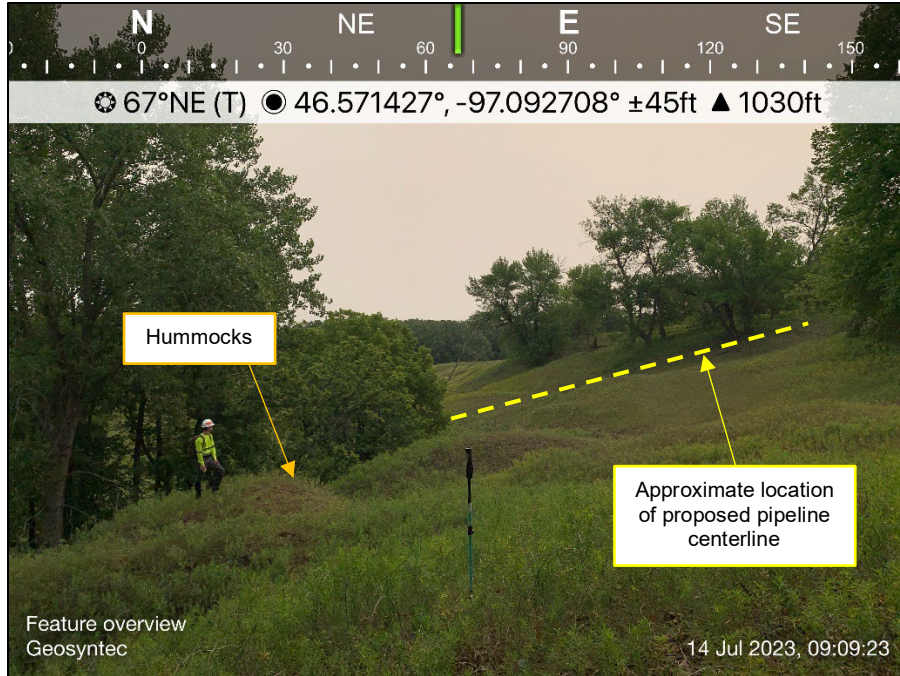
View facing northeast across the slope towards the proposed pipeline centerline. Hummocks visible in the foreground have been modified and exaggerated by cattle traffic and erosion. The proposed pipeline centerline is approximated by the dashed yellow line.

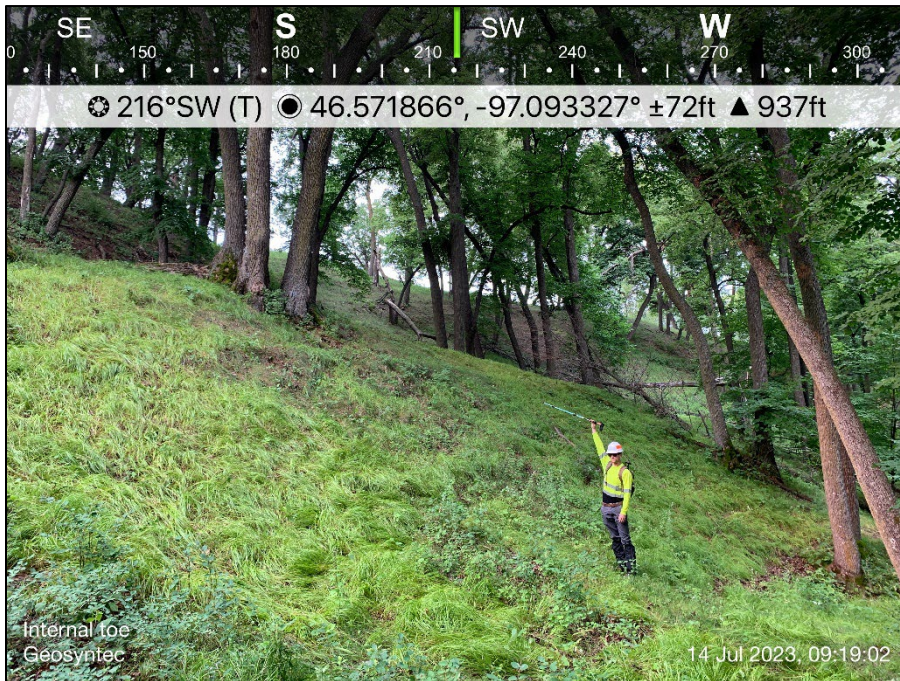
View facing southwest at an internal landslide toe that was approximately 10 feet high and located approximately 150 feet west of the proposed pipeline centerline.

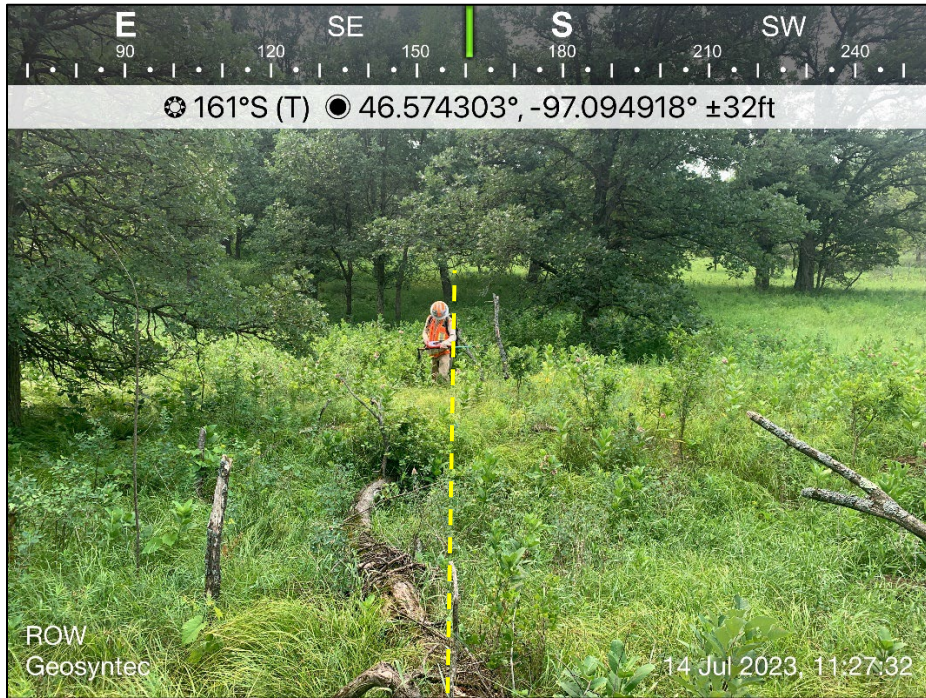
View facing south along the proposed pipeline centerline. The site consisted of a gradual and smooth slope with no evidence of landslide disturbance. The proposed pipeline centerline is approximated by the dashed yellow line.

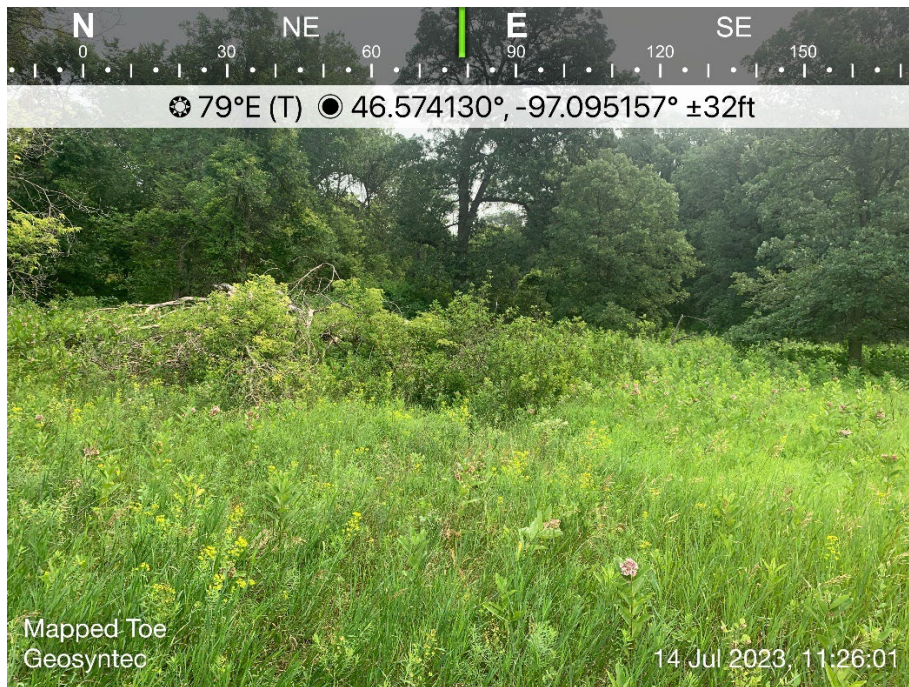
View facing east at the mapped toe which corresponded with a mound of material that did not appear consistent with a landslide toe and may be related to differential weathering of the underlying geologic material.

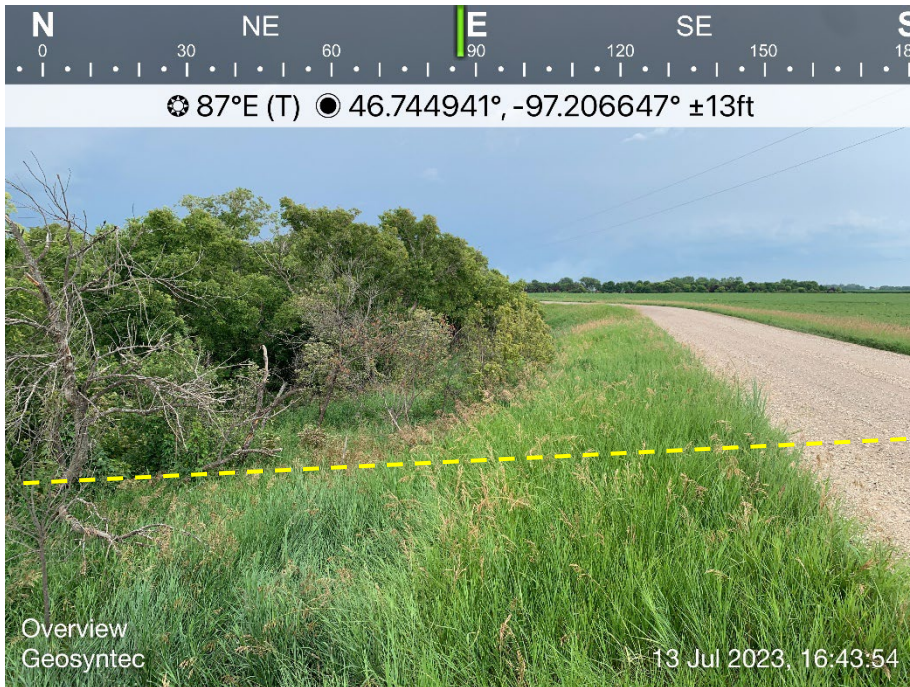
Looking east along the slope in the vicinity Site #14. The approximate proposed pipeline centerline is located near the center of the image (dashed yellow line). The proposed pipeline centerline crosses a possible recently active bank slump in the left portion of the image. Note the road was undisturbed.

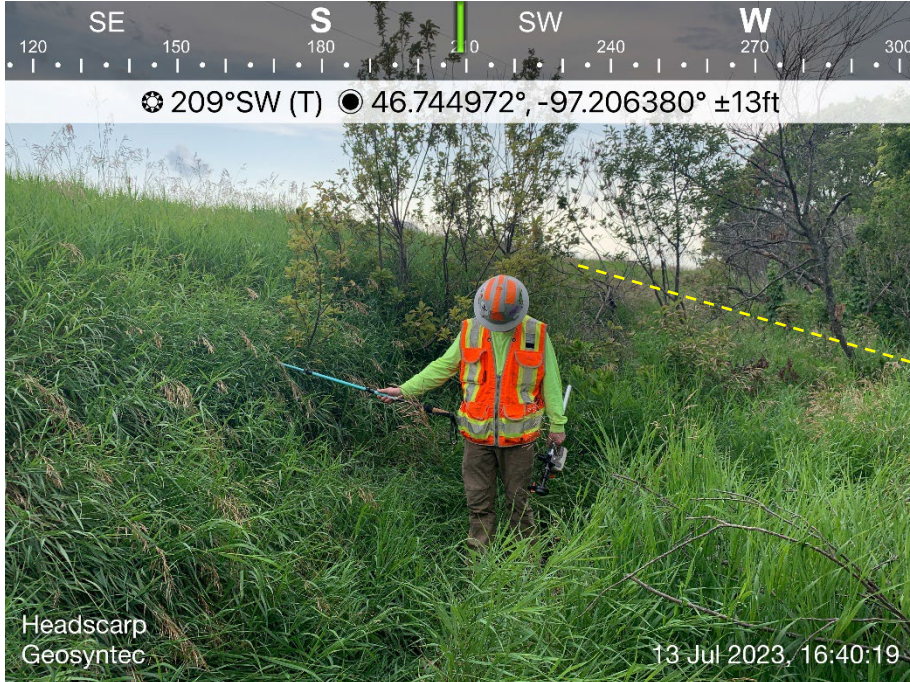
Looking southwest at a possible 3-foot high headscarp crossed by the proposed pipeline centerline. The approximate location of the proposed pipeline centerline is represented by the dashed yellow line.

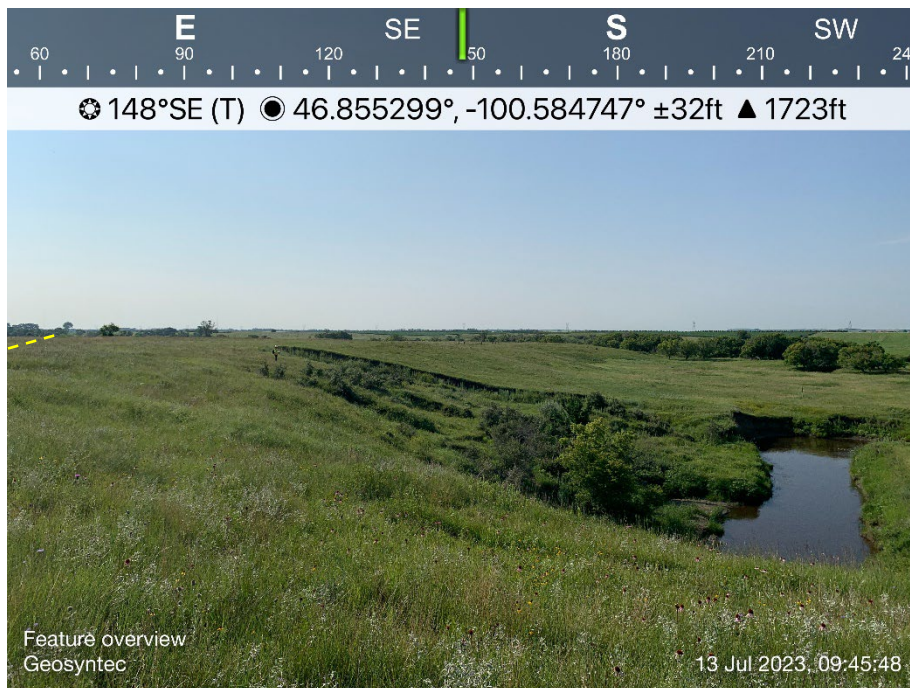
Looking southeast towards Site #15 mapped by the NDGS where recently active landslide morphology was observed approximately 98 ft from the proposed pipeline centerline. The approximate proposed pipeline is located at the far left of the image (dashed yellow line).

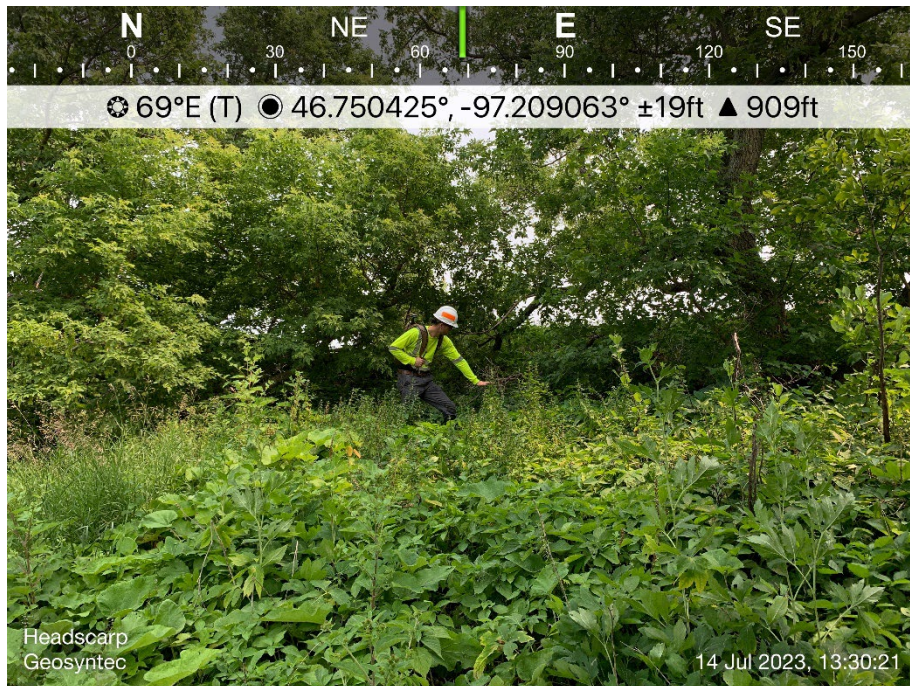
Looking northeast at the possible 3-foot high headscarp of the inactive bank slump at Site #17. The approximate proposed pipeline is located beyond the crest of the slope in a cultivated farm field.

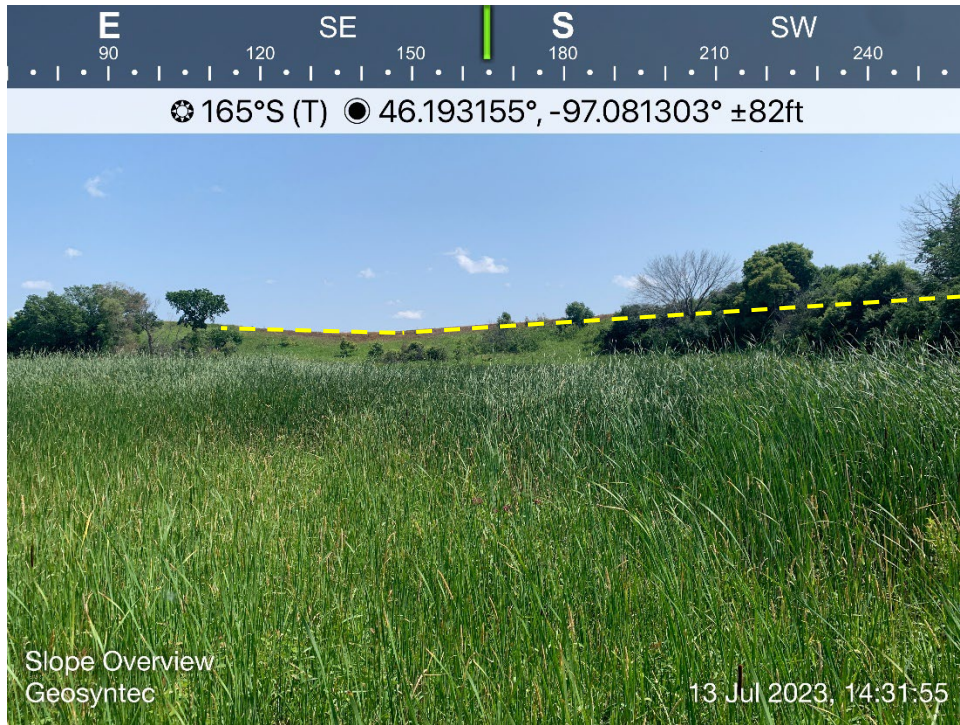
Looking south across the slope in the vicinity NDT-211 (MP 3.5-3.7). The approximate proposed pipeline is located in the center of the image (dashed yellow line). No landslide morphology was observed in the vicinity of the proposed pipeline.

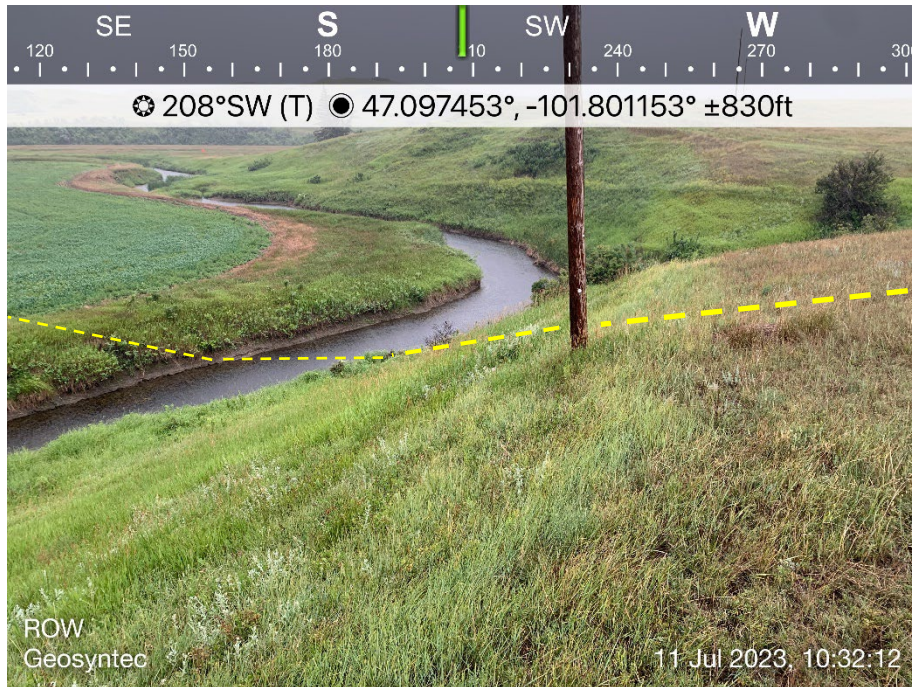
Looking southwest across the slope in the vicinity NDL-325B (MP 4.6-4.7). The approximate proposed pipeline is located in the center of the image (dashed yellow line). No landslide morphology was observed in the vicinity of the proposed pipeline.

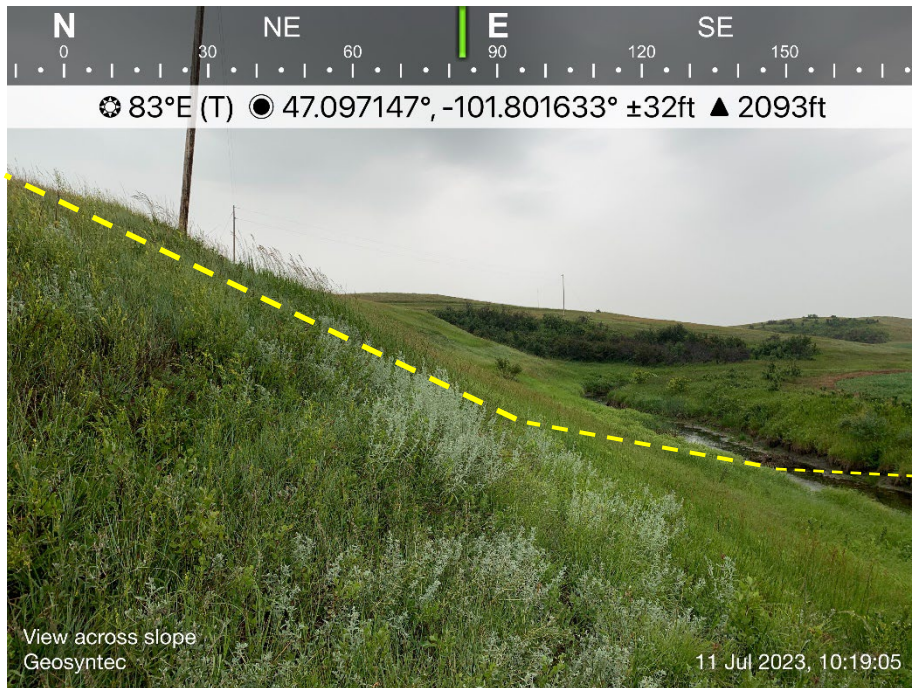
Looking east across the slope in the vicinity NDL-325B (MP 4.6-4.7). The approximate proposed pipeline is located in the center of the image (dashed yellow line). No landslide morphology was observed in the vicinity of the proposed pipeline.

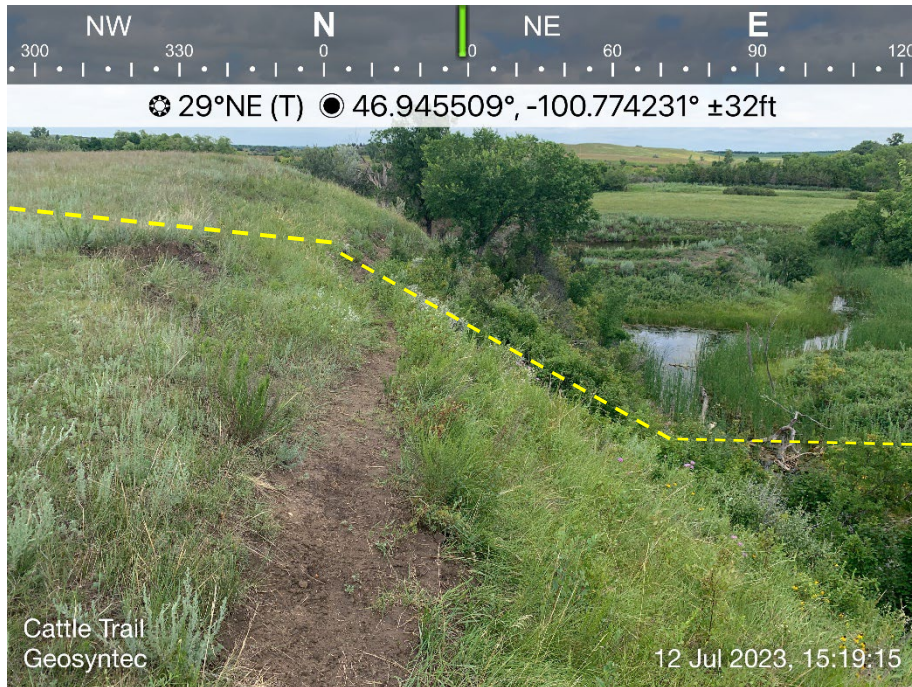
View across slope looking towards the north. The approximate proposed pipeline crosses the center of the image (dashed yellow line). A cattle trail is shown in the center of the photo.

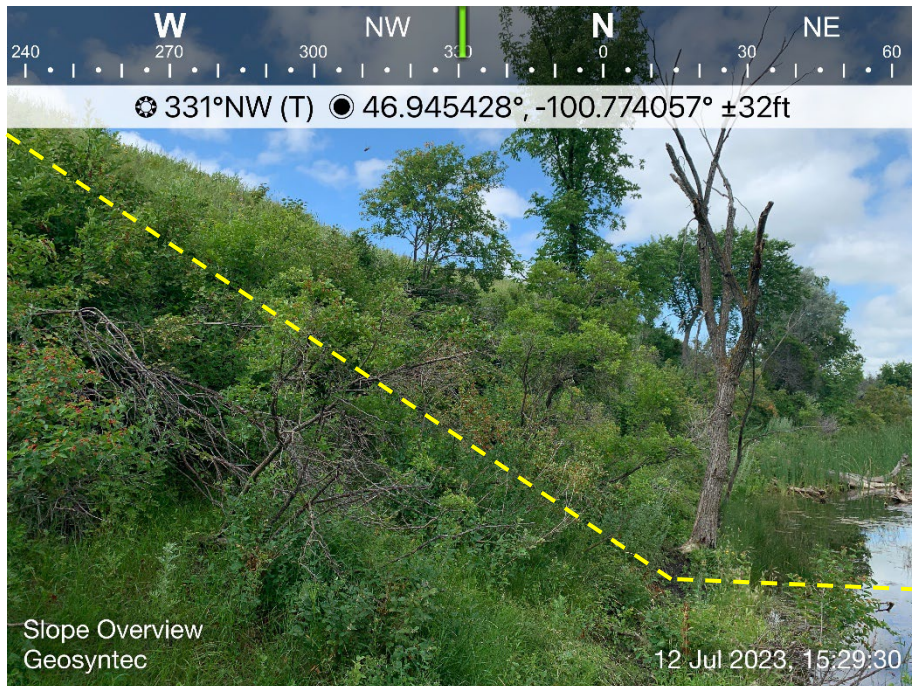
View across slope looking towards the north-northwest. The approximate proposed pipeline crosses the center of the image (dashed yellow line). The observed oxbow lake is located along the right side of the image.

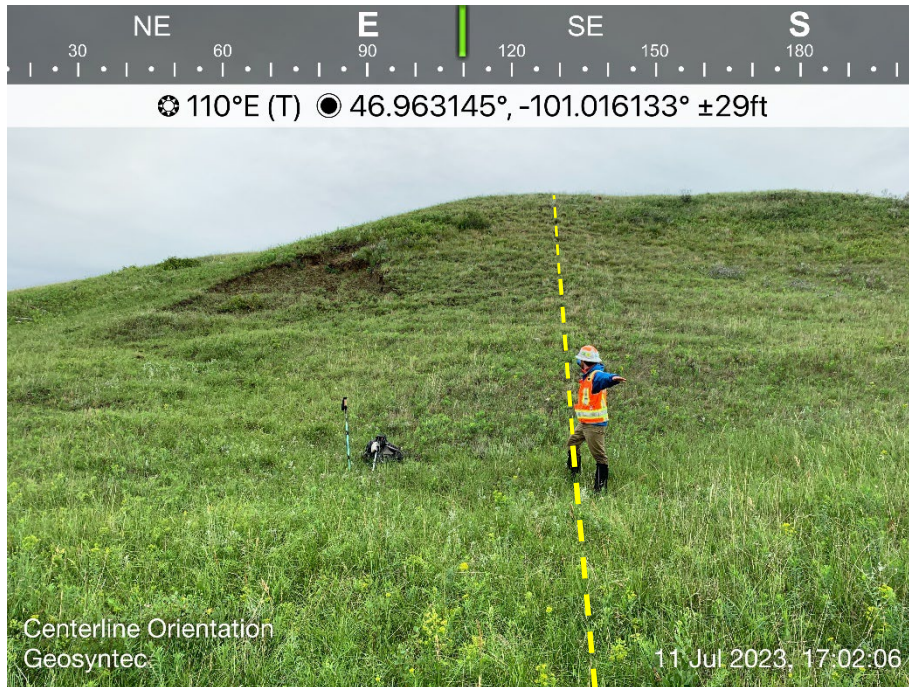
Looking east-southeast along the slope in the vicinity NDM-106 (MP 145.3-145.4). The approximate proposed pipeline is located along center right of the image (dashed yellow line). Recently active shallow landslide morphology was observed approximately 20 ft from the proposed pipeline centerline.

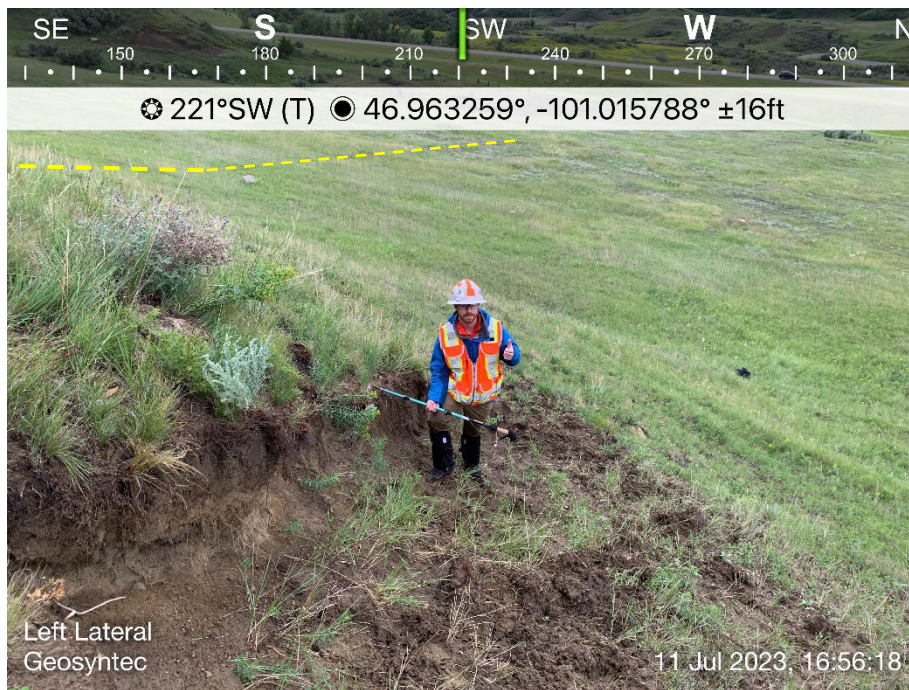
Looking southwest at the left lateral flank of the recently active shallow landslide. The approximate proposed pipeline is located along top left of the image (dashed yellow line). Recent cattle activity had exposed bare soil within the landslide.

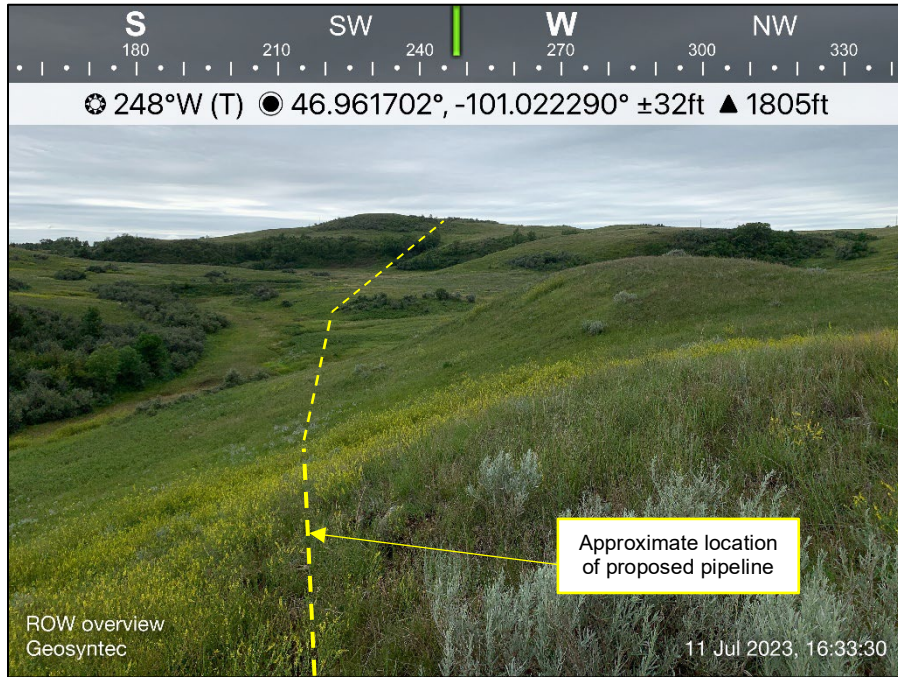
Looking southwest along the slope in the vicinity NDM-106 (MP 145.7-145.8). The approximate proposed pipeline is located along center left of the image (dashed yellow line). No landslide morphology was observed in the vicinity of the proposed pipeline.

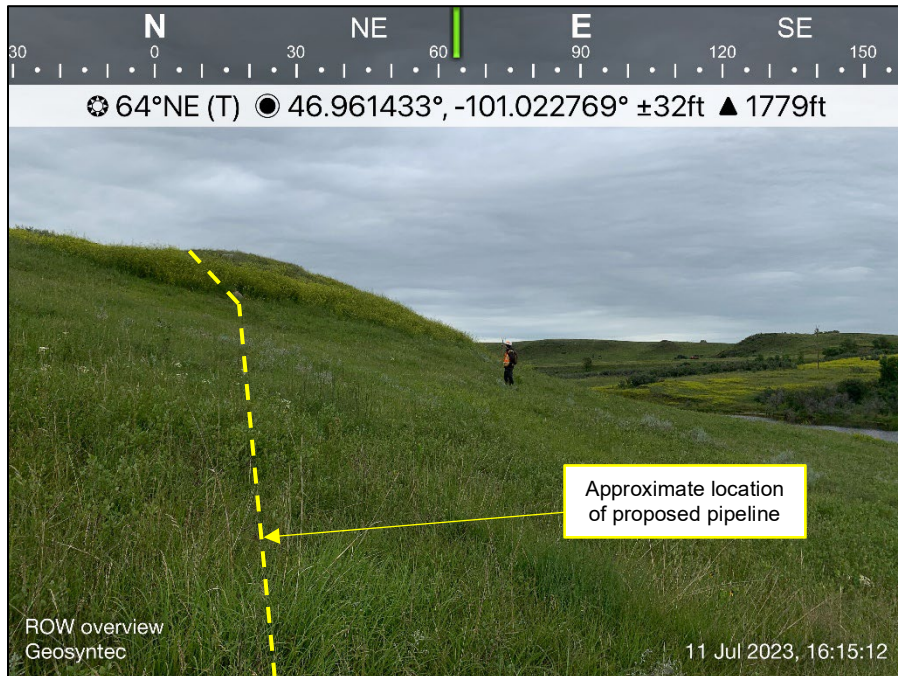
Looking northeast in the vicinity NDM-106 (MP 145.7-145.8) and along the proposed pipeline alignment, which climbs the ridgeline and appeared to be in good condition at the time of visit. The approximate proposed pipeline is located along center left of the image (dashed yellow line). No landslide morphology was observed in the vicinity of the proposed pipeline.
