In the Matter of the Application of SCS Carbon Transport LLC for Certificate of Corridor Compatibility and Route Permit for the Midwest

Case No.: PU-22-391

# DIRECT TESTIMONY OF JACK WILLINGHAM

A. I am sponsoring Willingham Direct Exhibit 1, which is a copy of the May 26, 2022, PHMSA Failure Investigation Report related to the CO2 pipe rupture in Satartia, Mississippi, that occurred in February 2020. I am also sponsoring Willingham Direct Exhibit 2, which is a statement from the Shelby County Iowa Board of Health, as an exemplar of County concerns and issues that can confront any county, detailing its public health concerns related to pressurized CO2; Willingham Direct Exhibit 3 is a true and accurate copy of my live sworn testimony during the Iowa IUB hearing; Willingham Direct Exhibits 4 and 5 are true and accurate recordings of 911 emergency calls my department received during the Satartia CO2 pipeline rupture. Willingham Direct Exhibit 6 is testimony filed with the IUB from Debrae Burns, regarding his experience being exposed to CO2 during the 2020 pipe rupture.

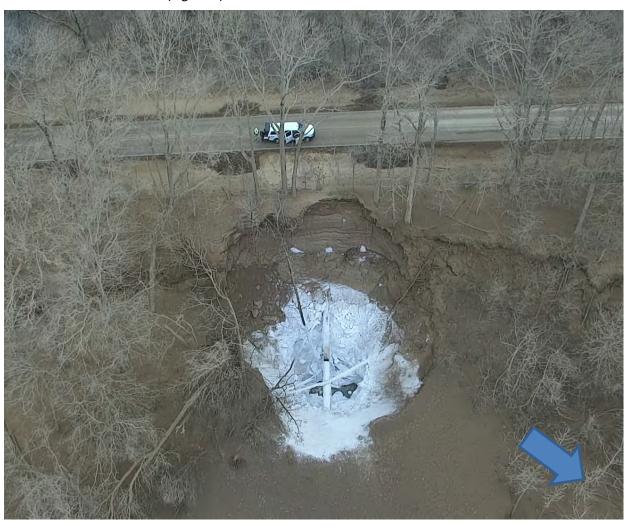
Figure 2: Vehicle is Parked on HWY 433 - The White is Ice Generated by the Release of CO<sub>2</sub> - The Blue Arrow Points North (Aerial Drone Photograph Courtesy of the Mississippi Emergency Management Agency)

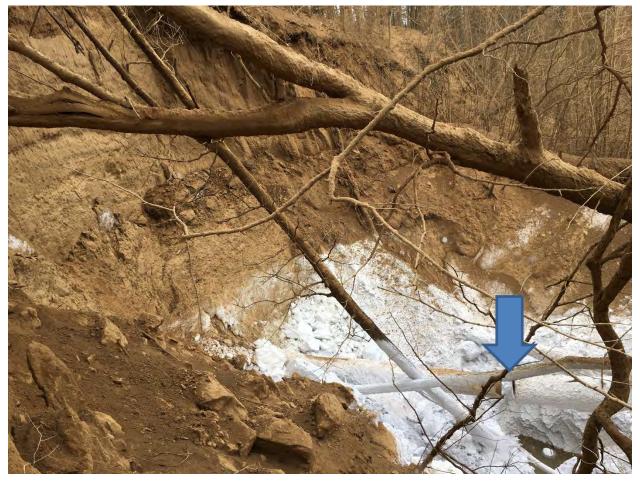
Figure 3: Crater Created by the Rupture Containing Fallen Debris (dry ice, and the failed pipe sections)
(Blue Arrow is Pointing at the Pipeline Separation)

The pipeline separated at a girth weld. The pipeline self-excavated due to the discharge of  $CO_2$ . The auto refrigeration generated by the  $CO_2$  discharge and accompanying chance in phase covered the area with a thick layer of ice (Figures 2, 3, and 4). The upstream section of pipe was not covered in ice, and a slightly jagged edge was observed on the rupture edge (Figure 4). The crater was an estimated 40-feet-deep on the downstream (HWY 433) side and about four-feet-deep on the upstream side.

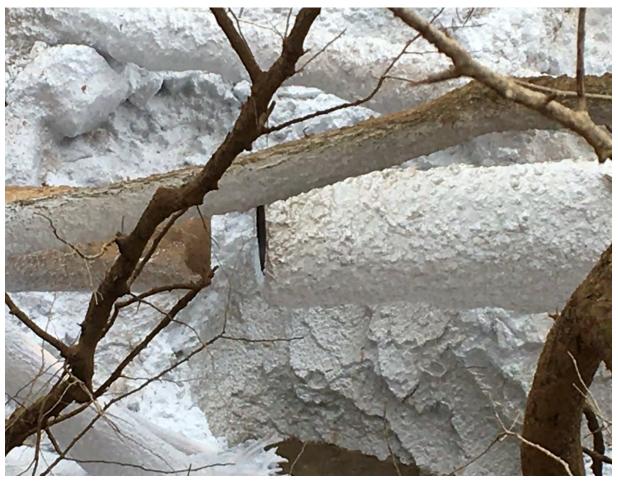
Figure 4: The failed pipe sections shown separated by a few inches.

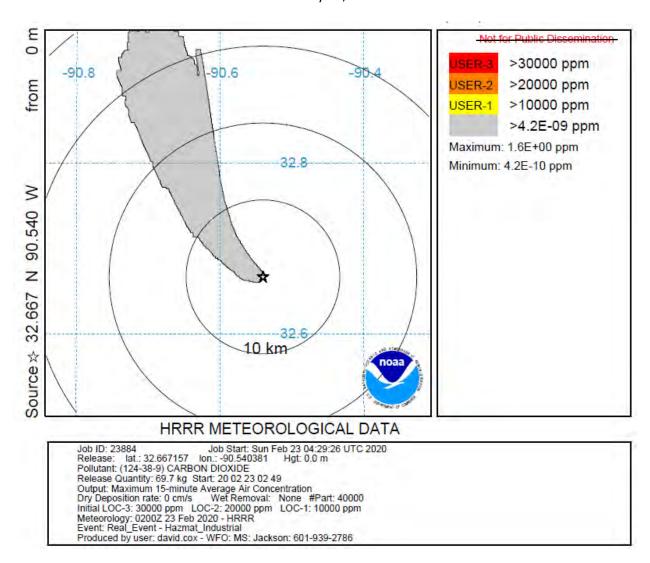
Figure 5: This Chart Shows the Plume Model Data Generated by the National Weather Service/NOAA - The Model Indicates the Direction a Plume or Cloud of CO<sub>2</sub> Would Have Followed from Ground Level While Dissipating, According to Atmospheric Data at the Time of the Release - Each Ring is 10 Kilometers (Satartia is Less Than Two Kilometers Northwest of Release Site, Indicated by the Star)<sup>8</sup>

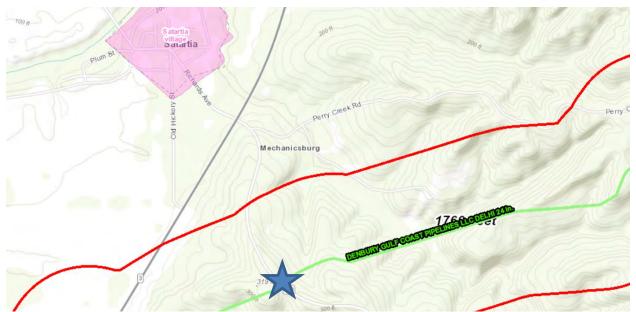
Prior to the accident in 2011, Denbury had contracted a third-party company to generate an affected radius model for a potential CO<sub>2</sub> release. Denbury used the model to generate a zone along the pipeline ROW to identify pipeline segments which were within or "could affect" an HCA and to develop its Public Awareness Program (PAP). The model established a zone for the Delhi Pipeline (Figure 6) that left Satartia outside of the affected radius, and therefore the pipeline segment was not identified by Denbury as a "could affect" HCA. Additionally, Satartia was not included in Denbury's PAP or considered in any local

emergency response plans. The rupture location was one mile from the center of Satartia, where the entire town was evacuated.

Figure 6: Topographical Map Showing the Delhi Pipeline (Green) and Denbury's Buffer Zone (Red) on Either Side of the Pipeline and the Proximity to Satartia (Blue Star Indicates the Rupture Site)

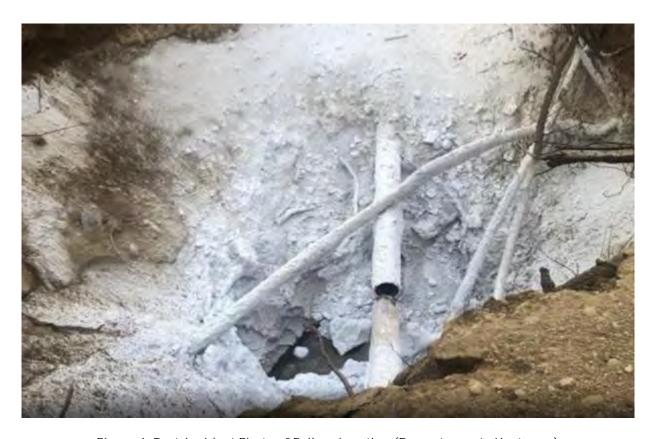
Figure 4. Post-Incident Photo of Failure Location (Downstream to Upstream)

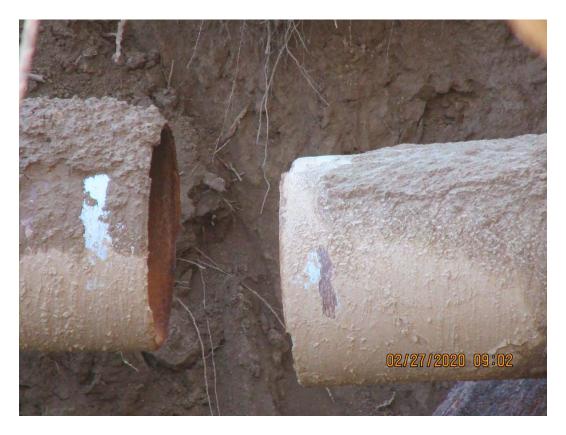
Figure 8. Delhi 24-inch Transmission Line Failure - As-Found Condition at Girth Weld

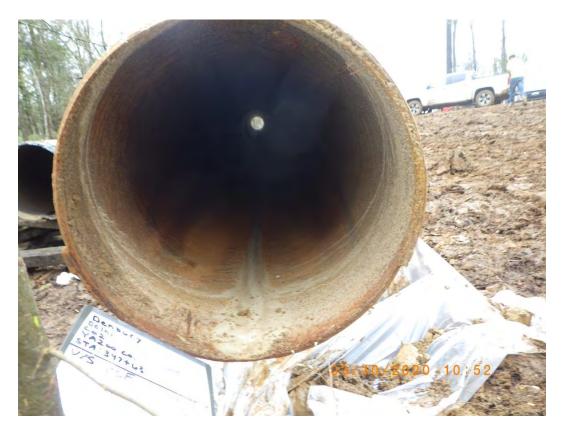
Figure 11. Internal Condition of Pipe Sample During Removal

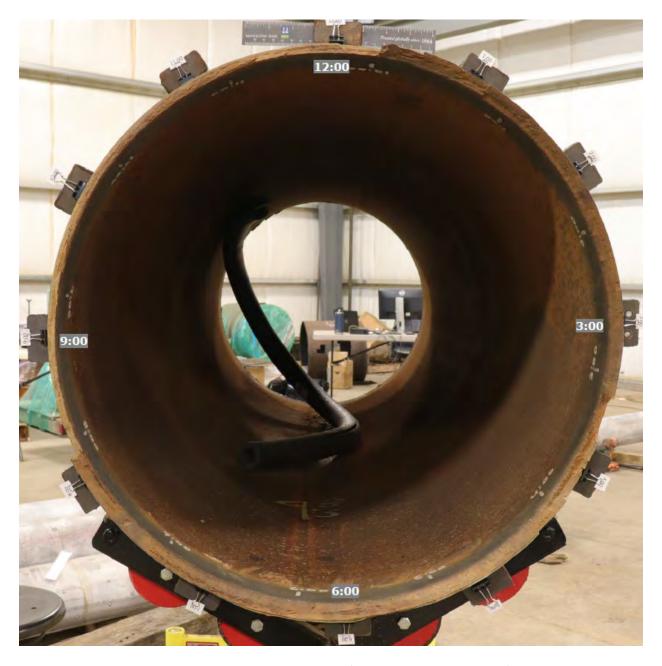
Figure 15. PS A Fracture Surface (Upstream to Downstream)

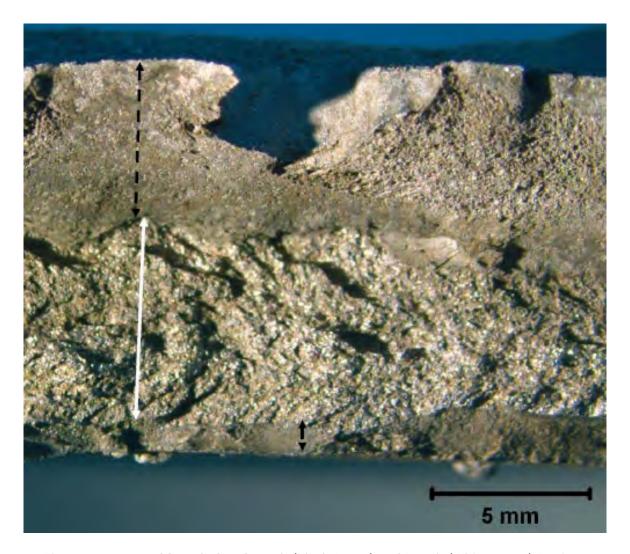
Figure 17. Image of Sample S2 - Smooth (Black Arrow) and Rough (White Arrow) Regions

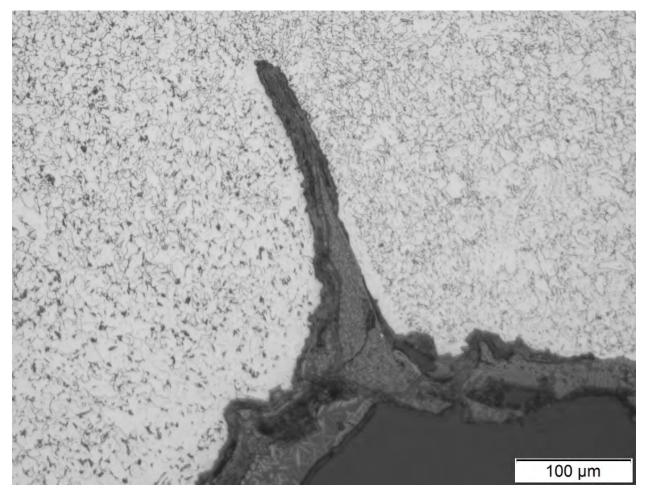
Figure 35. Close Up View of Sample MU1 Flaw

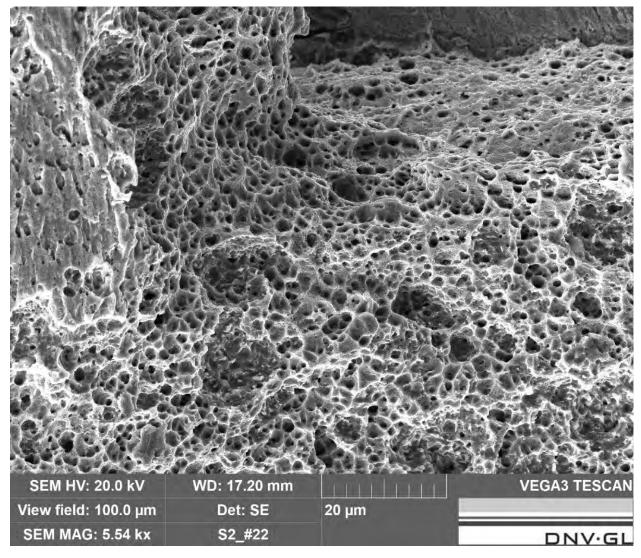
Figure 36. Sample S2 – Dimples Associated with Ductile Fracture

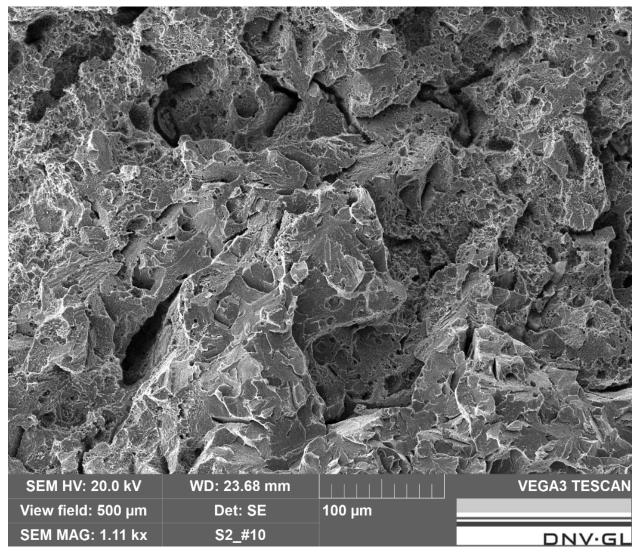
Figure 37. Sample S2 – Facets Associated with Brittle Fracture

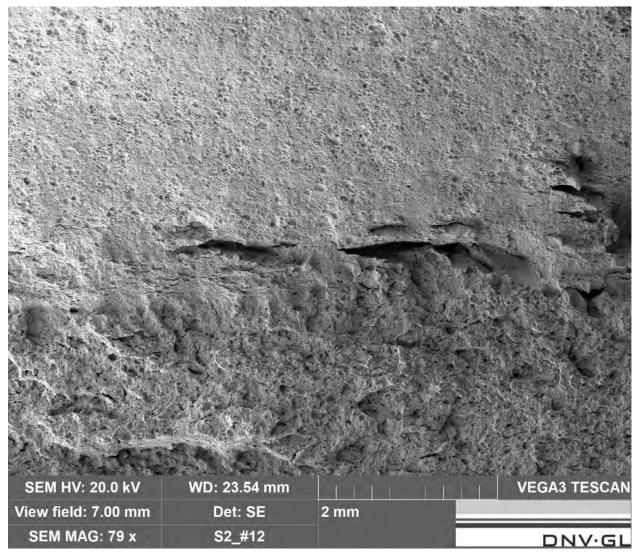
Figure 38. Sample S2 – Tears Mid-Wall (Smooth Region)

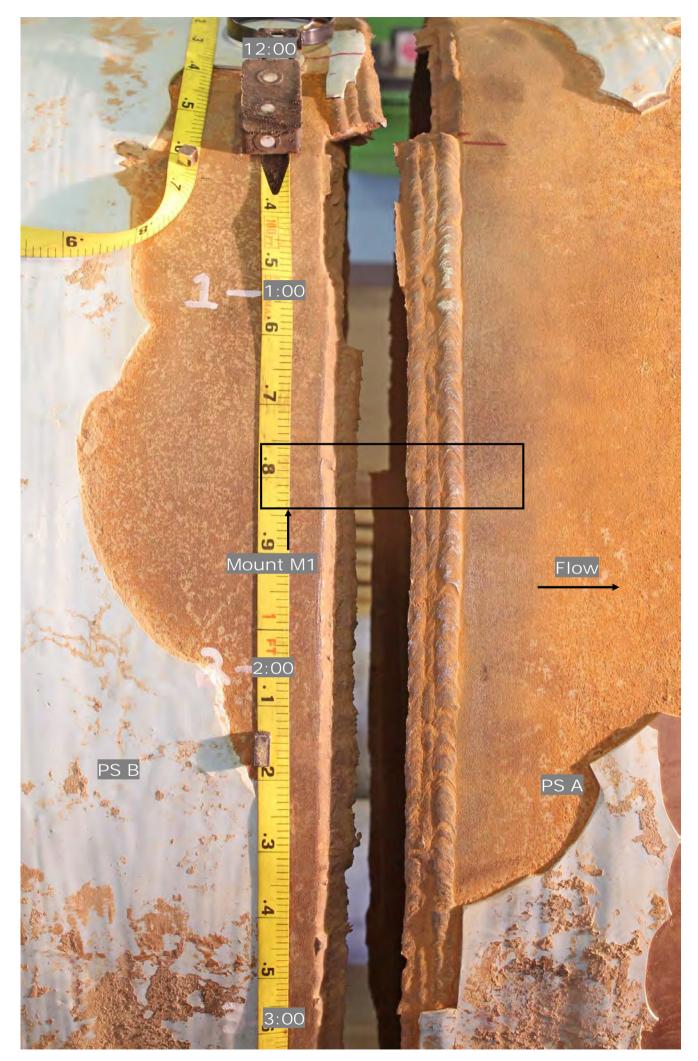
Figure 11. Photograph of the external of surfaces of PSs A and B adjacent to the fracture surfaces, between the 12 and 3 o'clock orientations, showing the failed girth weld and the morphology of the coating. The tape measure indicates the approximate distance CW of TDC (looking D/S convention).

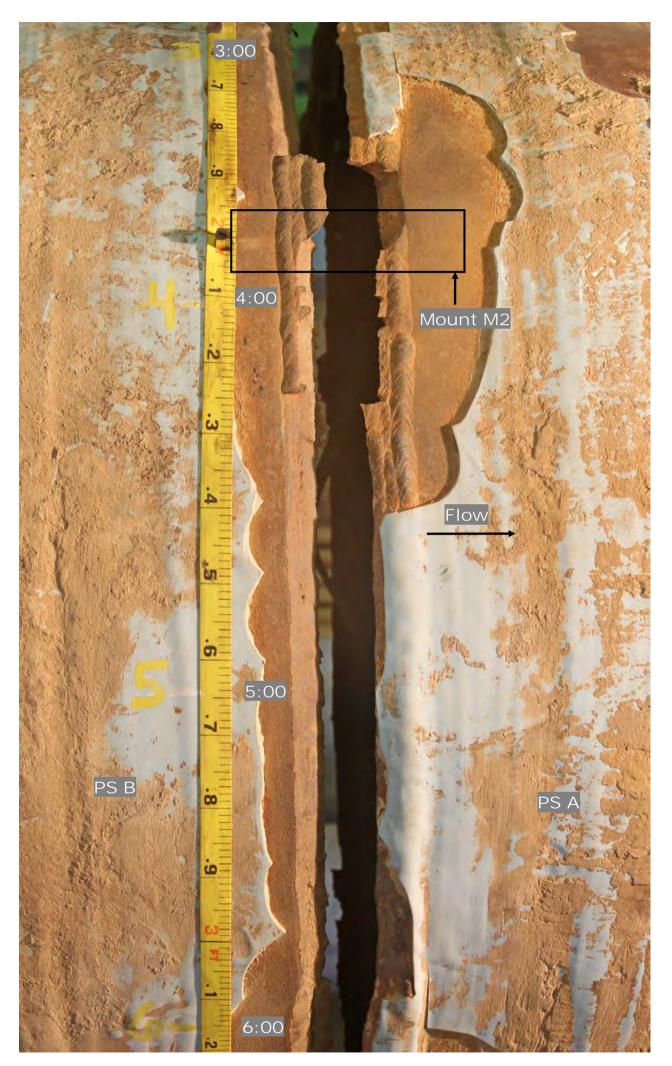
Figure 12. Photograph of the external of surfaces of PSs A and B adjacent to the fracture surfaces, between the 3 and 6 o'clock orientations, showing the failed girth weld and the morphology of the coating. The tape measure indicates the approximate distance CW of TDC (looking D/S convention).

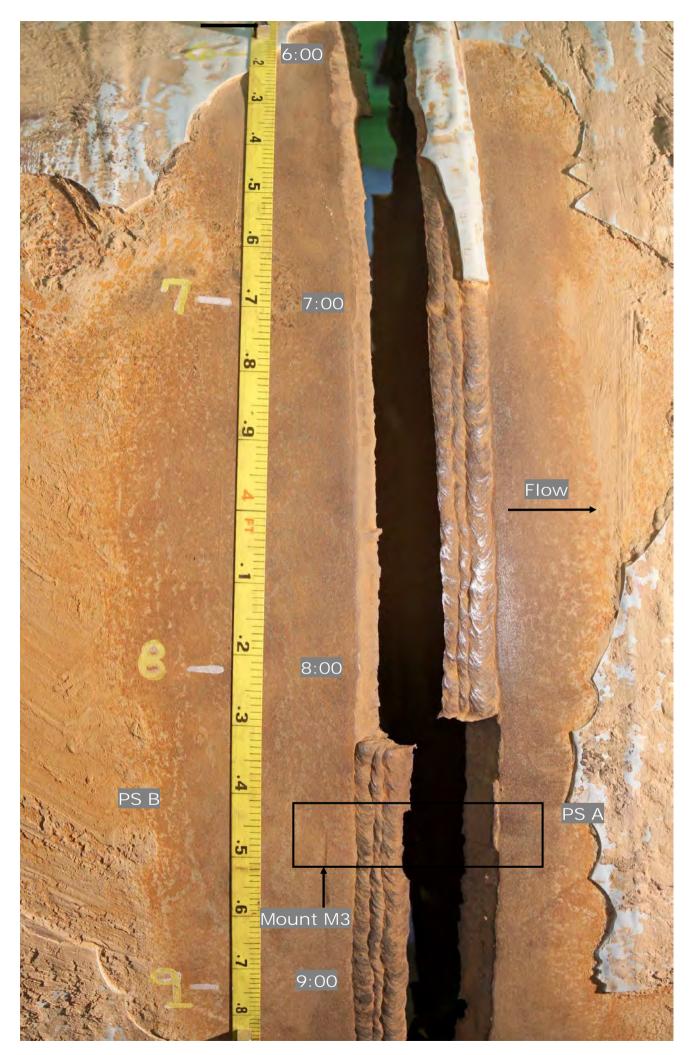
Figure 13. Photograph of the external of surfaces of PSs A and B adjacent to the fracture surfaces, between the 6 and 9 o'clock orientations, showing the failed girth weld and the morphology of the coating. The tape measure indicates the approximate distance CW of TDC (looking D/S convention).

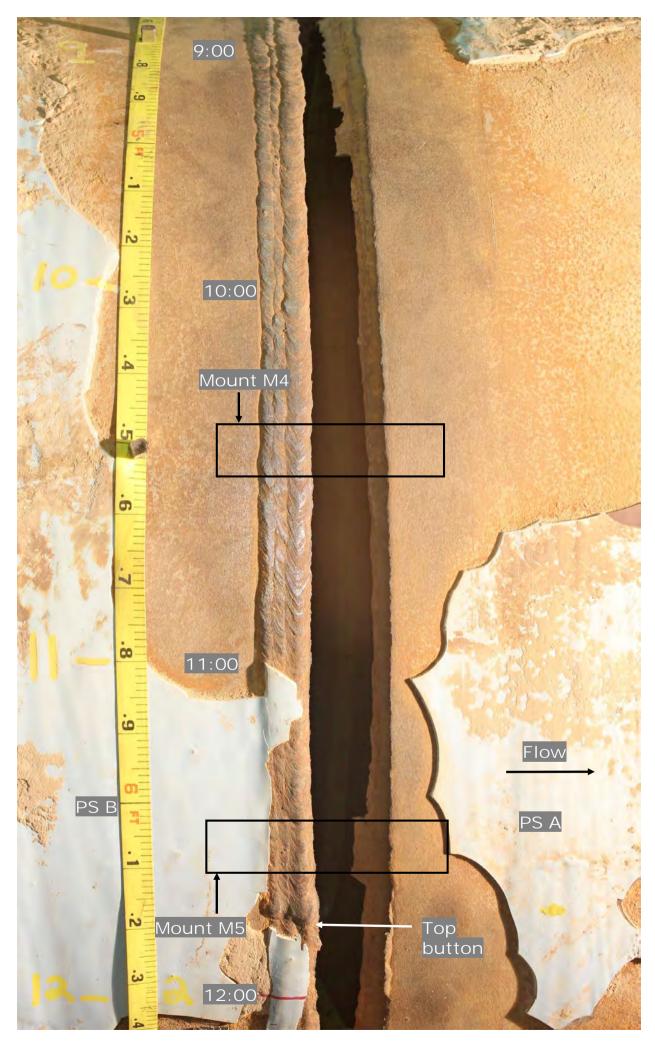
Figure 14. Photograph of the external of surfaces of PSs A and B adjacent to the fracture surfaces, between the 9 and 12 o'clock orientations, showing the failed girth weld and the morphology of the coating. The tape measure indicates the approximate distance CW of TDC (looking D/S convention).

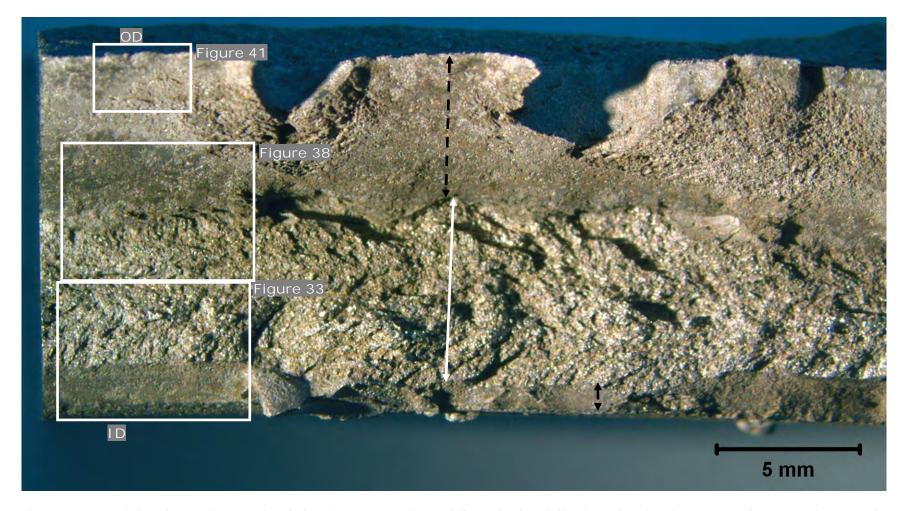
Figure 32. Light photomicrograph of the fracture surface of Sample S2, following cleaning in ENPREP® 214. The sample was removed near the 4:00 orientation from PSA; area indicated in Figure 23. The black, dashed double arrows indicate smooth regions and the white double arrow indicates a rough region.

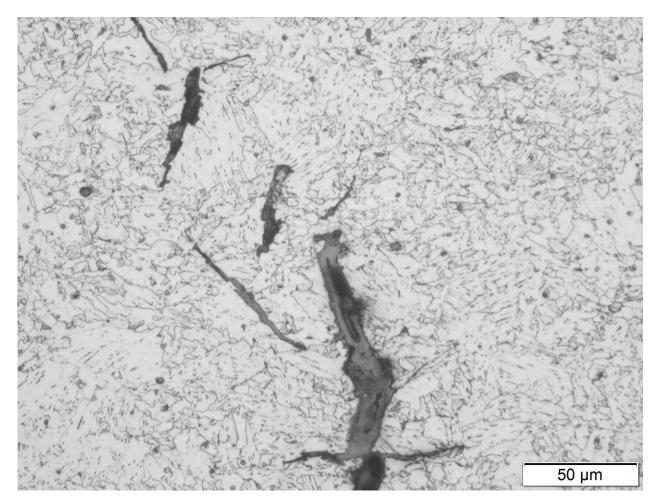
Figure 60. High magnification light photomicrograph of Mount M2 at fissures (2% Nital Etchant); area indicated in Figure 59.
