# 200 MW Oliver Wind IV Wind Energy Center Project Oliver County

## *Topsoil Inspection Report*

**Docket Number: PU-23-317**

Prepared for North Dakota Public Service Commission

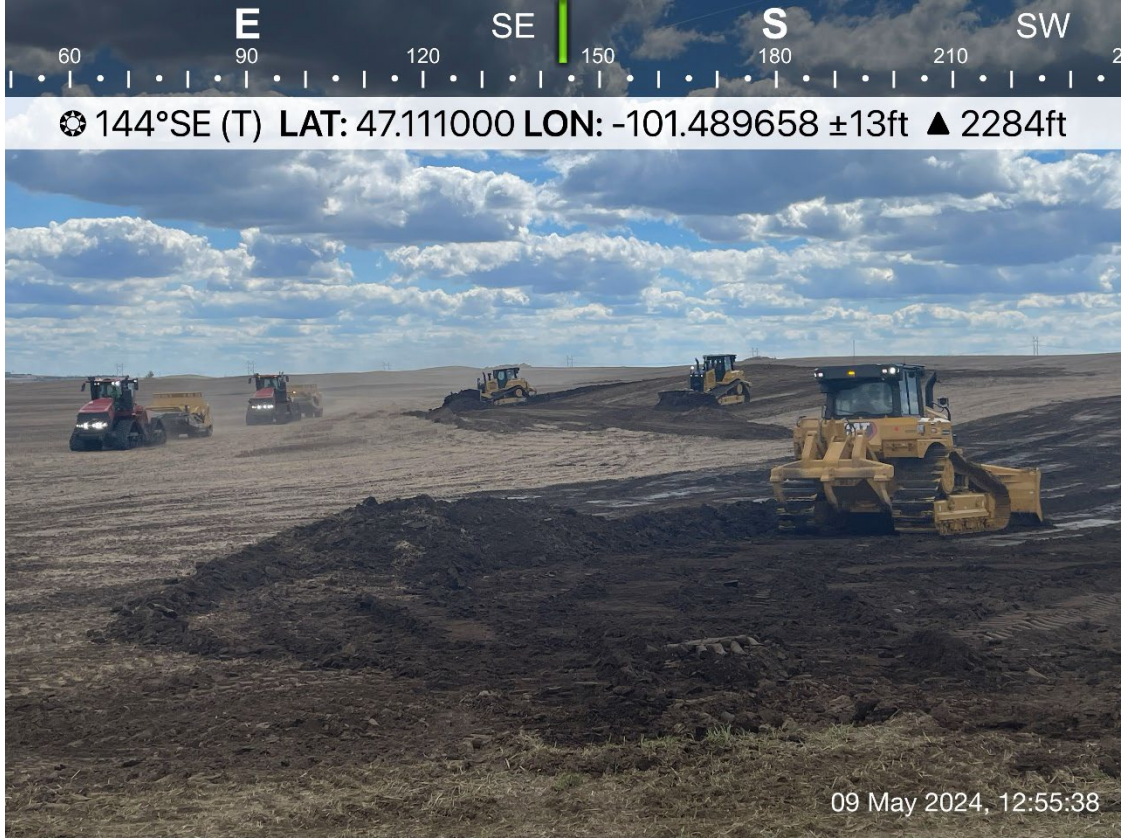
<p>Photo #: 7</p> <p>Direction: North</p> <p>Description: Subsoil layer starting to appear after topsoil was removed along west end of laydown yard site.</p> <p>Observers: Peterson/Calkins</p> <p>Date: 05/9/2024</p> <p>Latitude: 47.110454</p> <p>Longitude: -101.489630</p>

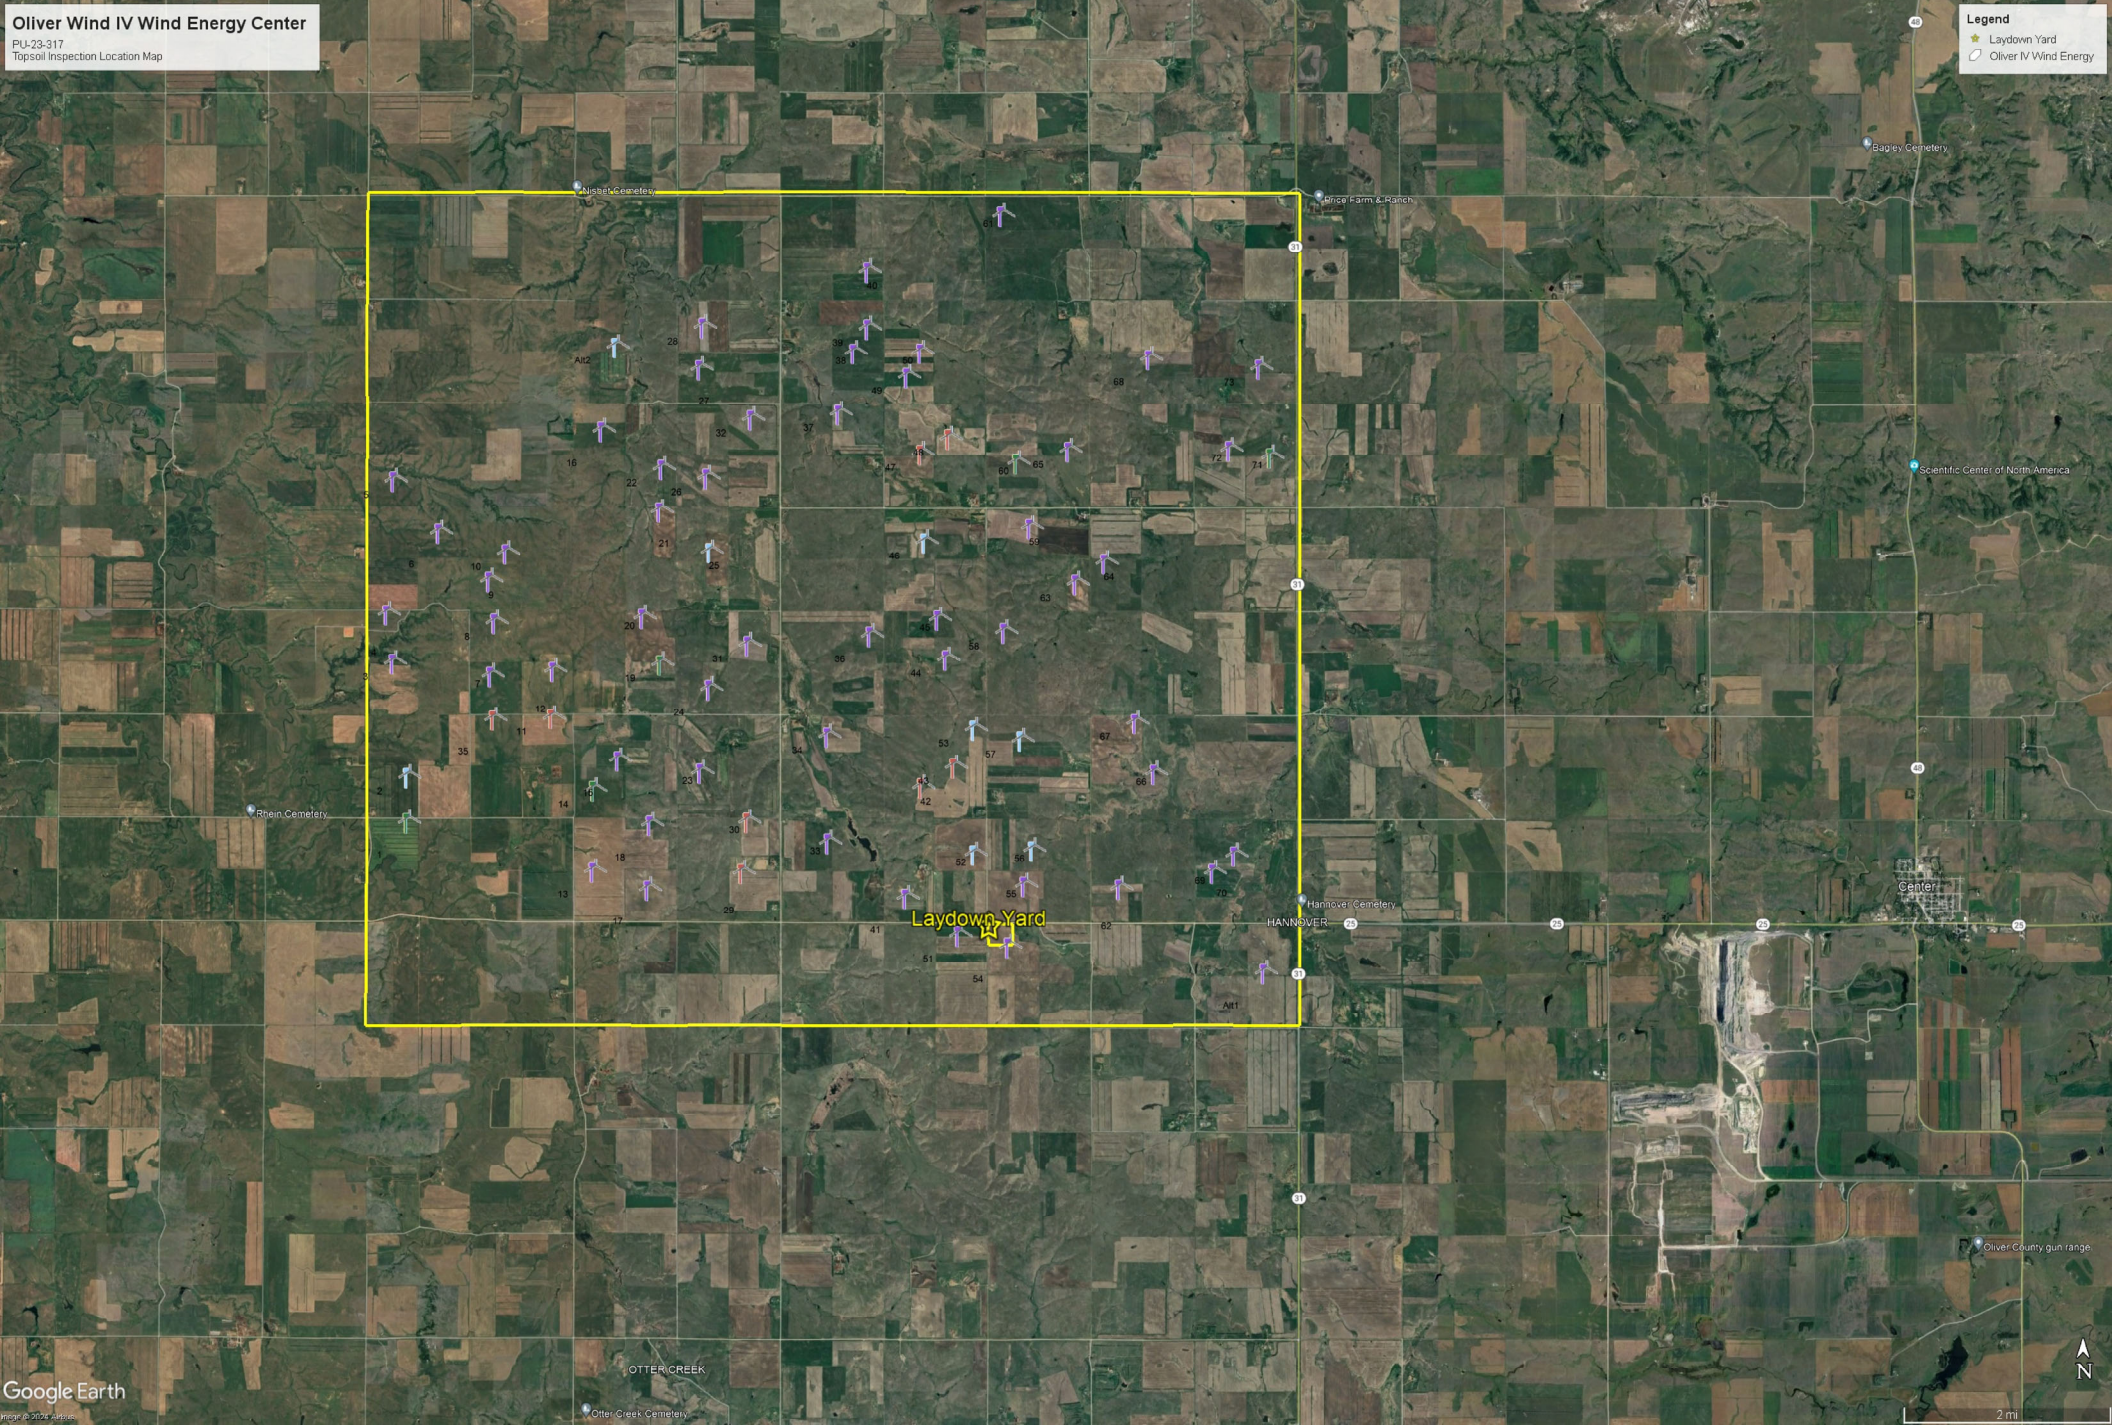
<div data-bbox="82 212 1187 306"> <div> <div>E</div> <div>SE</div> <div>S</div> <div>SW</div> </div> <div> <div>60</div> <div>90</div> <div>120</div> <div>150</div> <div>180</div> <div>210</div> <div>240</div> </div> </div> <div data-bbox="142 312 1136 352"> <div> <div>☼</div> <div>153°SE (T)</div> <div>LAT: 47.111119</div> <div>LON: -101.489552 ±13ft</div> <div>▲ 2283ft</div> </div> </div> <div data-bbox="82 359 1187 1043">   <div data-bbox="906 993 1175 1020">10 May 2024, 10:33:12</div> </div>	<p>Photo #: 9</p> <p>Direction: Southeast</p> <p>Description: Bulldozers, scrapers, and graders removing remaining topsoil from laydown yard site.</p> <p>Observers: Peterson/Calkins</p> <p>Date: 05/10/2024</p> <p>Latitude: 47.111119</p> <p>Longitude: -101.489552</p>
<div data-bbox="82 1064 1187 1159"> <div> <div>NE</div> <div>E</div> <div>SE</div> <div>S</div> </div> <div> <div>30</div> <div>60</div> <div>90</div> <div>120</div> <div>150</div> <div>180</div> <div>210</div> </div> </div> <div data-bbox="134 1165 1144 1203"> <div> <div>☼</div> <div>119°SE (T)</div> <div>LAT: 47.110965</div> <div>LON: -101.489868 ±13ft</div> <div>▲ 2292ft</div> </div> </div> <div data-bbox="82 1209 1187 1892">   <div data-bbox="906 1841 1175 1869">10 May 2024, 10:33:57</div> </div>	<p>Photo #: 10</p> <p>Direction: Southeast</p> <p>Description: Topsoil pile on east side of laydown yard site.</p> <p>Observers: Peterson/Calkins</p> <p>Date: 05/10/2024</p> <p>Latitude: 47.110965</p> <p>Longitude: -101.489868</p>
