## **Oliver Wind IV Wind Energy Center**

### **Construction Inspection Report**

***Docket Number: PU-23-317***

Prepared for North Dakota Public Service Commission

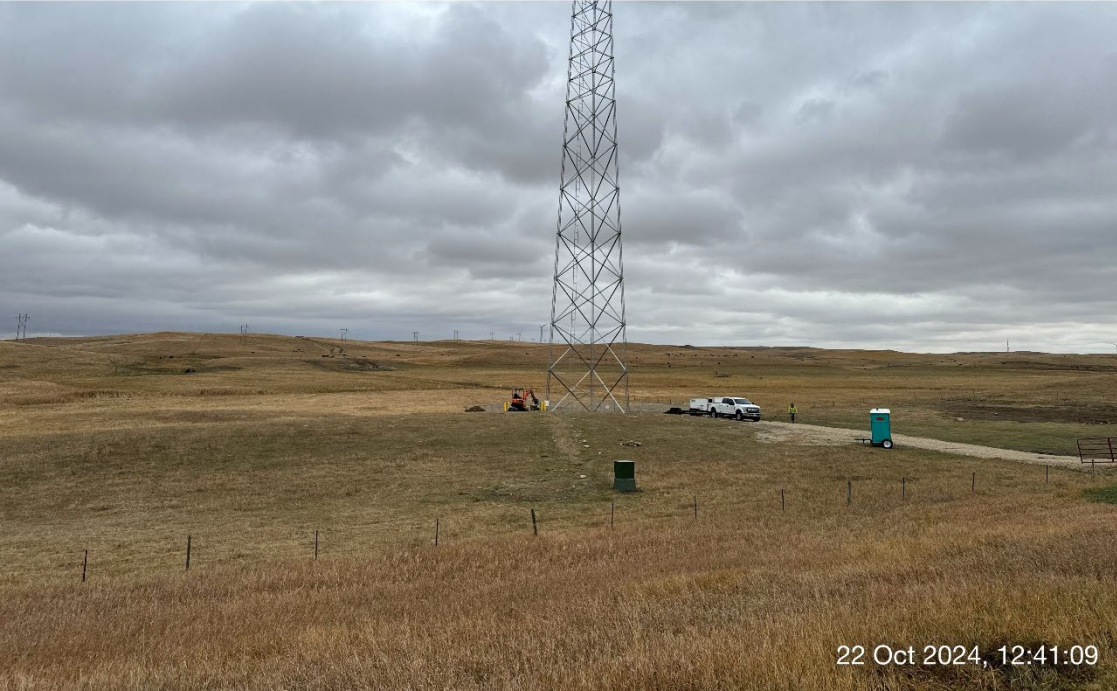
<p>22 Oct 2024, 12:41:09</p>	<p>Photo #: 5</p> <p>Direction: Northeast</p> <p>Description: Tower constructed on east side of 49<sup>th</sup> Ave SW near Turbine 31.</p> <p>Observer: Zach Peterson</p> <p>Date: 10/22/2024</p> <p>Latitude: 47.147364</p> <p>Longitude: -101.532144</p>
<p>S 180 210 SW 240 W 270 NW 300 330</p> <p>☼ 249°W (T) LAT: 47.176461 LON: -101.498025 ±13ft ▲ 2175ft</p>

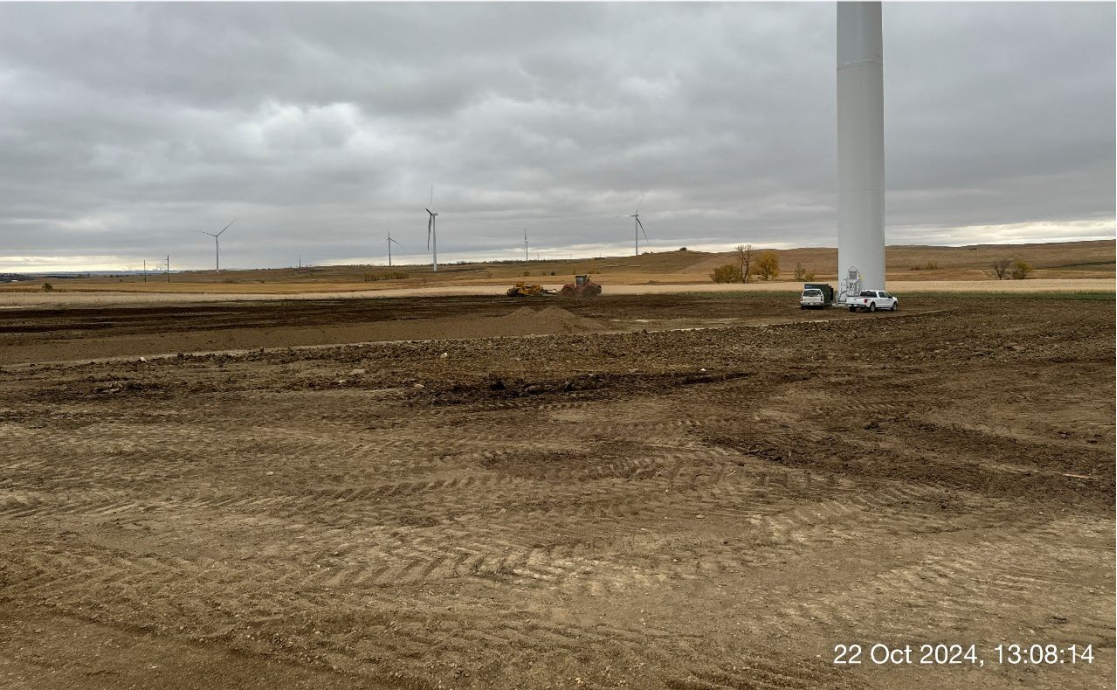
<p>22 Oct 2024, 13:08:14</p>	<p>Photo #: 6</p> <p>Direction: West</p> <p>Description: Reclamation ongoing at Turbine 48.</p> <p>Observer: Zach Peterson</p> <p>Date: 10/22/2024</p> <p>Latitude: 47.176461</p> <p>Longitude: -101.498025</p>

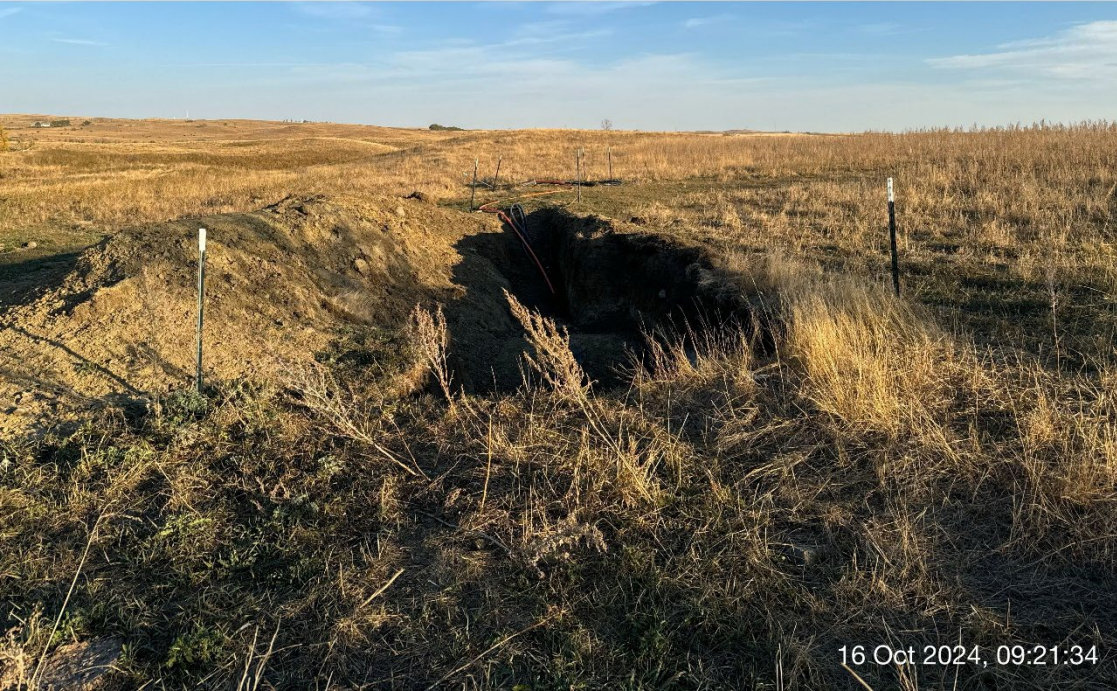
During the construction inspections, the most prevalent issue noted was the improper segregation of topsoil and subsoil from excavated and stripped areas. It was noted that several pits excavated for collection lines and transformers had excavated subsoil on top of and mixed in with excavated topsoil. Photos of these areas are shown in **Photos 9, 12, and 14** in the photo log of this report. This issue relates to **Certification #14** which states *"Company understands and agrees that topsoil, up to 12 inches, or topsoil to the depth of cultivation, whichever is greater, over and along trench areas, roadways, and location of associated facilities must be carefully stripped and segregated from the subsoil. Any area on which excavated subsoil will be placed must first be stripped of topsoil. The stripped topsoil must not be stockpiled in natural drainages and must be protected from water erosion. Care must be taken to protect topsoil from unnecessary compaction by heavy machinery. Unless otherwise approved by the Commission, topsoil must be removed before topsoil freezes in the late fall/early winter to the point that frost inhibits proper soil segregation. After backfilling with subsoil is completed, any excess subsoil must be placed over the excavation area, blending the grade into existing topography. Topsoil must be replaced over areas from which it was stripped only after the subsoil is replaced."*

<p>16 Oct 2024, 09:21:34</p>	<p>Photo #: 9</p> <p>Direction: North</p> <p>Description: Open pit for collection line with no fence and mixed pile of topsoil and subsoil.</p> <p>Observer: Zach Peterson</p> <p>Date: 10/16/2024</p> <p>Latitude: 47.125872</p> <p>Longitude: -101.447314</p>
<p>SE 120 S 180 SW 240 W 270</p> <p>☀ 196°S (T) LAT: 47.118923 LON: -101.440521 ±13ft ▲ 2145ft</p>

Issue	Recommendations
<b>Topsoil Segregation</b>	Any removed topsoil from stripped areas and connection line pits must be segregated from removed subsoil.
<b>Buried Garbage and Fence Material</b>	Any human waste must be cleaned up and disposed of prior to reclamation of a site. Any fence material must be replaced prior to reclamation of an area and any unused material from original fences and gates must be removed prior to reclamation of the site.
<b>Damaged Trees</b>	If trees are damaged during construction activities, the trees must be inventoried, removed, and replaced according to the Tree and Shrub Mitigation Plan.
<b>SWPPP BMPs</b>	Silt fence, waddles and other erosion devices will need to be monitored until vegetation is reestablished along ROW and replaced when necessary.

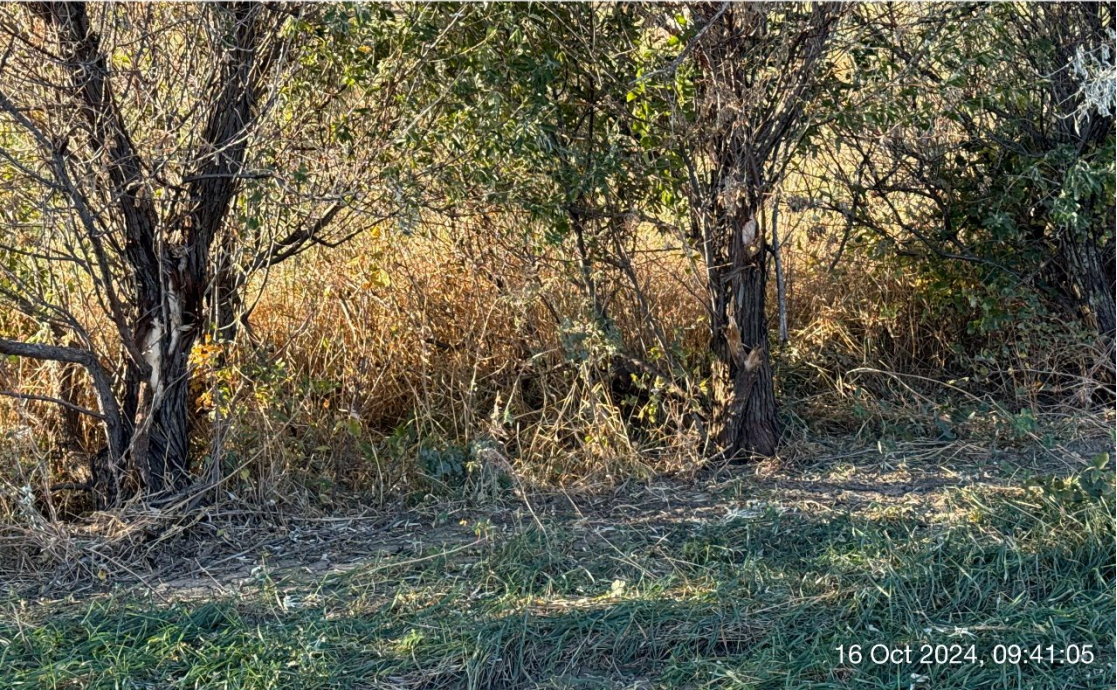
Other minor issues noted during the construction inspection included trees damaged by heavy equipment but not removed according to the Tree and Shrub Mitigation Plan, and SWPPP BMPs in need of repair. These issues are shown in **Photos 10** and **13** in the photo log of this report.

<p>16 Oct 2024, 09:41:05</p>	<p>Photo #: 10</p> <p>Direction: South</p> <p>Description: Russian Olive shelter belt damaged by heavy equipment near Turbine 70.</p> <p>Observer: Zach Peterson</p> <p>Date: 10/16/2024</p> <p>Latitude: 47.118923</p> <p>Longitude: -101.440521</p>

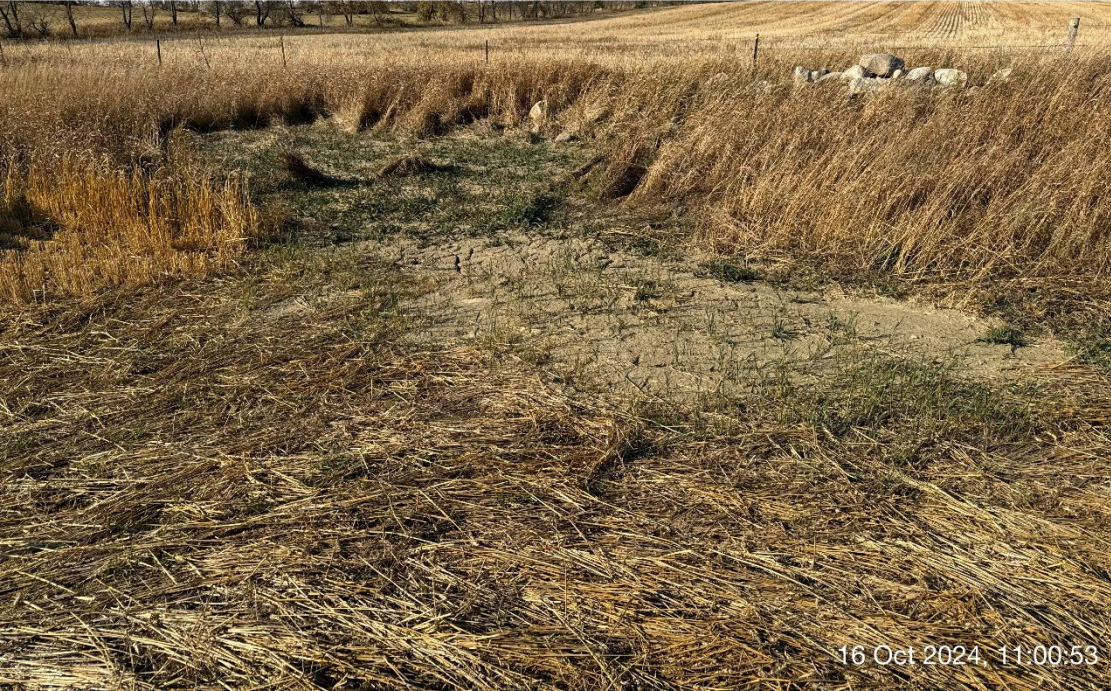
<p>Photo #: 13</p> <p>Direction: West</p> <p>Description: Sediment runoff from widened access road between Turbines 56 and 57.</p> <p>Observer: Zach Peterson</p> <p>Date: 10/16/2024</p> <p>Latitude: 47.131231</p> <p>Longitude: -101.479134</p>

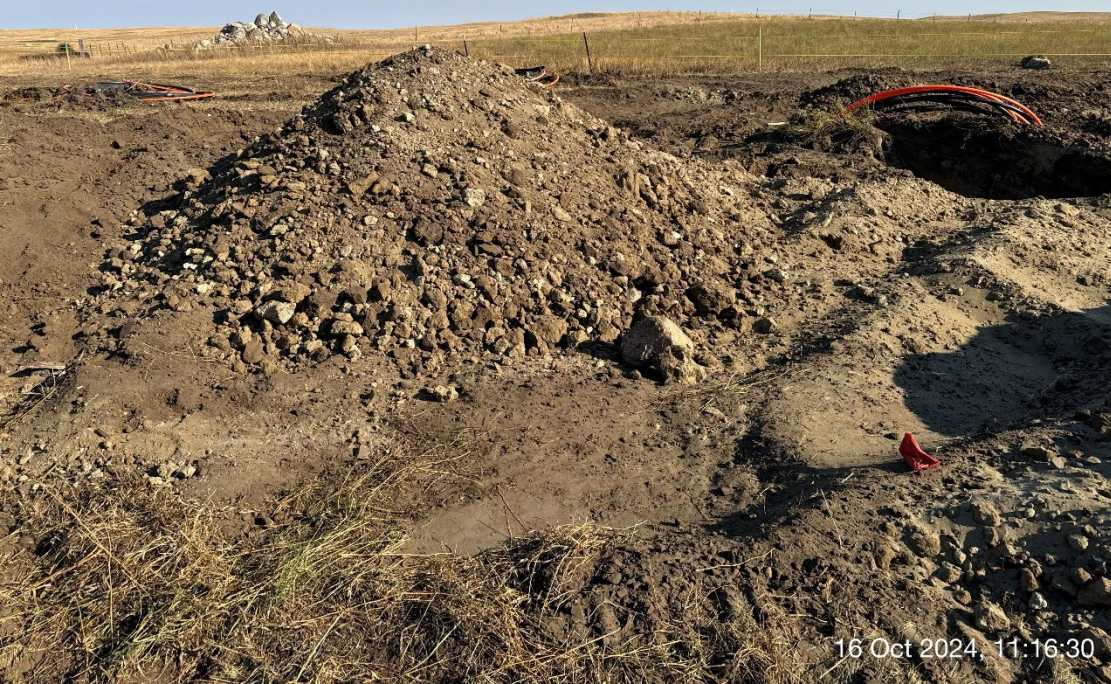
<p>Photo #: 14</p> <p>Direction: Northeast</p> <p>Description: Piles of mixed topsoil and subsoil near collection line pit at Turbine 57.</p> <p>Observer: Zach Peterson</p> <p>Date: 10/16/2024</p> <p>Latitude: 47.136226</p> <p>Longitude: -101.484147</p>
