Oliver Wind IV 345kV Transmission Line Project Oliver County

Topsoil Inspection Report

Docket Number: PU-23-318

Prepared for North Dakota Public Service Commission

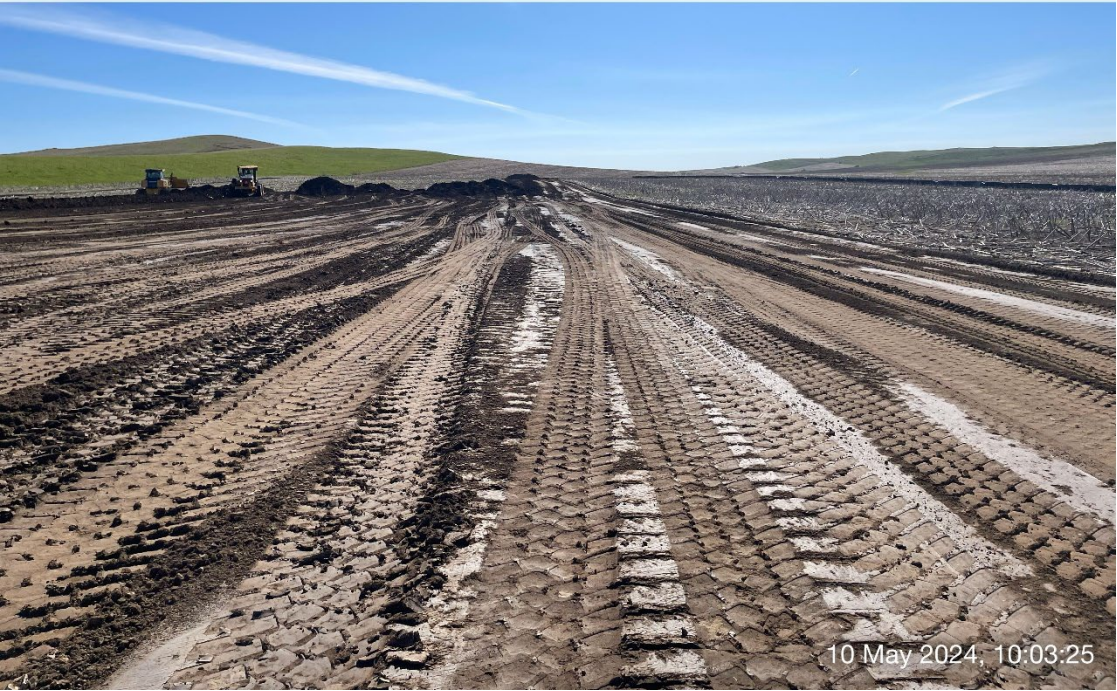
<p>10 May 2024, 10:03:25</p>	<p>Photo #: 3</p> <p>Direction: East</p> <p>Description: Dozer and Scraper pushing stripped topsoil into piles on east end of substation site.</p> <p>Observer: Zach Peterson</p> <p>Date: 05/10/2024</p> <p>Latitude: 47.168228</p> <p>Longitude: -101.488784</p>
<p>N 330 0 30 NE 60 E 90 120 SE 150</p> <p>☉ 60°NE (T) LAT: 47.168154 LON: -101.487795 ±13ft ▲ 2143ft</p>   <p>10 May 2024, 10:04:30</p>	<p>Photo #: 4</p> <p>Direction: Northeast</p> <p>Description: Topsoil piles on east end of substation site.</p> <p>Observer: Zach Peterson</p> <p>Date: 05/10/2024</p> <p>Latitude: 47.168154</p> <p>Longitude: -101.487795</p>

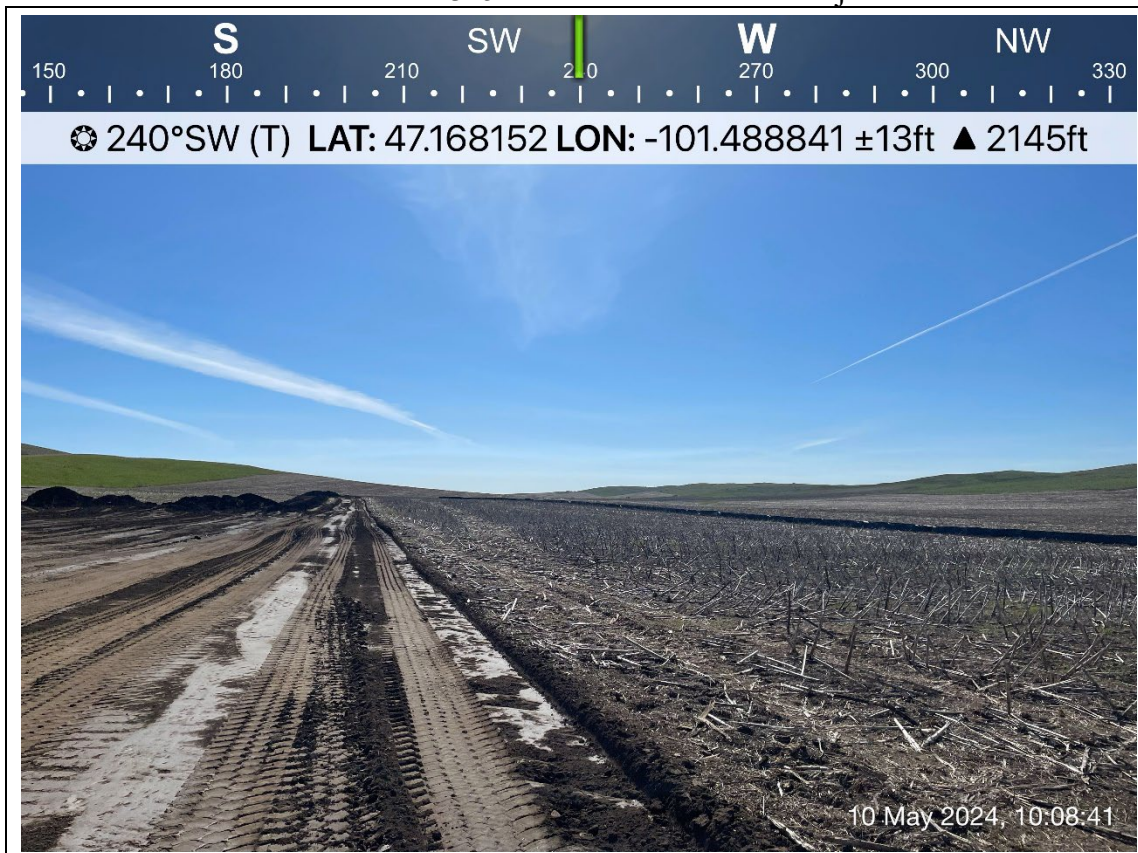
<p>Photo #: 7</p> <p>Direction: Southwest</p> <p>Description: Topsoil piles and silt fence running along south side of substation site.</p> <p>Observer: Zach Peterson</p> <p>Date: 05/10/2024</p> <p>Latitude: 47.168152</p> <p>Longitude: -101.488841</p>

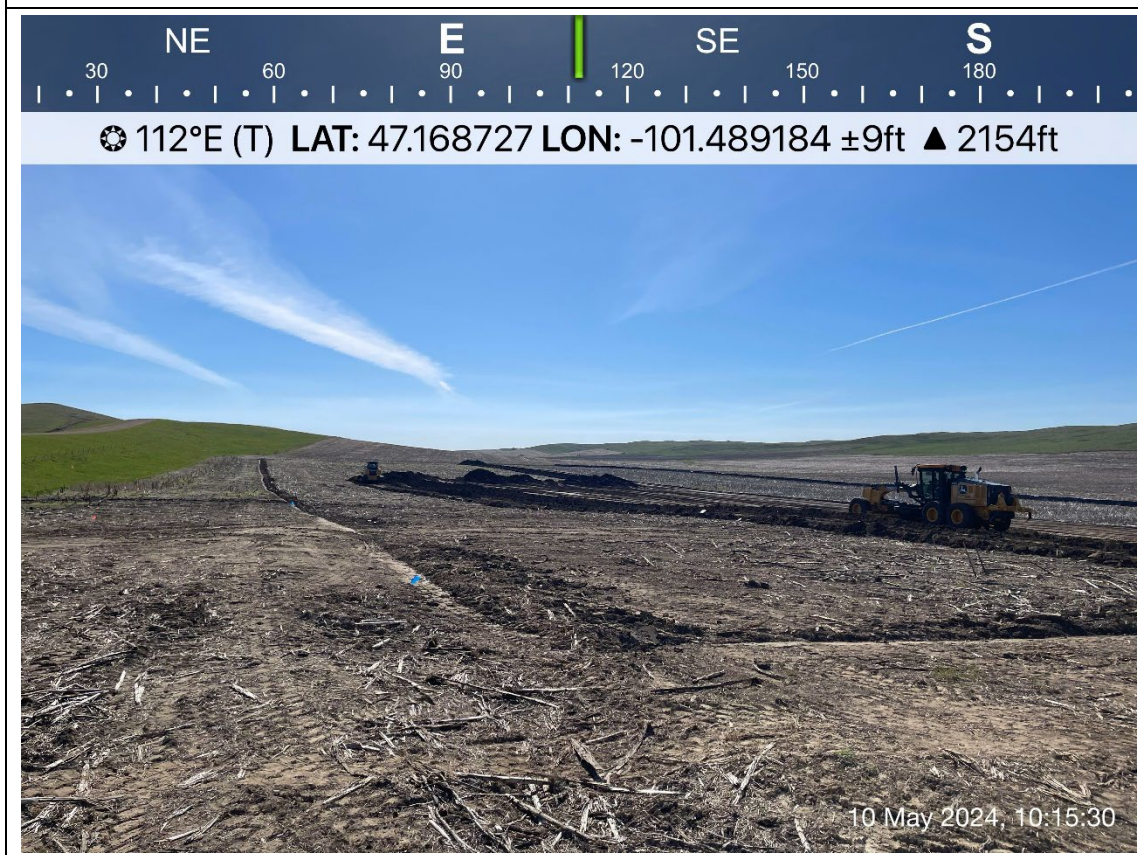
<p>Photo #: 8</p> <p>Direction: Southeast</p> <p>Description: Dozer and Scraper moving northward stripping topsoil from substation site.</p> <p>Observer: Zach Peterson</p> <p>Date: 05/10/2024</p> <p>Latitude: 47.168727</p> <p>Longitude: -101.489184</p>
