**Basin Electric Pioneer to Judson 345kV Transmission Line**

**Williams County, North Dakota**

***Topsoil Inspection Report***

***Docket Number: PU-23-338***

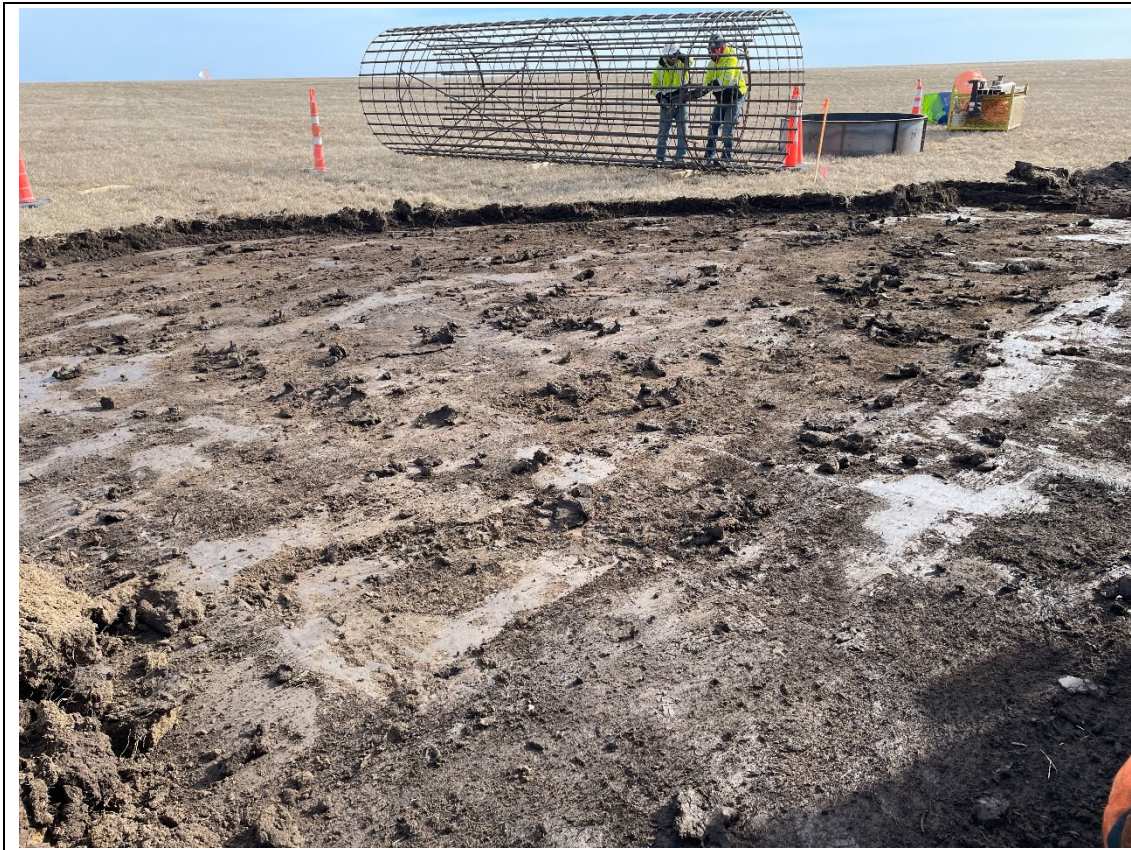
Photo #: 1

Description: Area of stripped topsoil where removed soil from foundation excavation was placed, note the color change showing the subsoil.

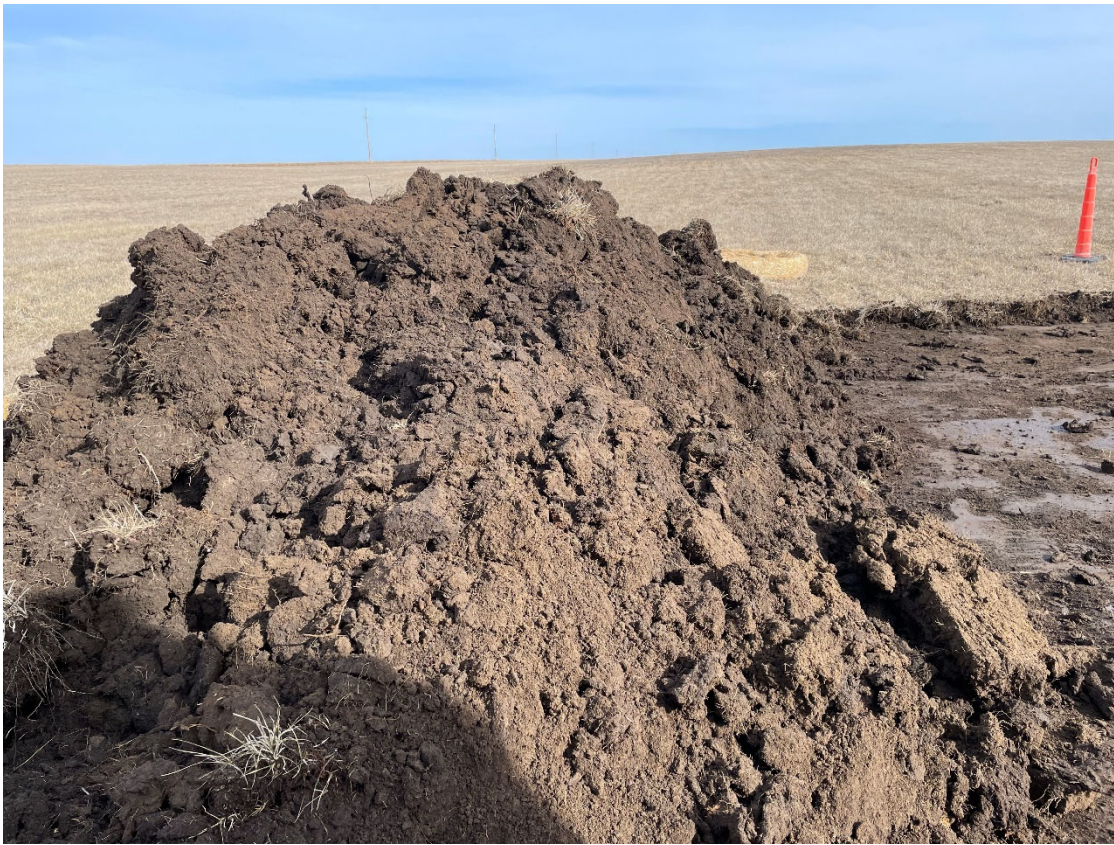
Photo #: 2

Description: View showing the pile of topsoil removed from area shown in previous photo.

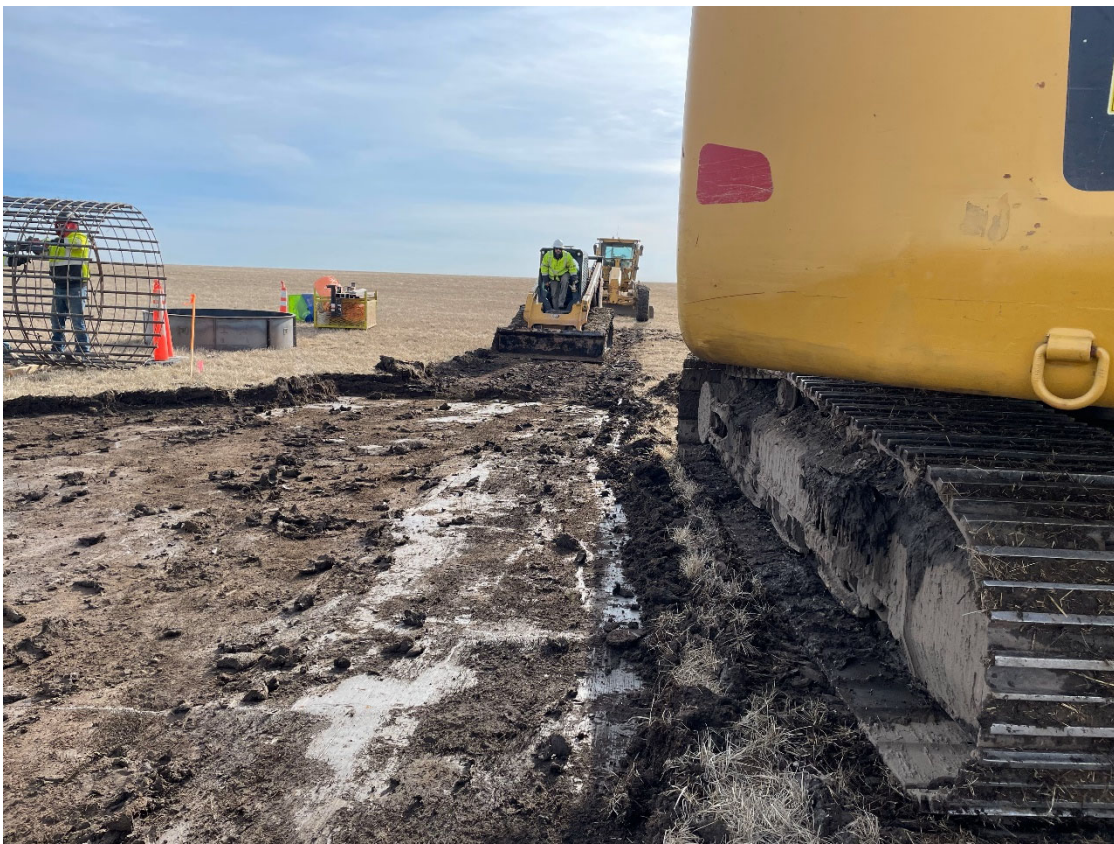
Photo #: 3

Description: View of the skid steer removing topsoil.

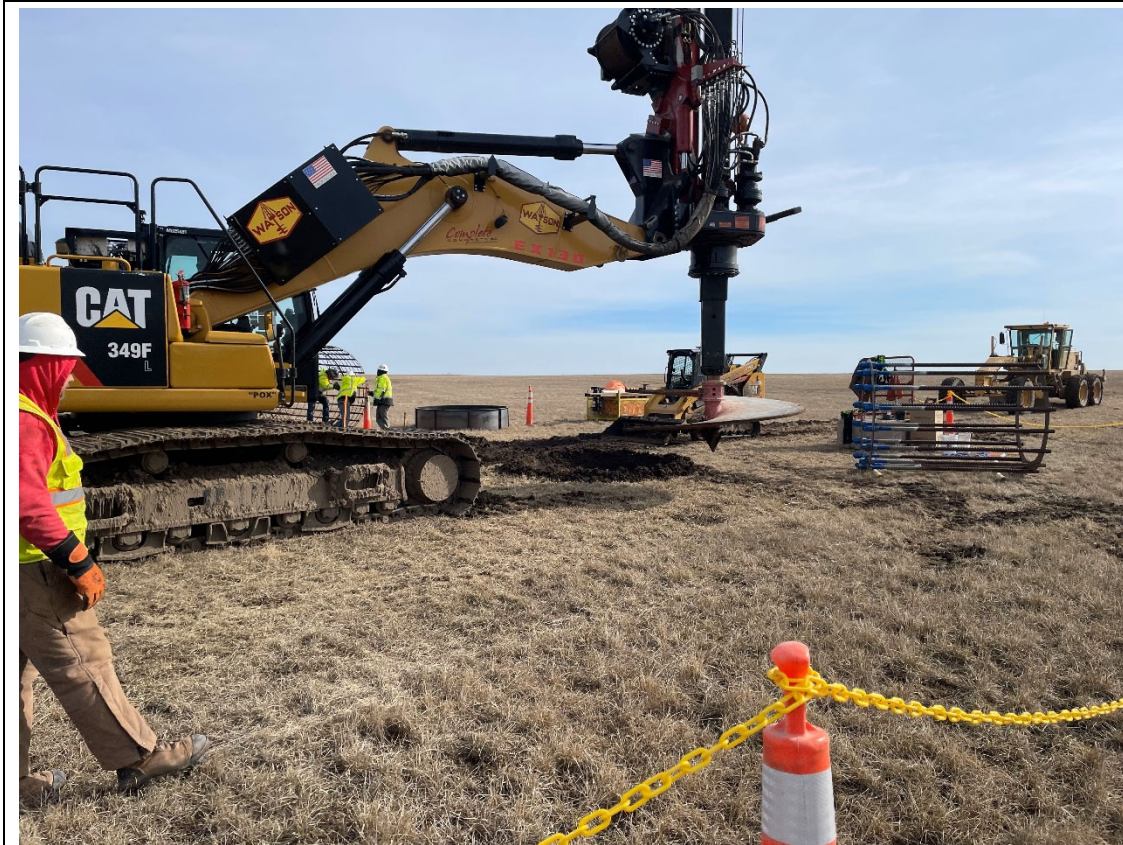
Photo #: 4

Description: View of Auger used to bore 20ft hole.

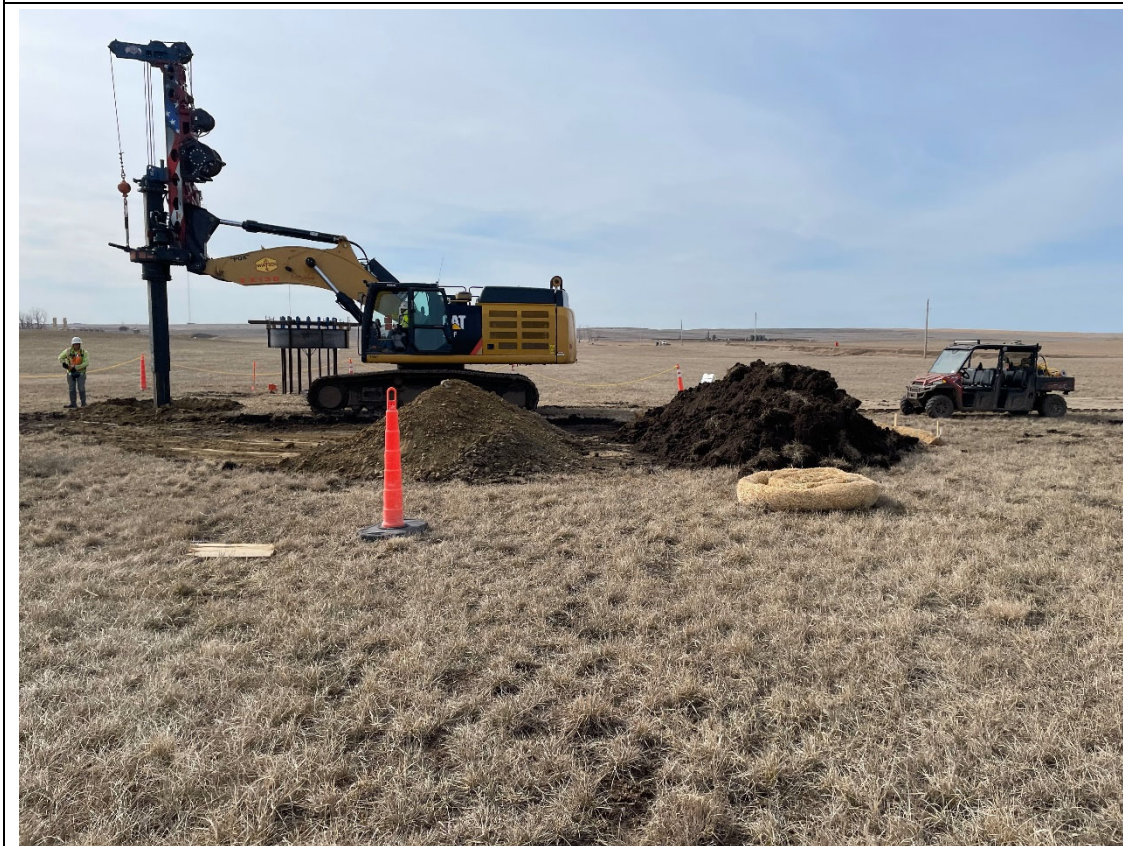
Photo #: 5

Description: View of Auger boring hole with topsoil (right) and subsoil (left) piles in the foreground.

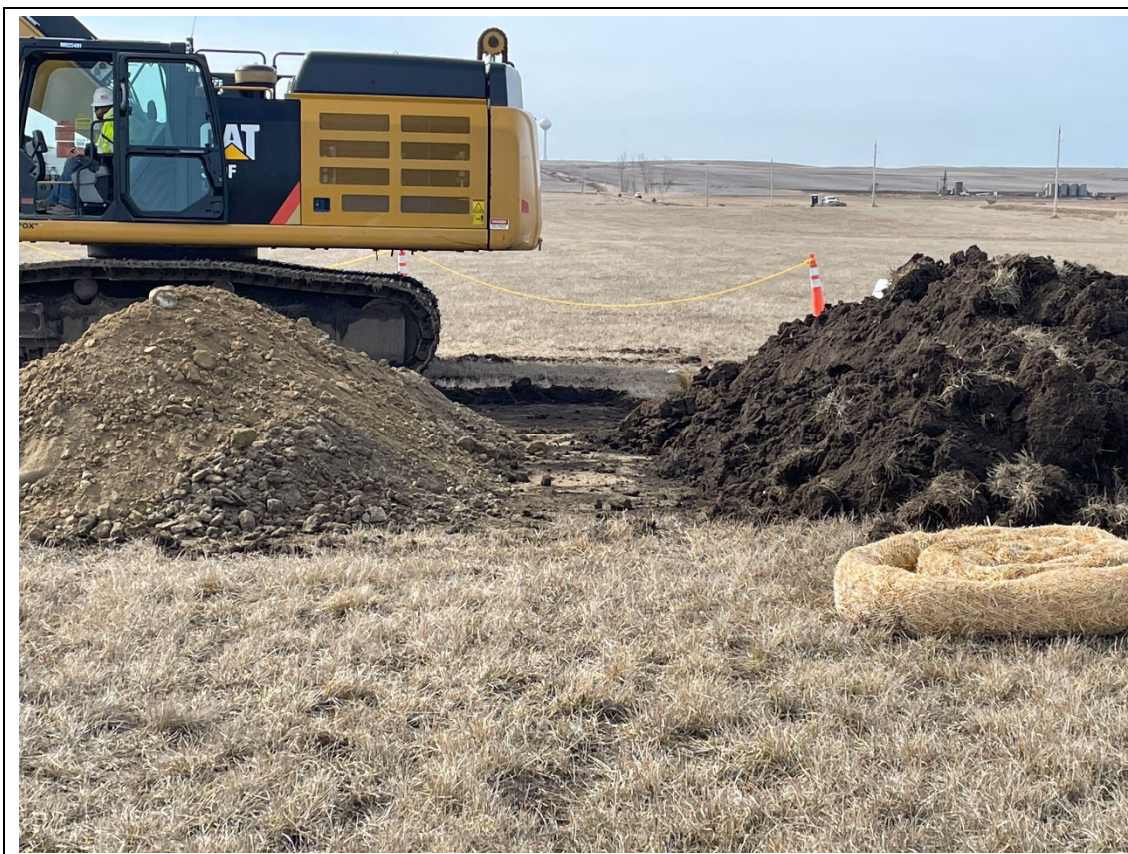
Photo #: 6

Description: View showing berms of topsoil (right) and subsoil (left) before wattle is placed.
