Casey and Julie Voigt v. Coyote Creek Mining Company, LLC

Case No. RC-23-348

Inspection Reports

### INSPECTION REPORT

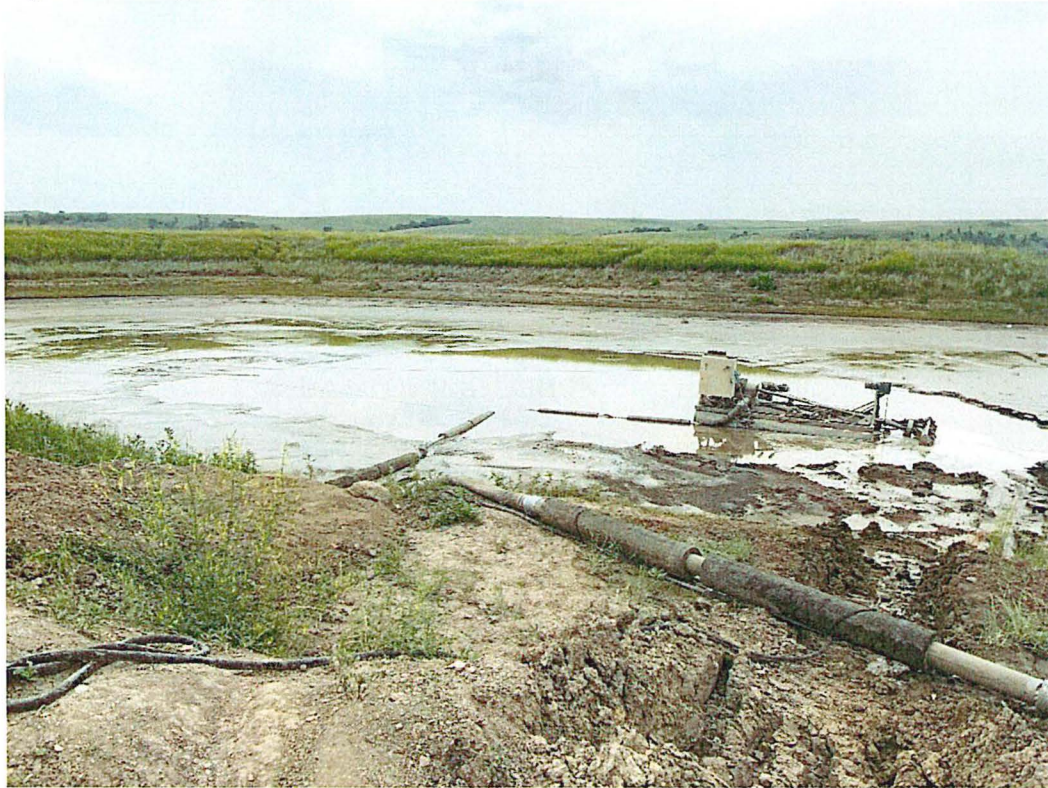
Figure 1. Dredging operation in sediment pond P30-02.

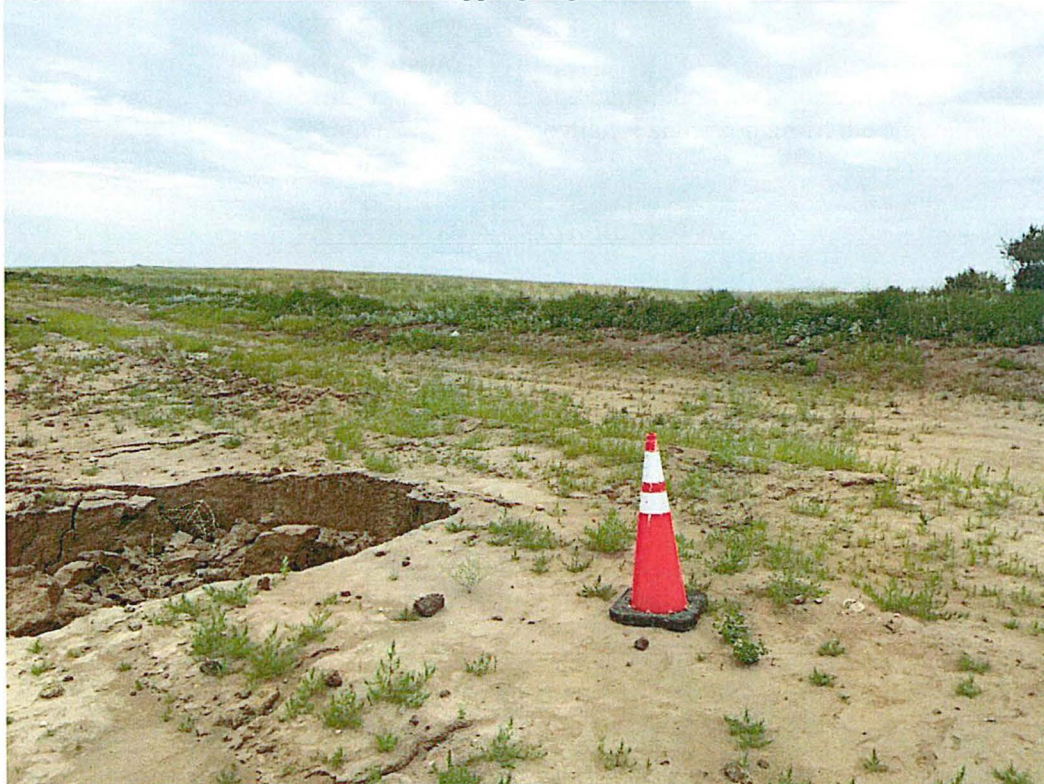
Significant head cutting erosion was observed near the stripping edge in the SW¼ of Section 25 (**Figure 2**). Coyote Creek Mine will have to mitigate this to prevent the erosion feature from expanding to the adjacent undisturbed land.

Figure 2. Head cut erosion near the stripping edge in the SW $\frac{1}{4}$  of Section 25.

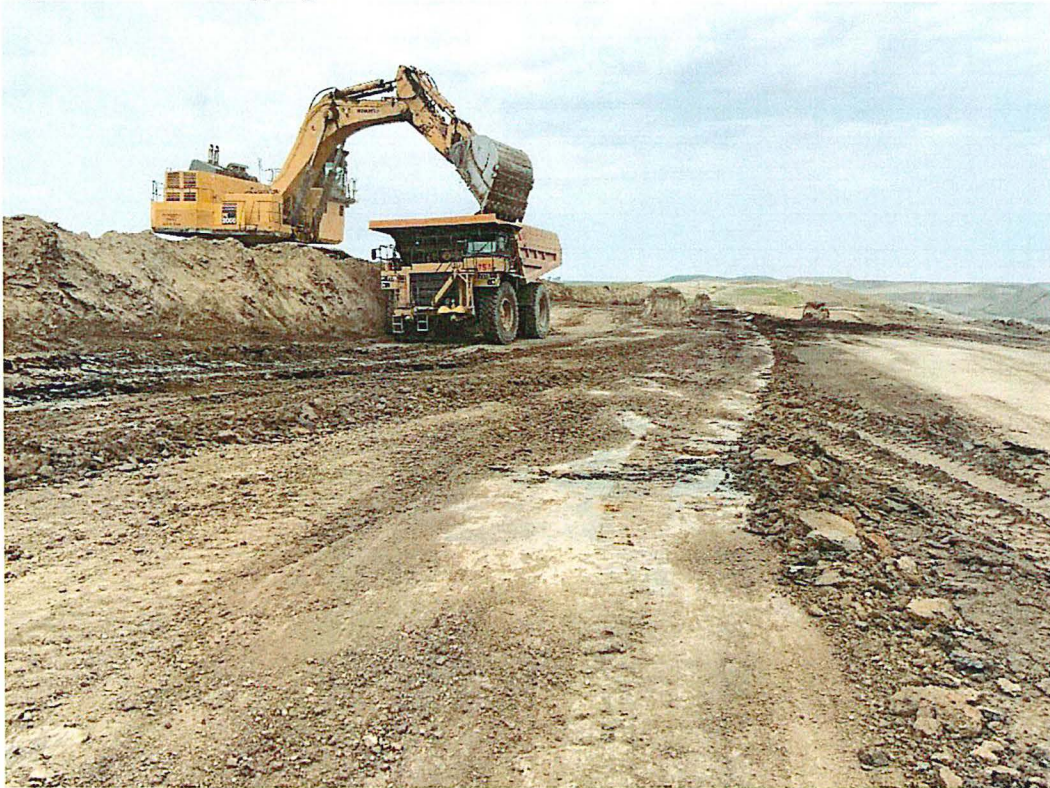
An excavator was stripping subsoil and loading trucks in the SW¼ of Section 6, which was being directly respread on grade approval COY-035 by a dozer (**Figure 3**). Several SPGM monuments showing deep lift subsoil removal were observed in the removal area, and it appeared that adequate subsoil had been salvaged. Coyote Creek Mine predicted that the subsoil removal would be completed in the coming days and an official subsoil removal approval request would be submitted to the Reclamation Division prior to overburden removal.

Figure 3. Subsoil stripping in the SW¼ of Section 6.

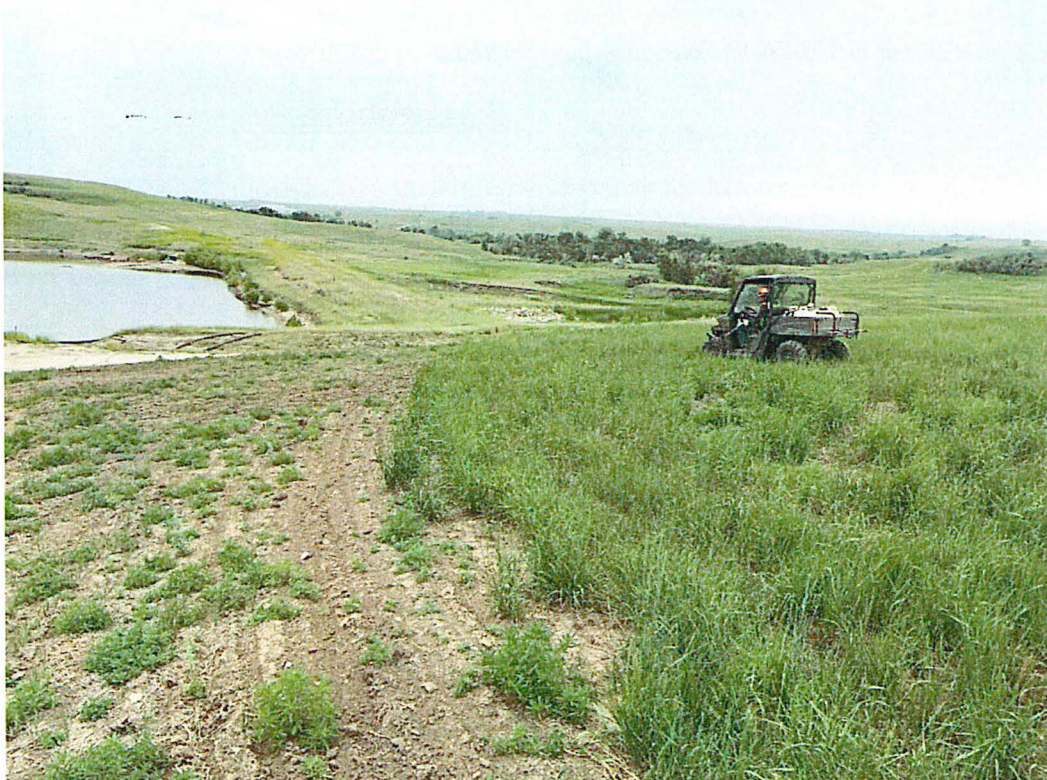
Grade approval areas COY-022 and COY-029 in the N½ of Section 6 were inspected (**Figure 4**). COY-022 appeared to be well vegetated, and it was currently being spot sprayed for brome. COY-029 was sparsely vegetated with weeds and little to no grass was observed. It was reported that COY-029 was reseeded two weeks ago since the original seeding last fall was ineffective.

Figure 4. Spot spraying weeds on grade approval COY-022 near the boundary between COY-029.

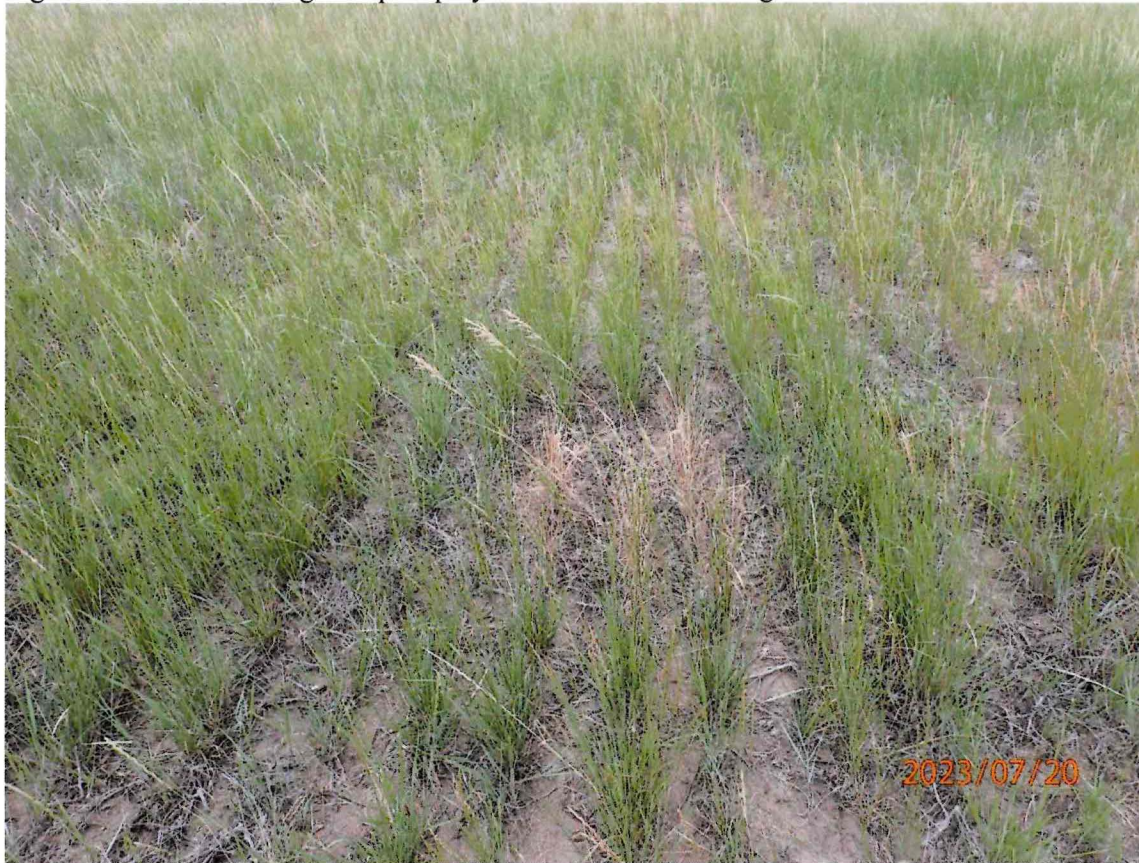
Figure 1: Smooth brome grass spot sprayed on reclaimed native grassland in Section 36.

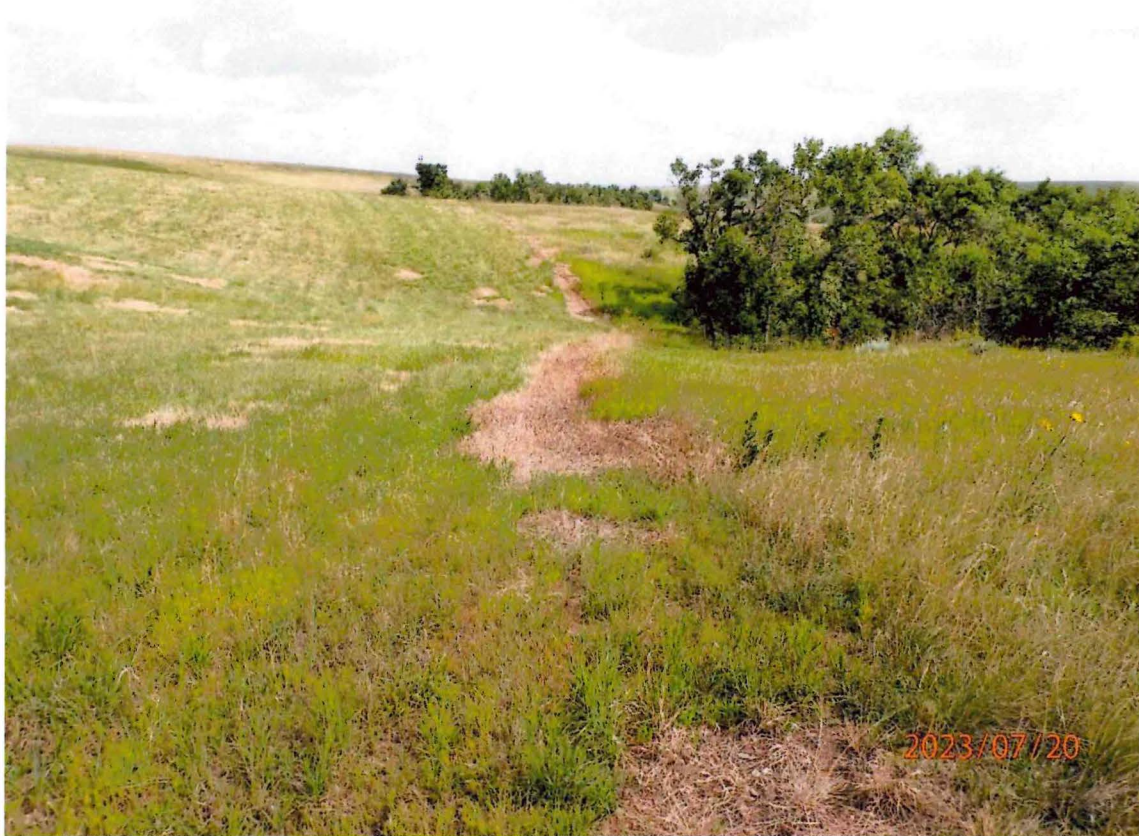
Figure 2: Smooth Brome grass spot sprayed in SE<sup>1</sup>/<sub>4</sub> of Section 24.

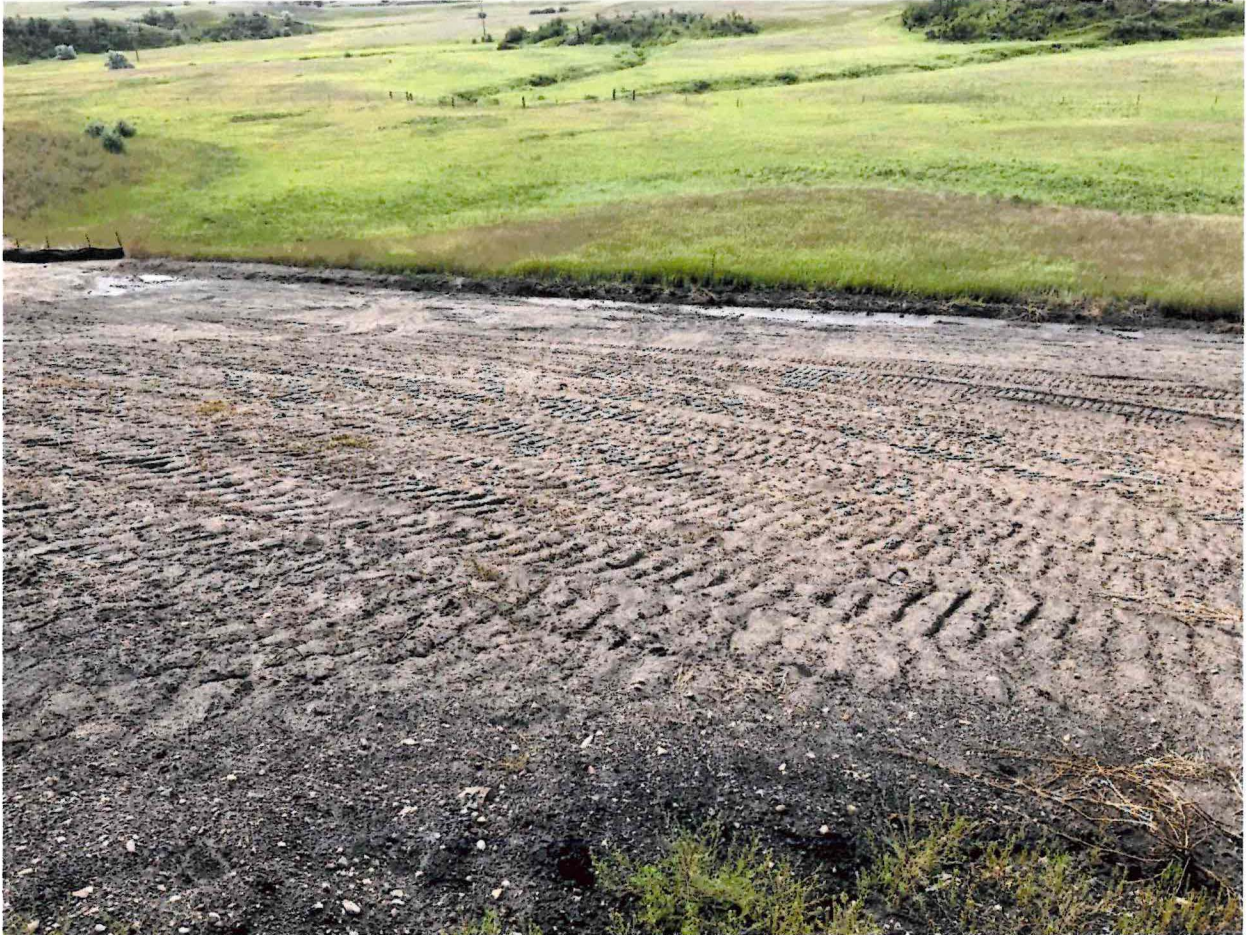
The south embankment of the primary haul road in Section 10 has been recently graded to address some gully erosion caused by surface water runoff. An additional silt fence at the toe of the south embankment and a ridged edge was also observed serving to protect the existing vegetation south of the toe from sediment deposition during rain events (**Figure 1**).

**Figure 1:** The south embankment along the primary haul road located in Section 10 has been regraded to address gully and rill erosion that was observed on previous inspections. A silt fence has been installed on the east end of the embankment toe. The ridged edge bordering the existing undisturbed vegetation has been defined to direct water to the west where more erosion control features exist such as another silt fence and a sump.

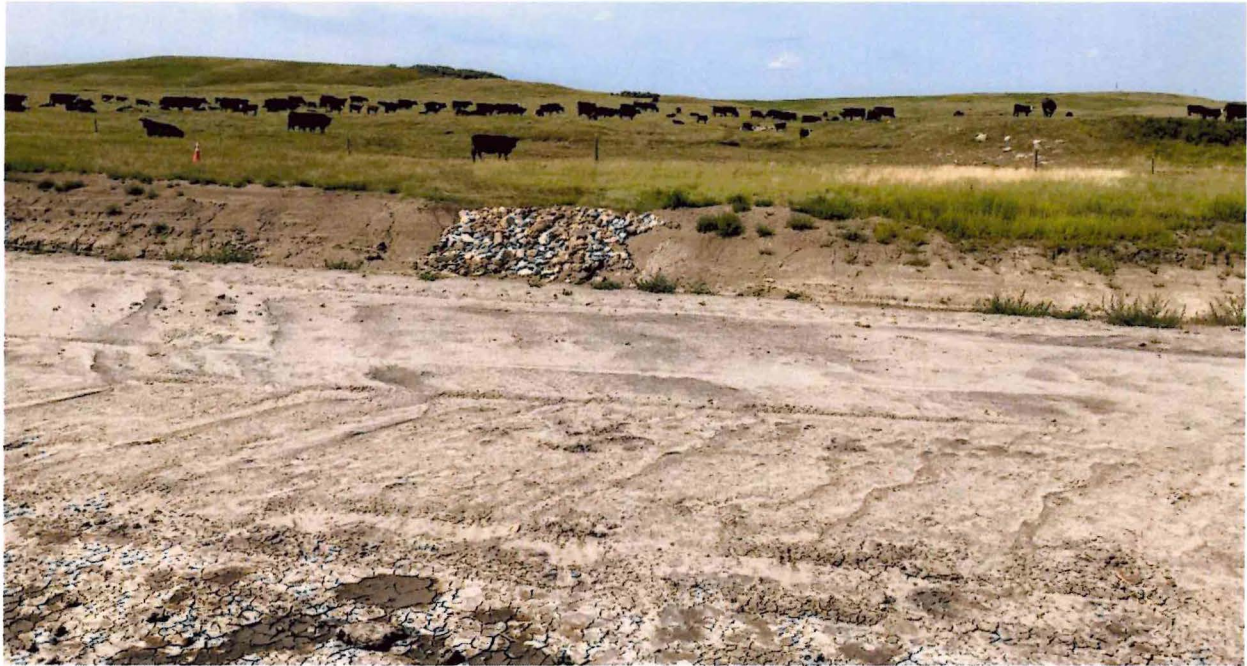
**Figure 2:** Riprap has been installed to minimize water erosion within the tie-in embankment of the west ditch of the dragline access trail located in the N½ of Section 1.

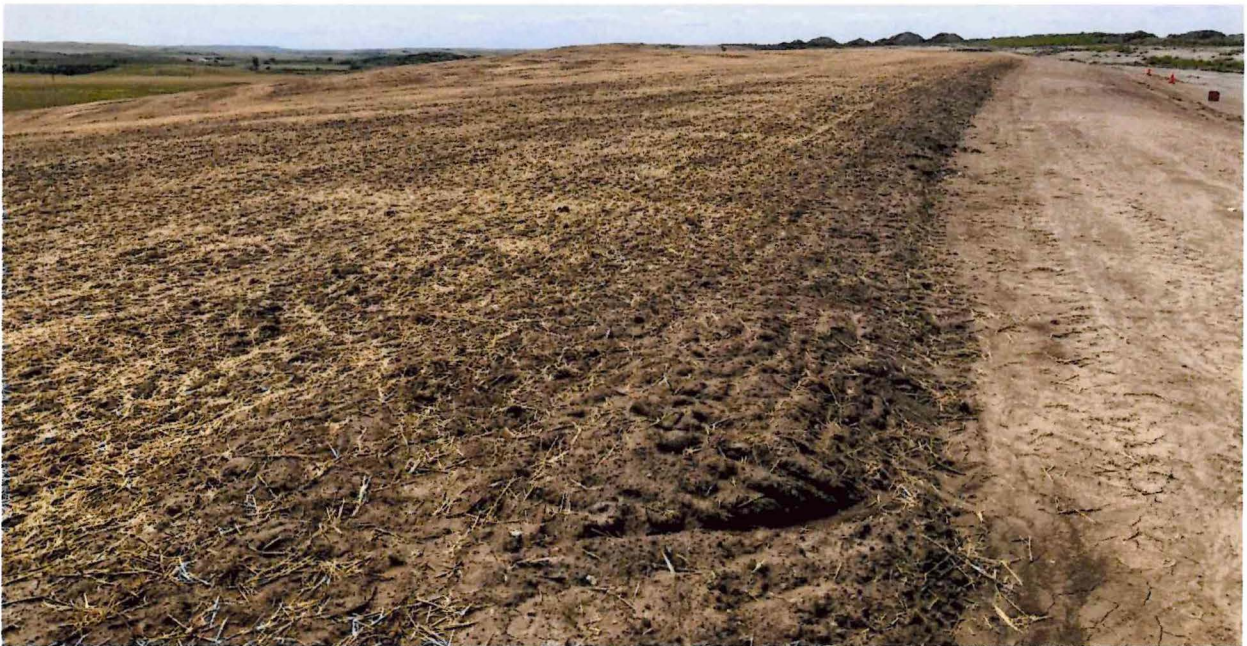
**Figure 3:** Grade approval COY-035, located in Section 6 and approved 5/9/2023, has been respread with SPGM, seeded with oats, and mulched.

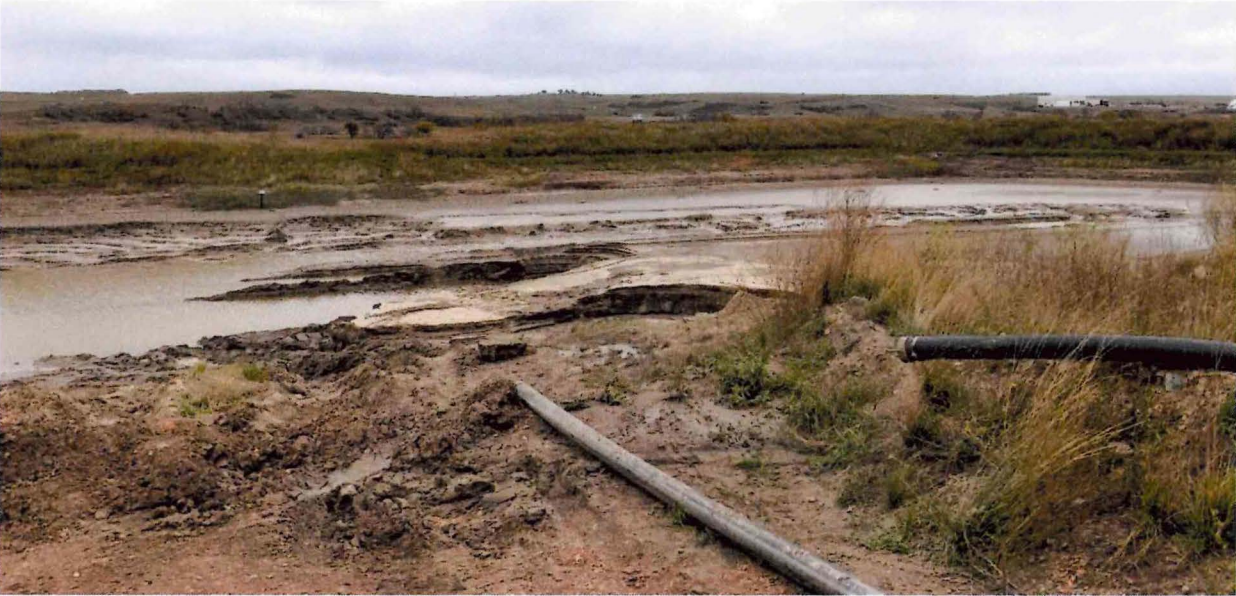
**Figure 1:** Sedimentation Pond P30-02 located in the NW¼ of Section 30 was observed to have sediment within the pond basin. Pond P30-02 was previously dredged in the summer of 2023 but the dredger was unable to successfully remove all of the sediment; therefore, CCMC plans to utilize a long reach backhoe to remove the remaining sediment.
