Casey and Julie Voigt v. Coyote Creek Mining Company, LLC

Inspection Reports

INSPECTION REPORT

DATE OF INSPECTION: May 10, 2023
TYPE OF INSPECTION: Complete
PERMITTEE - MINE: Coyote Creek Mining Company, LLC - Coyote Creek Mine
PERMITS INSPECTED: NACC-1302
PERSONS ACCOMPANYING INSPECTORS: Jeremy Eckroth
INSPECTION CONDITIONS: The inspection was conducted between 9:00 a.m. and 12:30 p.m. CDT. Skies were initially overcast but cleared as the inspection proceeded. The temperature ranged from 60 to 75° F. Access was unrestricted.

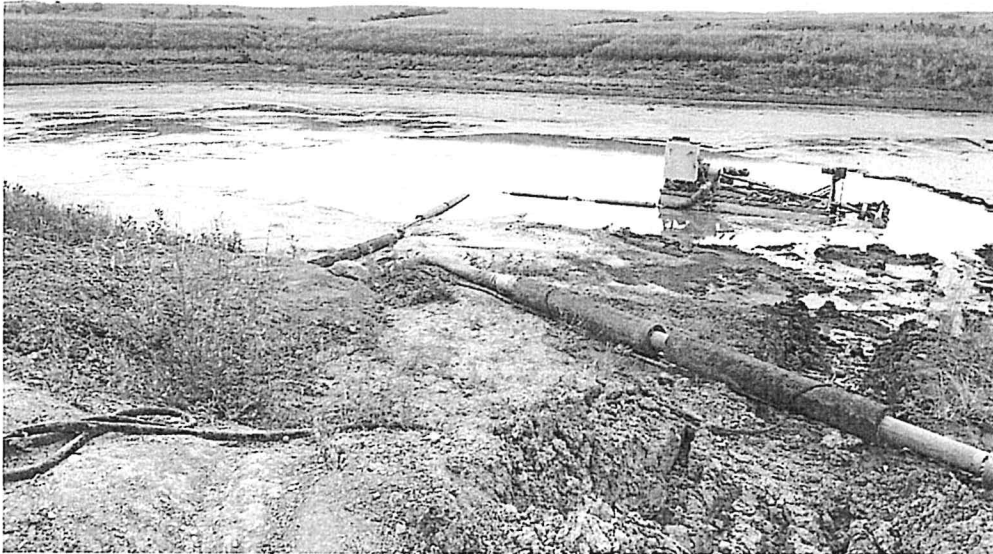
Figure 1. Dredging operation in sediment pond P30-02.

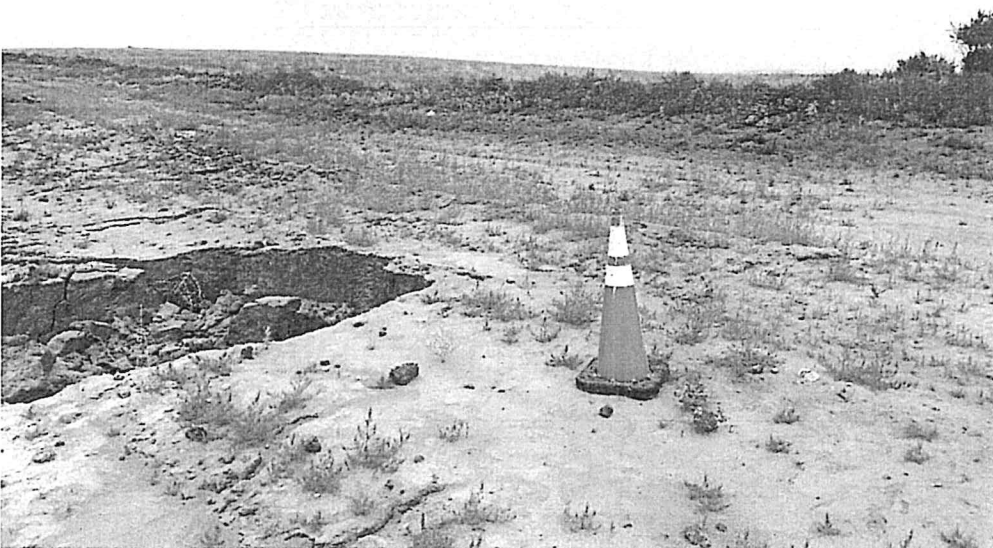
Significant head cutting erosion was observed near the stripping edge in the SW¼ of Section 25 (**Figure 2**). Coyote Creek Mine will have to mitigate this to prevent the erosion feature from expanding to the adjacent undisturbed land.

Figure 2. Head cut erosion near the stripping edge in the SW¼ of Section 25.

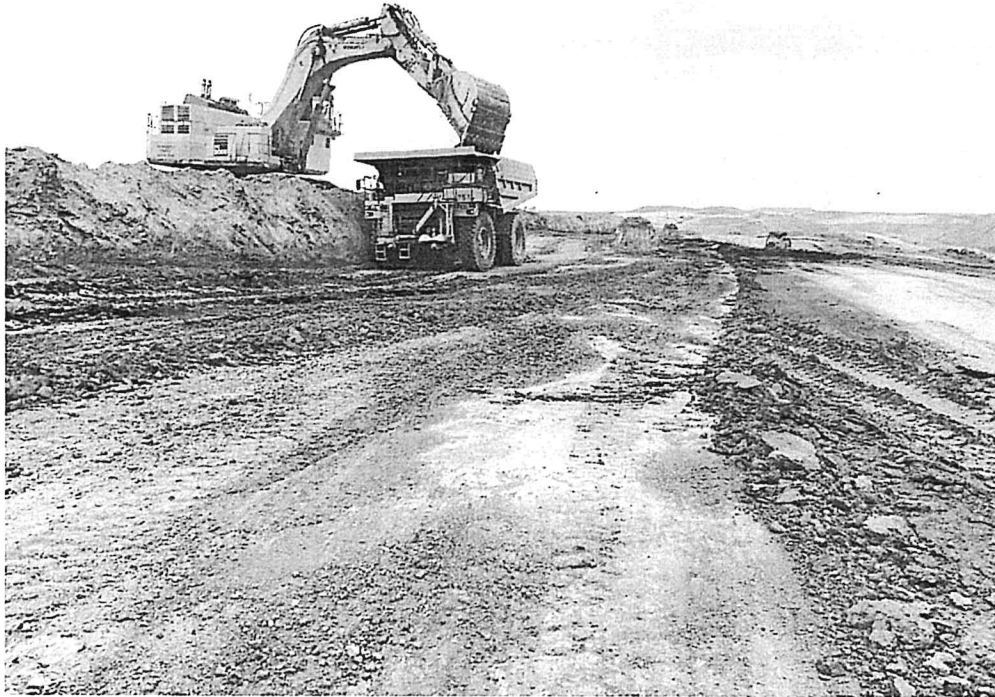
An excavator was stripping subsoil and loading trucks in the SW¼ of Section 6, which was being directly respread on grade approval COY-035 by a dozer (**Figure 3**). Several SPGM monuments showing deep lift subsoil removal were observed in the removal area, and it appeared that adequate subsoil had been salvaged. Coyote Creek Mine predicted that the subsoil removal would be completed in the coming days and an official subsoil removal approval request would be submitted to the Reclamation Division prior to overburden removal.

Figure 3. Subsoil stripping in the SW¼ of Section 6.

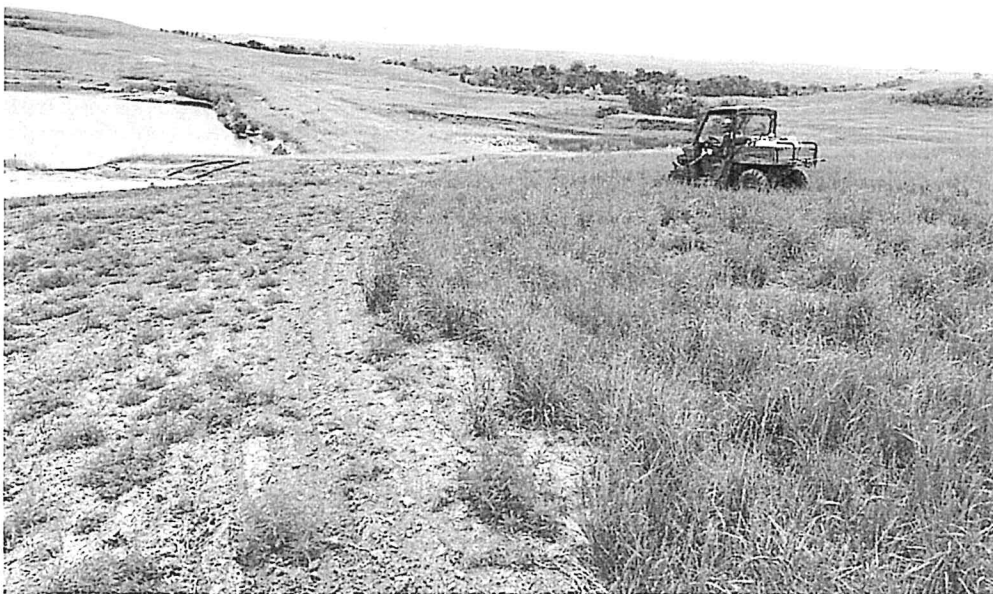
Grade approval areas COY-022 and COY-029 in the N½ of Section 6 were inspected (**Figure 4**). COY-022 appeared to be well vegetated, and it was currently being spot sprayed for brome. COY-029 was sparsely vegetated with weeds and little to no grass was observed. It was reported that COY-029 was reseeded two weeks ago since the original seeding last fall was ineffective.

Figure 4. Spot spraying weeds on grade approval COY-022 near the boundary between COY-029.

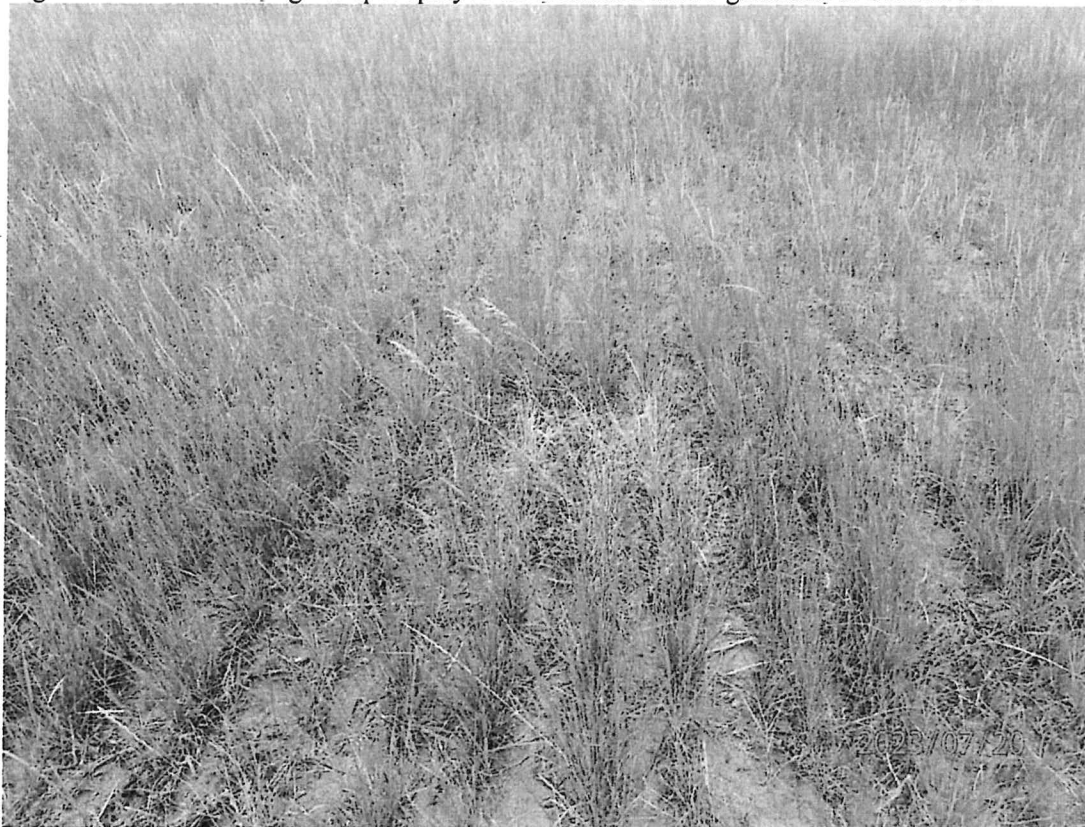
Figure 1: Smooth brome grass spot sprayed on reclaimed native grassland in Section 36.

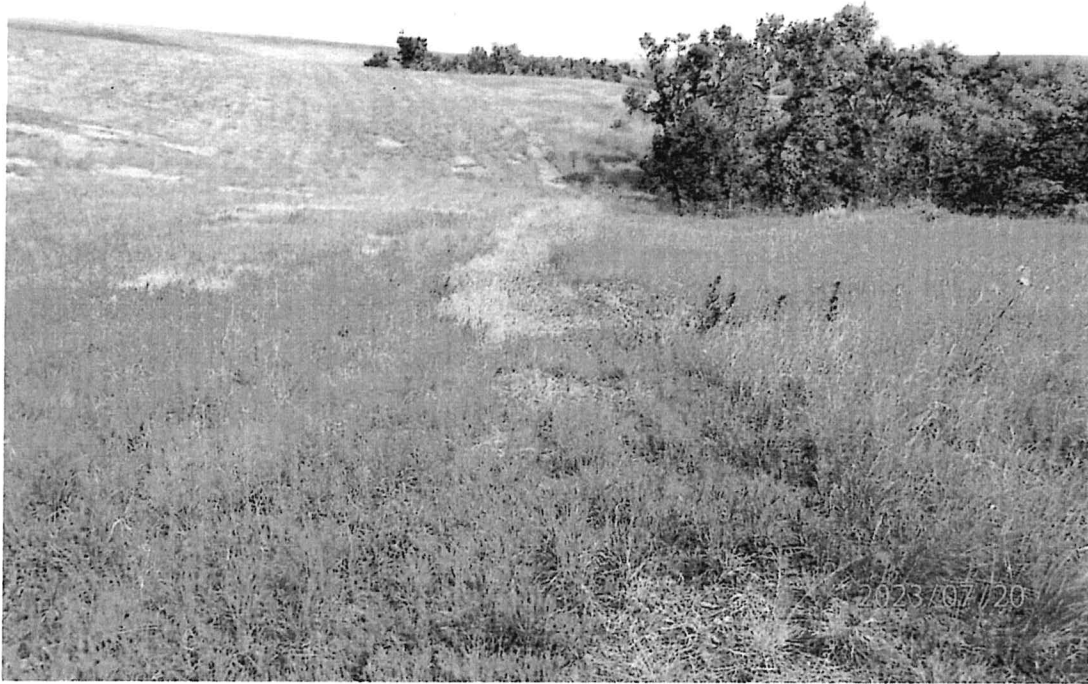
Figure 2: Smooth Bromegrass spot sprayed in SE¼ of Section 24.

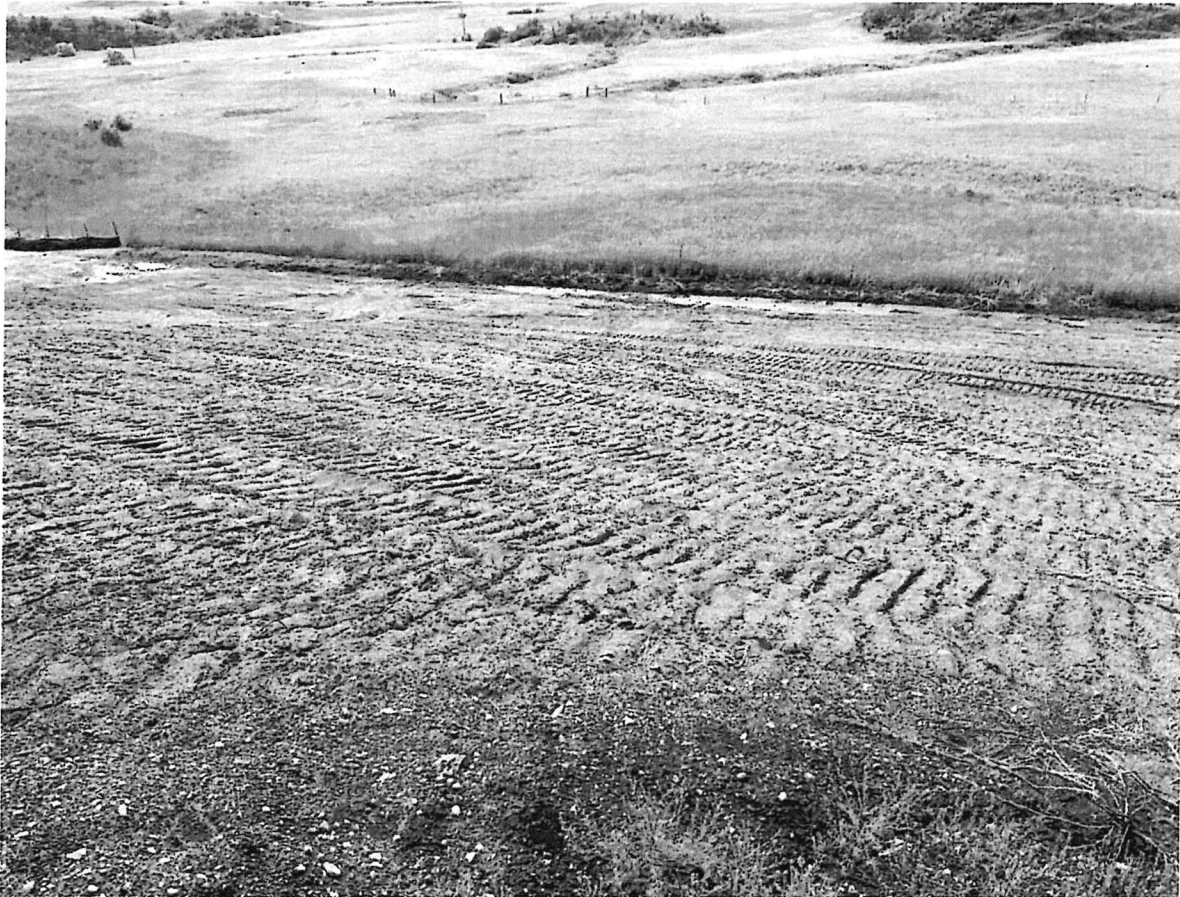
The south embankment of the primary haul road in Section 10 has been recently graded to address some gully erosion caused by surface water runoff. An additional silt fence at the toe of the south embankment and a ridged edge was also observed serving to protect the existing vegetation south of the toe from sediment deposition during rain events (**Figure 1**).

Figure 1: The south embankment along the primary haul road located in Section 10 has been regraded to address gully and rill erosion that was observed on previous inspections. A silt fence has been installed on the east end of the embankment toe. The ridged edge bordering the existing undisturbed vegetation has been defined to direct water to the west where more erosion control features exist such as another silt fence and a sump.

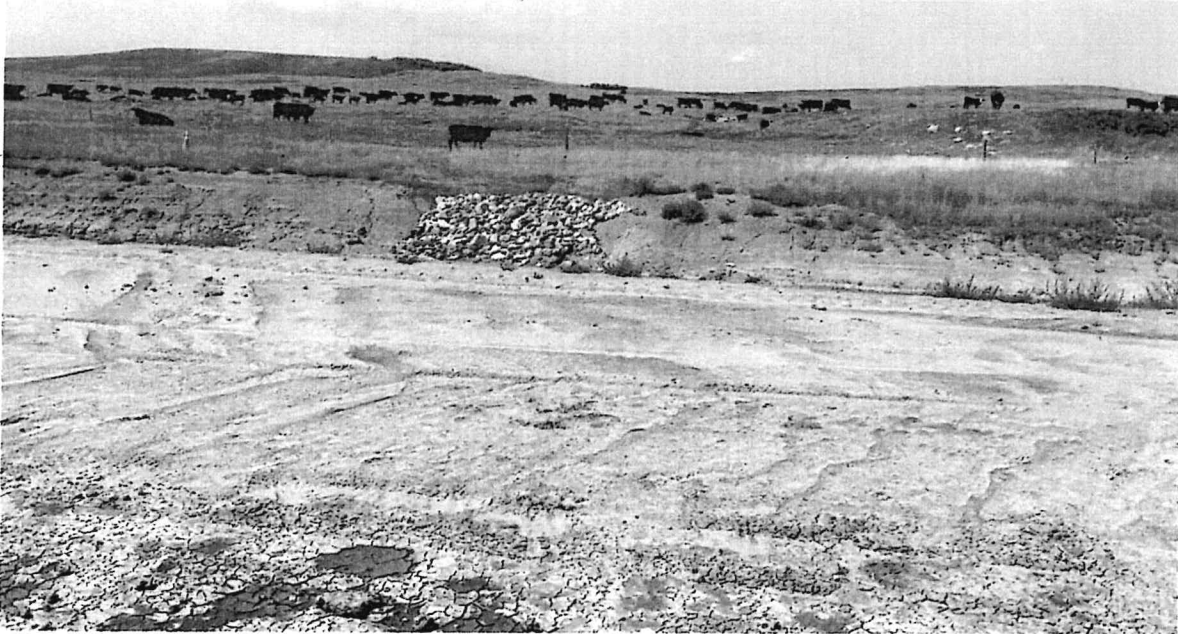
Figure 2: Riprap has been installed to minimize water erosion within the tie-in embankment of the west ditch of the dragline access trail located in the N½ of Section 1.

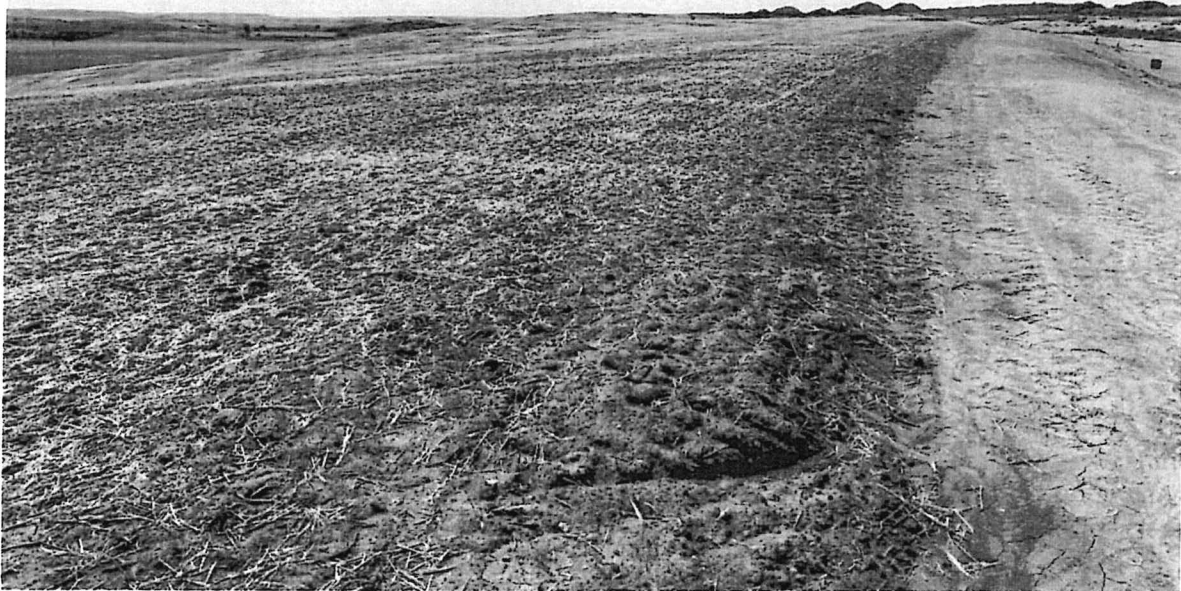
Figure 3: Grade approval COY-035, located in Section 6 and approved 5/9/2023, has been respread with SPGM, seeded with oats, and mulched.

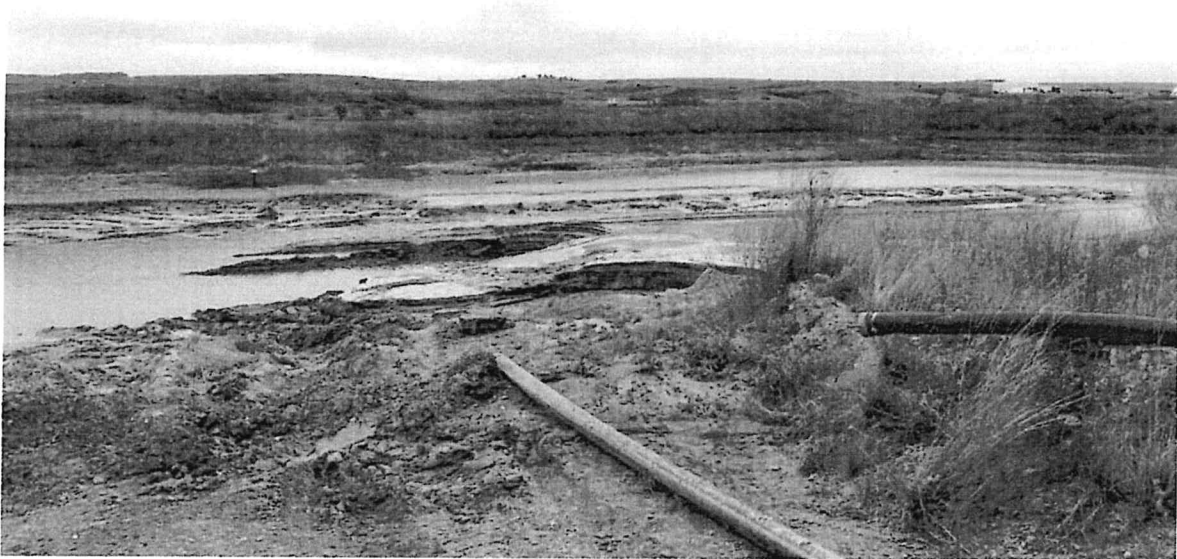
Figure 1: Sedimentation Pond P30-02 located in the NW¼ of Section 30 was observed to have sediment within the pond basin. Pond P30-02 was previously dredged in the summer of 2023 but the dredger was unable to successfully remove all of the sediment; therefore, CCMC plans to utilize a long reach backhoe to remove the remaining sediment.
