Supplemental CR Exhibit 57 - Exhibit 40 - Inspection Reports (Color)

Casey and Julie Voigt v. Coyote Creek Mining Company, LLC

Inspection Reports

INSPECTION REPORT

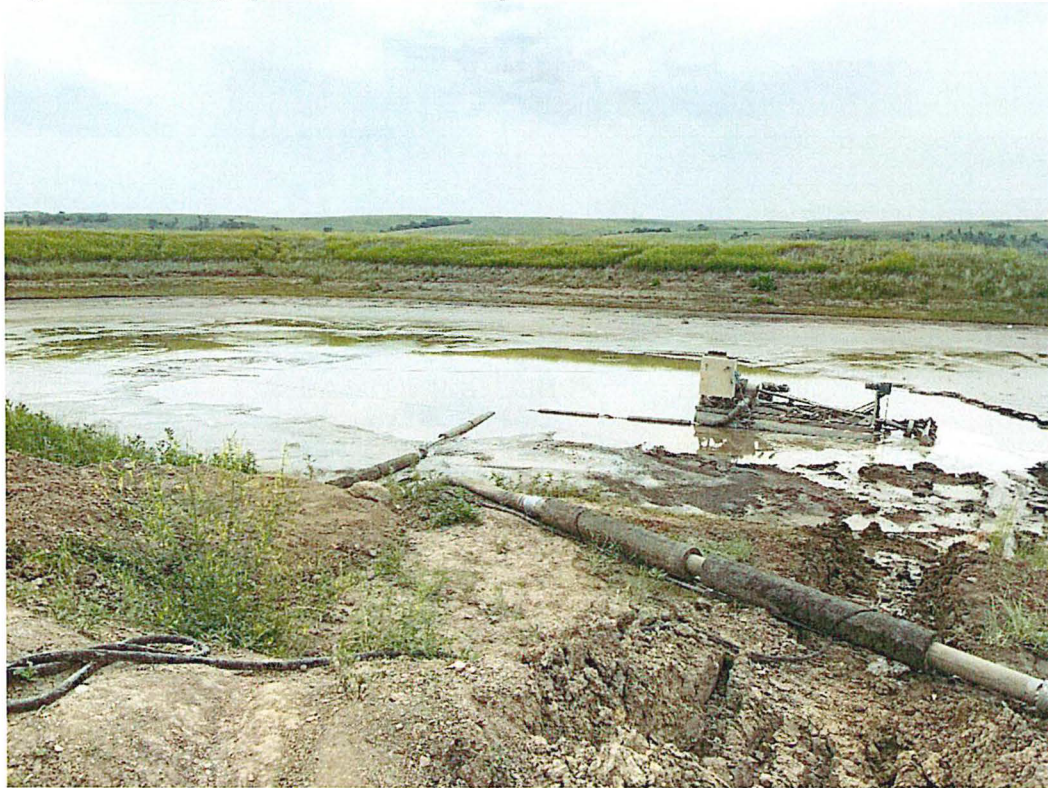
Figure 1. Dredging operation in sediment pond P30-02.

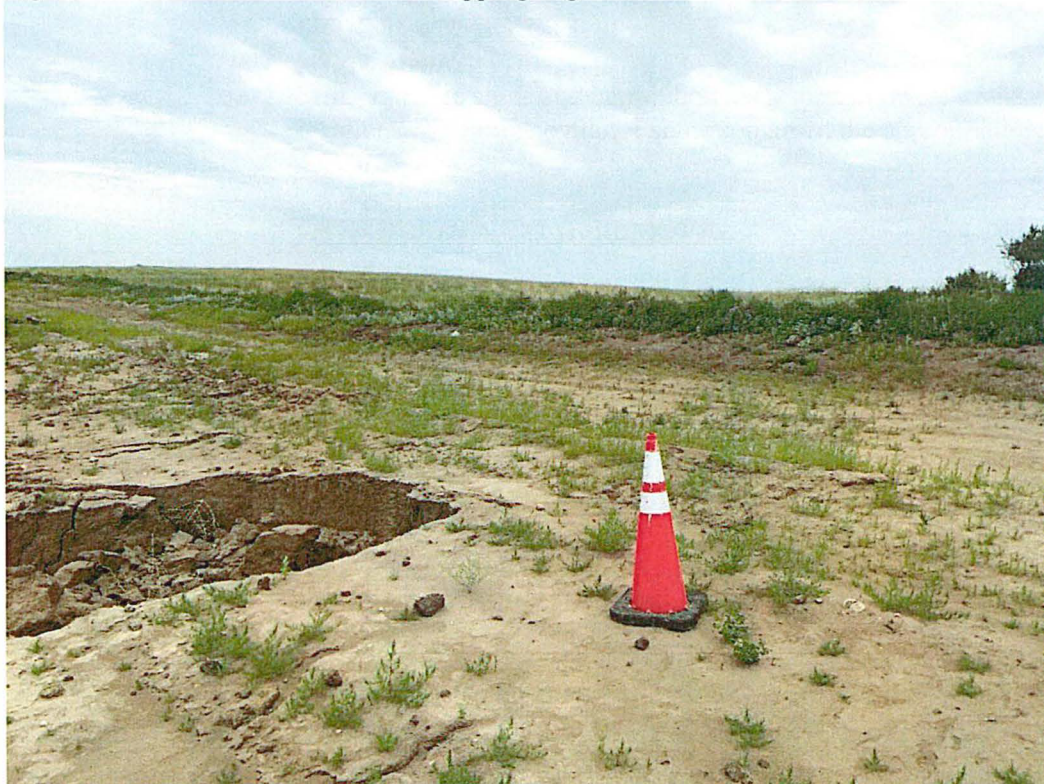
Significant head cutting erosion was observed near the stripping edge in the SW¼ of Section 25 (**Figure 2**). Coyote Creek Mine will have to mitigate this to prevent the erosion feature from expanding to the adjacent undisturbed land.

Figure 2. Head cut erosion near the stripping edge in the SW $\frac{1}{4}$ of Section 25.

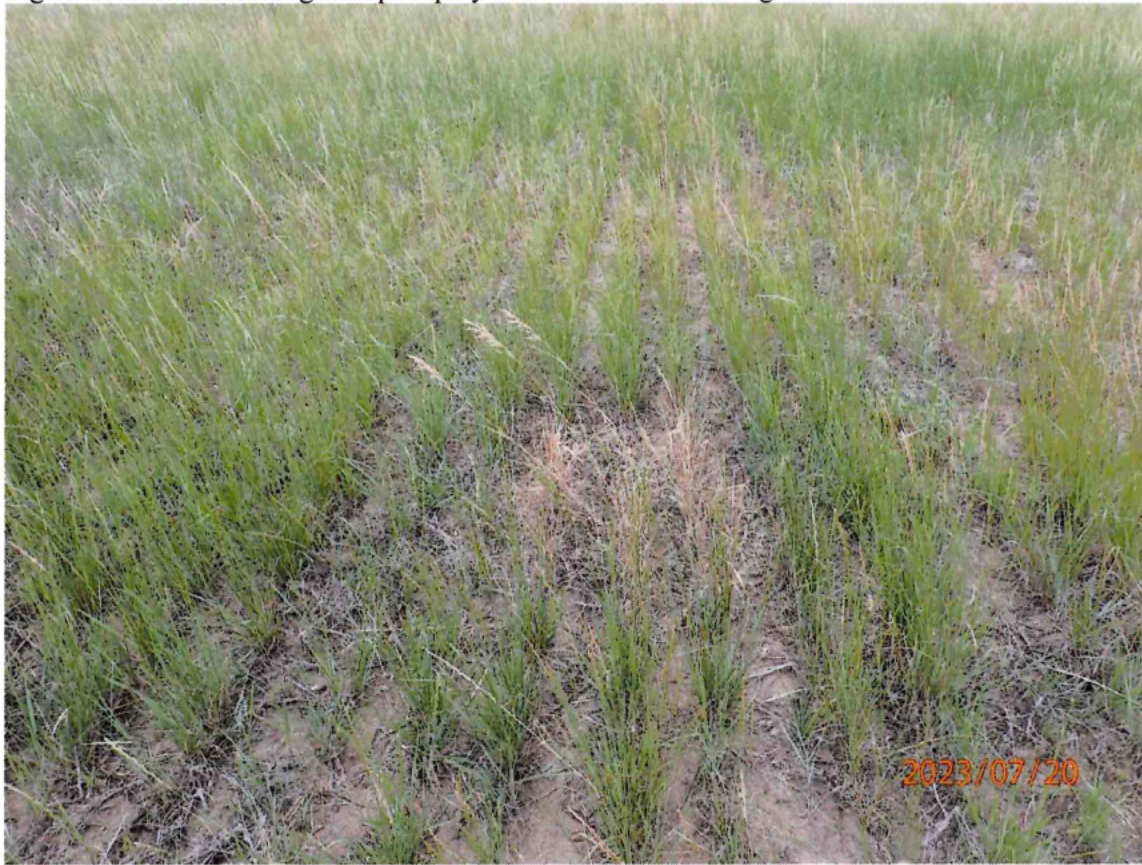
Figure 1: Smooth brome grass spot sprayed on reclaimed native grassland in Section 36.

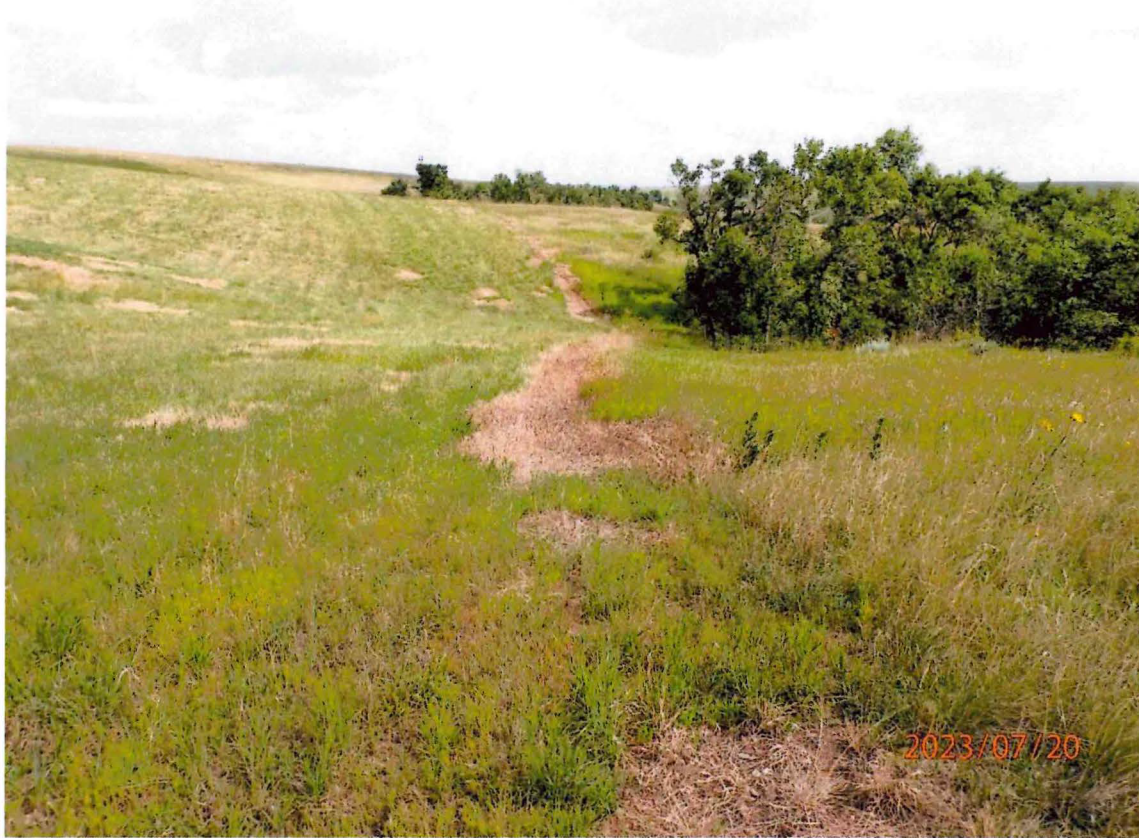
Figure 2: Smooth Brome grass spot sprayed in SE¼ of Section 24.

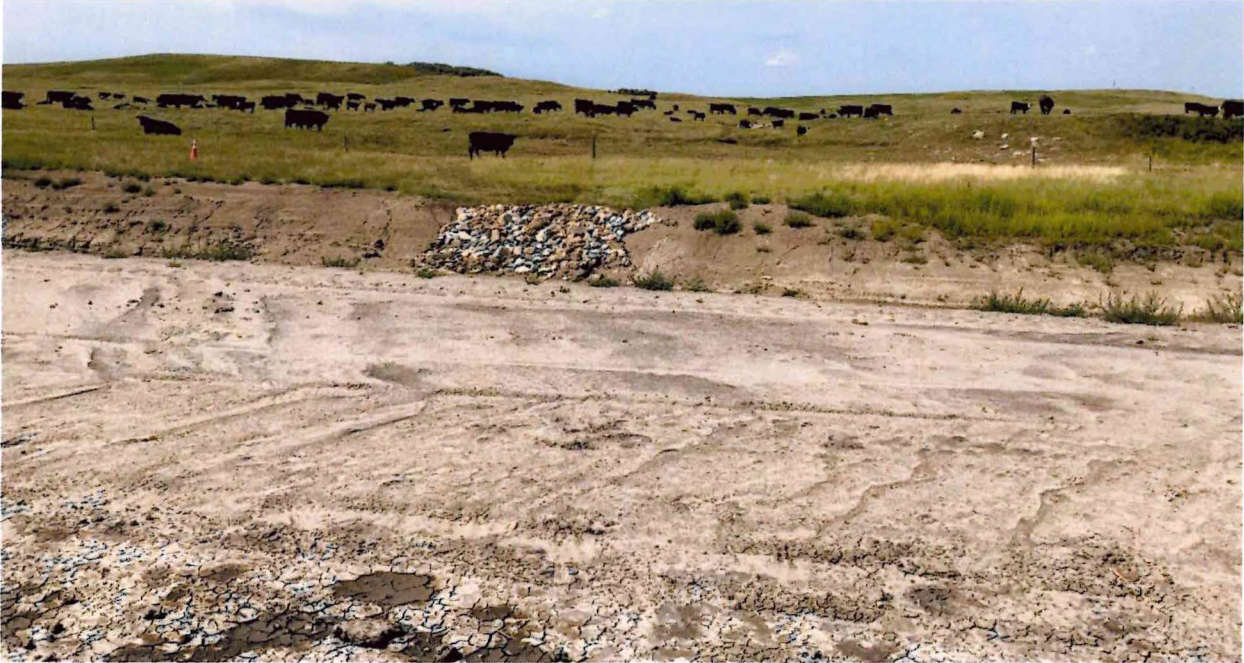
Figure 2: Riprap has been installed to minimize water erosion within the tie-in embankment of the west ditch of the dragline access trail located in the N½ of Section 1.

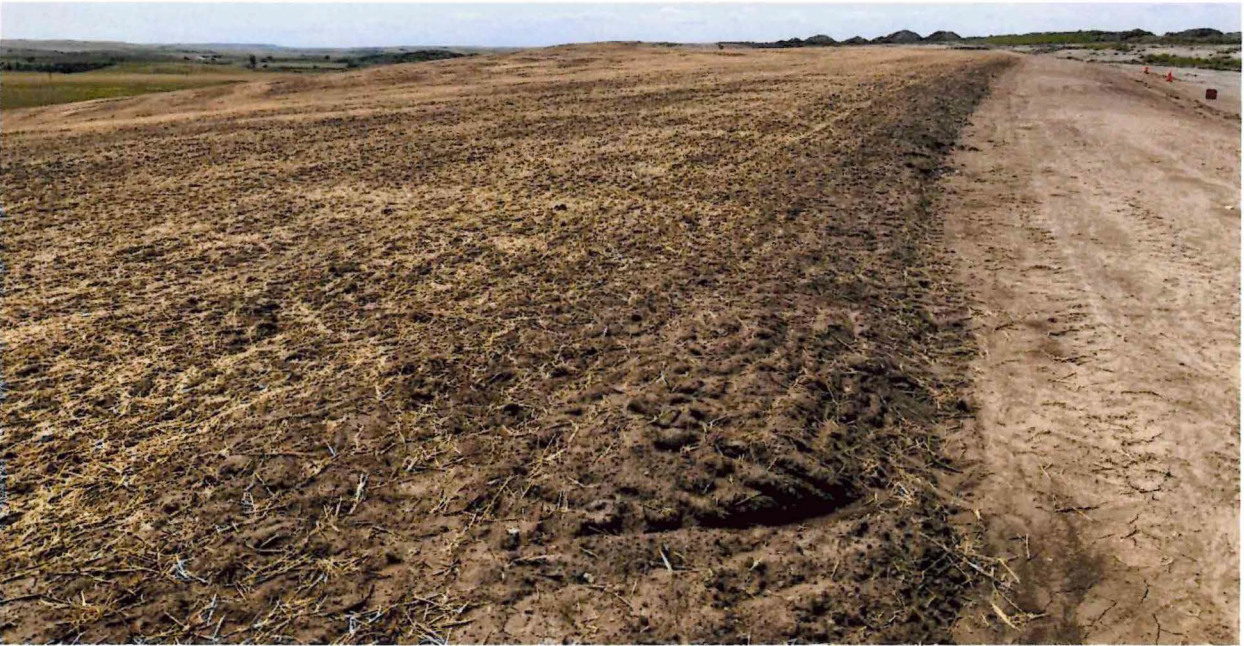
Figure 3: Grade approval COY-035, located in Section 6 and approved 5/9/2023, has been respread with SPGM, seeded with oats, and mulched.

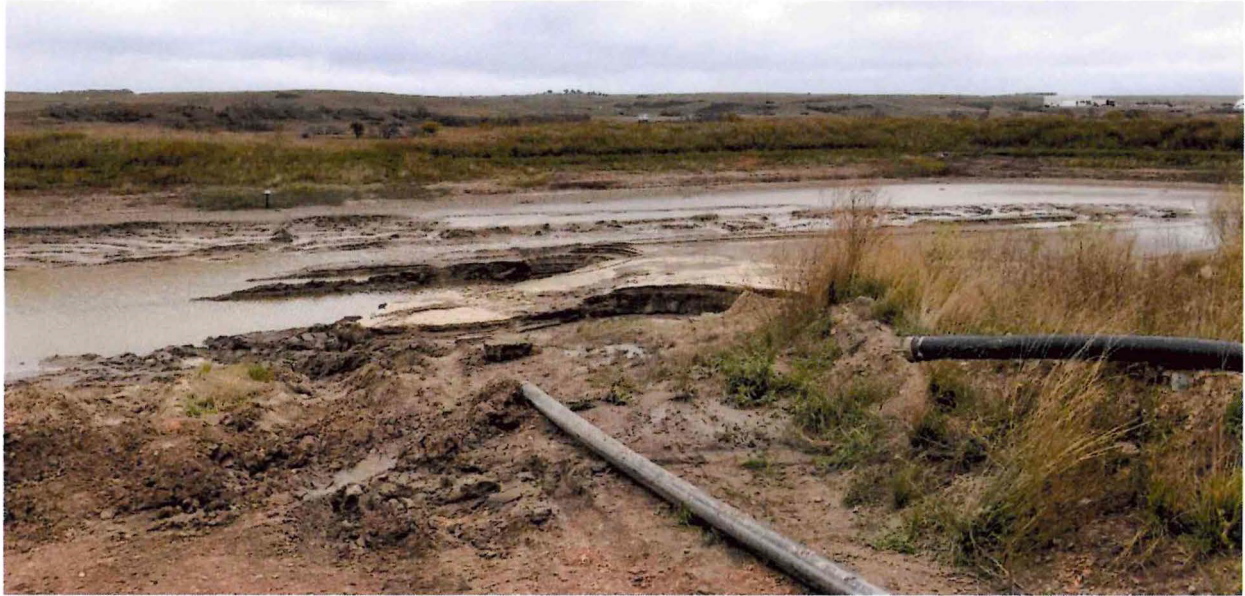
Figure 1: Sedimentation Pond P30-02 located in the NW¼ of Section 30 was observed to have sediment within the pond basin. Pond P30-02 was previously dredged in the summer of 2023 but the dredger was unable to successfully remove all of the sediment; therefore, CCMC plans to utilize a long reach backhoe to remove the remaining sediment.
