Public Service Commission State of North Dakota

INSPECTION REPORT

DATE OF INSPECTION: November 9, 2023
TYPE OF INSPECTION: Partial
PERMITTEE - MINE: Westmoreland Beulah Mine (WBM) - Beulah Mine
PERMITS INSPECTED: KRSB-8603; KRSB-8802
PERSONS ACCOMPANYING INSPECTORS: None
INSPECTION CONDITIONS: The inspection was conducted between 10:00 a.m. and 12:00 p.m. CST. Skies were cloudy, and the temperature was near 31° F.

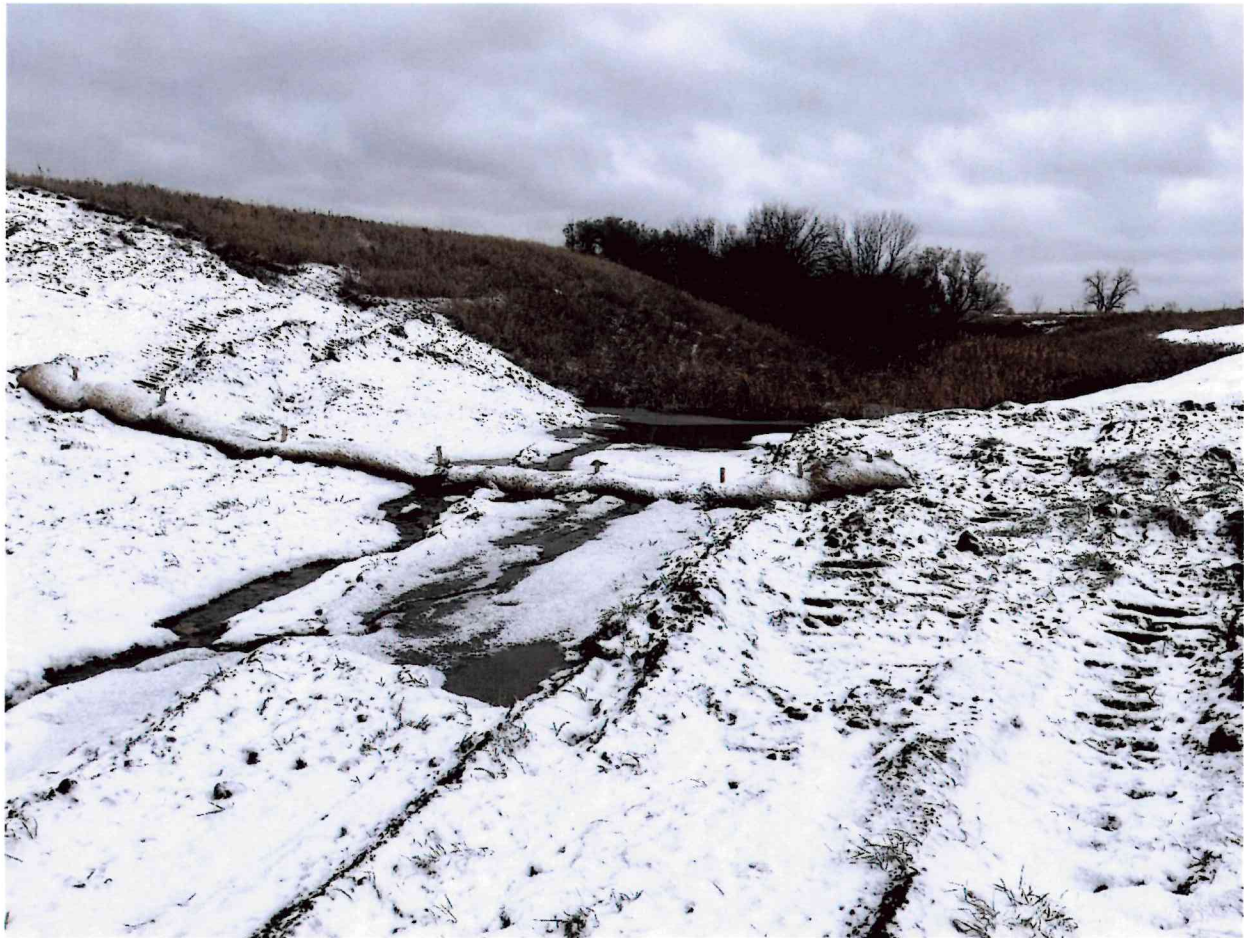
Significant erosion of SPGM was discovered along the reconstructed drainageway within grade approval Gold-01-2022 in Section 22 of Permit KRSB-8603, which was approved on June 30, 2023. At the time of the inspection, the grade approval area had been respread with topsoil and subsoil. The grade approval area had not been mulched, but bales of hay were located adjacent to the respread area on graded spoil. Several fiber rolls had been placed perpendicular to the drainageway within the respread area, but surface water runoff was passing below them through erosional features (**Figures 1 and 3**). In addition, a significant head cut has developed near the eastern edge of the grade approval adjacent to graded spoil (**Figure 2**).

Figure 1 – Upstream end of reconstructed drainageway within grade approved area Gold-01-2022 — (looking southwest) in Permit KRSB-8603.

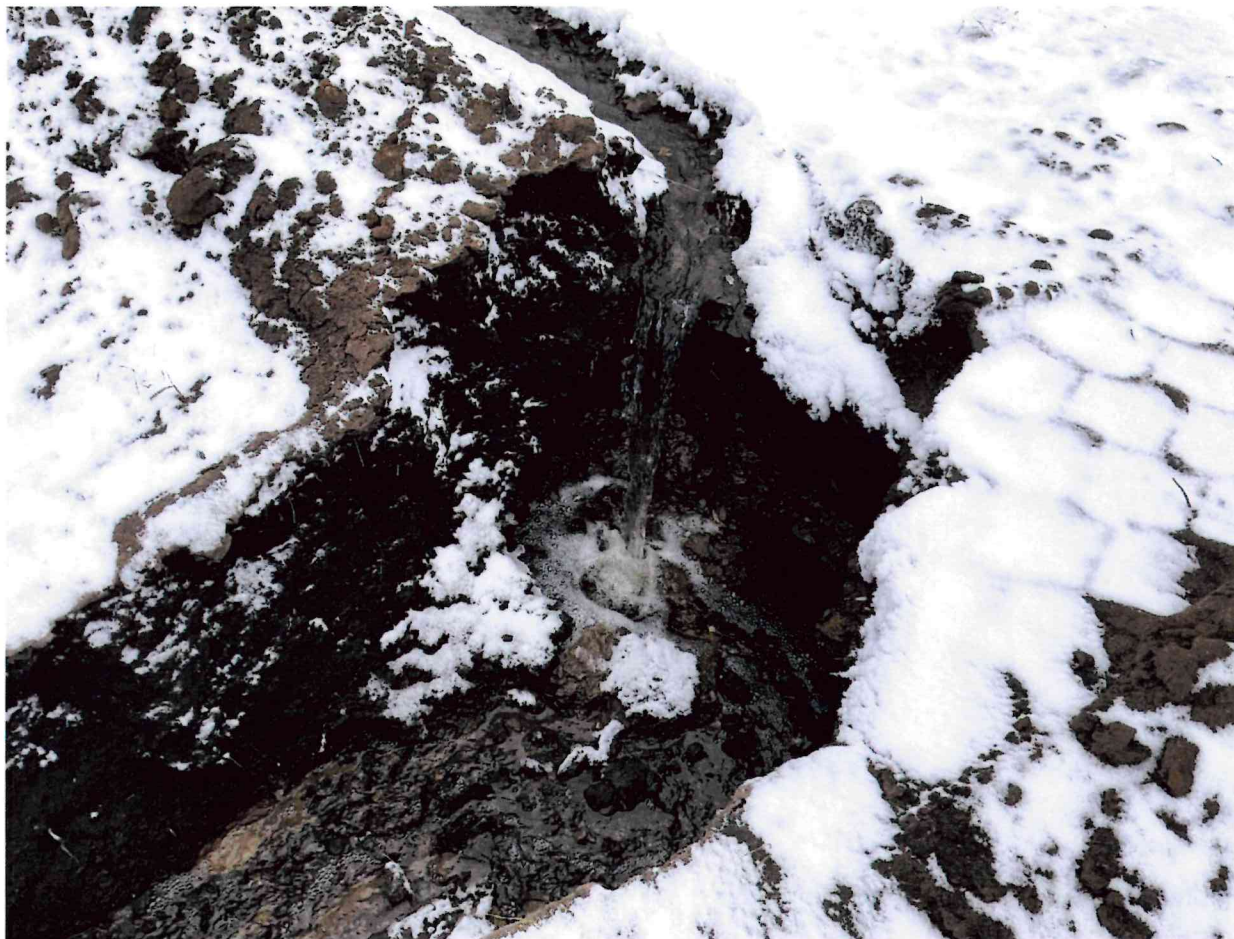
Erosional features were present along the entire length of the reconstructed drainageway (approximately 150 feet in length and three to six inches deep) above the head cut. The head cut was approximately three feet deep and the erosional feature below the head cut continued for approximately ten feet downstream of the head cut to the edge of the grade approval area. **Figures 4 and 5** depict the erosional features immediately above and below the head cut. The surface water runoff from this area is controlled by sediment pond P112.

Additional information regarding the events that led up to the erosion of this area was requested from WBM. According to WBM, the Gold-01-2022 grade approval was respread with subsoil in July 2023 and topsoil was respread from October 19th to October 23rd, 2023. They indicated that no water was passing through drainageway while they were resspreading SPGM in the grade approval. They also stated that the mine received approximately 13 inches of snow, which had a snow-water equivalent of 1.33 inches, from October 26th to October 27th and 0.5 inches of rain was received on November 6th. NDAC 69-05.2-15-04(5) requires appropriate measures to be taken to protect areas from water erosion and NDAC 69-05.2-22-05 requires that mulching or other stabilizing practices be used on all regraded and topsoiled areas to control erosion. WBM failed to properly stabilize the respread area to protect it from erosion.

Figure 2 – A head cut and plunge pool that has formed on the east edge of grade approval Gold-01-2022 in Permit KRSB-8603.

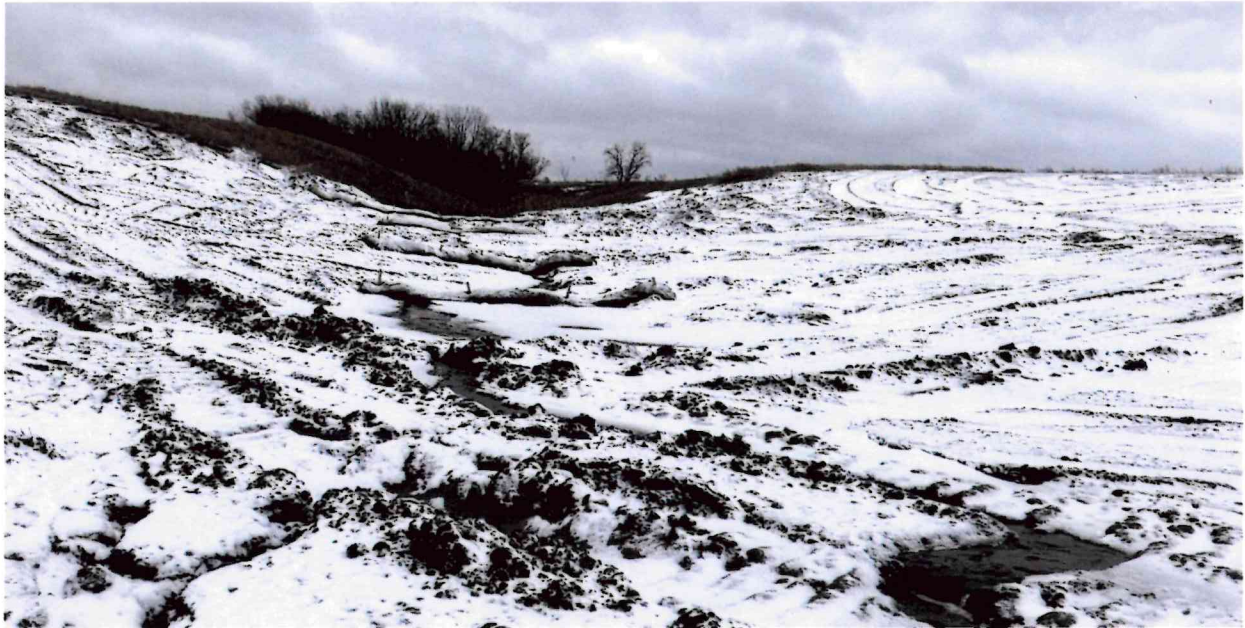
Figure 3 – Erosional features and the poorly shaped drainageway within grade approval Gold-01-2022 in Permit KRSB-8603 — (above the head cut; looking southwest).

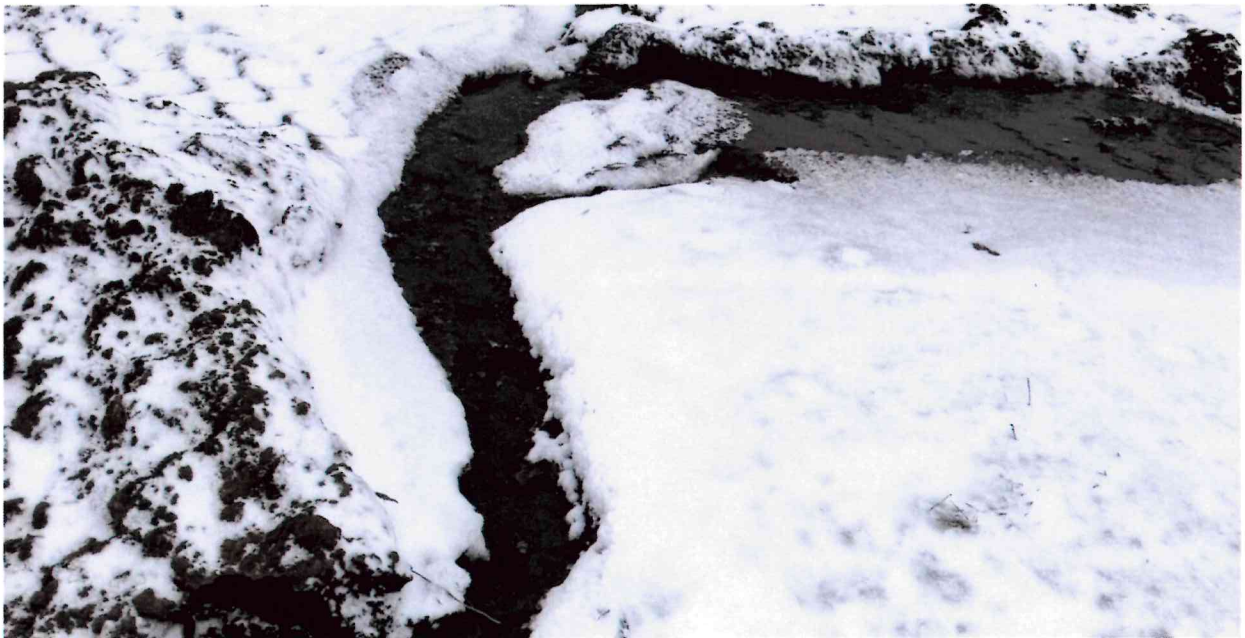
Figure 4 – Erosional feature immediately above the head cut in Permit KRSB-8603.

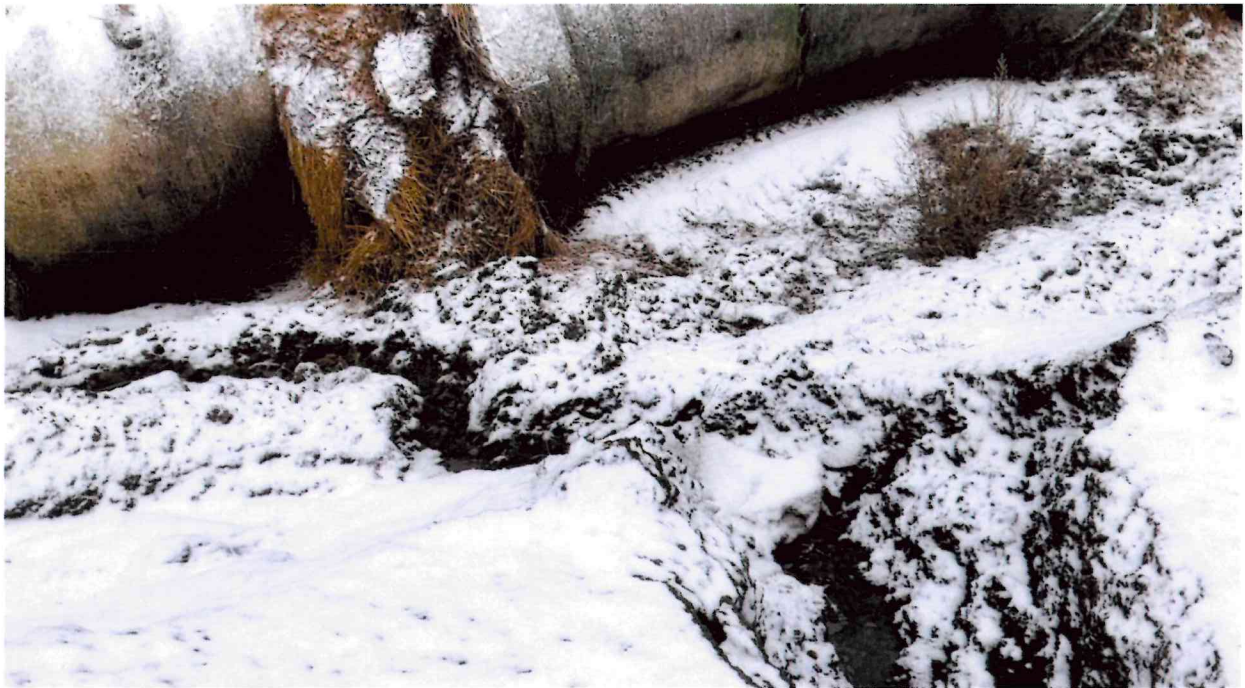
Figure 5 – Erosional feature immediately below the head cut and plunge pool.
