Public Service Commission
State of North Dakota

INSPECTION REPORT

DATE OF INSPECTION: November 15, 2023

PERMITTEE - MINE: Westmoreland Beulah Mine - Beulah Mine

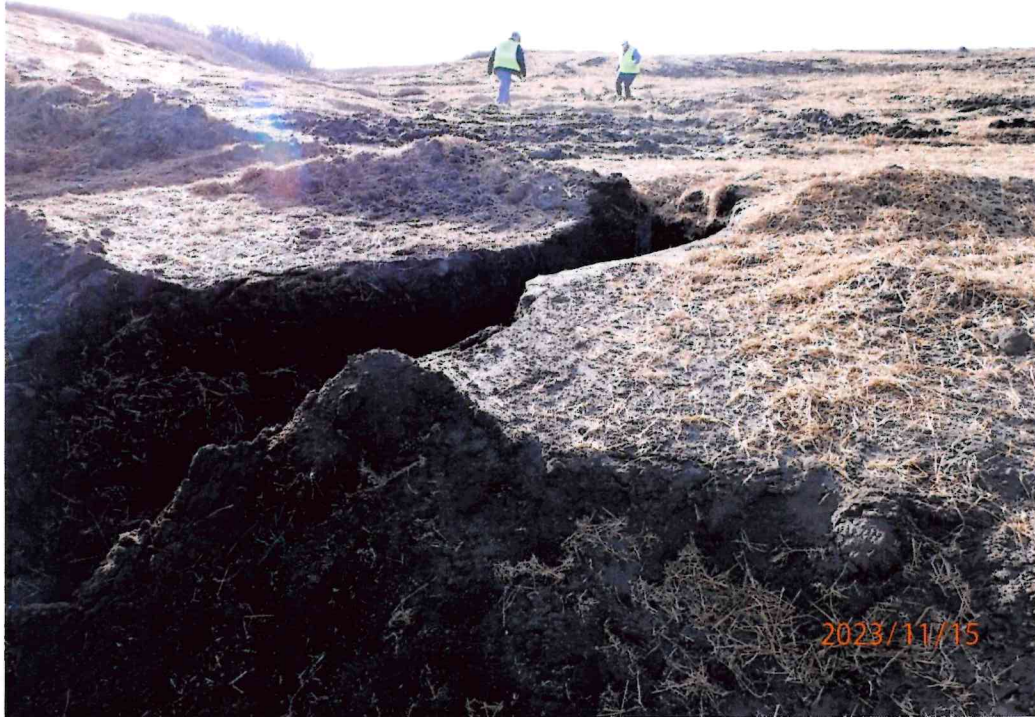
In follow-up to the inspection conducted November 9, 2023, the recently reclaimed drainageway in the NE¼NW¼SW¼ of Section 22 of Permit KR5B-8603 was inspected. This drainageway is associated with the Gold_1_2022 grade approval request on Schmidt et. al. property. An active headcut and a rill/gully were observed in the drainageway. The headcut has formed where surface water runoff is passing from the respread topsoil and subsoil onto adjacent graded spoil that is about 5 feet lower in elevation. No measures were in place to prevent headcutting from occurring and water was flowing through the drainage. A series of straw wattles were observed in the reclaimed drainageway, but surface water runoff was passing under the straw wattles. This drainageway was recently mulched and the mulch was obscuring a clear view of the rill/gully. The rill/gully appeared to be about 1 foot wide and about 9 inches deep and it extended the length of the reclaimed drainageway. The headcut was about 3 feet deep, 3 to 4 feet wide, and about 8 feet in length. Photographs of the headcut and rill/gully were taken and are on file with the Reclamation Division. Three of these photographs are included in Figures 1, 2, and 3 at the end of this report.

The head cut revealed that at least two feet of topsoil had been respread in the Schmidt et. al. drainage way. Mr. Sharp indicated that the Schmidt et. al. surface owners did not have a soil mixing agreement, a decision was made to respread topsoil at a greater depth than planned in the drainage way to deplete the Schmidt et. al. topsoil stockpile. Exposed respread subsoil along the stripping edge in the drainage way appeared to contain a lot of gray colored spoil-like material.

Figure 1: Head cut and rill/gully on Schmidt et. al. property in NE $\frac{1}{4}$ NW $\frac{1}{4}$ SW $\frac{1}{4}$ of Section 22 of Permit KRSB-8603.

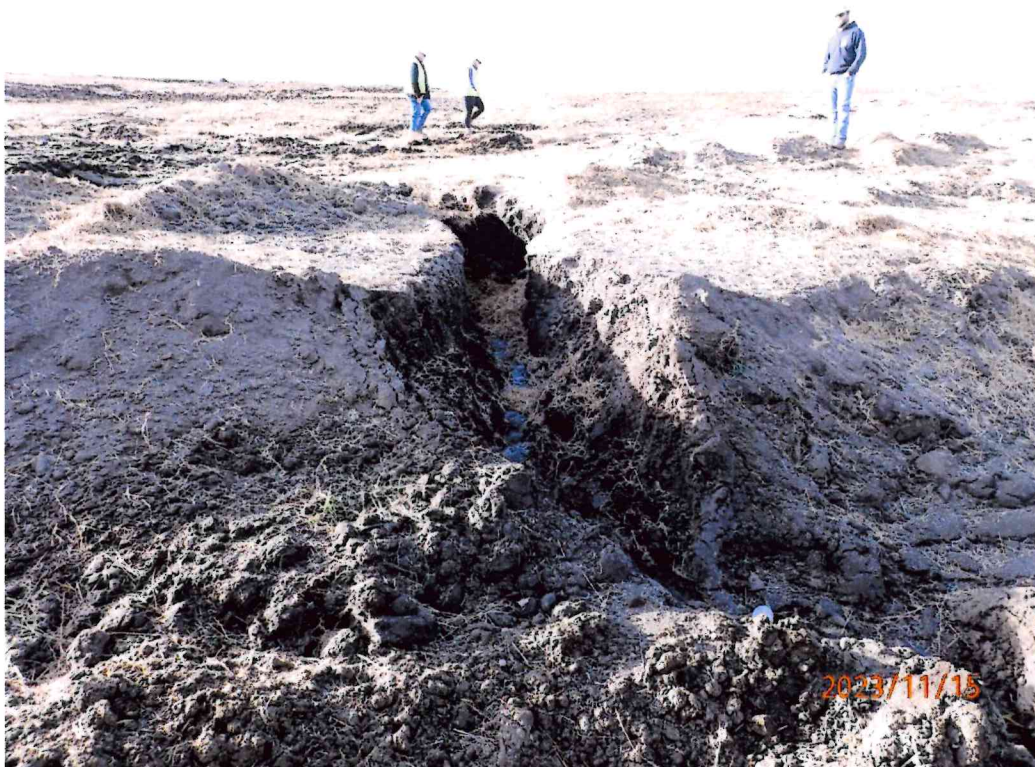
Figure 2: Head cut and rill/gully on Schmidt et. al. property in NE $\frac{1}{4}$ NW $\frac{1}{4}$ SW $\frac{1}{4}$ of Section 22 of Permit KRSB-8603.

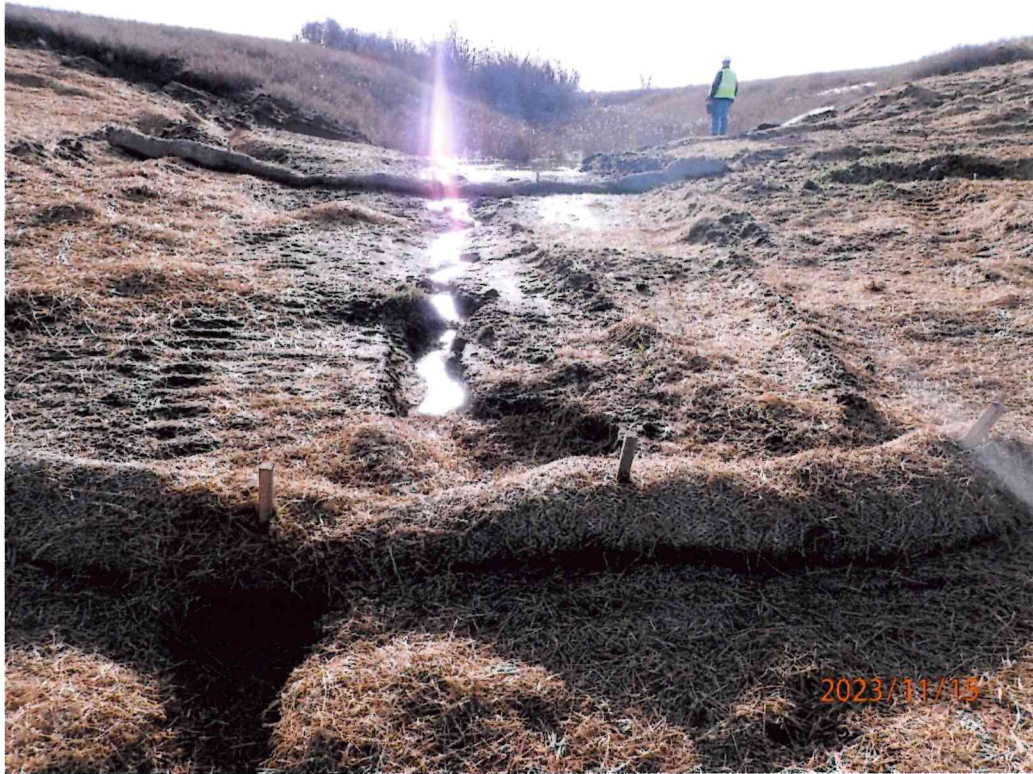
Figure 3: Head cut and rill/gully on Schmidt et. al. property in NE¼NW¼SW¼ of Section 22 of Permit KRSB-8603.
