# Public Service Commission

### INSPECTION REPORT

DATE OF INSPECTION: September 6, 2023

PERMITTEE - MINE: Westmoreland Beulah Mine - Beulah Mine

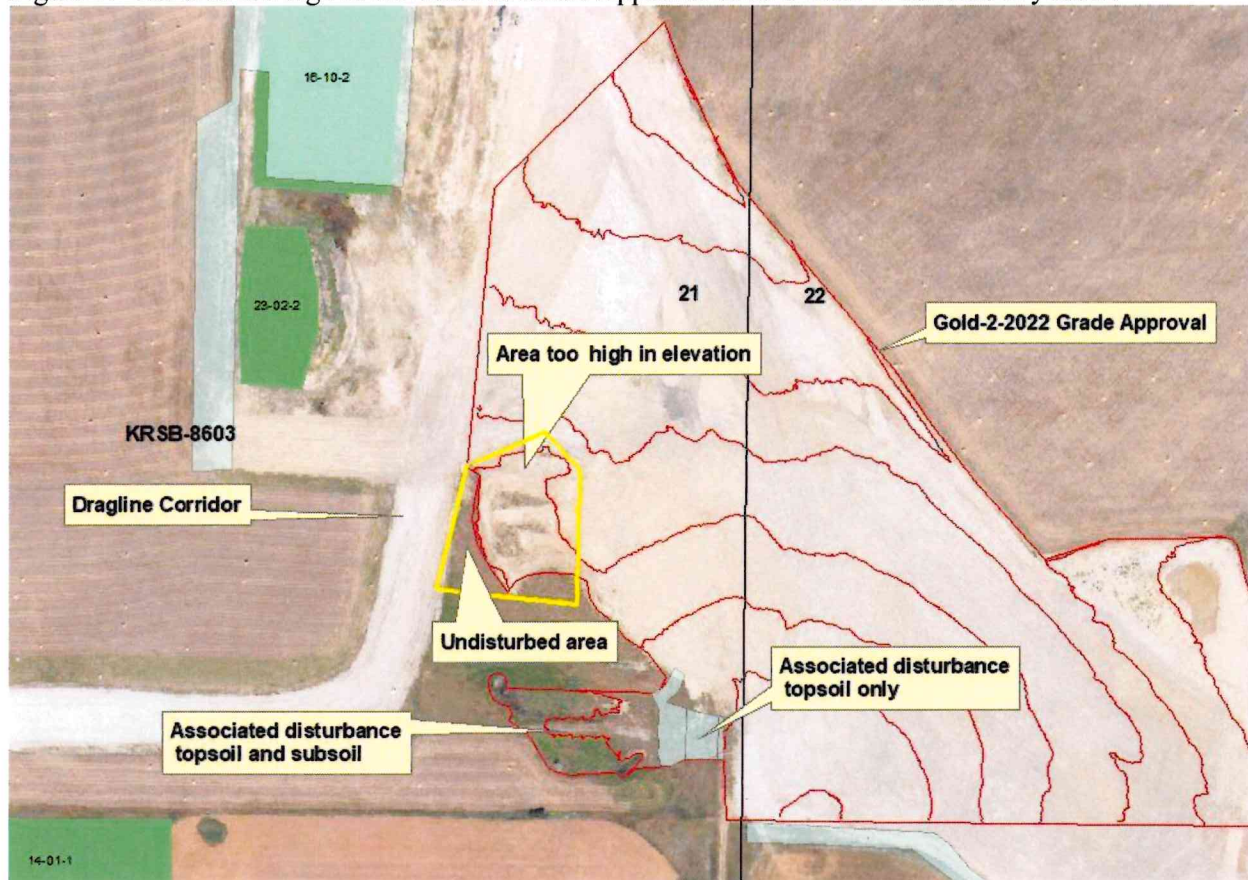
Muddy conditions limited access to Gold-2-2023 grade approval request. Most of this grade approval request area has been disked. The grade approval area has been shaped as depicted on the topographic map accompanying the request. Additional spoil is needed in areas where two feet of SPGM will not allow the reclaimed land to blend appropriately into adjacent reclaimed lands. The west side of this grade approval is located at the base of subsoil stockpile 16-10-2. This may hinder equipment access to the dragline corridor, and it is not clear how runoff from the dragline corridor will pass northward if this area is respread with SPGM.

Additional shaping is needed on a portion of this grade approval in the southeast corner of the NE¼ of Section 21. Figure 1 below depicts this area. Undisturbed land between the grade approval request and the dragline corridor is several feet higher in elevation than the grade approval area to the north. This area needs to be lowered in elevation to blend the grade approval request area and dragline corridor into adjacent undisturbed lands. WBM could make a written request to remove topsoil and subsoil from this undisturbed area. The topsoil could be placed on that portion of the grade approval area requiring topsoil only in the southeast corner of the NE¼ of Section 21. This could be accomplished prior to grade approval because the grade approval process does not apply to areas affected by associated mining disturbance, which is the case in this instance. Subsoil from this area could then be placed on the associated disturbance area requiring subsoil and topsoil in the southeast corner of the NE¼ of Section 21. Overburden under the subsoil could then be used where needed along the north and south sides of the grade approval request area. A corridor would need to be maintained through the area requiring topsoil only to maintain access to the area requiring both topsoil and subsoil located to the west. The pre-mine soils map, Exhibit 2.4.7 in the permit, indicates that there is 12 to 20 inches of topsoil and 40 to 48 inches of subsoil in this area. The topsoil and subsoil respread depths on areas of associated disturbance are to be determined by the depths present prior to disturbance (detailed soil survey).

Figure 1: The area too high in elevation in Grade Approval Gold-2-2023 is outlined in yellow.
