STATE OF NORTH DAKOTA
PUBLIC SERVICE COMMISSION

CASE No. PU-23-361

Basin Electric Power Cooperative
Roundup-Kummer Ridge 345-kV Transmission Line
Dunn & McKenzie Counties

Short Elliott Hendrickson Inc.
TOPSOIL INSPECTION REPORT

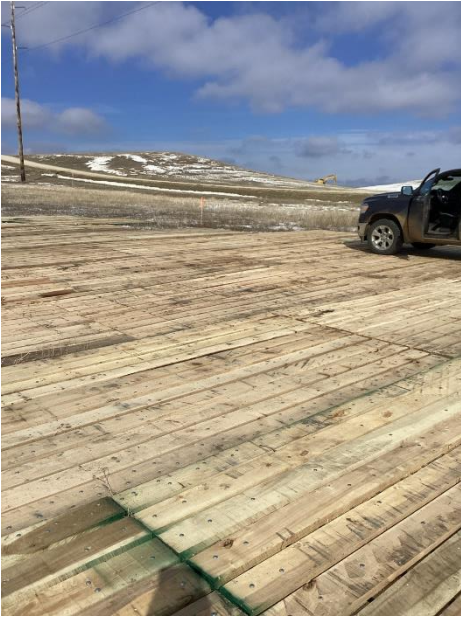
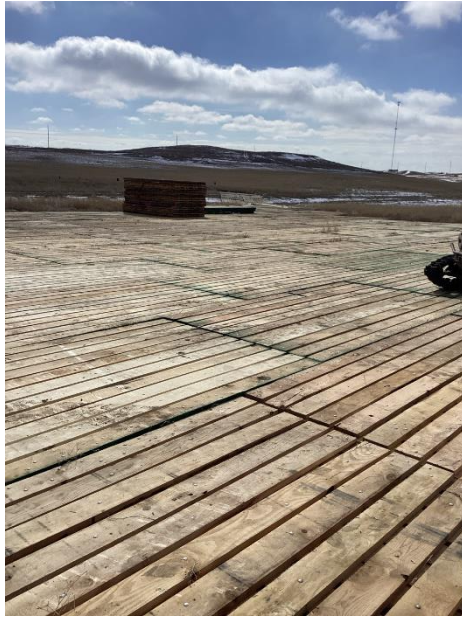
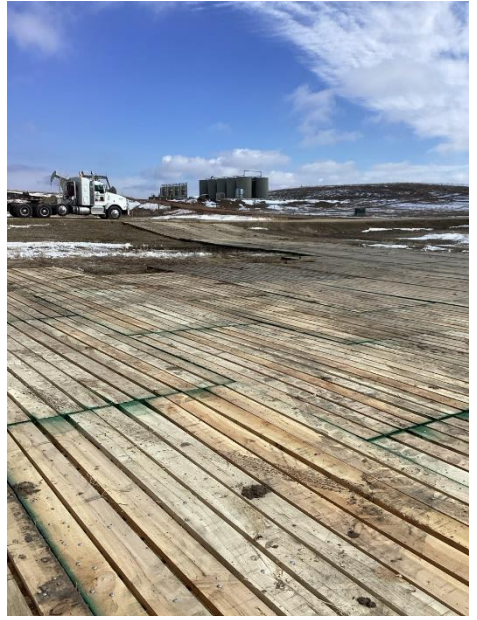
* TB Timberline had laid out wood matting to protect topsoil disturbance in wetland areas as identified in reporting included with the "Consolidated Application for Certificate of Corridor Compatibility". See photos #1 for example of the matting being laid out.

Overall Comments: Started Construction inspection at Structure #366-057 & #366-058. Wood matting was being spread at Structure #366-30 through #366-40's to limit impact to site vegetation and soils. See image #1 for example at Structure #366-057 site. Crain pad was excavated at Structure #366-058 using excavator and flat bucket for topsoil removal.

Point 1, Structure #366-057 site layout. Example of matting in use for site disturbance limitation

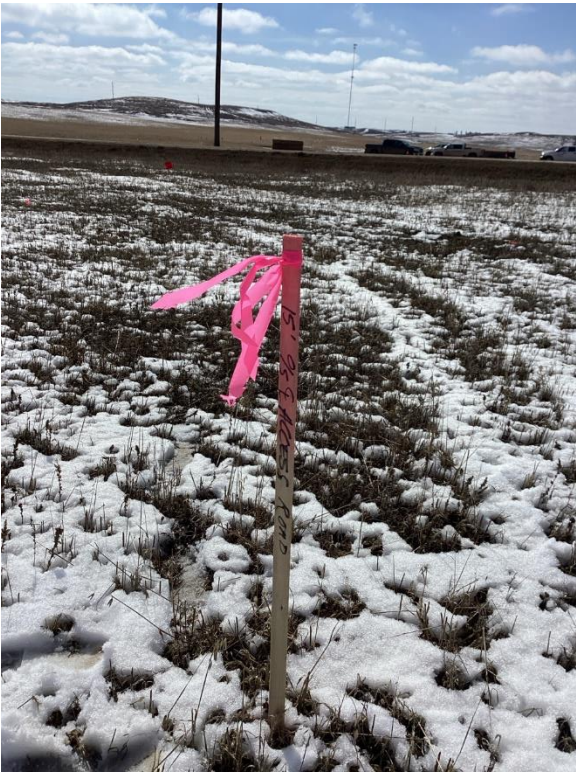
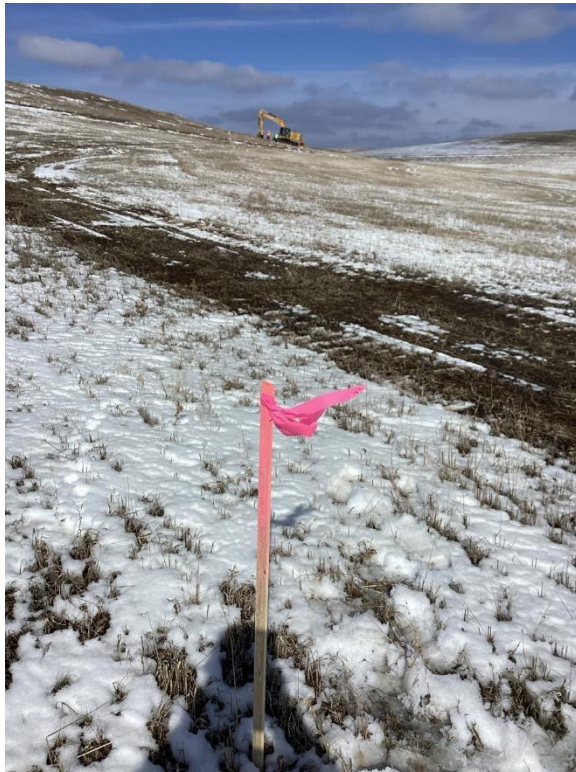
Point 2, Between Structure #366-057 & #366-058. Alignment and Flagging

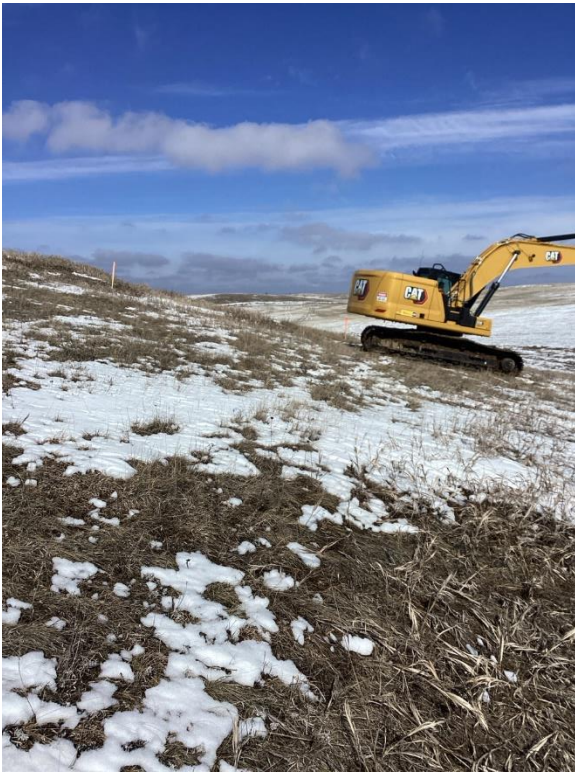
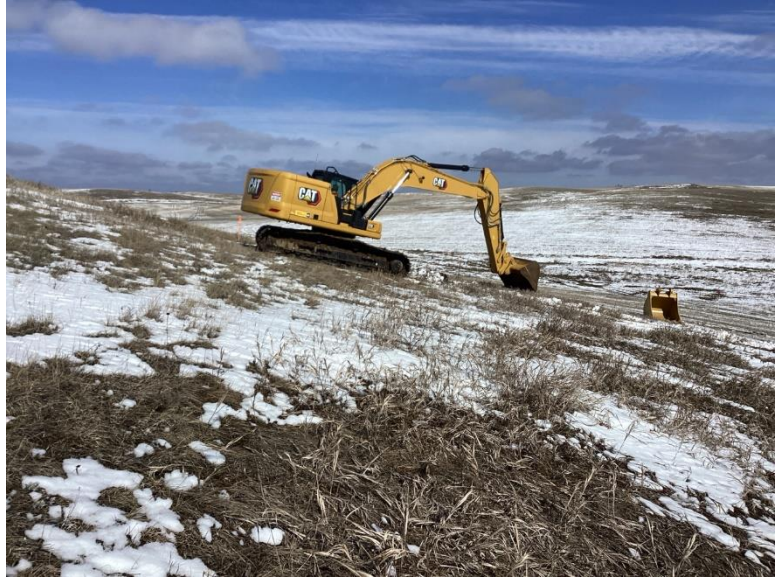
Point 3, Structure #366-058. Start of topsoil removal

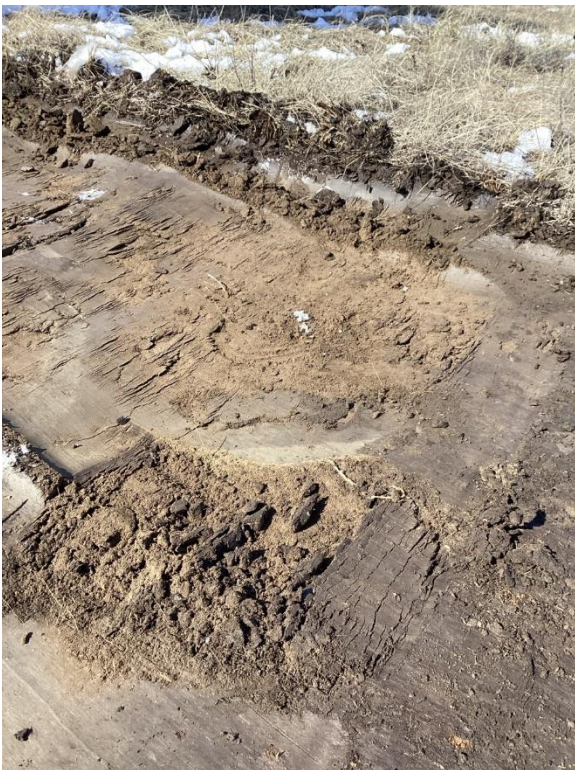
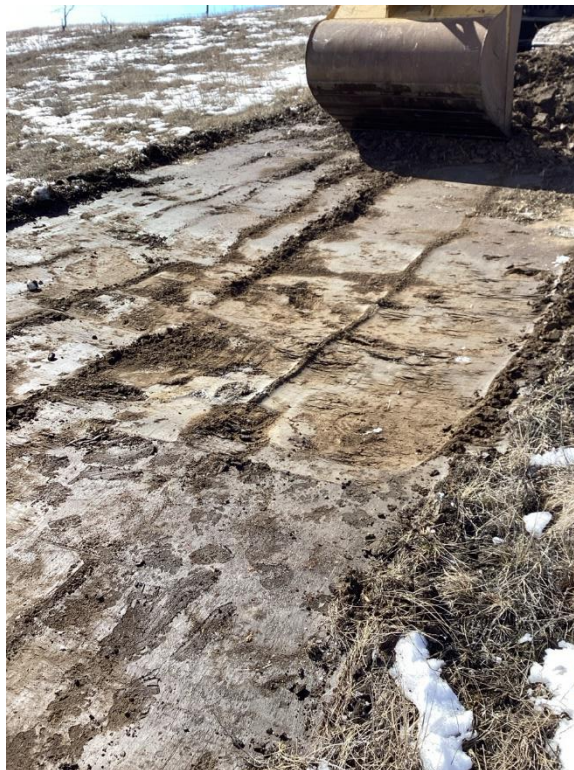
* TB Timberline performed topsoil removal at Structure # 366-058 using an excavator. At start, a smooth edged bucket was used to scrape topsoil but due to frost in the soils at approximately 10-12 inches thick, it was not effective. A bucket with teeth was used to break up the topsoil and then piled on the up-slope side of the location. See photos #4, 6, 7, and 9 as evidence of topsoil removal.

Comments: Use of excavator with flat bucket to peel back topsoil. Topsoil is frozen resulting in shaving of topsoil to remove. Upon inspection it was found that the topsoil is only approximately 4" thick in this area before it is changing to sandy loam subsoil

Point 4, Structure # 366-058. Topsoil removal depth shallow at approx. 4"

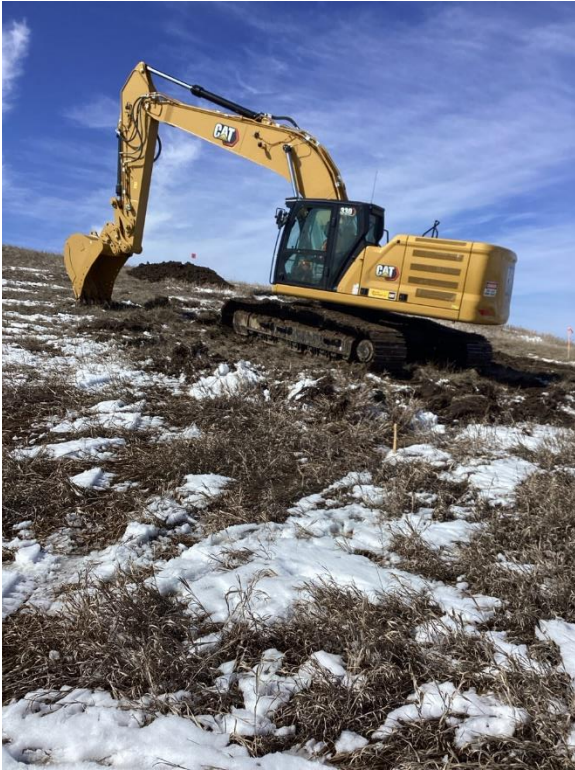
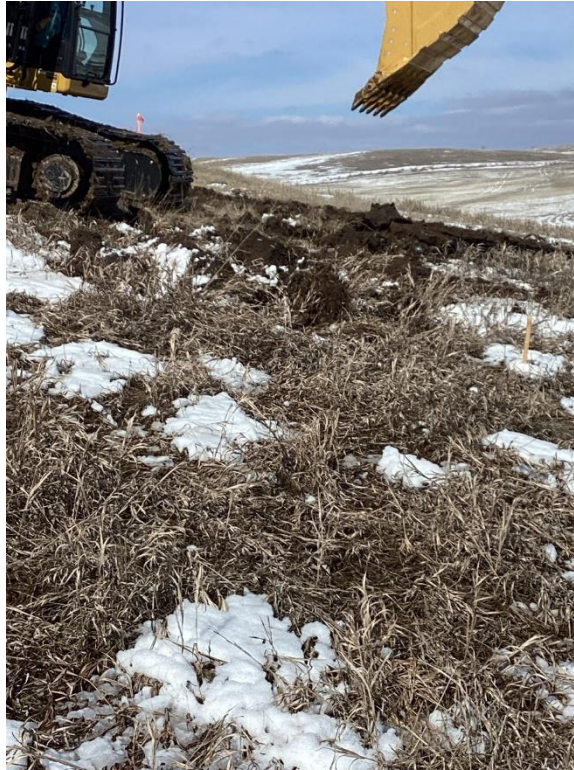
Comments: Excavator used bucket with teeth to break topsoil up to then scrape off with smooth bucket

Point 5, Structure #366-058. Broken up topsoil with tooth bucket

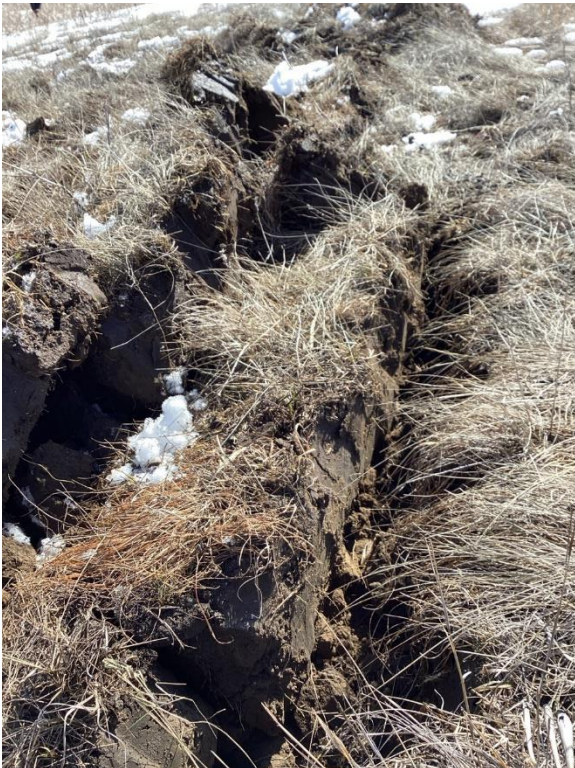
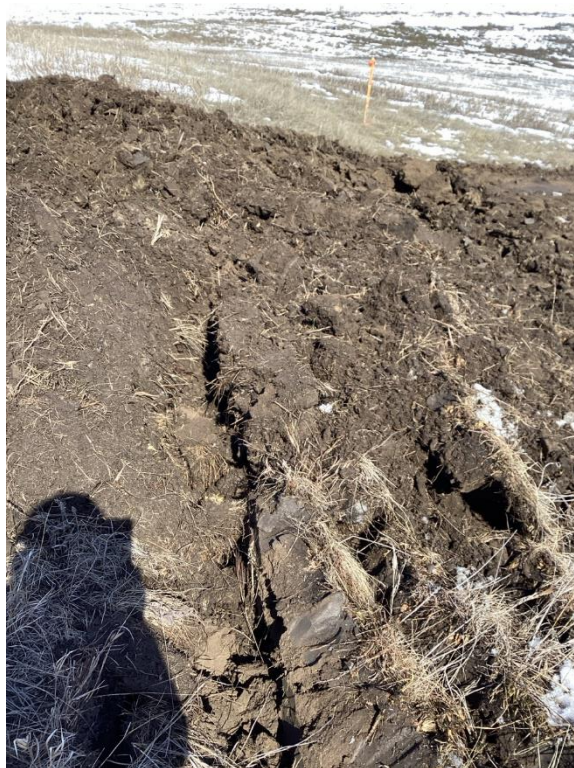
Point 6, Structure 366-058. Evidence of topsoil layers

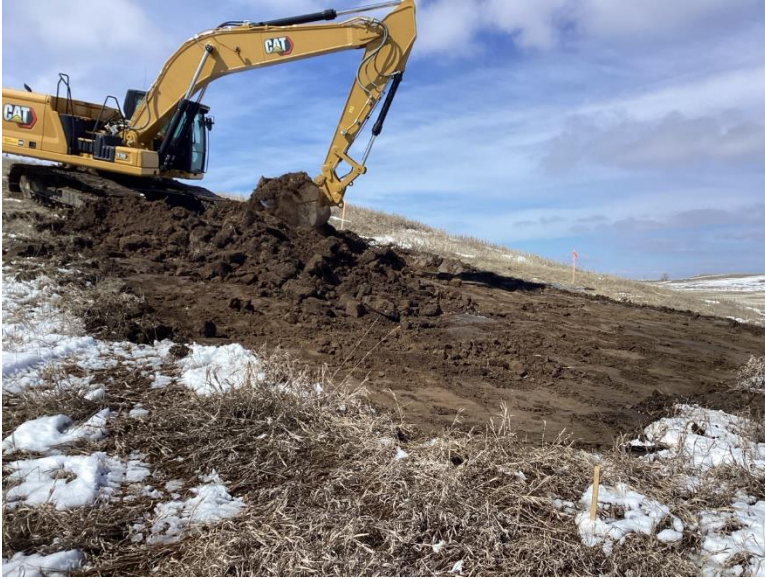
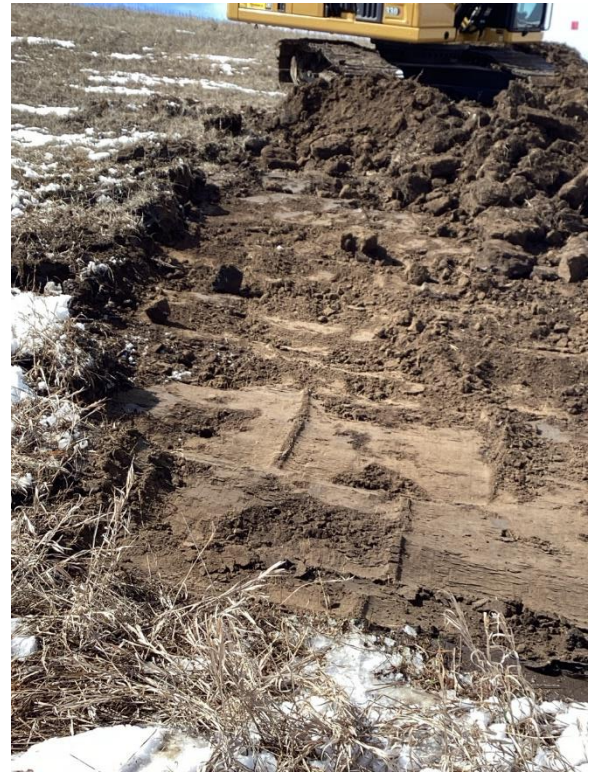
Point 7, Structure #366-058. Topsoil Removal

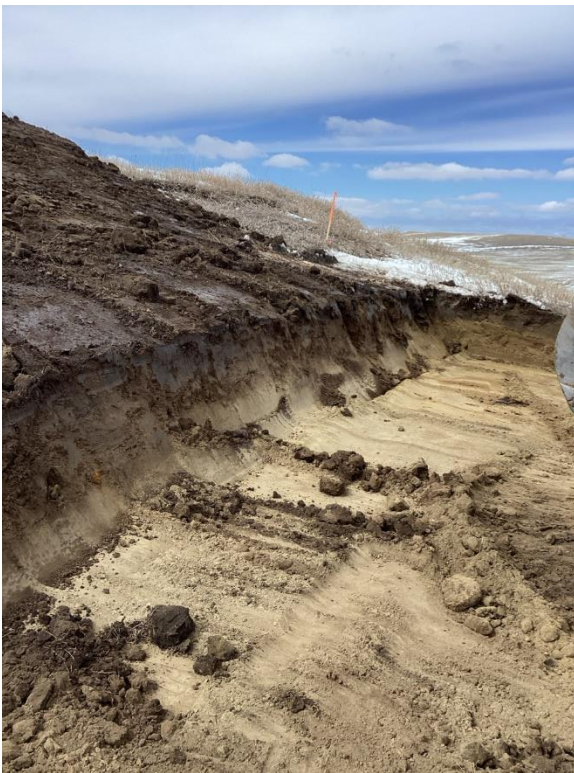
Comments: After topsoil, subsoil started to be cut and shaped for pad area. Kept within the limits of the topsoil stripping

Point 8, Structure #366-058. Start of subsoil cut and clear line of soil type transition

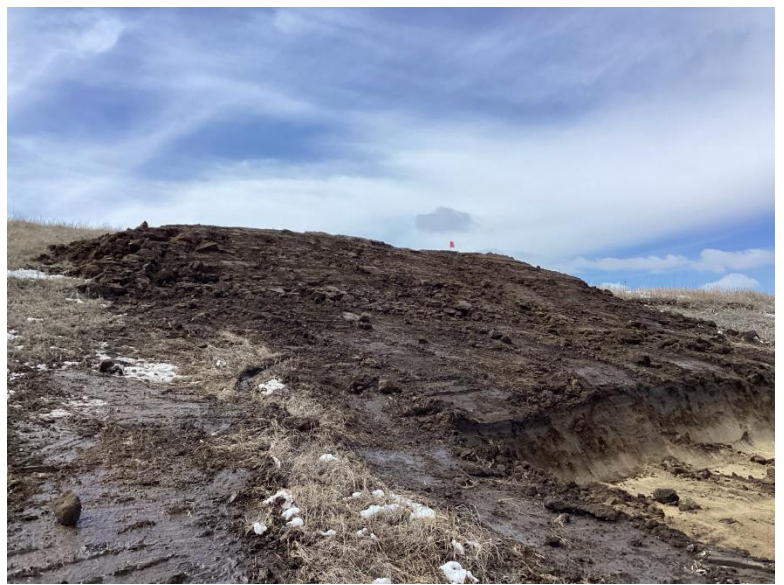
* Topsoil was stockpiled and packed with bucket on up-slope side of the pad area. A ditch was cut along the subsoil pad to facilitate drainage around the pad where planned silt fence will be placed for erosion control measures.

Point 9, Structure #366-058. Finished topsoil storage pile

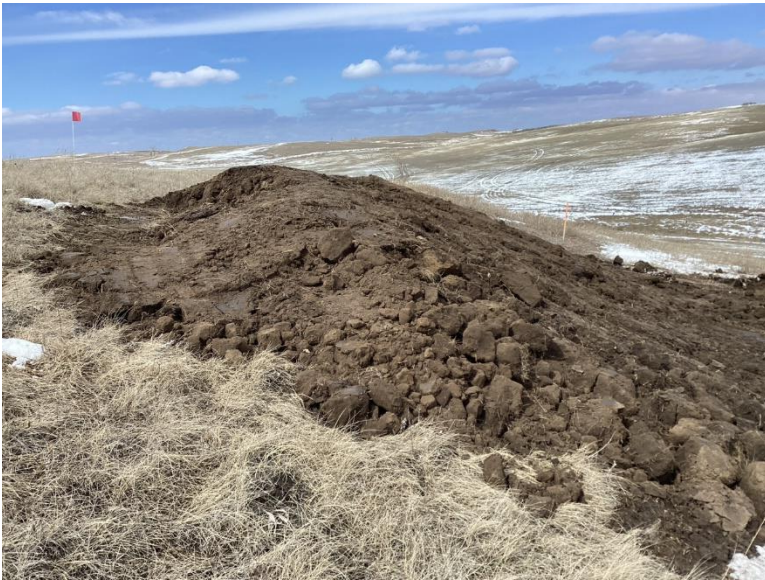
Point 10, Structure #336-058. Topsoil Pile

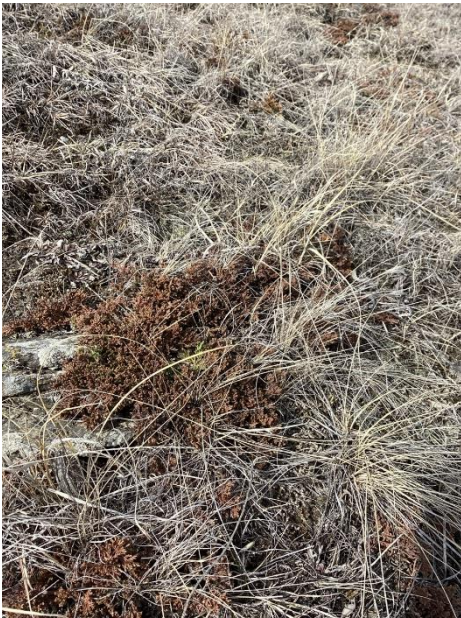
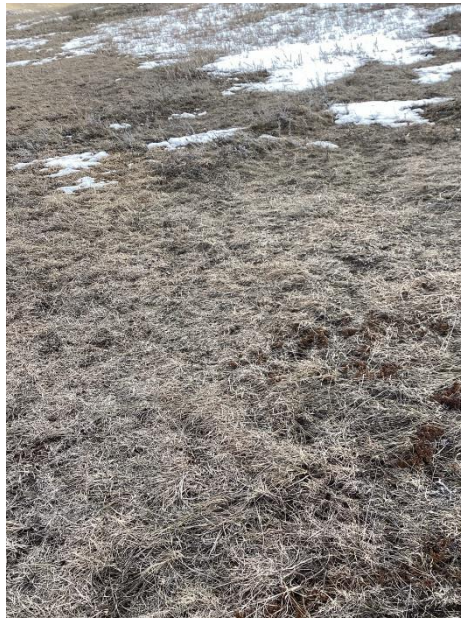
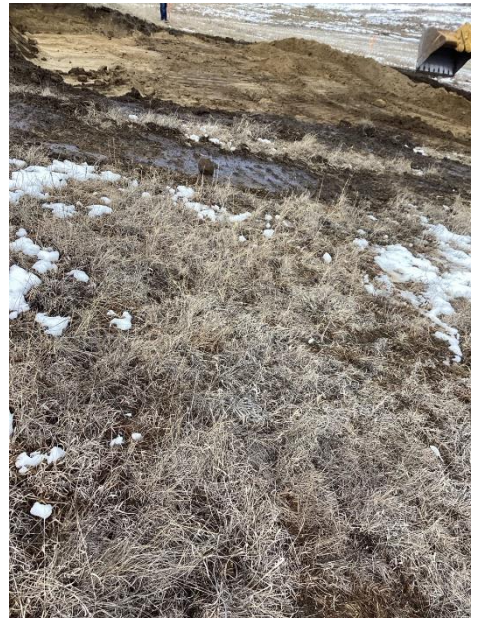
Point 11, Structure #336-058. Existing vegetation (example)

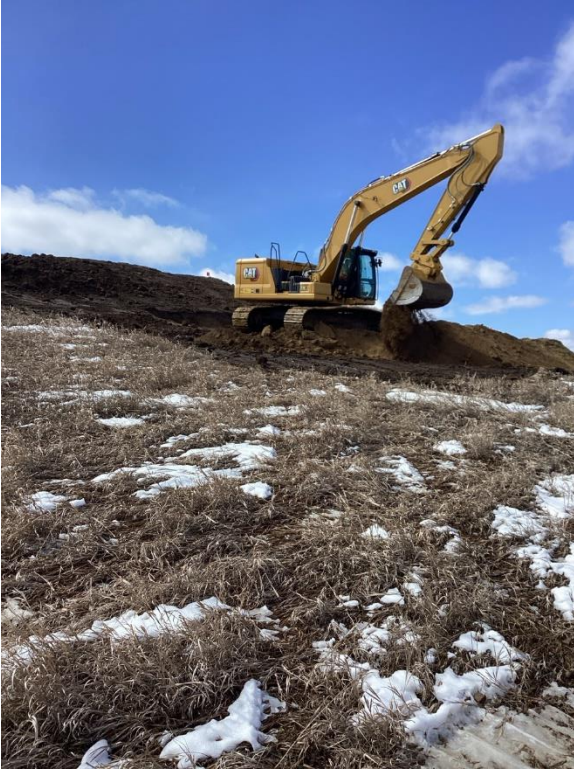
Point 12, Structure #336-058. Pad construction

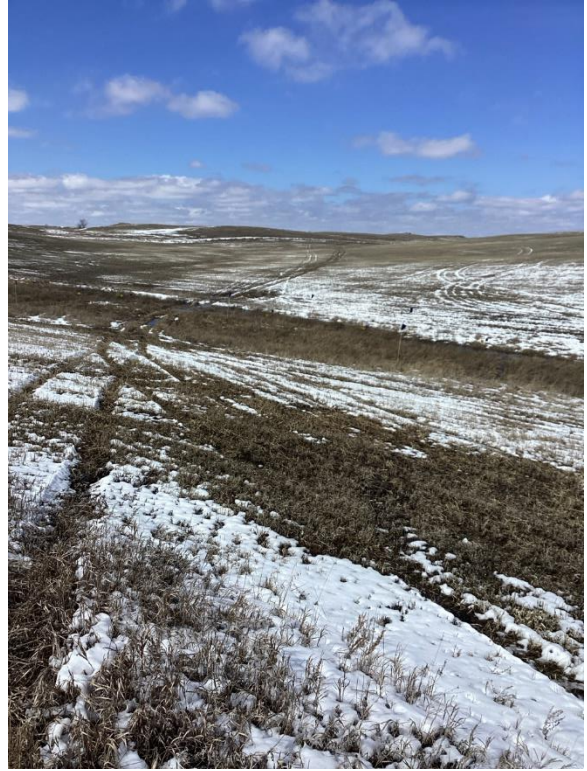
Point 13, West of Structure #336-058. Wetland crossing near pad excavation.

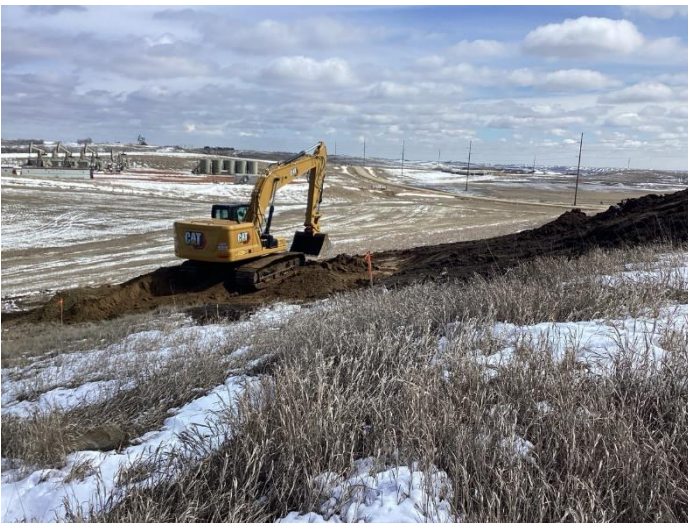
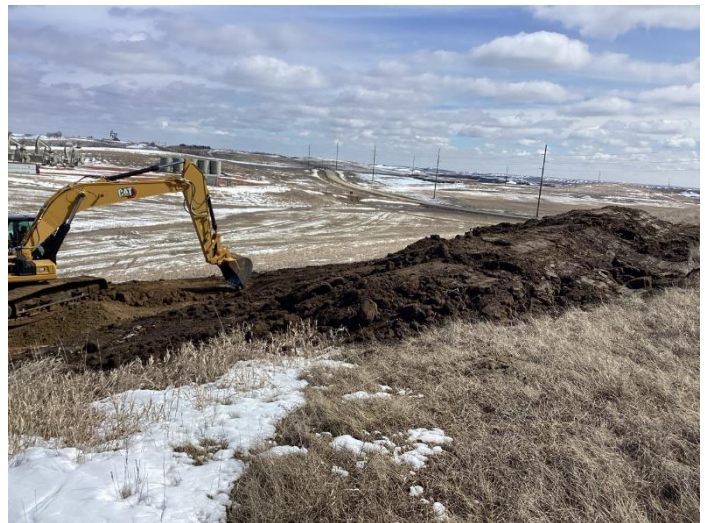
Point 14, Structure #338-058. Pad construction from east side

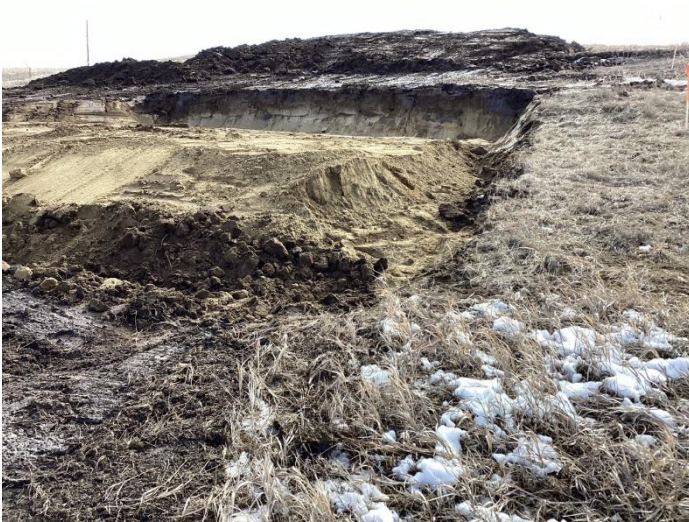
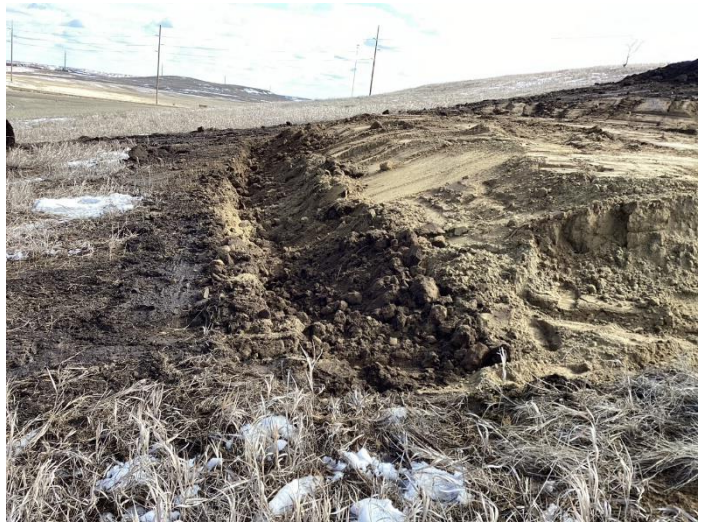
Comments: Constructed a ditch along the perimeter of the pad to direct flow to the NW corner which is downhill. Plan to install sediment fence along the south boarder to collect any sediment runoff.

Point 15, Structure #338-058. Drainage ditch cut along pad bottom

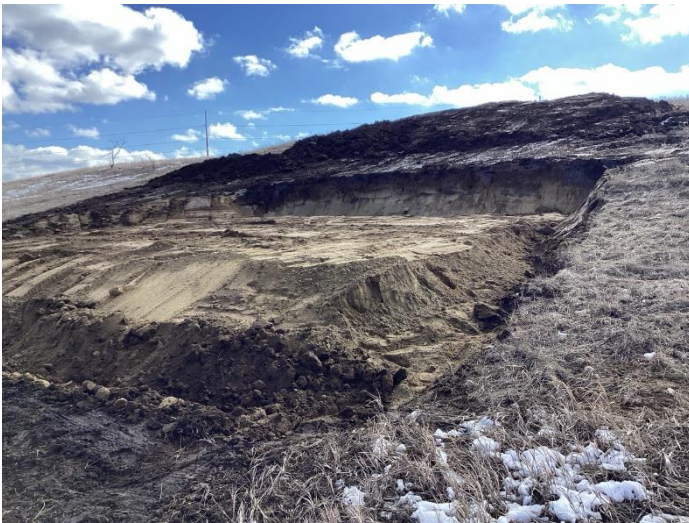
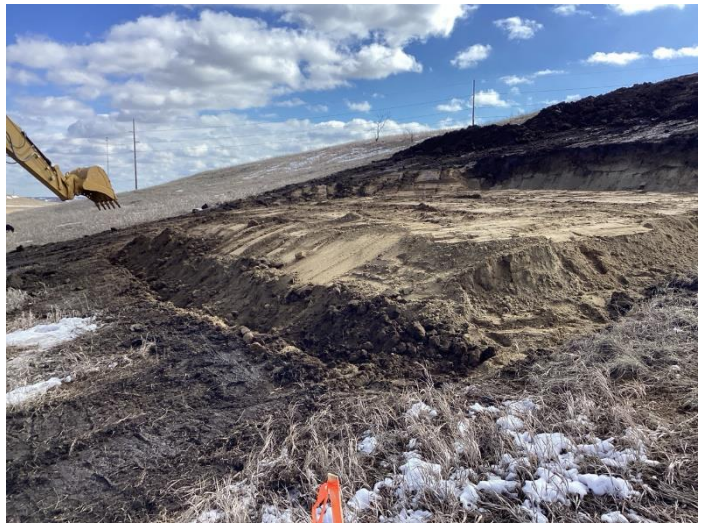
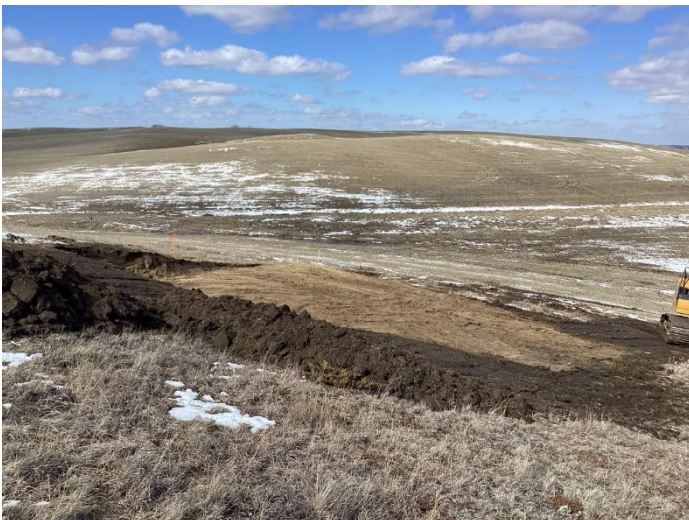
Point 16, Structure #336-058. Finished pad after topsoil and grading complete
