Basin Electric Power Cooperative

Roundup-Kummer Ridge 345-kV Transmission Line Dunn-
McKenzie Counties

Case No. PU-23-361

Construction Inspection Report

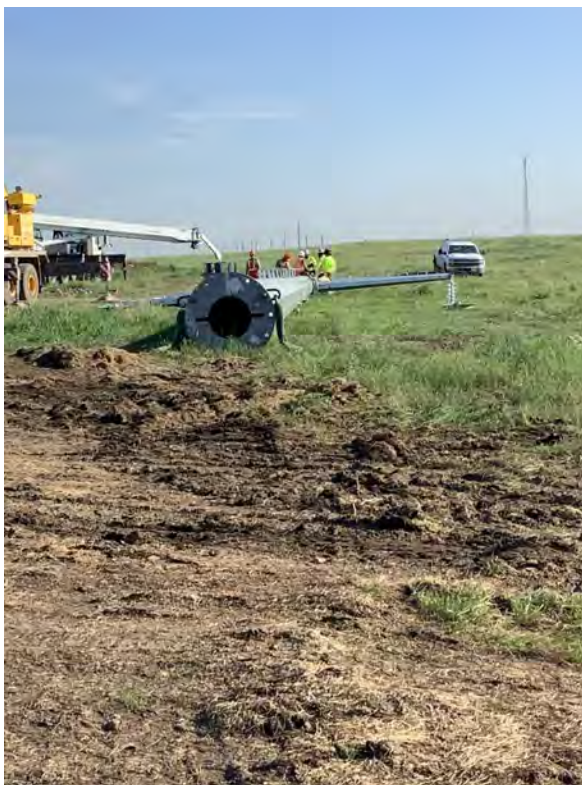
Location: Structure 163

Notes: Crew is assembling transmission line structure.

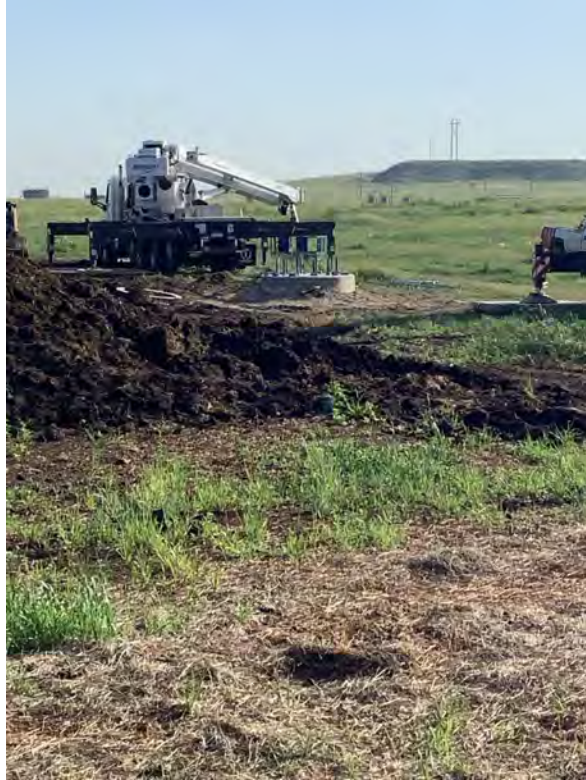
Location: Structure 163

Notes: Foundation of structure 163, awaiting finished structure to be installed.

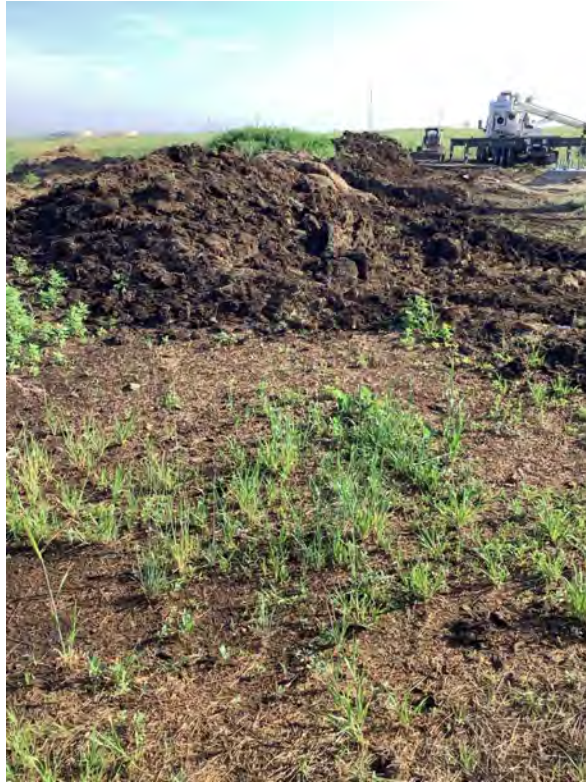
Location: Structure 163

Notes: Stockpiled topsoil. No ESC covering, but fairly flat area.

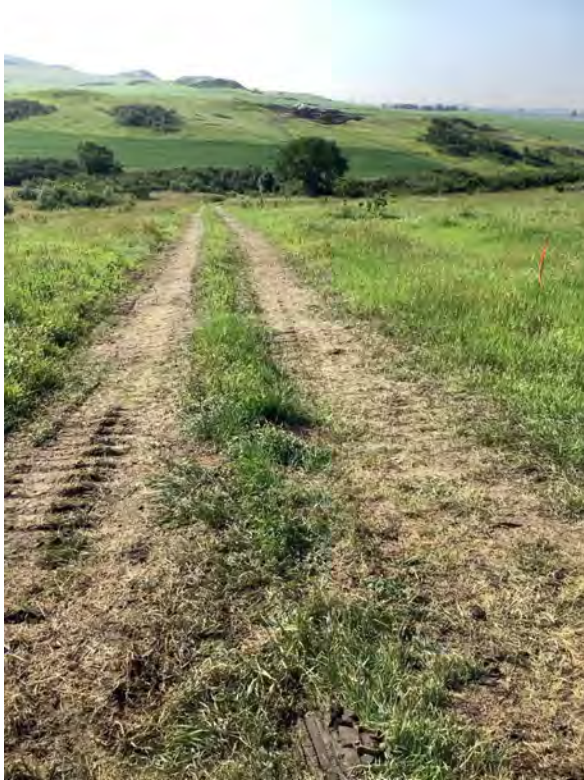
Location: Structure 163

Notes: ROW path to structure 162.

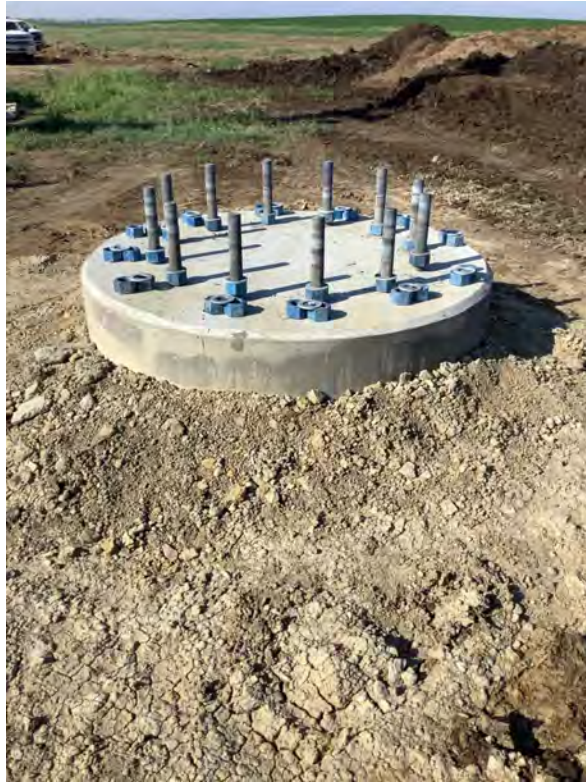
Location: Structure 163

Notes: Closer look at foundation of structure 163.

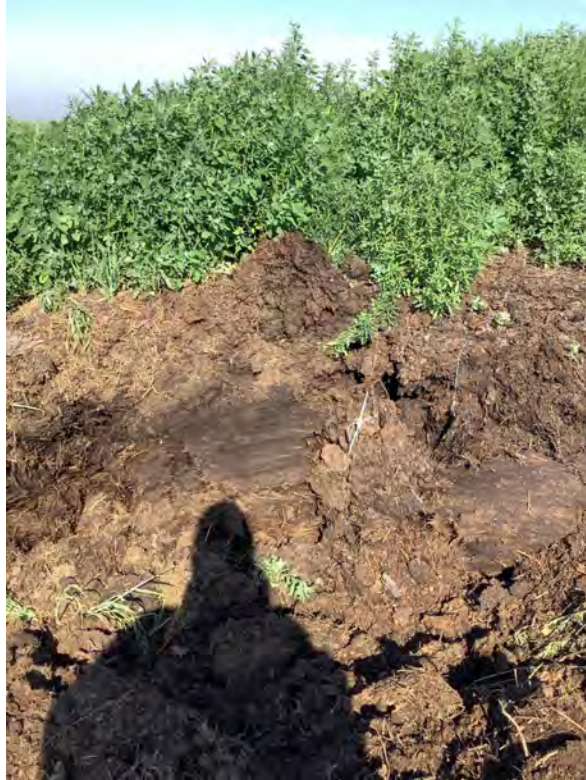
Location: Structure 163

Notes: Closer look at stockpiled topsoil, segregated from subsoils.

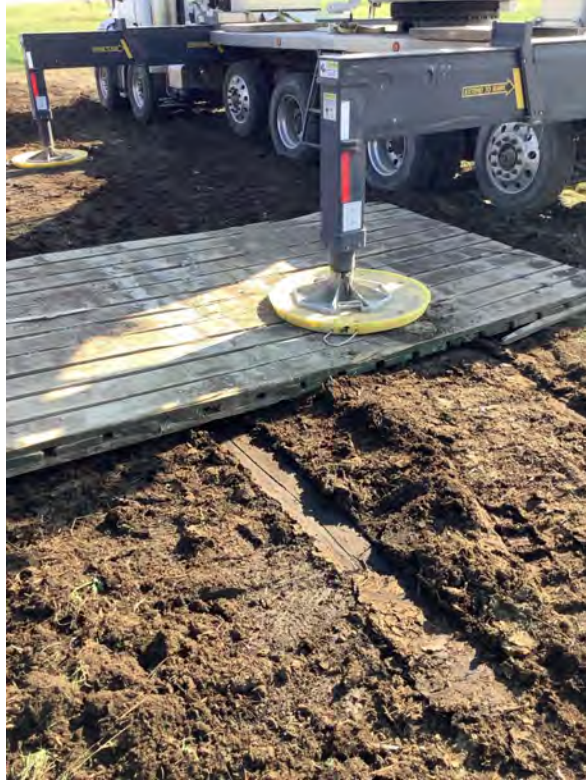
Location: Structure 163

Notes: Crew is using wooden rafts to ensure stability for their cranes.

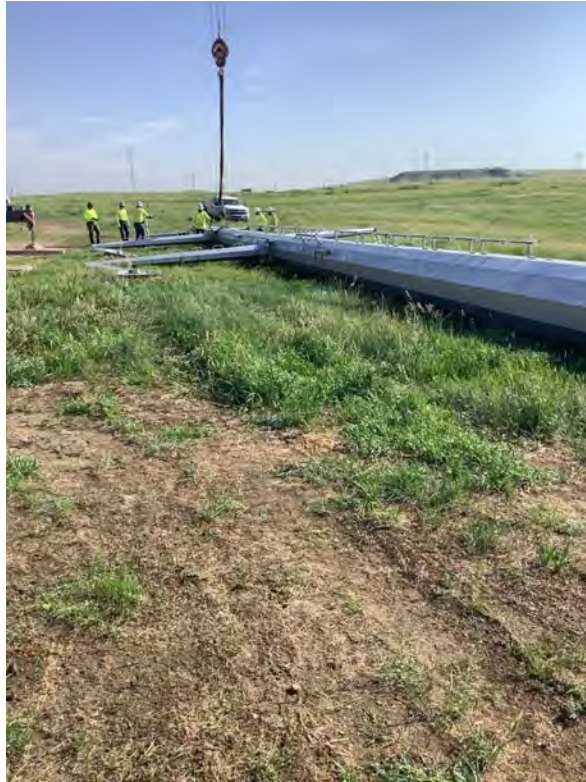
Location: Structure 163

Notes: Crew preparing to transport structure 163 to its foundation.

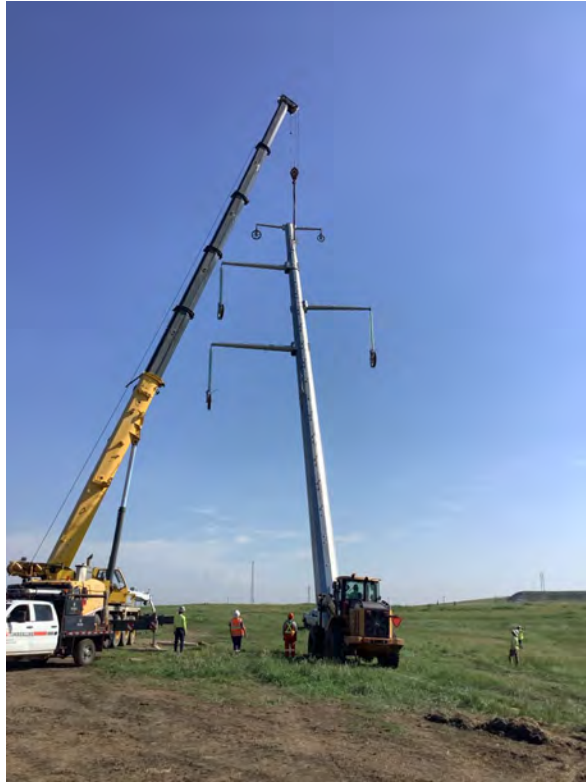
Location: Structure 163

Notes: Crew has structure vertical. Ready to move to foundation.

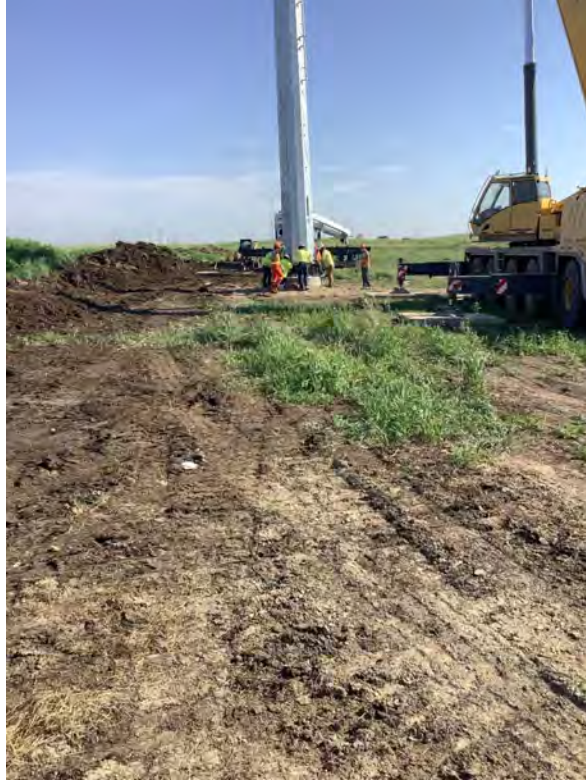
Location: Structure 163

Notes: Crew preparing to set structure on its foundation.

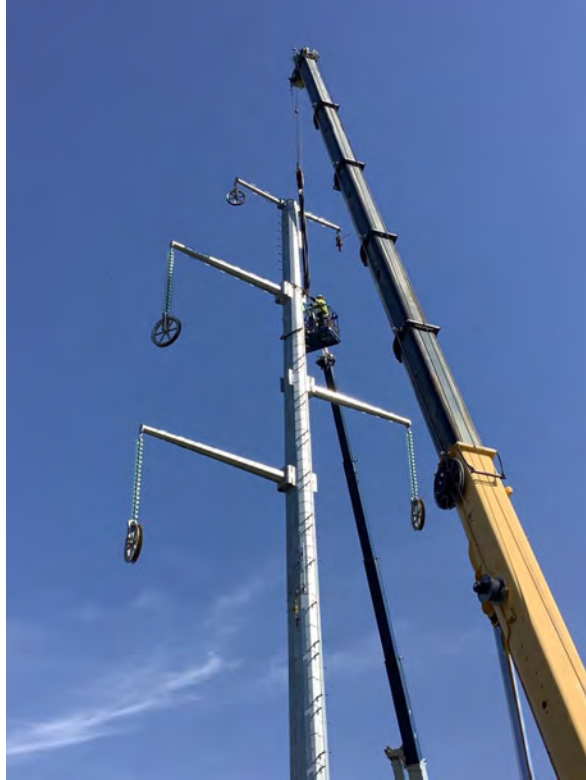
Location: Structure 163

Notes: Crew removing harness for crane.

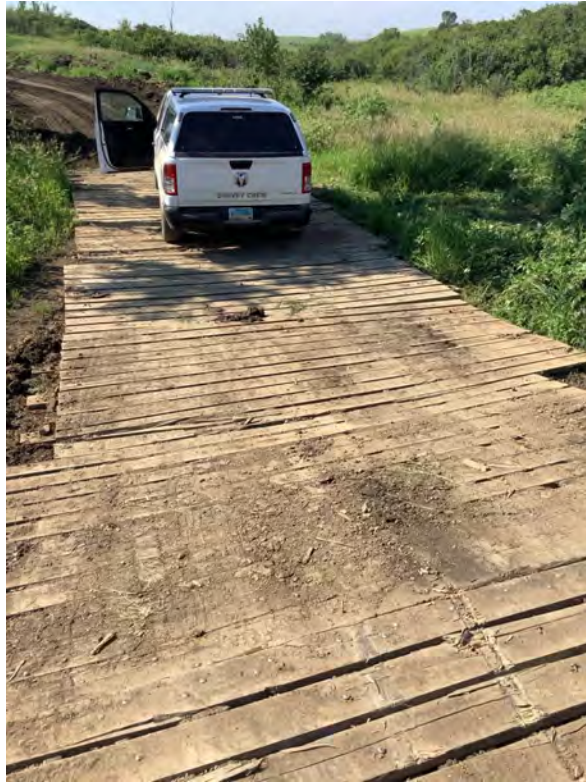
Location: Halfway between structures 163 and 162

Notes: Planking used to allow easier travel and less disruption of a vegetated valley.

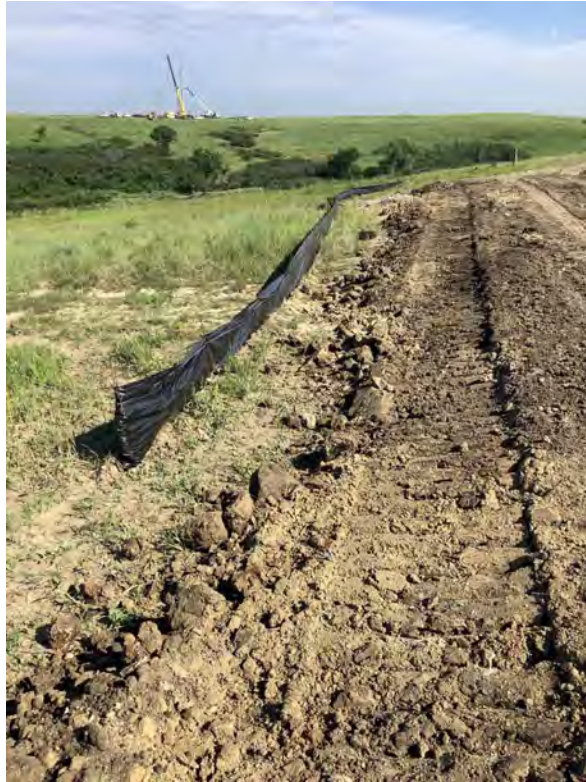
Location: Structure 162

Notes: Silt fence in place on W side of ROW at structure 162.

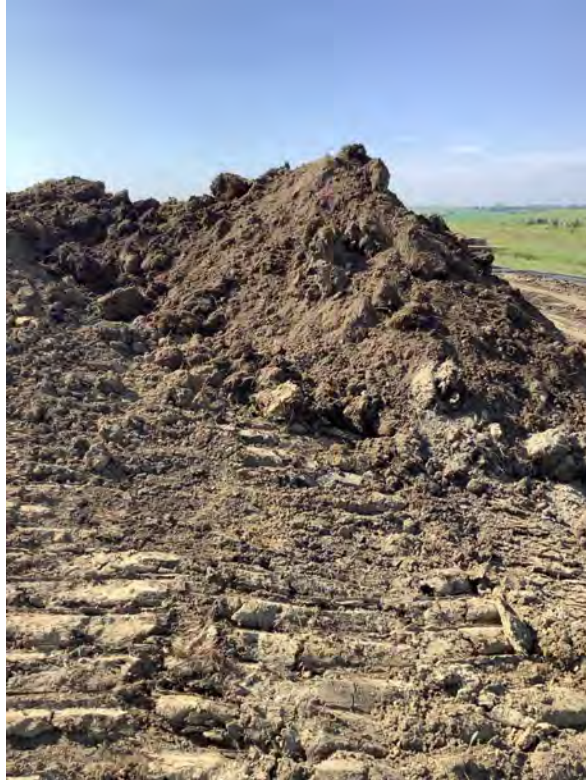
Location: Structure 162

Notes: Topsoil showing full segregation from subsoil. No esc around it. Nearest silt fence is 20 feet away to west.

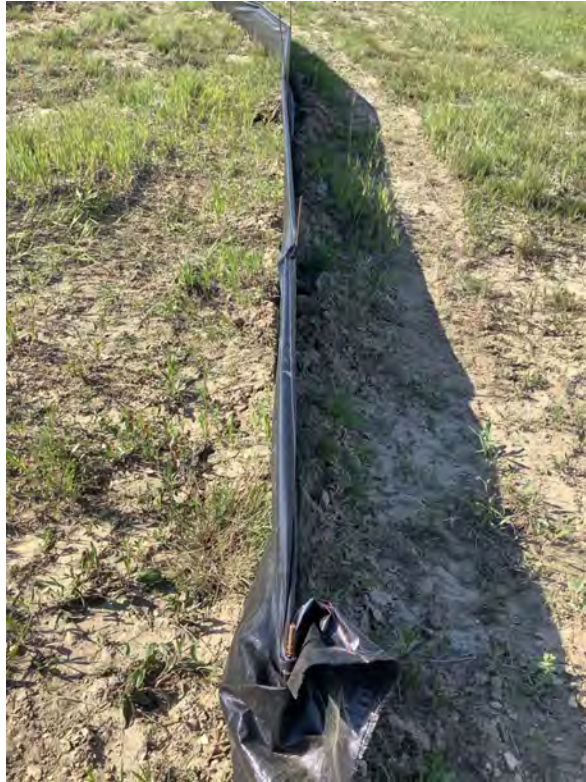
Location: Structure 162

Notes: Silt fence is installed correctly and you can see silt built up on east side.

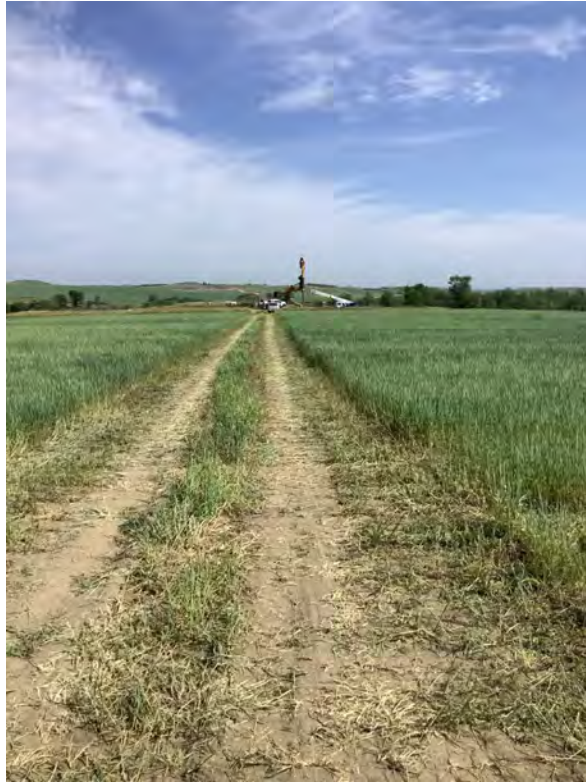
Location: Halfway between structures 135 and 136

Notes: Drilling and pouring operations on structure 136: wide shot

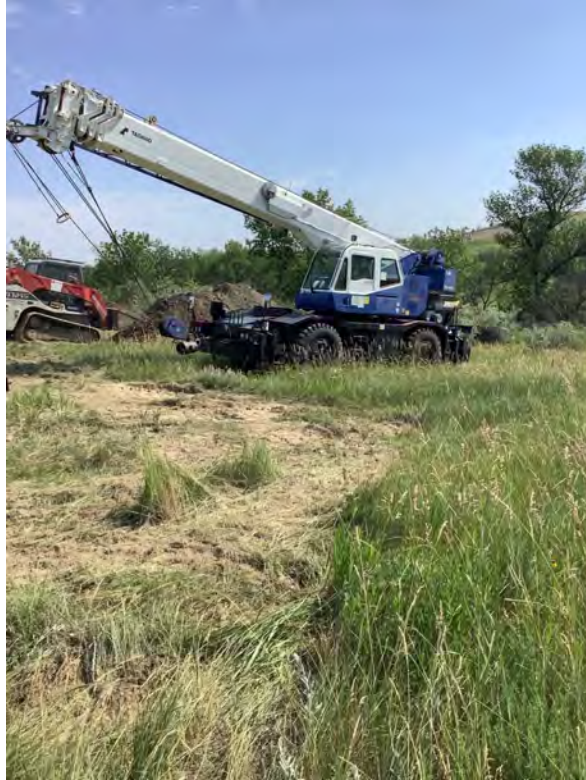
Location: Structure 136

Notes: Small crane used to lower mold into excavation hole

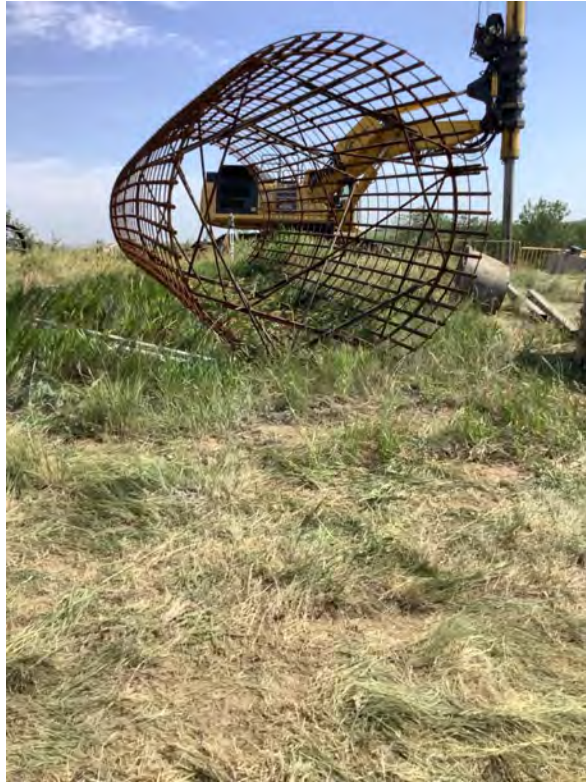
Location: Structure 136

Notes: Rebar cage for foundation of structure 136

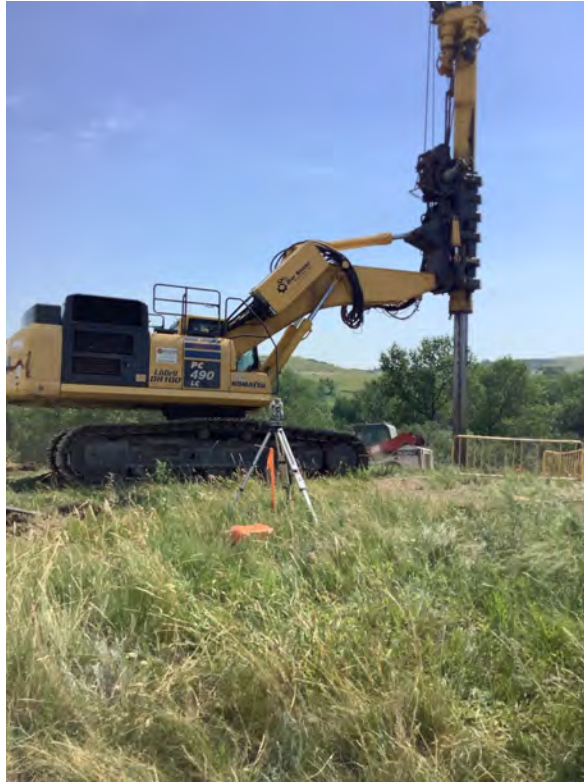
Location: Structure 136

Notes: Tracked driller. Currently drilling hole for foundation.

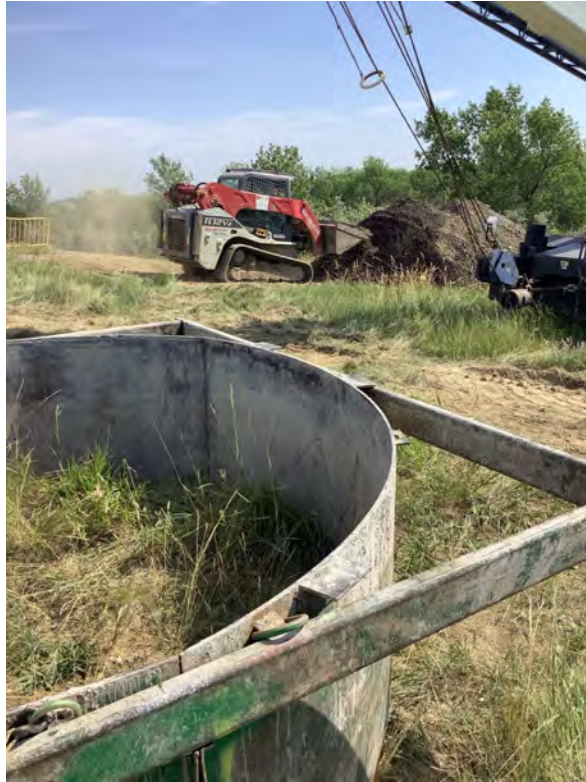
Location: Structure 136

Notes: Skidsteer used to move excavated material to a stock pile

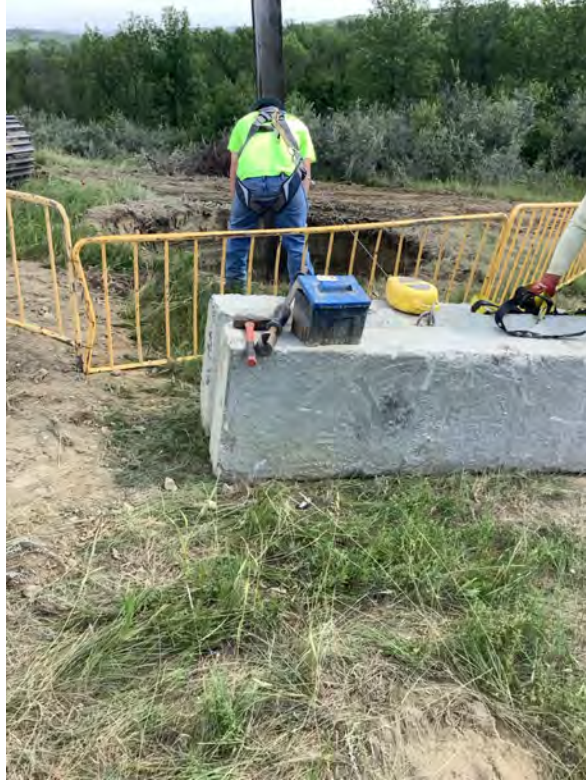
Location: Structure 136

Notes: Crew using proper ppe (pfas) while standing next to a dangerous drop.

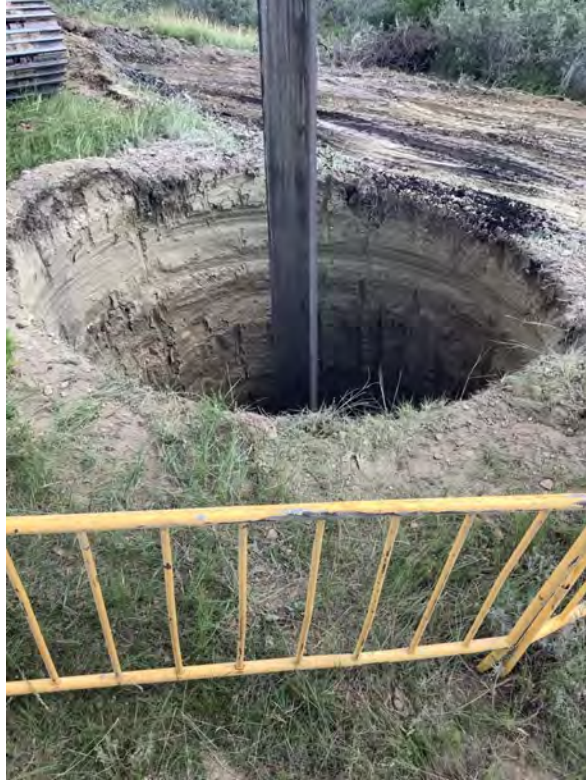
Location: Structure 136

Notes: Drilling operations of foundation: close up

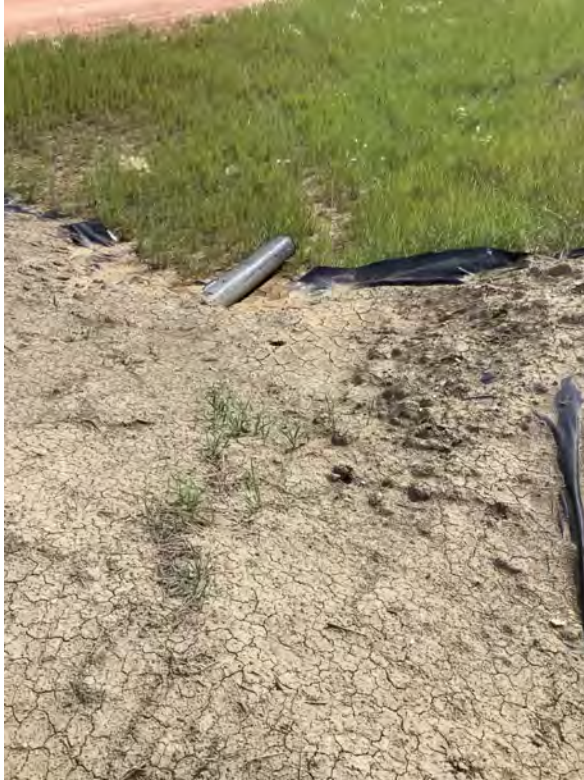
Location: Halfway between structures 135 and 136

Notes: Erosion control blanket and pipe in place where crew had to build access point over a ditch.

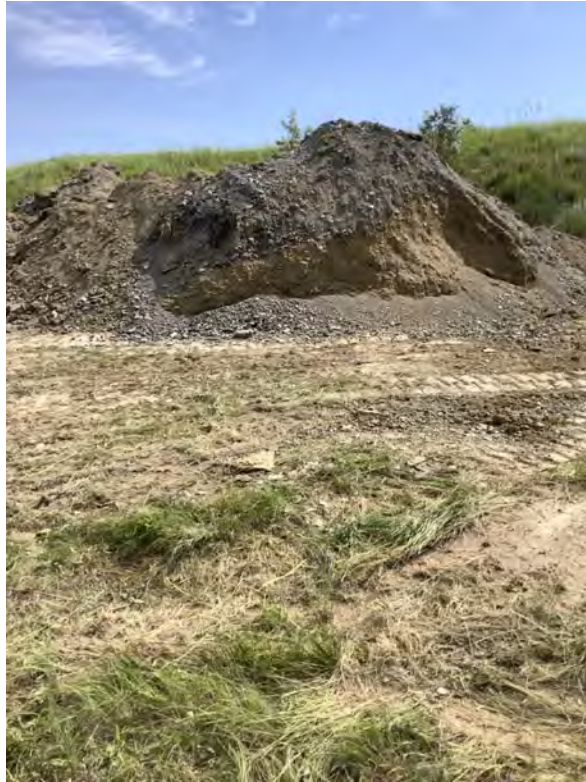
Location: Structure 135

Notes: Stockpile of excavated material from foundation spot. No ESC present.

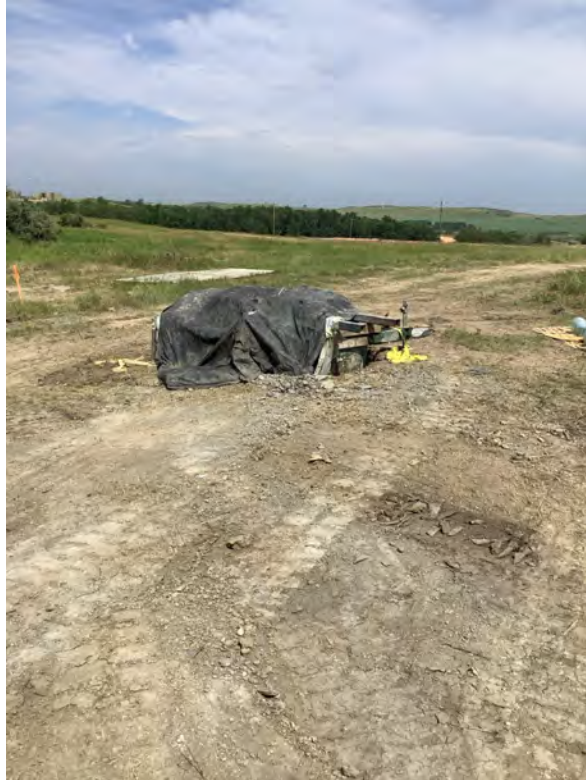
Location: Structure 135

Notes: Forms in place for concrete pour. Rebar cage installed (shown in next picture). Tarp covering to ensure unwanted moisture stays out.

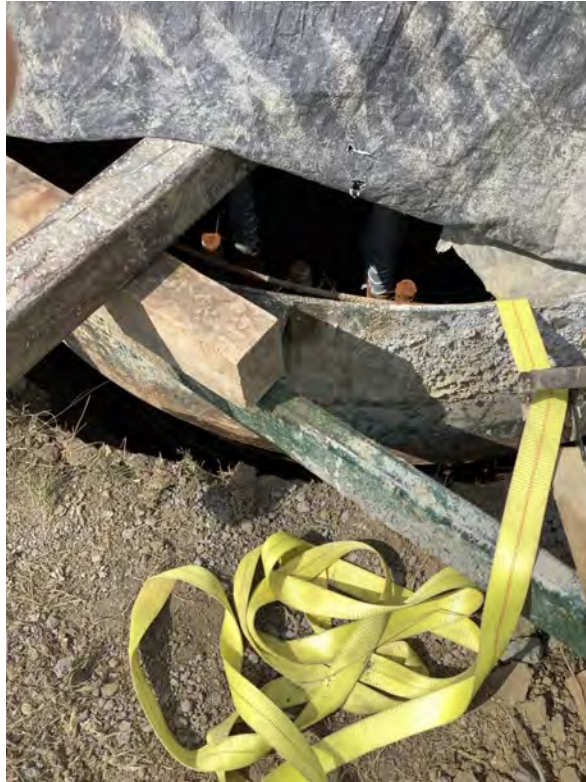
Location: Structure 135

Notes: Rebar cage for foundation pour.

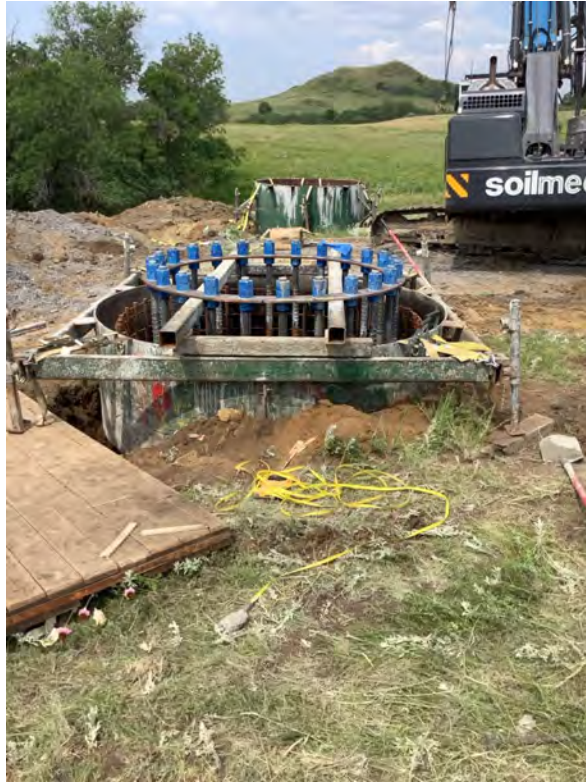
Location: Structure 112

Notes: Foundations drilled. Concrete operations currently taking place.

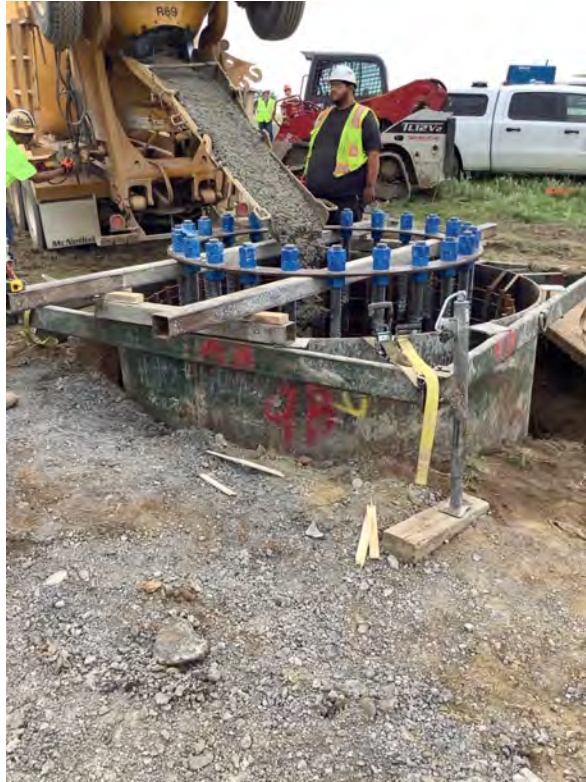
Location: Structure 112

Notes: Crew pouring right foundation for h structure 112

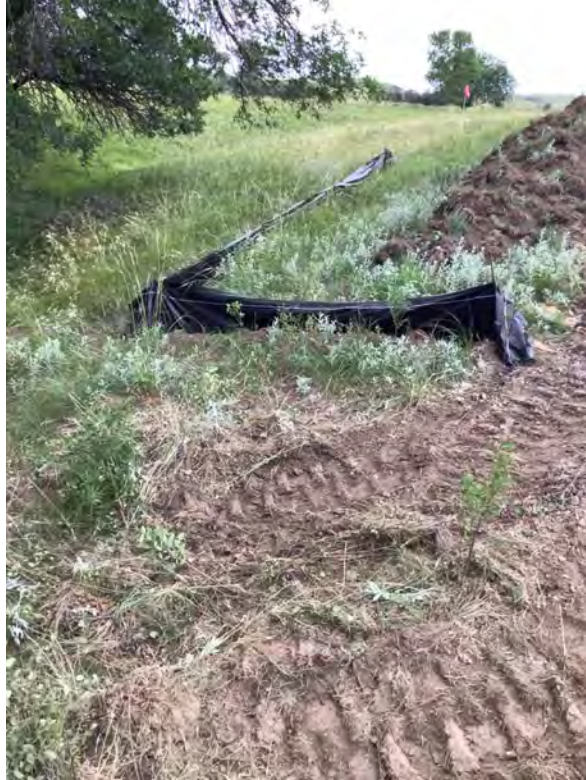
Location: Structure 112 ROW

Notes: Silt fence for topsoil stockpile

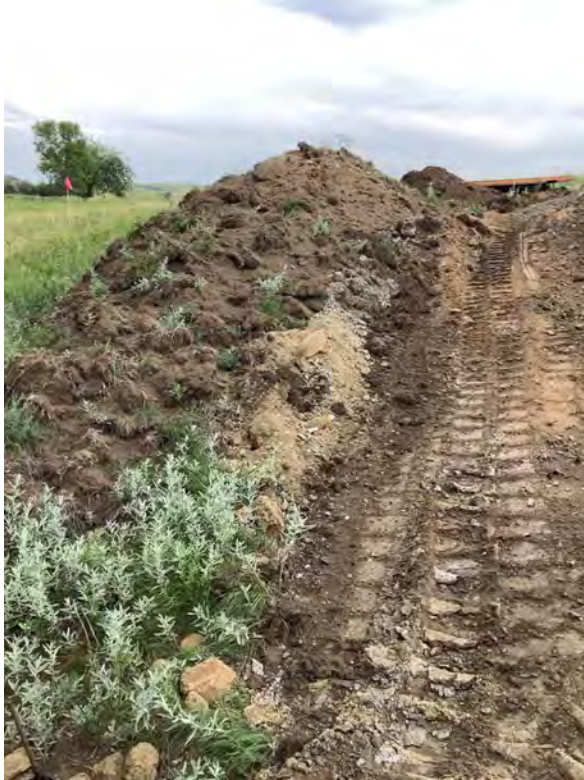
Location: Structure 112

Notes: Stockpile of excavated material.

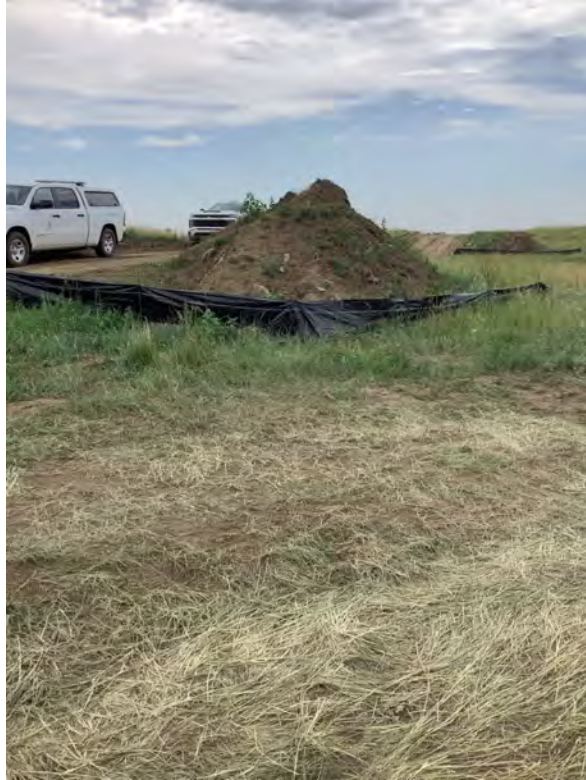
Location: NE of structure 112

Notes: Topsoil pile with silt fence. Segregation has been sufficiently maintained.

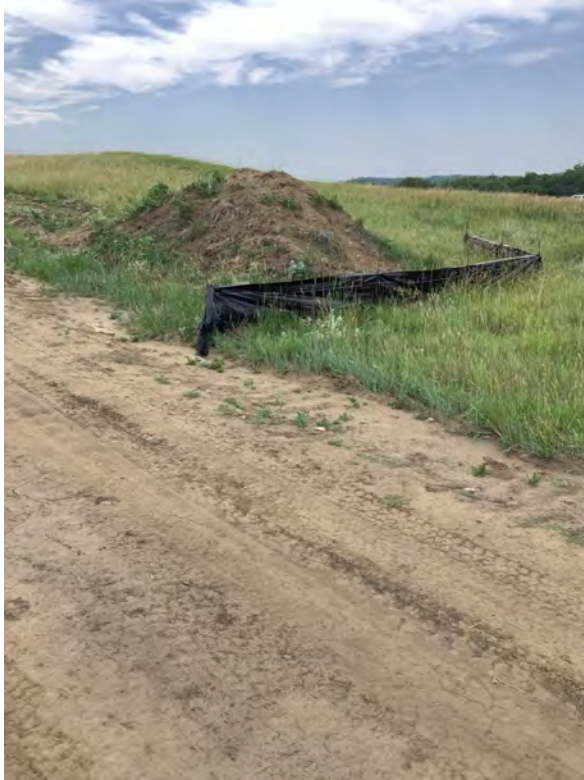
Location: NE of structure 112

Notes: Another topsoil pile with silt fence installed.

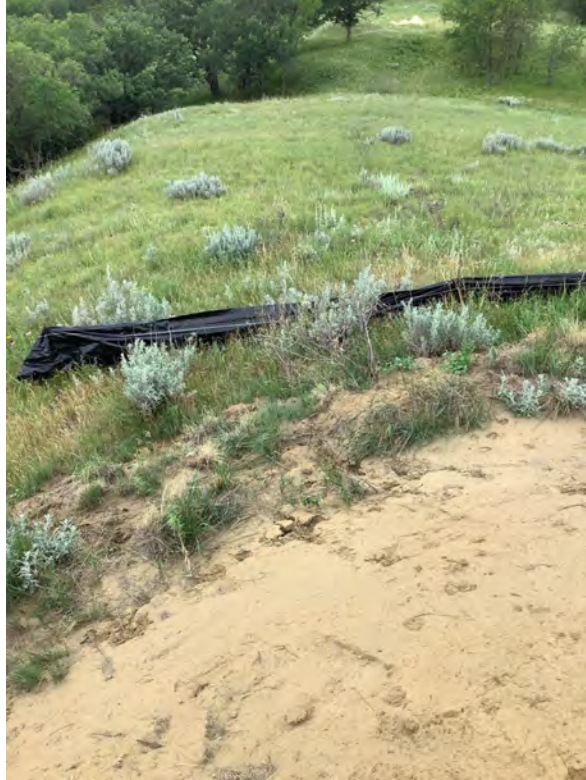
Location: Structure 111

Notes: Silt fence installed on downslope of structure location

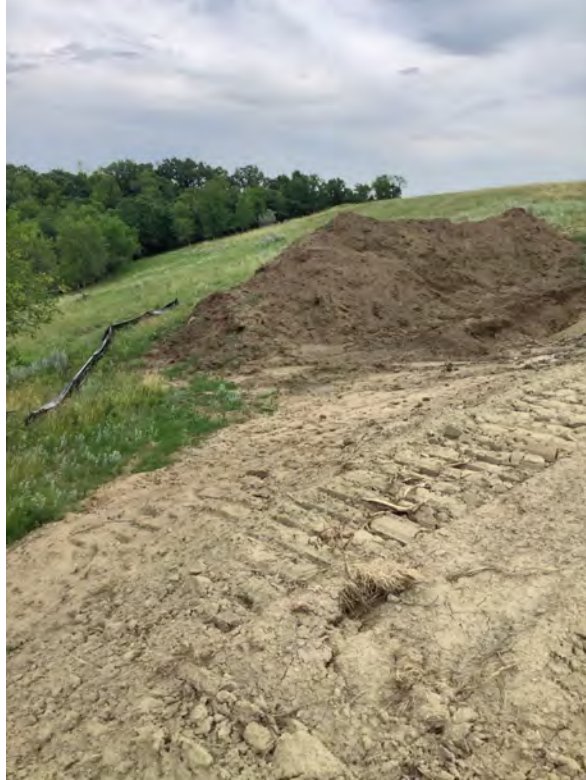
Location: Structure 111

Notes: Topsoil stockpile guarded by silt fence on downslope.

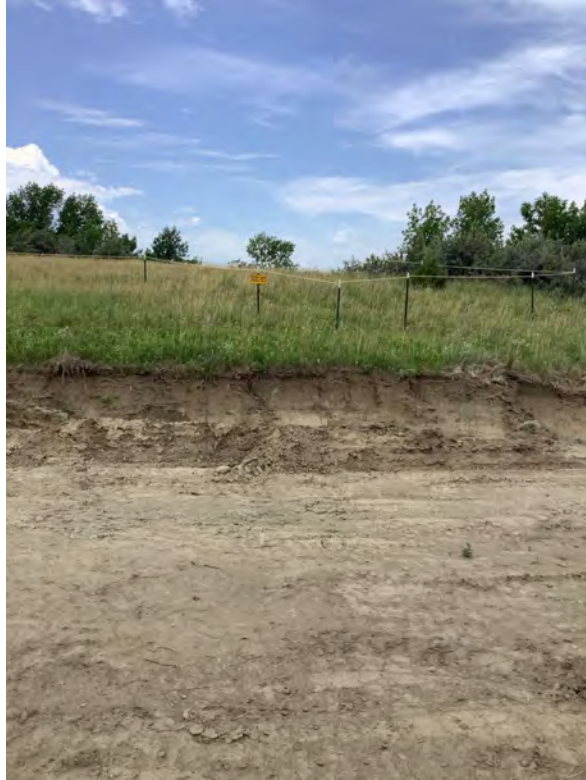
Location: Structure 120

Notes: Dakota skipper butterfly avoidance area intact. No signs of damage to habitat.

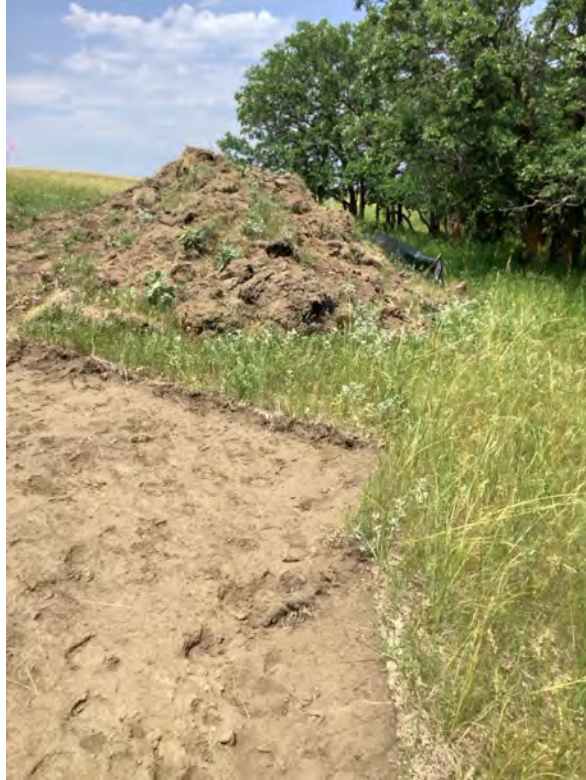
Location: Structure 103

Notes: Topsoil stockpile protected on east side by silt fence

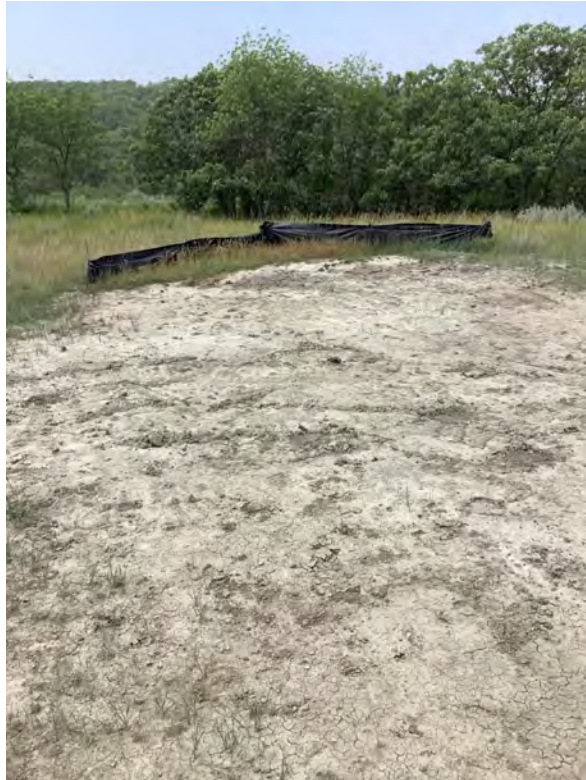
Location: Structure 107

Notes: Silt fence installed on site

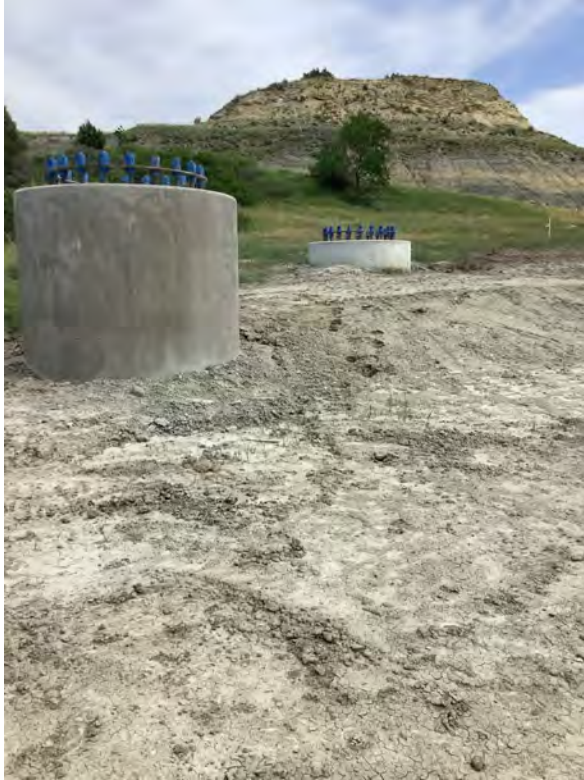
Location: Structure 107

Notes: Foundations finished on structure 107. Awaiting tower.

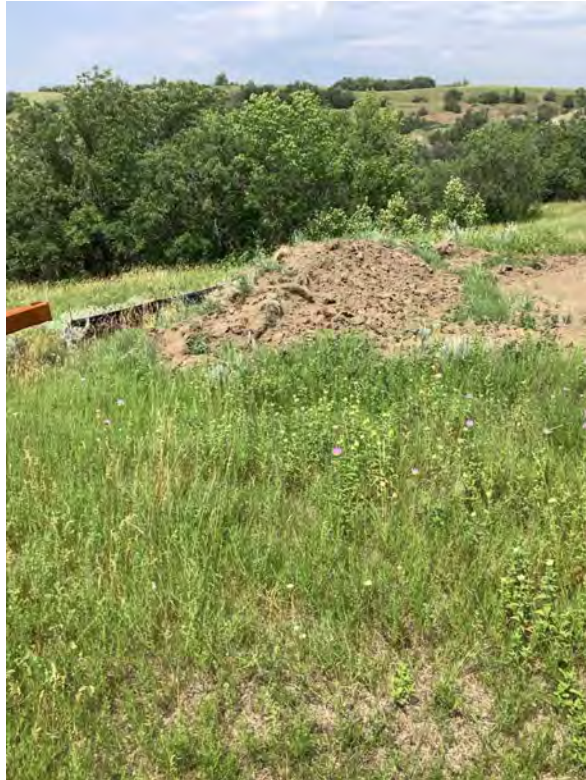
Location: Structure 108

Notes: Topsoil stockpiled and protected by silt fence.

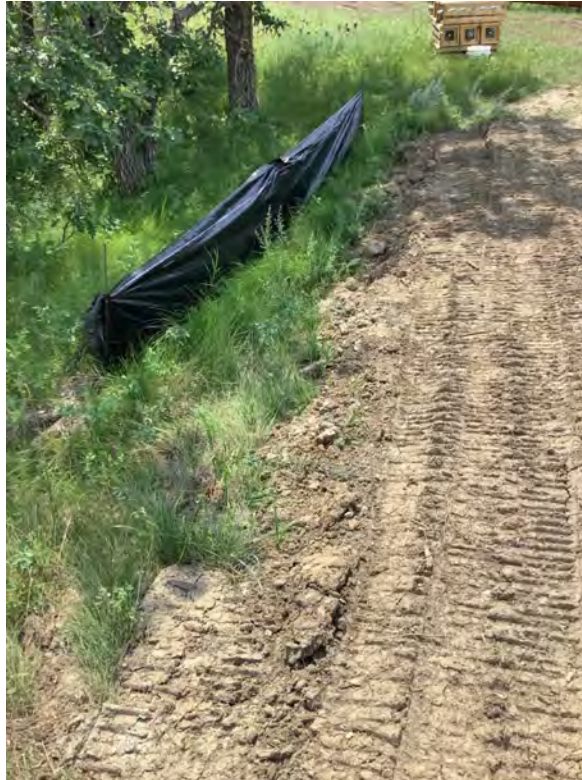
Location: Structure 108 access route

Notes: Silt fence installed on downstream side of curve to prevent silt erosion

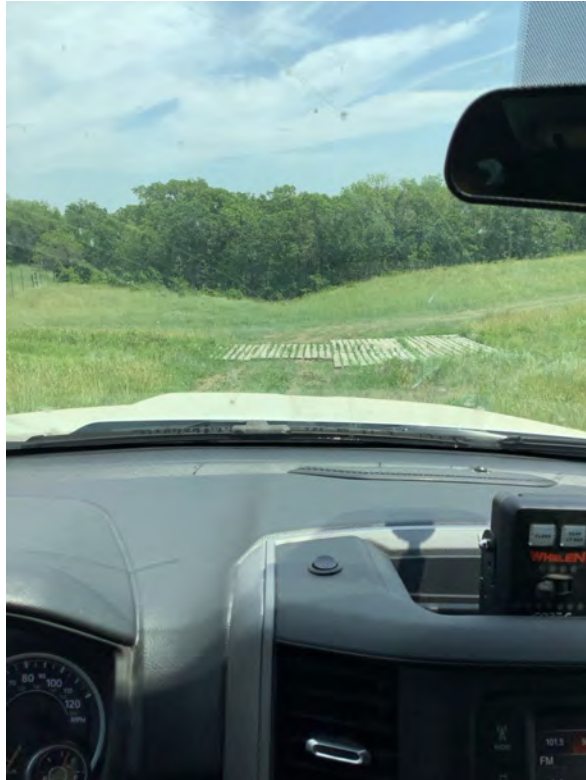
Location: Access road to structure 110

Notes: Boards in place to reduce impact to native lands.

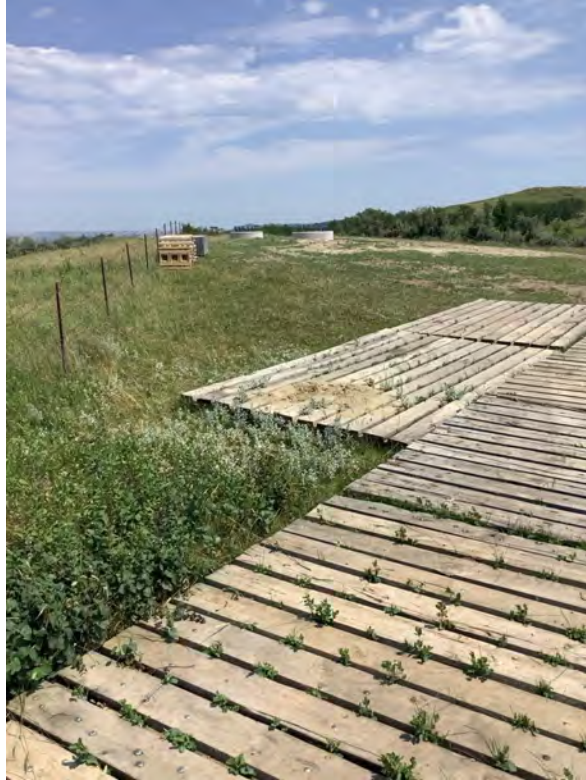
Location: Structure 62

Notes: Foundations for structure 62.

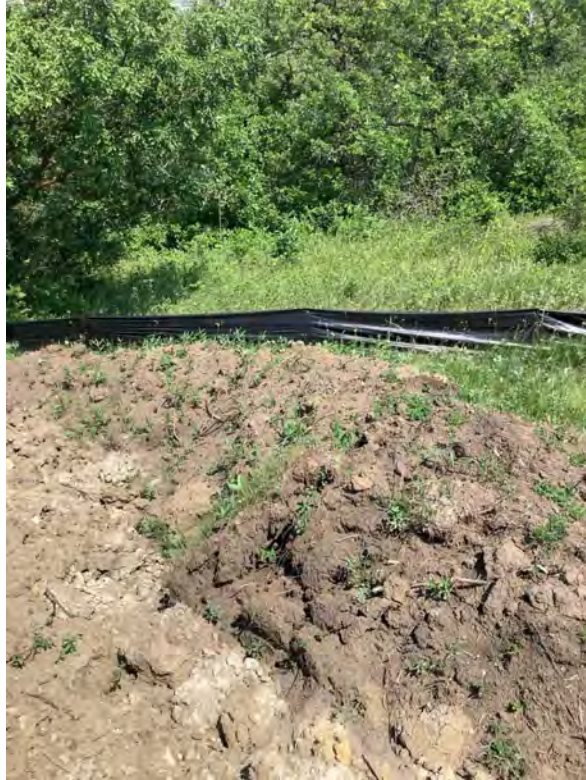
Location: Structure 63

Notes: Topsoil stockpiled and protected by silt fence

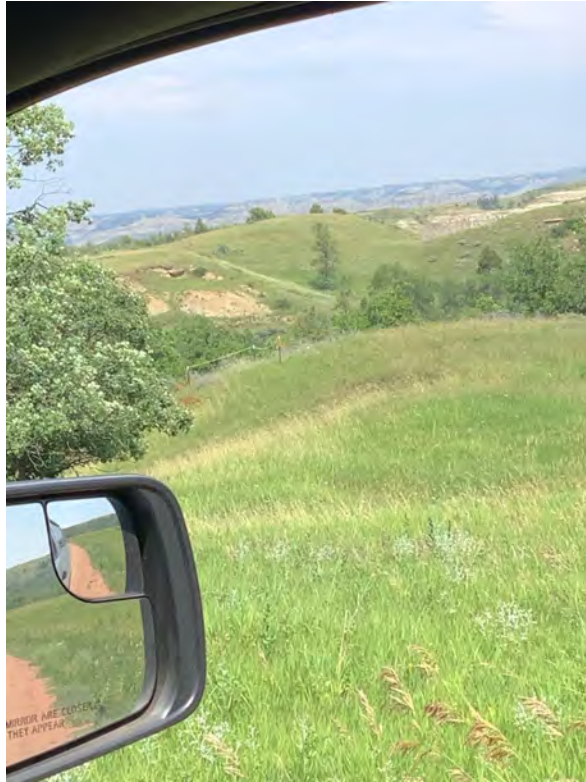
Location: Between structures 66 & 67

Notes: Dakota skipper butterfly habitat avoidance zone. No signs of damage.

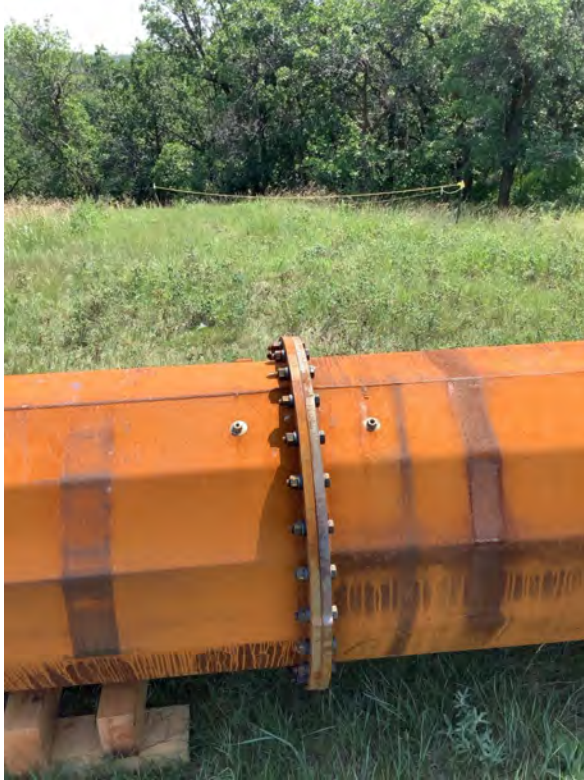
Location: Structure 67

Notes: Avoidance area.

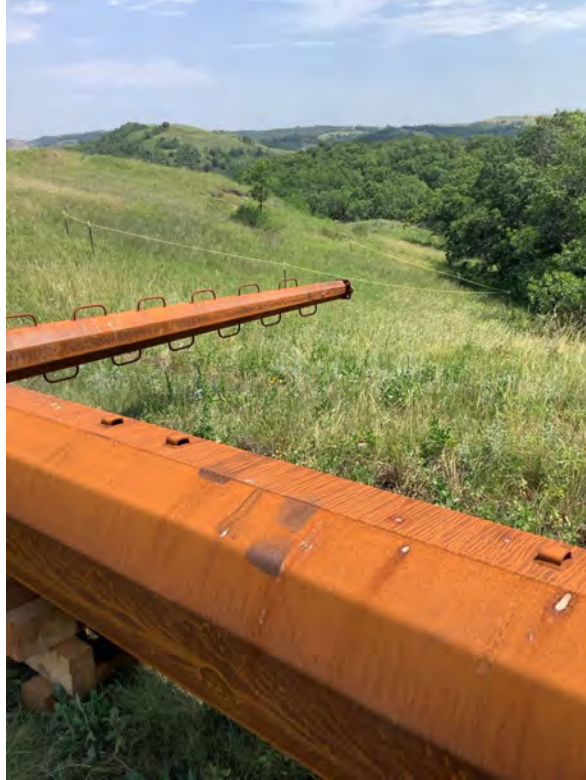
Location: Structure 67

Notes: Avoidance area is untouched.

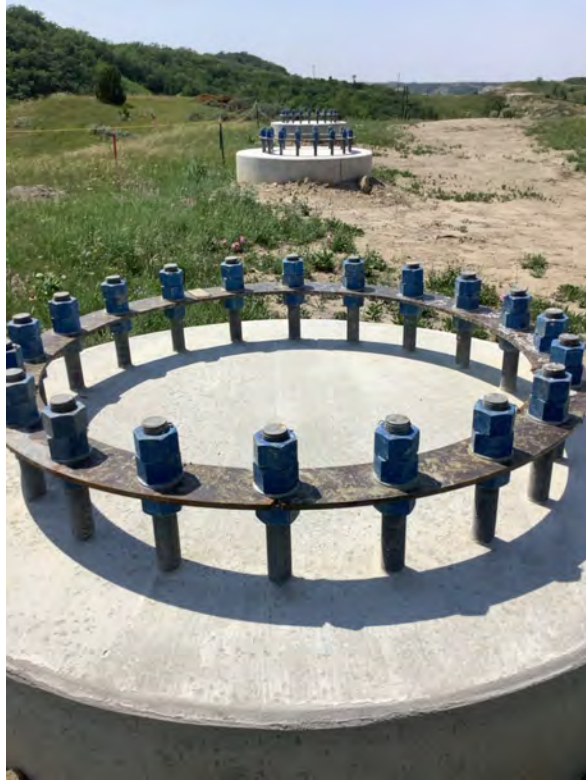
Location: Structure 68

Notes: Foundations poured for this structure.

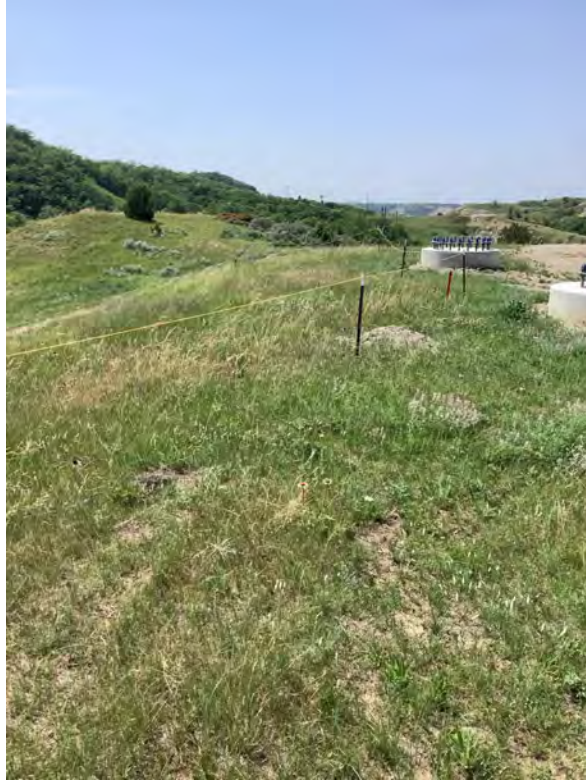
Location: Structure 68

Notes: Avoidance area untouched.
