Basin Electric Power Cooperative

Roundup-Kummer Ridge 345-kV Transmission Line Dunn-
McKenzie Counties

Case No. PU-23-361

Construction Inspection Report

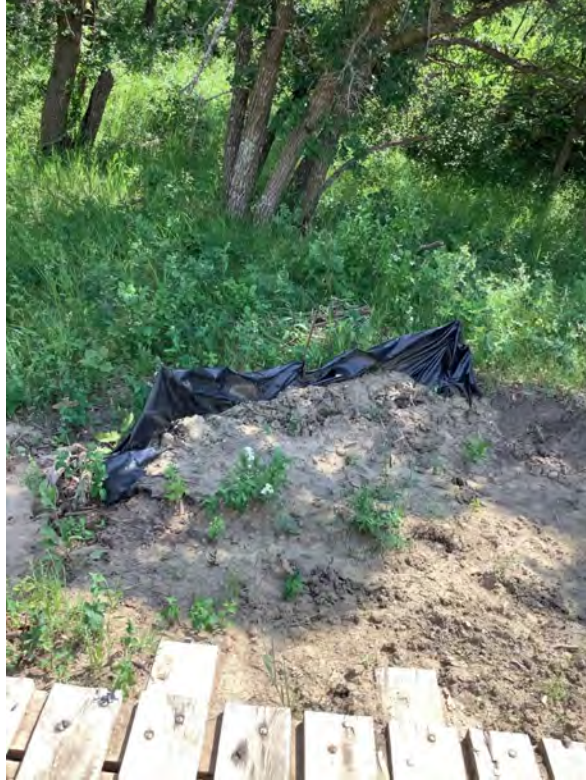
Location: Structure 68 access road

Notes: Silt fence installed to prevent soil deposition. Recommend cleaning.

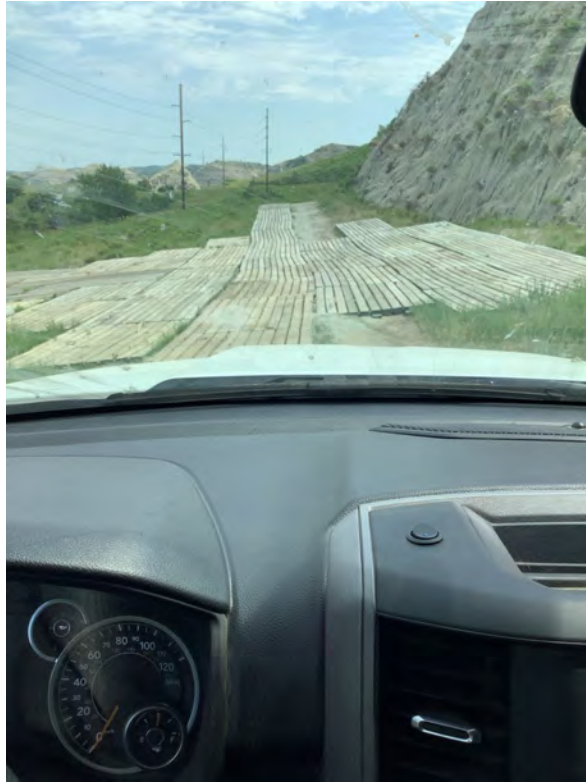
Location: Structure 72 access road and running north to south

Notes: Extensive planking installed to ensure minimal impact to environment and ease of travel for equipment.

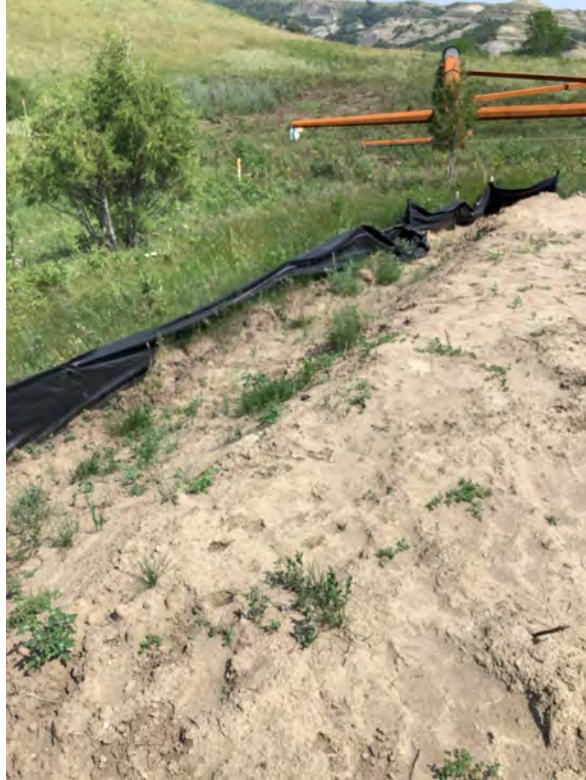
Location: Structure 71

Notes: Silt fence installed on north side of site

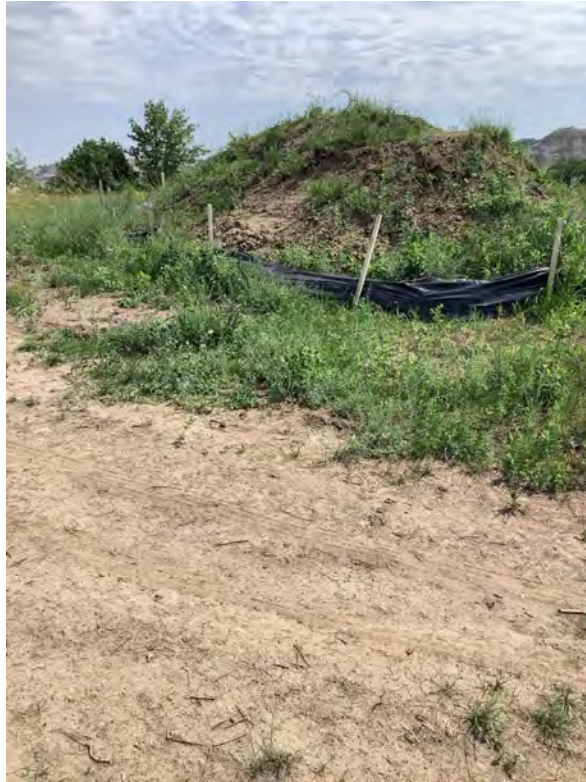
Location: Structure 71

Notes: Silt fence installed for top soil but needs fixing.

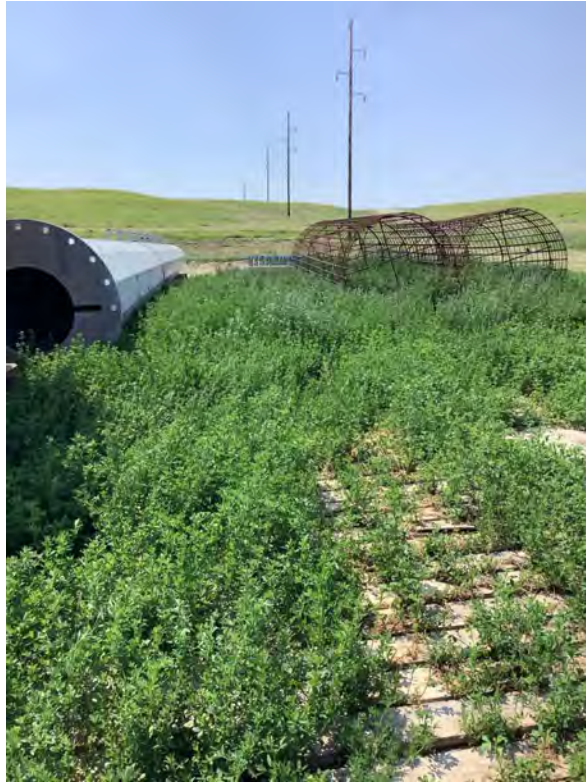
Location: Structure 57

Notes: Foundation is poured. Only install remains. Vegetation already growing back. Planks everywhere

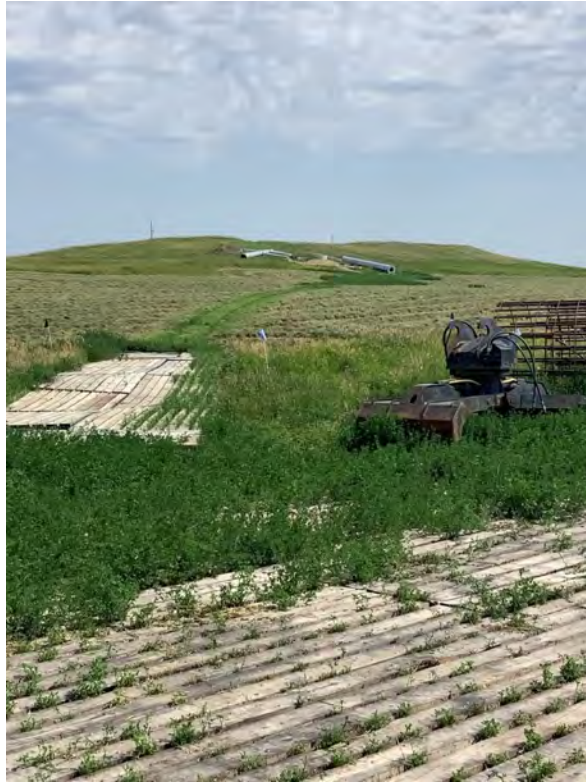
Location: Structure 57

Notes: Structure 56 also has finished foundation. Unable to reach with truck due to supplies blocking path.

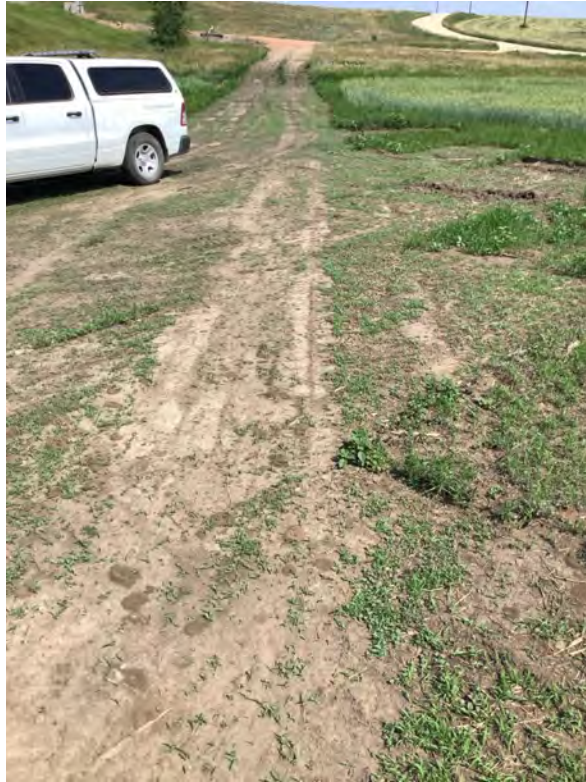
Location: Access road to structure 58

Notes: Planking has been removed.

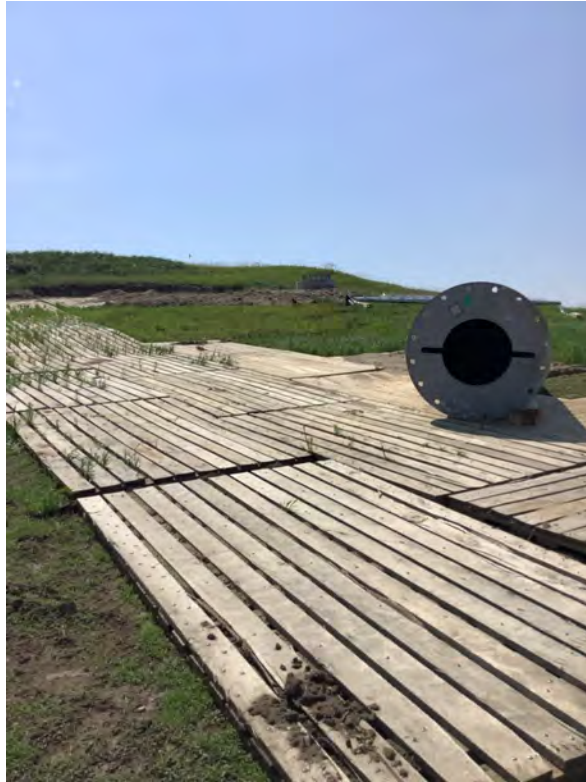
Location: Structure 58

Notes: Foundation installed. Planking still in place.

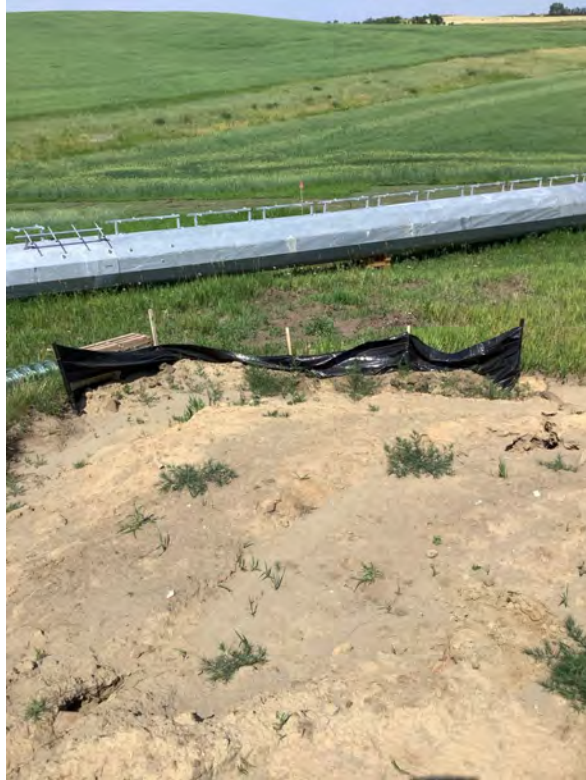
Location: Structure 58

Notes: Silt fence installed on east side of site to prevent erosion.
