Basin Electric Power Cooperative

Roundup-Kummer Ridge 345-kV Transmission Line Dunn-
McKenzie Counties

Case No. PU-23-361

As-Built Inspection Report

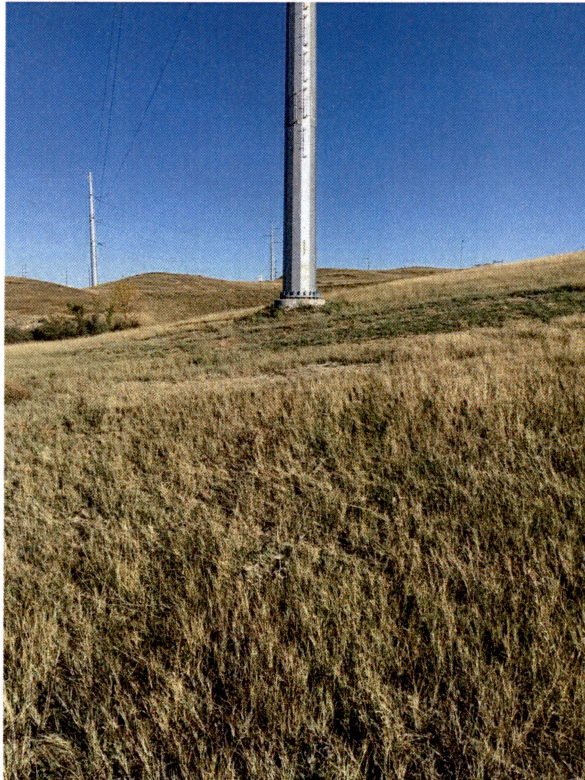
Photo Number: 1

Notes: Vegetative cover in progress. There are a few minor spots of bare ground with evidence of soil erosion. Dung in field indicated these might be rolling grounds for cattle?

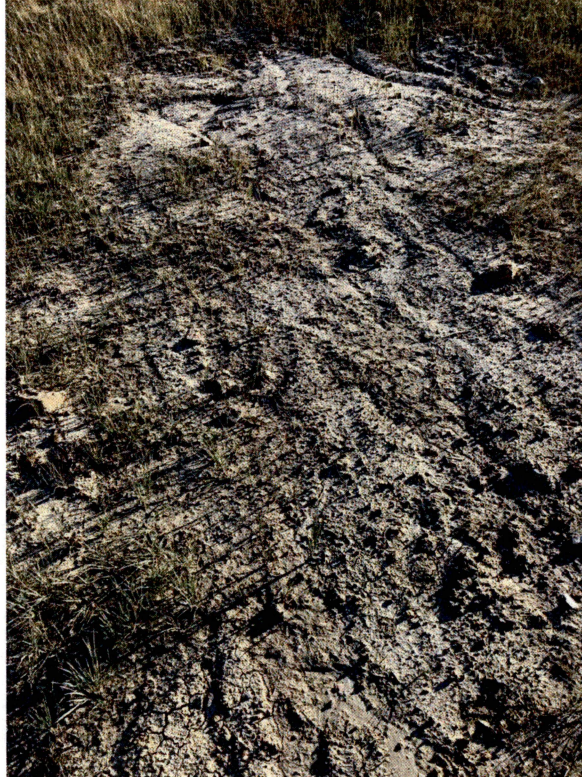
Photo Number: 2

Notes: Bare spot. Unsure if like this before construction.

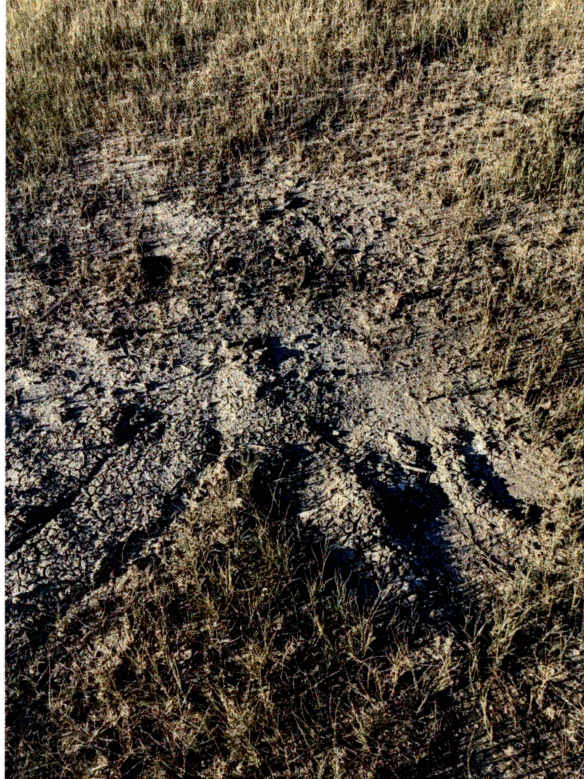
Photo Number: 3

Notes: Small bare spot. Unsure if this was condition of soil before construction due to geology and topography of area.

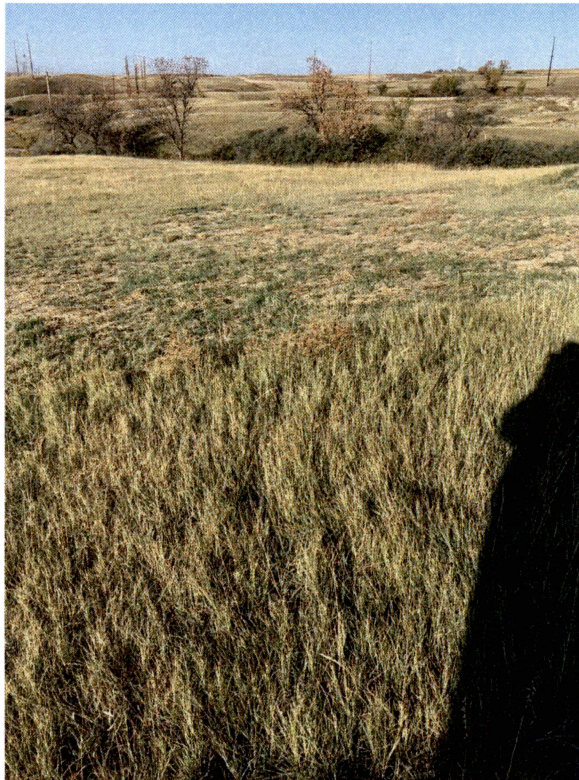
Photo Number: 4

Notes: Partial vegetative cover. Land agent said they plan on doing spot seeding as needed.

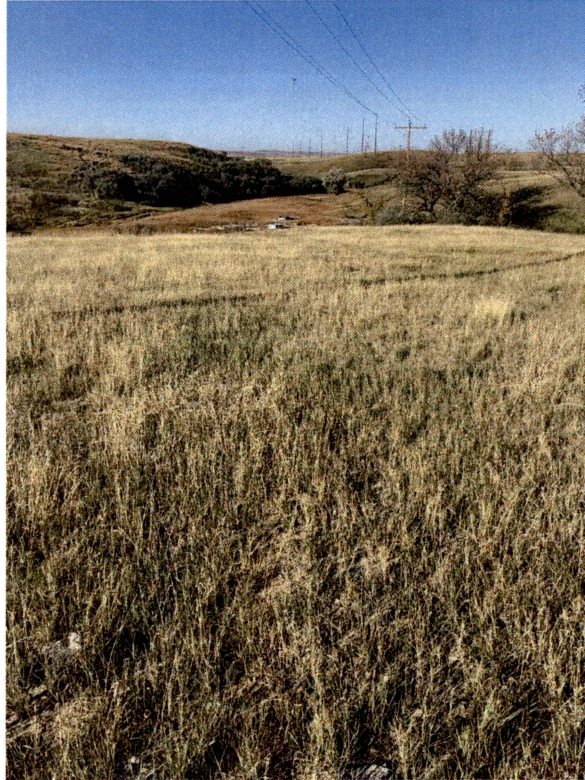
Photo Number: 5

Notes: Downslope of ROW, no evidence of erosion. Vegetative cover evident.

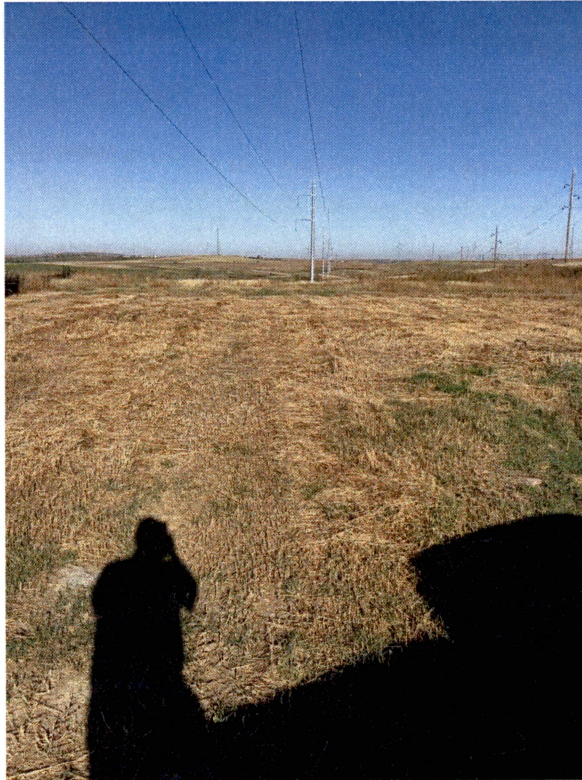
Photo Number: 6

Notes: Vegetative cover evident, looks like landowner mowed for baling.

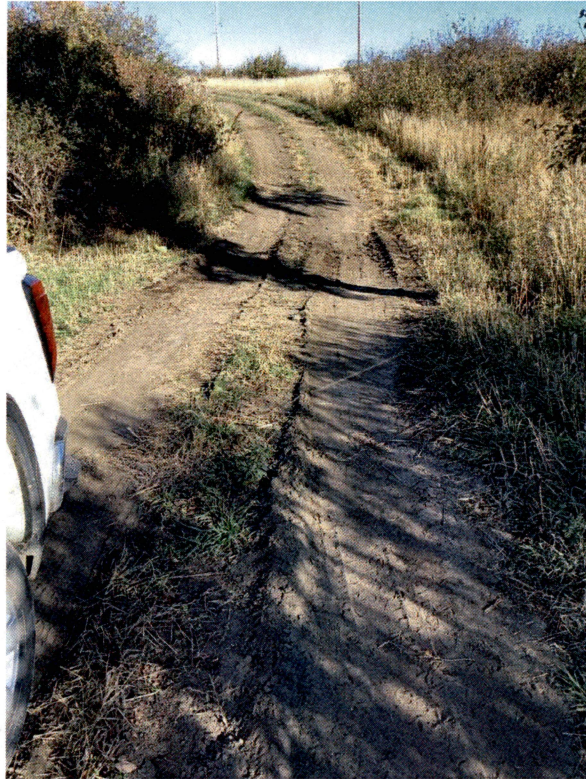
Photo Number: 7

Notes: Planking has been removed from lowland crossing.

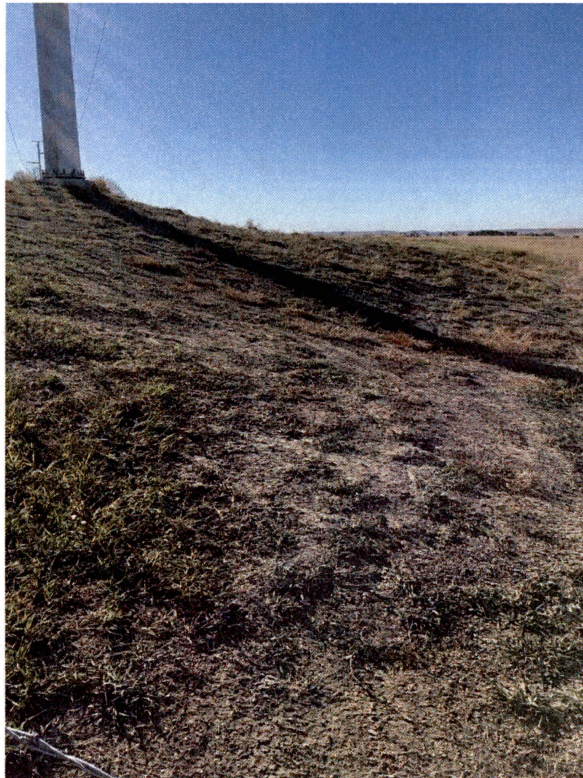
Photo Number: 8

Notes: Partial vegetative cover.

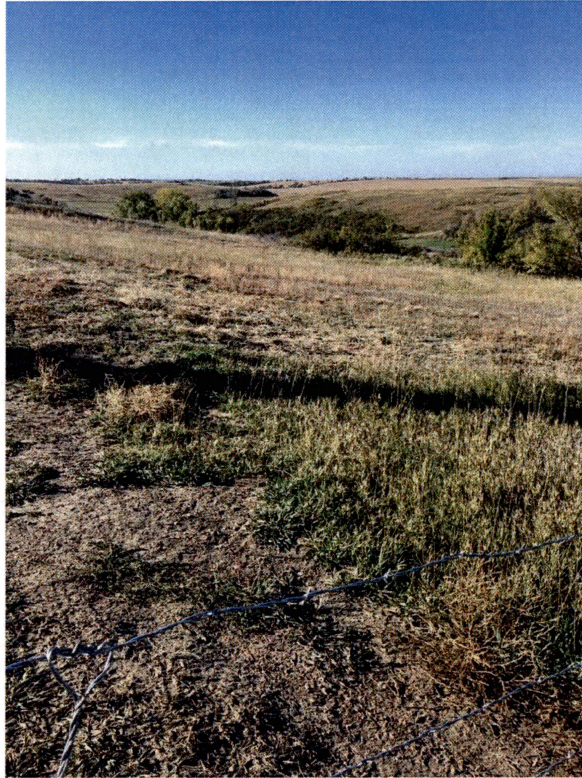
Photo Number: 9

Notes: Silt fence removed, vegetative cover evident on downslope.

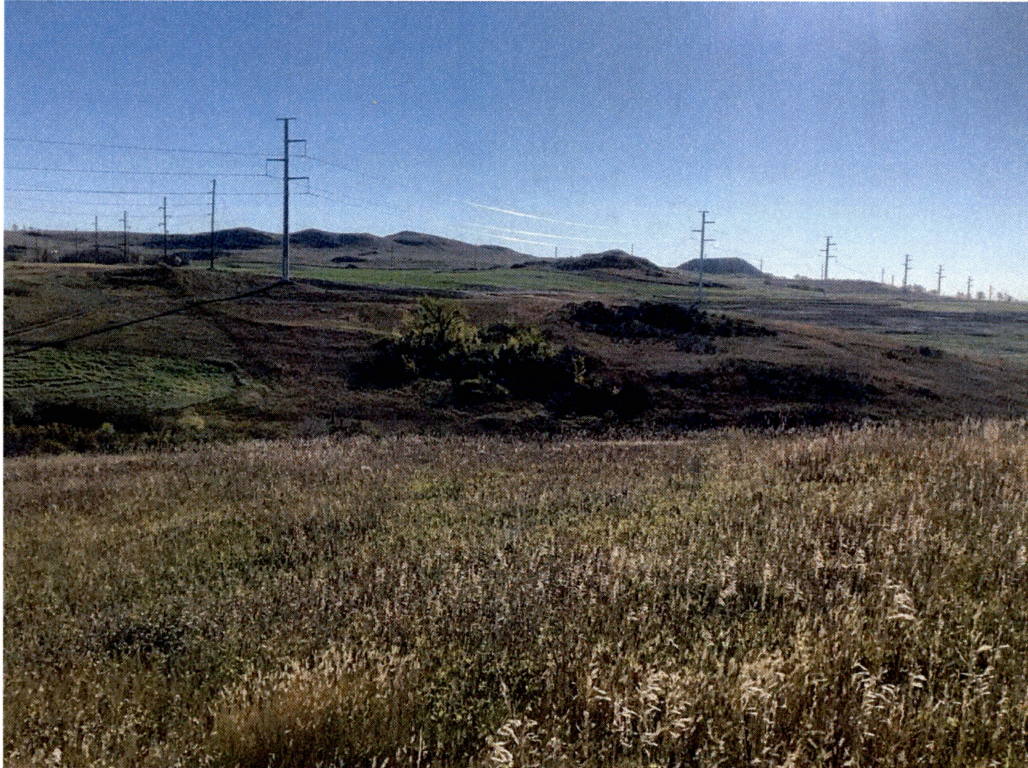
Photo Number: 10

Notes: View of structures 162, 161, and 160 from afar, confirms that vegetative cover is preventing runoff erosion.

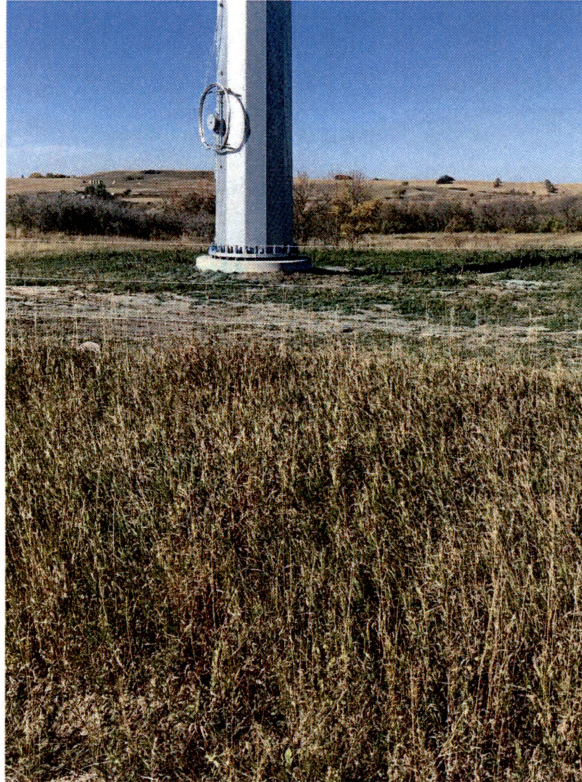
Photo Number: 11

Notes: Hard to tell in picture, but in naked eye I can see that bare spots in this area were recently seeded and mulched.

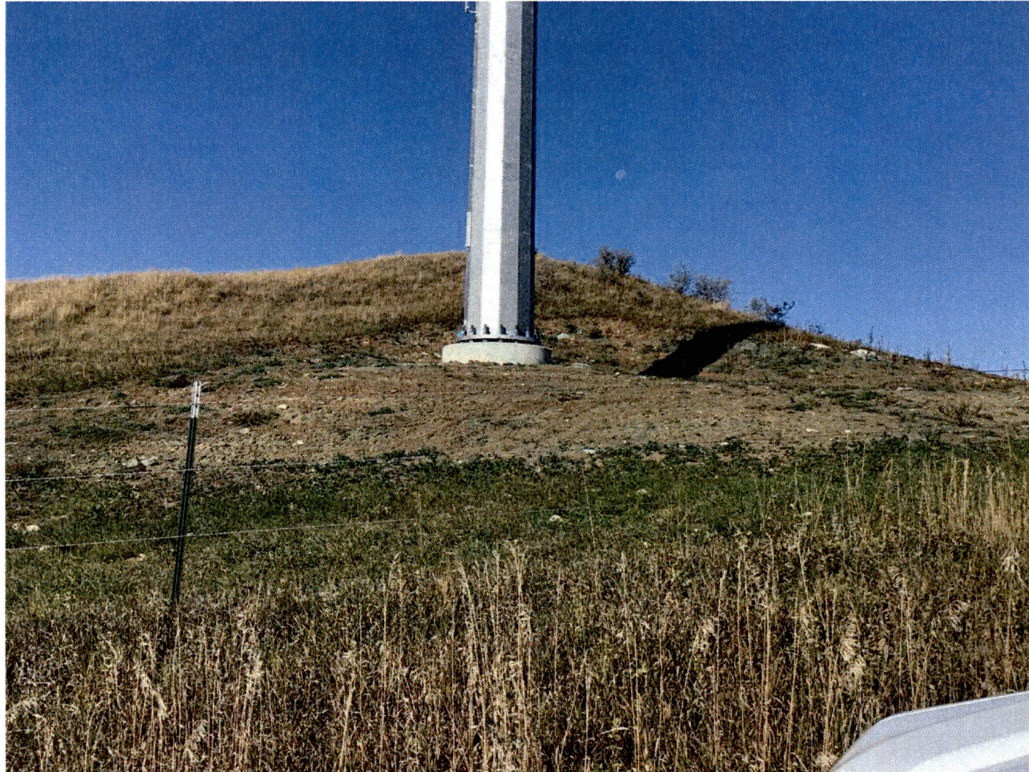
Photo Number: 12

Notes: Not clear in picture, but looks like this structure was recently seeded and mulched. No evidence of erosion.

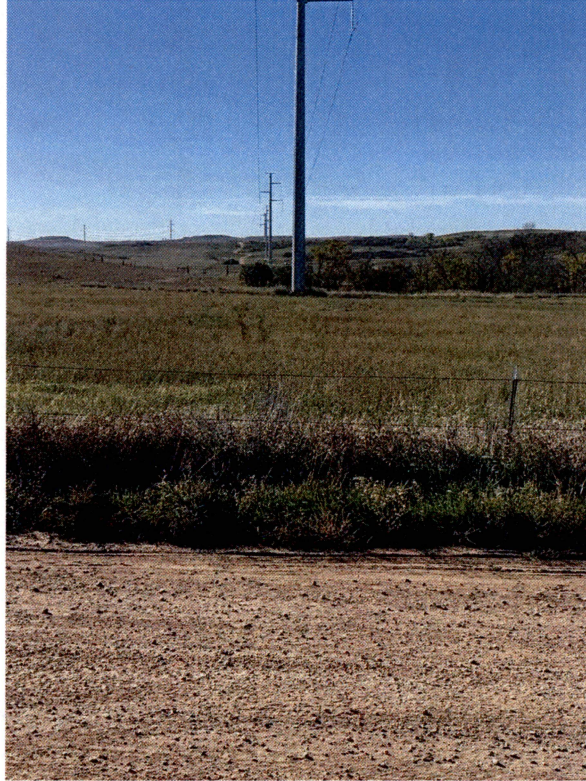
Photo Number: 13

Notes: Unable to reach 152, however from here it looks like there's abundant vegetation present.

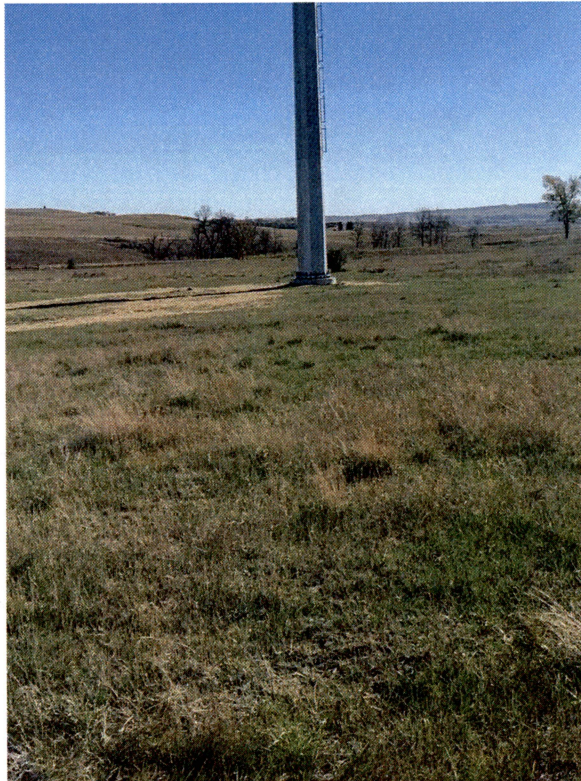
Photo Number: 14

Notes: Structure 151 looks to have been straw mulched very recently. No issues.

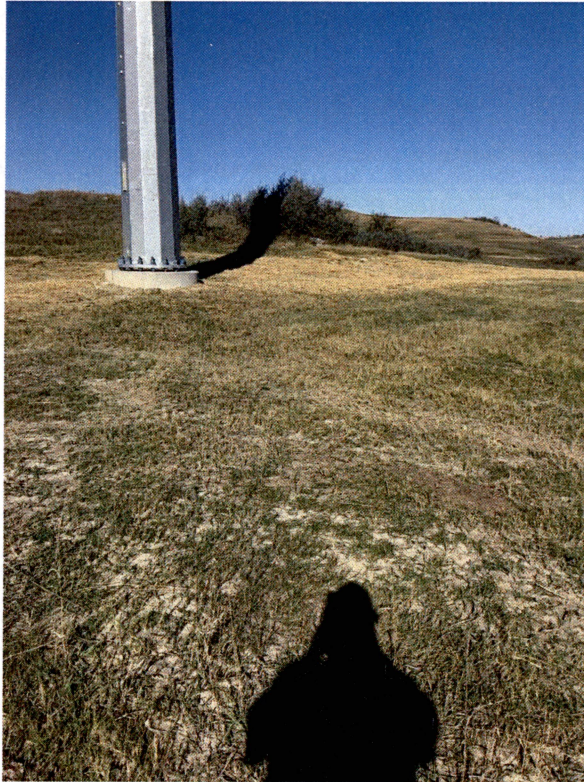
Photo Number: 15

Notes: Structure recently straw mulched. No issues or evidence of erosion.

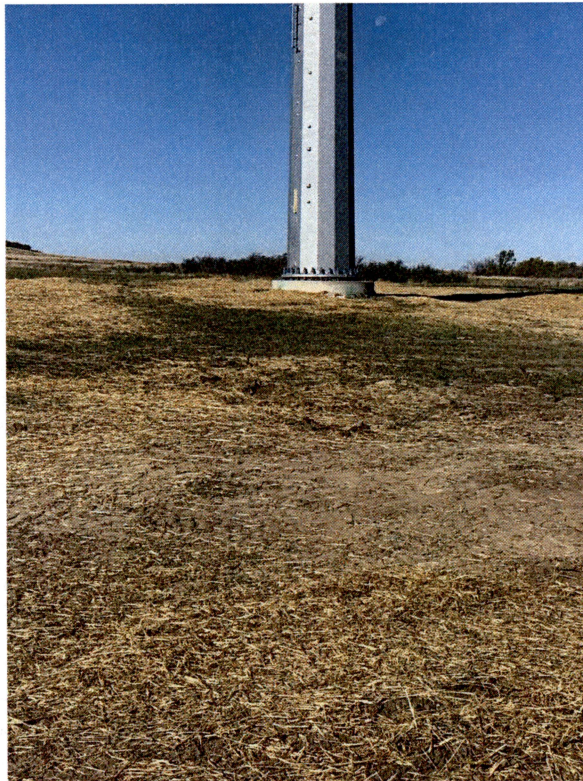
Photo Number: 16

Notes: Area around structure recently mulched. No issues.

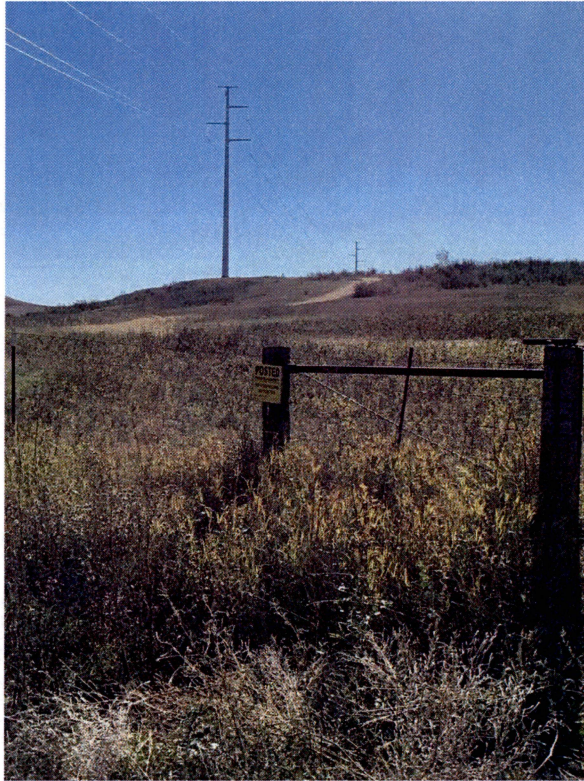
Photo Number: 17

Notes: Unable to access property, however, can see access road to 145 is mulched. Assuming structure has been as well.

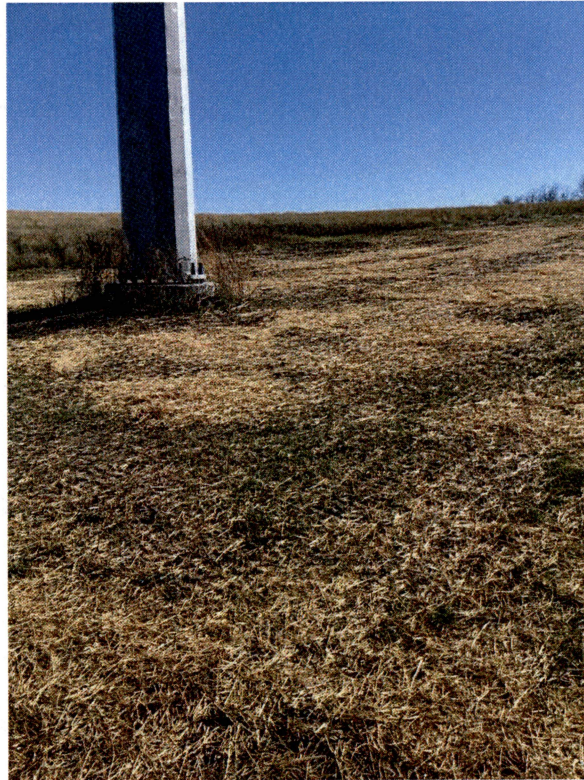
Photo Number: 18

Notes: Structure 142 mulched.

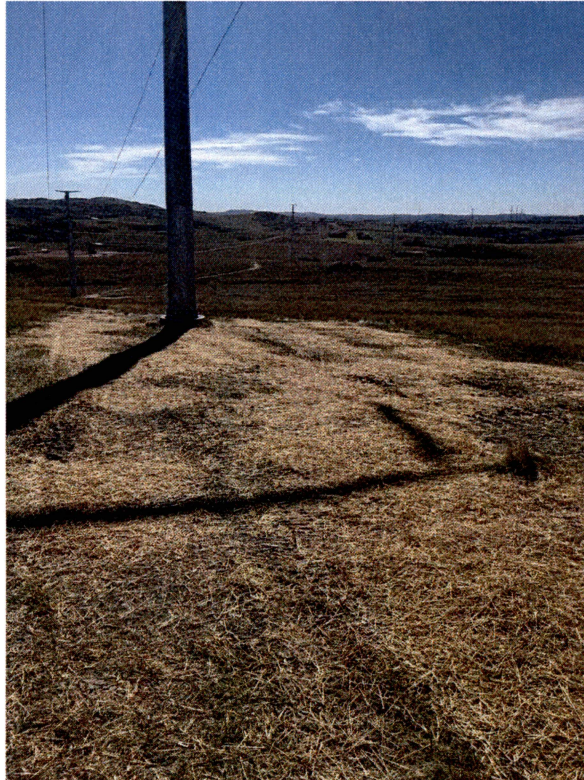
Photo Number: 19

Notes: Structure and access road have been mulched. No signs of runoff erosion or other issues. 140-134 can also be seen in the distance.

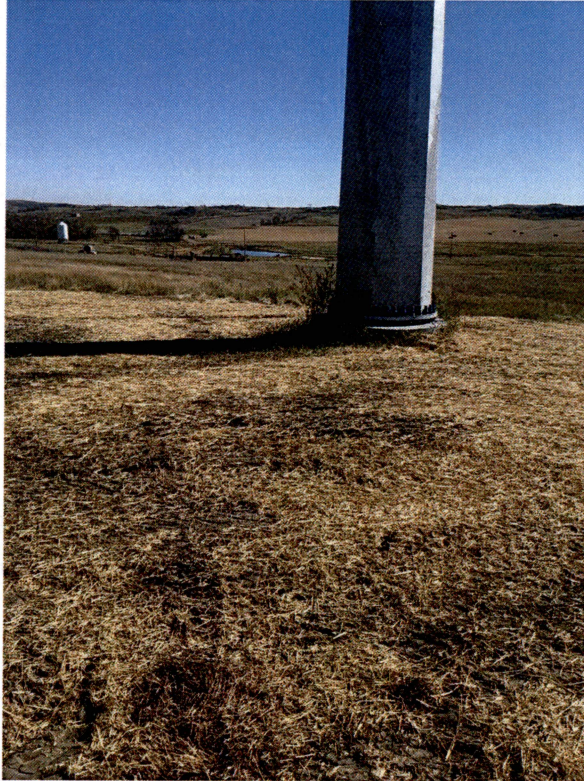
Photo Number: 20

Notes: 140 has mulching complete and no evidence of runoff erosion. No issues.

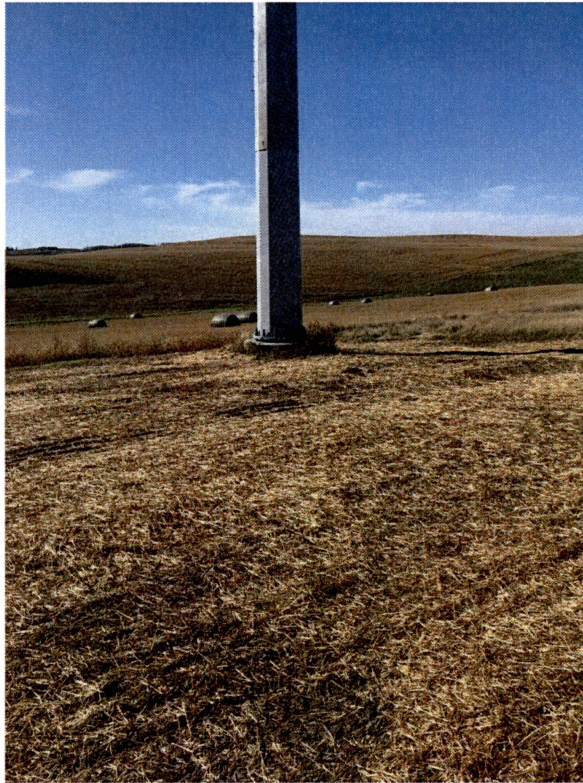
Photo Number: 21

Notes: Mulched, no sign of erosion due to runoff. No issues.

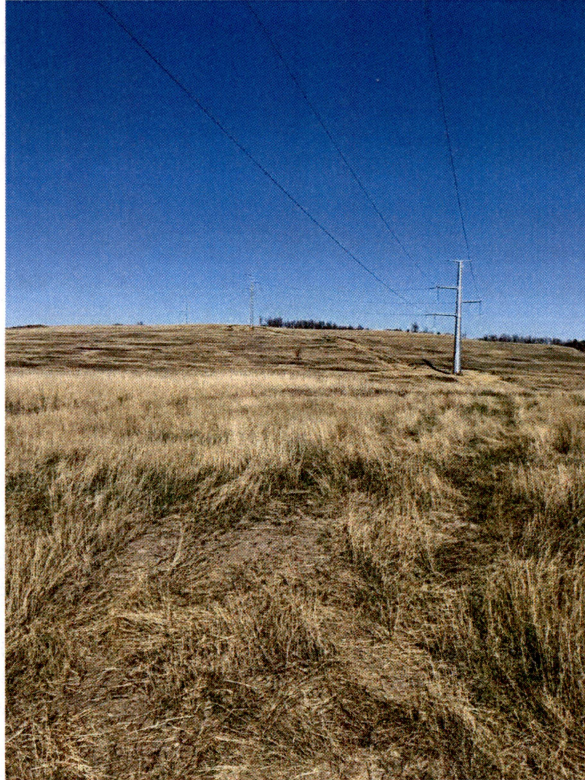
Photo Number: 22

Notes: Zoomed out view of mulching for structures 140 and 141 with access roads, 142 is in view as well.

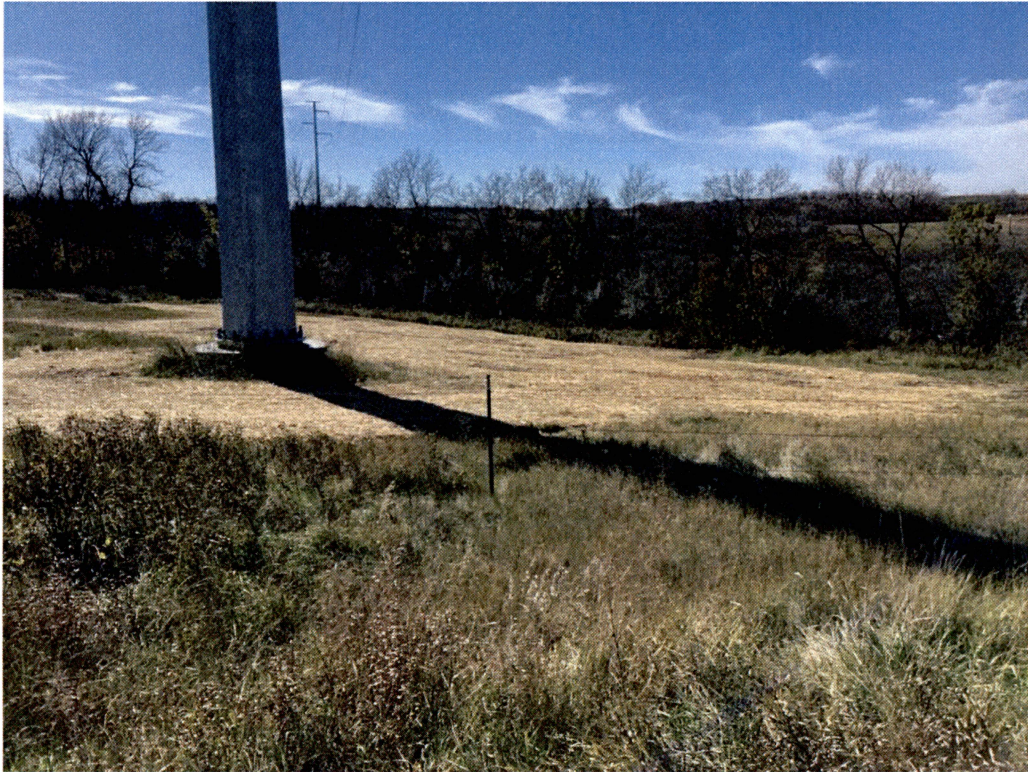
Photo Number: 23

Notes: Site is mulched, no evidence of runoff erosion. No issues, unsure how crews accessed this spot.

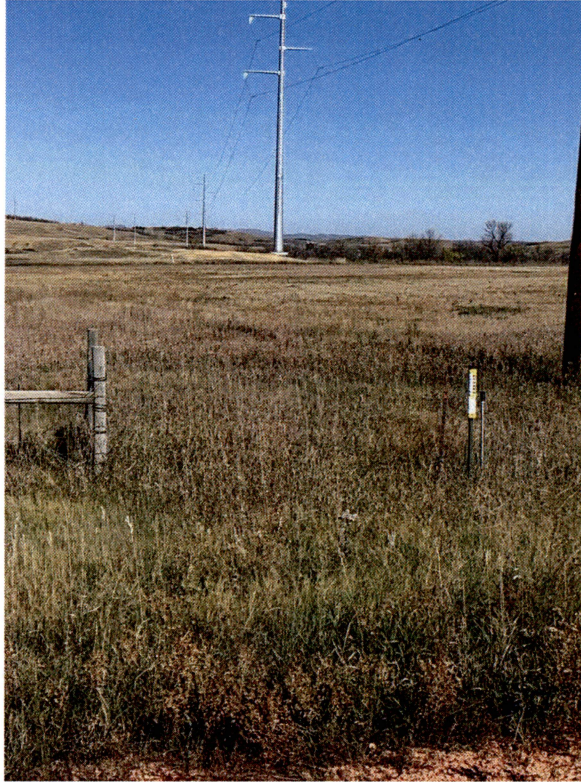
Photo Number: 24

Notes: 136 seems mulched from here. Unable to gain access to property.

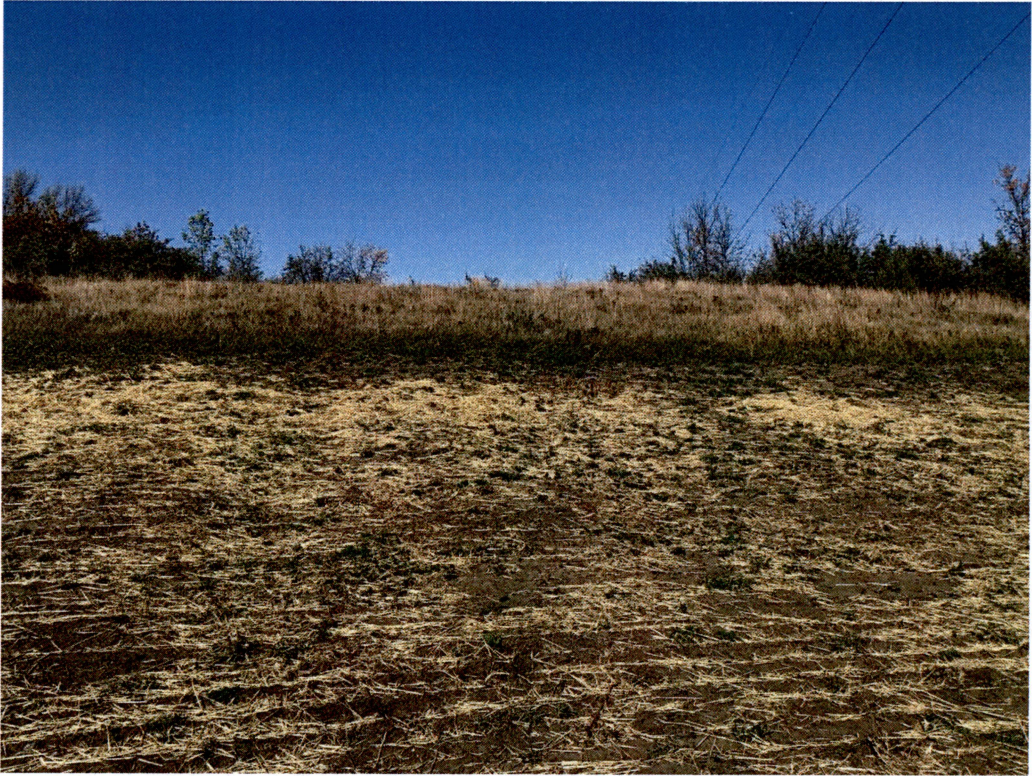
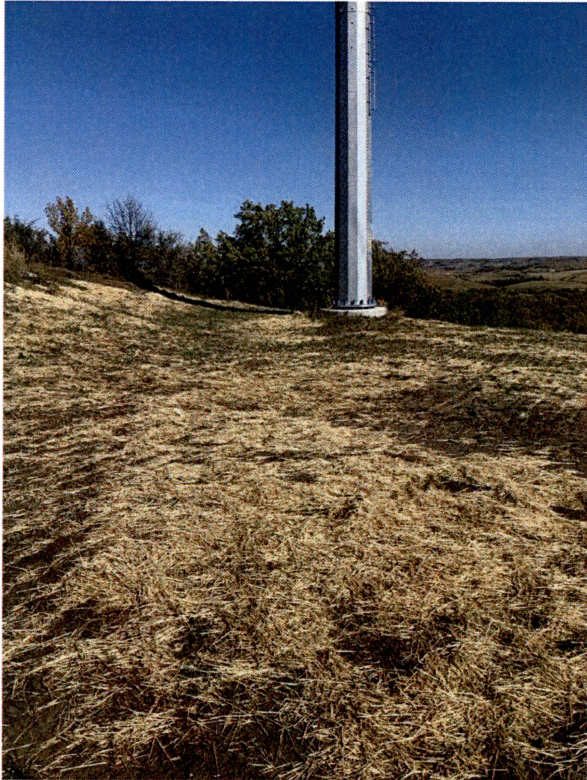
Photo Number: 25-26

Notes: No evidence of disturbed avoidance areas, evidence of discing, which indicates seeding, and lots of straw mulch.

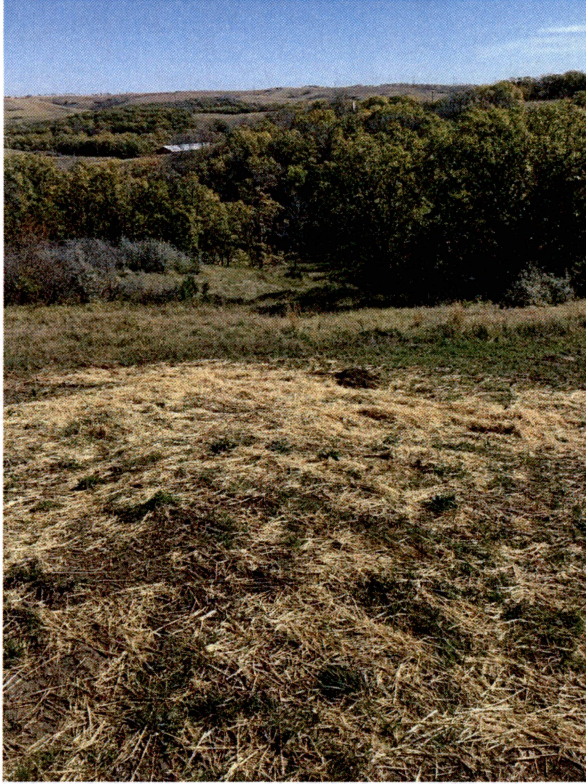
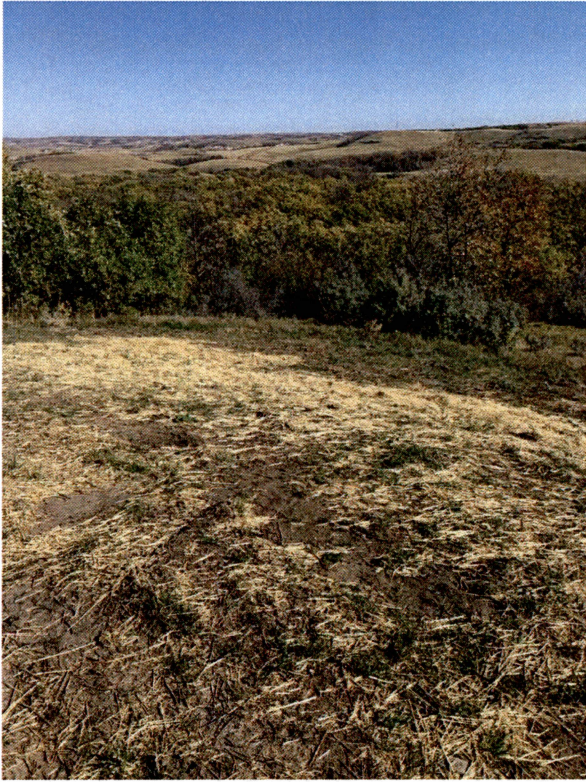
Photo Number: 27-28

Notes: No evidence of runoff erosion, no issues.

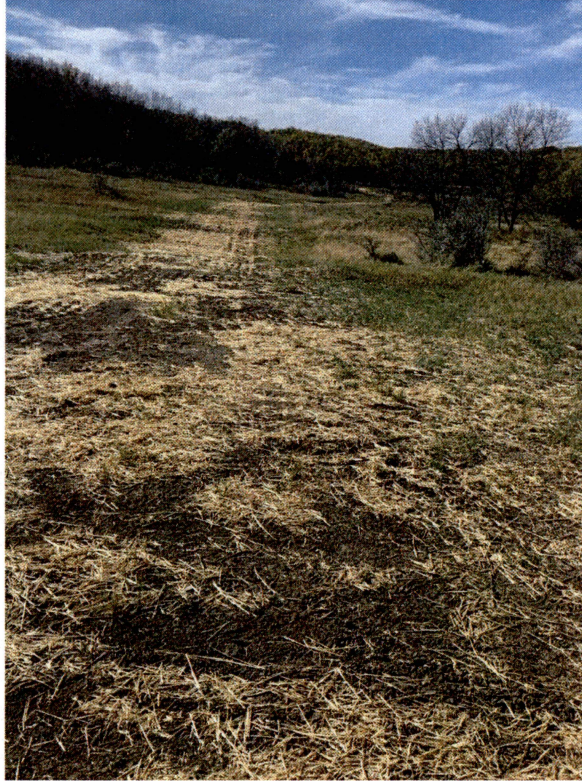
Photo Number: 29

Notes: Access road has been seeded and mulched.

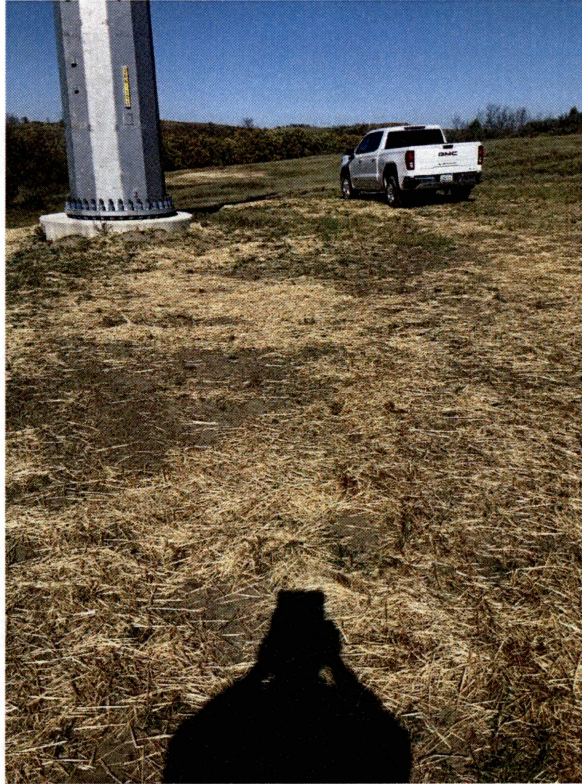
Photo Number: 30

Notes: Seeding and mulching evident, some bare patches, likely wind related.

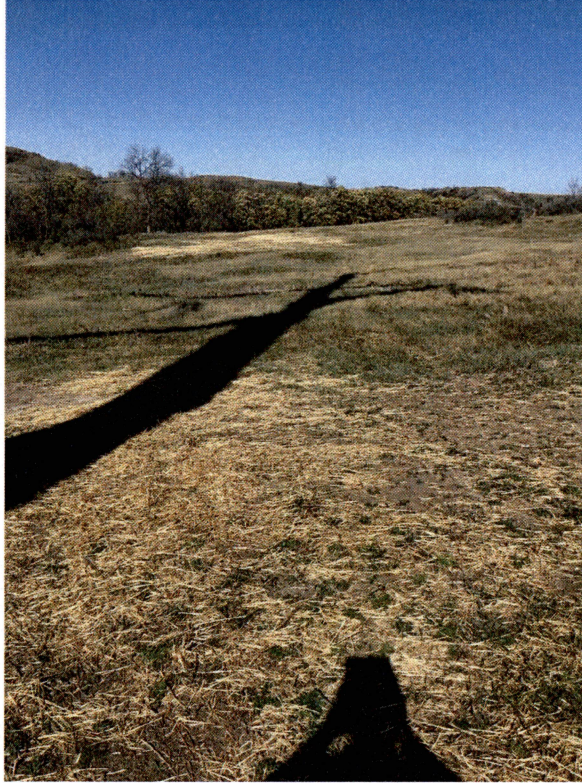
Photo Number: 31

Notes: Vegetative cover, looks like some seeding and mulching took place. No signs of runoff erosion. No issues.

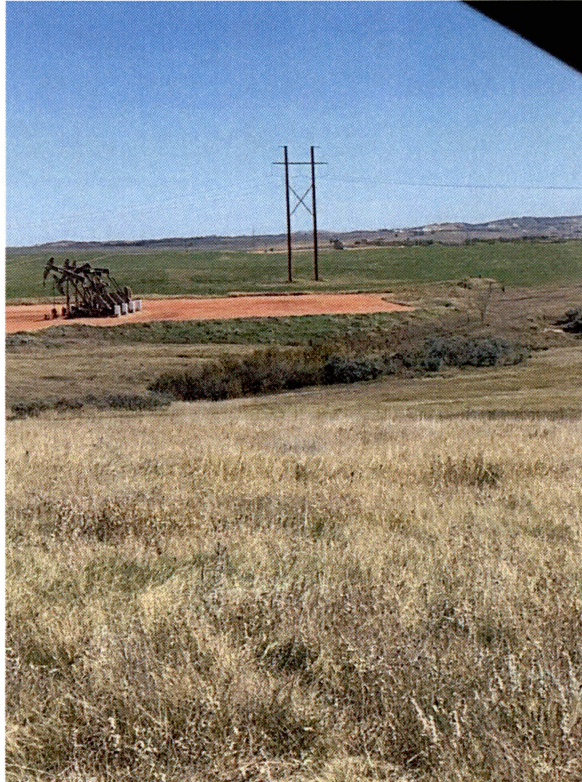
Photo Number: 32

Notes: H structure 114. Vegetative cover visible from this far away.

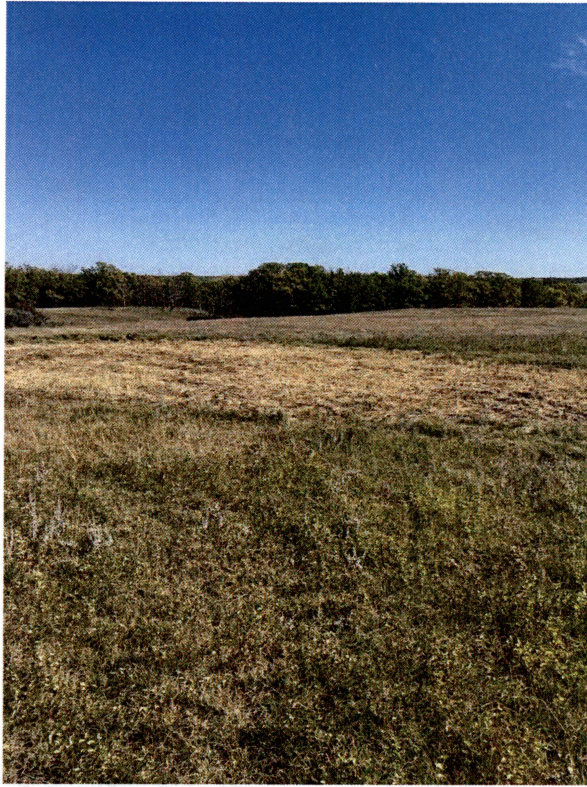
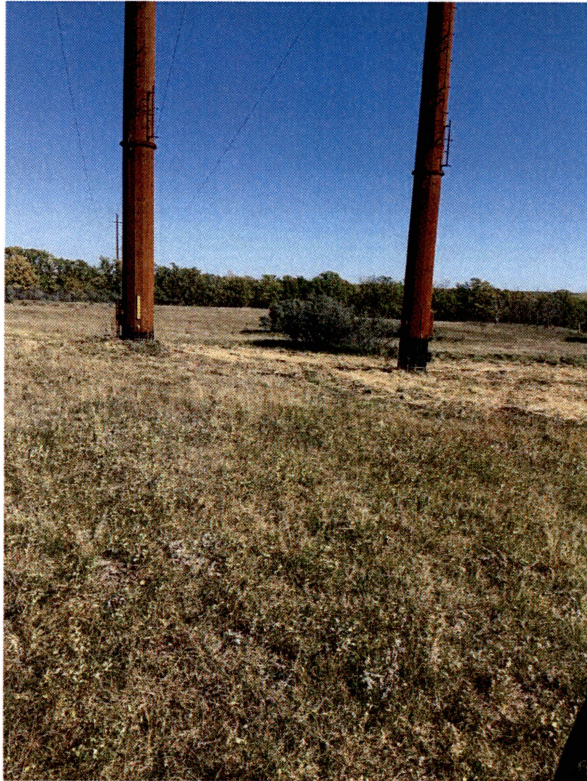
Photo Number: 33-34

Notes: No evidence of soil erosion. Seeding and mulching complete, no issues.

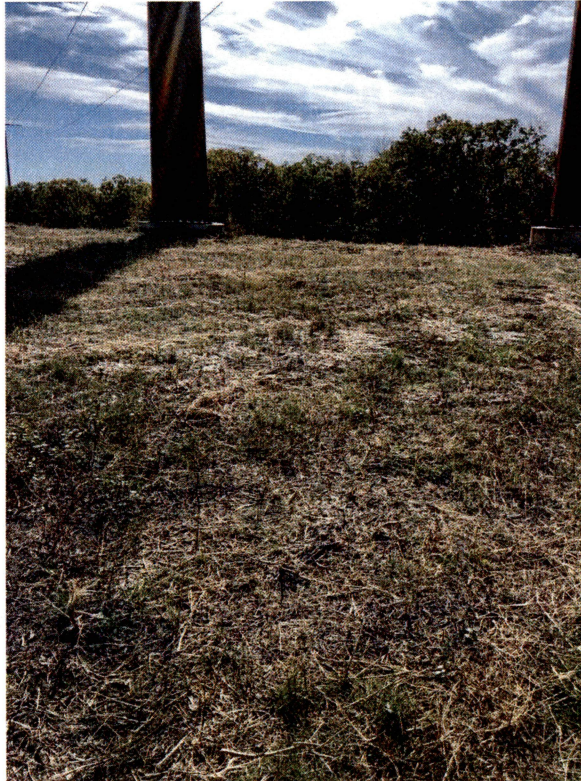
Photo Number: 35

Notes: Vegetative cover abundant.

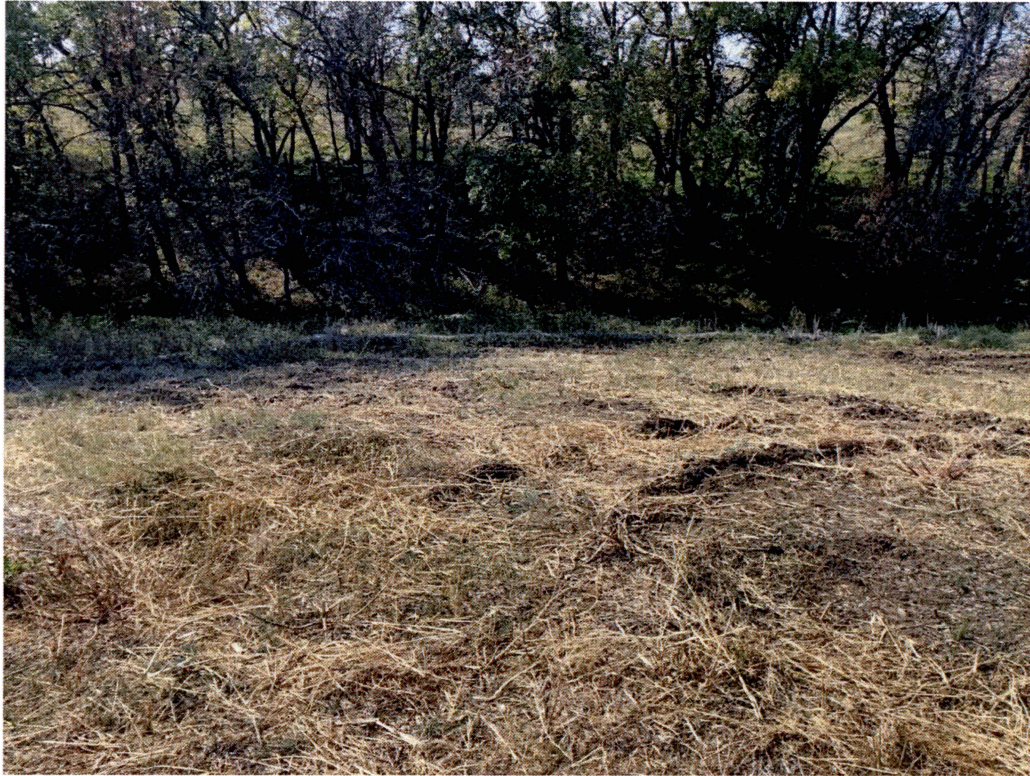
Photo Number: 36

Notes: Fiber rolls installed as permanent erosion control.

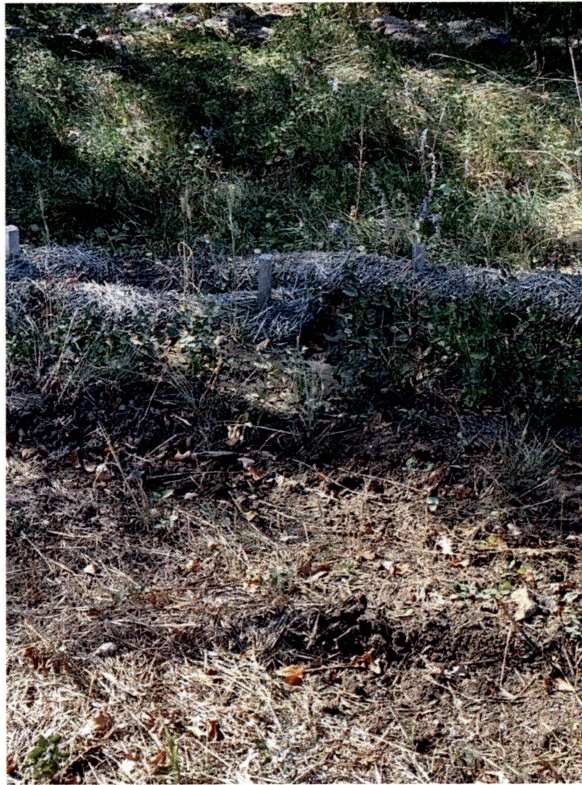
Photo Number: 37

Notes: One section where sediment has built up. Assuming was built up before reclamation happened.

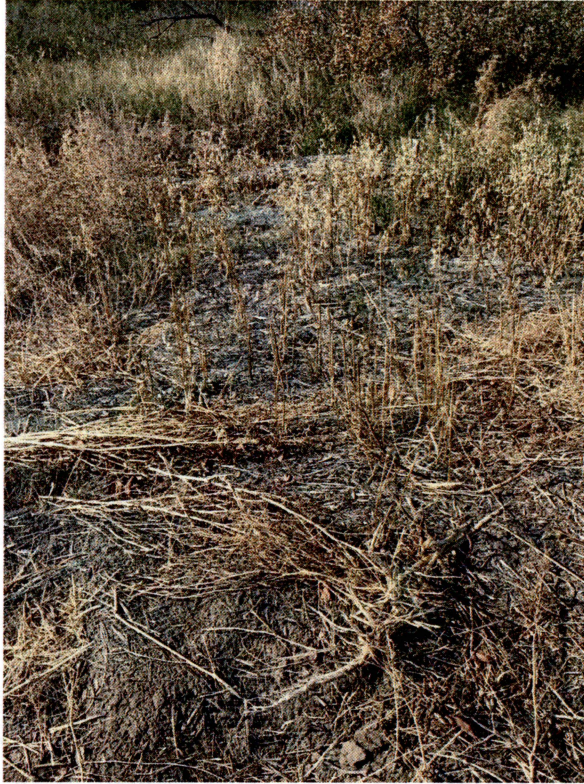
Photo Number: 38

Notes: Erosion control blanket in place.

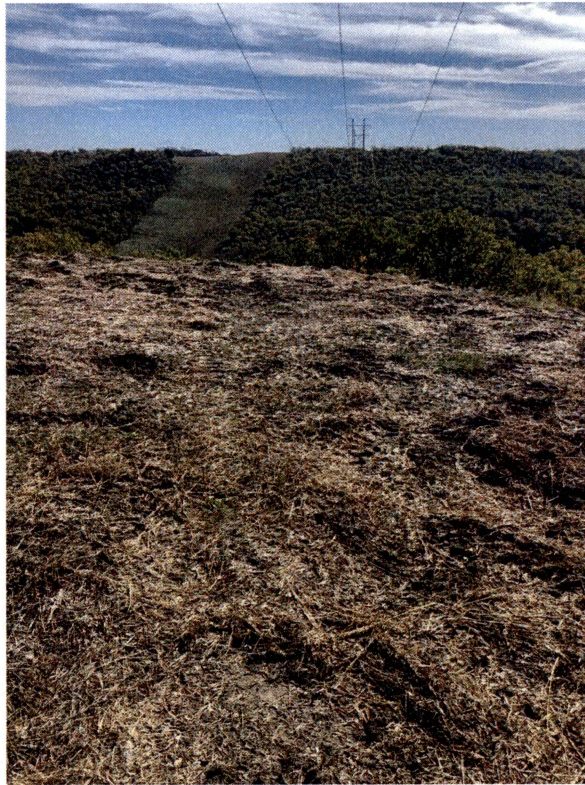
Photo Number: 39

Notes: Seeding and mulching complete. No evidence of runoff. No issues.

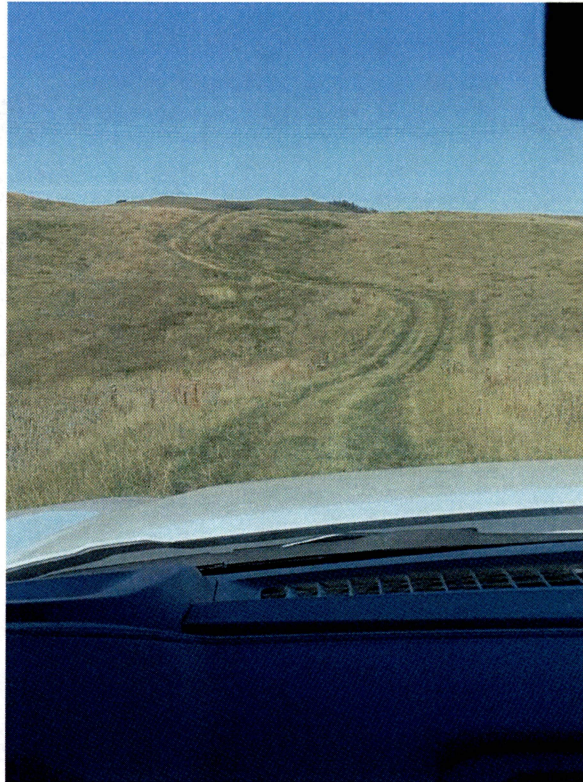
Photo Number: 40

Notes: Vegetative cover is taking hold in tire ruts.

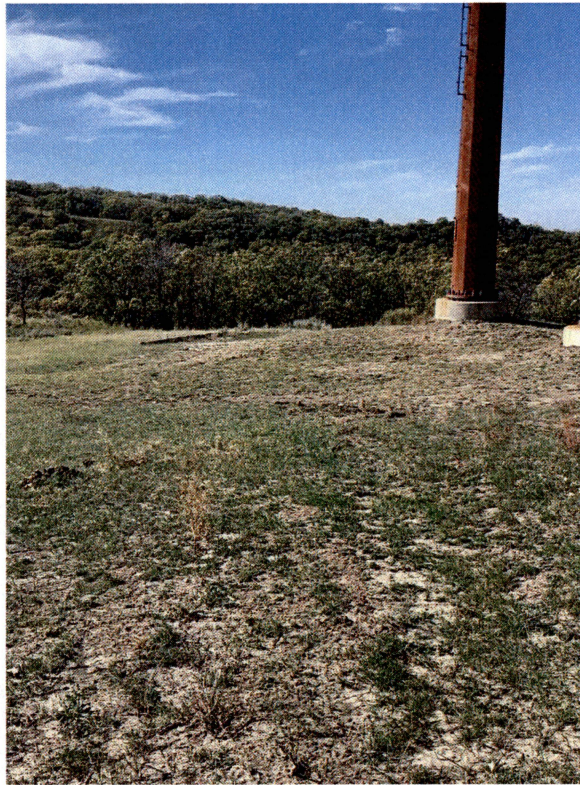
Photo Number: 41

Notes: Fiber roll in place. Vegetative cover established. No issues.

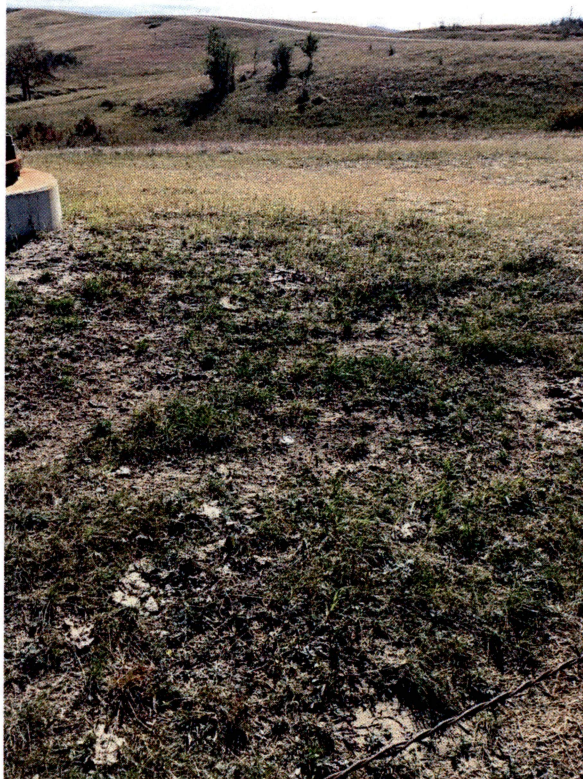
Photo Number: 42

Notes: Abundant vegetative cover. No issues.

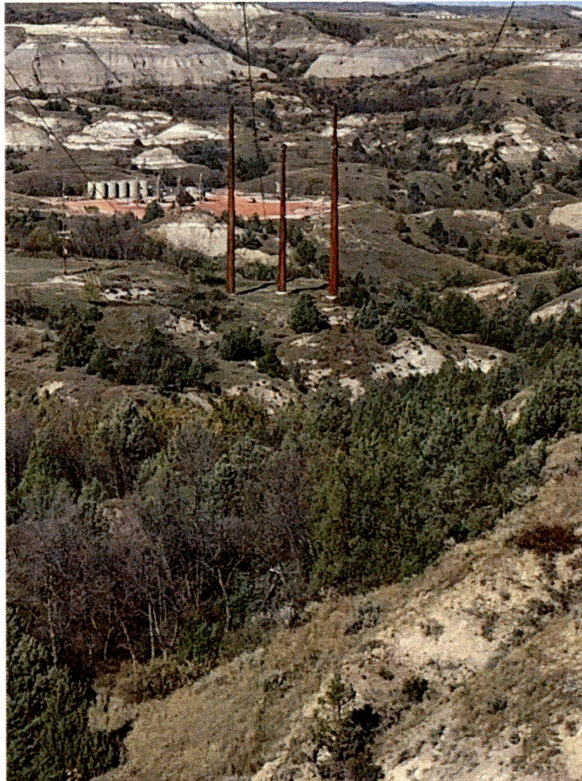
Photo Number: 43

Notes: Looking at 69 from a distance, vegetative cover evident.

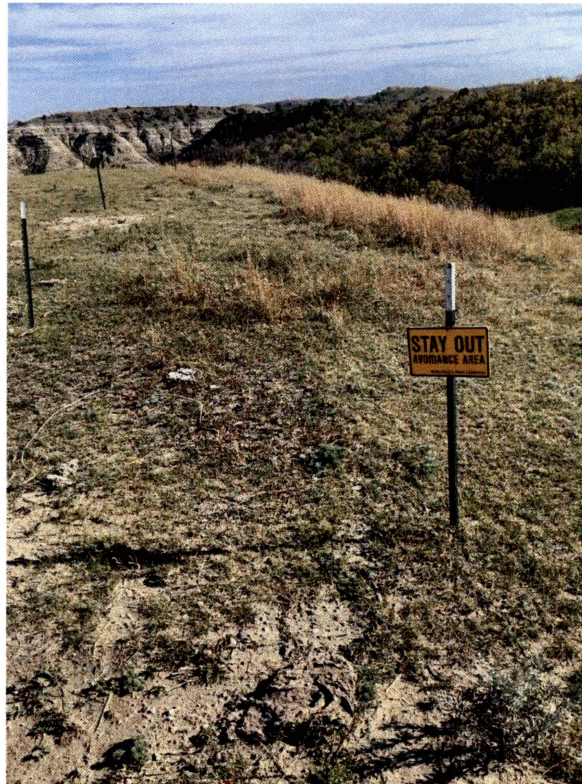
Photo Number: 44

Notes: Avoidance area ropes are down, no damage evident to actual avoidance area. Wildlife?
