Basin Electric Power Cooperative

Roundup-Kummer Ridge 345-kV Transmission Line Dunn-
McKenzie Counties

Case No. PU-23-361

As-Built Inspection Report

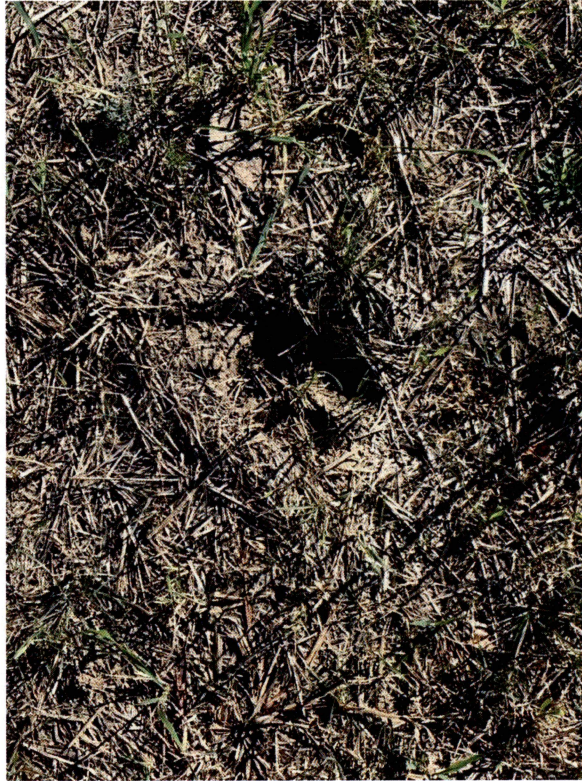
Photo Number: 45

Notes: Bison track, combined with presence of lots of dung begs the question if bison aren't responsible for breaking the cords for the avoidance area.

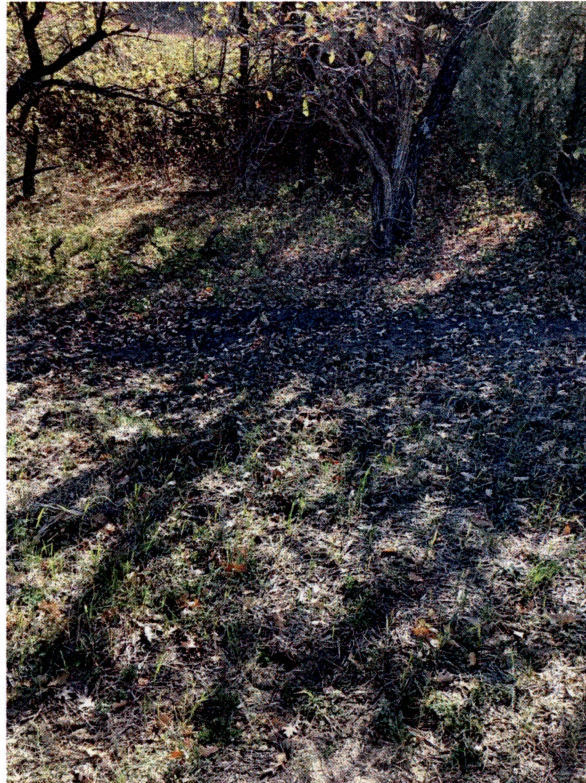
Photo Number: 46

Notes: Silt fence removed. Looks like silt buildup was addressed as per request in construction inspection. Access road has vegetative cover developing.

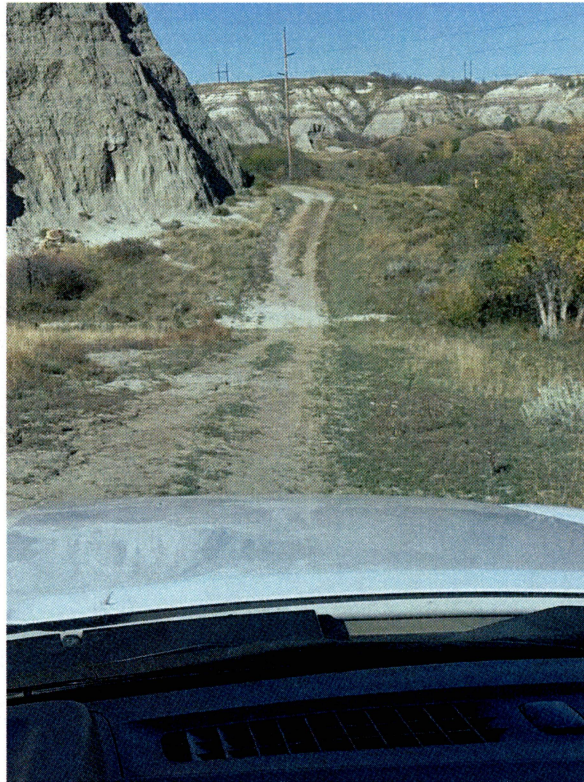
Photo Number: 47

Notes: Conditions of access road now that planking has been removed.

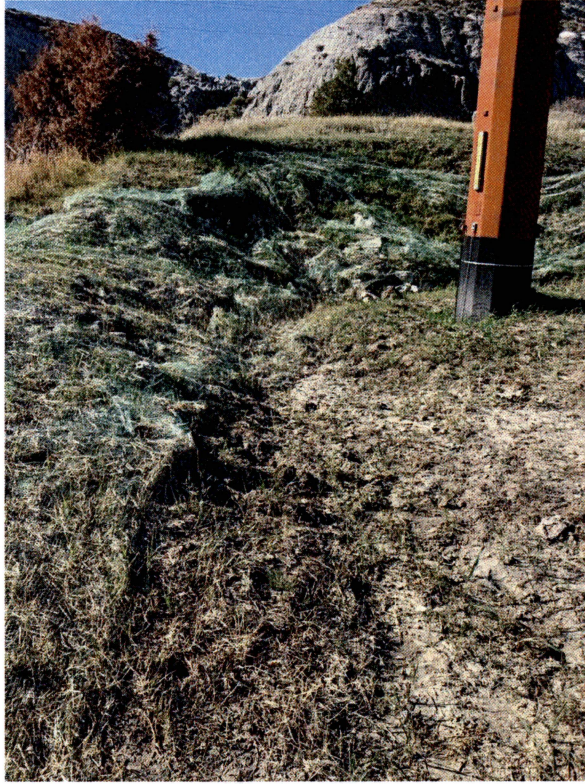
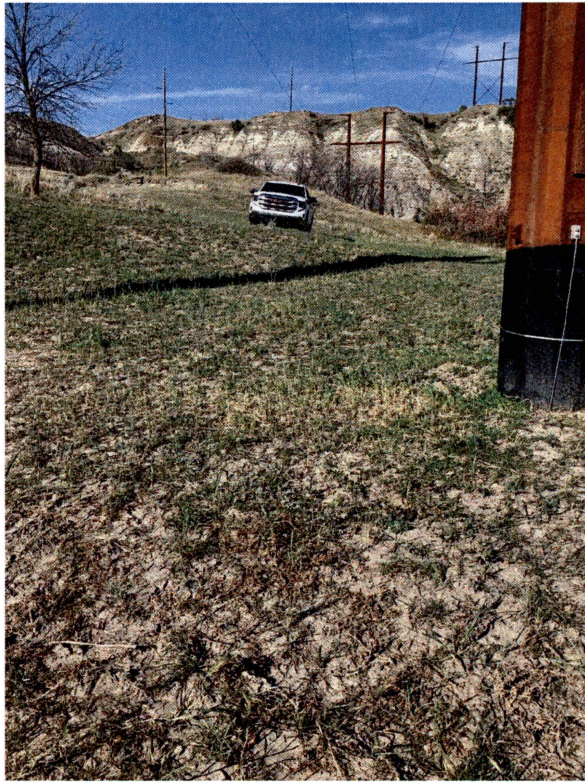
Photo Number: 48-49

Notes: Lots of erosion control blanket in use. Otherwise vegetative cover seems to be establishing itself. No issues.

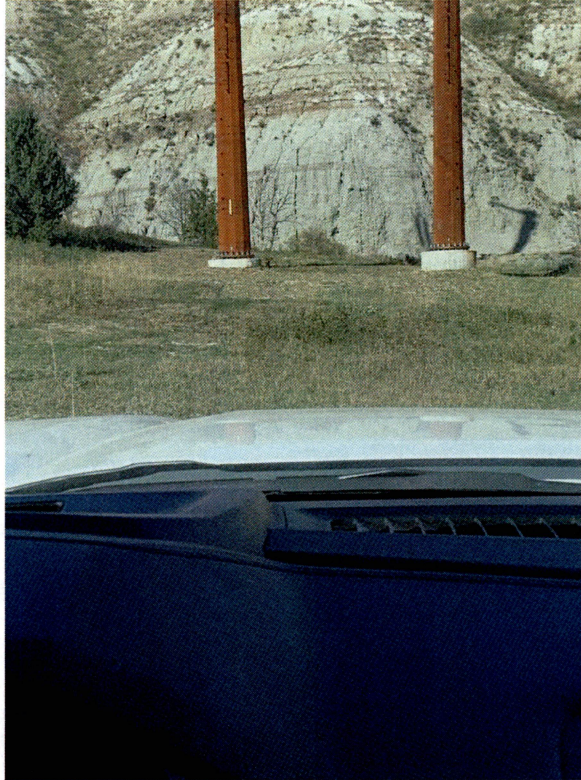
Photo Number: 50

Notes: Vegetative cover evident, no signs of erosion other than in the badlands themselves.

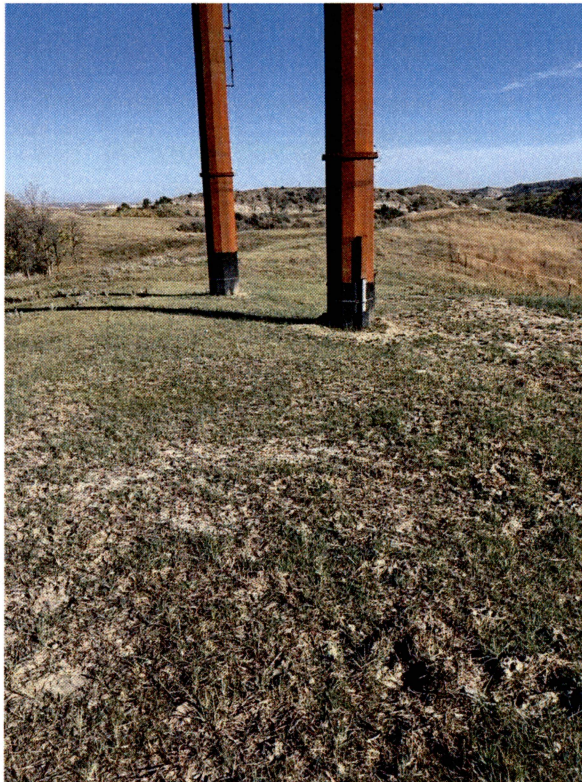
Photo Number: 51

Notes: Vegetation in progress.

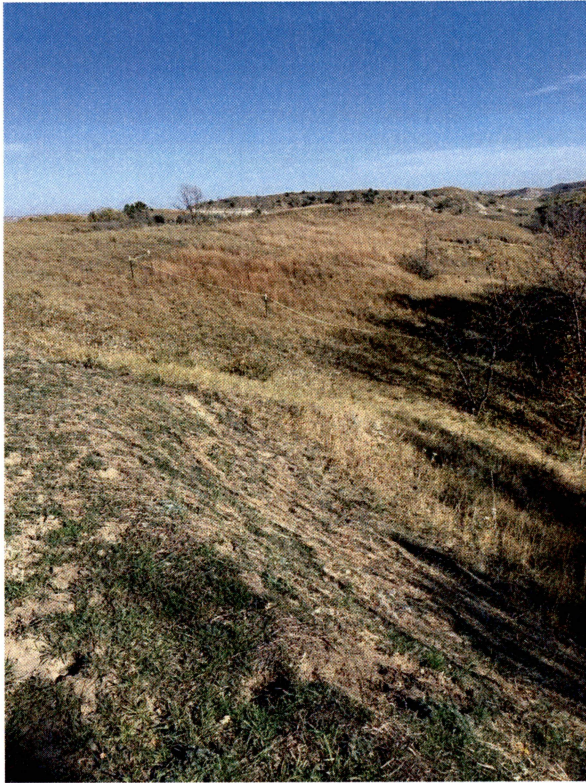
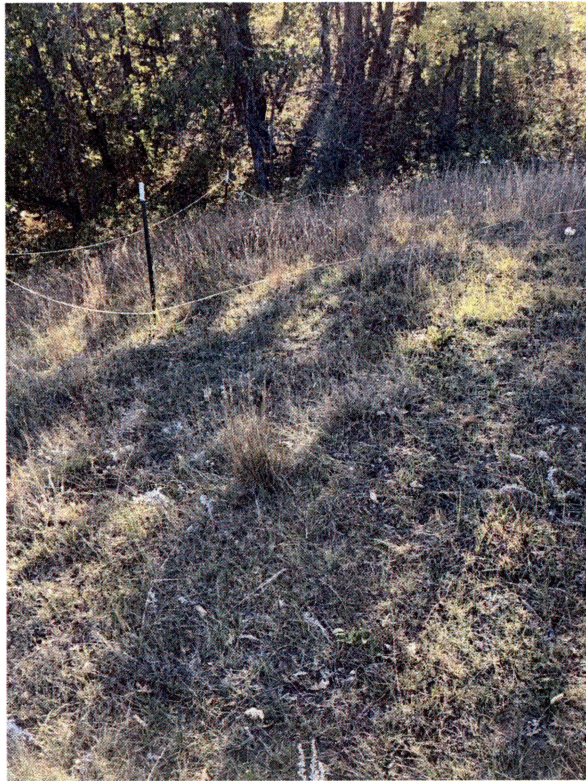
Photo Number: 52-53

Notes: Avoidance areas remain undisturbed, no issues.

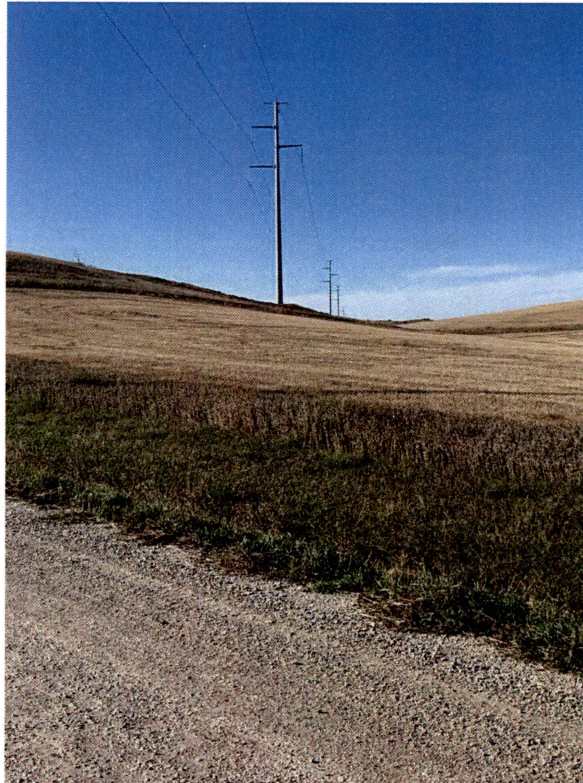
Photo Number: 54

Notes: Landowner seems to have full access to land now and cultivation is evident.

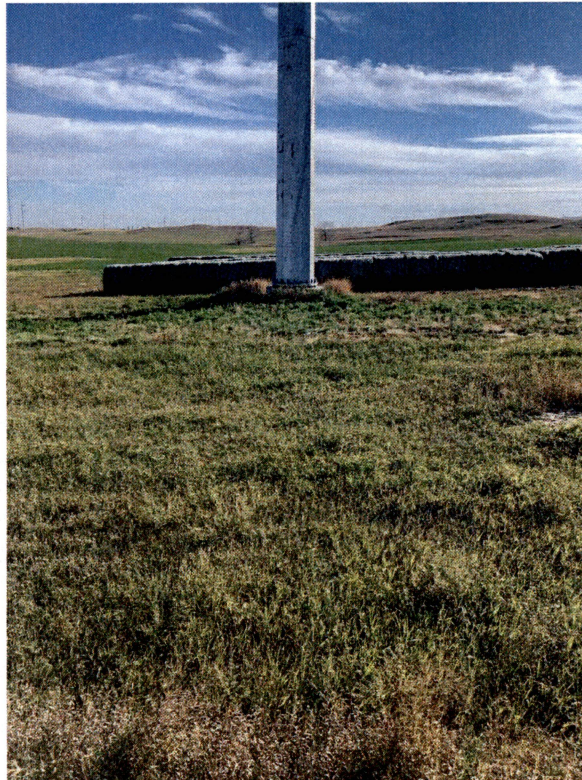
Photo Number: 55

Notes: Vegetative cover present.

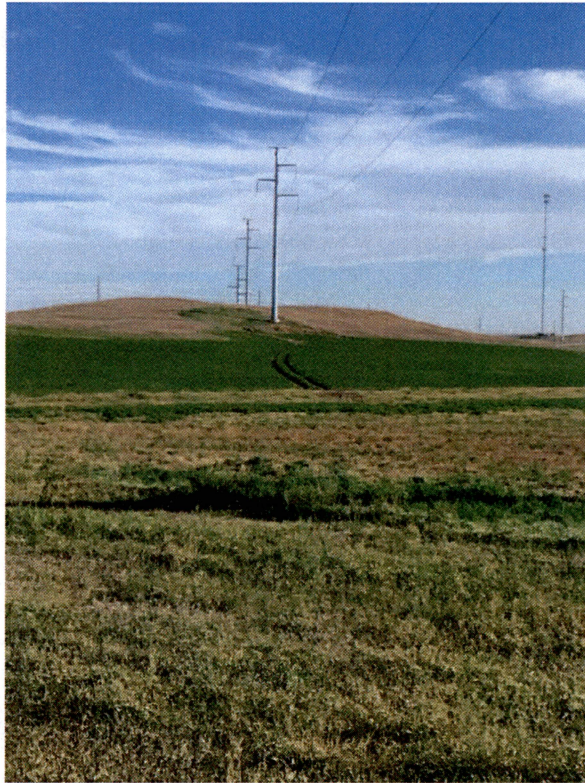
Photo Number: 56

Notes: Structure 56 with evidence of vegetative growth.

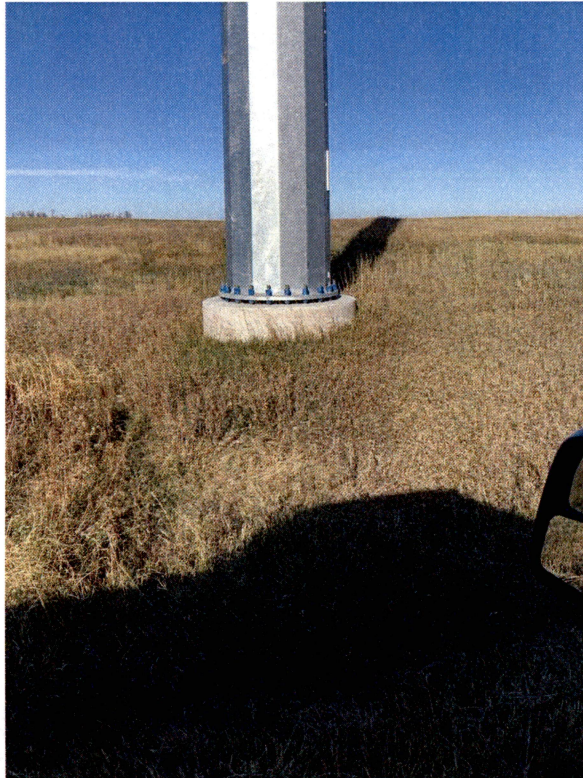
Photo Number: 57

Notes: Full vegetative cover.

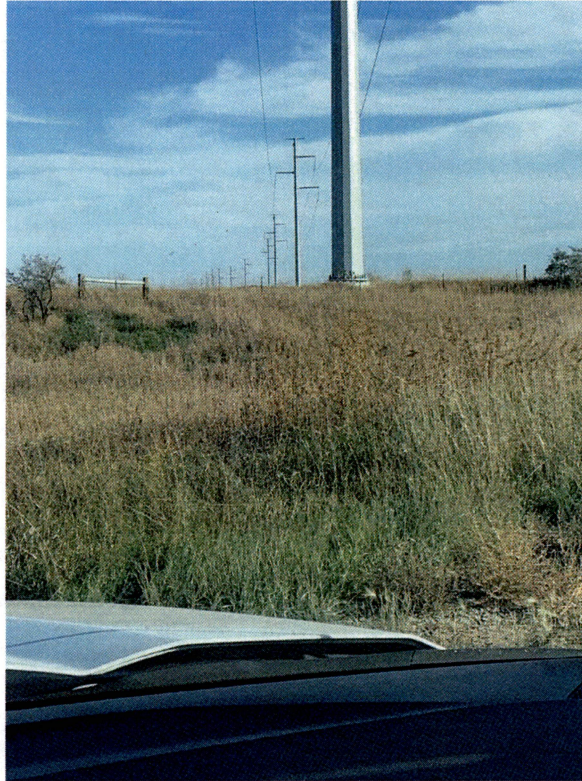
Photo Number: 58

Notes: Abundant vegetative growth.

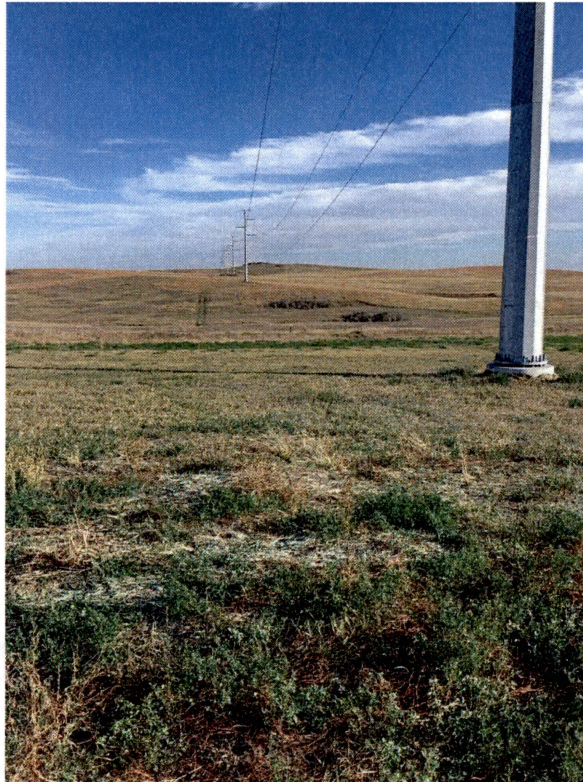
Photo Number: 59

Notes: Structures 24, 23, 22, and 21 all have vegetative cover.
