Subject: Depth of Cover for the Thunder Butte Pipeline

Geohazard Investigation  
Thunder Butte Pipeline Project

Thunder Butte Petroleum Services Clean Fuels Refinery  
Geological Hazard Investigation

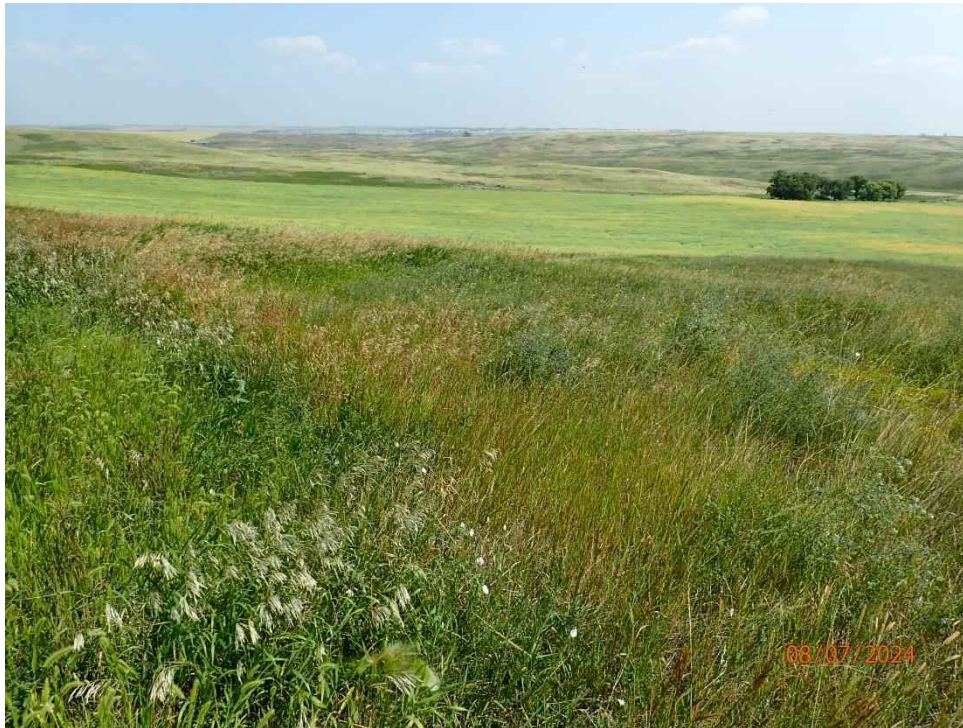
**Location ID:** AOC3

AOC3	0 foot from existing pipeline	Steep slope (9.9°; 5.65H:1V) along the pipeline between farm fields that warranted inspection; no signs of instability were observed; likely stable.	87-89

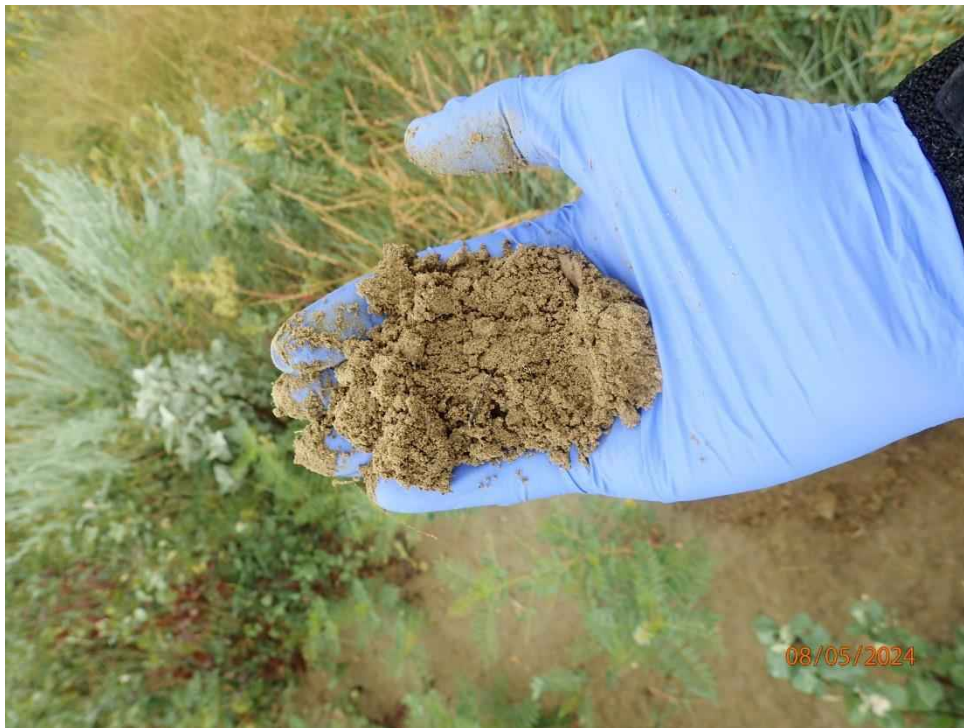
**Location ID: S1**

Feature ID	Distance from Pipeline	Description	Photo Number(s) Appendix C
S1	870 feet from existing pipeline	Scarp at top of slope; rotational slide with displaced material downslope; tension cracks around slide; unstable.	90-93
S2	350 feet existing pipeline	Existing landslide. Two scarps located about 4 ft above bottom of slope, likely will progress upslope; unstable.	100-103
S3	1,200 feet from existing pipeline	No obvious signs of instability observed; appears to be erosion near base of slopes and erosion rills downslope to unnamed stream; likely stable.	123-128
AOC1	15 feet from existing pipeline	Area along pipeline shows disturbance and lack of vegetation on crest (80 feet long, visible in aerial imagery); likely stable. See Figure 1 in <b>Appendix E</b> .	139
AOC2	25 feet from existing pipeline	Steeper 21-foot tall slope (18.4°) located 25 feet south of pipeline; slope is well vegetated but top along pipeline lacks vegetation and is vulnerable to erosion (AOC1); conditionally stable. See Figure 1 in <b>Appendix E</b> .	140-142

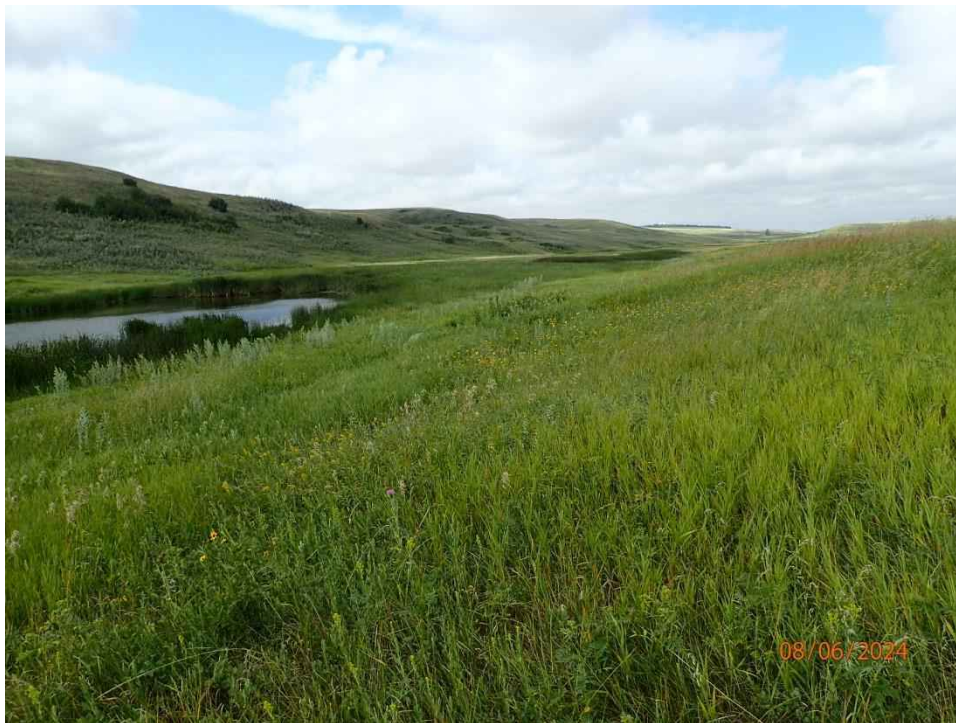
**Location ID: S3**

S3	48.0988	-102.0570	NDGS Slide No. 3 along unnamed stream	No obvious signs of instability observed, appears to be erosion near base of slopes and erosion rills downslope to the unnamed stream. Existing pipeline.	CL,CH (sandy soil in field)	123-128	Likely Stable
W1	48.3041	-102.3626	Stream crossing No. 1, branch of Little Knife River	Branch of Little Knife River with surveyed cross section. Existing pipeline.	ML,CL	1-3	Likely Stable
W2	48.3040	-102.3649	Stream crossing No. 2 at Little Knife River	Little Knife River with surveyed cross section. Existing pipeline.	ML,CL	4-20	Likely Stable
W5	48.1931	-102.2039	Waterway No. 5, unnamed stream	Existing pipeline	CL,CL	54-60	Likely Stable
W7	48.1728	-102.1624	Stream crossing No. 7 at unnamed stream	Unnamed stream with surveyed cross section, slopes < 3 ft tall. Existing pipeline.	ML,CL	65-73	Likely Stable
W9	48.1319	-102.1218	Stream crossing No. 9 at unnamed stream	Unnamed stream with surveyed cross section. Existing pipeline.	ML,CL	94-99	Likely Stable

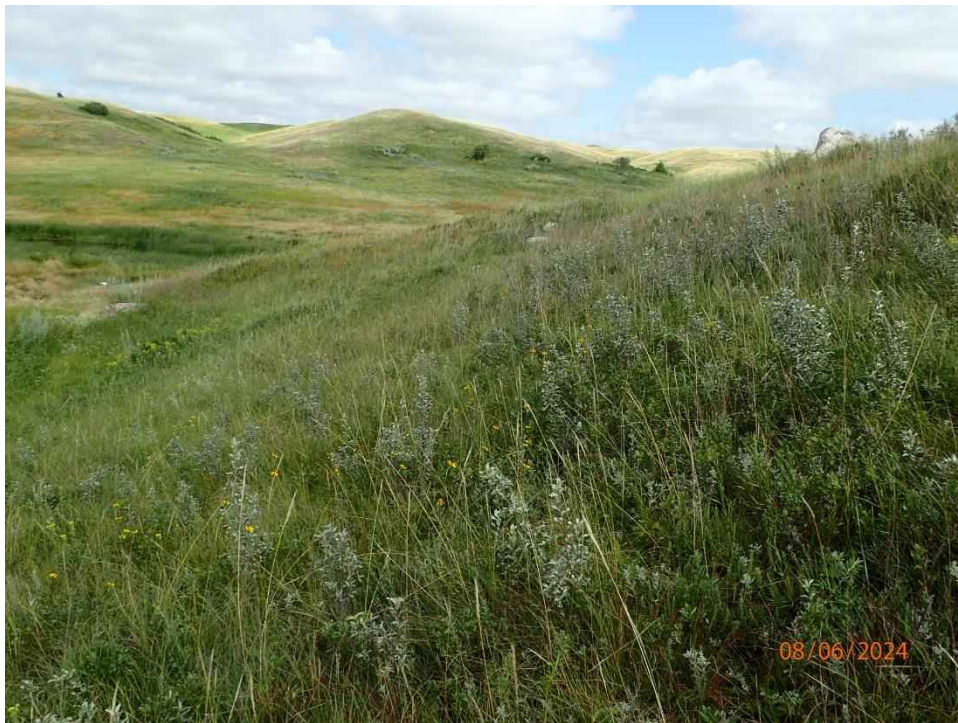
**Location ID: AOC2**

Two additional potential landslide features were added during the field work, noted as area of concern (AOC) AOC2 and AOC3. Feature AOC2 is a 21-foot tall, steeper slope (18.4°) along the south side of the pipeline that presently does not exhibit signs of instability but should be monitored for changes over time. AOC1 is an 80-foot long area along the pipeline that lacks vegetation and may be susceptible to erosion. AOC1 should also be monitored but the area currently has adequate pipeline DOC. AOC3 drew attention due to its steeper slope in between farm fields and was surveyed. No signs of instability were observed during the survey of AOC3. Potential landslide areas are summarized in **Table 1**. All potential landslides are located along the existing pipeline. The photograph numbers listed in **Table 1** are referencing the photolog provided in **Appendix C**.

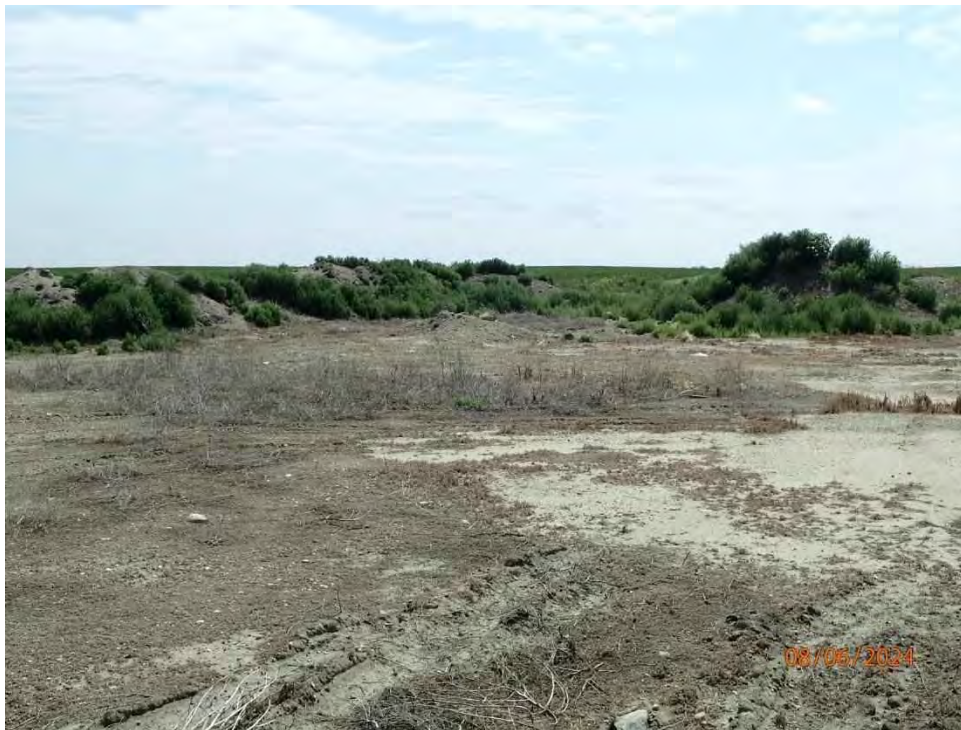
**Location ID:** AOC4

AOC4	48.0056	-101.9096	Cleared area with spoil piles, no visual excavation, looking southeast	Area required observation to verify not a potential hazard. Near proposed pipeline.	ML,CL	174, 177	Likely Stable
F1	48.2732	-102.3108	No apparent farm ditch between fields	Existing pipeline.	CL,SC-SM	27	Stable
F2	48.2258	-102.2449	No apparent farm ditch between fields	Existing pipeline.	CL/ML,CL	49	Stable
F6	48.0940	-102.0556	No apparent farm ditch between fields	Existing pipeline.	ML,CL	143	Likely Stable
F7	48.0841	-102.0374	No apparent farm ditch between fields	Existing pipeline.	ML,CL	144	Likely Stable
F8	48.0143	-101.9196	No apparent farm ditch between fields	Existing pipeline.	ML,CL	170	Stable
F9	47.9962	-101.9028	No apparent farm ditch between fields	Near East Fork Shell Creek. Proposed pipeline.	CL/ML,CL	178	Stable
F10	47.9936	-101.9011	No apparent farm ditch between fields	Near East Fork Shell Creek. Proposed pipeline.	CL,SC-SM	189	Stable
