# Thunder Butte Pipeline, LLC

Thunder Butte Pipeline Project, Mountrail and Ward  
County, North Dakota

Case No. PU-24-86

Topsoil Removal Inspection Report

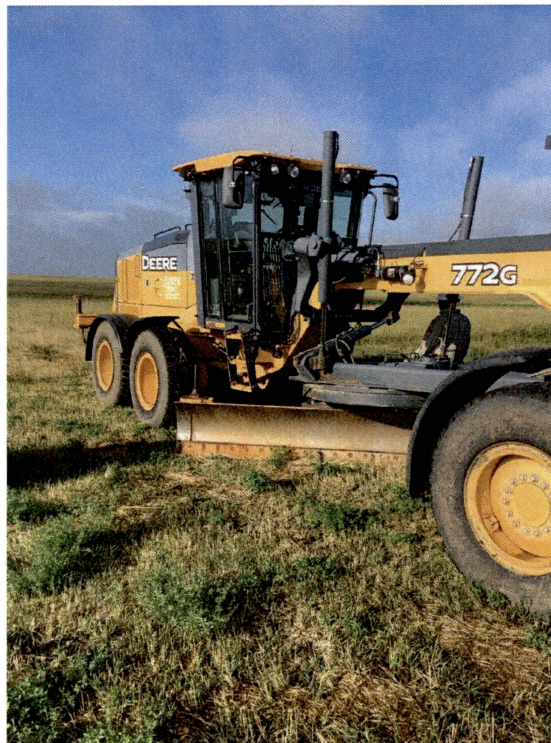
**Location:** Thunder Butte Staging Area - Point 1, photo 1

**Notes:** Deere 772 G grader

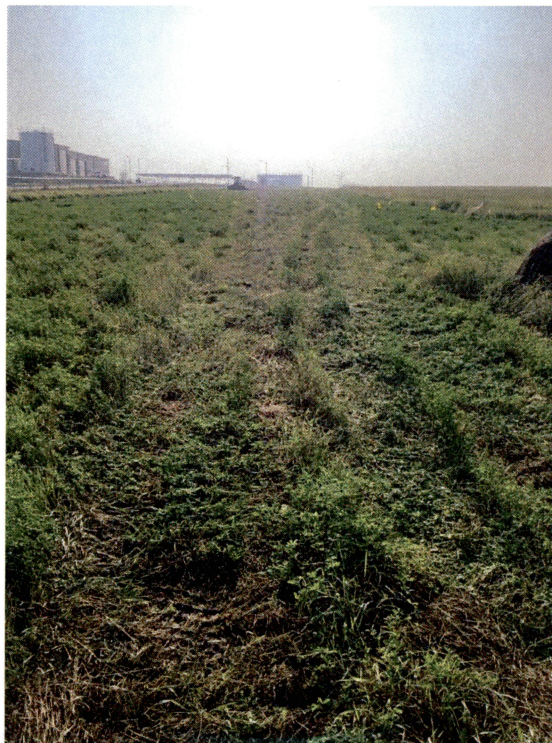
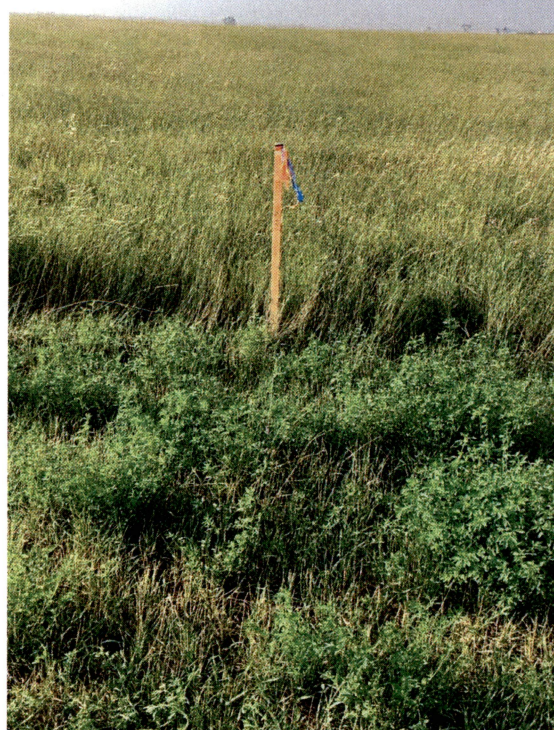
**Location:** Station 12+00 - Point 2, photos 2-3

**Notes:** Existing conditions and reference marker.

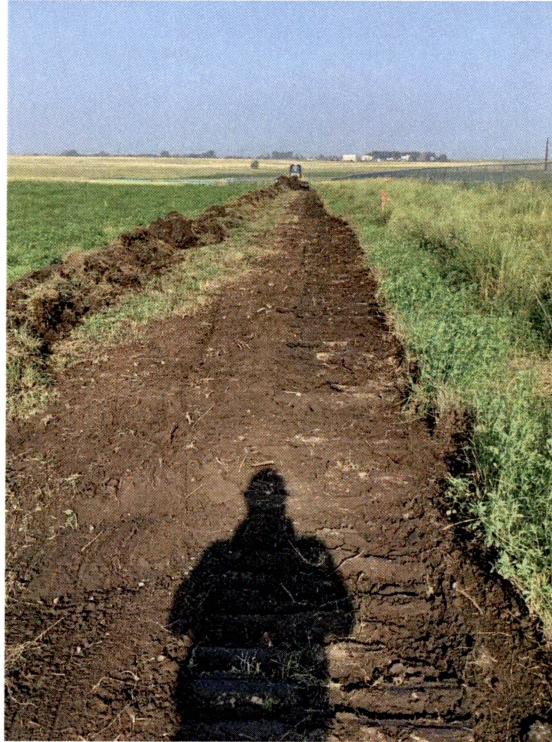
**Location:** Station 7+50 - Point 3, photo 4

**Notes:** Dozer making second pass at pipe alignment

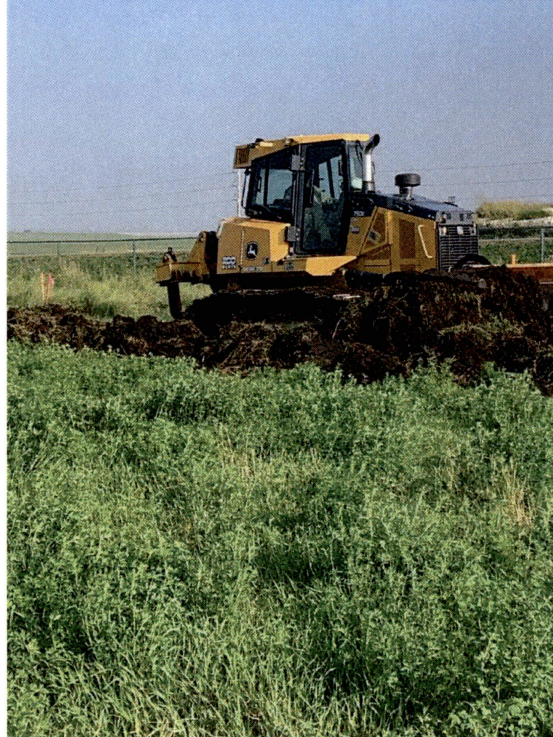
**Location:** Station 7+00 - Point 4, photo 5

**Notes:** Deere 750K bulldozer

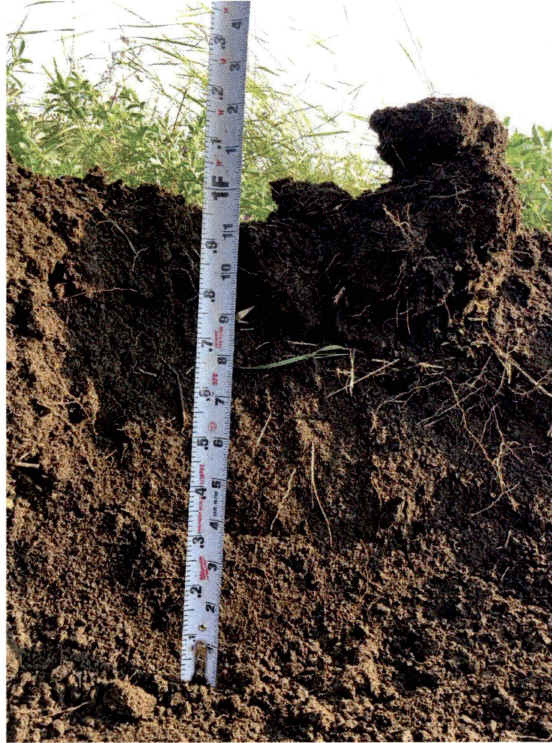
**Location:** Station 8+15 - Point 5, photo 6

**Notes:** Topsoil depth of 12+ inches, crew has excavated to the 12 inch requirement with no layer change in this spot.

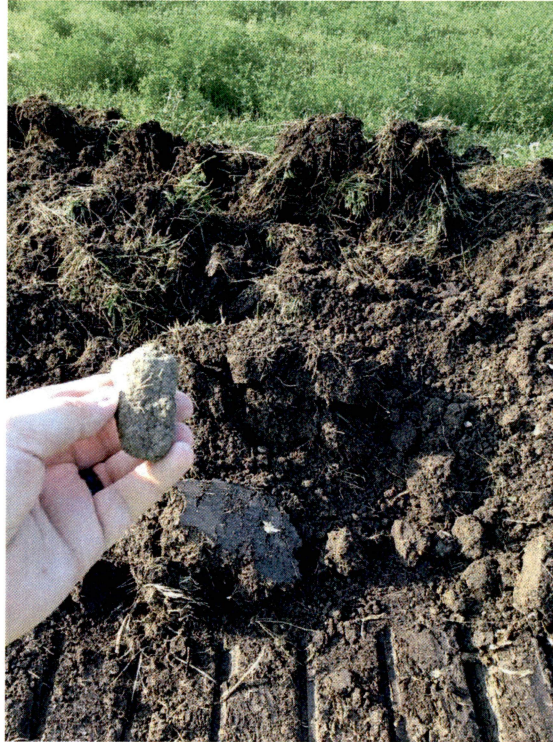
**Location:** Station 9+20 - Point 6, photo 7

**Notes:** One of the subsoils on site. Seems to be a light brown sandy clay loam. Topsoil in background for comparison. Found at depth of roughly 8 inches.

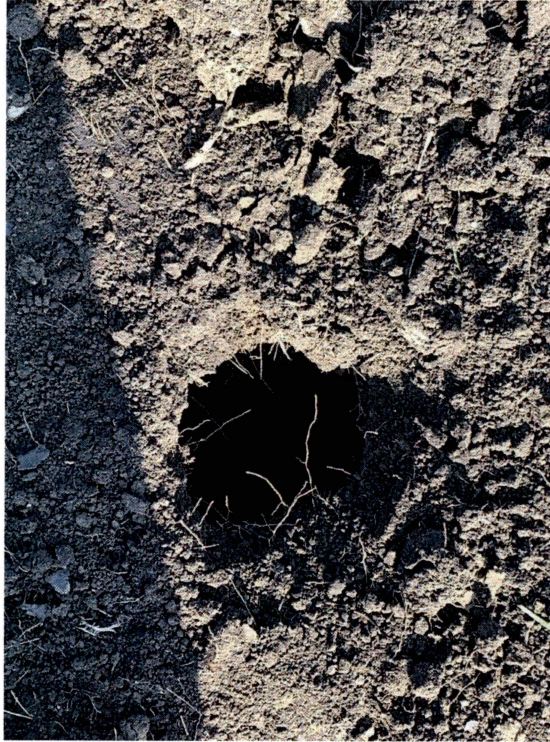
**Location:** Station 12+25 - Point 7, photo 8

<b>Other Remarks:</b> *During inspection, inspector noticed a perfectly circular, 8" diameter hole in the stripping area. Upon further investigation, it seemed to be approximately 3 feet deep. No signs of disturbed utilities, and none of us on the crew were sure what it was. Ralph used a piece of lath to mark the spot so crew can keep an eye on it and not accidentally bury it.

Site Disturbances Noted: An 8" diameter hole was discovered during topsoil stripping around Station 12+25. No evidence of a utility incident, but no one on crew nor inspector could tell if it was made by an animal or if it was man made. (See Photo P8). Crew placed Lath in hole to make sure no one lost it.

**Notes:** Odd hole in topsoil stripping area. Unsure if natural or if this is something hit. Will check with Ralph. Hole is approximately 8" in diameter and 3 feet deep.

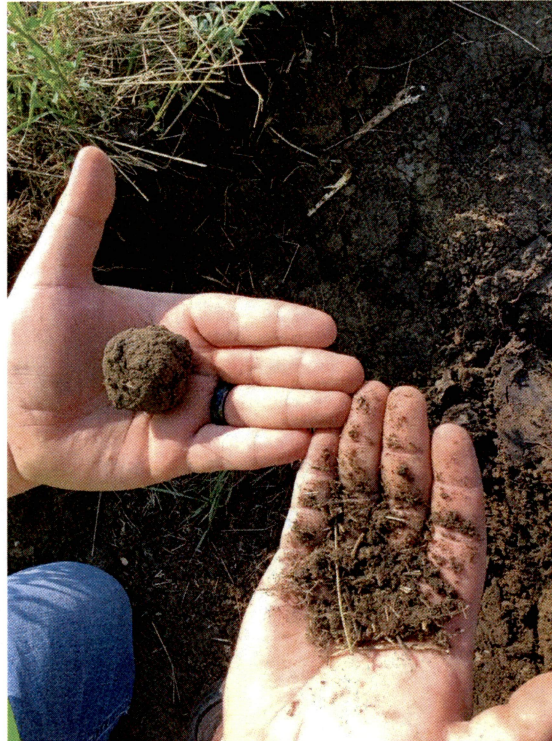
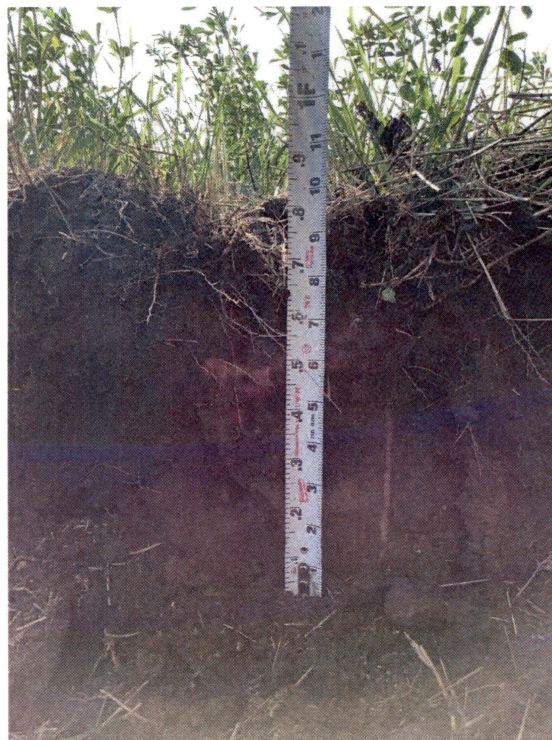
**Location:** Station 10+00 - Point 8, photos 9-10

**Notes:** Difference between topsoil and most prevalent form of subsoil. Subsoil seems a clayey loam and topsoil seem dusty and crumbly. Depth of topsoil in that spot is approximately 8"

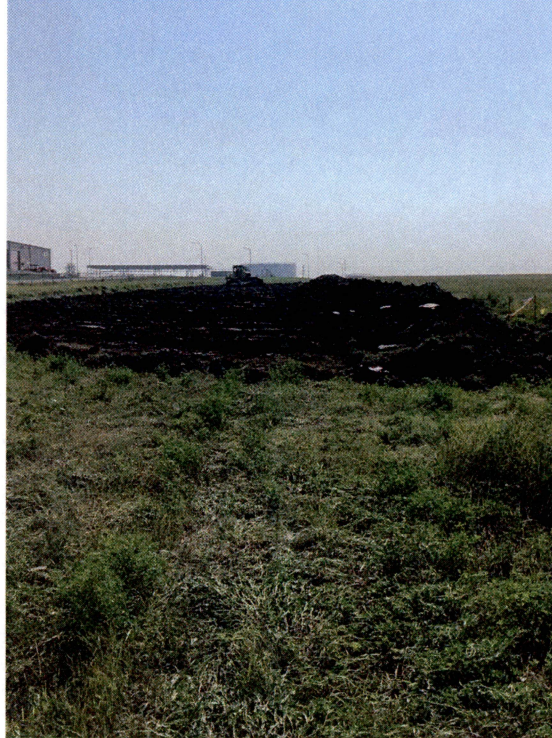
**Location:** Station 14+50 - Point 9, photo 11

**Notes:** Current progress of stripping and on the right side of photo can be seen topsoil windrow pile.

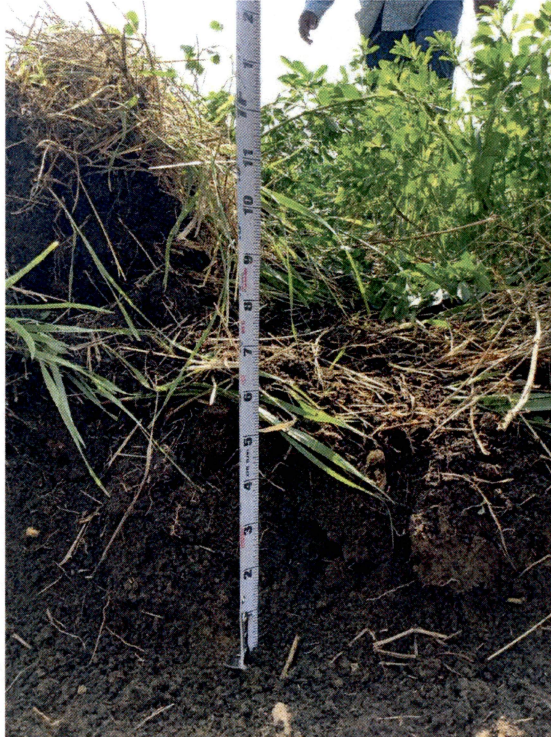
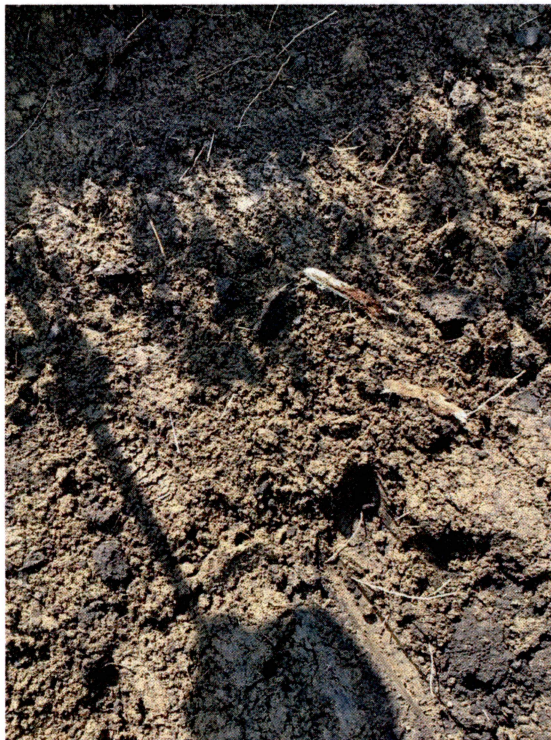
**Location:** Station 7+90 - Point 10, photos 12-13

**Notes:** Depth check, operator hit a new type of subsoil at depth of 6". Subsoil is a light brown sandy clay loam.

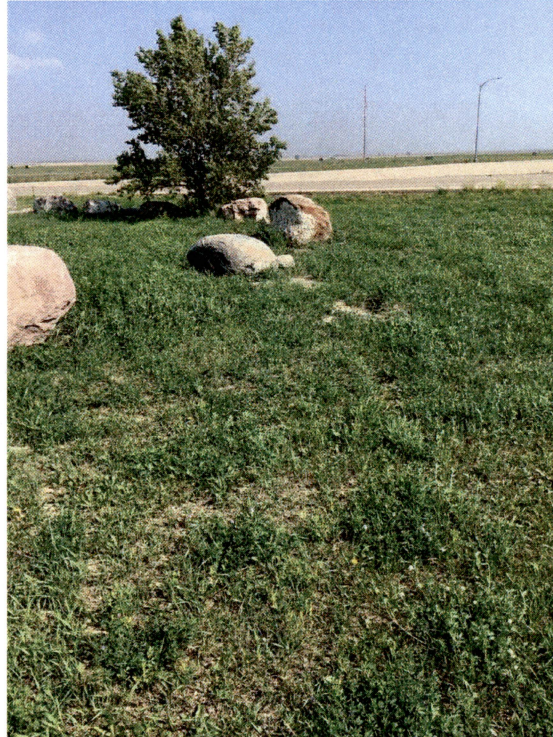
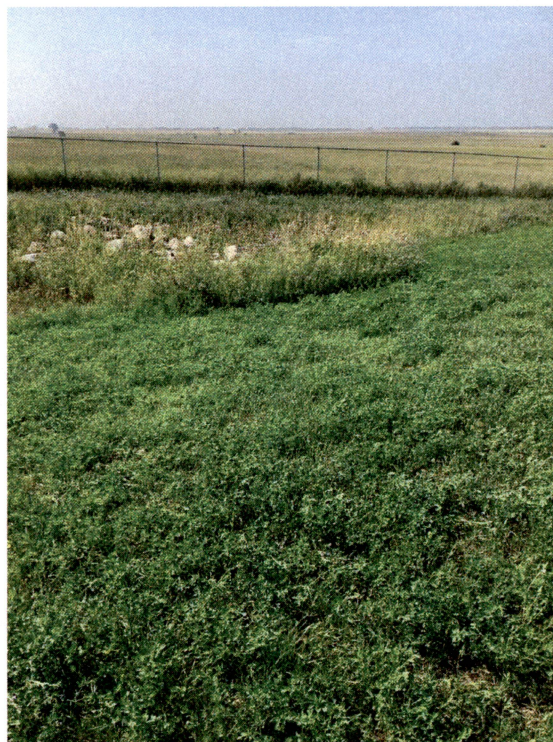
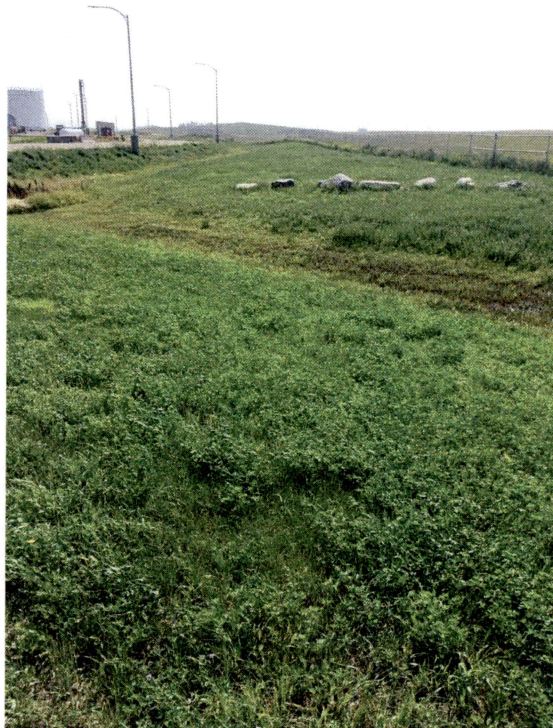
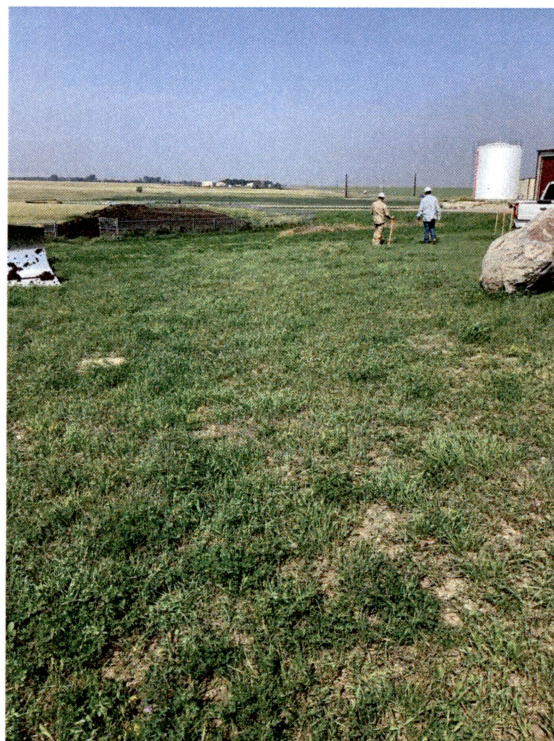
**Location:** Station 5+00 - Point 11, photos 14-17

**Notes:** E, S, W, N existing conditions east of fence

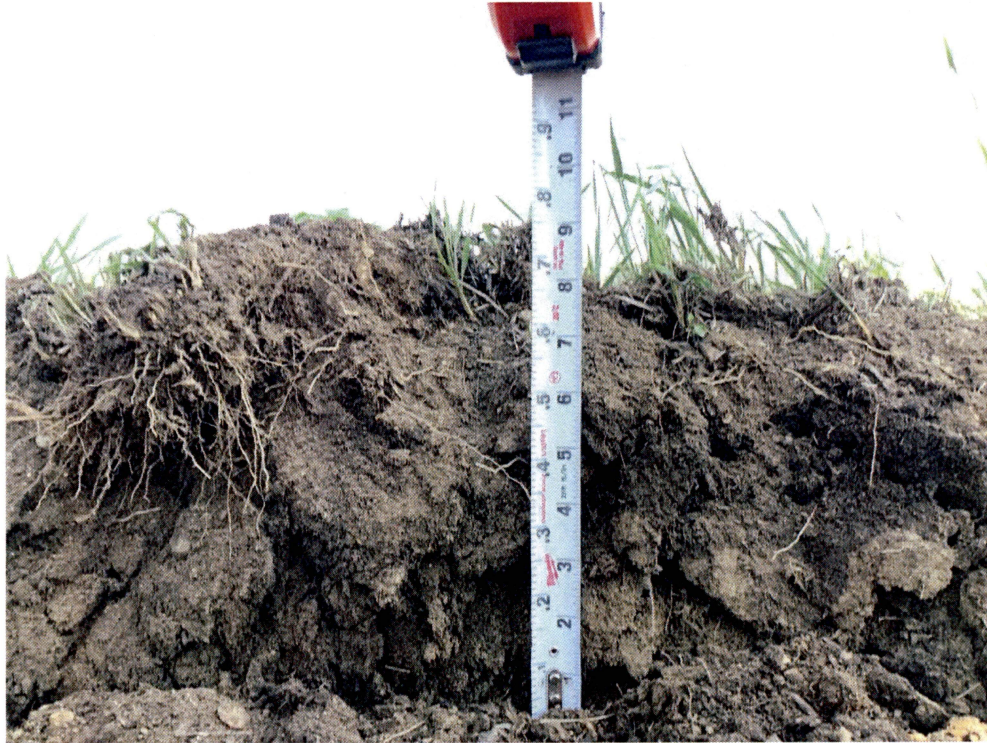
**Location:** Station 5+50 - Point 12, photo 18

**Notes:** Topsoil depth here only 4-6". Ralph thinks this is a result of when this facility was originally built and the grading that went into it.

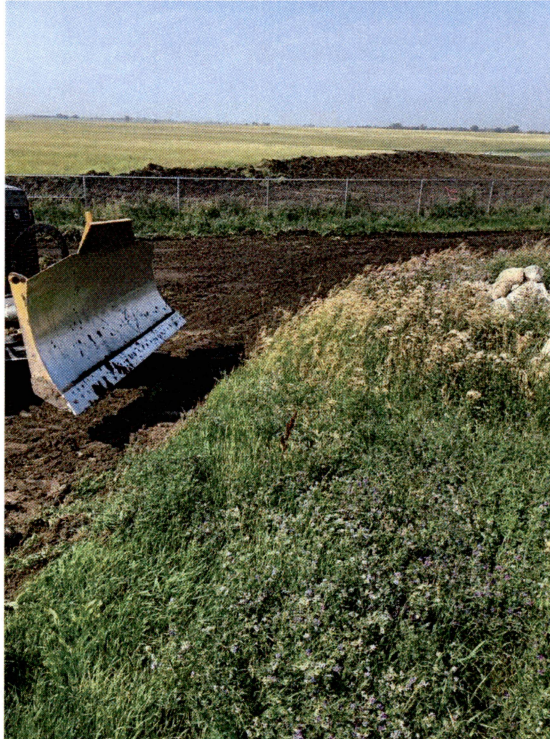
**Location:** Station 6+05 - Point 13, photo 19

**Notes:** Crew to remove fence and strip topsoil in that area when construction begins

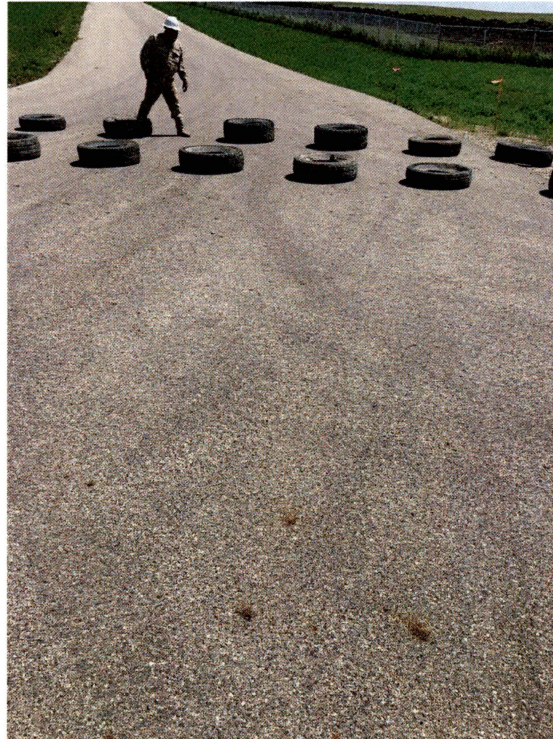
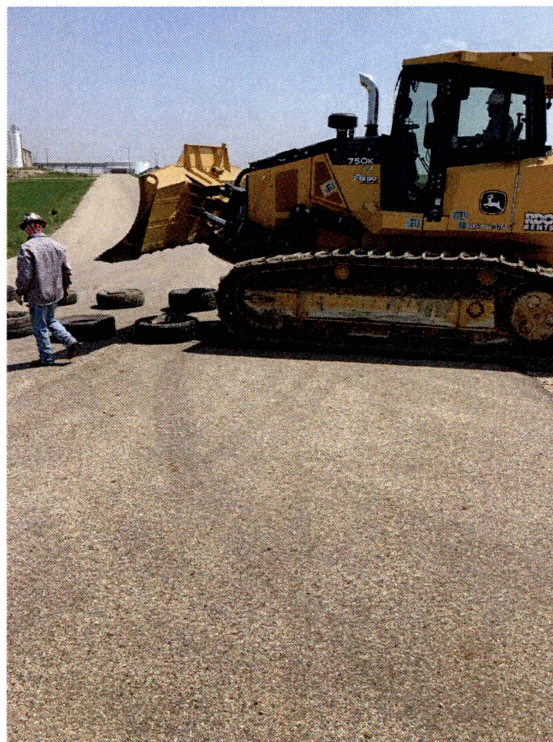
**Location:** Bend in access road - Point 14, photos 20-21

**Notes:** Tires set up for dozer crossing and dozer crossing.

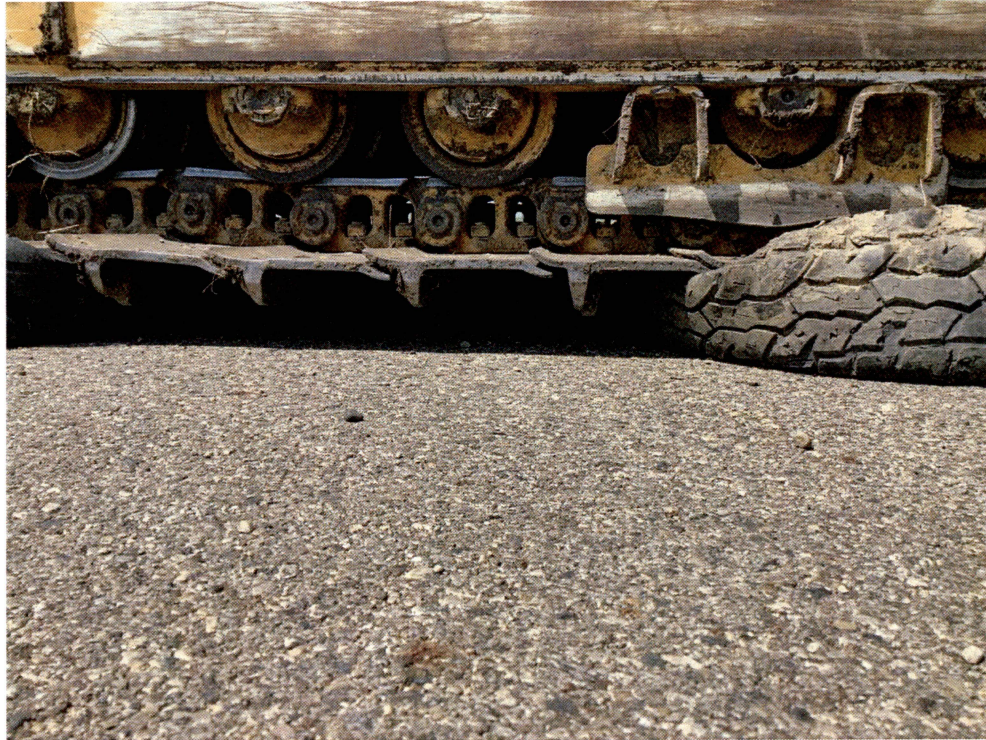
**Location:** Access road bend - Point 15, photo 22

**Notes:** Better angle of dozer crossing

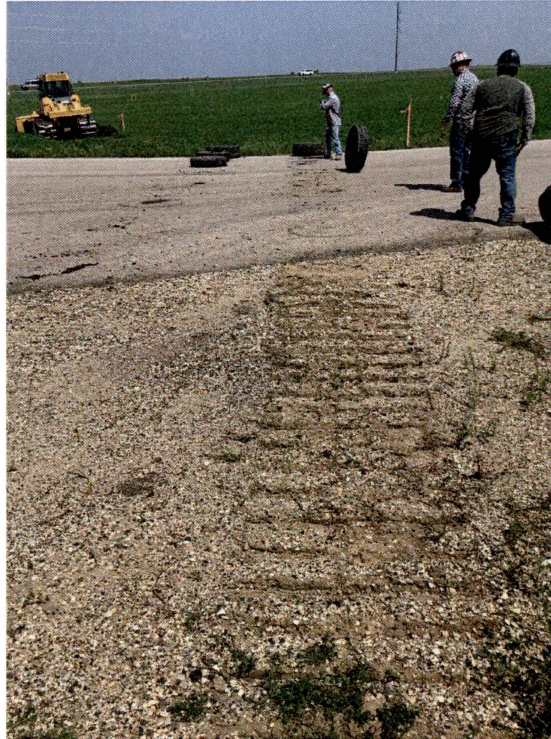
**Location:** Access road bend - Point 16, photo 23

**Notes:** Access road after crossing, no damage to pavement observed, gravel is tracked.

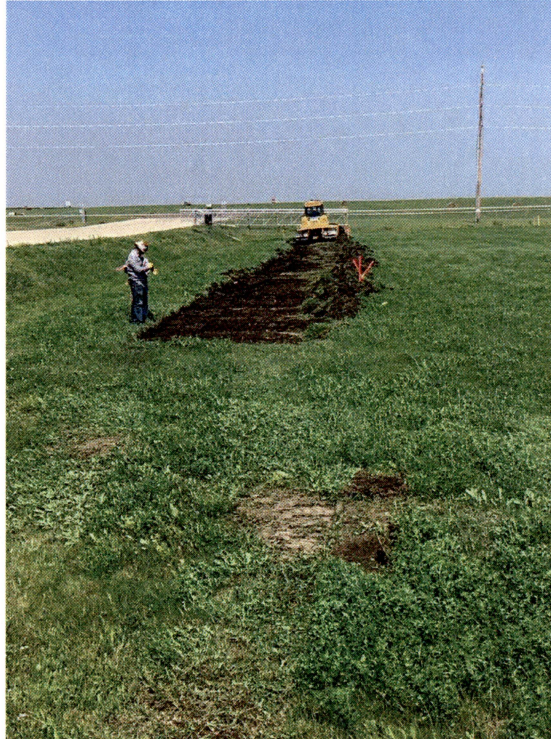
**Location:** Station 15+25 - Point 17, photo 24

**Notes:** Topsoil stripping north of access road and south of ND HWY 23

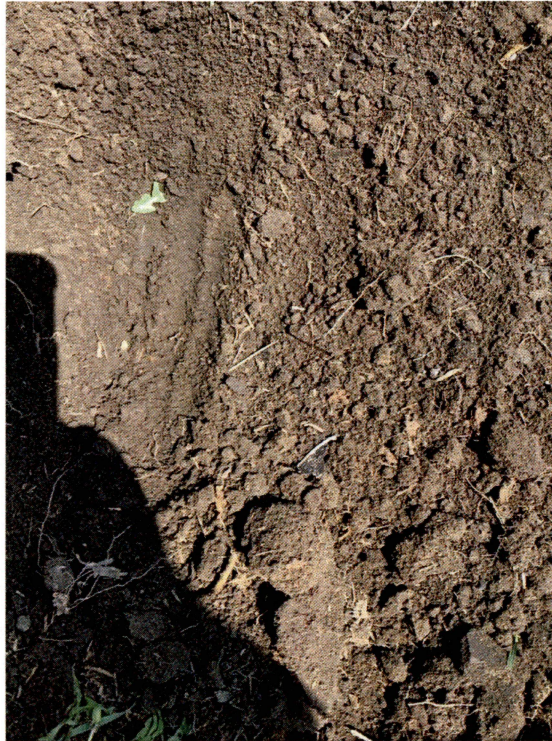
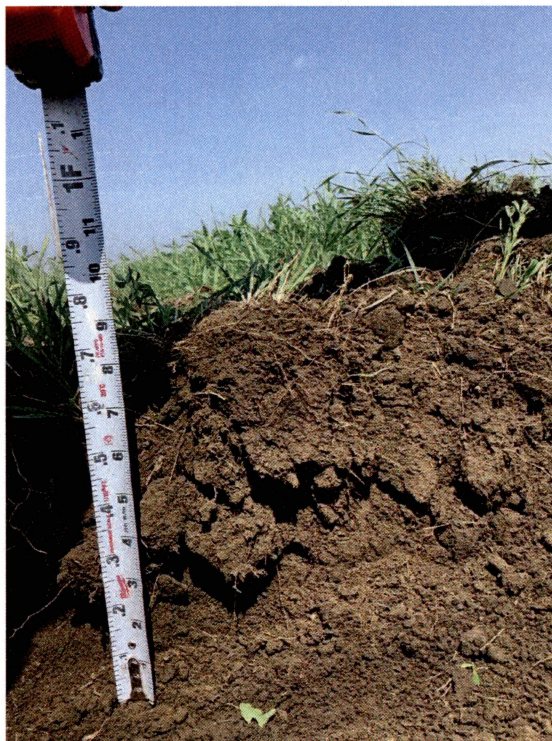
**Location:** Station 16+60 - Point 18, photos 25-26

**Notes:** Depth check north of access road. Station 16+60. 9 inches
