# Thunder Butte Pipeline, LLC

Thunder Butte Pipeline Project, Mountrail and Ward  
County, North Dakota

Case No. PU-24-86

Construction Inspection Report

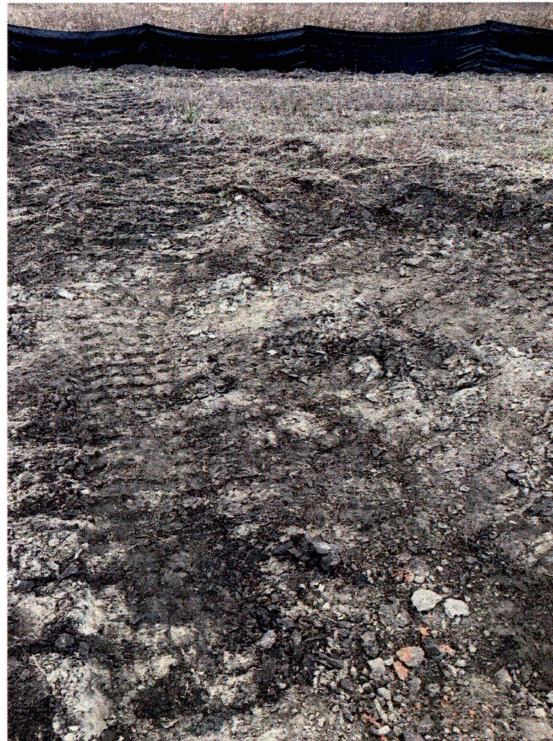
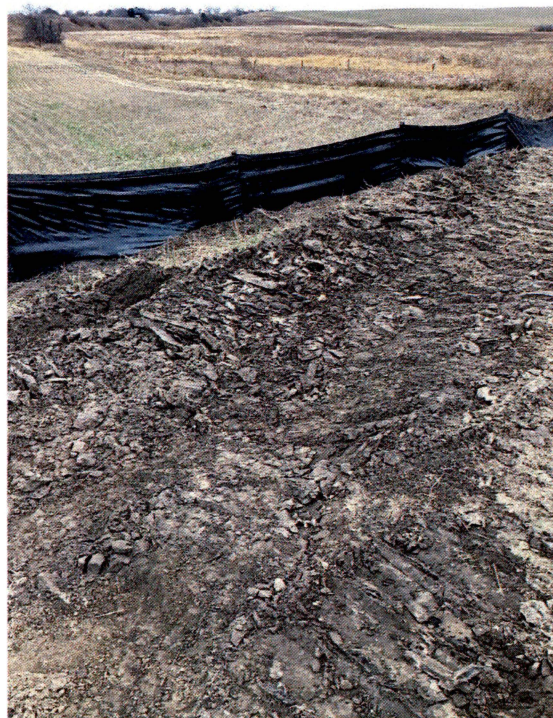
**Photo Number:** 1-2

**Notes:** Wetland buffer zone and silt fence in place. No evidence of buildup.

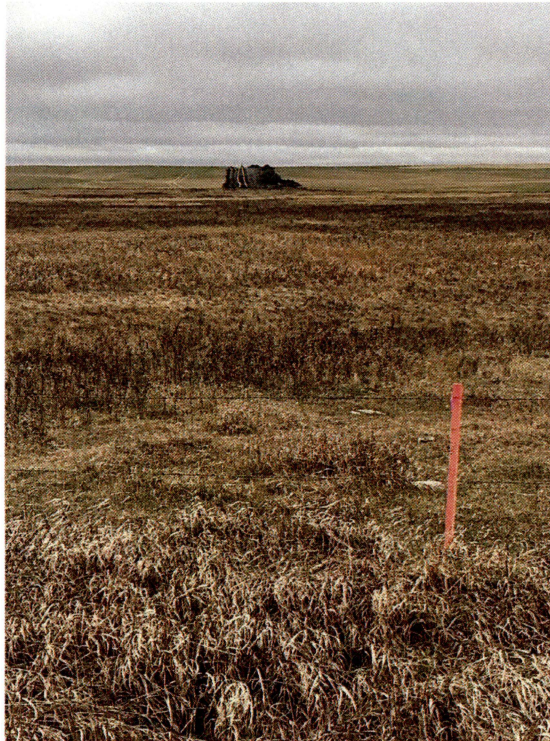
**Photo Number:** 3

**Notes:** Wetland undisturbed save for lath denoting pipeline center line. Can see across the way where operations resume.

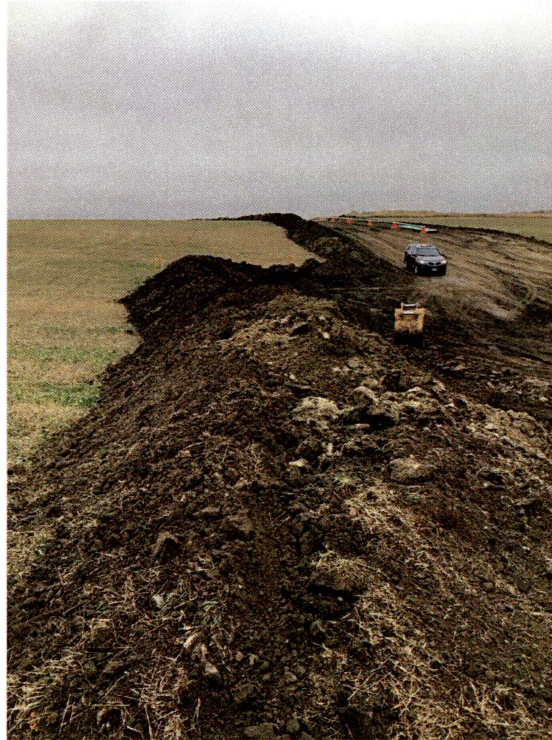
**Photo Number:** 4

**Notes:** Topsoil windrow

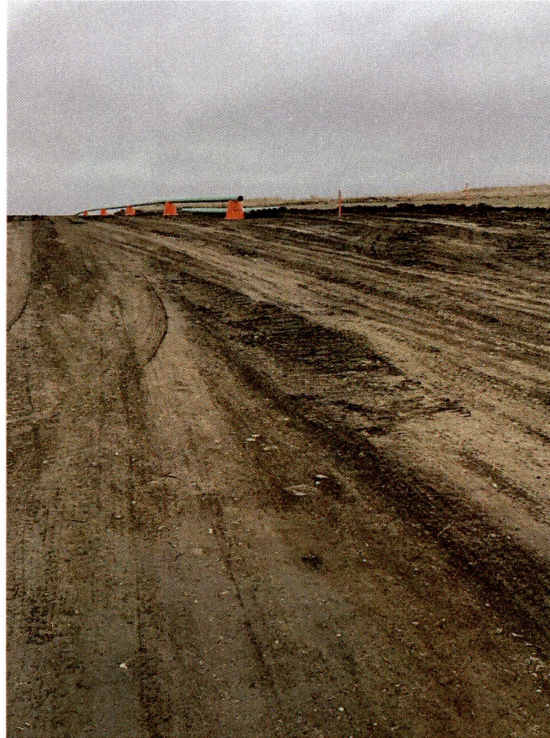
**Photo Number:** 5

**Notes:** Current progress of pipe run heading south.

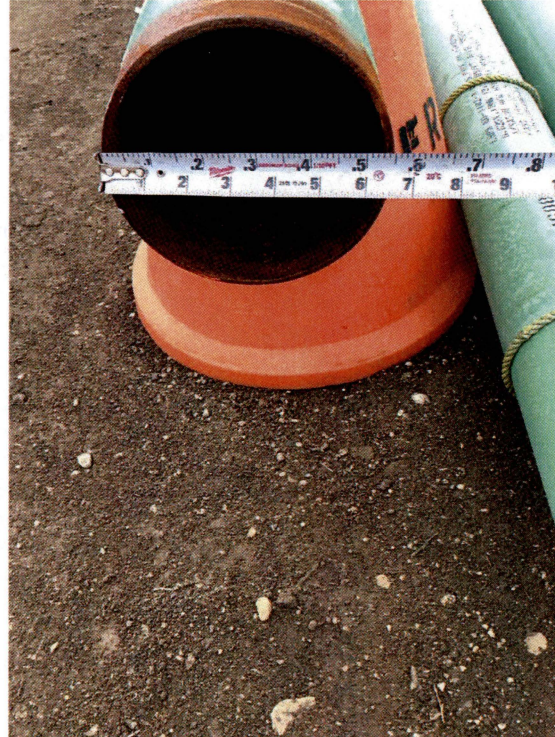
**Photo Number:** 6

**Notes:** 6.5" diameter pipe on pedestals and wood chocks to keep pipe clean and off the ground and level for welding.

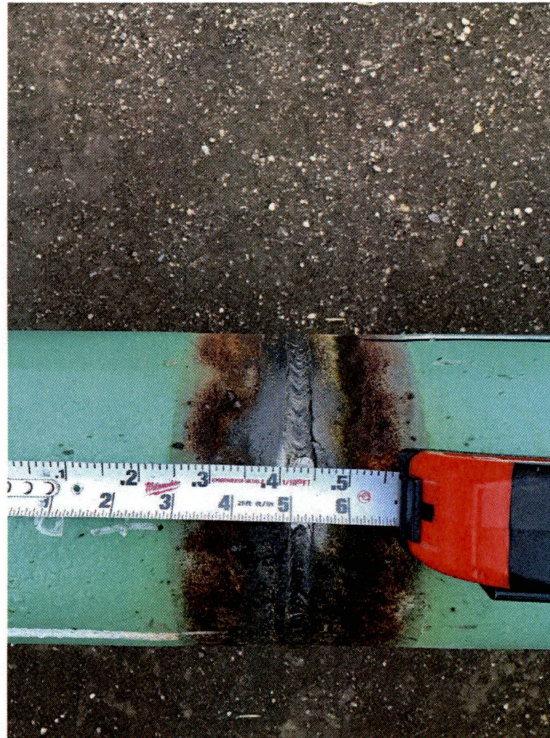
**Photo Number:** 7

**Notes:** Pipe weld, 0.5" width

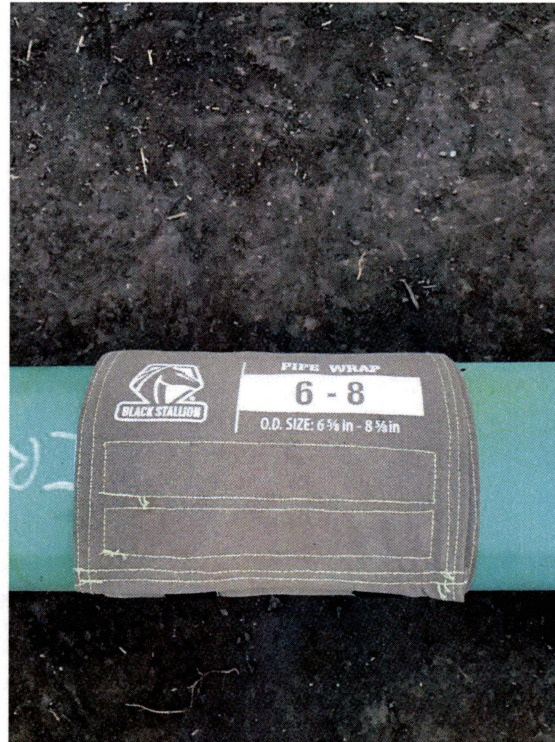
**Photo Number:** 8

**Notes:** Crew is using pipe wraps to hold sections of pipe together while waiting to be welded.

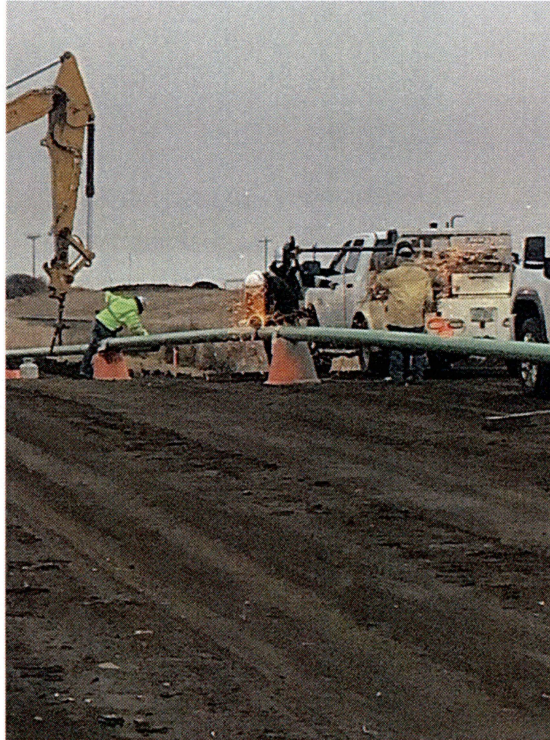
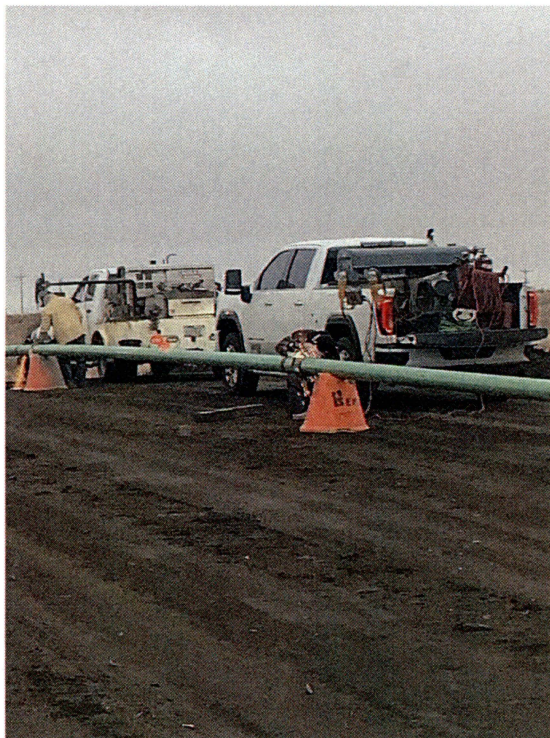
**Photo Number:** 9-10

**Notes:** 1. Crew welding a pipe section together. 2. Crew using a grinder to clean up the welds.

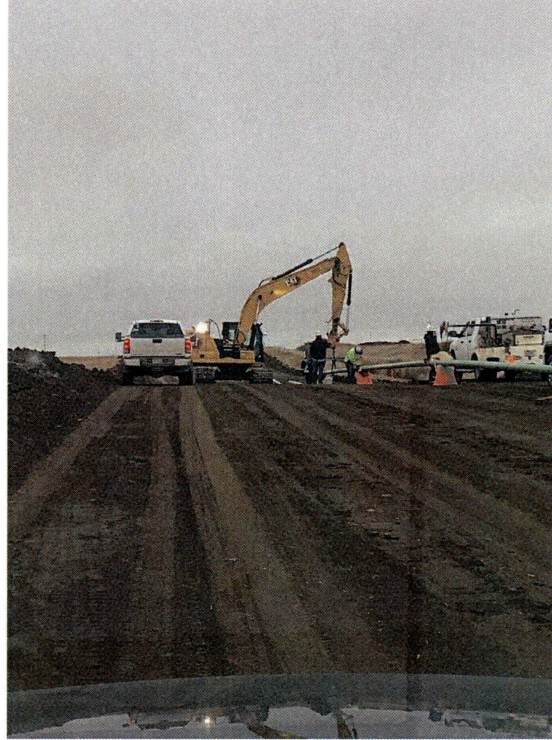
**Photo Number:** 11

**Notes:** CAT 320 track excavator. Currently has a hook attachment on it to hold the pipe in its elevated state so that crew can weld it to the next section.

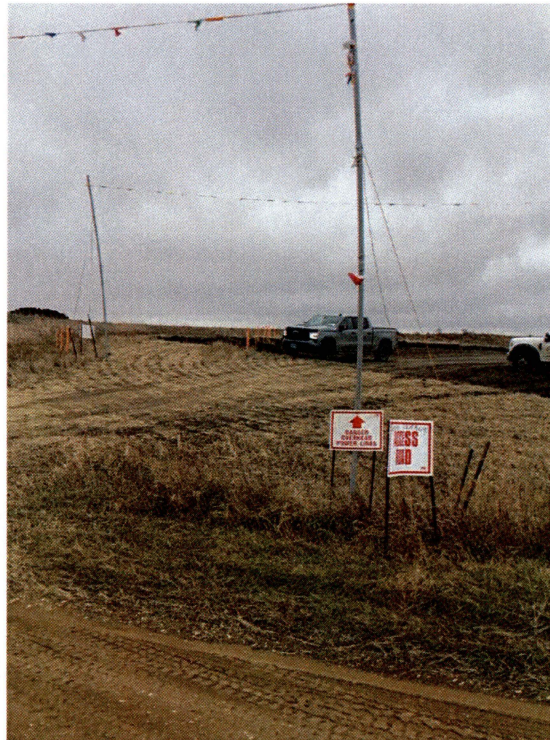
**Photo Number:** 12

**Notes:** Site safety: crew has poles and signage up warning about overhead power lines with streamers denoting maximum vertical height of vehicles and equipment.

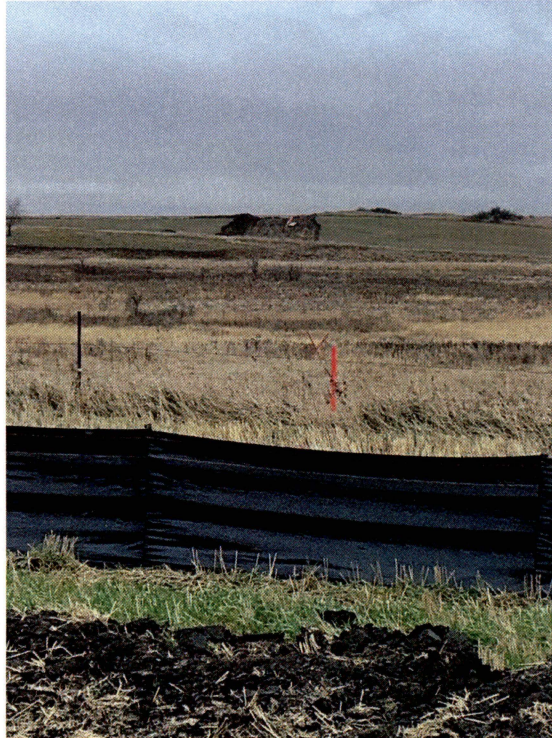
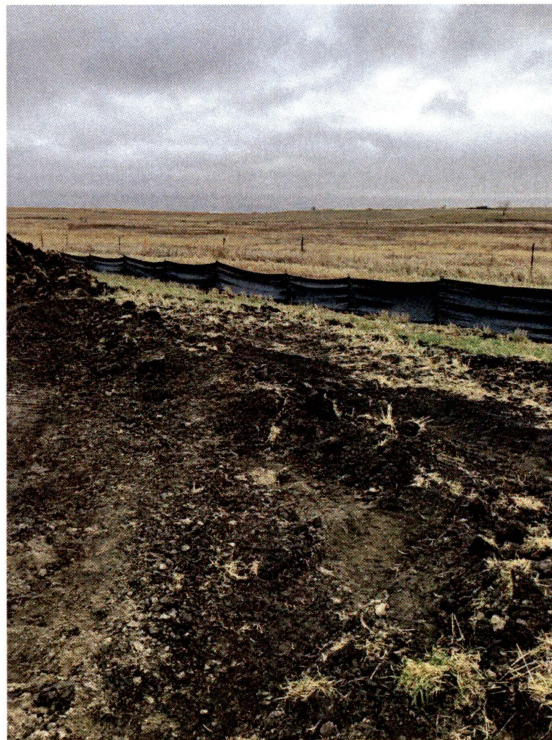
**Photo Number:** 13-14

**Notes:** South view of wetland avoidance area. Silt fence in place with no sign of sediment buildup.

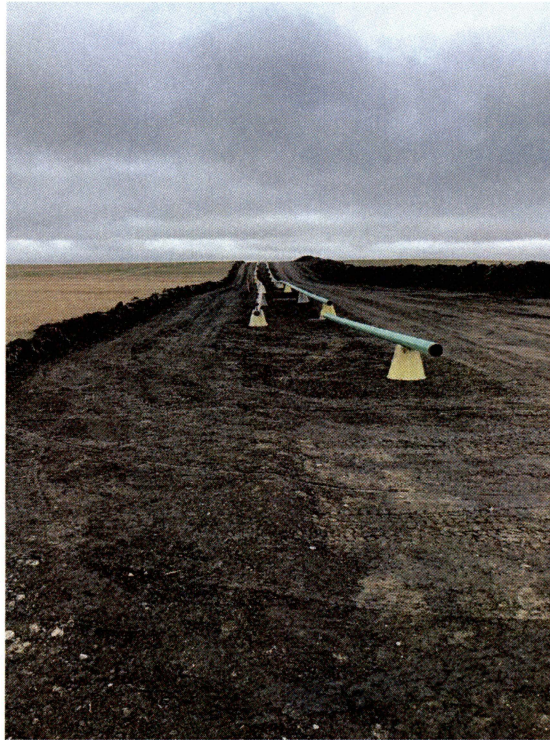
**Photo Number:** 15

**Notes:** Pipe run heading north. All these sections have already been welded.

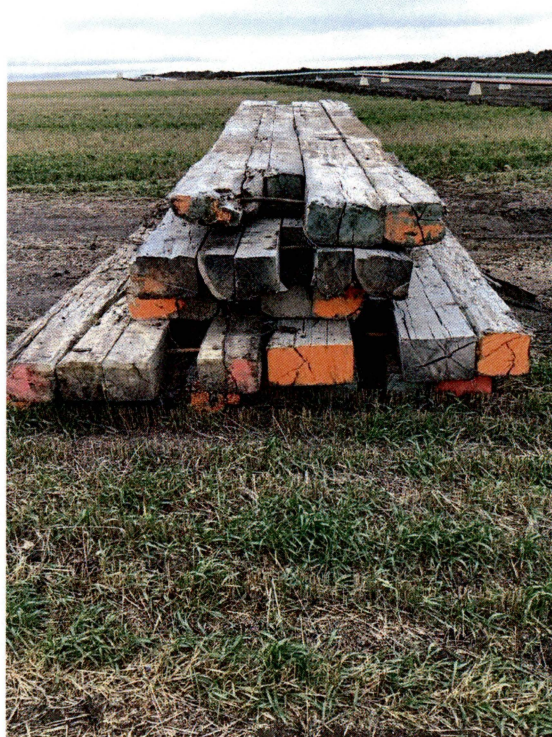
**Photo Number:** 16

-In one spot, planking was stored outside of project ROW, with no indication on the GIS map of being a storage area. This planking was placed on the old access road for NDPSC Project Case No. PU-24-361 (LOS to Tande Substation 345 kV Line). See Photos P16.

**Notes:** Area of concern: planking being stored outside of ROW.

-Move planking to approved laydown/staging area or within ROW.

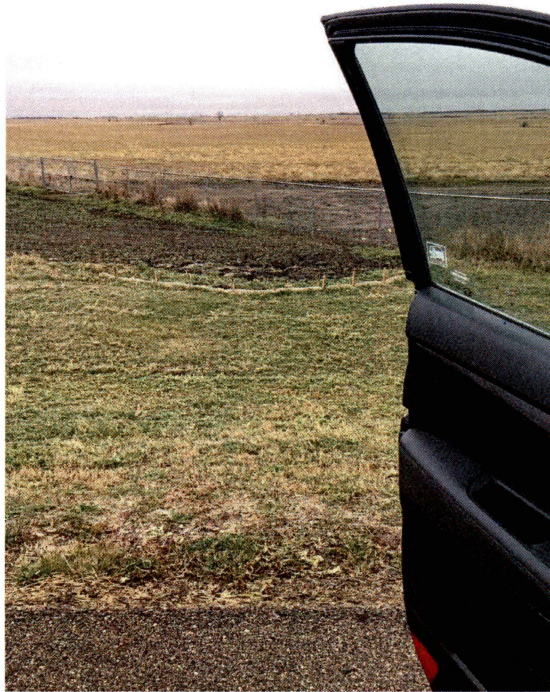
**Photo Number:** 17

**Notes:** Fiber roll in place.

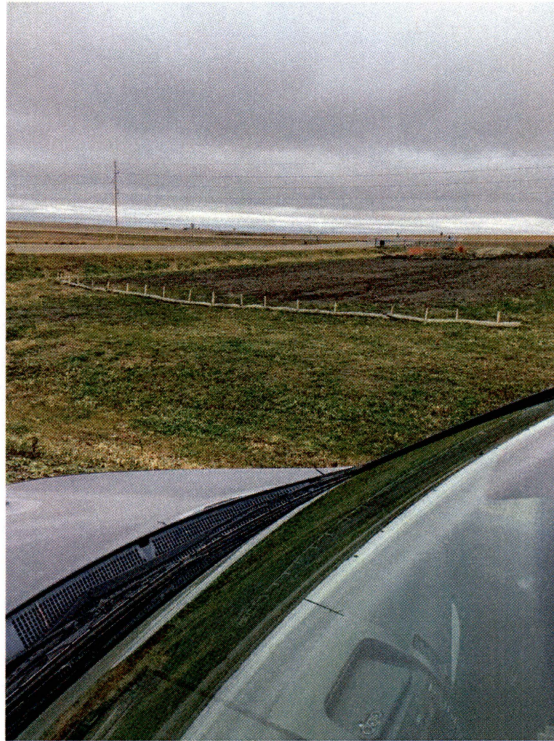
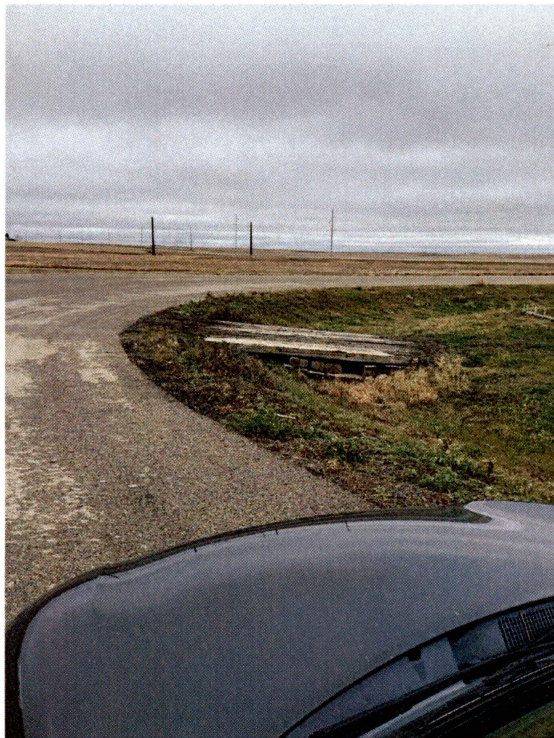
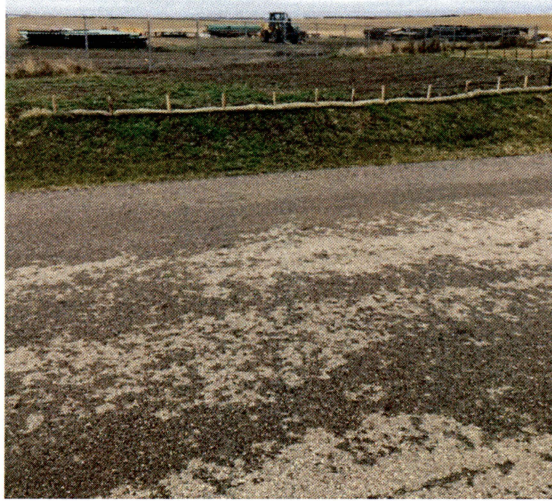
**Photo Number:** 18-20

**Notes:** Fiber roll installed north and south of road. Planning to not tear up ditch on north side of road.

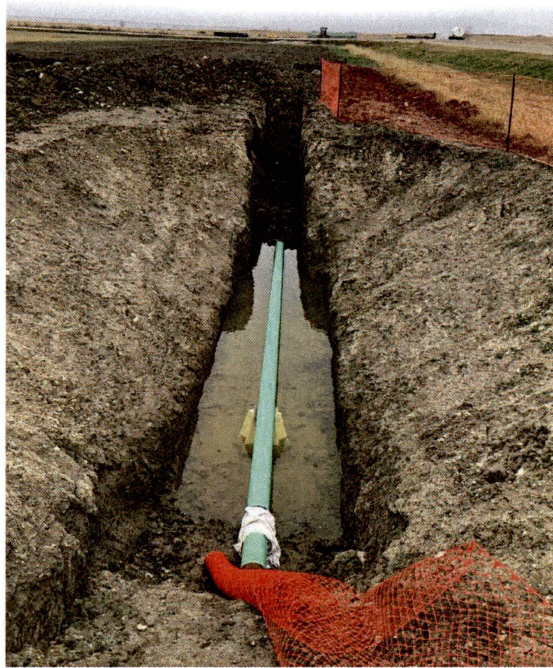
**Photo Number:** 21

**Notes:** Line bored south under access road. Does not appear crew has bored pipe under highway yet. Safety fence is up.

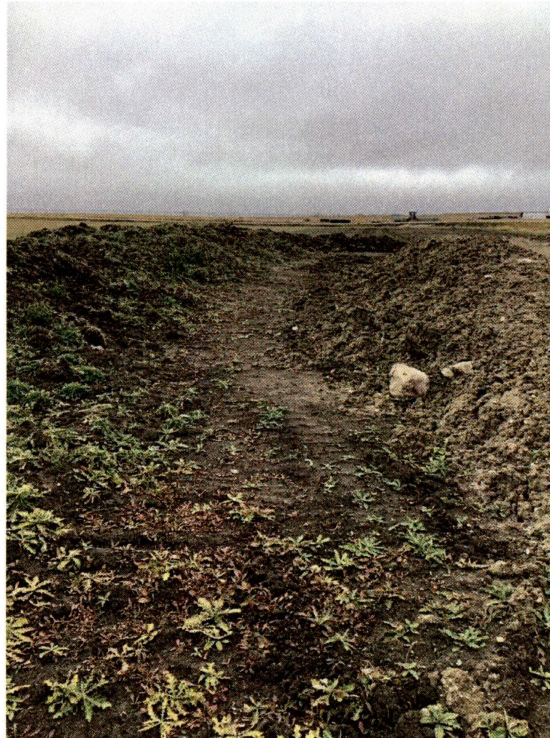
**Photo Number:** 22

**Notes:** Clear segregation between excavated subsoil (right) and stripped topsoil (left)

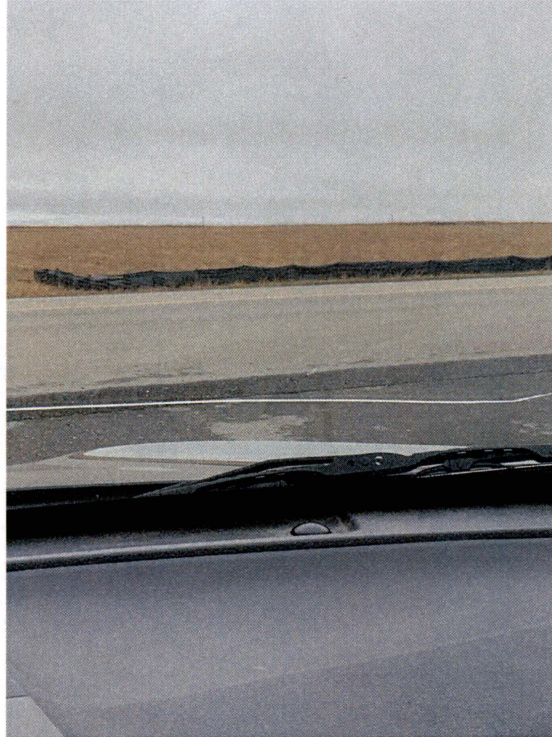
**Photo Number:** 23

**Notes:** Silt fence in place for pipe exit point.

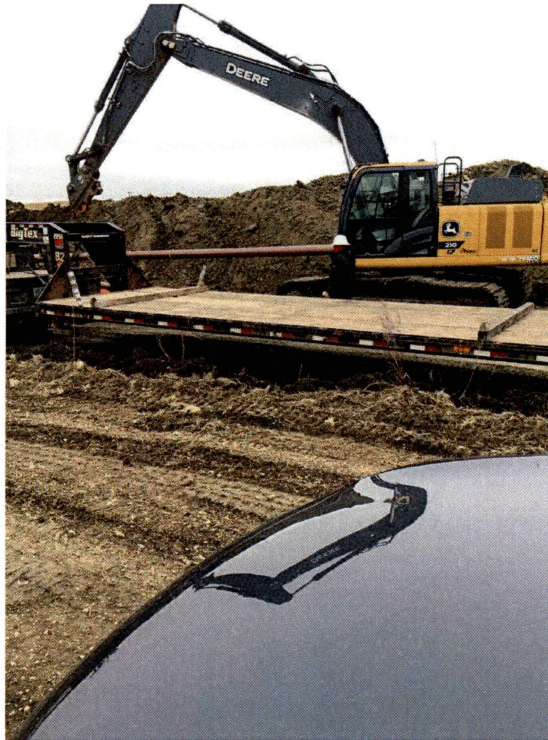
**Photo Number:** 24

**Notes:** Deere 210 track excavator with hook attachment is moving pipe sections into place south of railroad.
