# Badger Wind LLC

Amend-Badger Wind Project-Logan & McIntosh Counties

Case No. PU-24-87

Construction Inspection Report

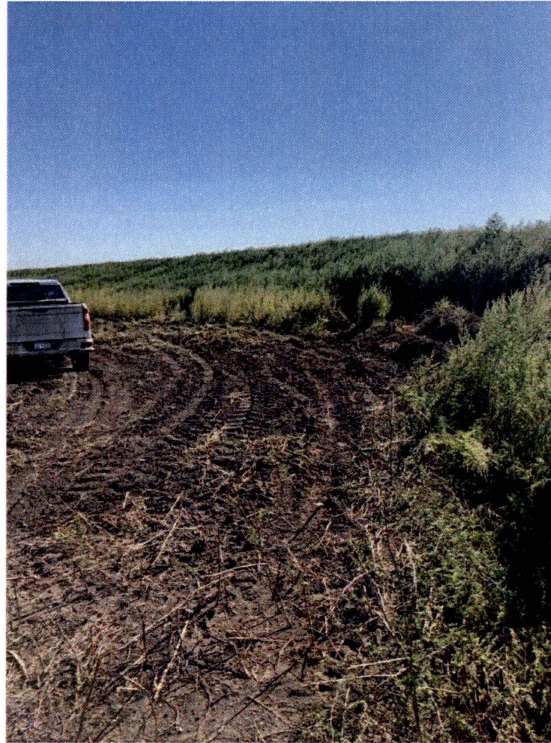
**Notes:** Current conditions of topsoil storage pile from October 24 topsoil stripping inspection. Vegetative cover abundant.

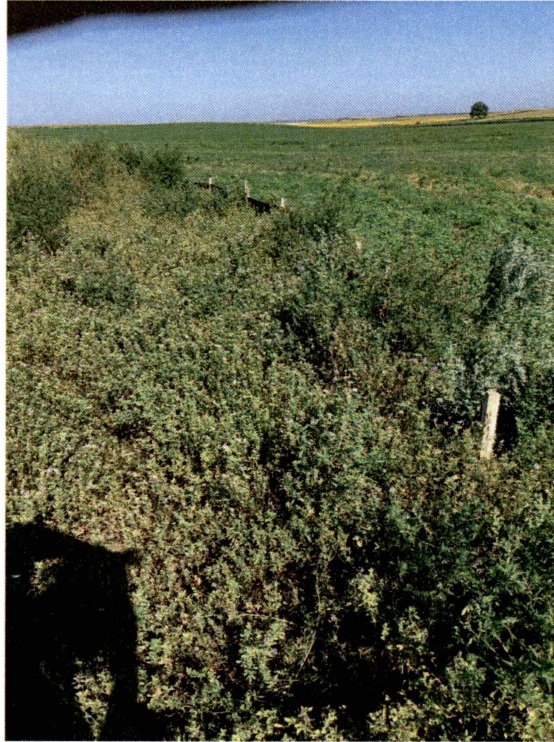
**Notes:** Current conditions of silt fence installed during last years topsoil inspection. No evidence of silt buildup. Acceptable condition

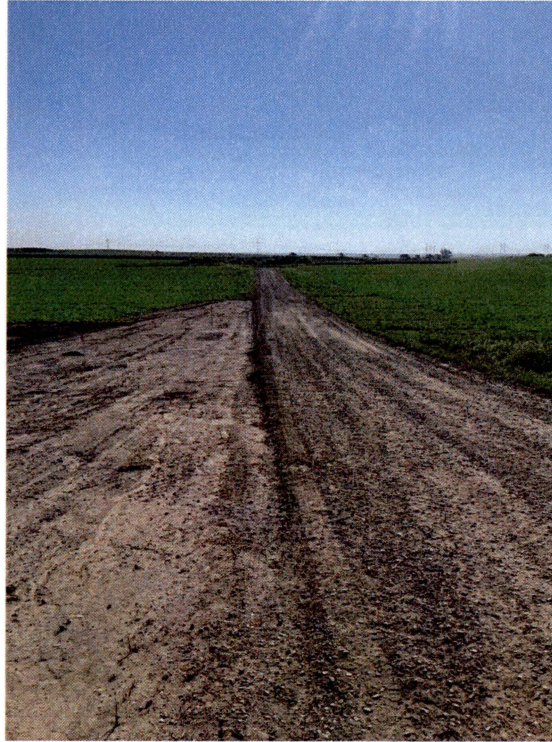
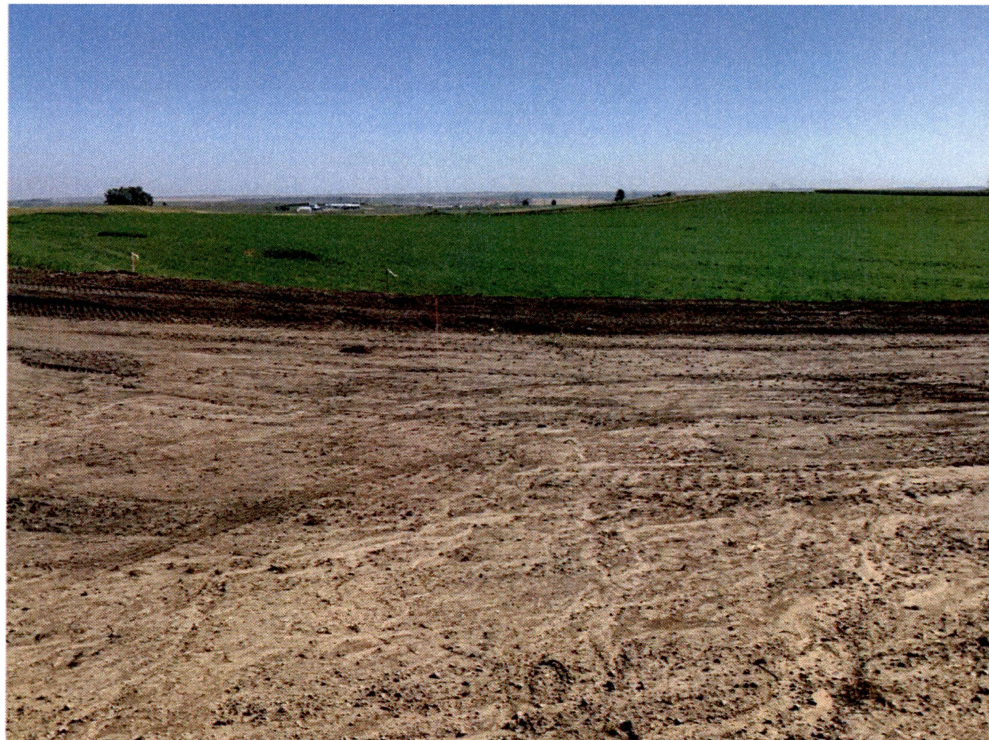
**Notes:** First photo condition of access road compared to last years inspection, second photo farmer planted field and contractor building curve for access road, topsoil stripped and windrowed. Either silt fence or fiber roll planned for ECM.

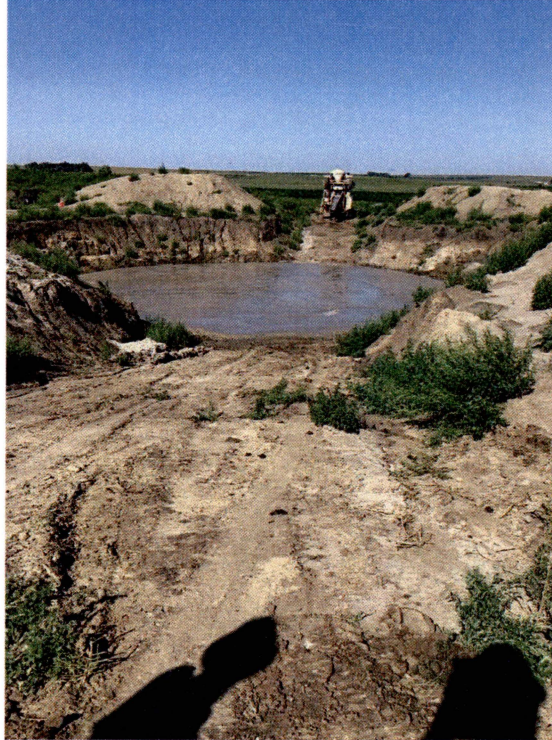
**Notes:** Structure seal slab just finished pouring. Concrete truck washing out slag onto subsoil and slab.

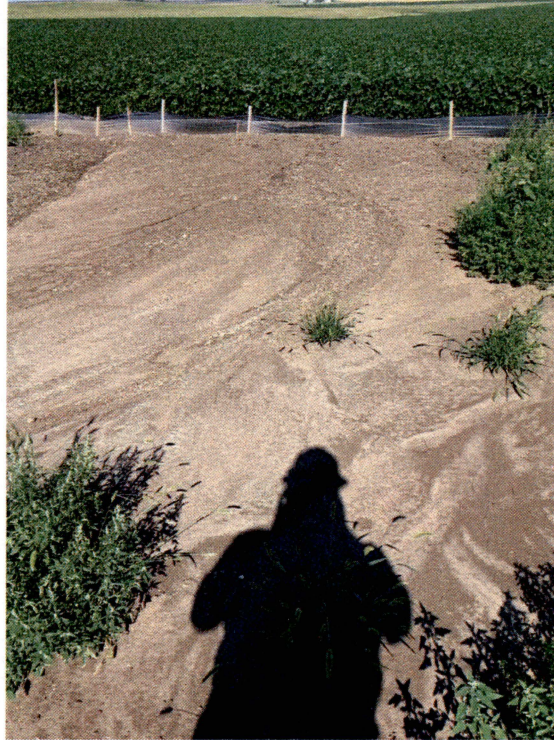
**ISSUES REQUIRING RESOLUTION:** Several areas throughout project footprint had silt fence that was either experiencing buildup of sediment or where posts had not been driven correctly in a section of the silt fence. See photos P6-8, 11-12, & 22 as evidence.

**Notes:** Silt fence installed last year. Evidence of silt deposition.

**PROPOSED RESOLUTION(S):** Contractor should have personnel go through project footprint and check all erosion control for silt deposits (and clean any deposits found), verify silt fence staking is adequate (and if not, reinstall those sections), and ensure to look for any wind degradation of silt fence and replace any silt fence deteriorated by the wind. SEH will verify that changes have occurred during next construction inspection.

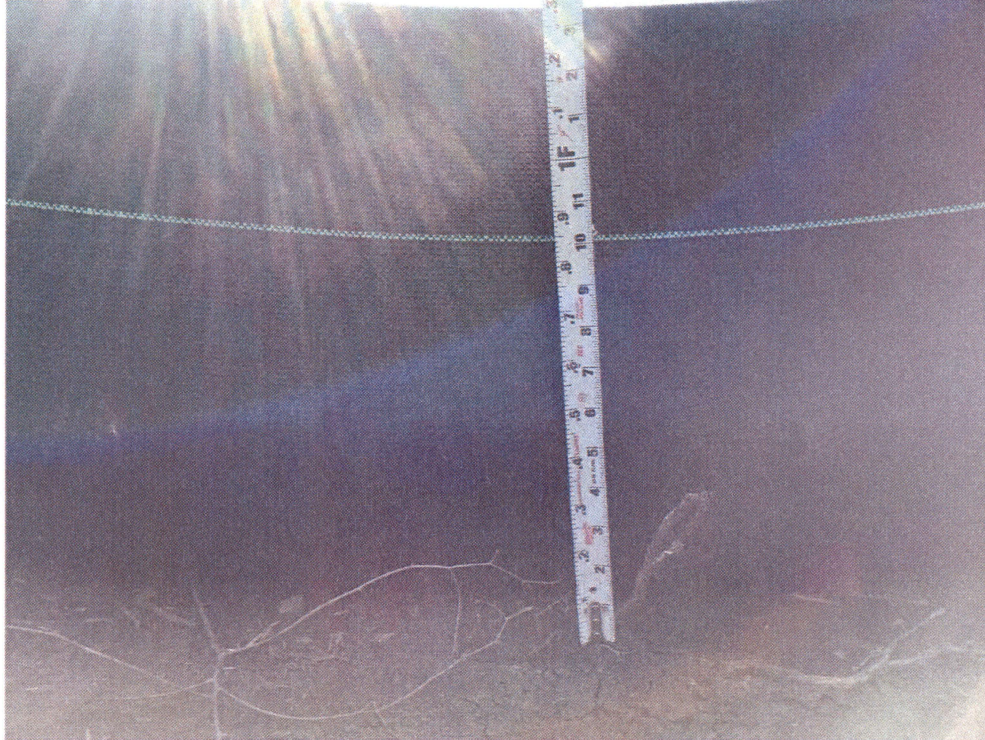
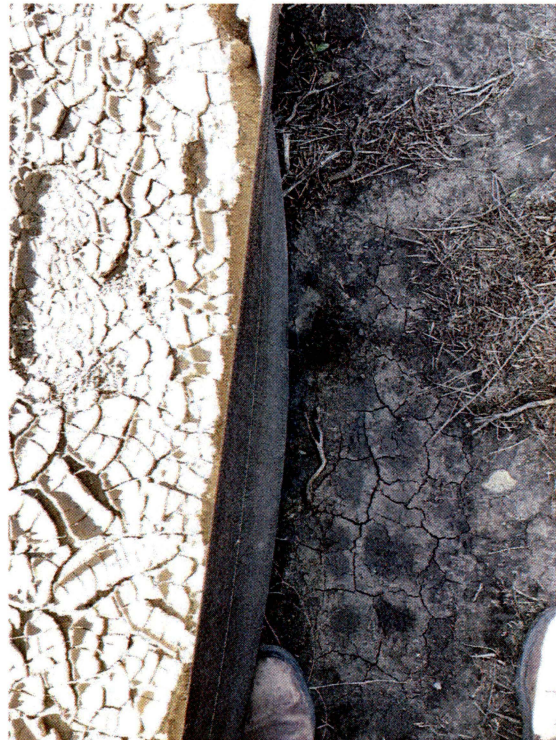
**Notes:** First picture, side by side view of silt fence soil elevations. Second picture shows the bulge in the fence where silt has built up to a depth above 6+ ". Needs to be cleaned.

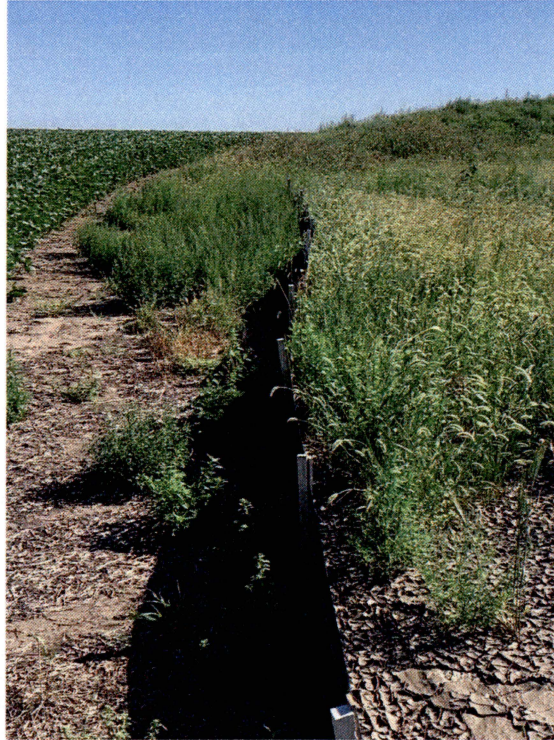
**Notes:** Same silt fence as previous points, showing that the cleaning needs are localized in one spot.

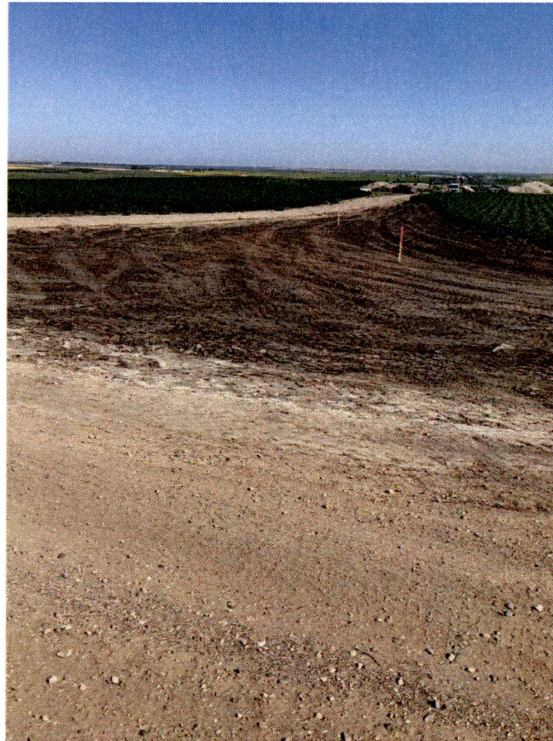
**Notes:** Conditions of access road, crew has stripped topsoil for a curve. Mild expected interference into established crops.

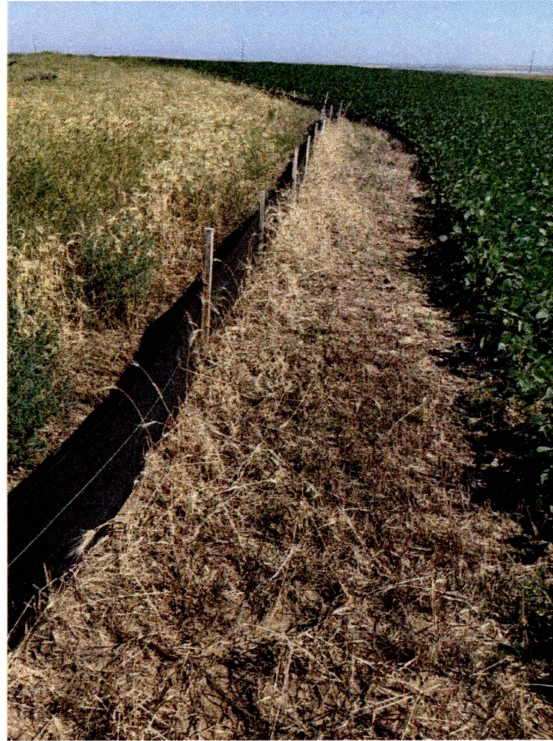
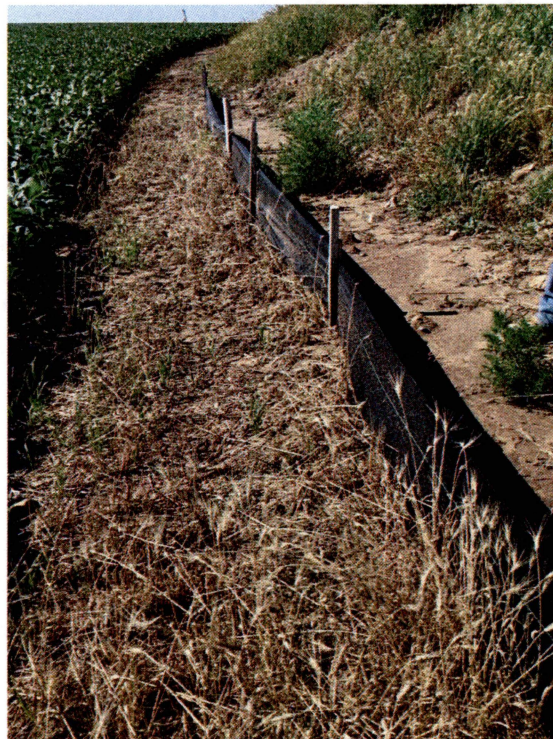
**Notes:** First photo looking north to previously installed silt fence. Second photo same silt fence looking south. Evidence of silt build up. Recommend cleaning.

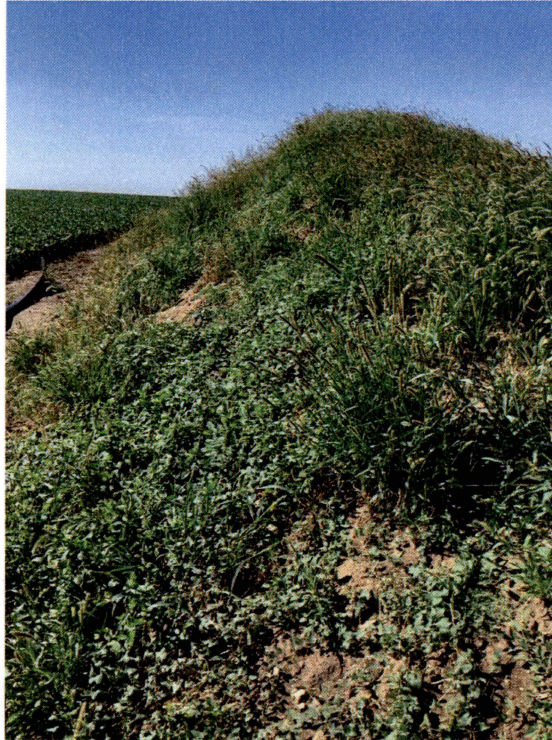
**Notes:** Topsoil pile shows ample evidence of vegetative cover, any not vegetated areas that eroded were caught by silt fence.

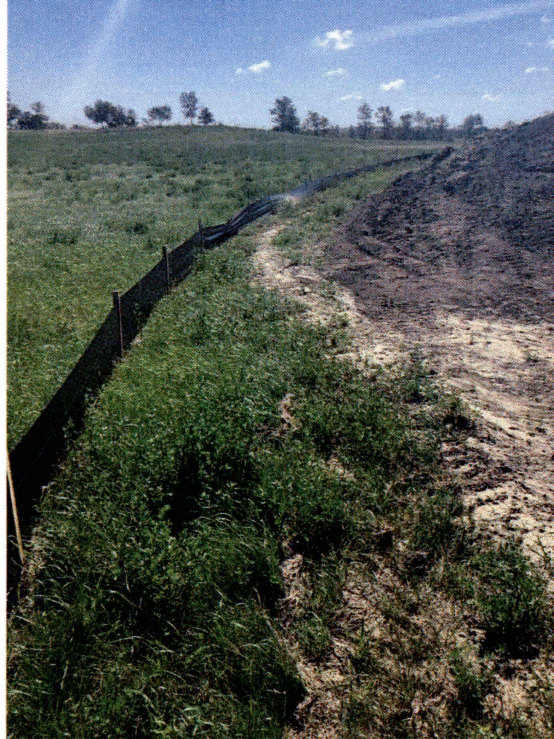
**Notes:** Silt fence installed. Evidence of 1 or 2 posts not driven correctly.

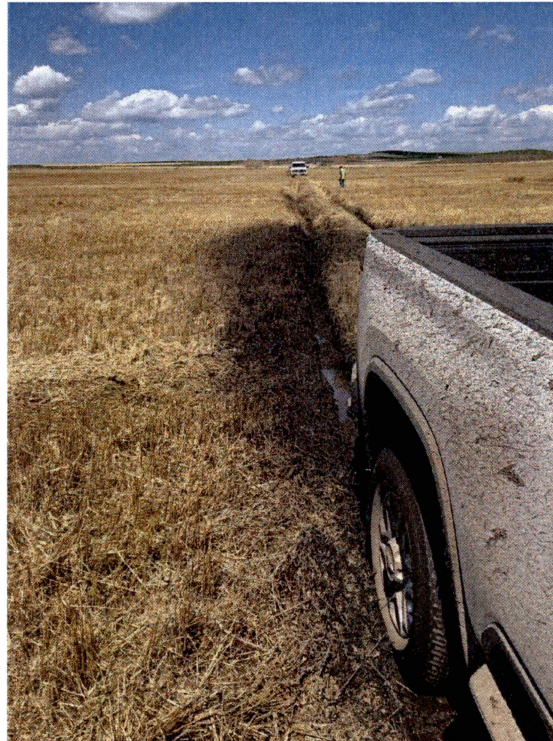
**Notes:** Truck got stuck. Crew coming to pull us out. Will verify reclamation when complete.

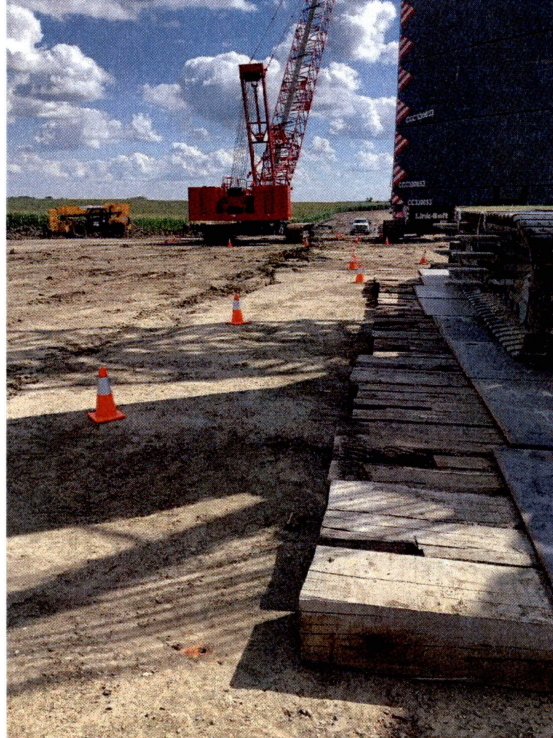
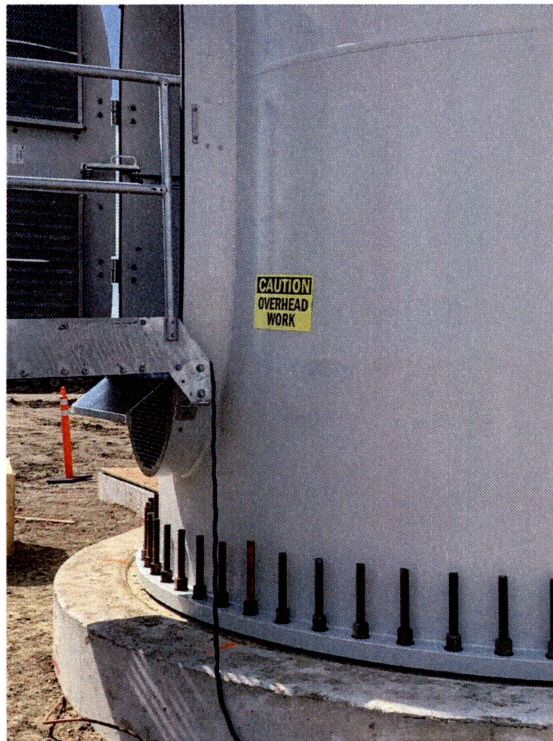
**Notes:** Site safety precautions in place, warning signs. Comes are in place for swing radii.
