# Badger Wind LLC

Amend-Badger Wind Project-Logan & McIntosh Counties

Case No. PU-24-87

Construction Inspection Report II

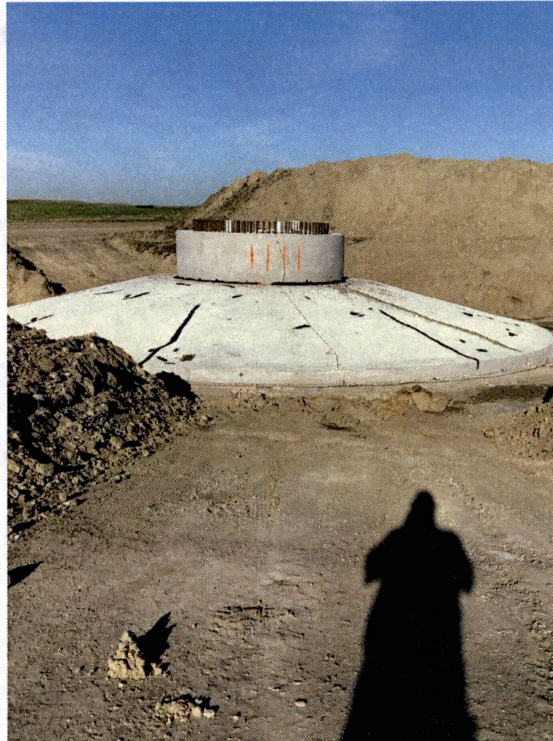
**Picture Number:** 1

**Notes:** One of the remaining poured foundations

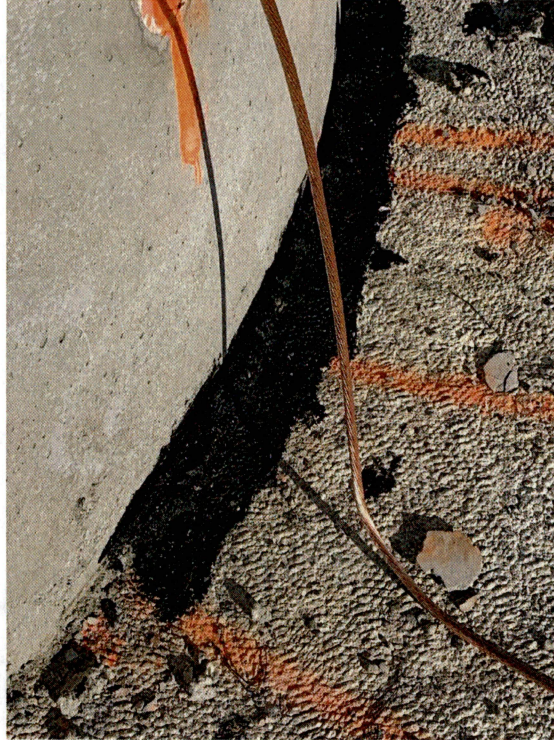
**Picture Number:** 2

**Notes:** Tack oil used to seal joint between concrete foundation and base.

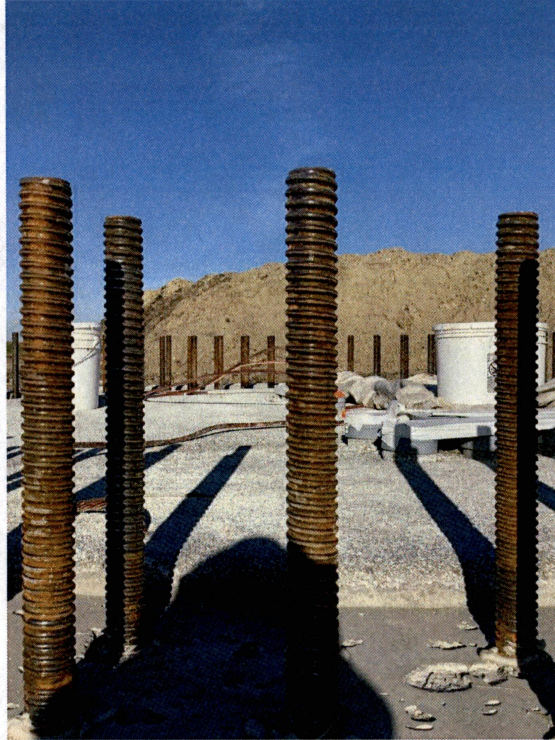
**Picture Number:** 3

**Notes:** Foundation rebar. No. 8 bar used, double layered, 6" oc spacing. 3" on both inner and outer clear cover.

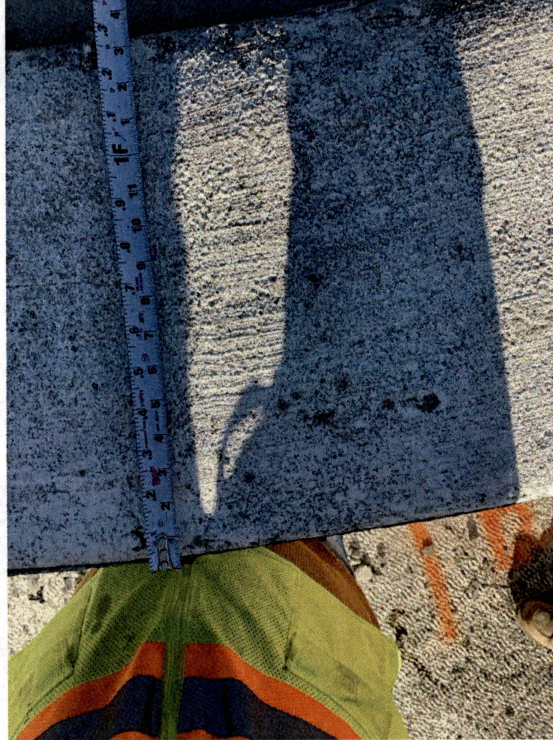
**Picture Number:** 4

**Notes:** Outer wall diameter 16".

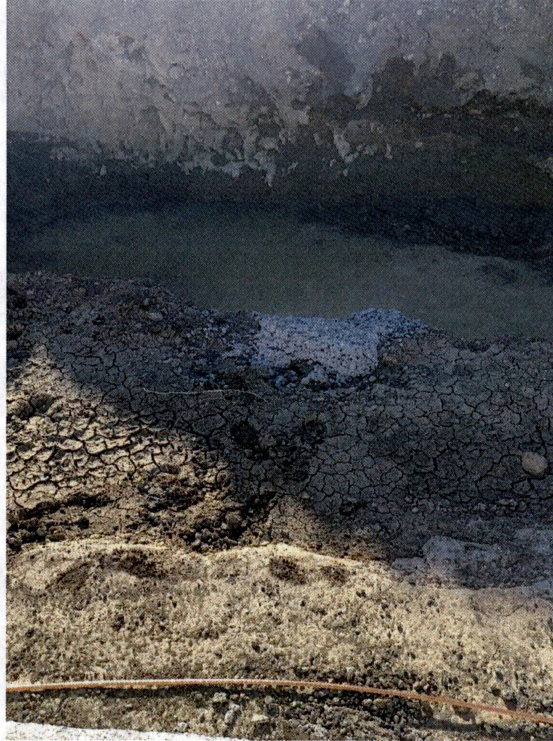
**Picture Number:** 5

**Notes:** Some standing water in drainage trench, will need pumped out before backfill.

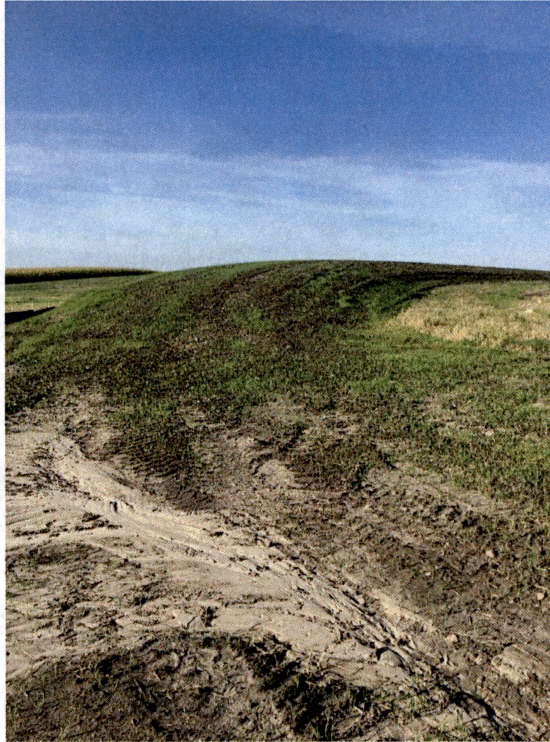
**Picture Number:** 6

**Notes:** Topsoil storage pile, very clear evidence of vegetative cover. Silt fence behind.

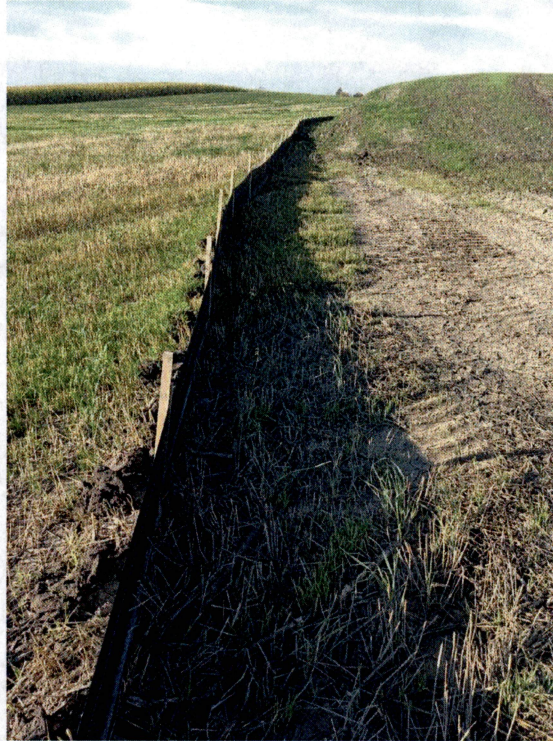
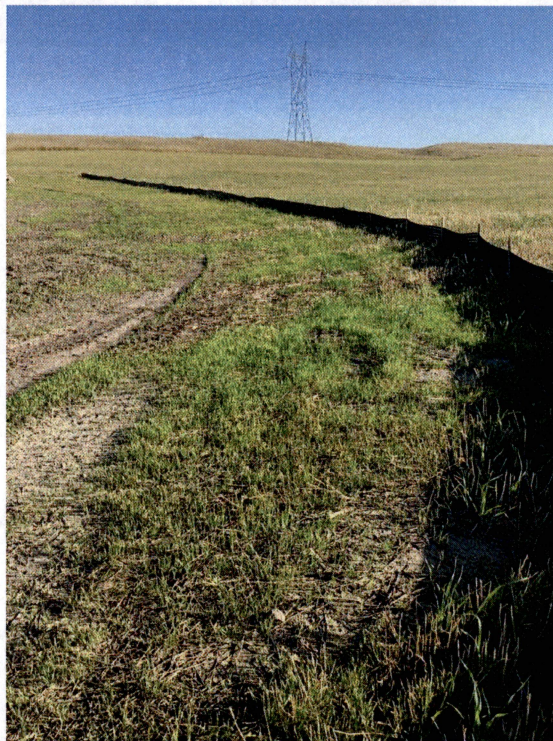
**Picture Number:** 7-8

**Notes:** Silt fence installed correctly. No evidence of sediment build up.

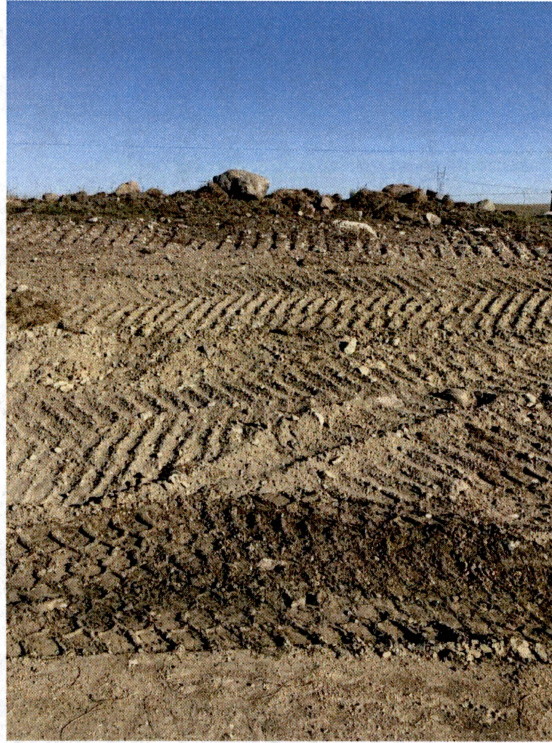
**Picture Number:** 9

**Notes:** Best Management Practices: notified Reed that when sloughing material or transporting equipment, tracks should be made parallel to road, not perpendicular to it, as it can promote erosion, which we don't want.

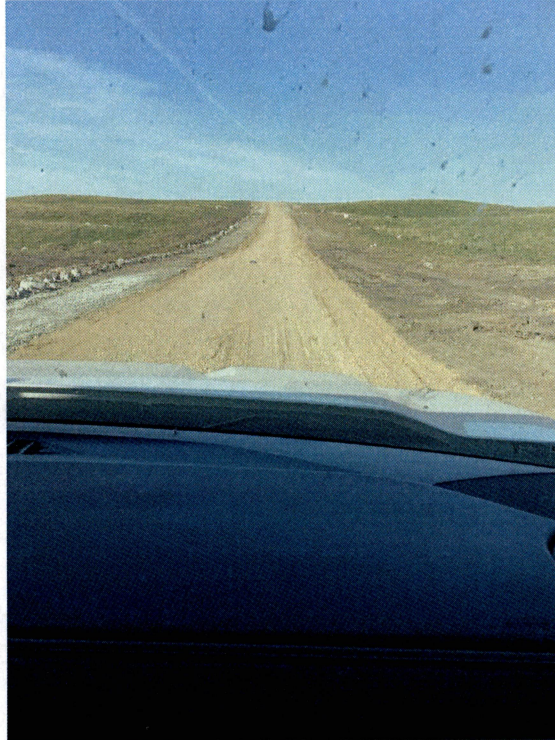
**Picture Number:** 10

**Notes:** Access road existing conditions.

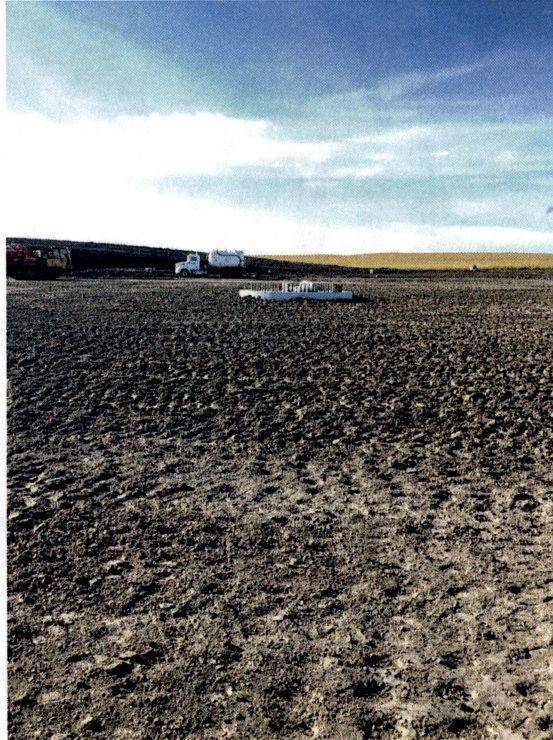
**Picture Number:** 11

**Notes:** Structure foundation freshly backfilled and compacted. Evidently compacted by sheep's foot.

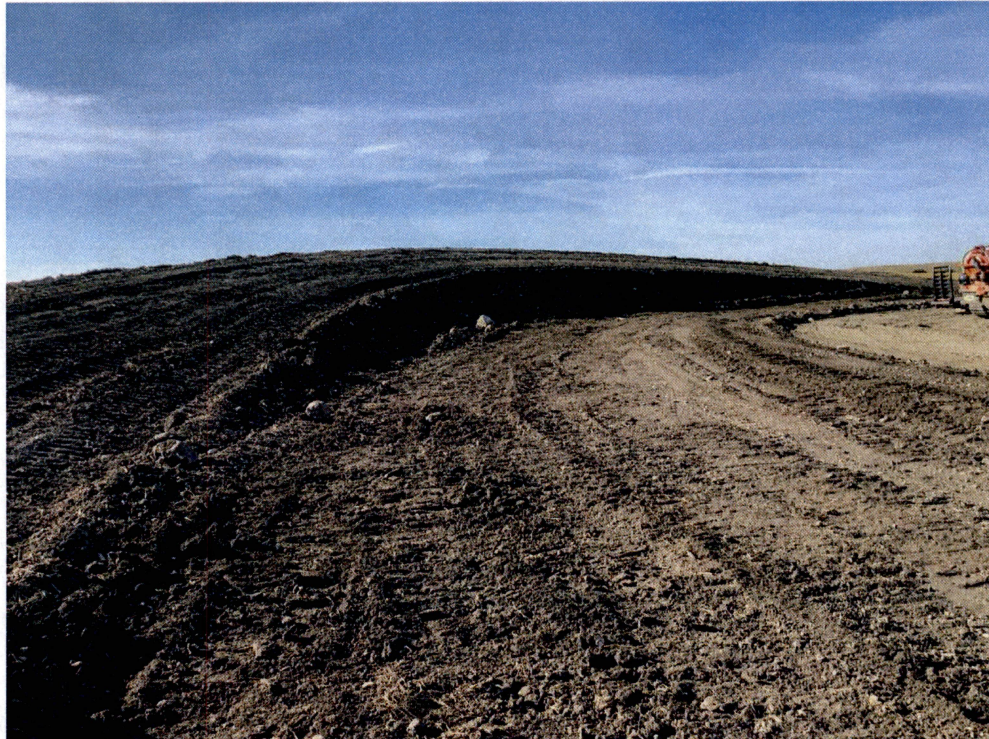
**Picture Number:** 14

**Notes:** Topsoil storage pile. No evidence of vegative cover. Stripped 2-3 weeks ago.

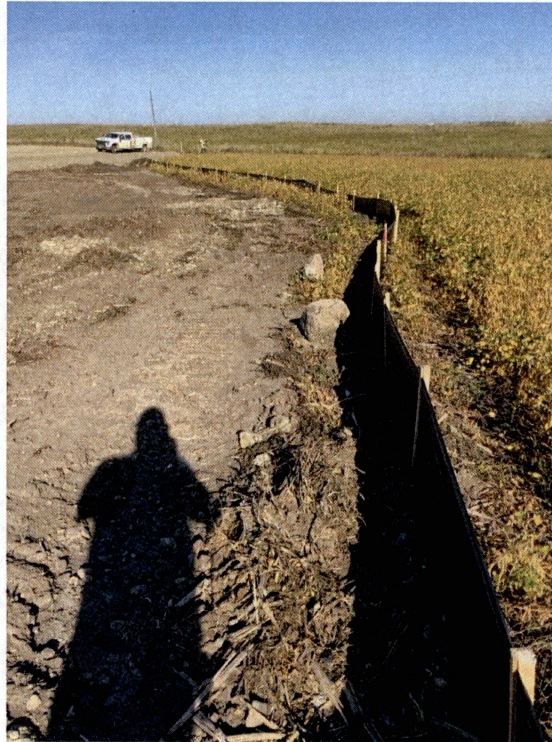
**Picture Number:** 15

**Notes:** Silt fence. No evidence of sediment deposition.

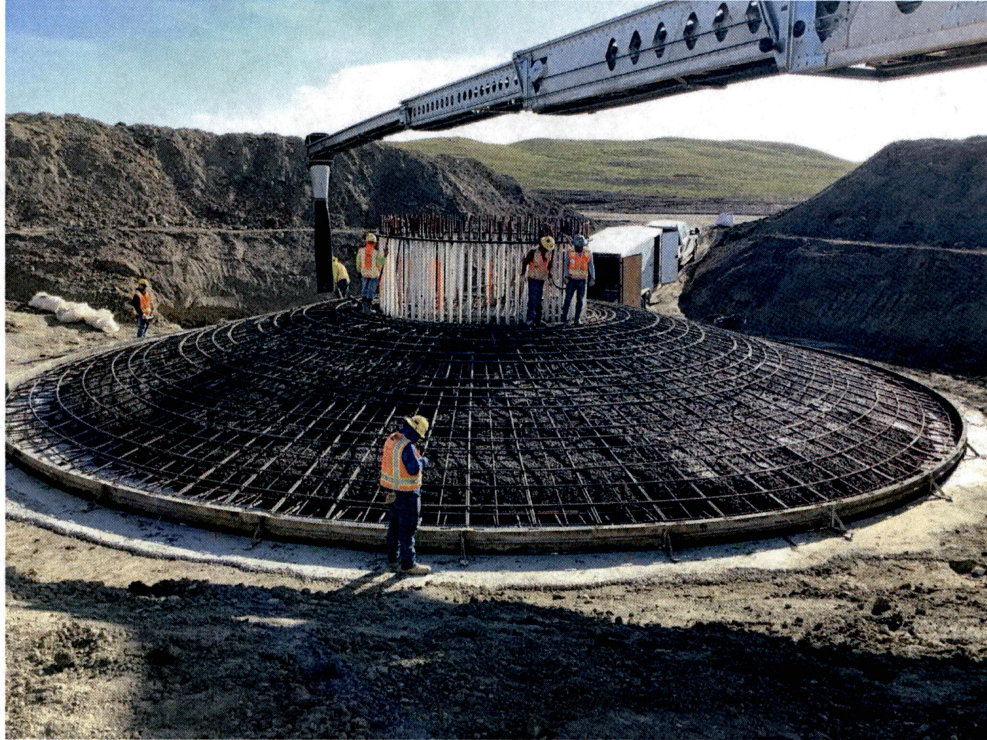
**Picture Number:** 20

**Notes:** Foundation rebar and pour. Crew vibrating concrete after placement.

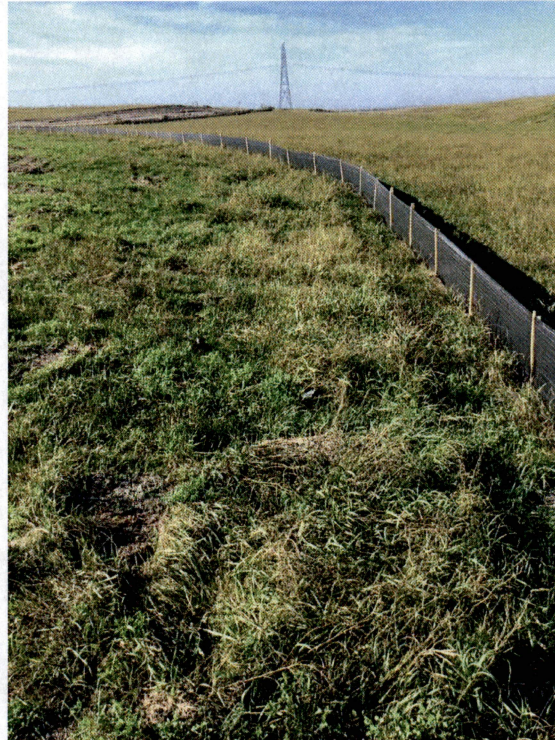
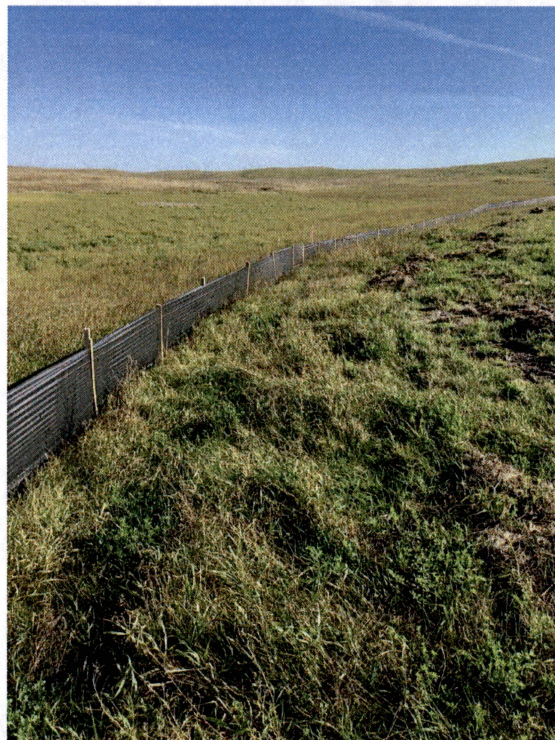
**Picture Number:** 21-22

**Notes:** Silt fence installed correctly, no evidence of sediment build up

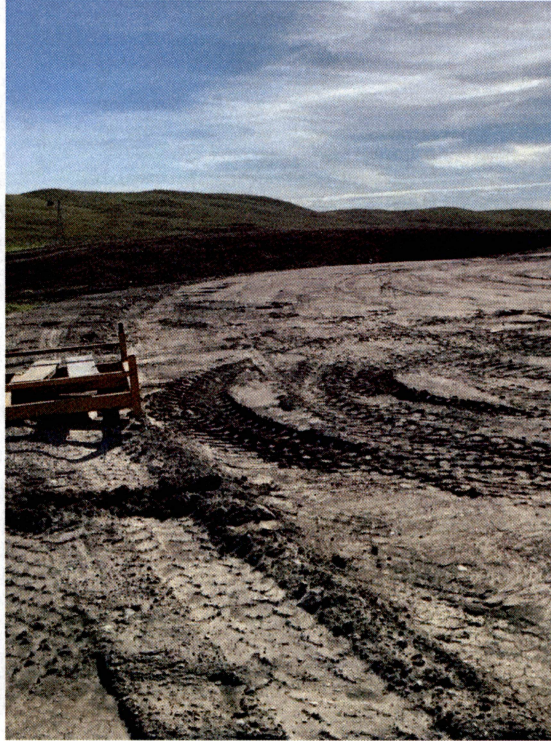
**Picture Number:** 23

**Notes:** Topsoil stockpile, no evidence of subsoil mixing.

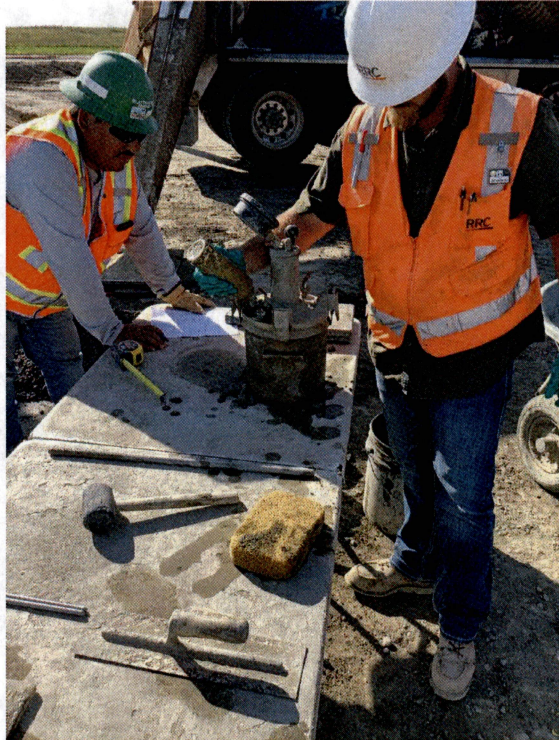
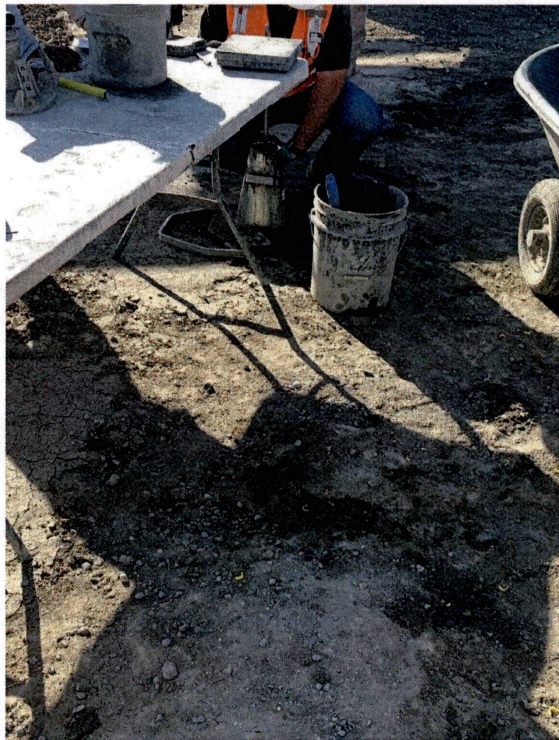
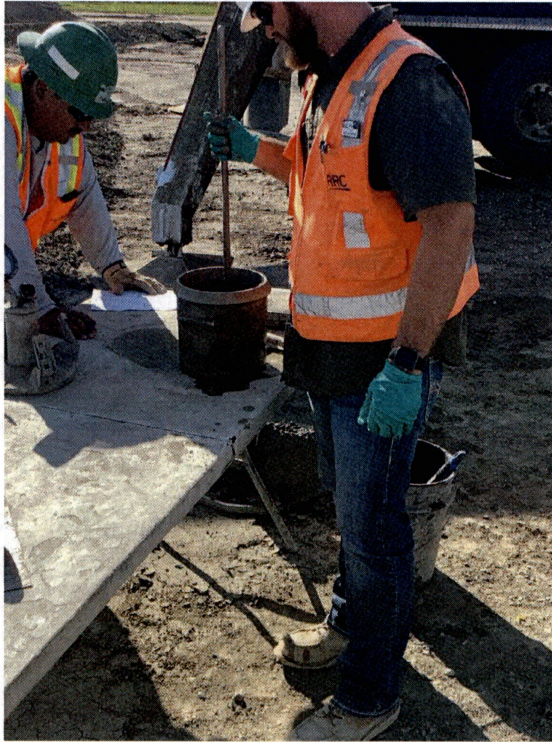
**Picture Number:** 28-30

**Notes:** Slump test result, 6", air content: 1.4%

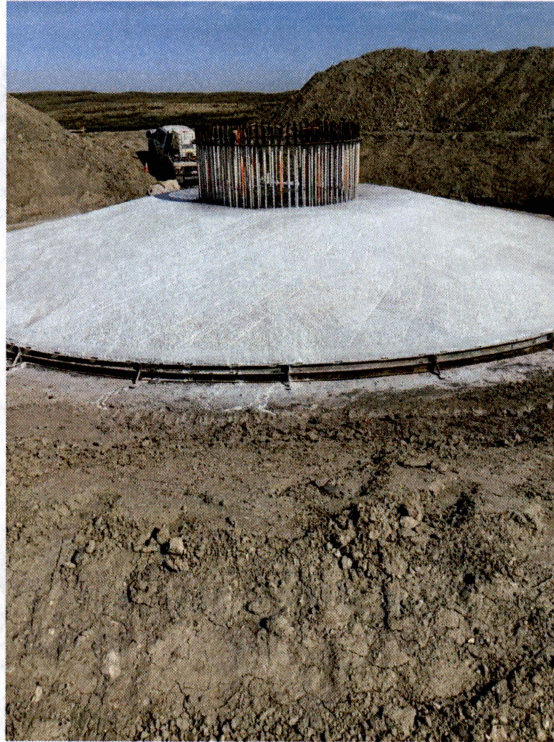
**Picture Number:** 31

**Notes:** Finished pad for tower, crew adding curing solution on top to prevent drying out.

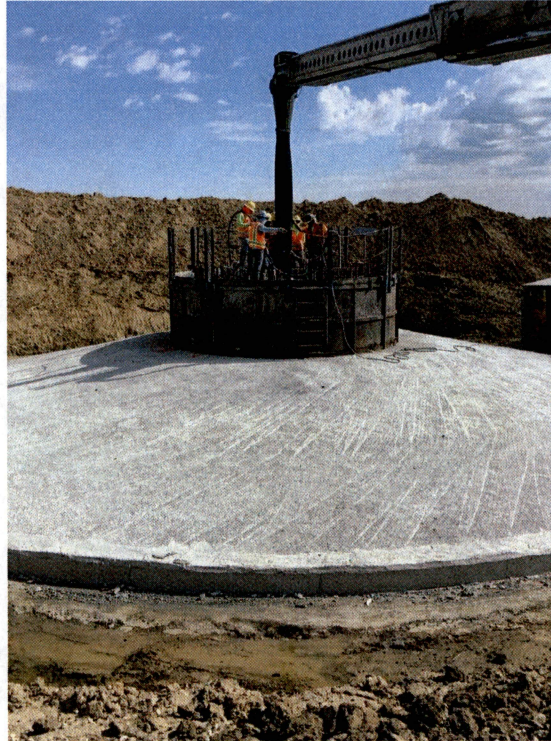
**Picture Number:** 37

**Notes:** Pouring pedestal using pump truck. Most recent concrete test passed.

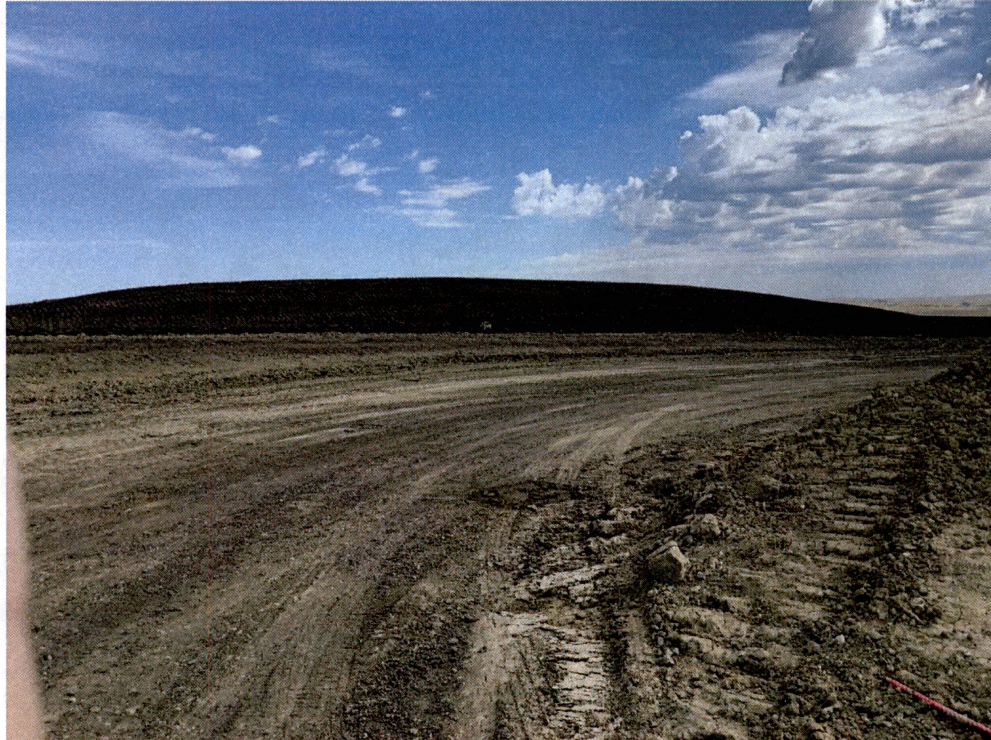
**Picture Number:** 38

**Notes:** Topsoil pile, no signs of subsoil contamination, noticing again tracks that encourage erosion by water rilling. Likely moot due to how topsoil was stored. No evidence of vegetative cover currently.

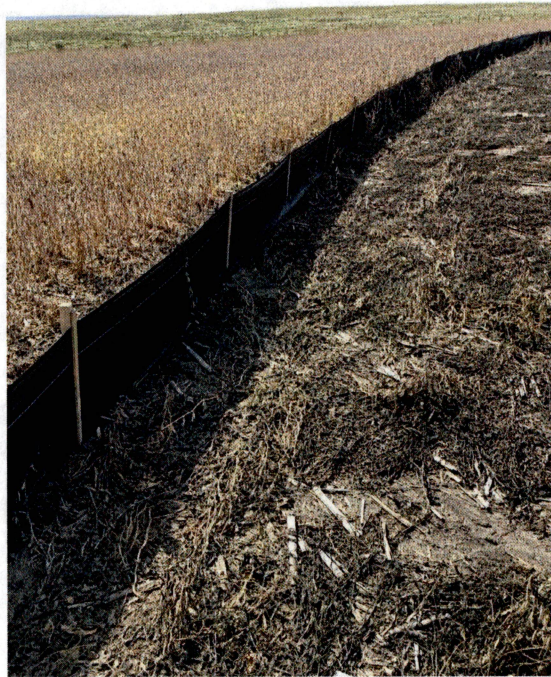
**Picture Number:** 39

**Notes:** Silt fence installed. Looking at lowest point, no sign of sediment deposition.

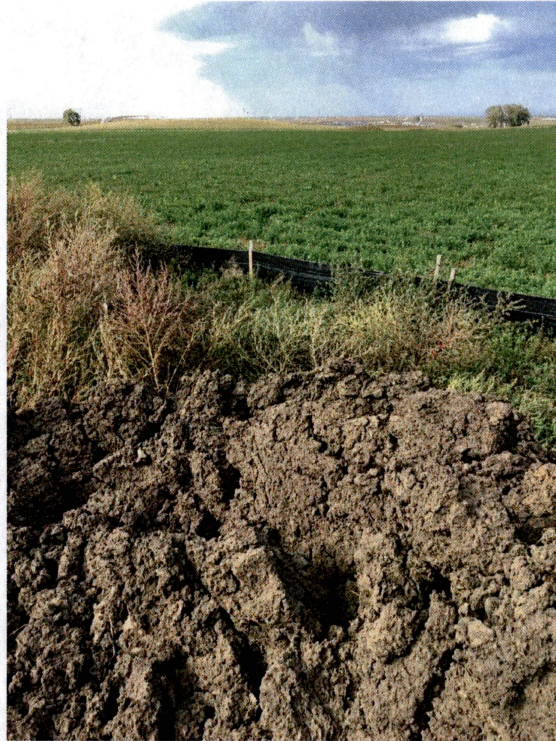
**Picture Number:** 42

**Notes:** Silt fence still surrounded by vegetative cover, no concerns.

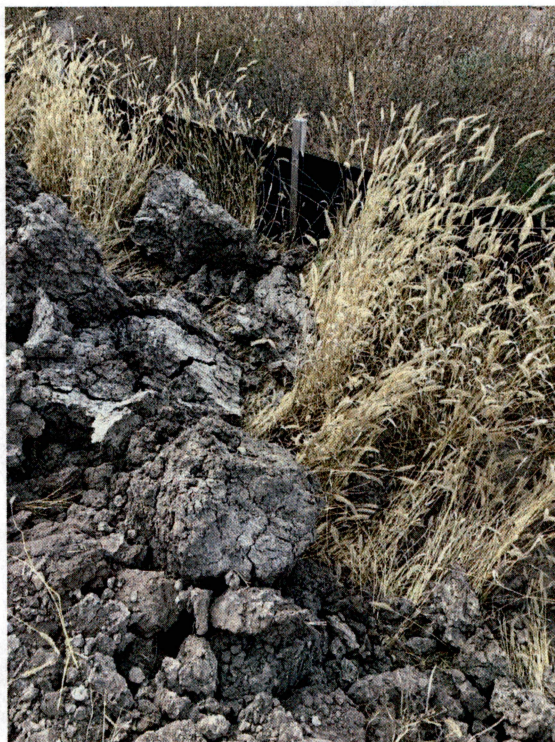
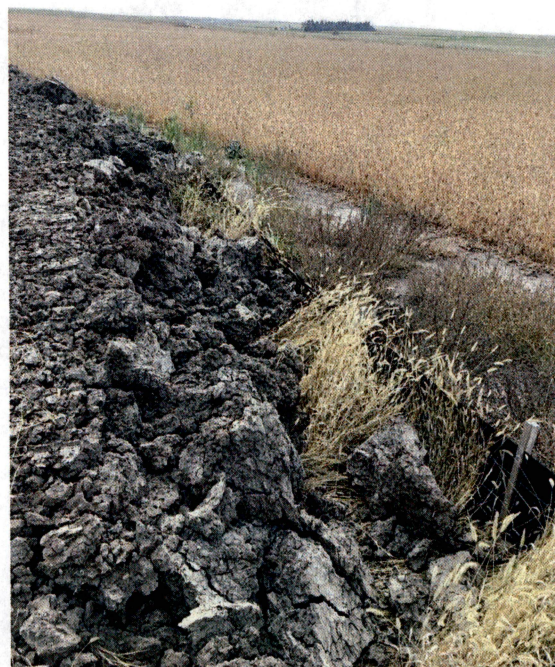
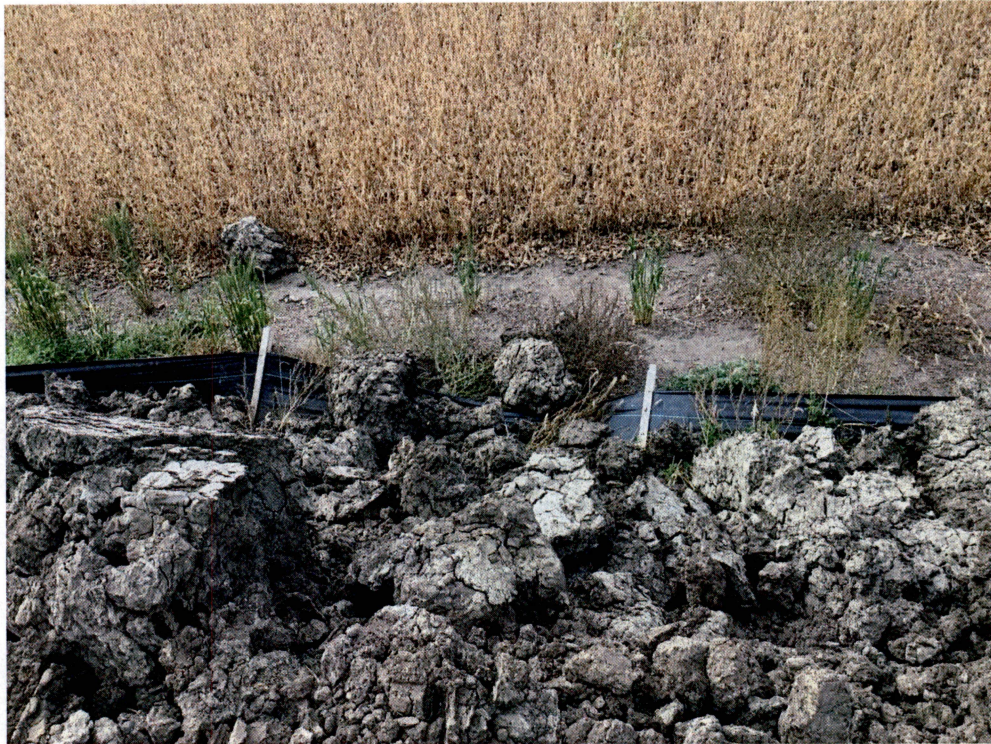
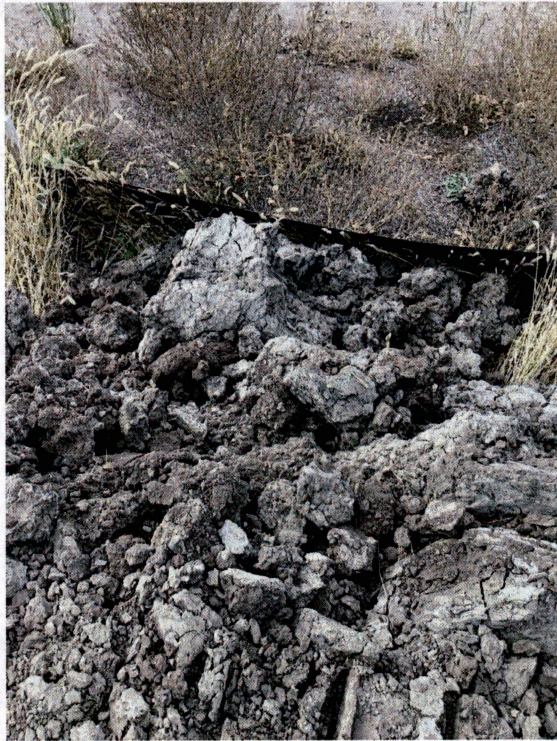
**Picture Number:** 45-48

**ISSUES REQUIRING RESOLUTION:** Inspector checked on Structure 22B01 after previously noting that sediment buildup was occurring on silt fence. Upon revisiting the site, it is not clear that cleaning ever occurred, and further the silt fence is in worse condition than previously documented, due to stockpiling of excess backfill too close to silt fence. Sections of this fence are leaning do to sediment build up and from large clods of subsoil rolling off pile into said fence. One section, approximately 10-15' wide is completely down and subsoil is encroaching on landowner's field. See photos P45-50 as evidence.

**Notes:** Area of concern: last time I was here, this section had sediment buildup, which I pointed out to Reed B. Upon returning to this spot they've placed excess subsoil from backfilling operations up against this silt fence and the weight of such large chunks has knocked loose posts and sections of fence.

**PROPOSED RESOLUTION(S):** Contractor needs to move stockpile of subsoil away from silt fence, move clods of subsoil that have rolled out of ROW back into ROW, and need to clean/replace down or otherwise compromised fence.

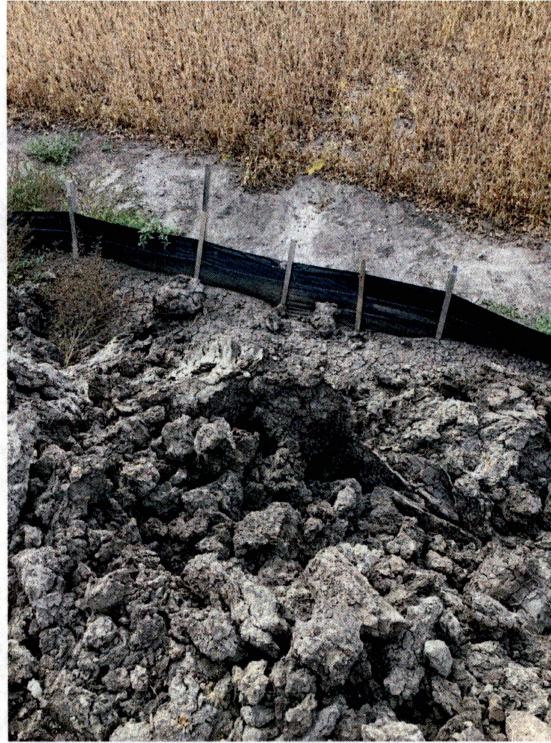
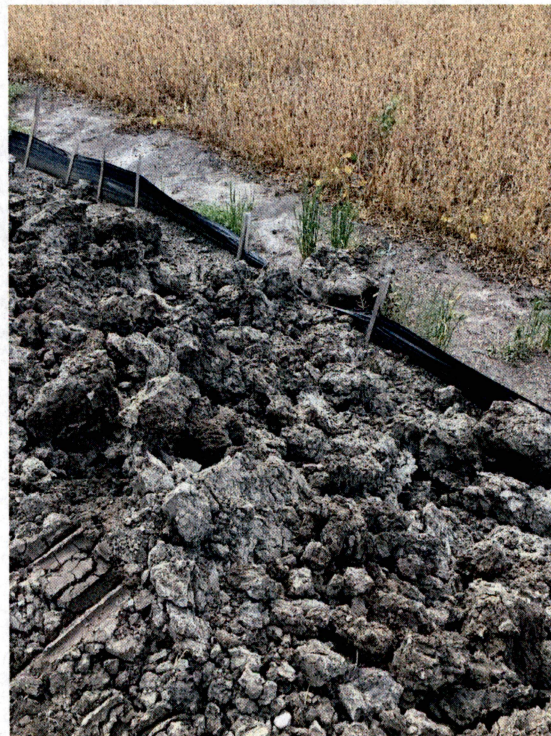
**Picture Number:** 49-50

**Notes:** Area of concern: it does not appear that silt buildup was removed after last inspection. Coupled with this new issue of large clods of subsoil pressing on and knocking over silt fence, I see this being an erosion risk for the land owner.

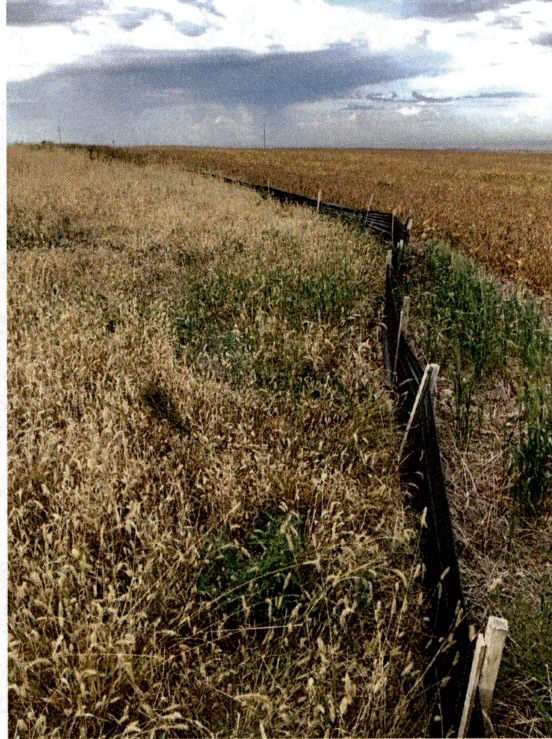
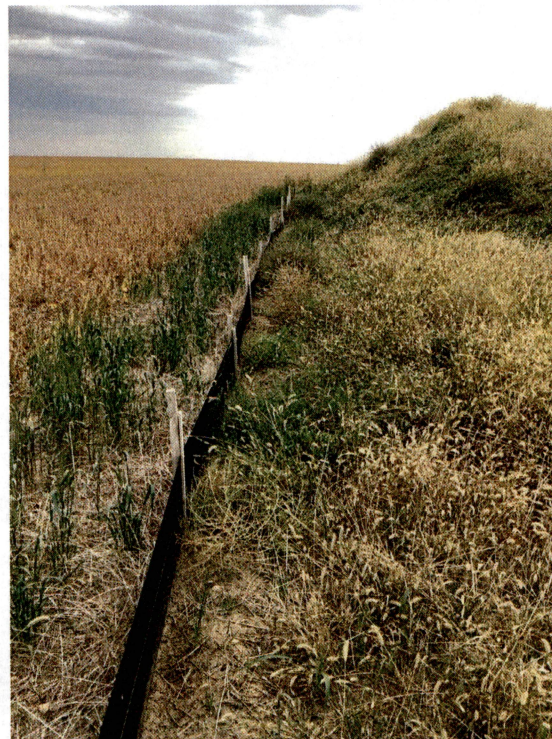
**Picture Number:** 52-53

**Notes:** Silt fence in good condition

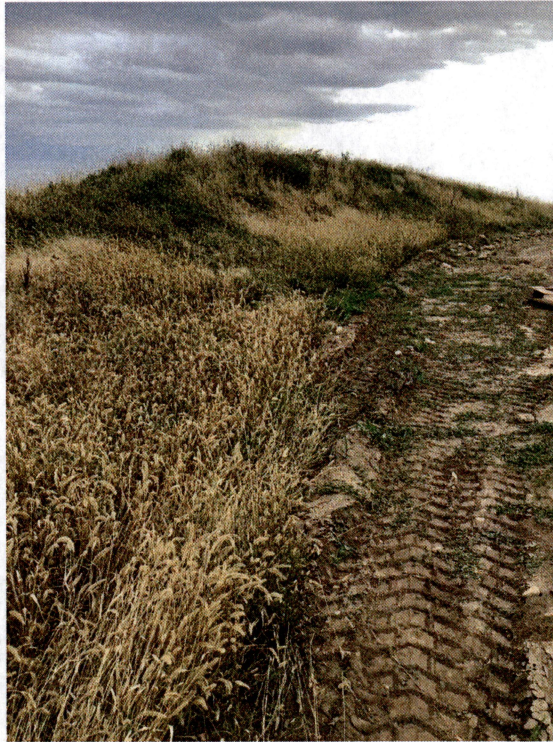
**Picture Number:** 54

**Notes:** Topsoil storage, vegetative cover evident.

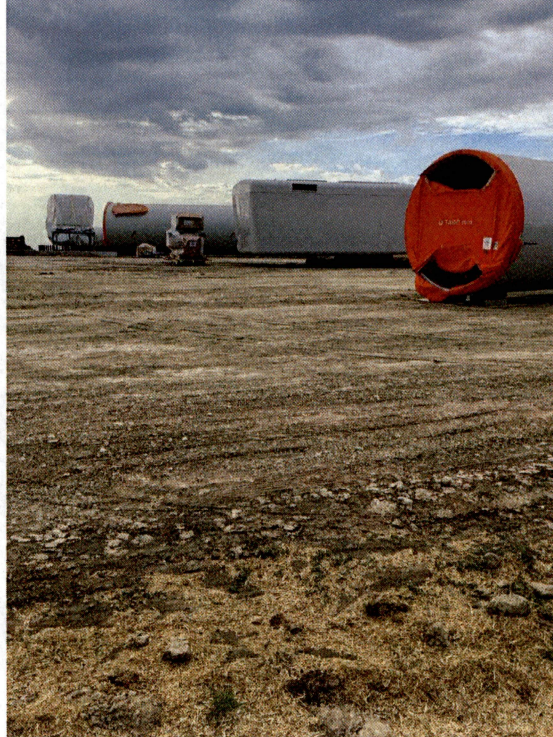
**Picture Number:** 55

**Notes:** Control structure progress: foundation and pedestal installed, subsoil backfilled. Structure to be built soon.
