**Basin Electric Antelope Valley to Neset 345kV Transmission Line**

**Williams County, North Dakota**

***Topsoil Inspection Report***

***Docket Number: PU-24-236***

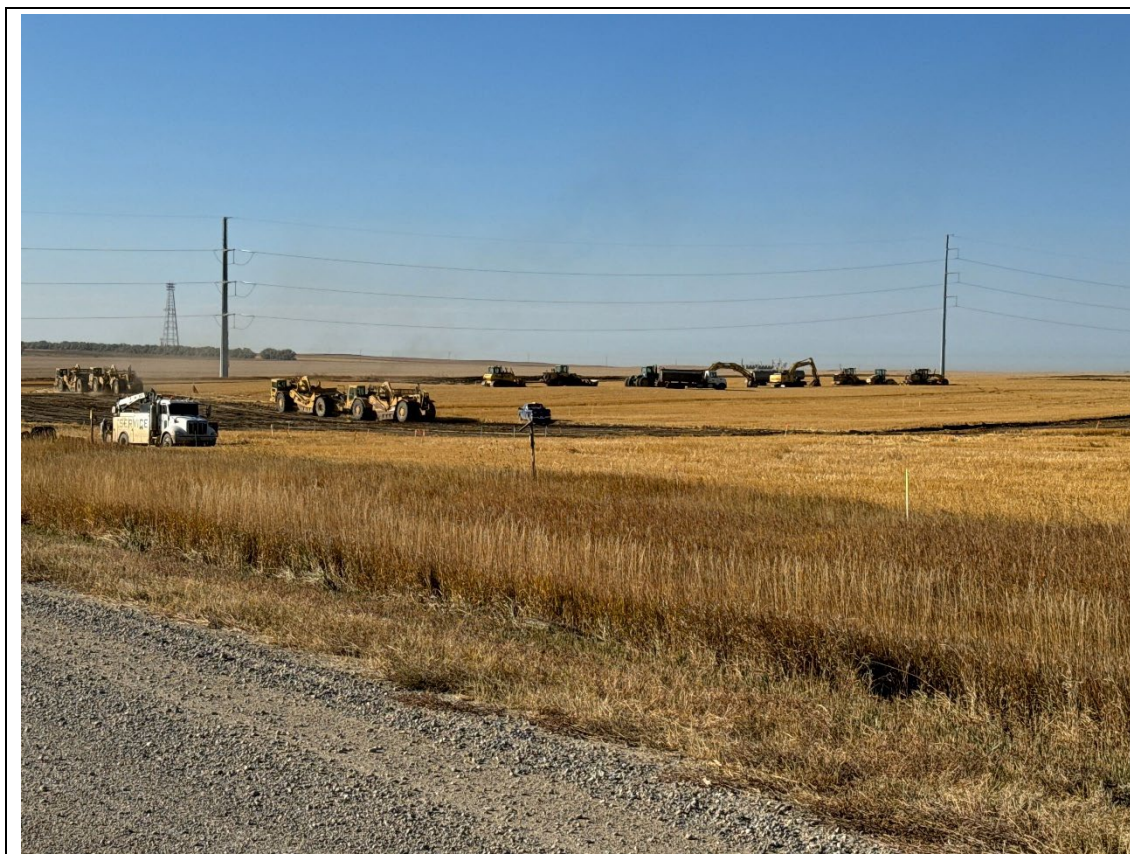
Photo #: 1

Description: Graders stripping perimeter of pad area with other equipment staged in the center.

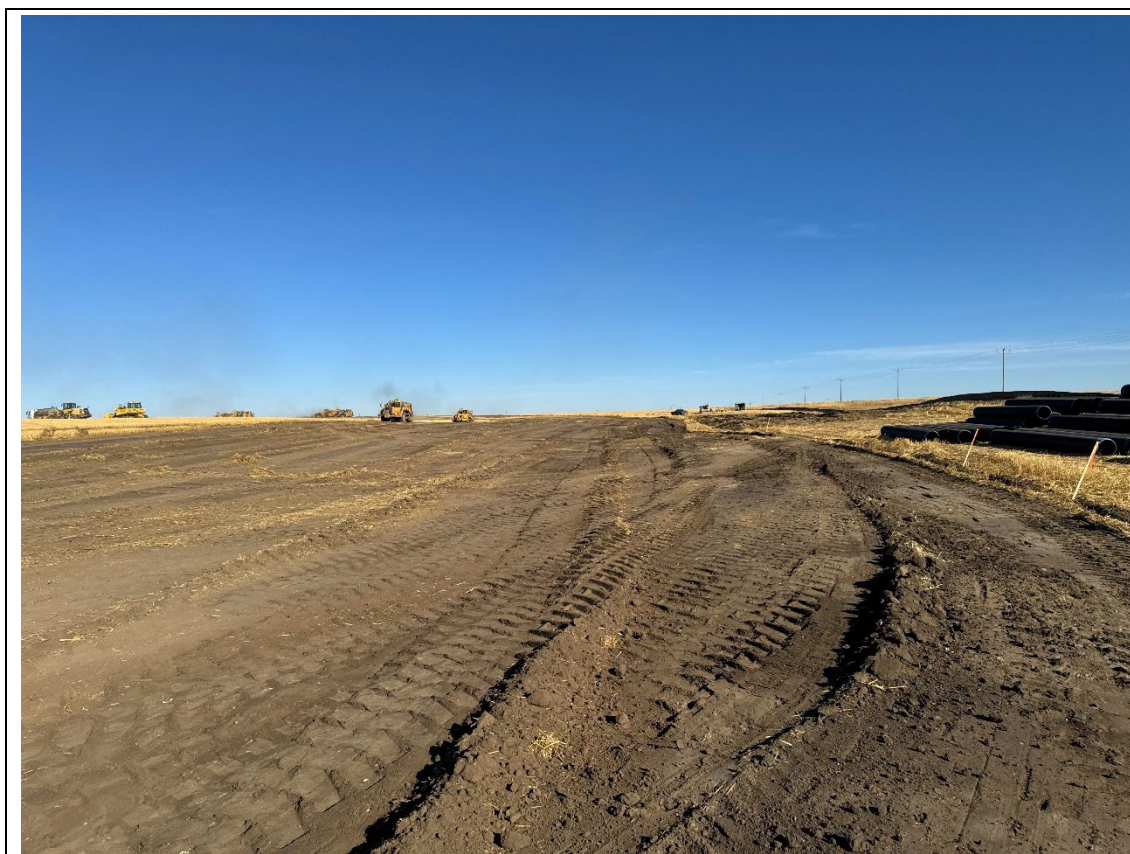
Photo #: 2

Description: Soil stripped to color change along the east edge of the project area with scraper and grader stripping topsoil from stubble field.

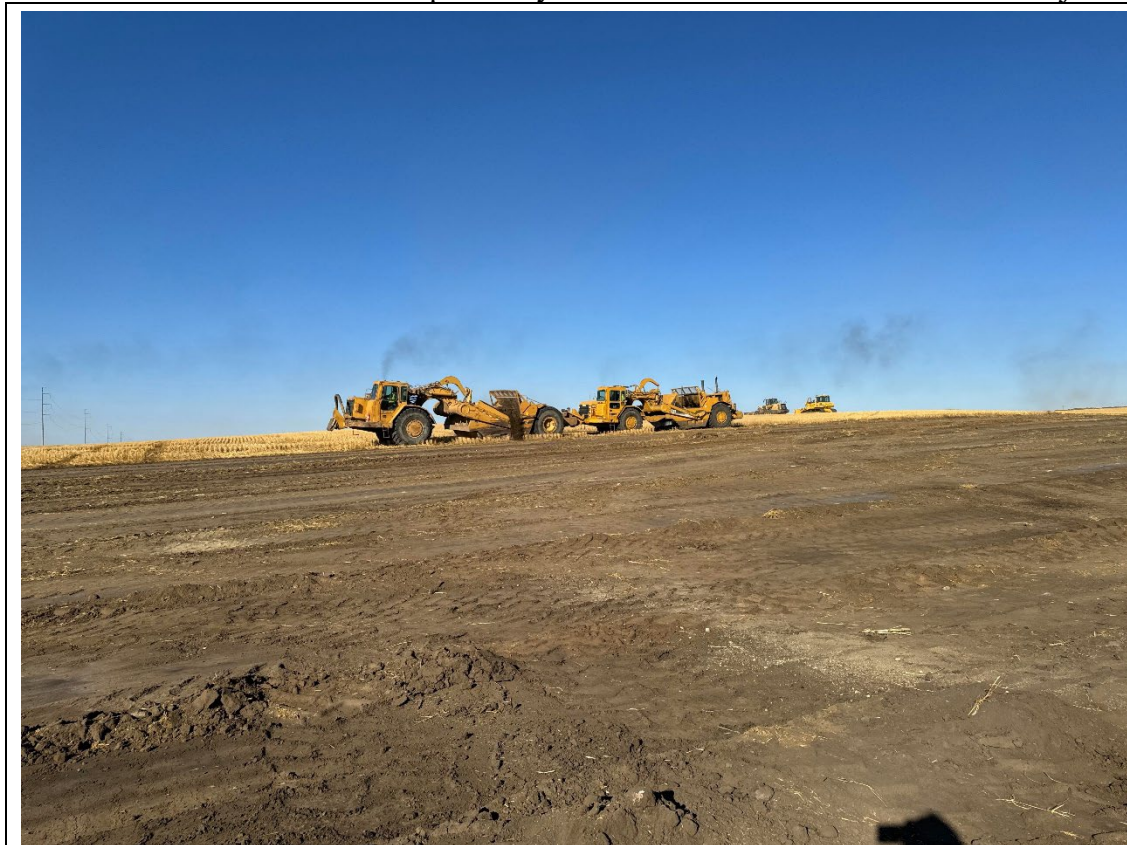
Photo #: 3  
Direction: West  
Description: Graders in tandem stripping topsoil from stubble field.  
Observer: Zach Peterson  
Date: 10/11/2024  
Latitude: 48.292653  
Longitude: -103.475324

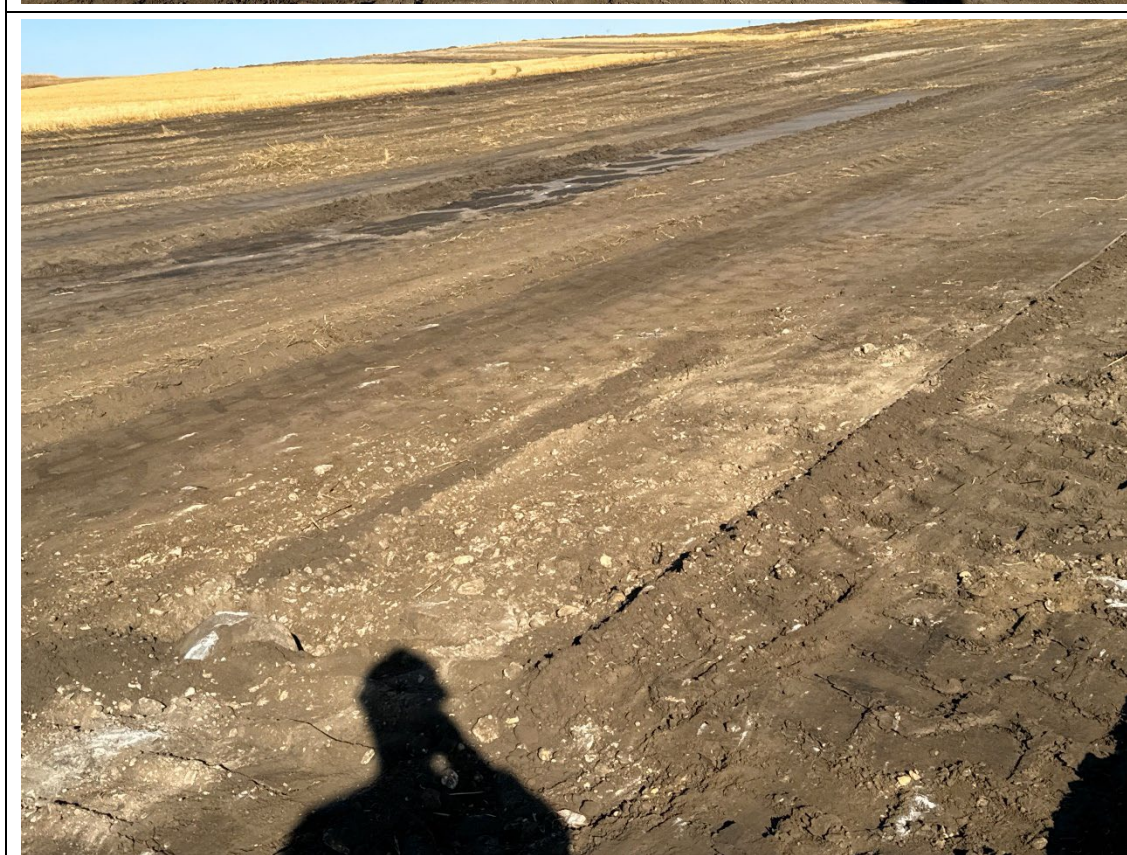
Photo #: 4  
Direction: Northwest  
Description: Topsoil stripped to change in soil color along east end of Project area.  
Observer: Zach Peterson  
Date: 10/11/2024  
Latitude: 48.293556  
Longitude: -103.475334

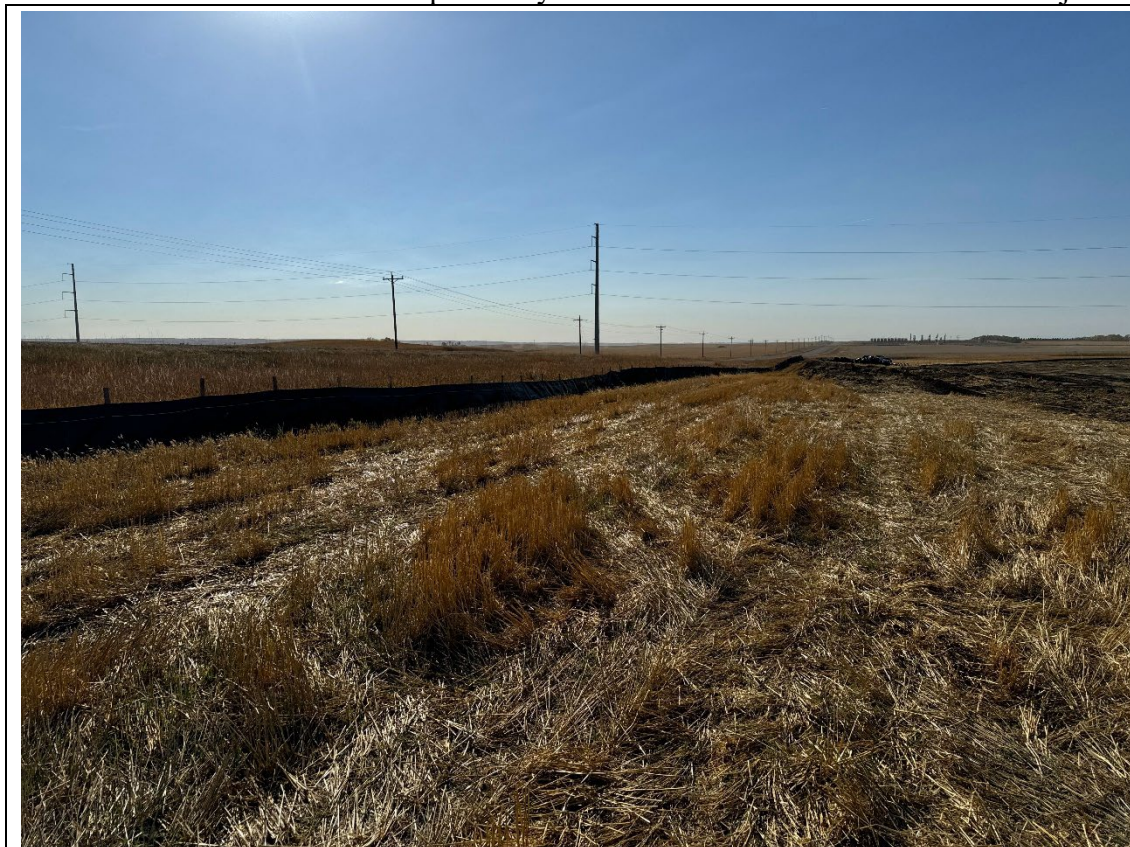
Photo #: 5  
Direction: South  
Description: Silt fence along eastern perimeter of Project area.  
Observer: Zach Peterson  
Date: 10/11/2024  
Latitude: 48.294096  
Longitude: -103.475124

Potential Issues	Recommendations
<b>SWPPP/BMPs</b>	Silt fence and straw wattles along the perimeter of the topsoil piles will need to be monitored regularly and replaced when necessary.

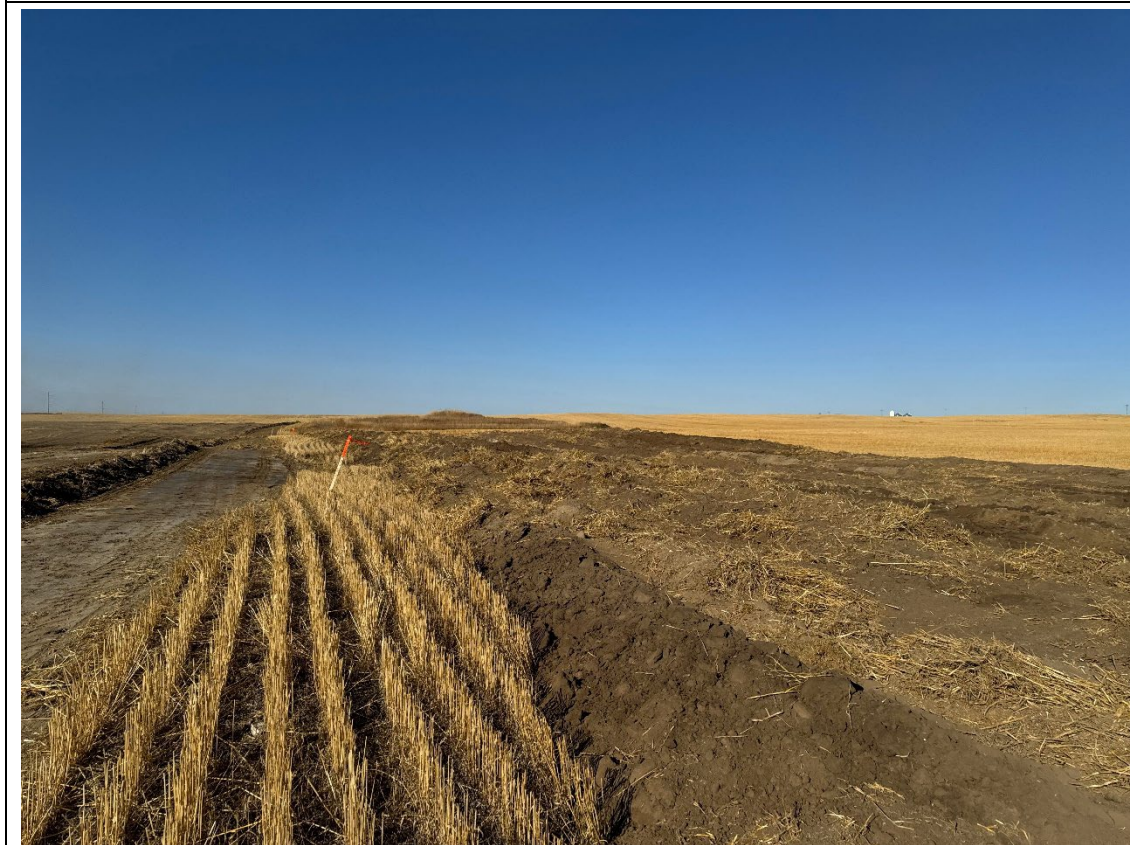
Photo #: 6  
Direction: West  
Description: Topsoil pile/berm along north end of Project area.  
Observer: Zach Peterson  
Date: 10/11/2024  
Latitude: 48.294715  
Longitude: -103.476395
