**PU-24-351
Offer Tail Power Company
Abercrombie Solar
Topsoil Inspection Report**

File No. 227708967

May 28, 2026

North Dakota Public Service Commission
600 E. Boulevard Avenue
Bismarck, ND 58505-0480

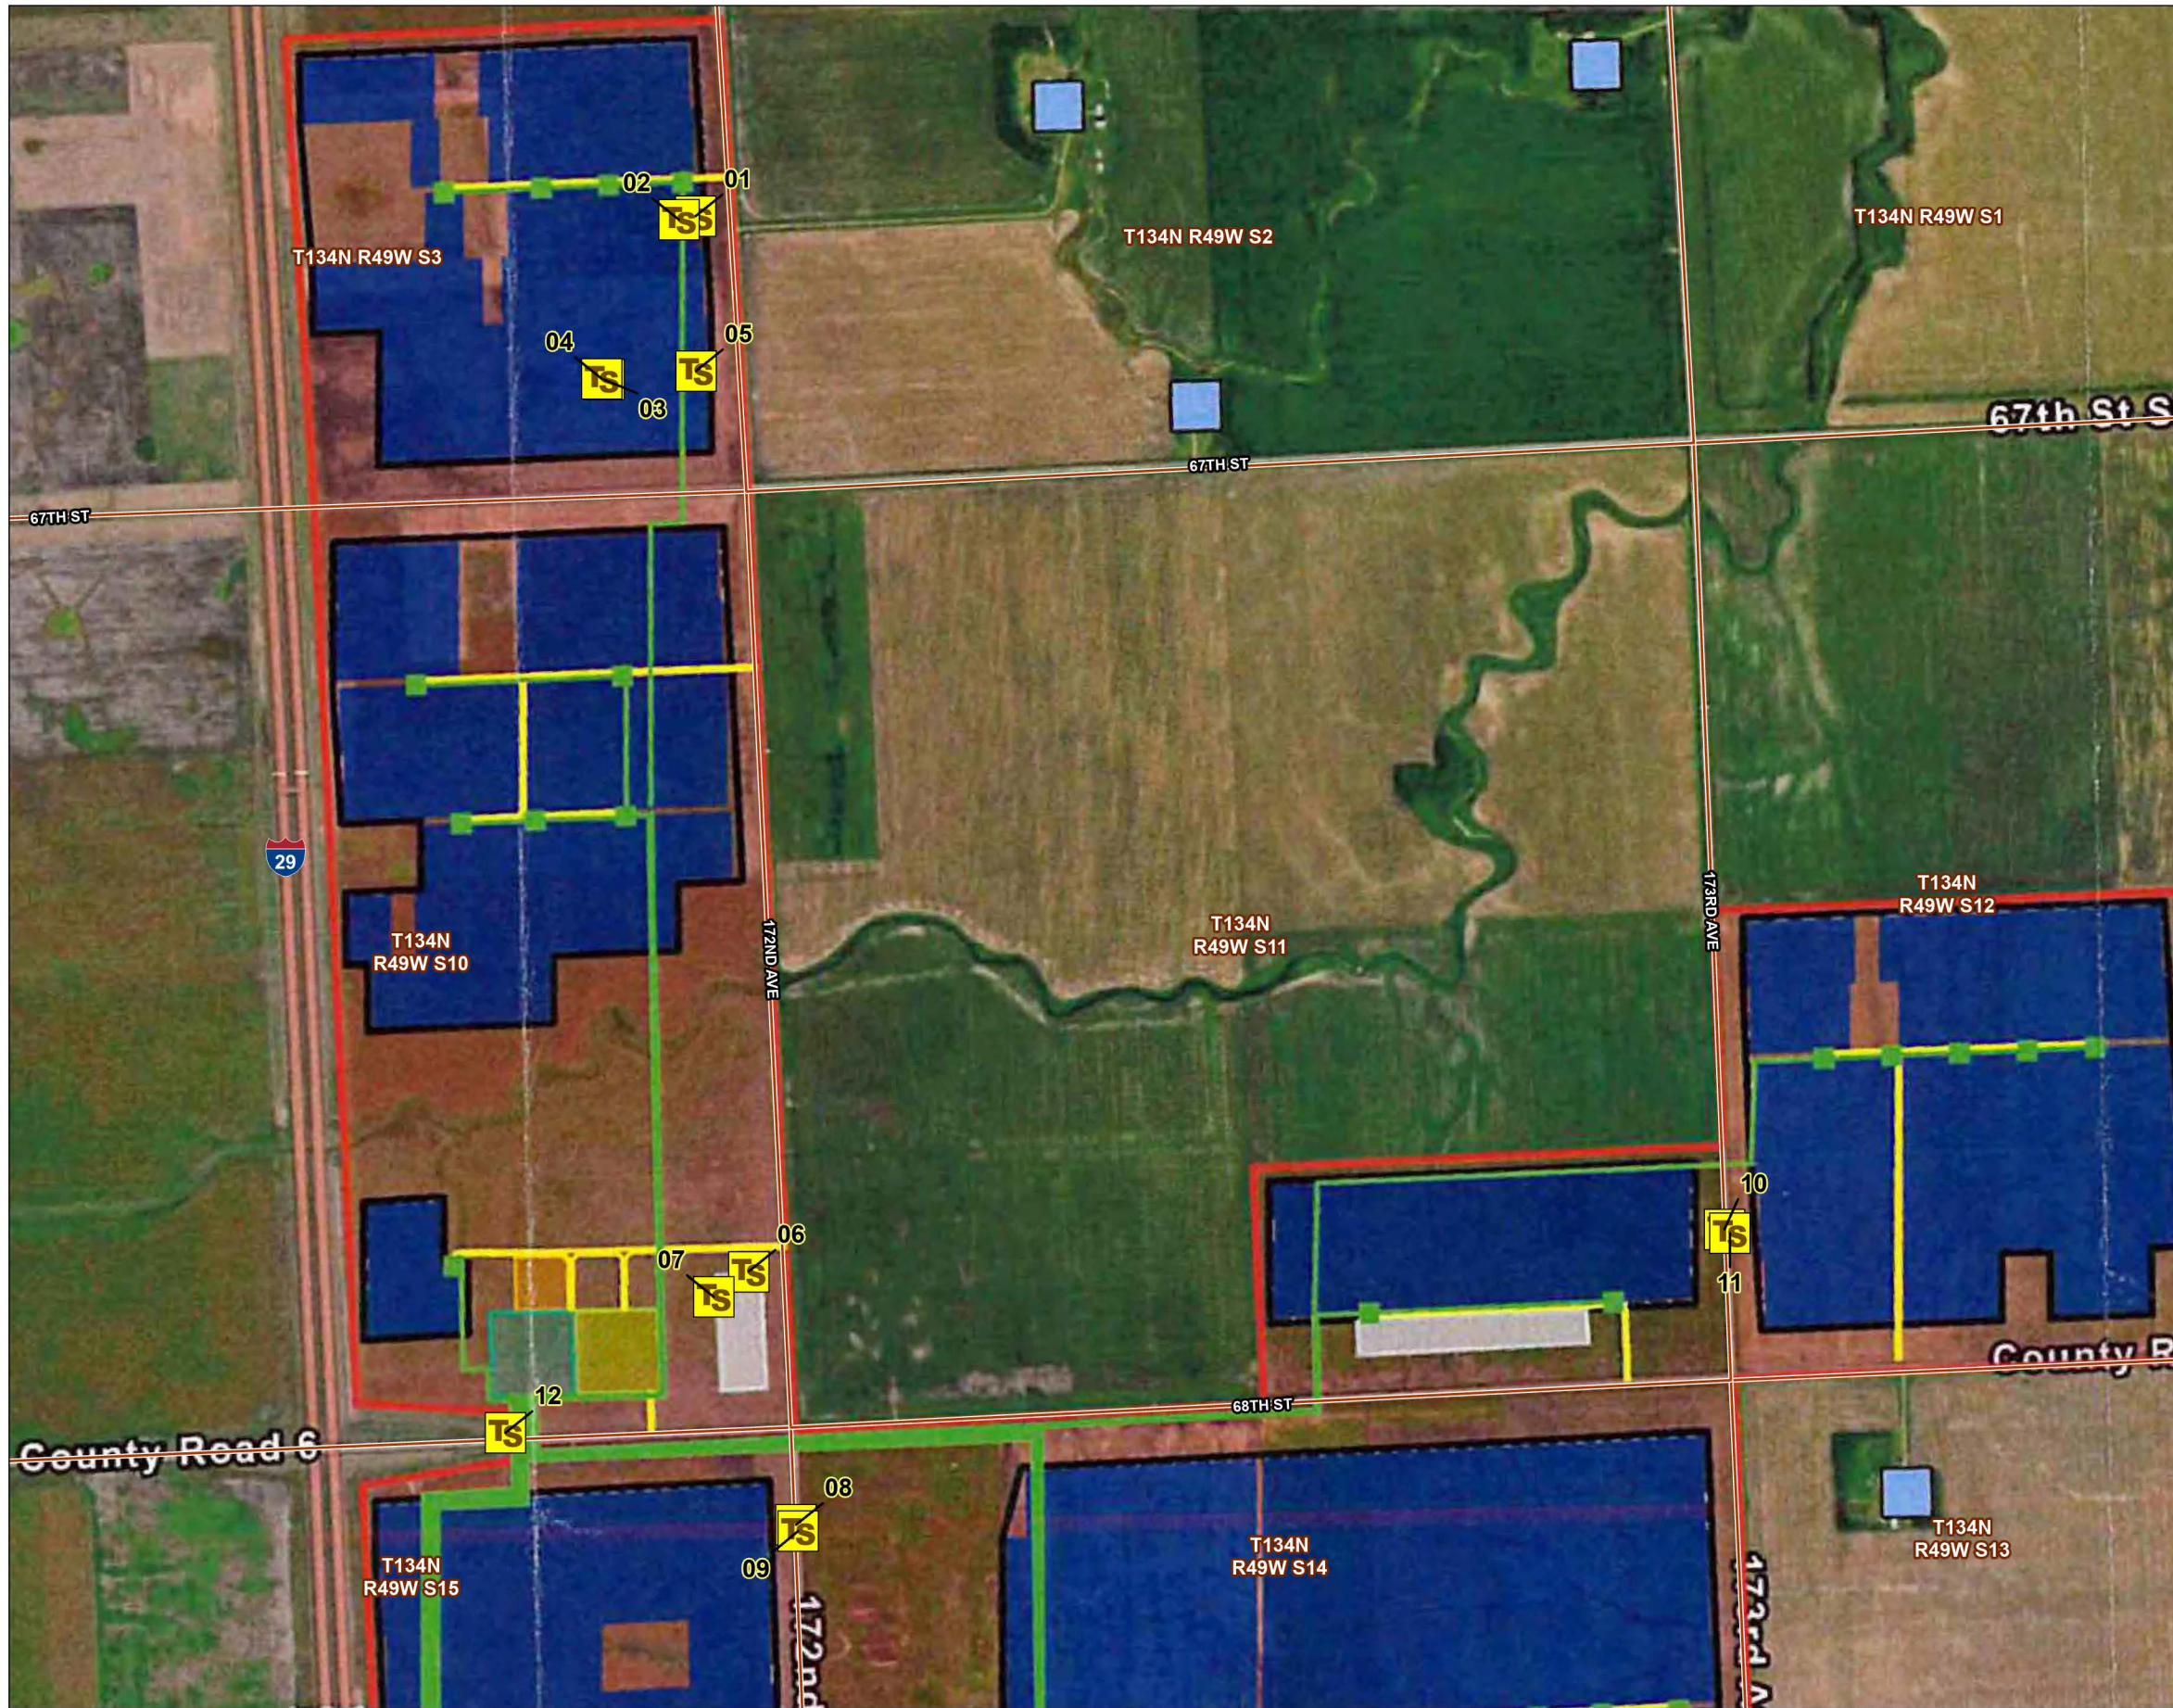
Figure 1: Topsoil Observation Locations Map

Stantec shared the PSC order provisions relating to topsoil stripping, segregation, and protection with individuals present during the inspection and provided opportunity for Otter Tail and its contractors to ask questions on expectations for topsoil stripping depths and segregation. Stantec then observed the contractor's topsoil stripping, segregation of stockpiling practices. Visual inspections were made by Stantec at various locations to confirm the proper depths of topsoil stripping were reached and mixing of the underlying subsoils were not being mixed with the topsoil being stripped. Additionally, two borings were observed within the project area crossing 172nd Ave SE. and 173rd Ave SE. These are marked at photo points 9 & 10 and 11 & 12 in Figure 1.

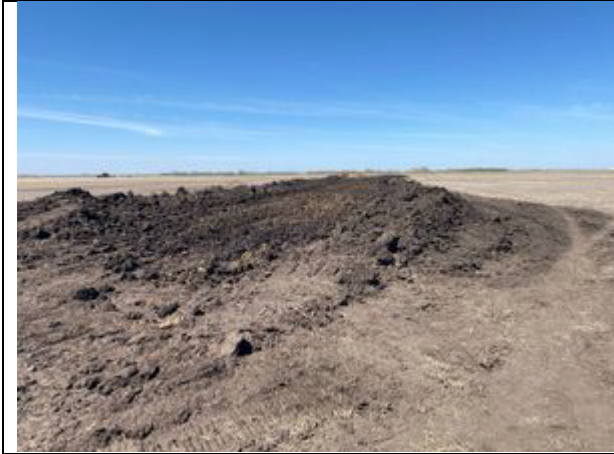
Observation Point: 1

Photo Description: Stripped topsoil for permanent road

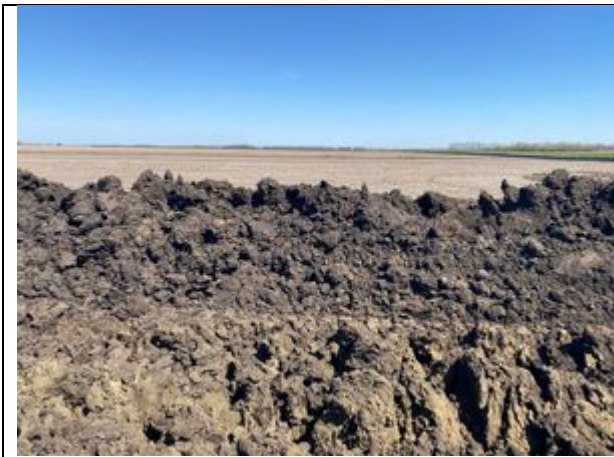
Observation Point: 2

Photo Description: Appropriate segregation of topsoil and subsoil along proposed road

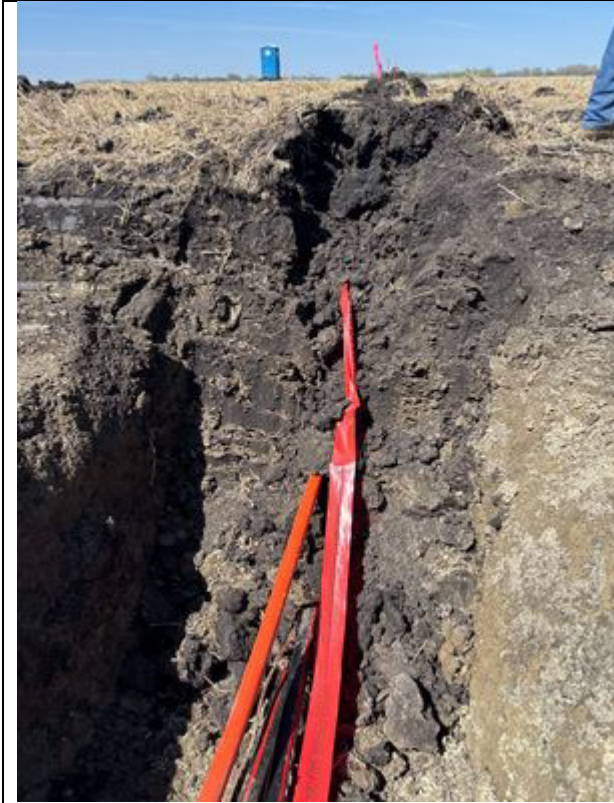
Observation Point: 3
Date Taken: May 13, 2026 11:26 AM
Direction Photo is Taken: West
Photo Description: Appropriate depth of utility trenched to 4ft below ground level
Latitude: 46.44371255
Longitude: -96.82269343

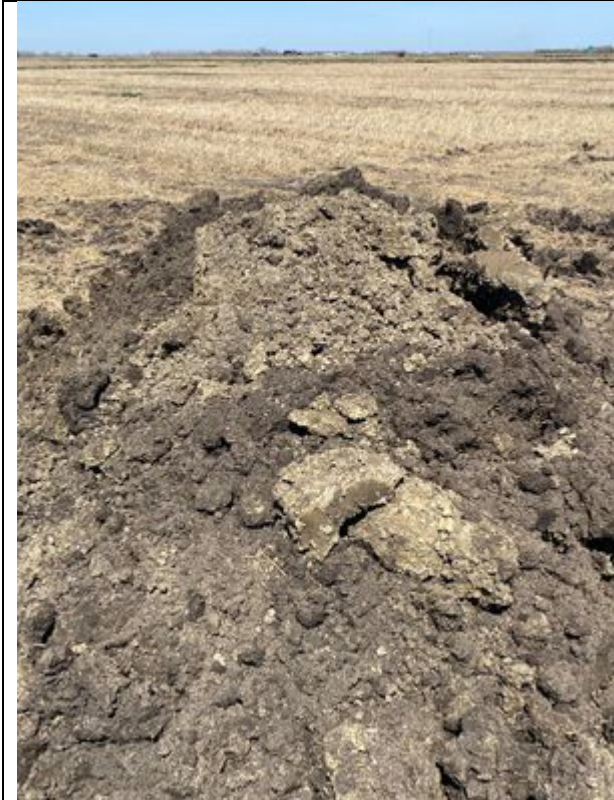
Observation Point: 4
Date Taken: May 13, 2026 11:29 AM
Direction Photo is Taken:
Photo Description: Minor subsoil mixing from utility borehole location. Discussed with Otter Tail representative to avoid large scale issues like this.
Latitude: 46.44372657
Longitude: -96.82274262

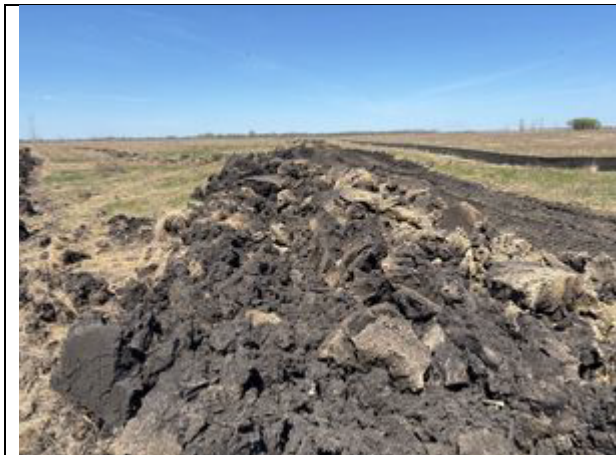
Photo Description: Some topsoil and subsoil mixing at laydown yard. Discussed with Otter Tail rep. Was informed equipment got stuck.

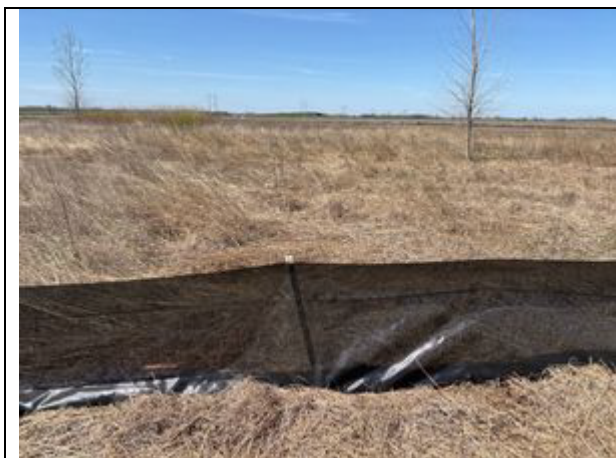
Photo Description: Appropriately installed silt fence excluding wetland

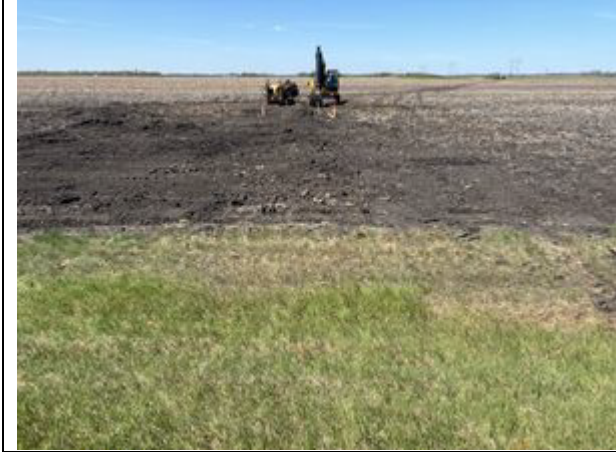
Photo Description: Appropriately bored under 172nd Ave

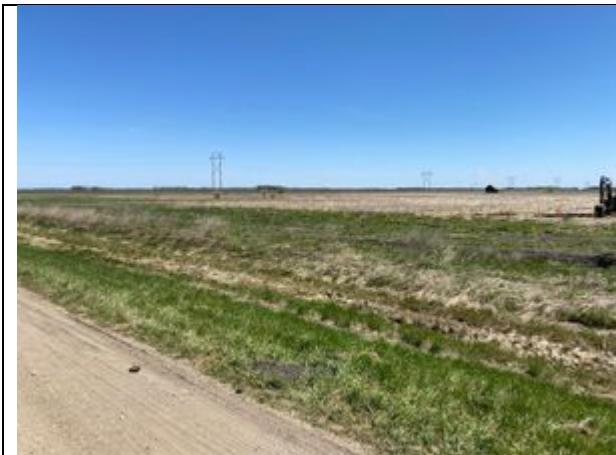
Photo Description: Completed Bore location under 172nd Ave. No issues

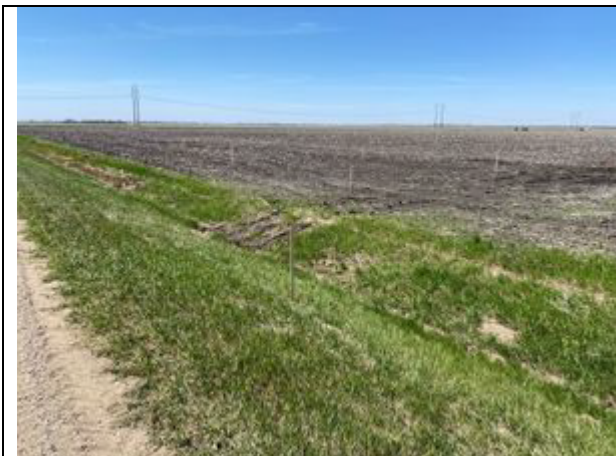
Photo Description: Completed Bore location under 173rd Ave. No issues

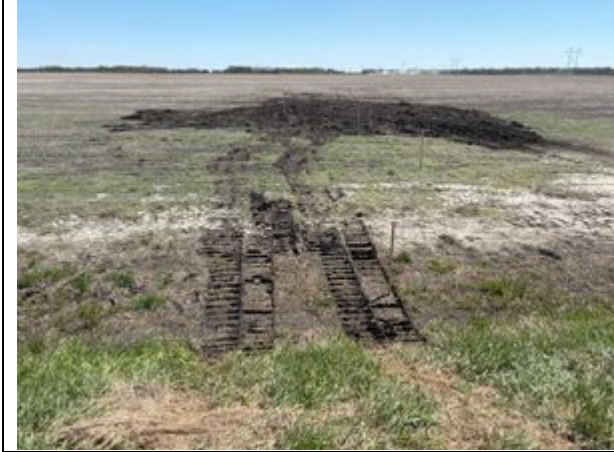
Photo Description: Appropriately bored under 173rd Ave

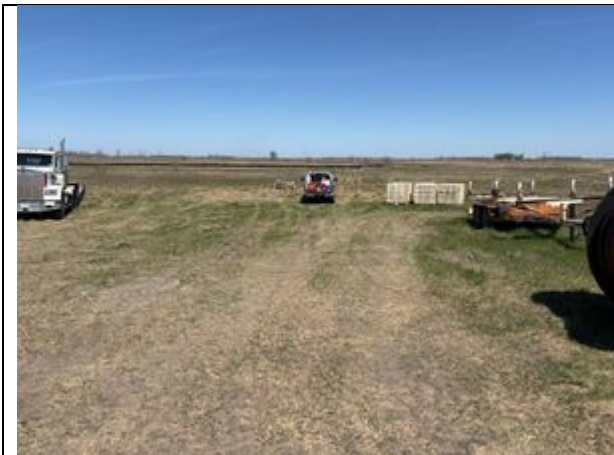
Photo Description: Overlooking proposed substation being used for equipment staging. Appropriate silt fence.
