2025 Buechler Velva Phase 3 AML Project

Contractor: Young Gun Construction, LLC.

Contract Number: AM-908-25

Buechler Velva Phase 3 Site Background

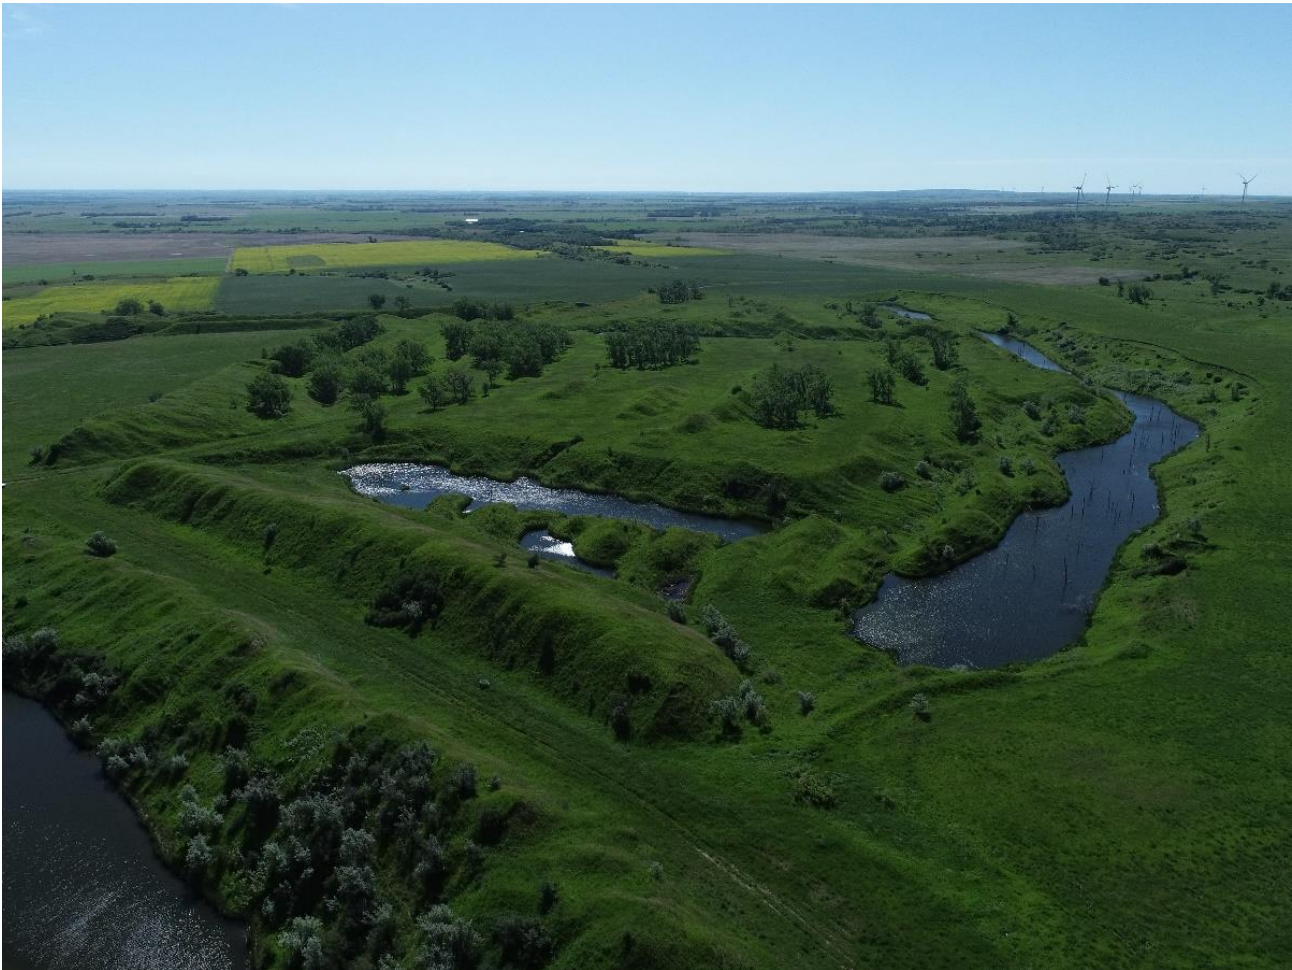
The abandoned surface coal mine (main site) was characterized by a steeply eroding highwall, 40 feet high and 2,900 feet long (**Figures 1 and 2**). Approximately 3,847 feet of silt fence were installed to control erosion and prevent sedimentation downstream (**Figure 3**). The contractor then began segregating topsoil and subsoil into piles. Next, the highwall was backsloped and backfilled with earthen material from adjacent spoil piles. Over 17 inches of rain fell during the construction of the project, creating extremely muddy conditions (**Figures 4 and 5**). A measured 912,022 cubic yards of spoil material were moved to reclaim the surface mine on the main site. Once backfilling and backsloping operations were complete, subsoil was respread. The trees felled in January were shredded, and the wood chips were incorporated and respread between the subsoil and topsoil layers to enhance vegetation (**Figure 6**). Surveys showed 68,386 cubic yards of topsoil and 116,617 cubic yards of subsoil were salvaged and respread (**Figure 7**). Manure was loaded and hauled from the landowners' nearby feedlot and respread over the steepest slopes in the reclaimed areas to help establish vegetation (**Figure 8**). Engineered drainage channels lined with erosion control blankets were installed to direct surface water runoff on the reclaimed area. A rock channel was installed on a steep area to control erosion and act as a drainage channel. A farm trail was re-established, graveled, and a flexible concrete mat was installed as a low-water drainage crossing. The remaining disturbed areas were seeded with locally adapted grass species and mulched. Approximately 1,807 feet of wattles were installed to prevent erosion in the newly disturbed areas (**Figure 9**). Reclamation at the main site was completed on October 22, 2025.

Figure 2: The surface mine in Section 1 before reclamation.

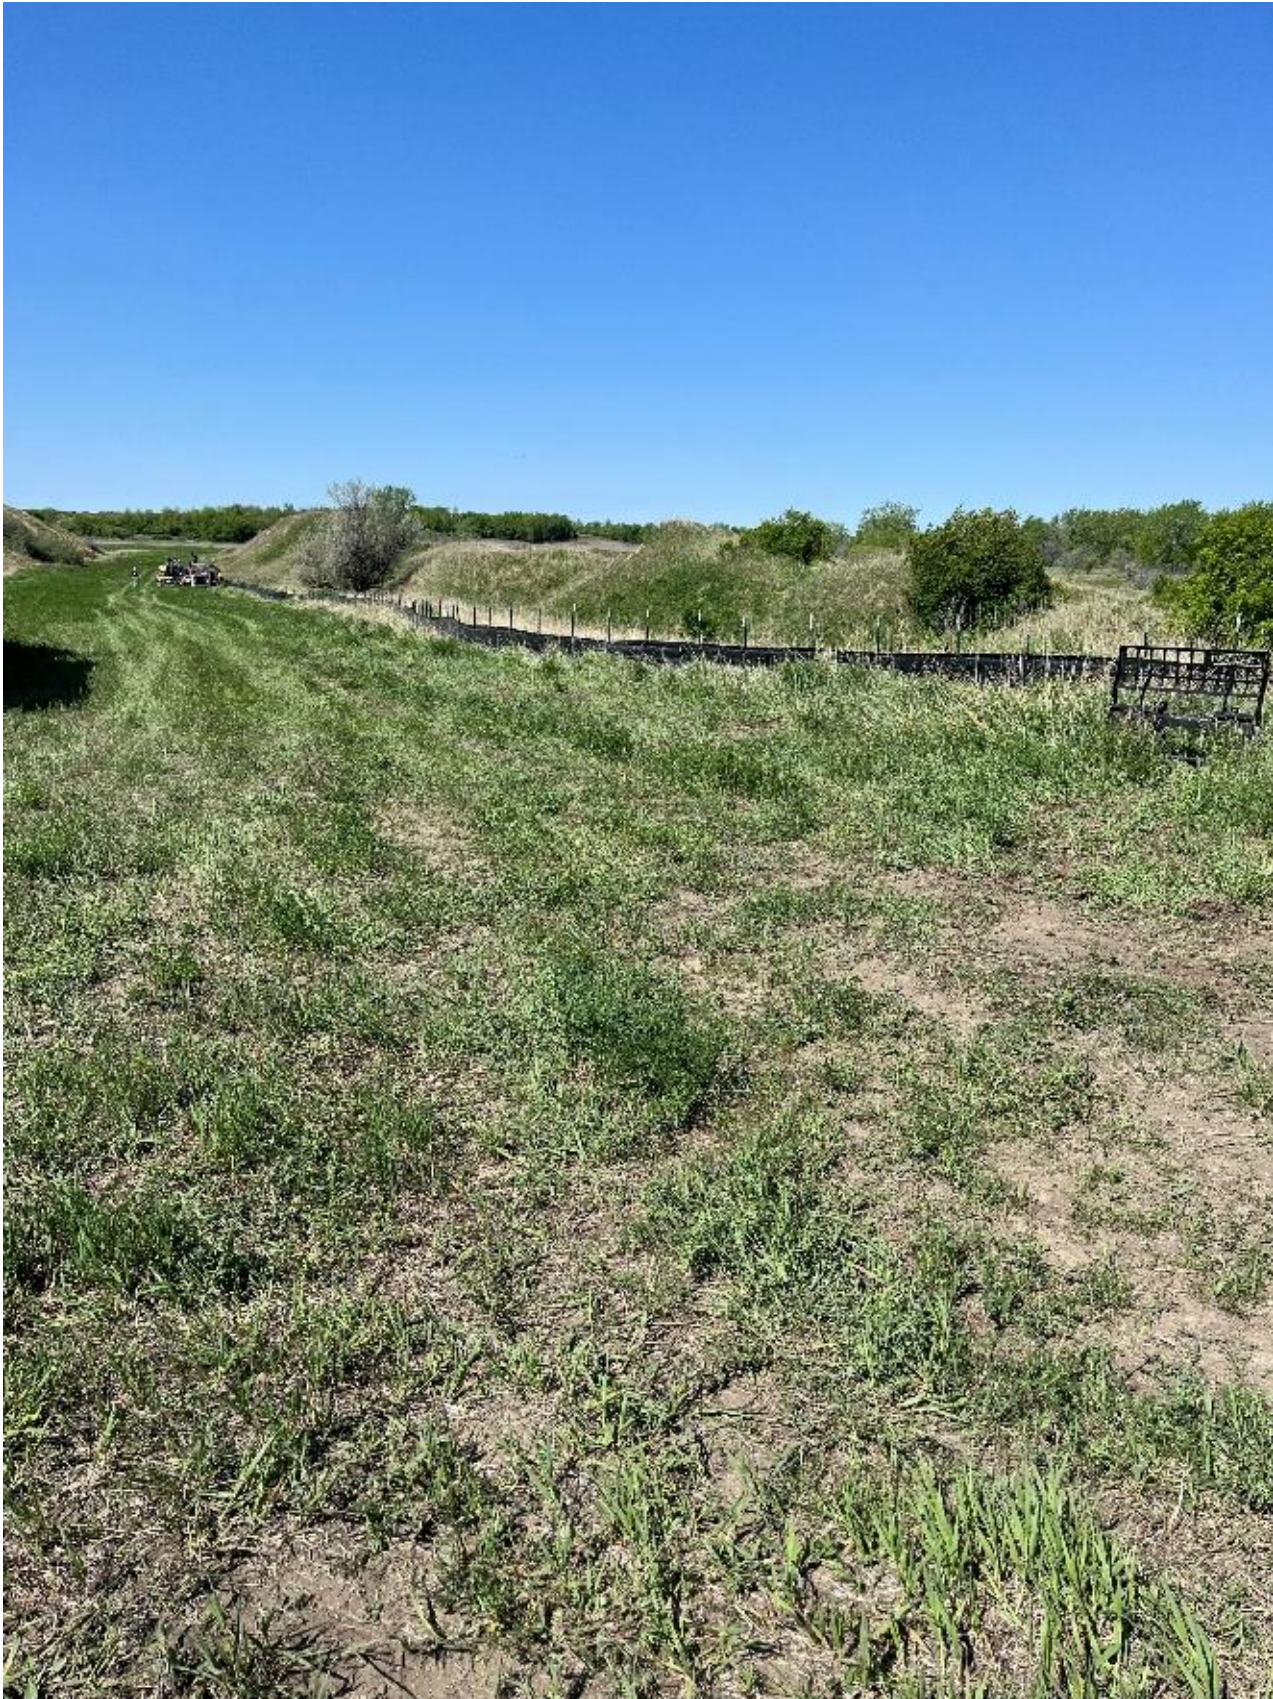
Figure 3: Over 3,800 feet of silt fence was installed to control sediment.

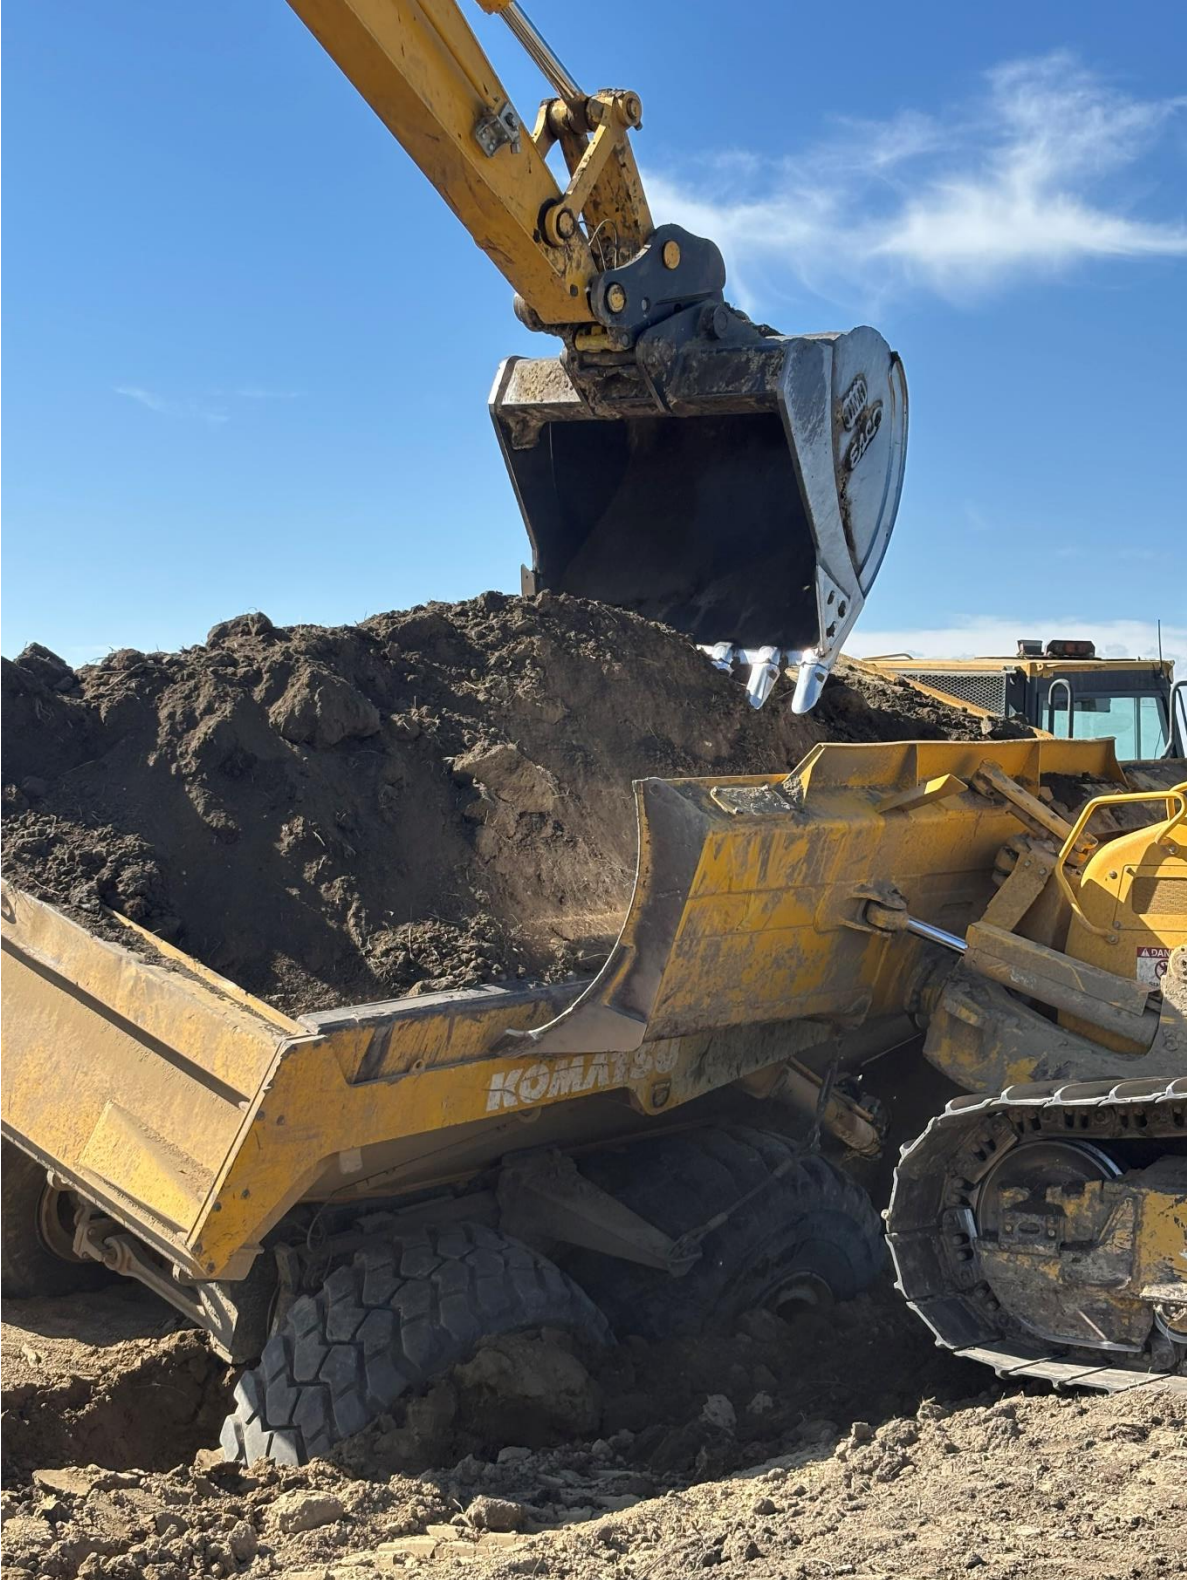
Figure 4: Over 17 inches of rain fell during the construction of the project, creating extremely muddy conditions.

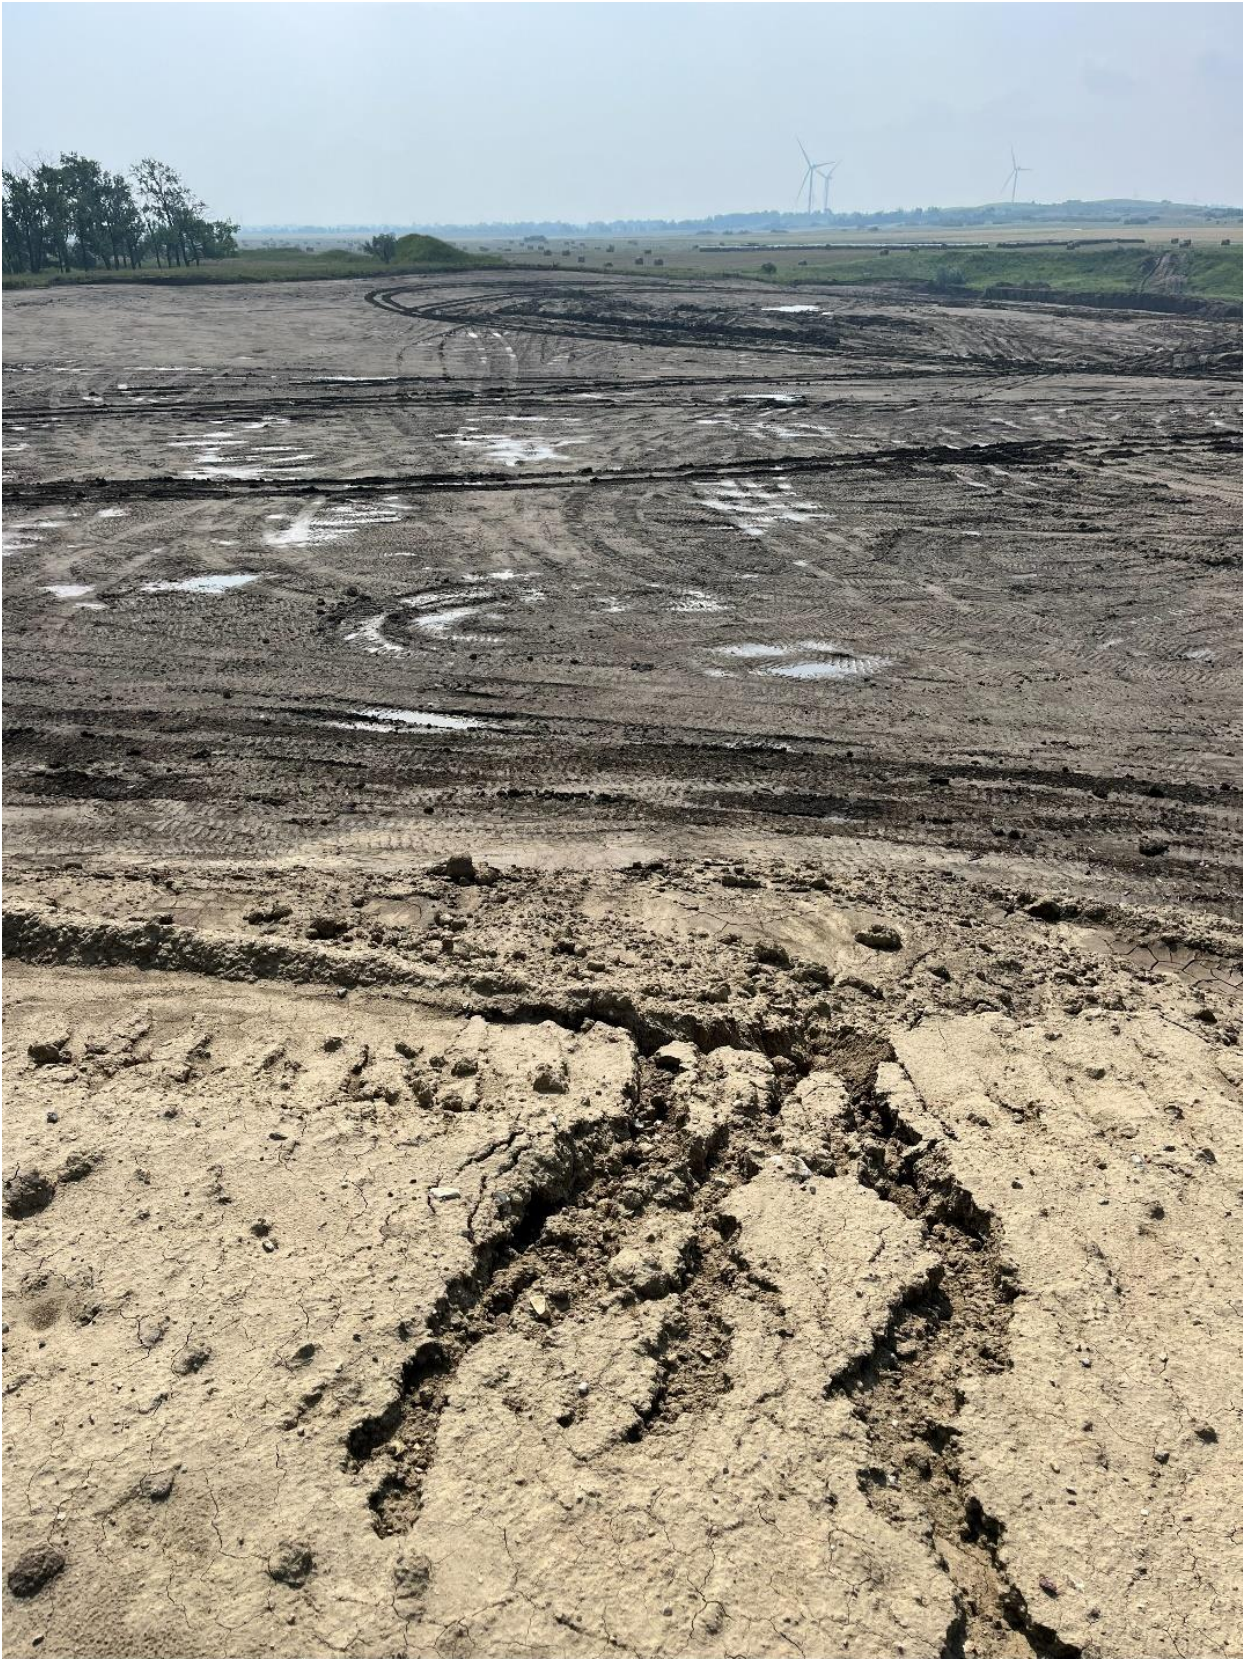
Figure 5: Dealing with muddy conditions was a continuous problem during active construction.

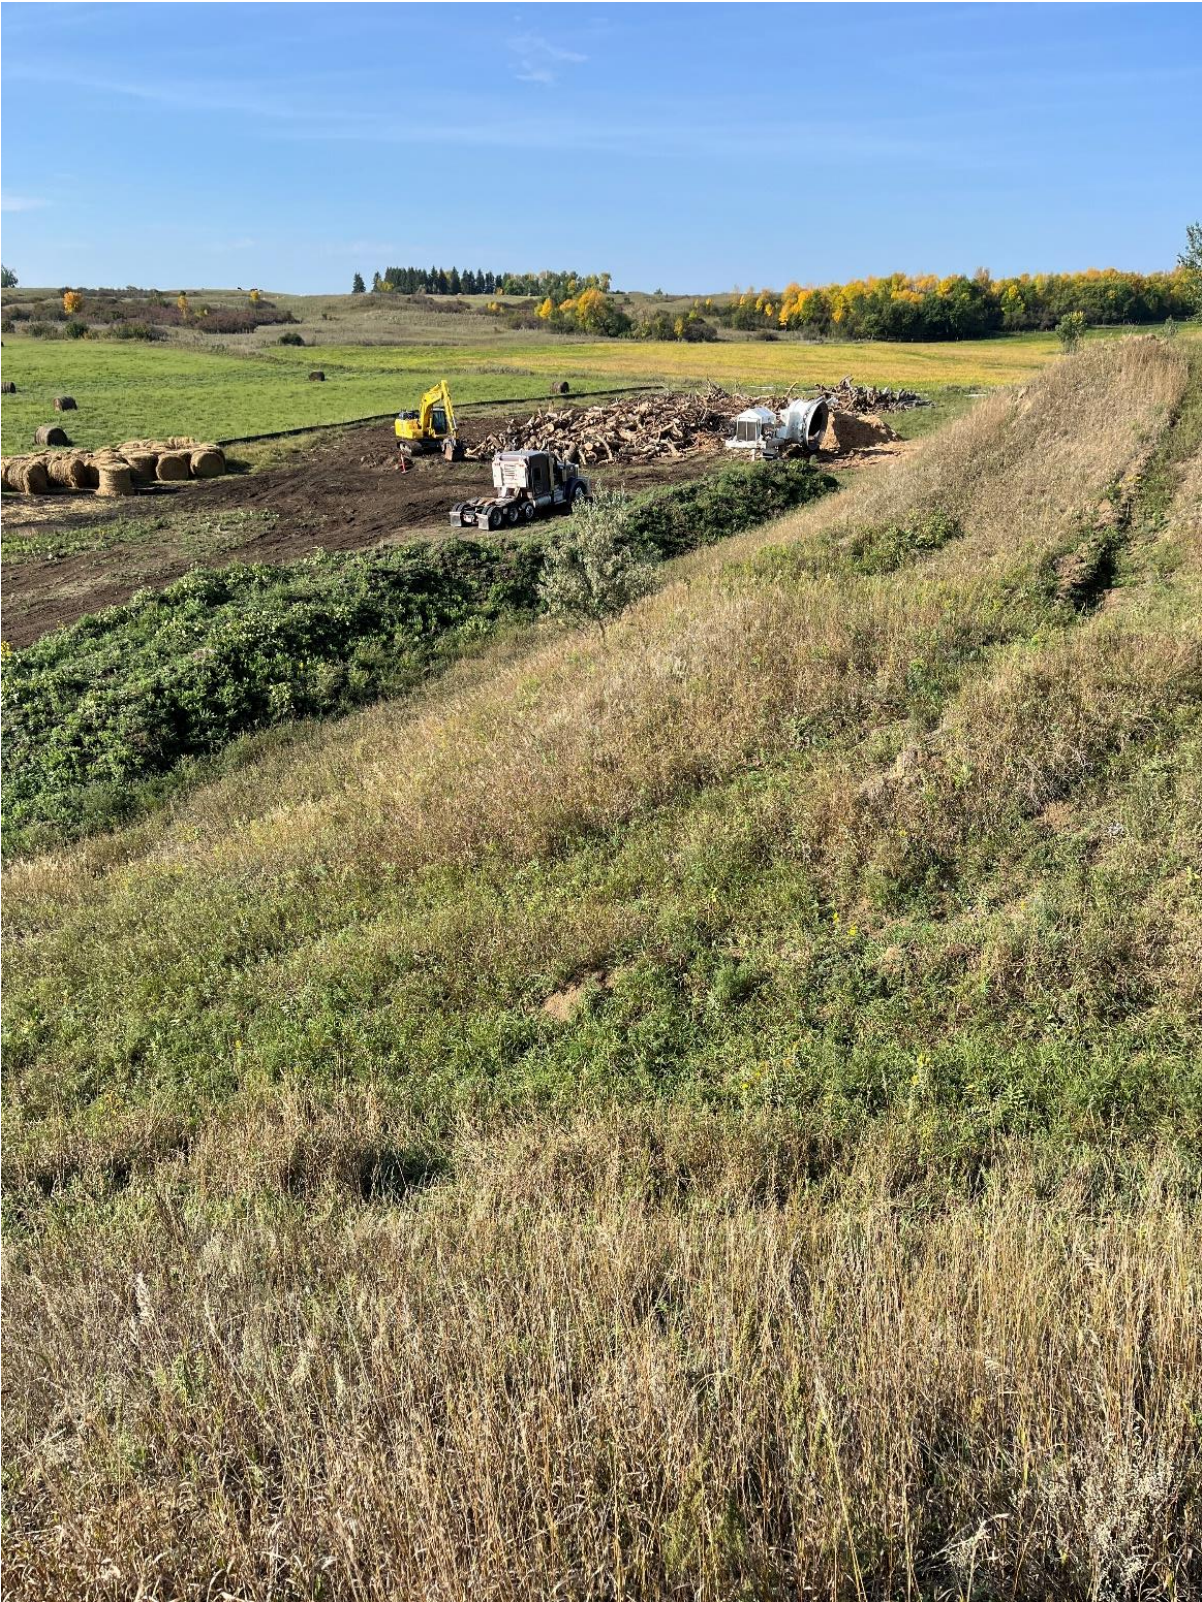
Figure 6: Over 600 trees were felled, shredded, and incorporated into the respread soil.

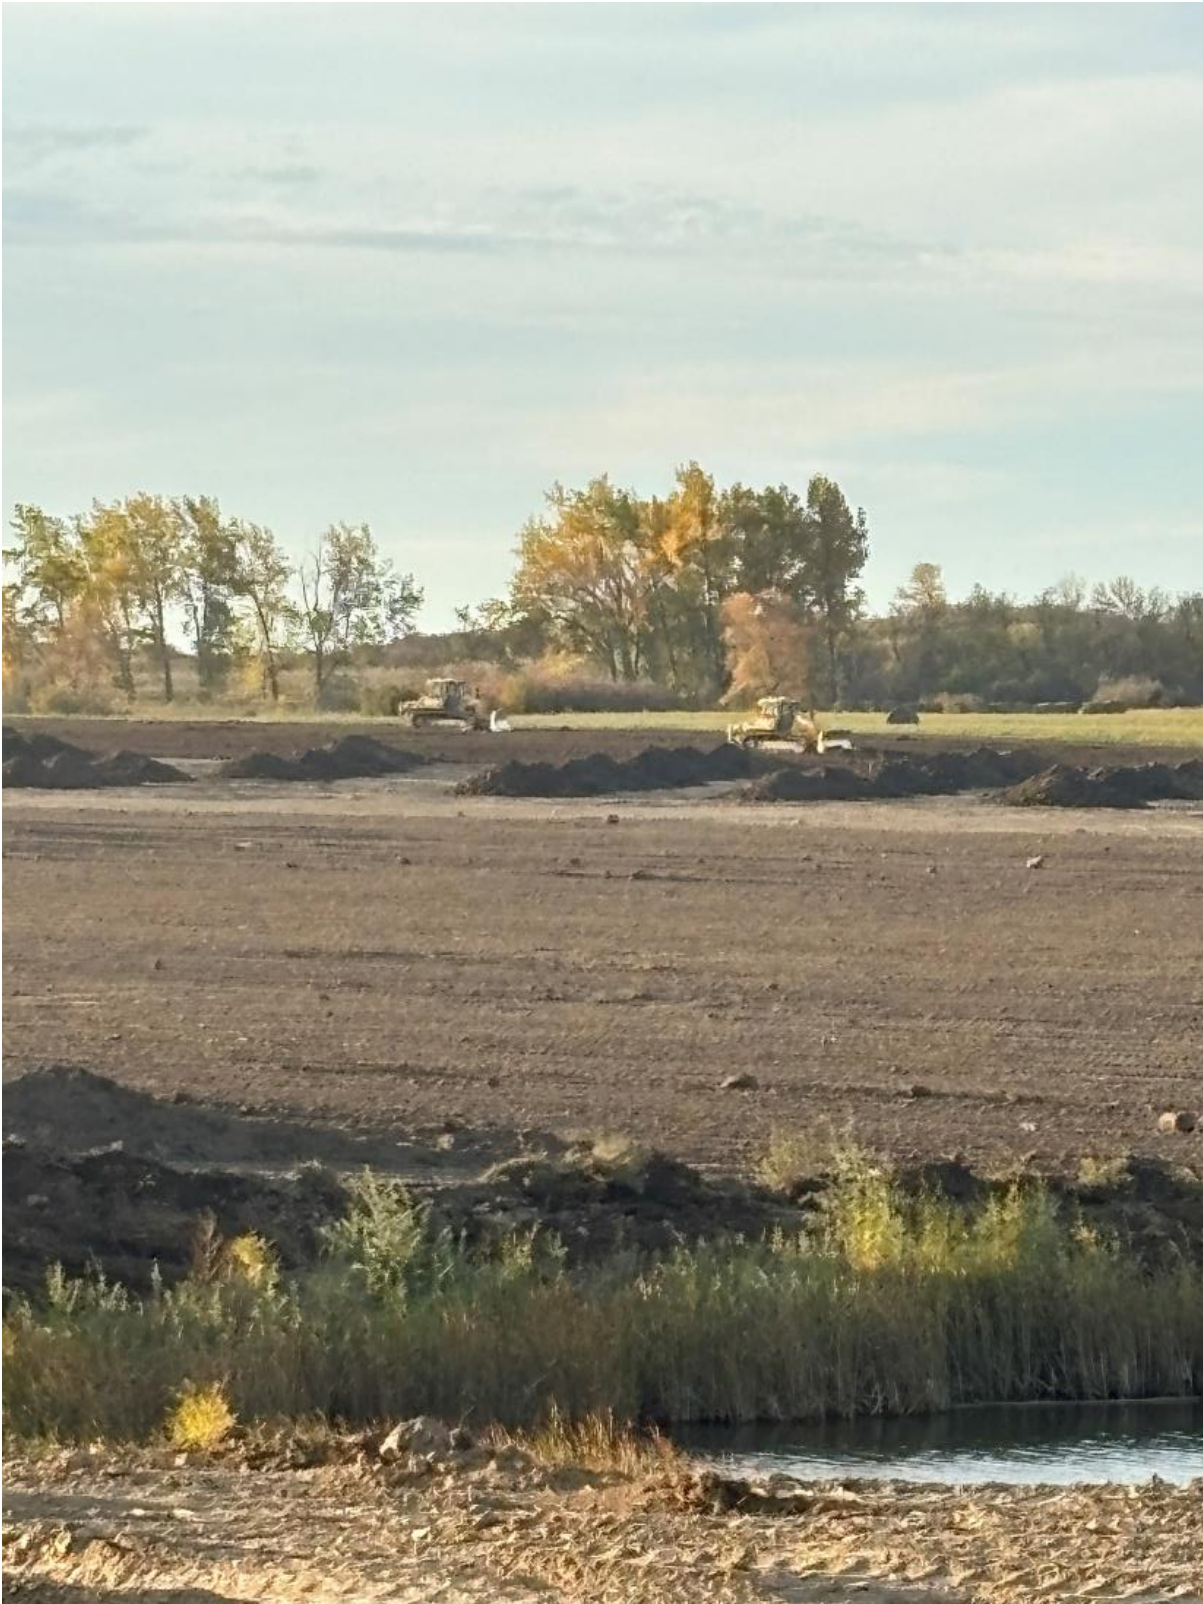
Figure 7: Dozers are respreading topsoil.

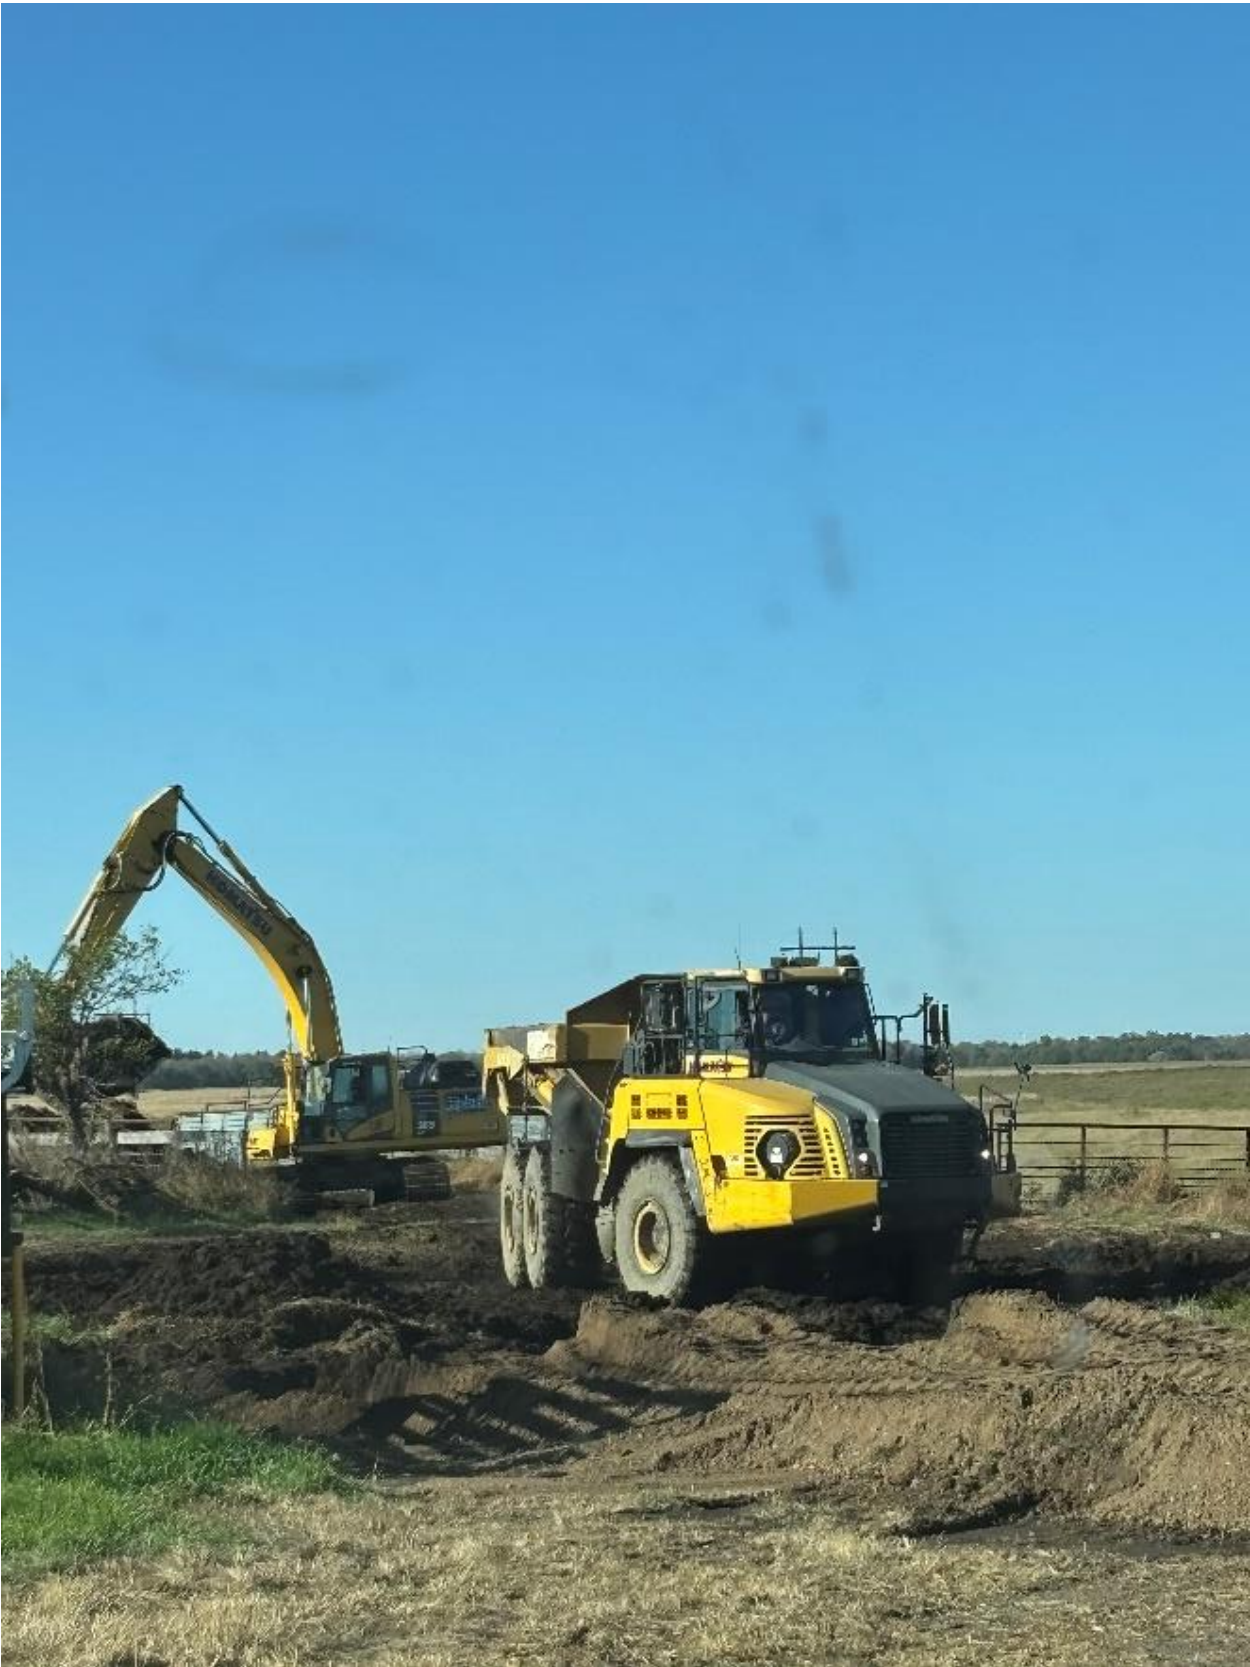
Figure 8: Manure is being loaded from the landowner's feedlot.

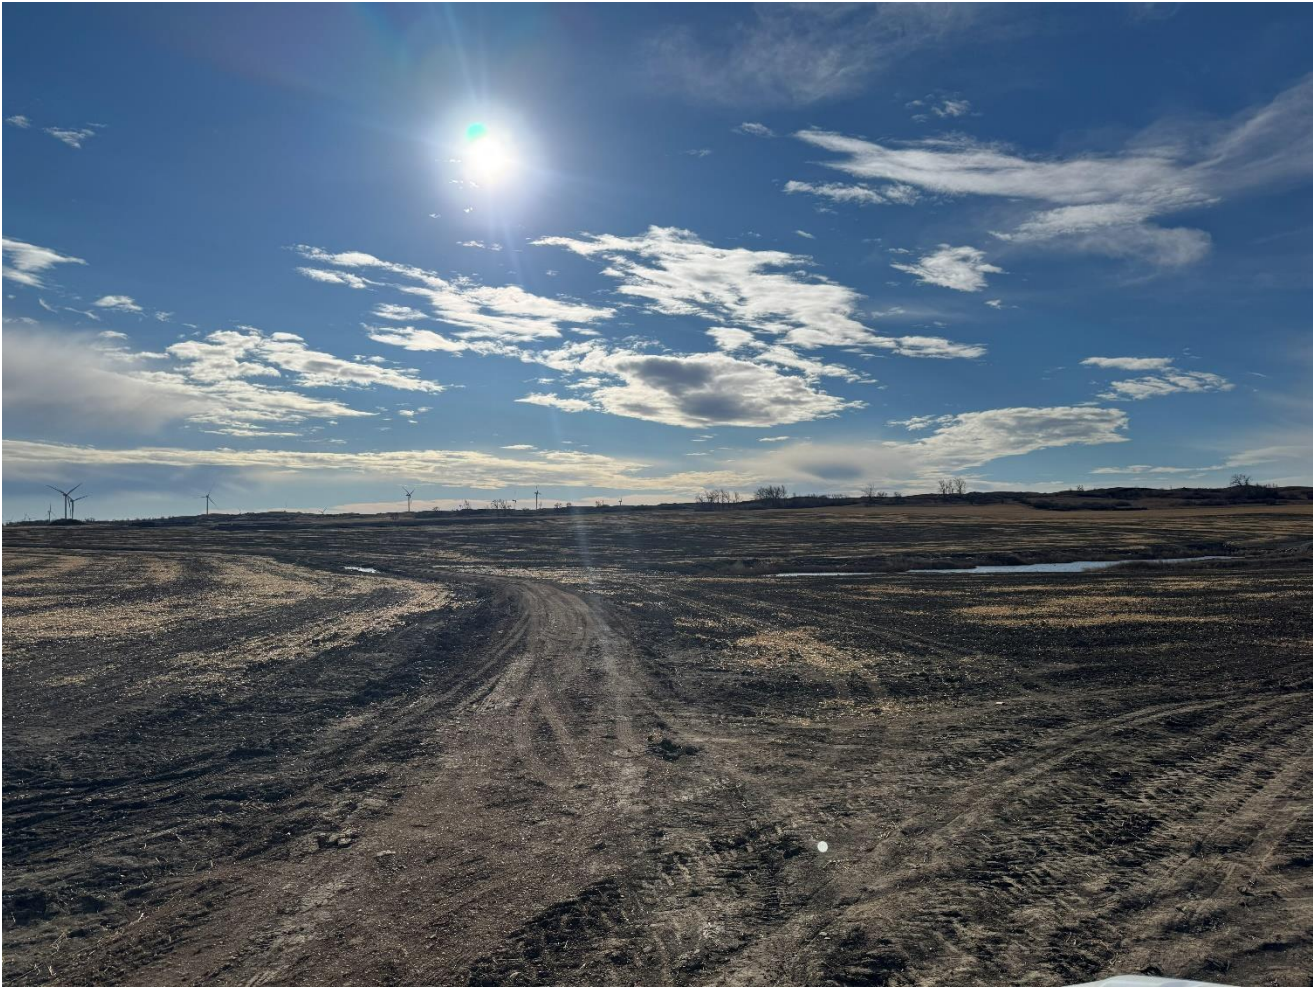
Figure 9: The main site in Section 1 after reclamation.

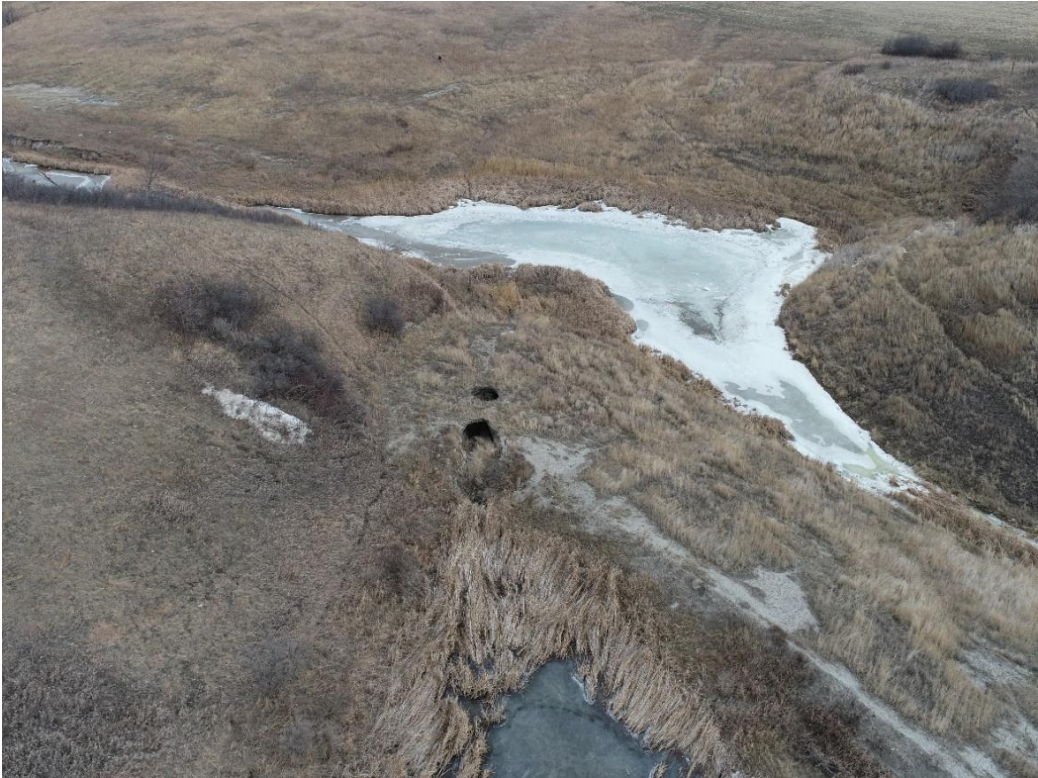
This project also included repairing two erosional areas in the 2021 Buechler Velva Phase 2 Project site (**Figure 10**). Repair work consisted of the excavation and disposal of an existing corrugated metal pipe, regrading, and the installation of a rip rap rock channel (**Figures 11 and 12**). The second area repaired was a 150-foot slope failure on a steeply sloped area near the former highwall. Topsoil was incorporated, and the area was regraded. The disturbed area was seeded and mulched (**Figure 13**). Straw wattles were installed to prevent erosion. The project was completed on November 14, 2025.

Figure 11: Erosional features on the reclaimed surface mine before construction.

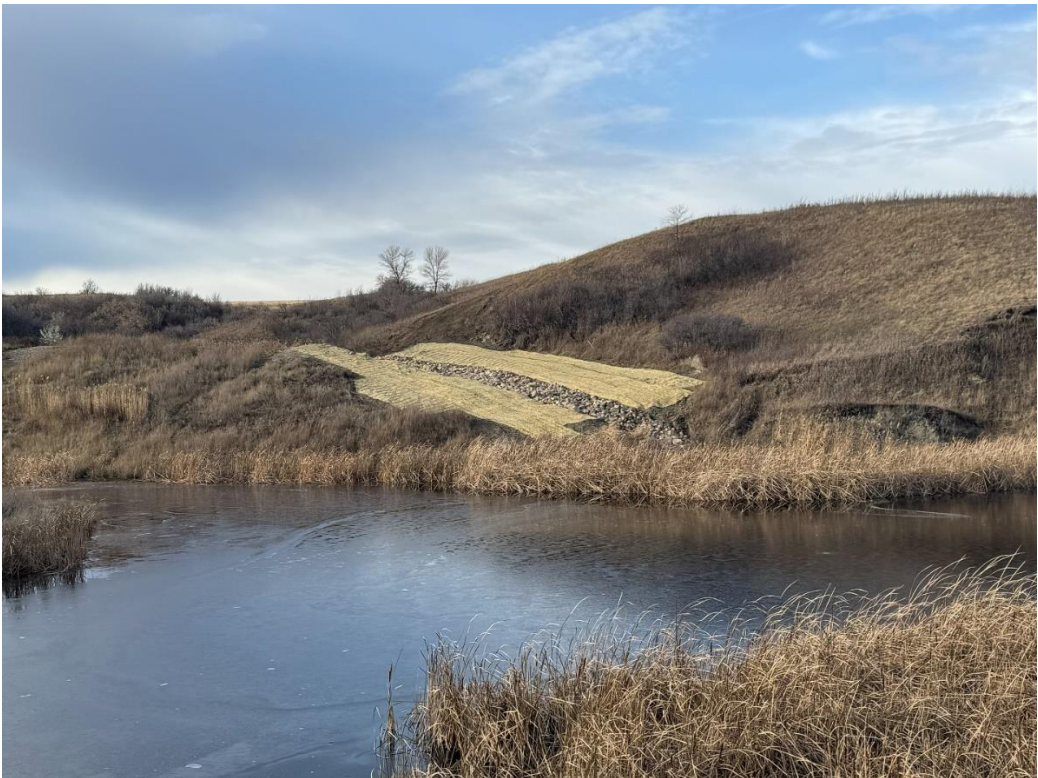
Figure 12: A rock channel was installed to replace a culvert with unstable, eroding soil.

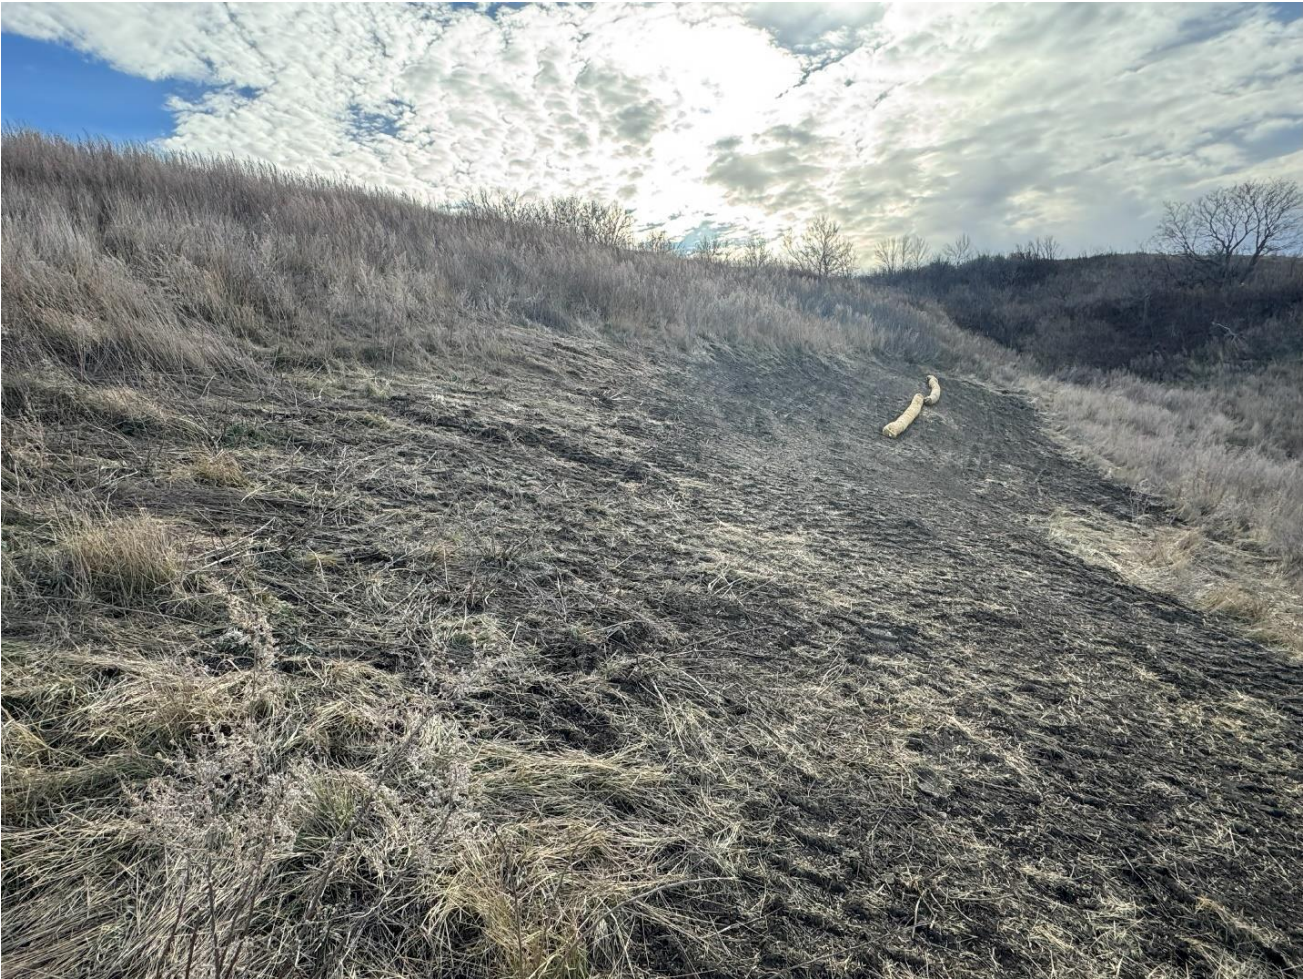
Figure 13: Repaired slope stability area after completion.
