Basin Electric Power Cooperative

345kV Mercer-McLean-Ward-Mountrail-Williams Counties

Case No. PU-24-361

Topsoil Removal Inspection Report

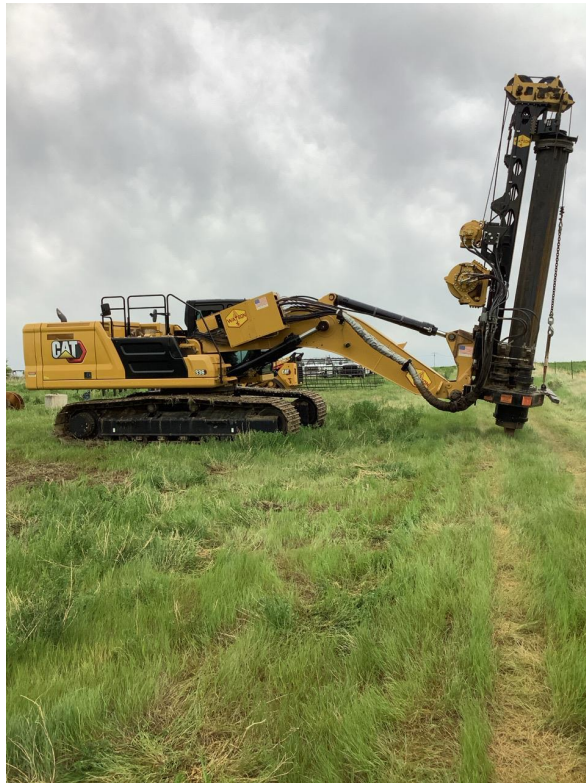
Location: Structure 182

Notes: CAT 336 track boring machine for pilot hole

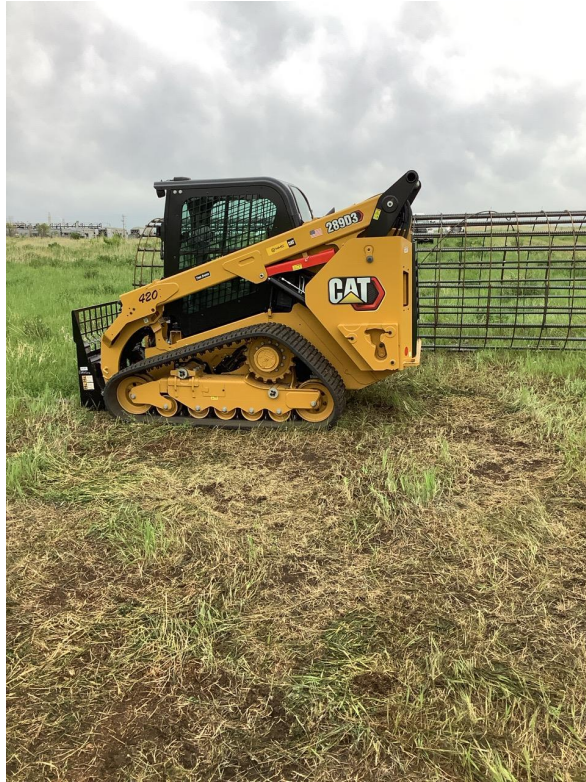
Location: Structure 182

Notes: CAT 289D3 skid steer with fork attachments

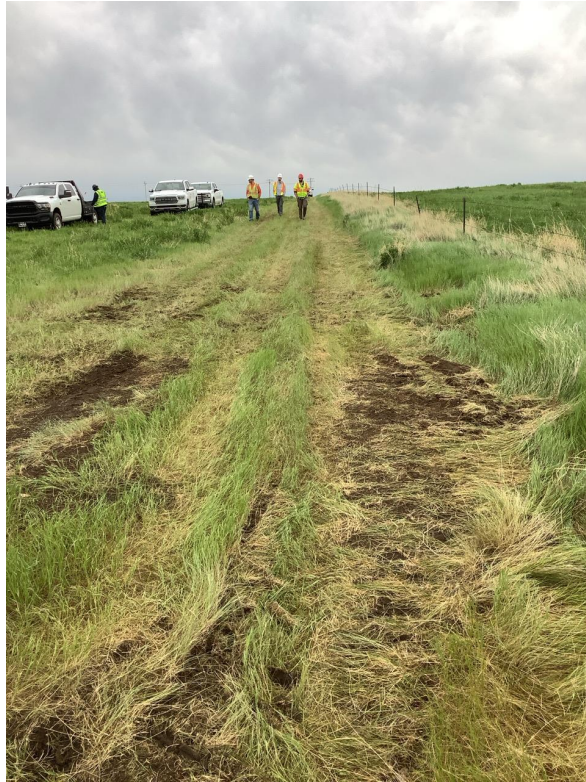
Location: Structure 182

Notes: Access road/ROW existing conditions heading south of structure 182.

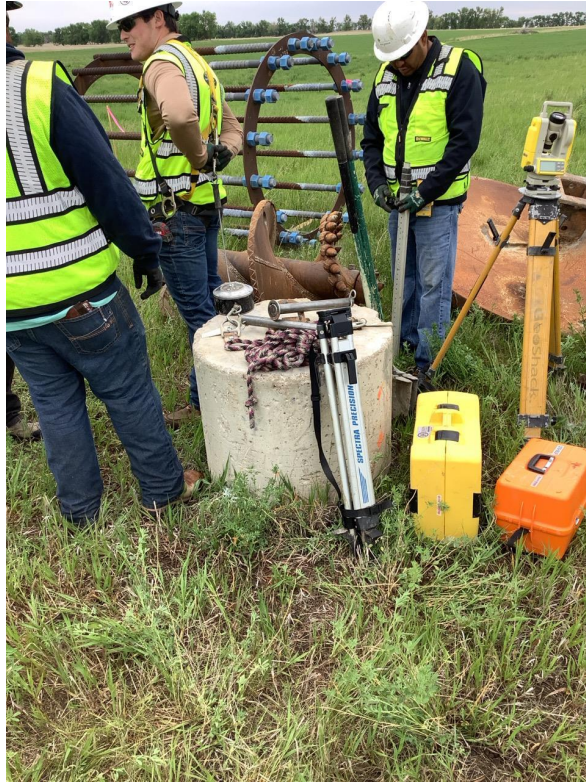
Location: Structure 182

Notes: Crew getting PFAS set up and survey equipment ready.

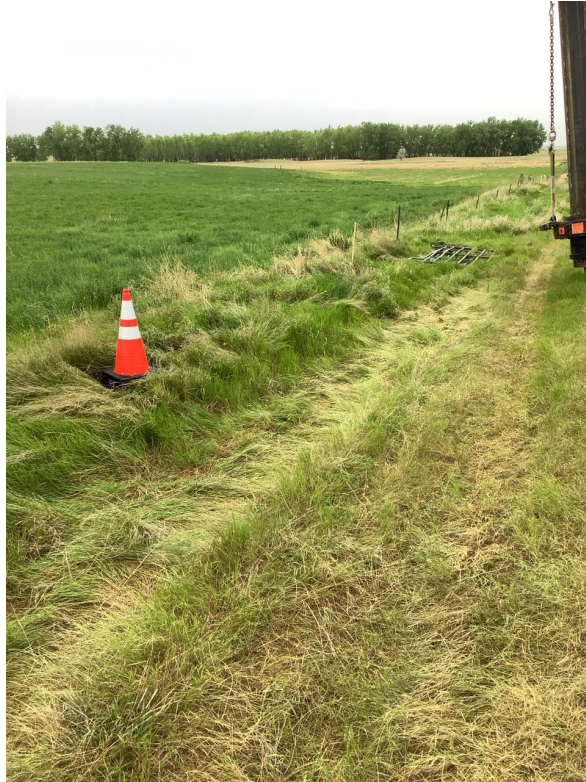
Location: Structure 182

Notes: Crew has cut wire fence to have access to ROW.

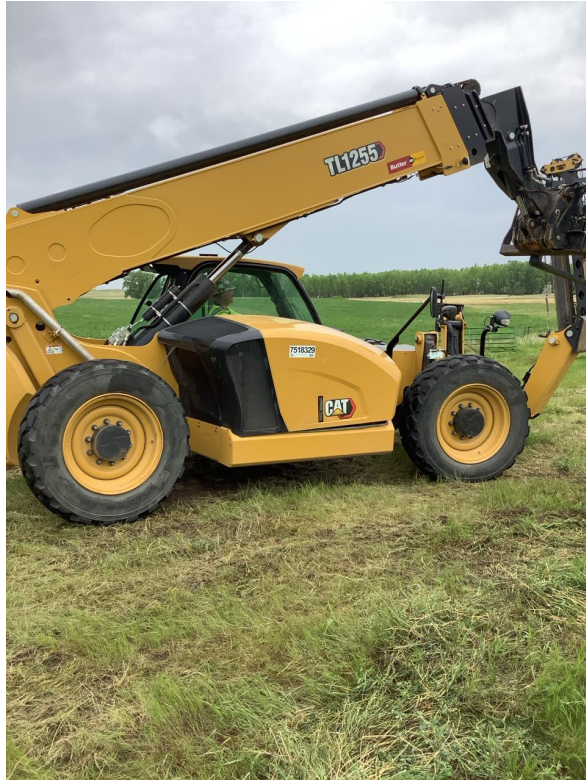
Location: Structure 182

Notes: CAT TL1255 crane with forks

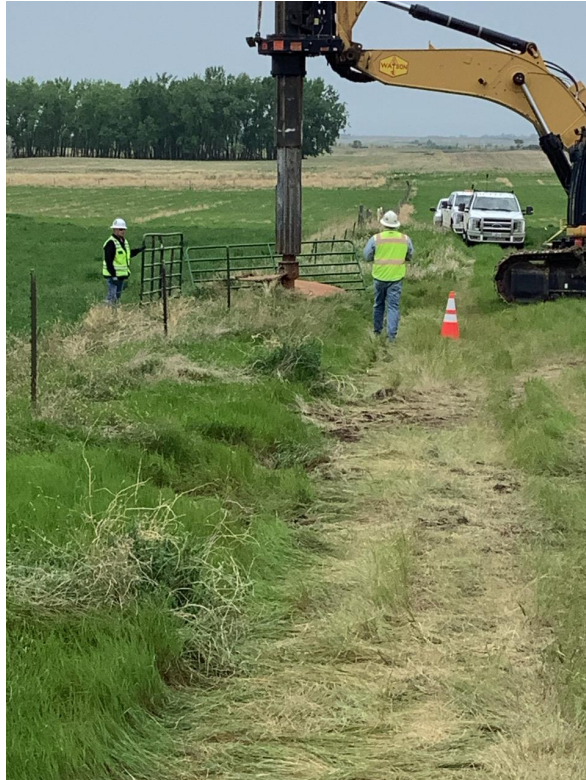
Location: Structure 182

Notes: Crew has begun boring hole for power pole foundation

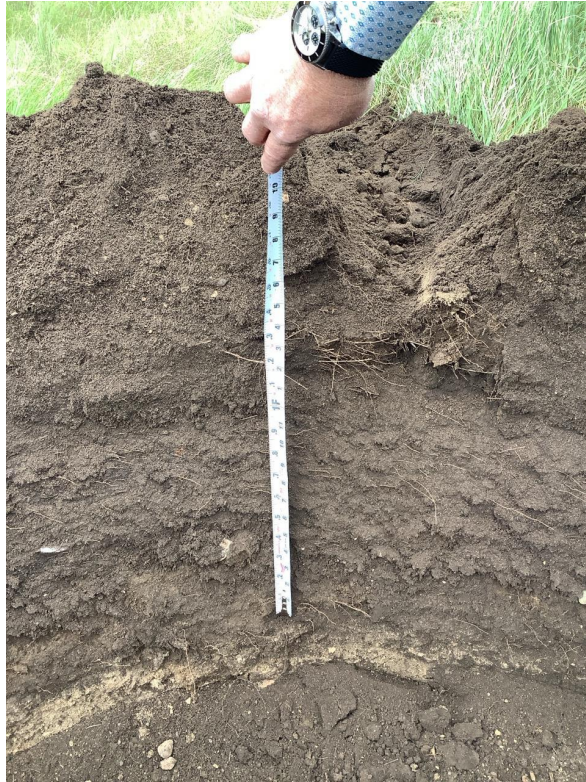
Location: Structure 182

Notes: Bore hole topsoil line at ~15 inches down

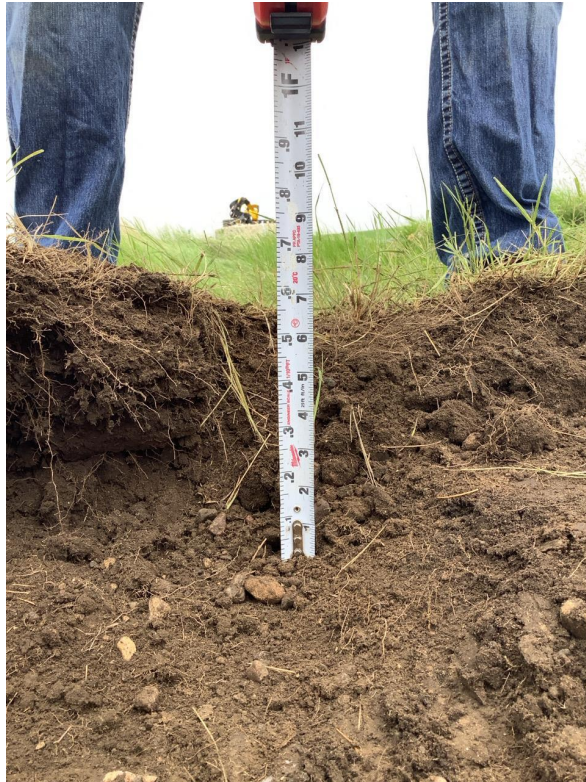
Location: Structure 182

Notes: Auger dump point. Skidsteer cleared topsoil so that no mixing occurs when subsoil is pulled out of auger hole.

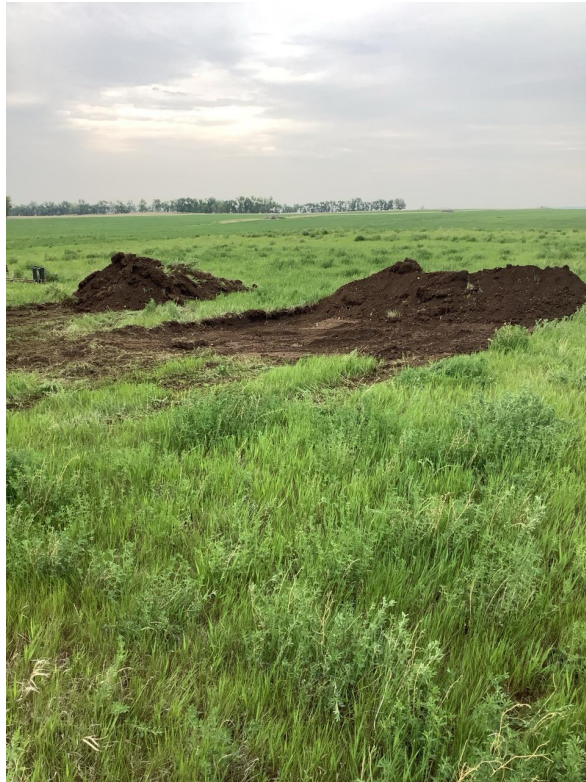
Location: Structure 182

Notes: Topsoil piles. Crew has fiber roll for emergency and weather, but plans on having topsoil back in place within 72 hours.

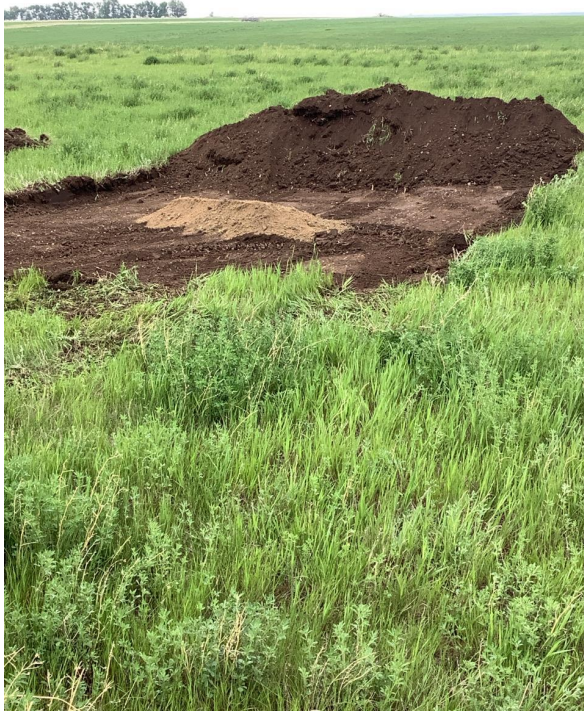
Location: Structure 182

Notes: Spoil pile. Visible subsoil layer. No evidence of topsoil and subsoil mixing. Adequate segregation.

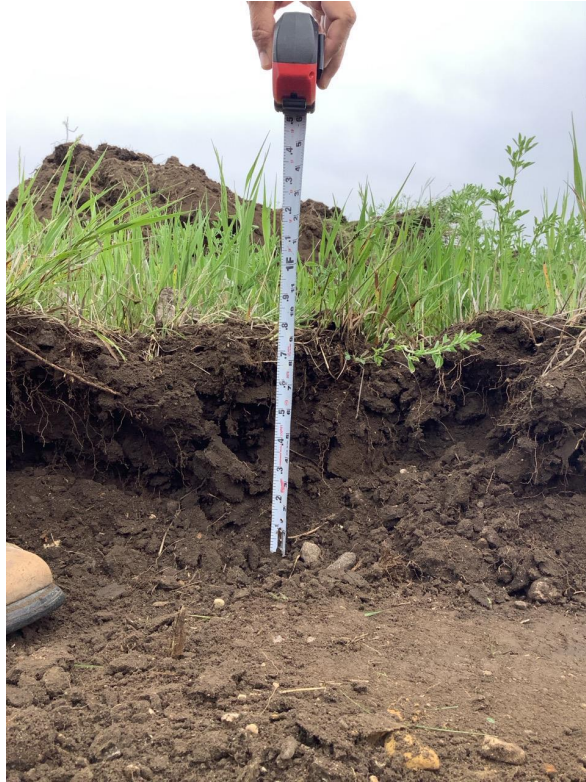
Location: Structure 182

Notes: Spoil pile mat topsoil depth of ~9 inches.

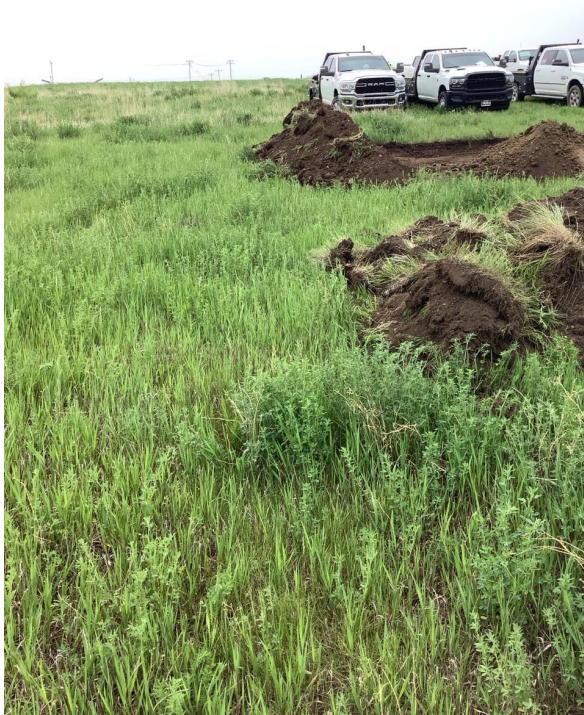
Location: Structure 182

Notes: Verification: topsoil piles ARE WITHIN ROW.

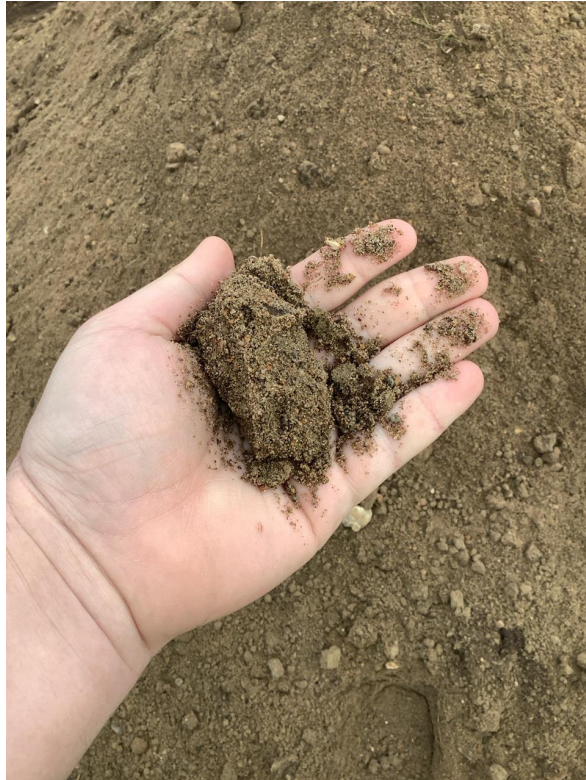
Location: Structure 182

Notes: Subsoil seems to be a light brown, moist clayey sand.

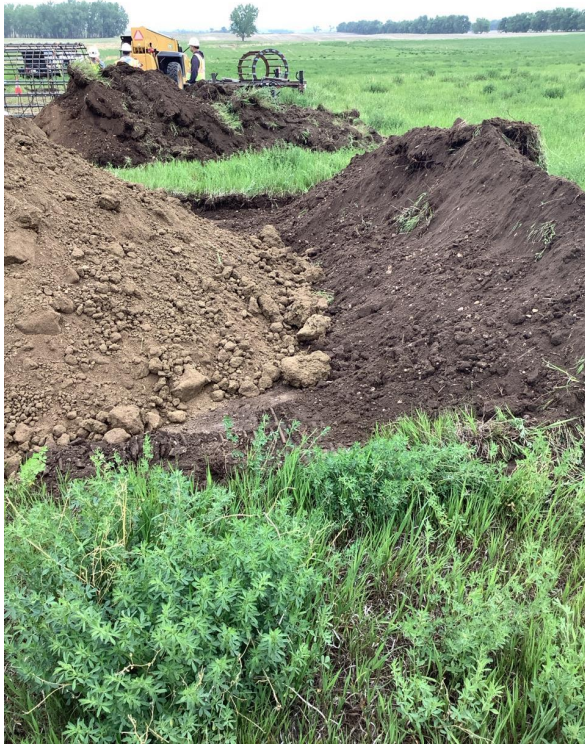
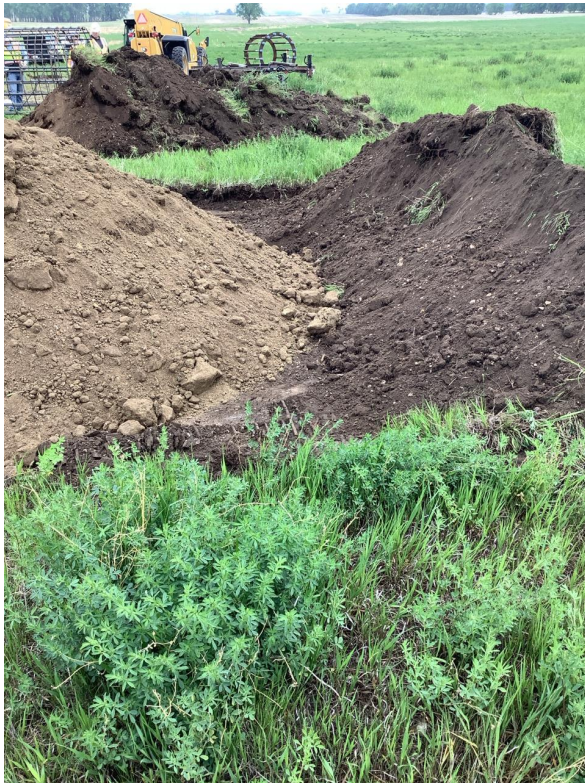
Location: Structure 182

No concerning issues were identified during inspection. Inspector only had to notify Silver Line foreman and equipment operator of one location at structure 182, where spoil pile was touching topsoil storage pile. Contractor began moving spoil pile away from topsoil storage pile.

Notes: Spoil pile is beginning to touch topsoil pile.

-Verify that at least 5' of clear space between spoil piles and topsoil storage piles be maintained for all current and future foundation boring operations.

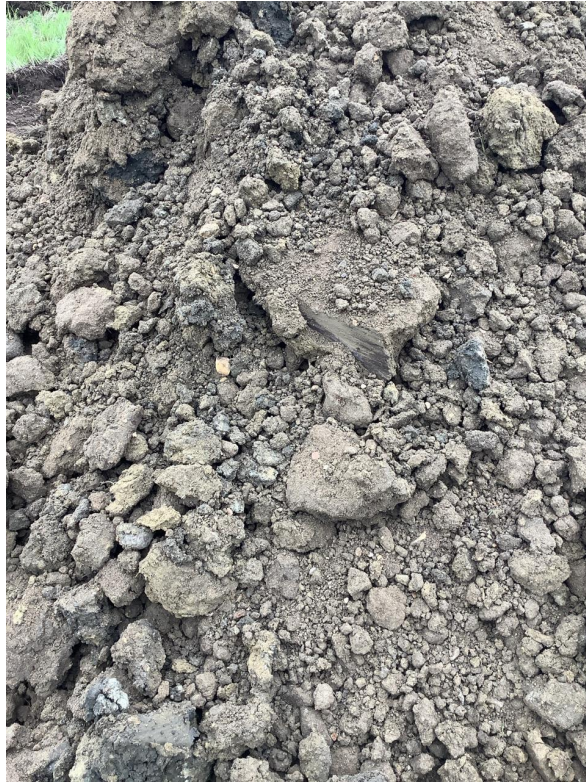
Location: Structure 182

Notes: Second layer of subsoil seems like a grayish brown fatty clay

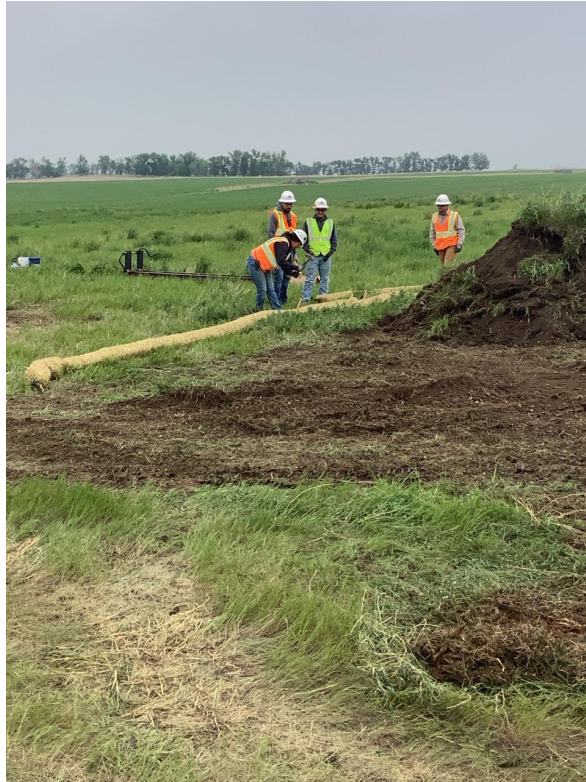
Location: Structure 182

Notes: Subcontractor is installing fiber roll for the topsoil piles.

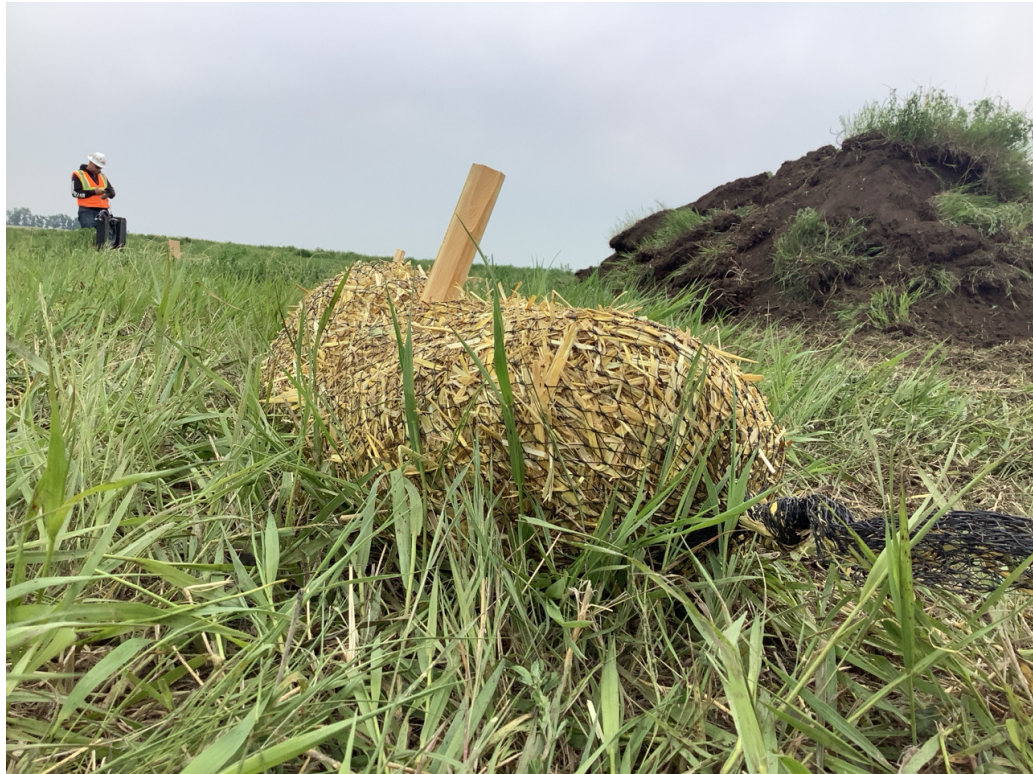
Location: Structure 182

Other Remarks: -Brink has several staging yards along the footprint of the project. I visited the first, where equipment, cages, and bolt assemblies are being held for foundation construction. -I noticed during topsoil stripping, Silver Line did not dig in fiber roll, opting instead to place and stake on the soil surface. This was not an issue where I inspected, given the surrounding area was still vegetated, acting as natural erosion control. Moving forward, should keep an eye on any fiber roll installed (P18-19)

Notes: Fiber roll pounded in place, however fiber roll was NOT dug into the ground which raises concern of material flowing under rolls.

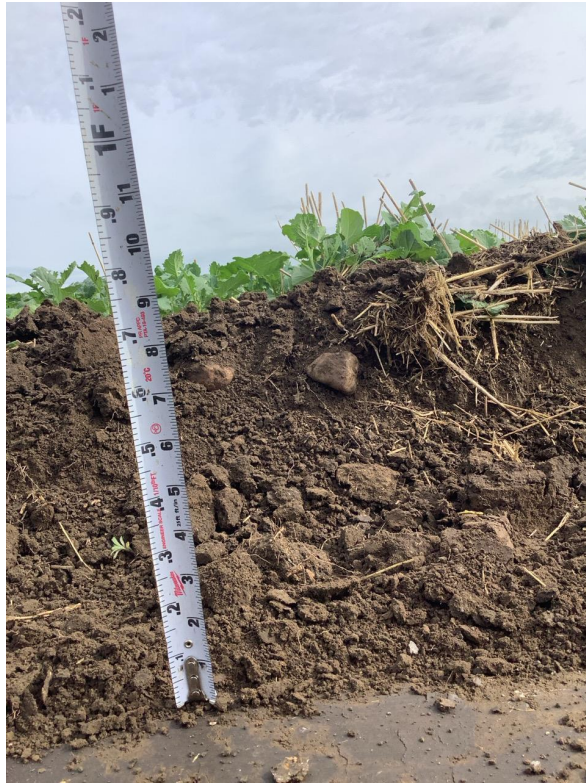
Location: Structure 546

Notes: Spoil spot, 8.5" of topsoil depth. Topsoil is light brown. Subsoil layer appears to be blueish brown lean clay.

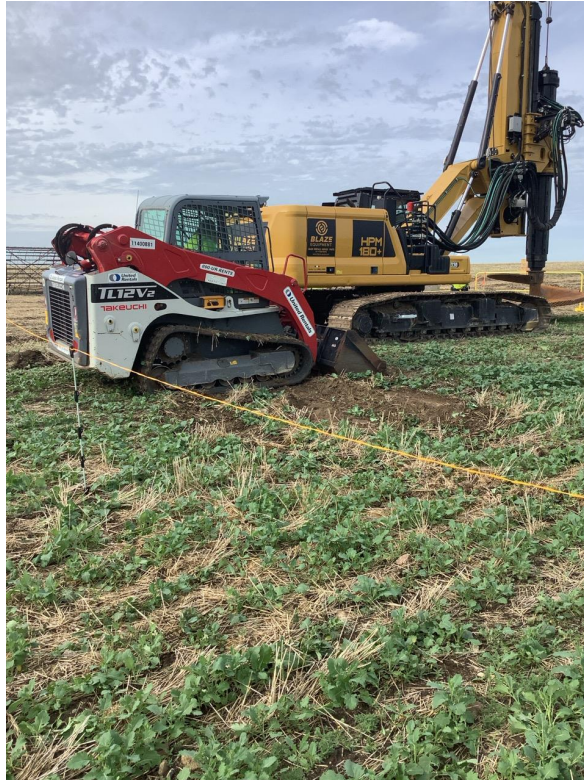
Location: Structure 546

Notes: Takeuchi TL12V2 skidsteer and CAT 330 track excavator with auger attachment

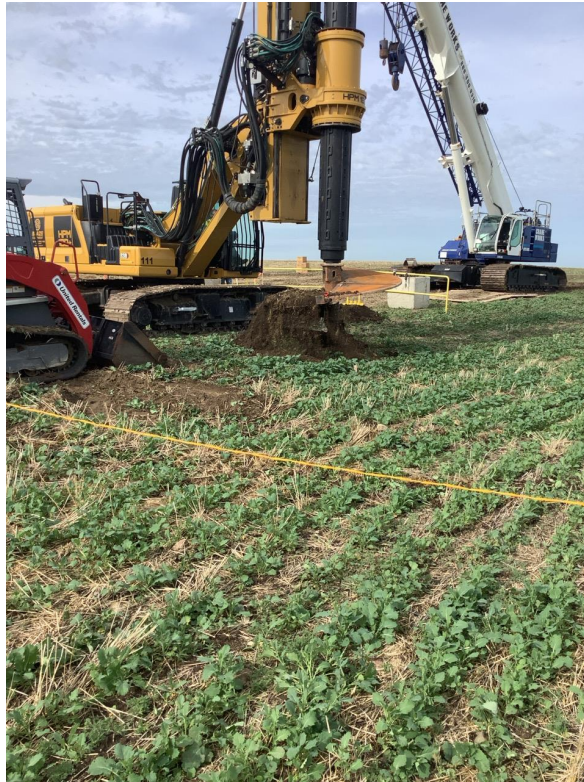
Location: Structure 546

Notes: Crew augured topsoil and skidsteer then began scraping spin off pad for subsoils being moved to spoil pile

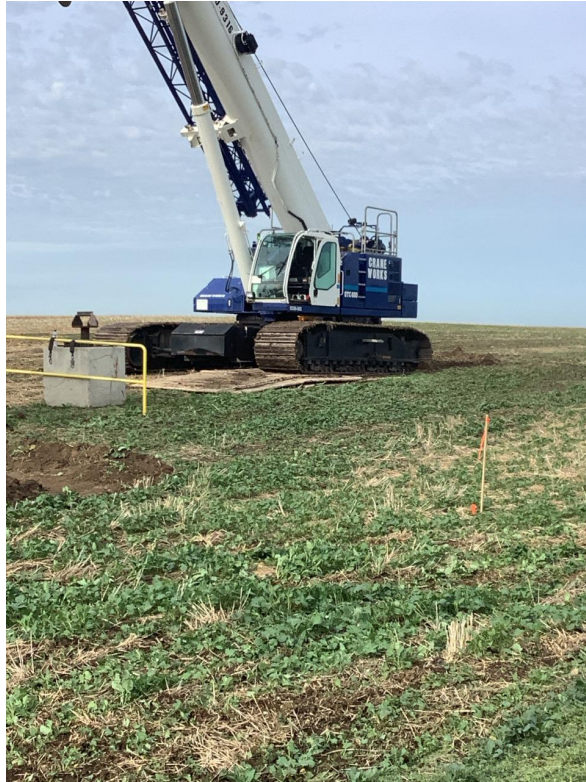
Location: Structure 546

Notes: GTC 600 crane

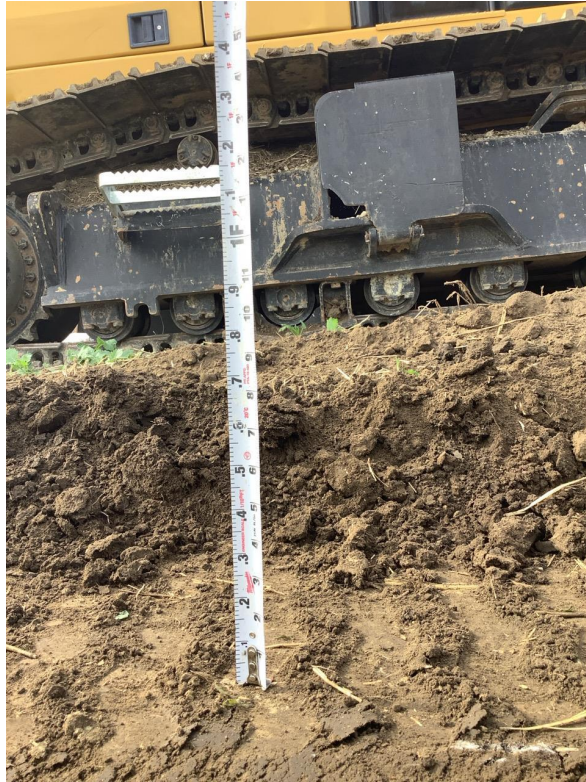
Location: Structure 546

Notes: Topsoil depth for auger shake off pad. 8.5-9"

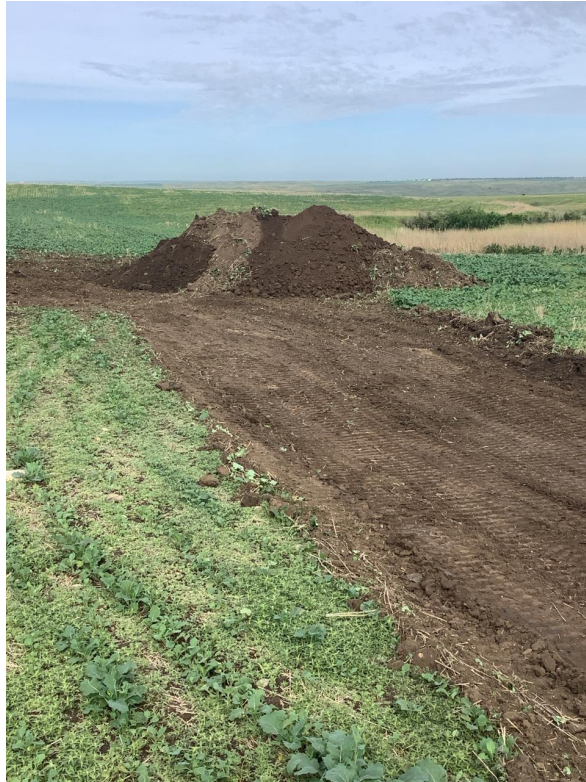
Location: Structure 546

Notes: Topsoil storage pile and adjacent spoil mat.

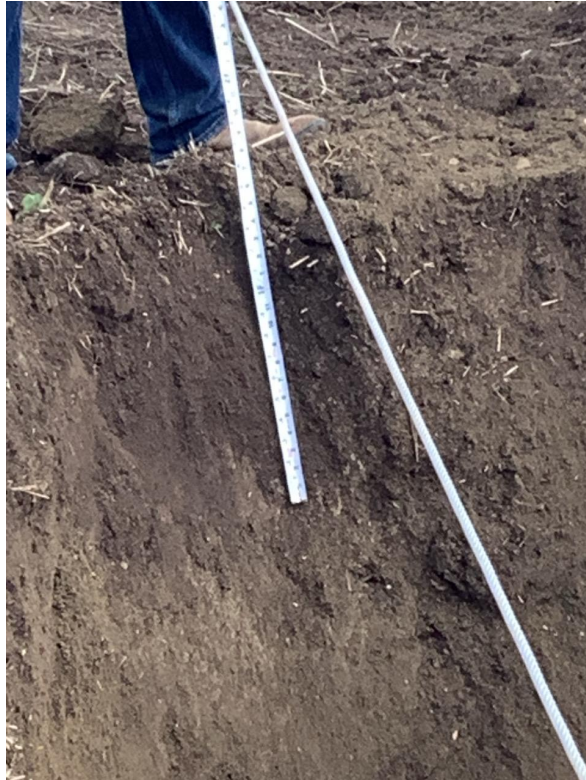
Location: Structure 546

Notes: Depth of topsoil at bore hole ~15 inches deep

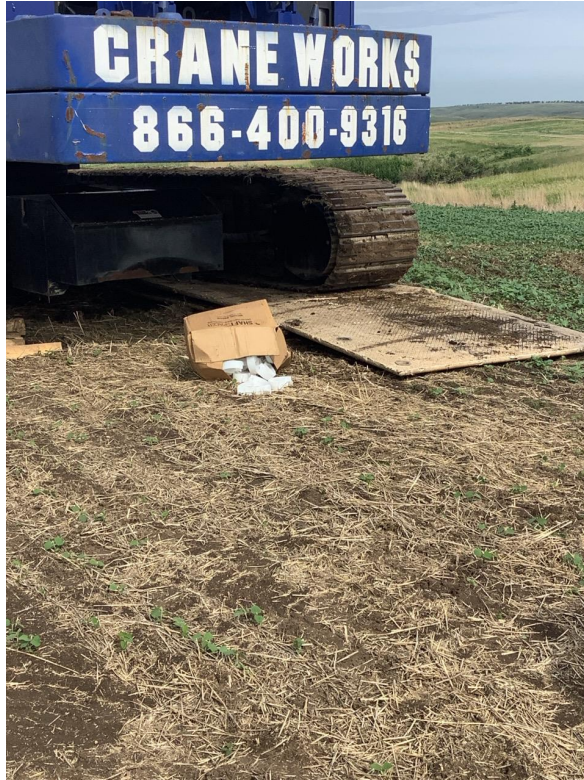
Location: Srtructure 546

Notes: Mat used to disperse weight of crane.

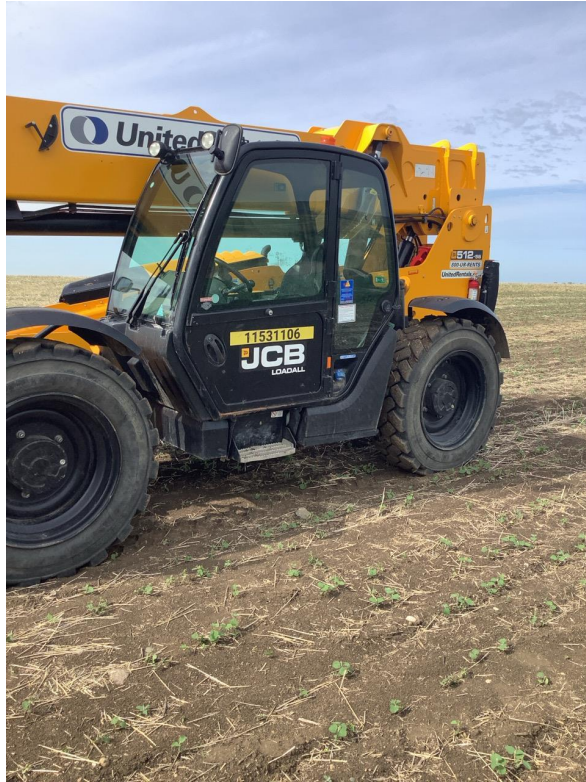
Location: Structure 546

Notes: JCB Loadall

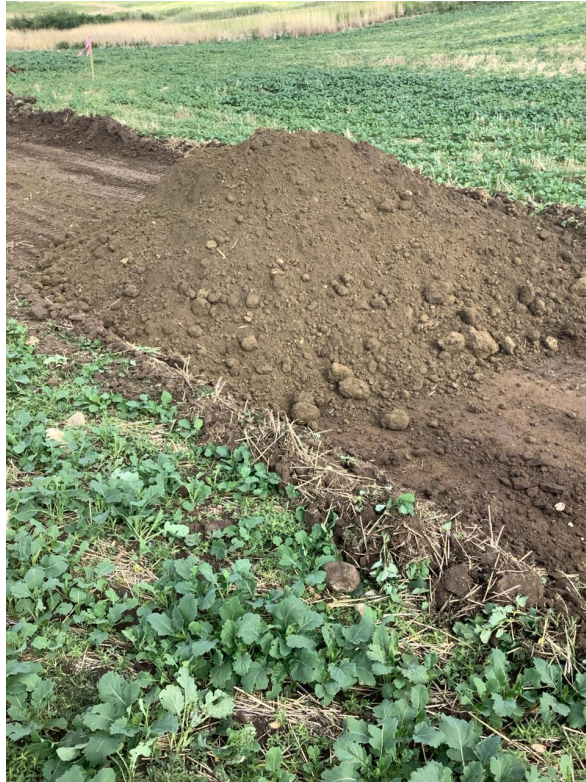
Location: Structure 546

Notes: Spoil being added to the spoil mat.

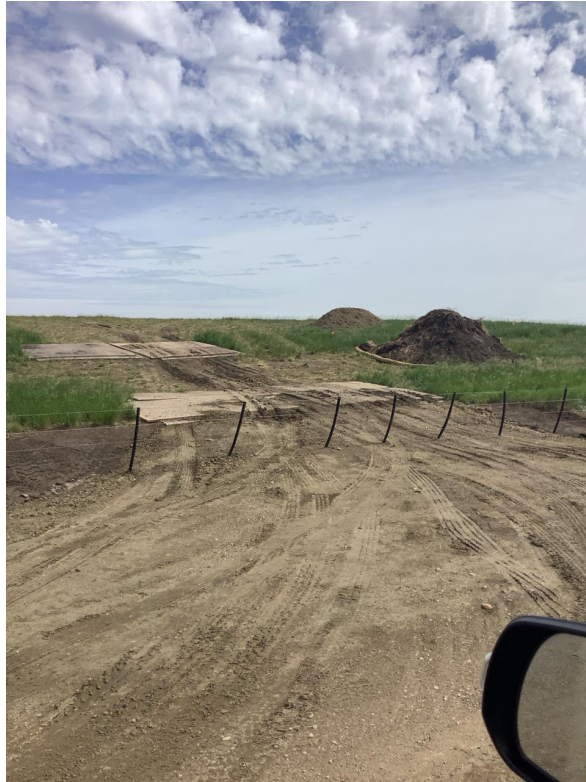
Location: Access road to structure 178

Notes: Haul road topsoil storage pile and planking to prevent damage

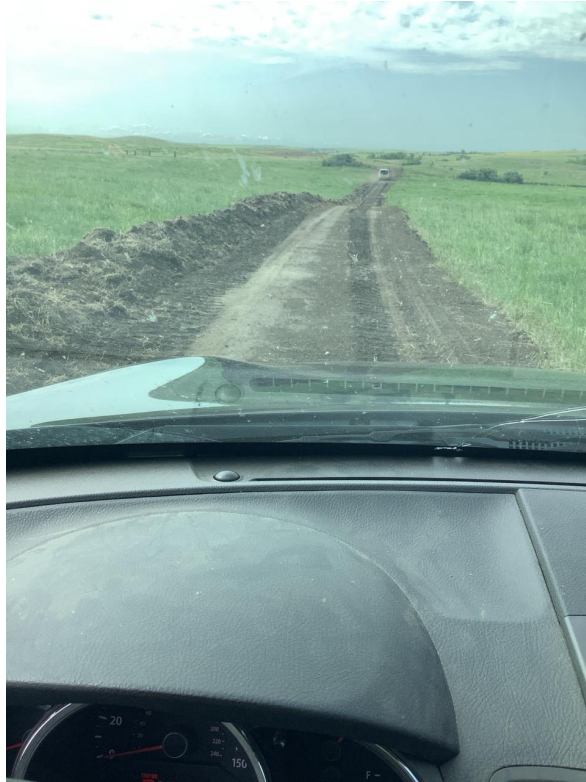
Location: Haul road to 177

Notes: Crew has stripped topsoil for access road.

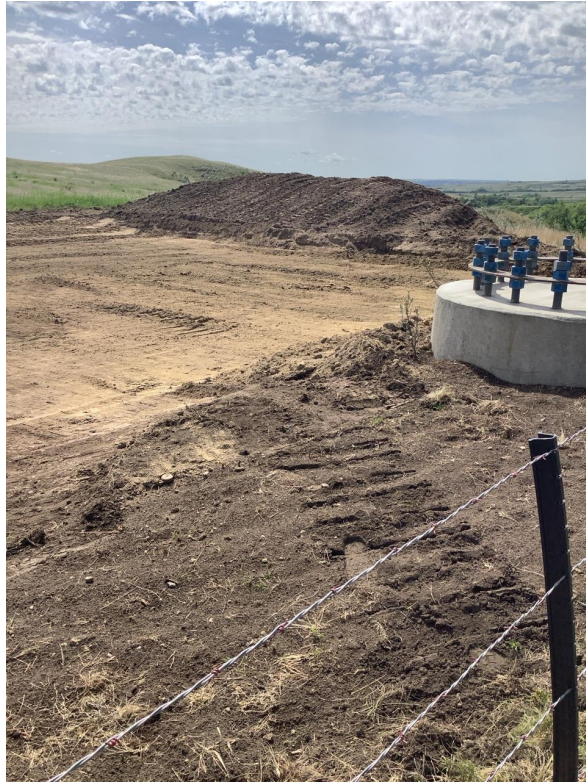
Location: Structure 175

Notes: Crane pad topsoil pile

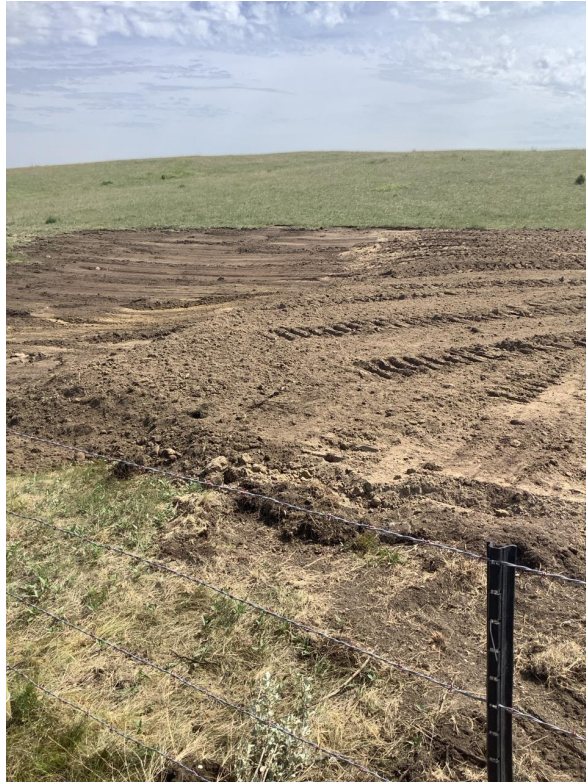
Location: Structure 175

Notes: Crane pad area.

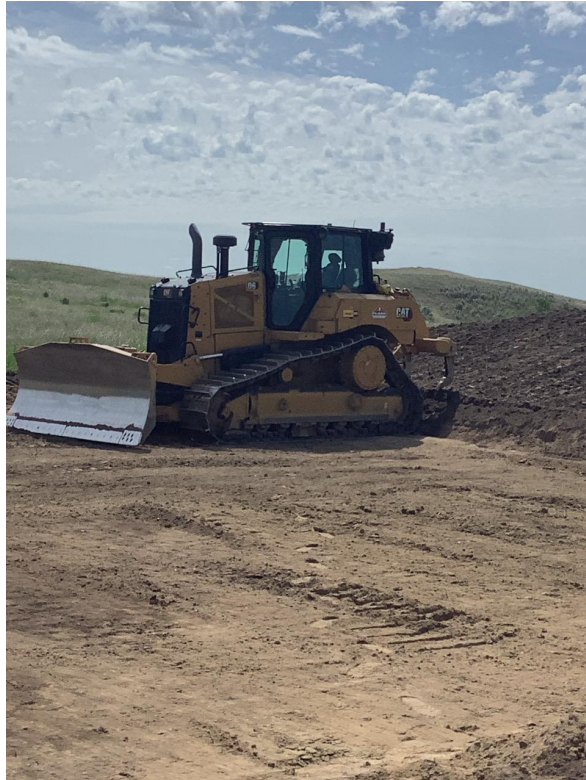
Location: Structure 175

Notes: CAT D6 dozer

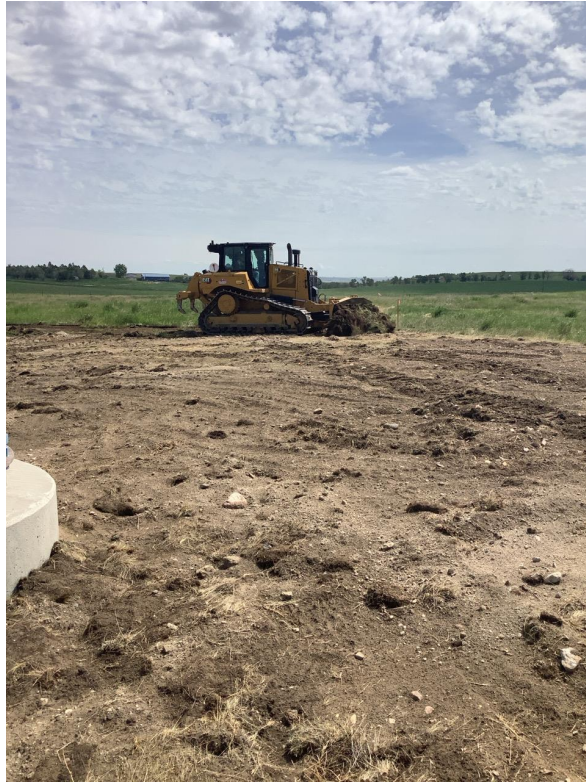
Location: Structure 176

Notes: Dozer stripping topsoil for next crane pad

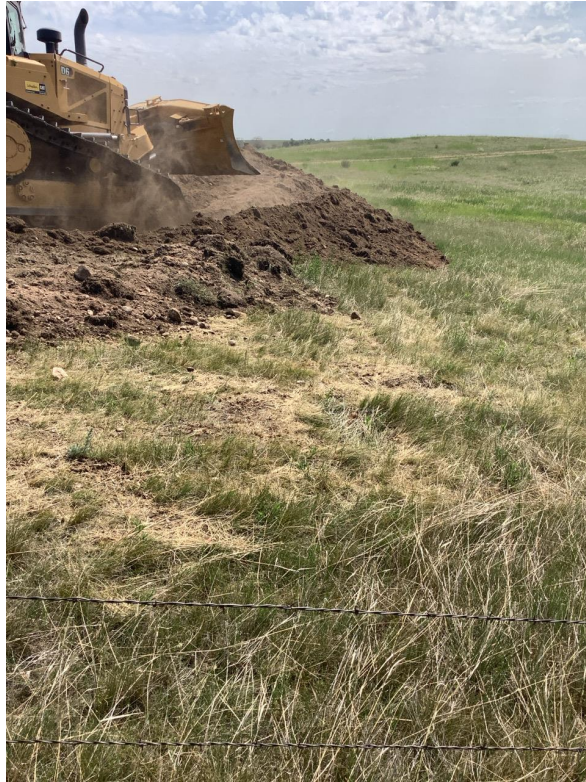
Location: Structure 176

Notes: Topsoil pile from crane pad

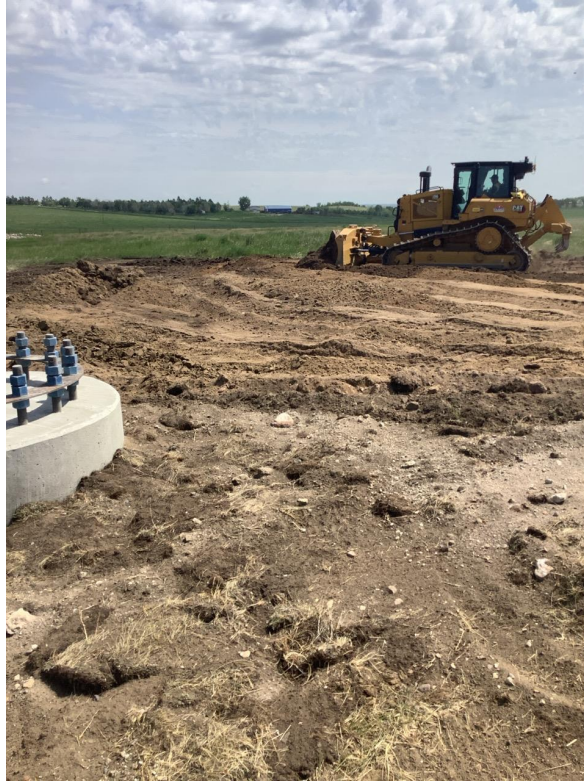
Location: Structure 176

Notes: Subsoil in this area is a light brown clayey sand. Excavator is pushing subsoil to spoil mat on north end of structure footprint, while the topsoil pile is at the south end. Both piles are on opposite ends of the slope meaning that contamination due to water erosion should not be an issue should it rain.

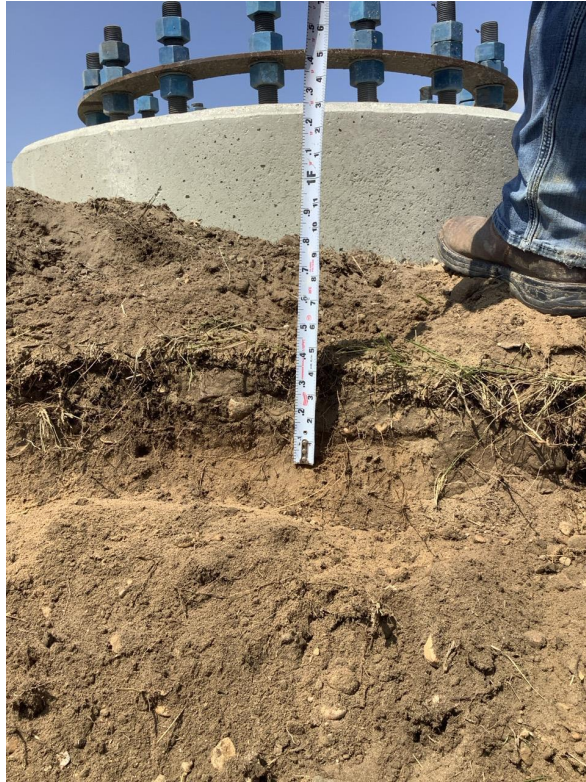
Location: Structure 176

Notes: Topsoil depth for structure approximately 4.5-5"
