Basin Electric Power Cooperative  
345kV Mercer-McLean-Ward-Mountrail-Williams Counties  
Case No. PU-24-361  
Construction Inspection Report I

RE: Case No. PU-24-361  
Basin Electric Power Cooperative  
345kV Mercer-McLean-Ward-Mountrail-  
Williams County  
Construction Inspection Report I

Project: Leland Olds to Tande Station 162 Mile 345kV Transmission Line

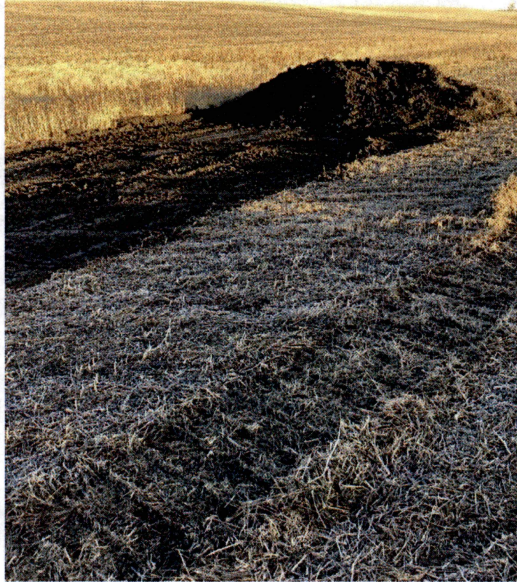
**Picture Number:** 1

**Notes:** Stripped topsoil

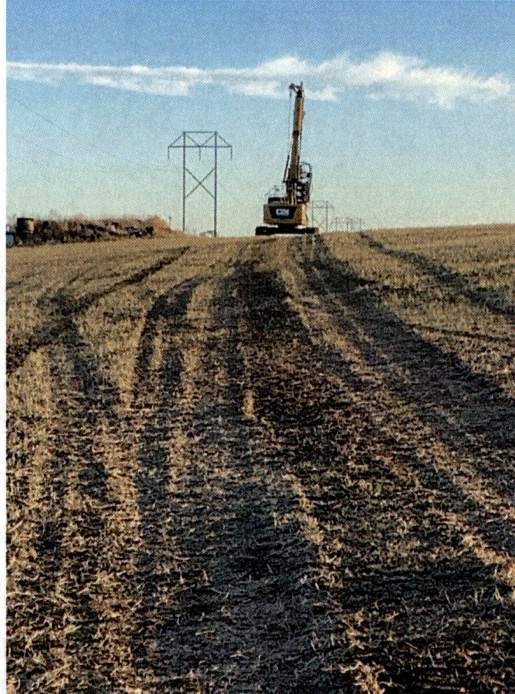
**Picture Number:** 2

**Notes:** CSZ Track excavator with Auger Attachment.

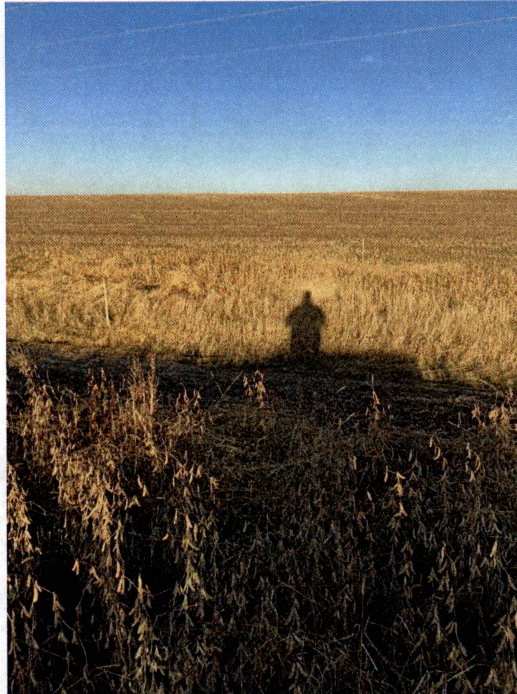
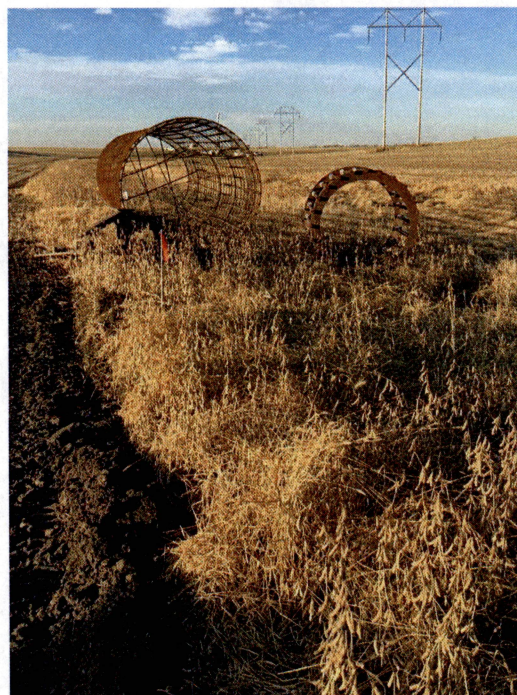
**Picture Number:** 3-4

**Notes:** Rebar cage, bolt assembly, and ROW conditions/condition of staking.

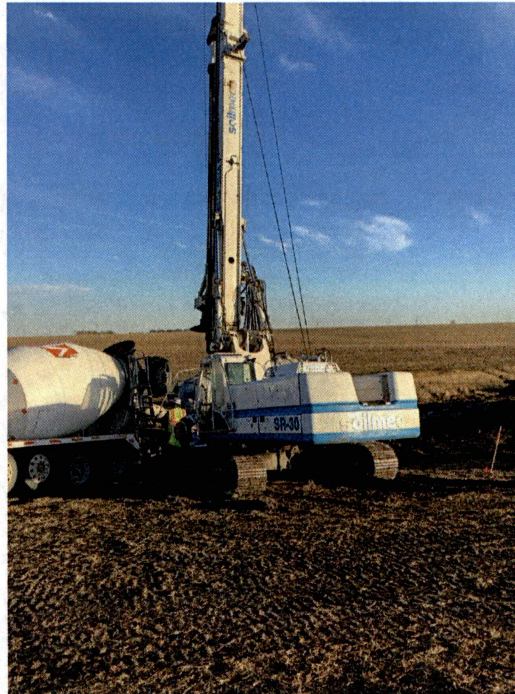
**Picture Number:** 5

**Notes:** SR-30 track excavator with auger attachment

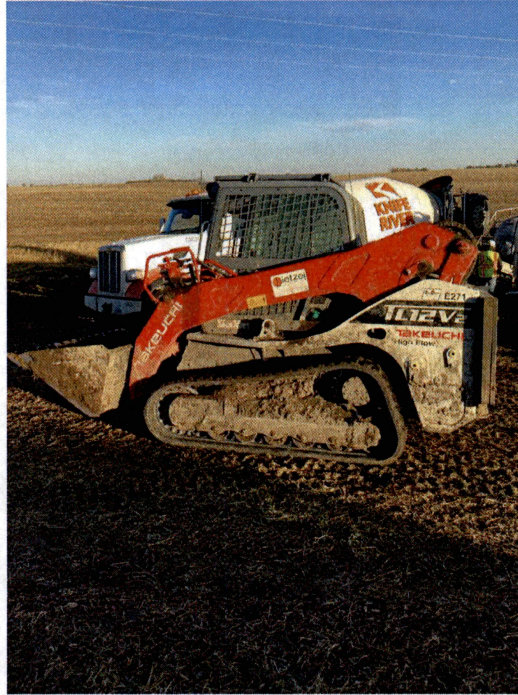
**Picture Number:** 6

**Notes:** Takeuchi skid steer. There are two of these at this site.

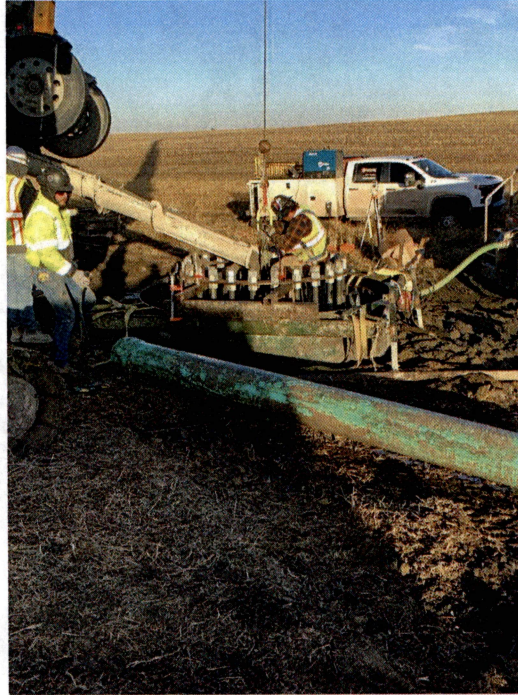
**Picture Number:** 7

**Notes:** Crew pouring foundation. Noted that employee overseeing the pour is wearing PFAS.

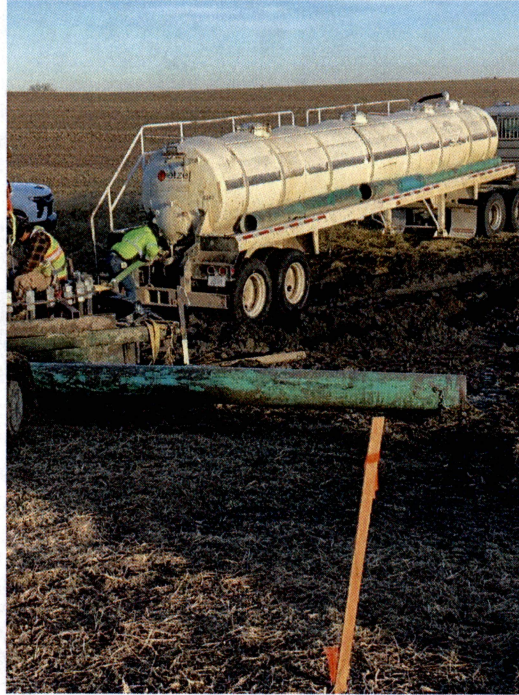
**Picture Number:** 8

**Time:** 3:35 PM  
**Description:** Water  
**Comments:** Discussed with Jaden about water on structure 098. He said they were expecting water at 18.5' depth, not 4' depth, so they got trucks there as fast as possible to pump out excess water.

**Notes:** Truck pumping out water from bored hole.

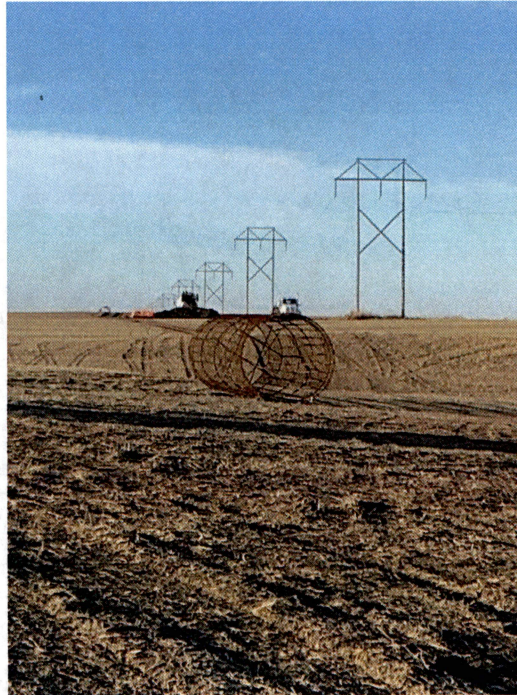
**Picture Number:** 9

**Notes:** Can see concrete truck washing out into pit. Will document pit when on site 097

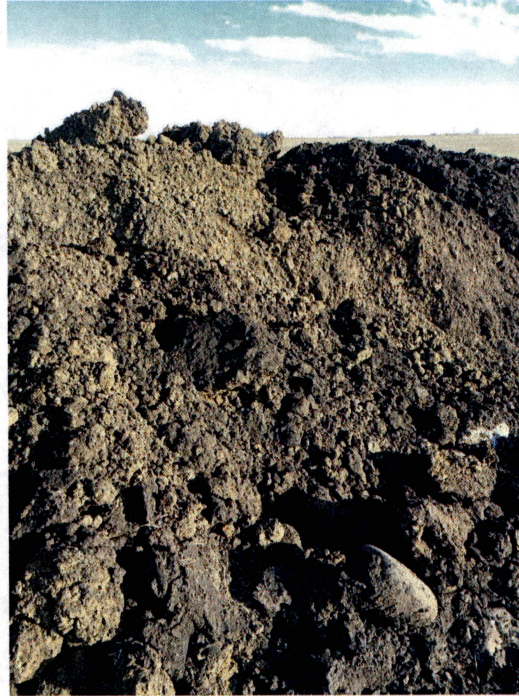
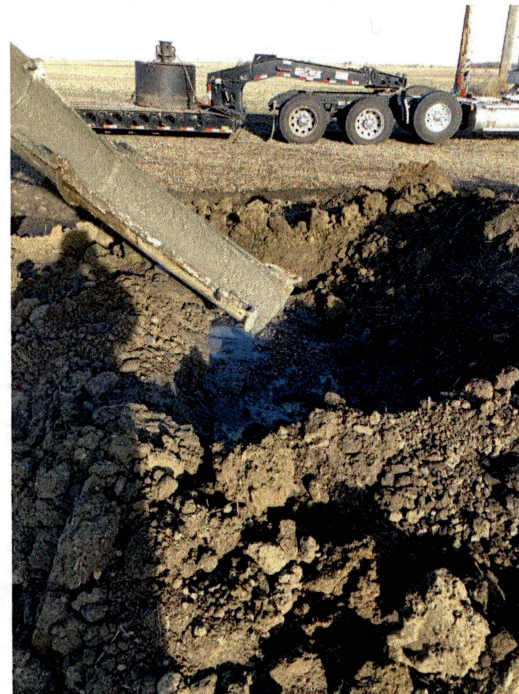
**Picture Number:** 11-12

**Notes:** Concrete wash out pit.

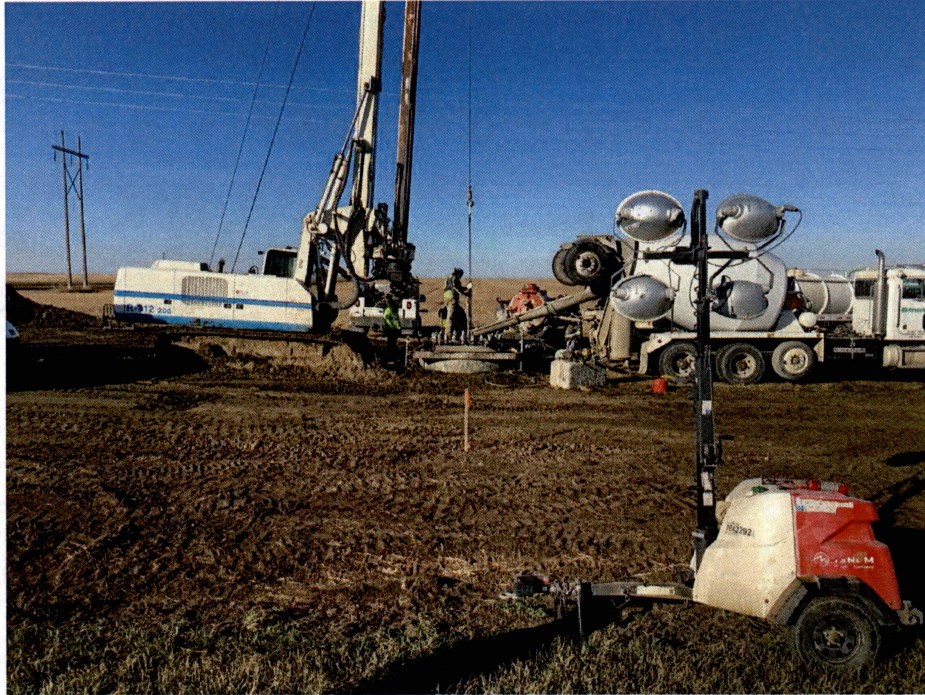
**Picture Number:** 13

**Notes:** Foundation pour in progress, R-312/200 track excavator with soil boring and crane capability.

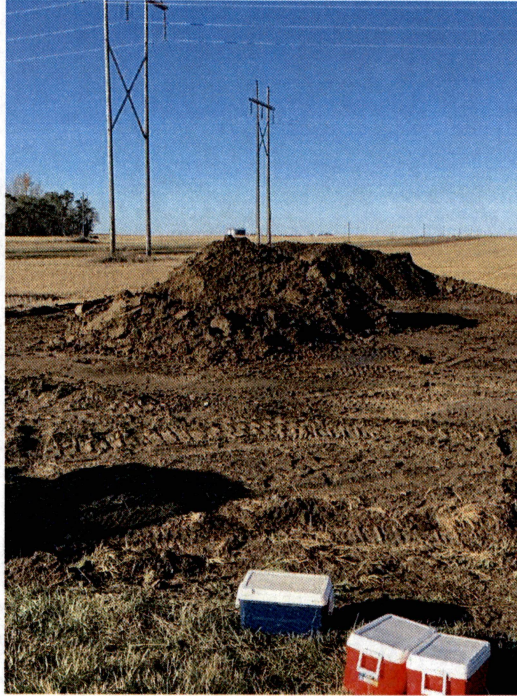
**Picture Number:** 14

**Notes:** Concrete washout area.

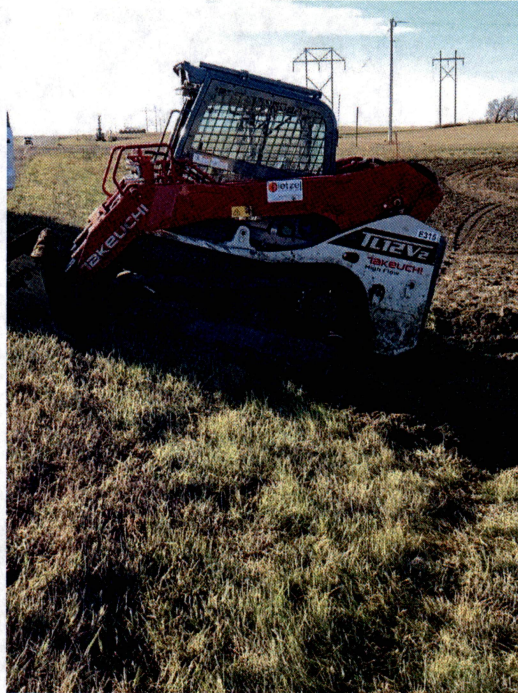
**Picture Number:** 15

**Notes:** Takeuchi skid steer

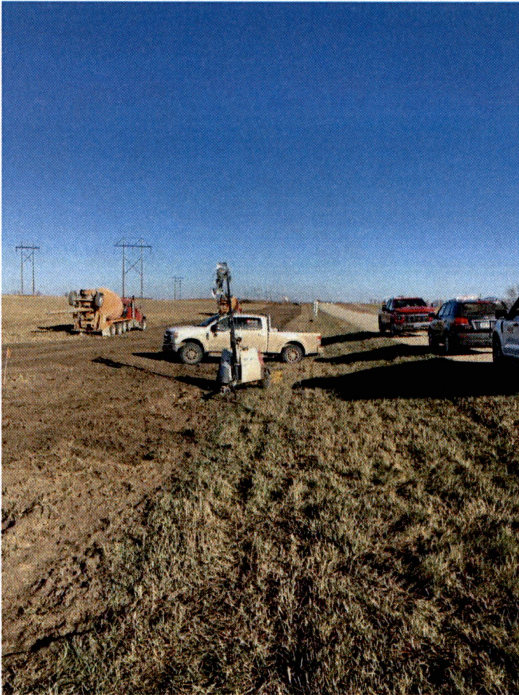
**Picture Number:** 16

**Notes:** ROW conditions.

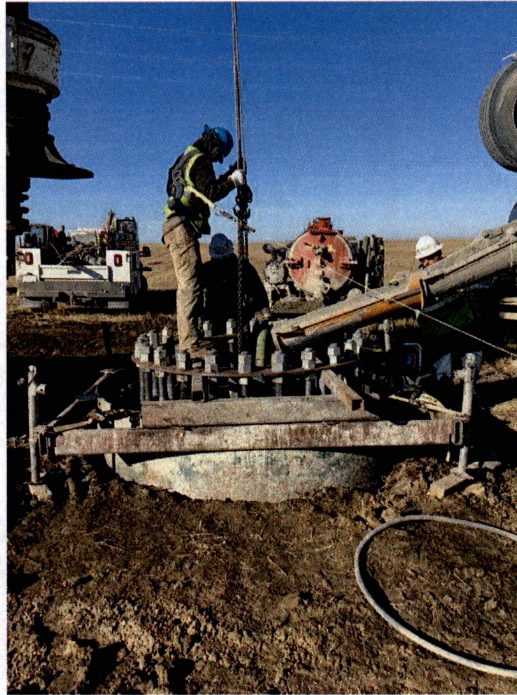
**Picture Number:** 17

**Notes:** Concrete truck 3 just pulled up to hole. Crew is wearing PFAS and secured to a block.

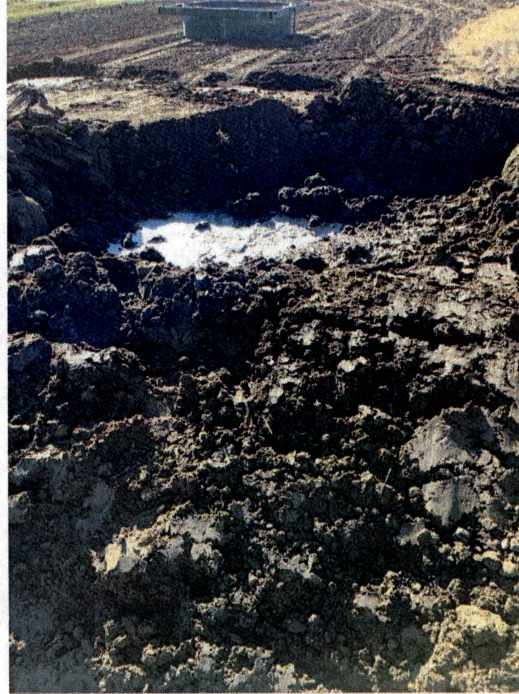
**Picture Number:** 18

**Notes:** Concrete washout

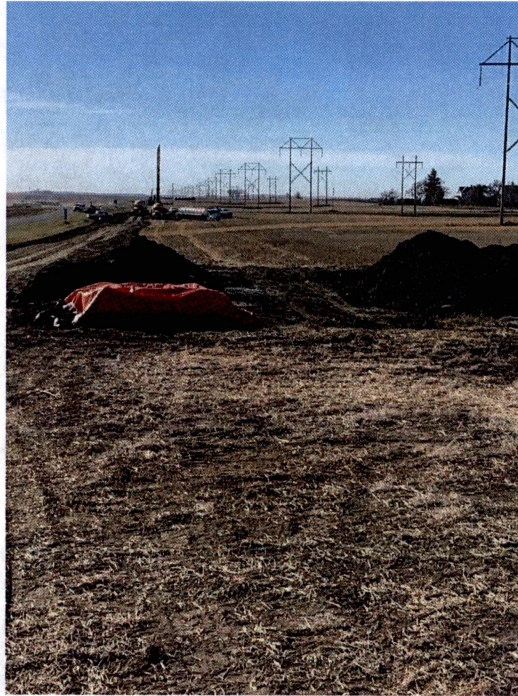
**Picture Number:** 19

**Notes:** Lots of space between topsoil and subsoil piles.

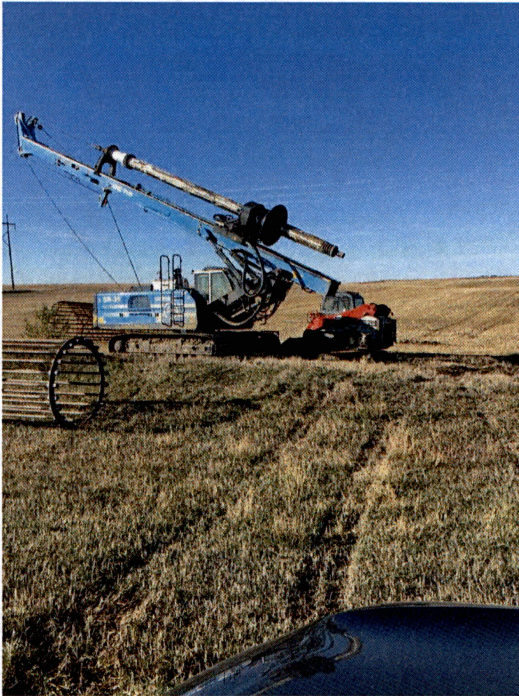
**Picture Number:** 20

**Notes:** SR-35 track excavator, Takeuchi skid steer.

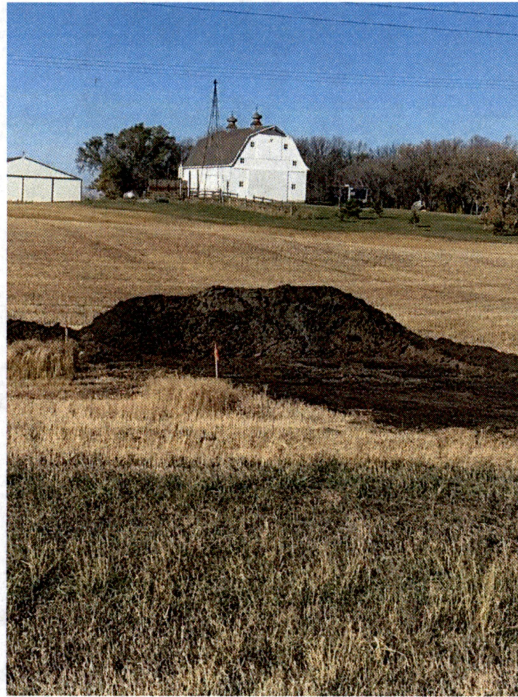
**Picture Number:** 21

**Notes:** Topsoil stripped for foundation hole.

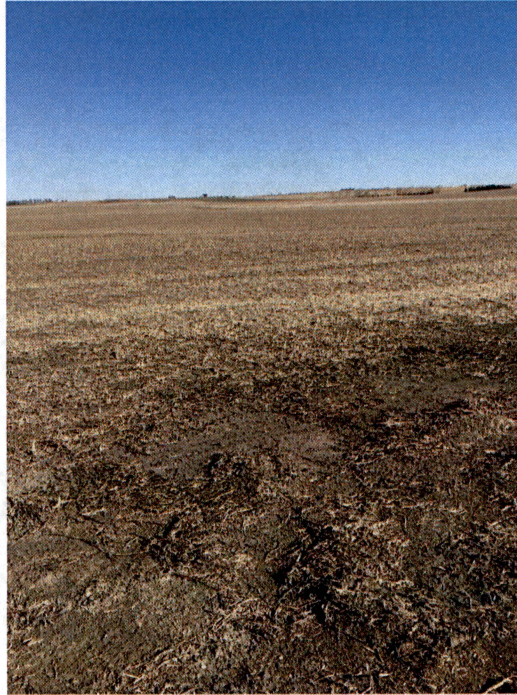
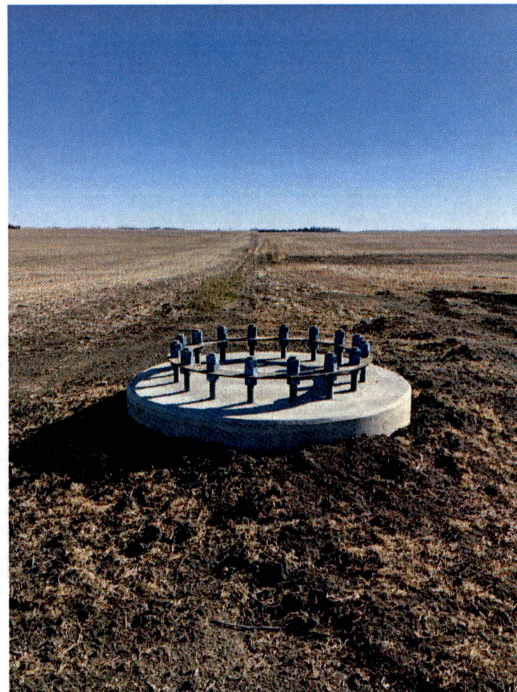
**Picture Number:** 22-23

**Notes:** Finished foundation and north site conditions

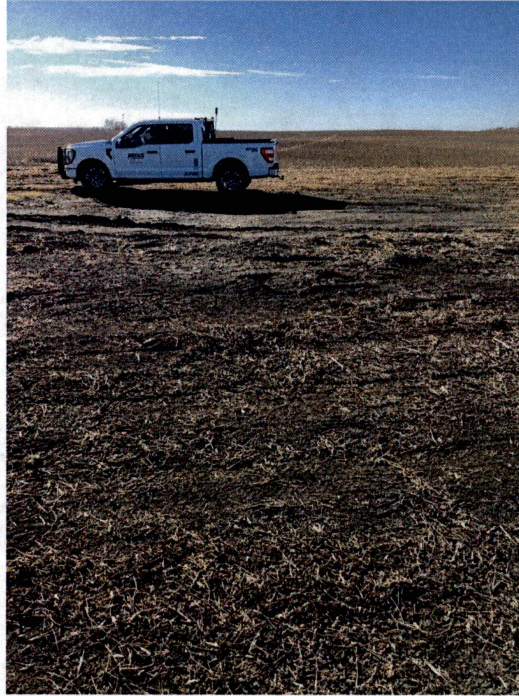
**Picture Number:** 24

**Notes:** Access road conditions

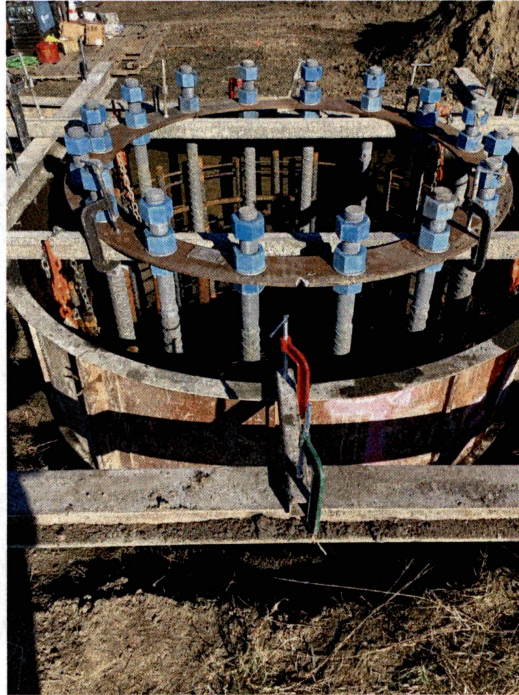
**Picture Number:** 25

**Notes:** Forms, rebar cage, and bolt assembly in place for concrete

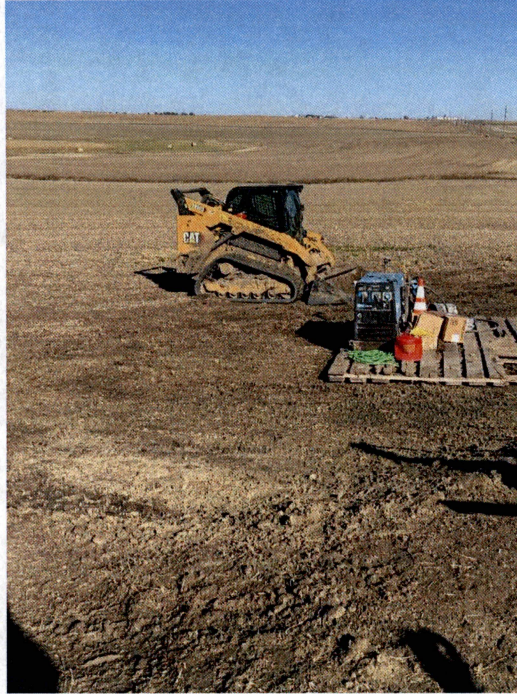
**Picture Number:** 26

**Notes:** CAT 289D3 skidsteer

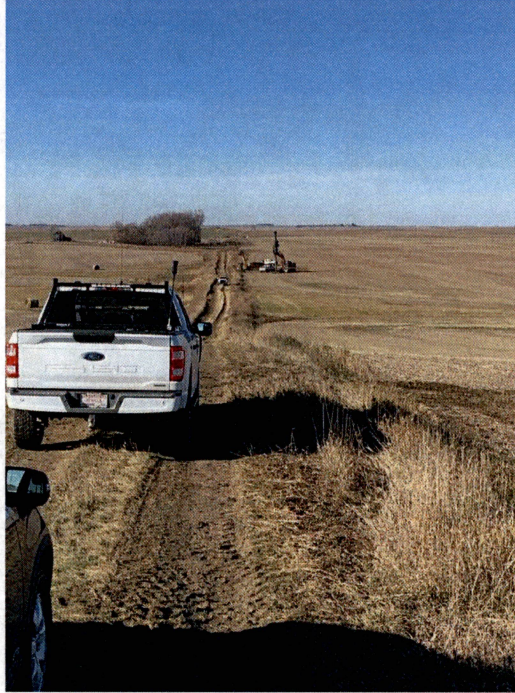
**Picture Number:** 27

**Notes:** Access road current conditions

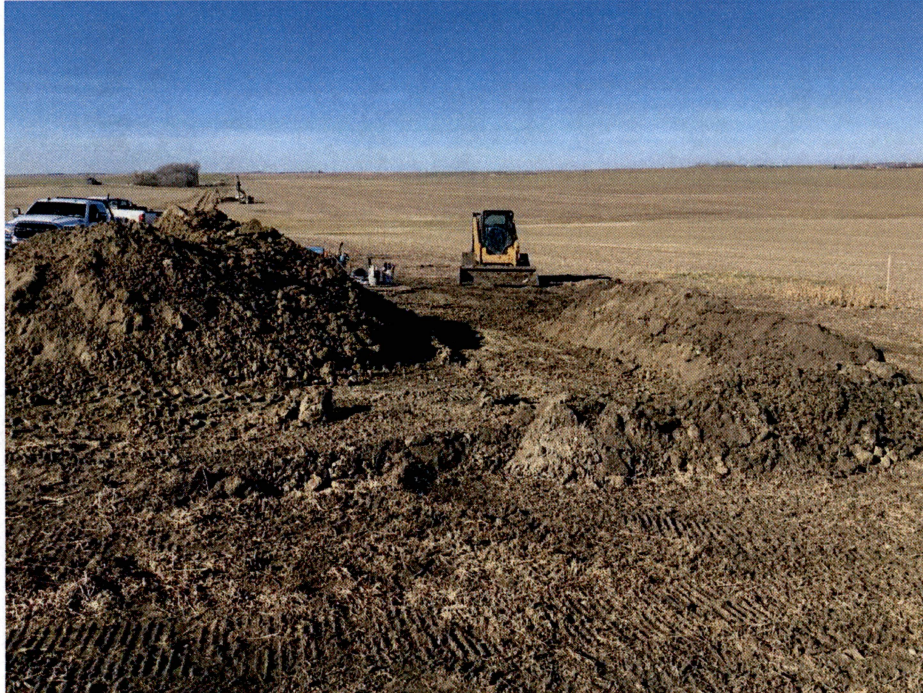
**Picture Number:** 28

**Notes:** Topsoil pile on right, subsoil on left, skidsteer width space between.

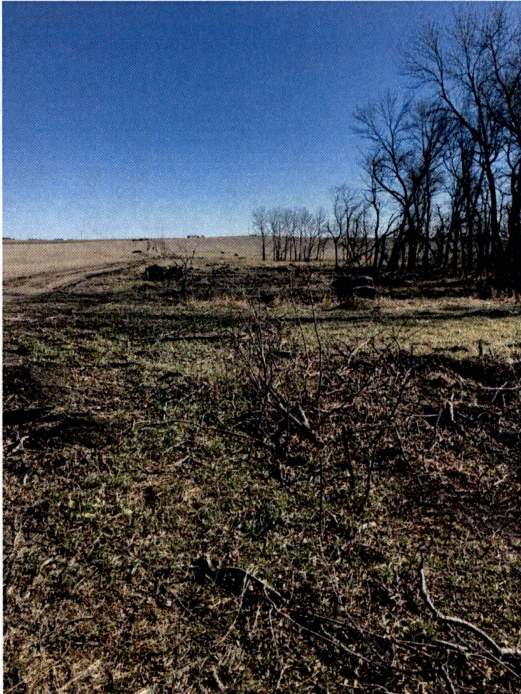
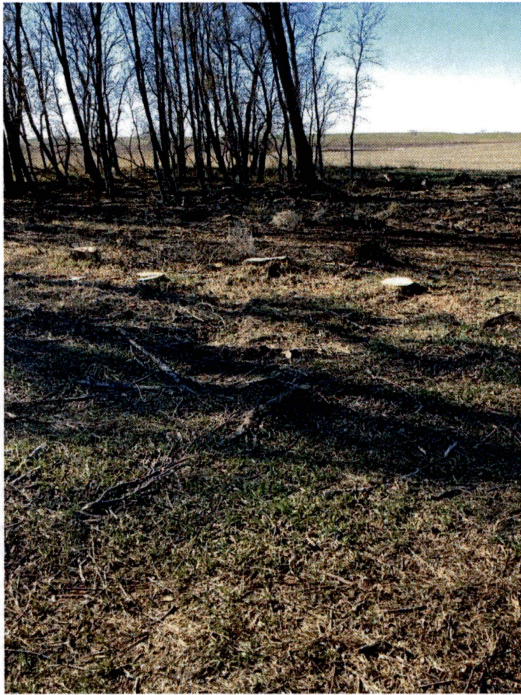
**Picture Number:** 29-30

**Notes:** Trees on south edge of ROW cut to make room for equipment.

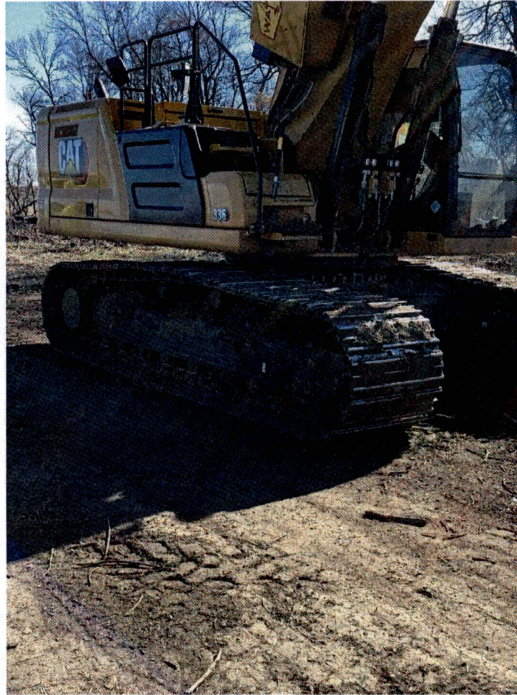
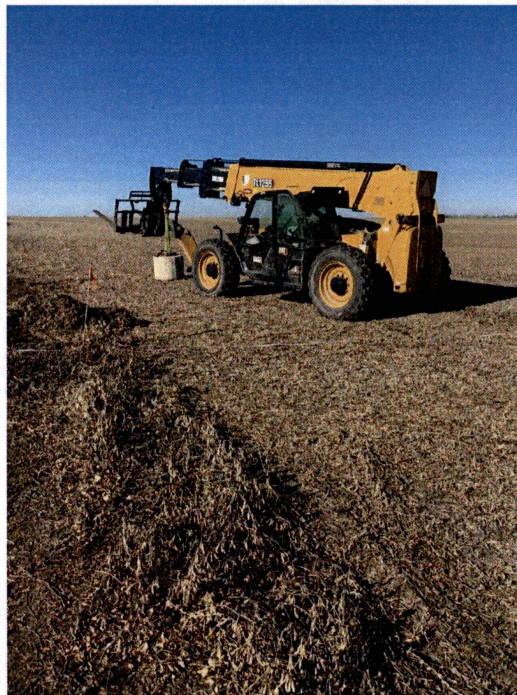
**Picture Number:** 31-32

**Notes:** CAT 336 track excavator, CAT TL1255, fork crane

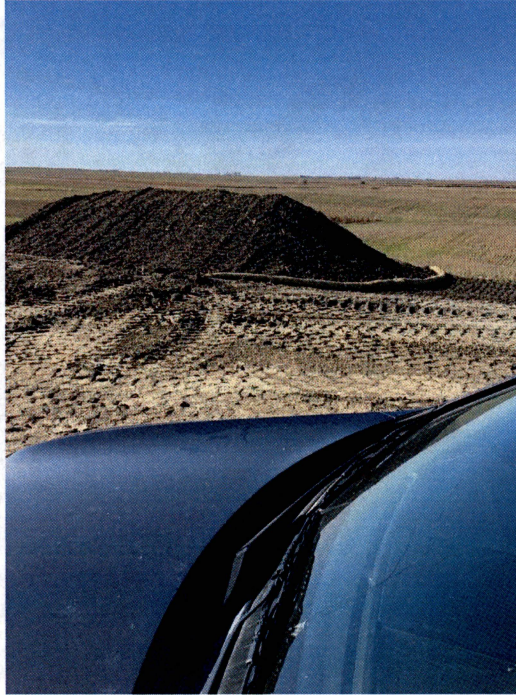
**Picture Number:** 33

**Notes:** Topsoil pile, fiber roll installed

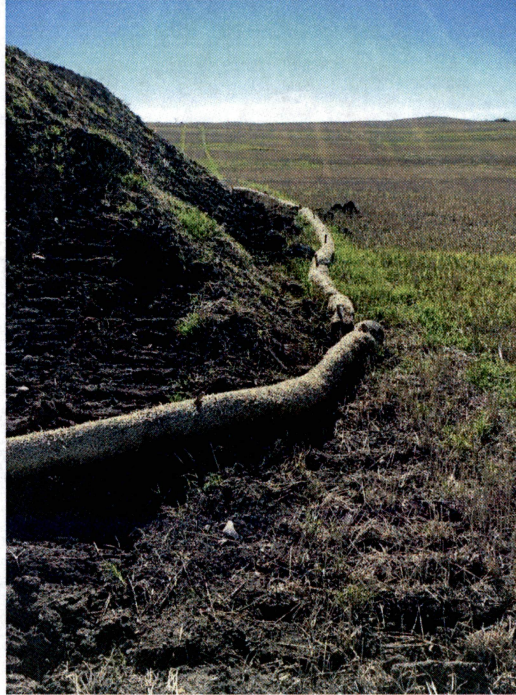
**Picture Number:** 34

**Notes:** Topsoil stockpile has fiber roll all way around.

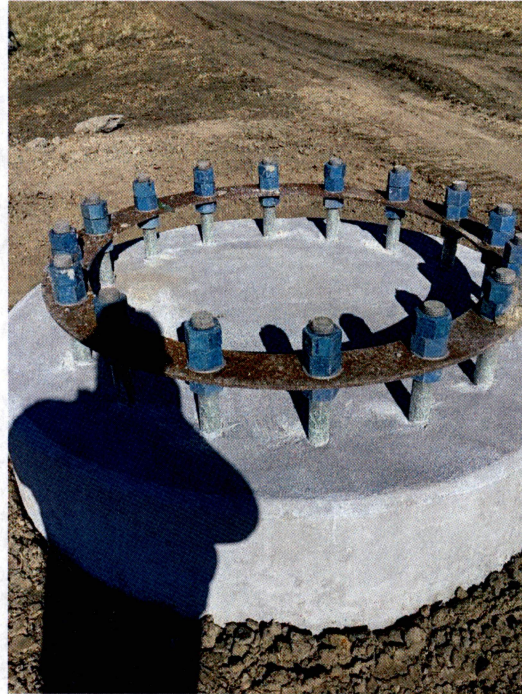
**Picture Number:** 35

**Notes:** Finished foundation.

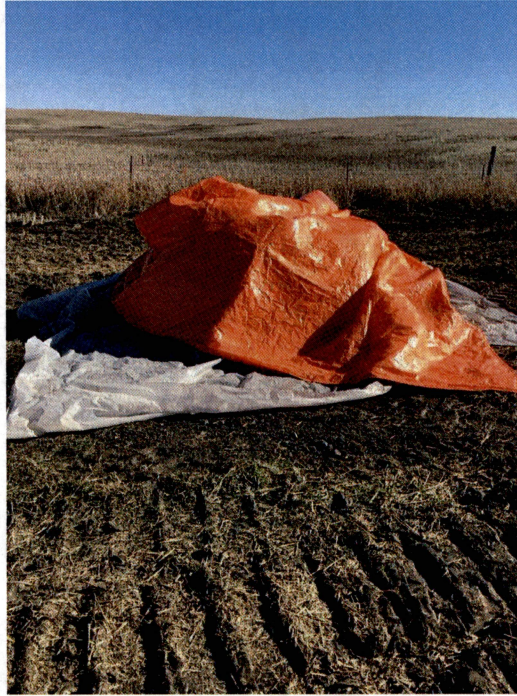
**Picture Number:** 36

**Notes:** Concrete blankets to insulate concrete during curing.

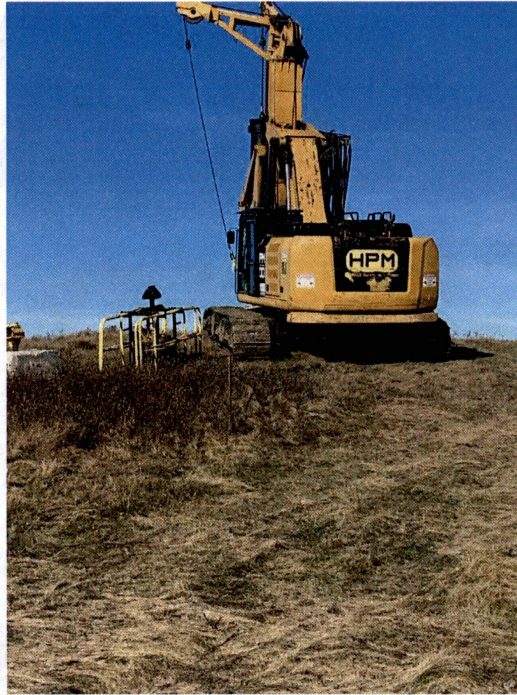
**Picture Number:** 37

**Notes:** HPM PM00 track excavator with bore attachments.

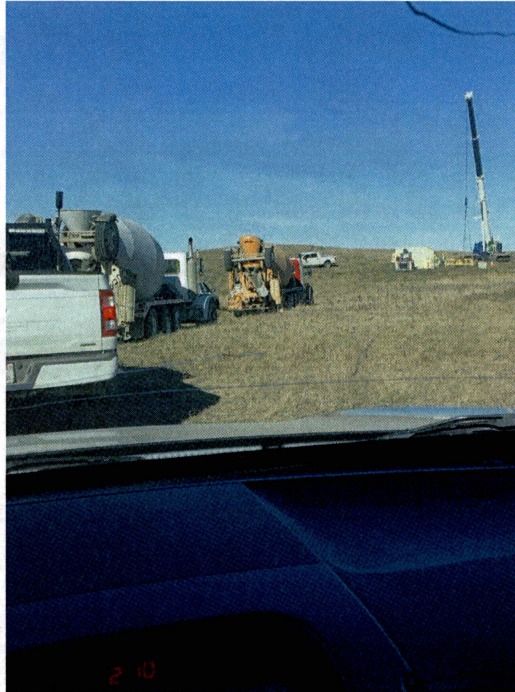
**Picture Number:** 38

**Notes:** Waiting for concrete trucks to move. Crew has rebar cage in place ready for concrete pour.

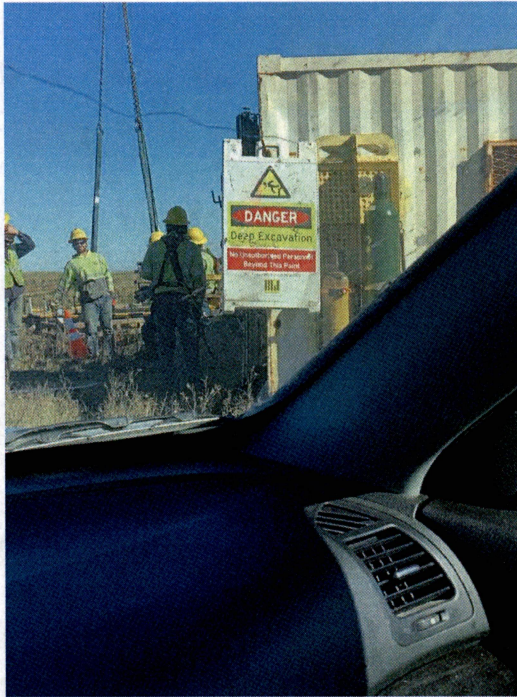
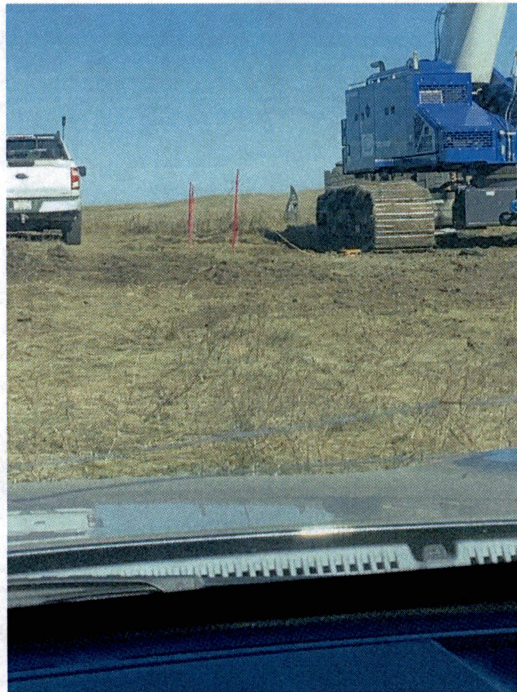
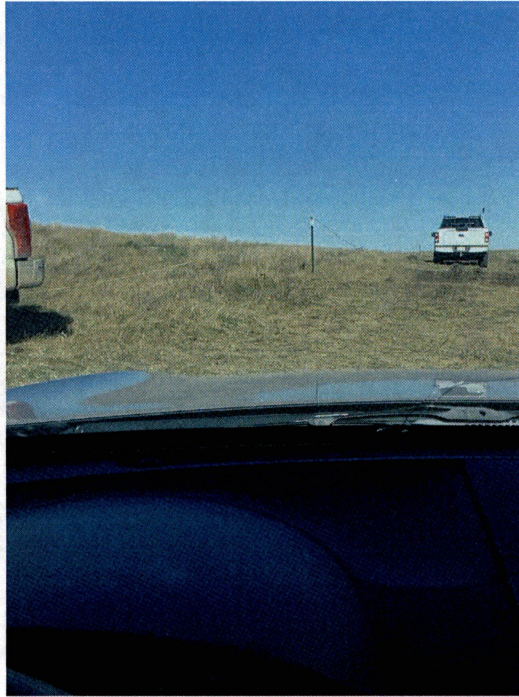
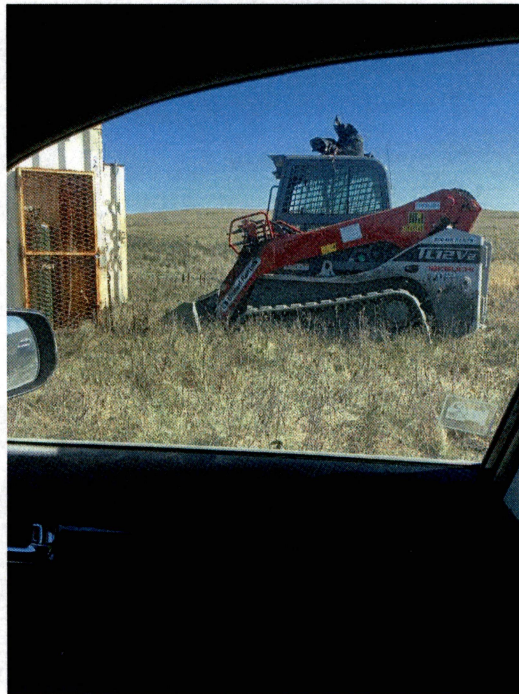
**Picture Number:** 39-42

**Notes:** Takeuchi skid steer, site safety warning sign, crane swing radius cordoned off, and avoidance area cordoned off, no evidence of disturbance.

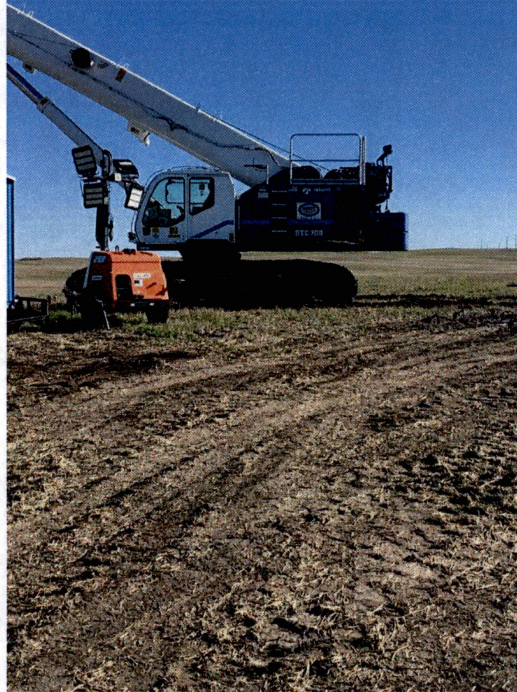
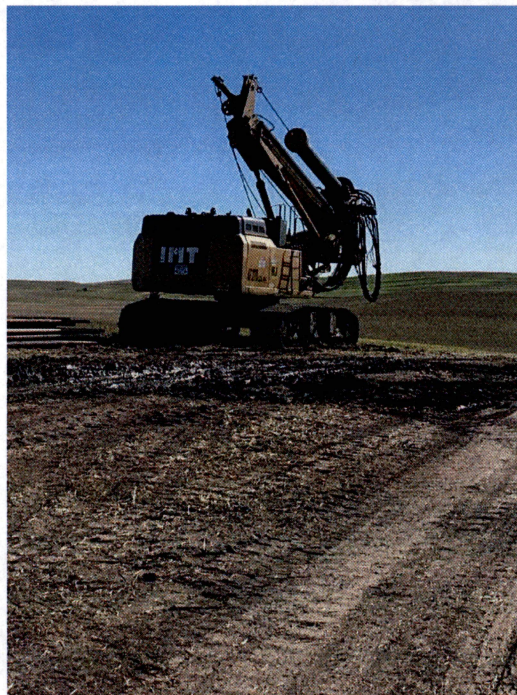
**Picture Number:** 43-44

**Notes:** Track crane and track dozer

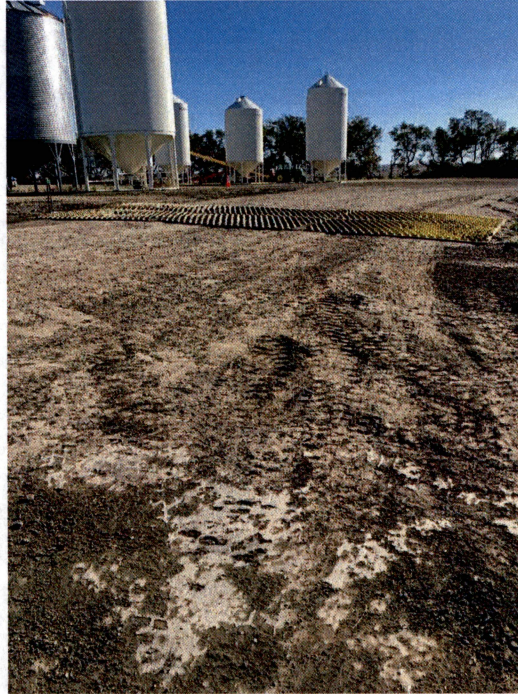
**Picture Number:** 45

**Notes:** SWPPP. Track out mat in place to reduce dust and dirt getting on road.

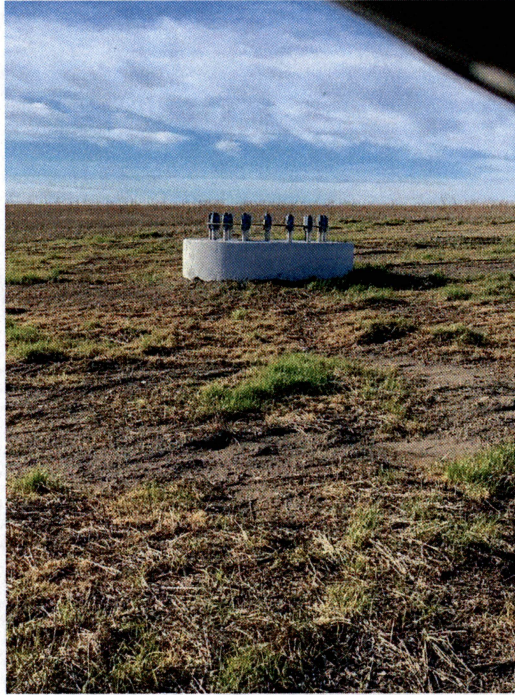
**Picture Number:** 46

**Notes:** Finished and seeded foundation. Structure to be erected next spring.

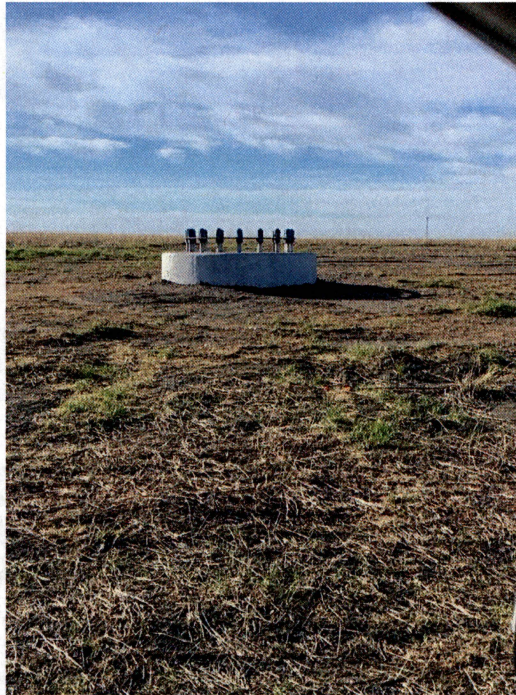
**Picture Number:** 47

**Notes:** Finished foundation

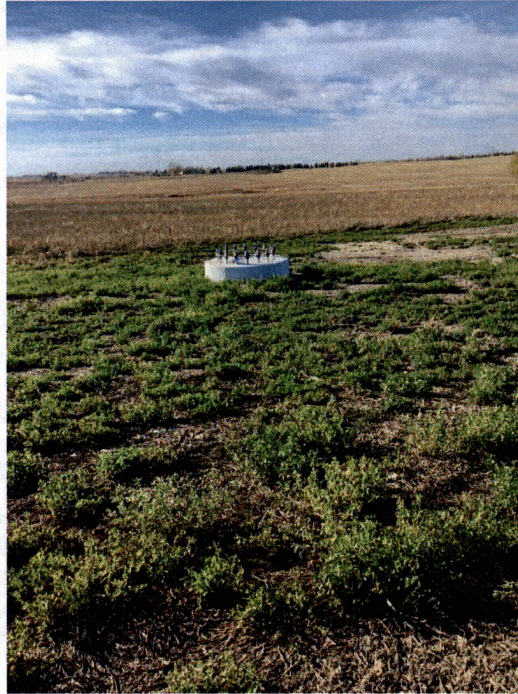
**Picture Number:** 48

**Notes:** Finished foundation

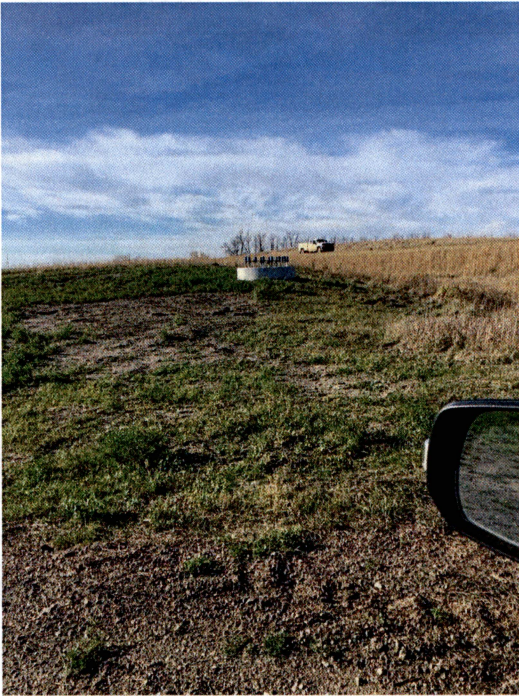
**Picture Number:** 49

**Notes:** Finished foundation
