GENERAL OBSERVATION REPORT

2025 Lehigh Road Phase X &
Scranton Phase IV Material Testing
Bid #408.25.03.002
Stark & Bowman Counties, ND
Project Number: M4251009

43 AM-24-369 Filed 06/18/2025 Pages: 17
Pre-Construction Structural Survey
Terracon Consultants, Inc.

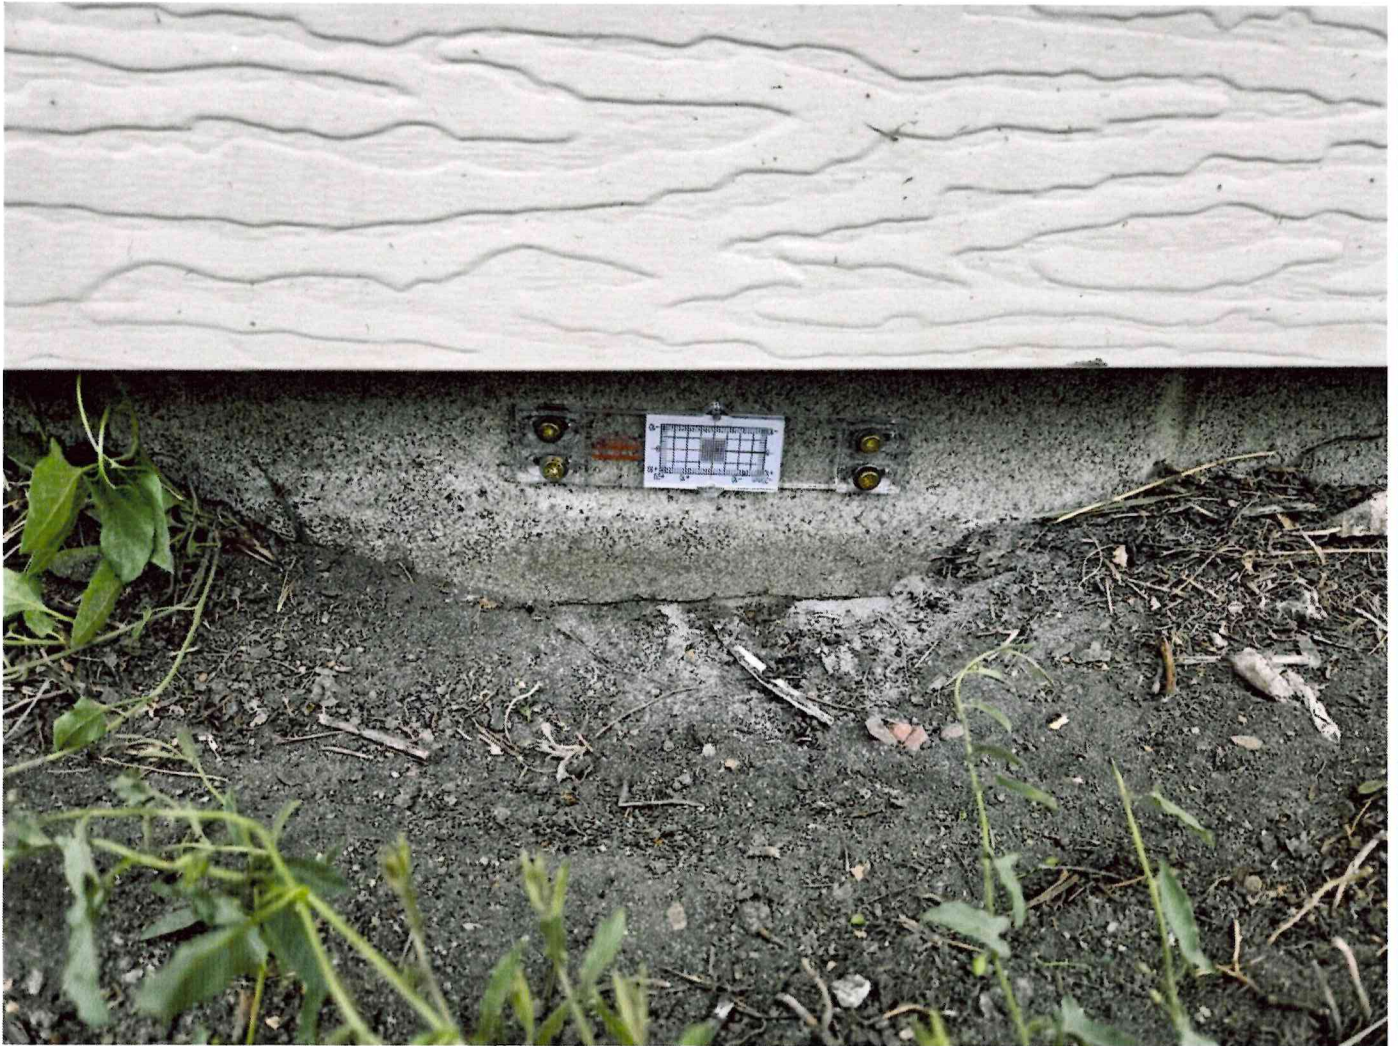
(P14) South side of garage crack monitor

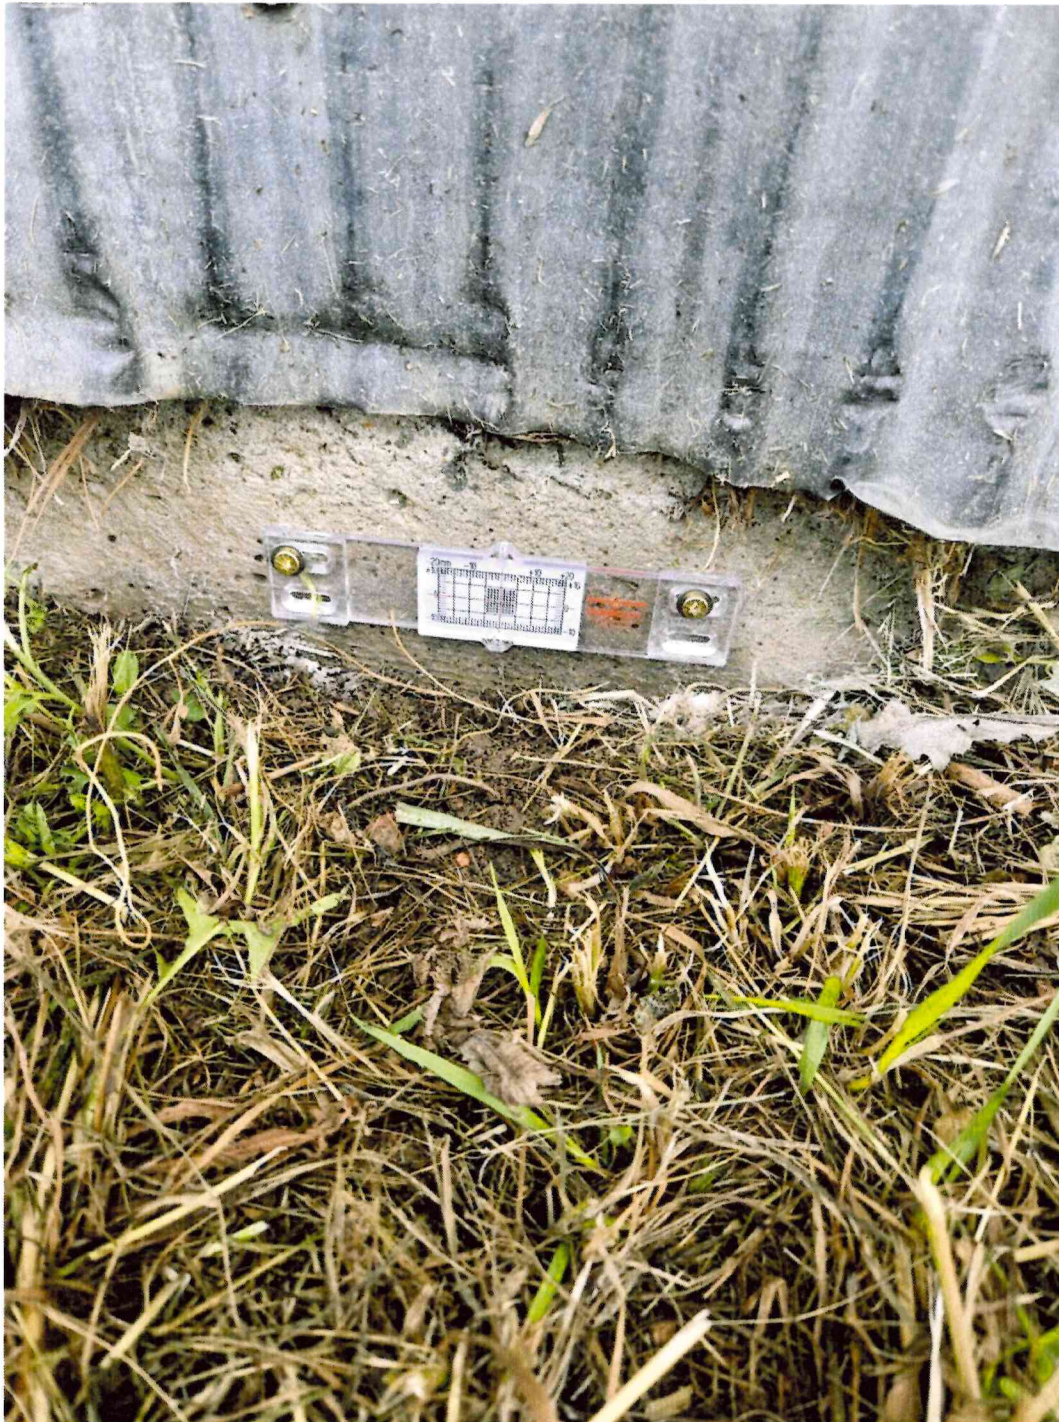
(P15) East side of shed crack monitor
